# Roosevelt Lodge Historic District

## Cultural Landscape Inventory

SHAPINS ASSOCIATES  
April 2007  
Final (100%) Submittal

YELLOWSTONE NATIONAL PARK  
WYOMING

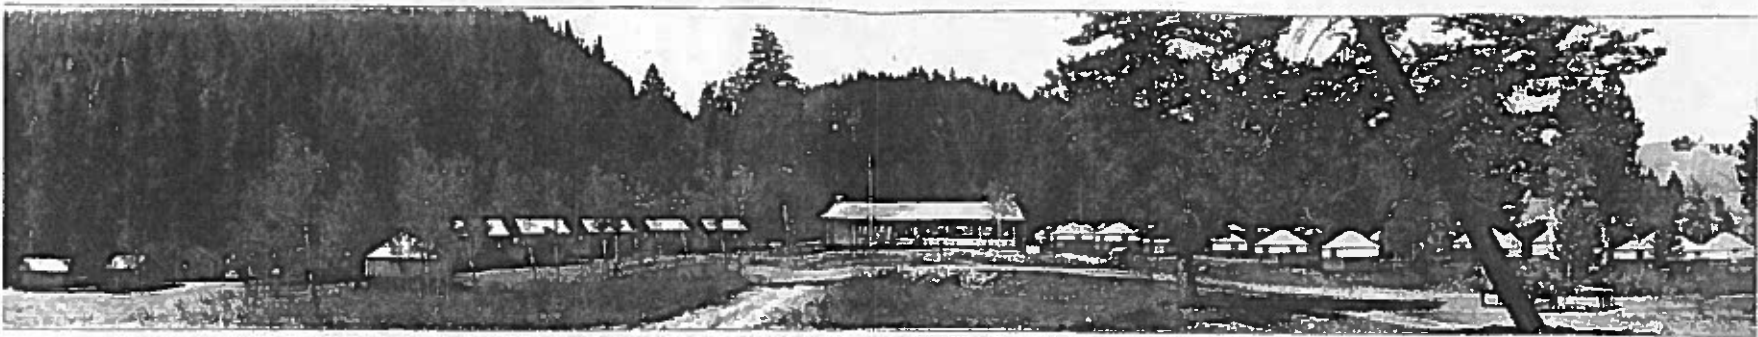
Panorama of Camp Roosevelt from Yellowstone Park Camps Company promotional pamphlet for 1923 season. Log cabins at base of slope are established, while other cabin areas are occupied by tents and other type cabins. Aspen grove and mature Douglas-firs are evident: c. 1922.

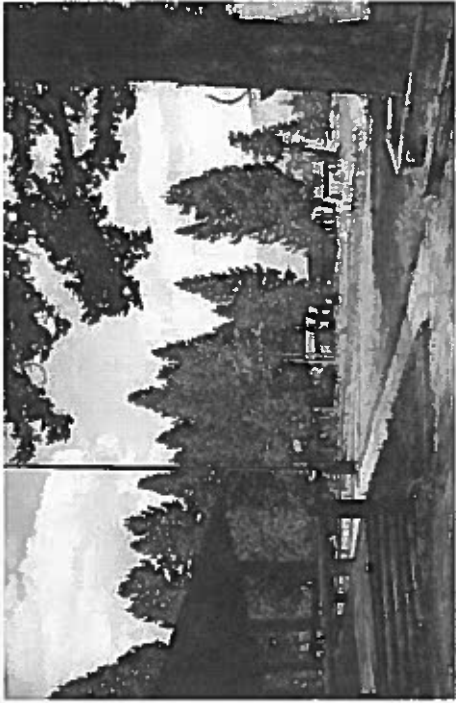
\*Photo 220: View to the cabins north of the lodge. Extension to porch on lodge is prominent in this view: c. 1924-1929.

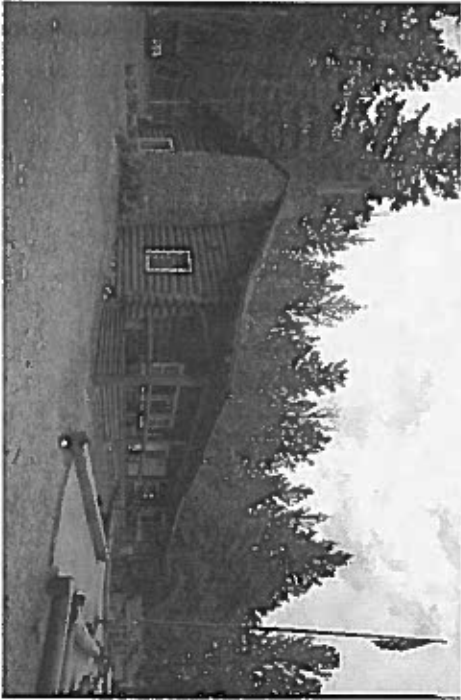
\*HABS, WYO, 15-TOWJU, 1A-1: By this point, the Douglas-fir has been removed and the parking lot/walkway defined by large peeled logs: HABS Survey c. 1977-1982?

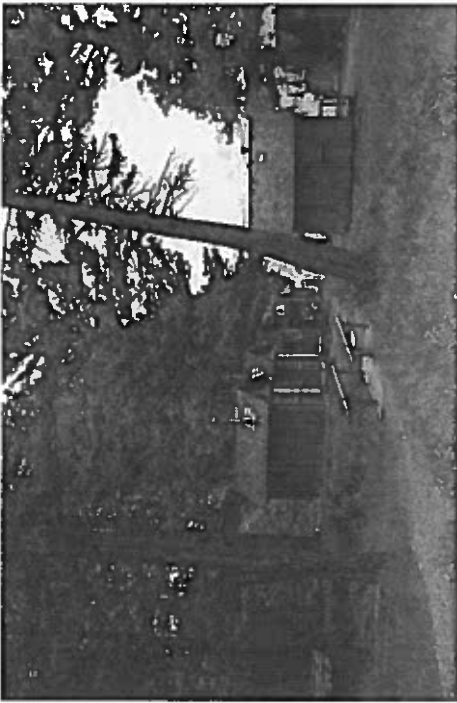
\*HABS, WYO, 15-TOWJU, 1-2: View across footbridge to Cabin Group C: HABS Survey c. 1977-82?

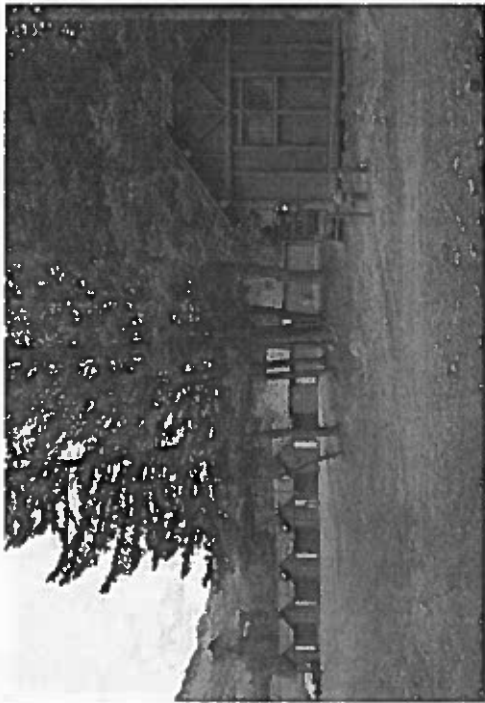
\*HABS, WYO, 15-TOWJU, 1-1: Informal gravel parking; gravel drive has been established east of the lodge between cabins and lodge: HABS Survey c. 1977-82?

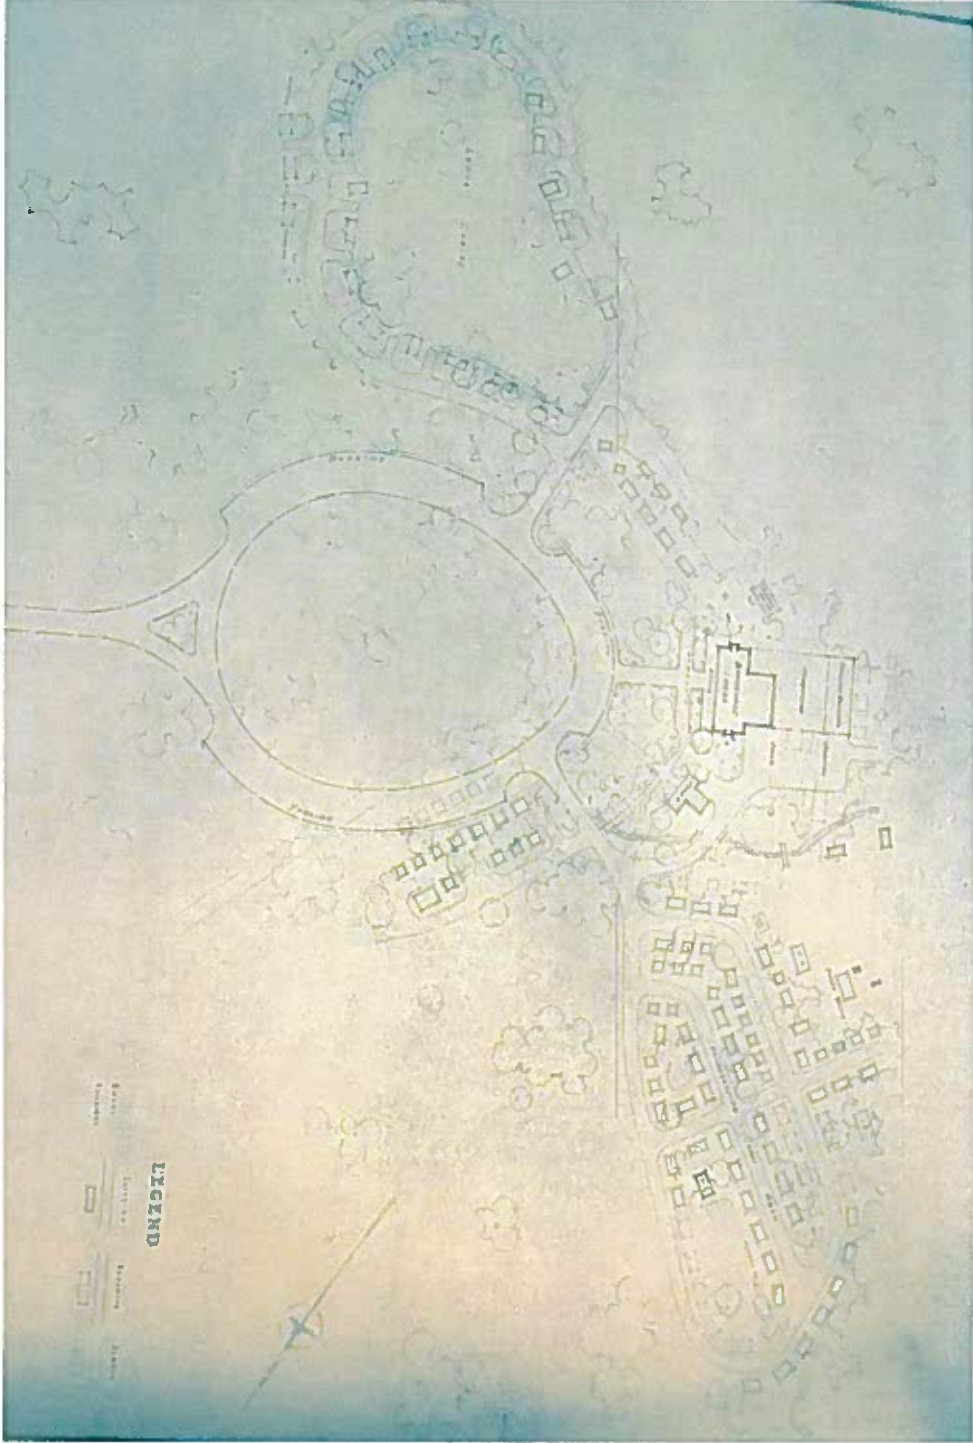
General Development Plan for Roosevelt Lodge, Part of the Master Plan for Yellowstone National Park, 1939. Existing features are represented as solid line, except for those proposed for removal, which are dotted; proposed features are dashed. Dramatic reconfiguration of the circulation system is proposed to preserve views to and from the lodge; existing access drives are slated for removal, as are several cabins or tent-cabins in the way of the proposed oval loop. No mention of the antler fence.

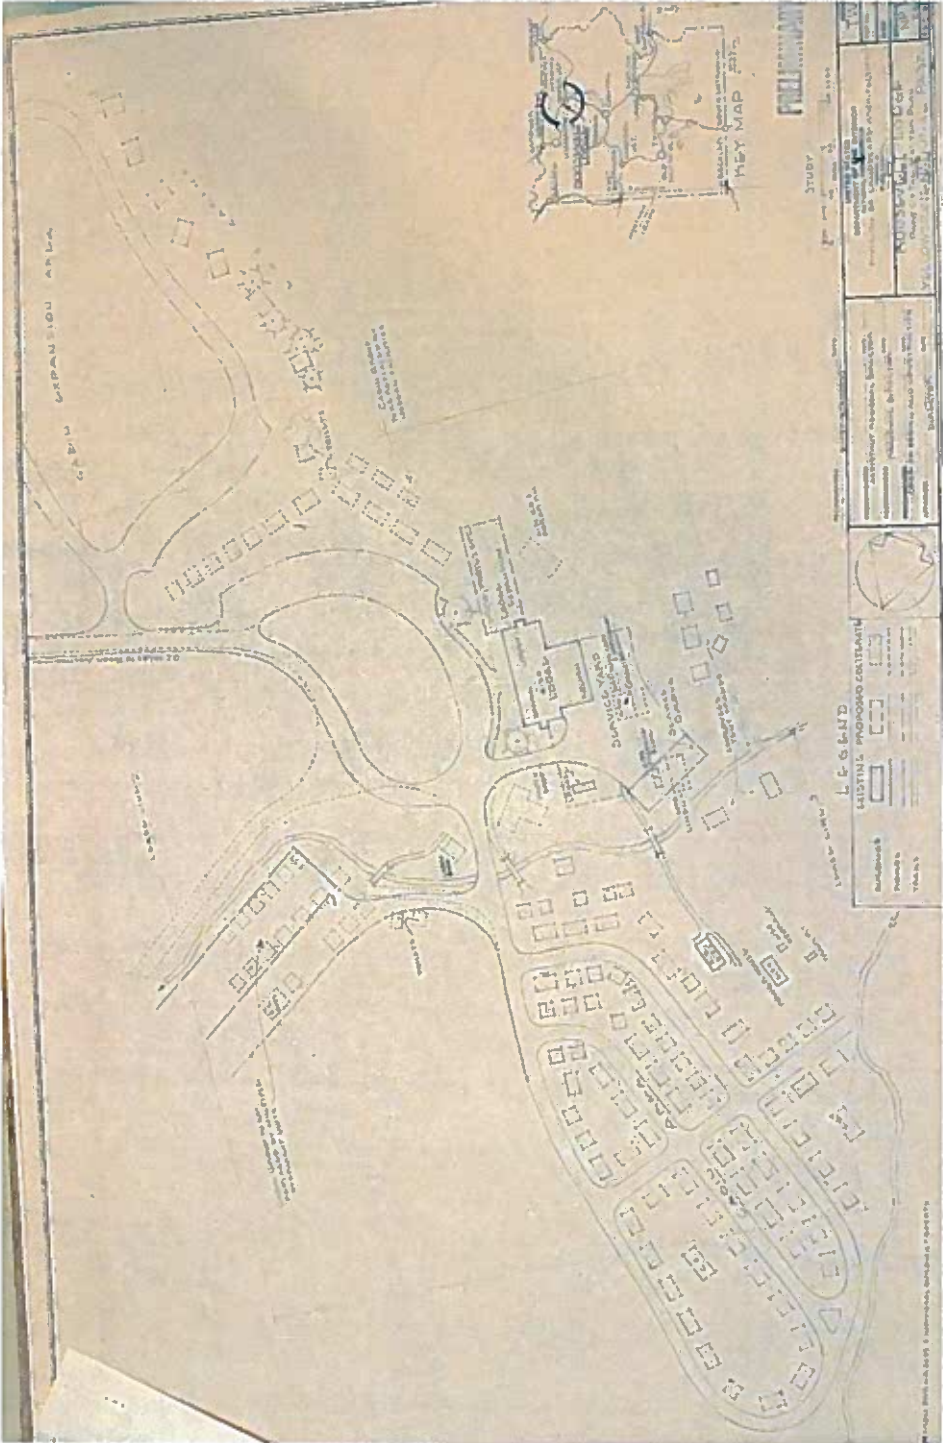
NP-YEL 2294, Preliminary Study for Roosevelt Lodge, Part of the Master Plan for Yellowstone National Park, Feb. 1952. By this point, the layout of the roads in the housekeeping cabins roughly follows the current configuration, except for the change necessitated by Lost Creek's migration. All current clusters of cabins are well established (some cabins are depicted as "proposed"). Reconfiguration of main access drives is still being considered. Existing parking lot may already be in place. As with 1929 map, this drawing depicts three footbridges spanning the channel.

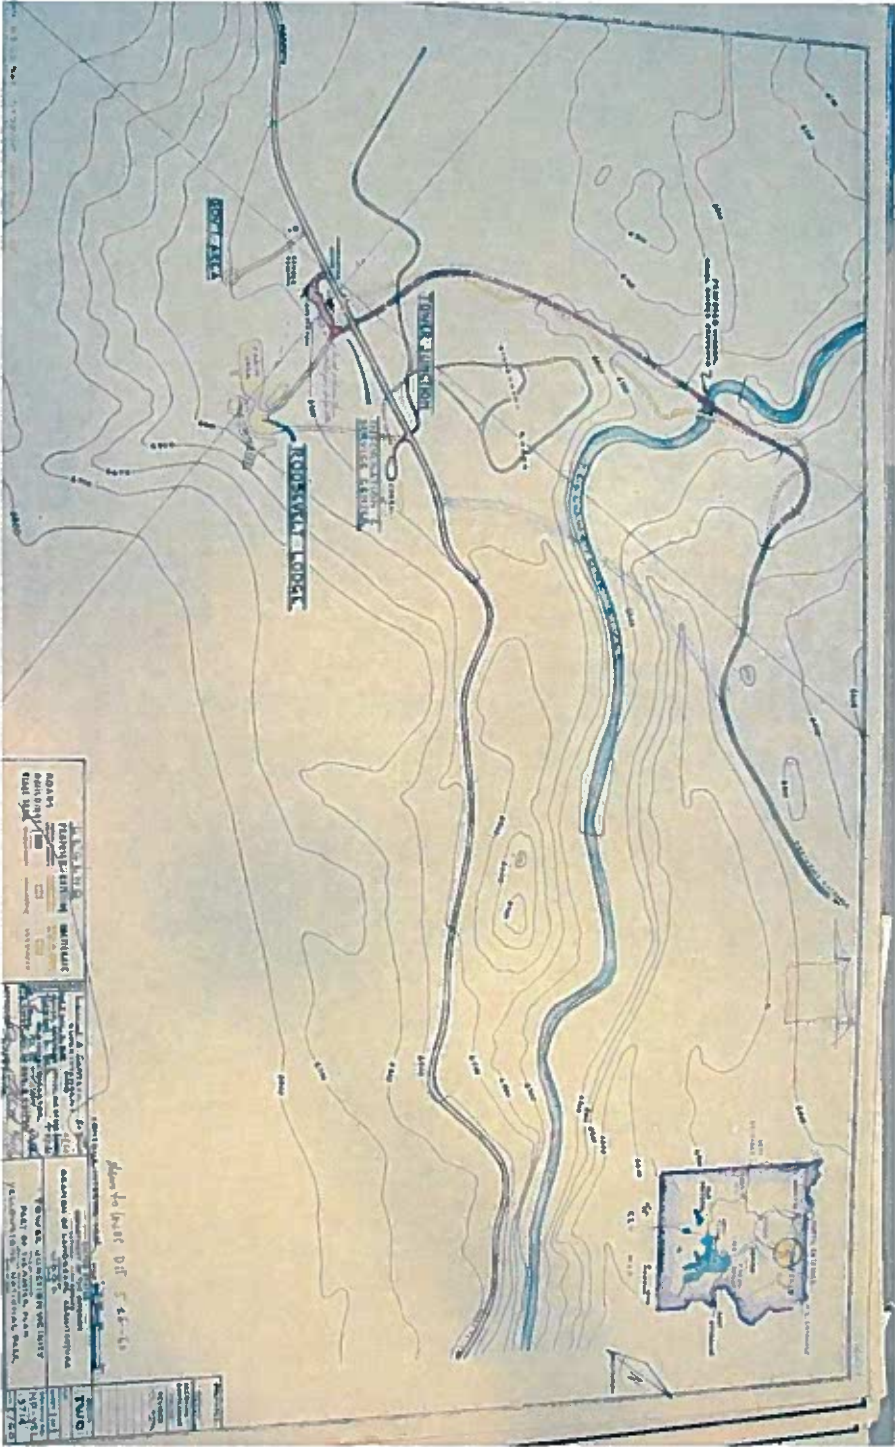
NP-YEL 3714, 1960. Tower Junction Vicinity, Part of the Master Plan for Yellowstone National Park. Map shows planned realignment of northeast entrance road, part of historic stagecoach road, and end of western access drive from Roosevelt Lodge, resulting in reconfigured junction. Also of note are other stagecoach roads drawn as "existing."

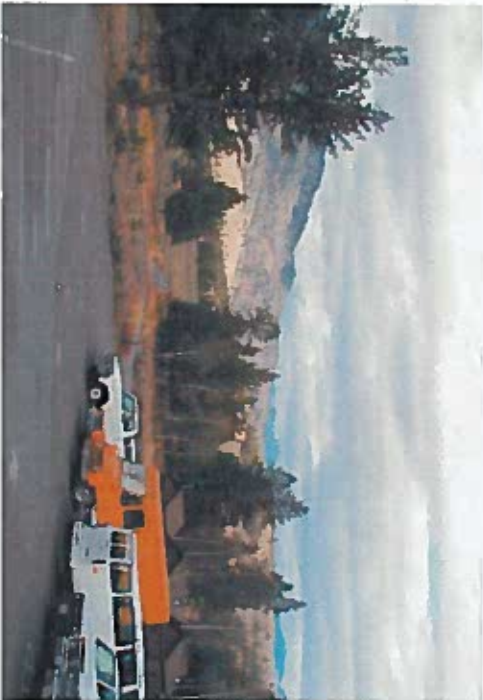
Views from the lodge porch have been compromised by the aphalt parking area (Shapins 2004).

runs the length of the building façade, only separated from the asphalt lot by one of the log curbs. Other walkways that lead to important buildings are also asphalt and lined with (smaller) peeled logs. Near the lodge building itself, the walk system does not reflect historic conditions. Gravel roads service the cabin areas. Just northwest of the main lodge, a curved informal gravel lot serves many employee cabins. This gravel lot is separated from the main lot by only a thin grassy strip. Combined with the asphalt parking lot and the wide asphalt path, the inescapable impression of the area in front of the lodge is of a broad expanse of paved surface.

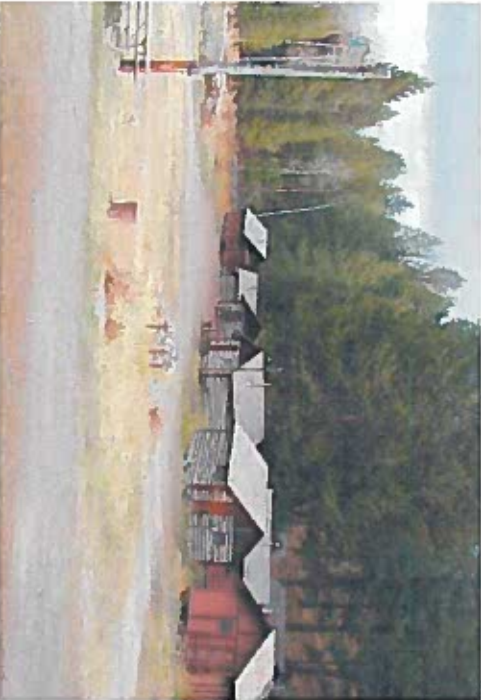
This cluster of log cabins were some of the first buildings built at Roosevelt Lodge. Over time, many frame cabins were brought to the area from other sections of the park (Shapins 2004).

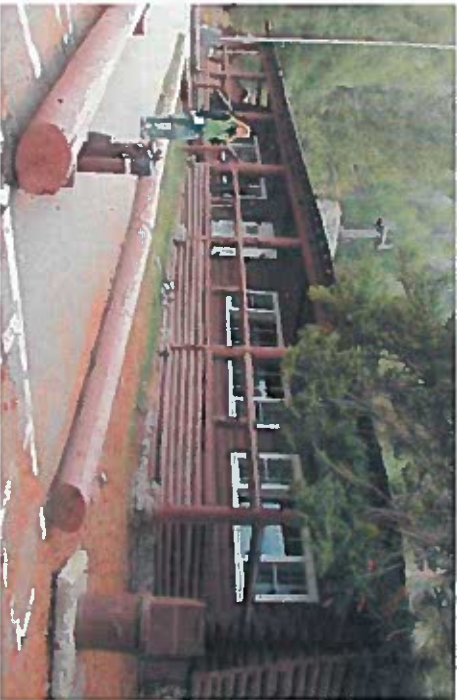
Built in 1919-1920, the lodge remains the center of the developed area. This walk and log curbing non-contributing (Shapins 2004).

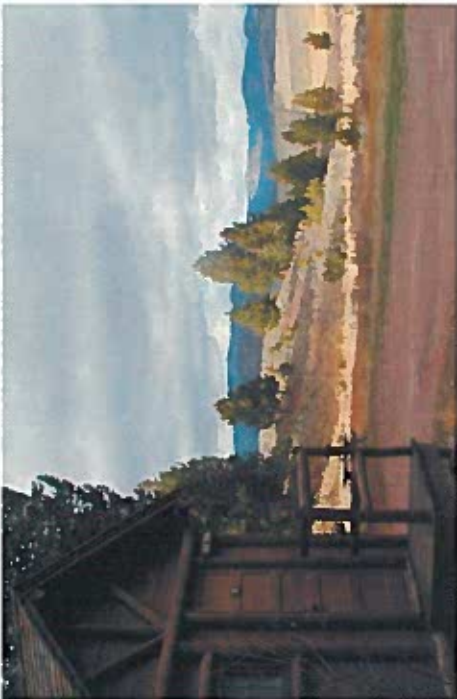
Open, distant views from the northern cabin cluster (Cabin Group C) are contributing features (Shapins 2004).

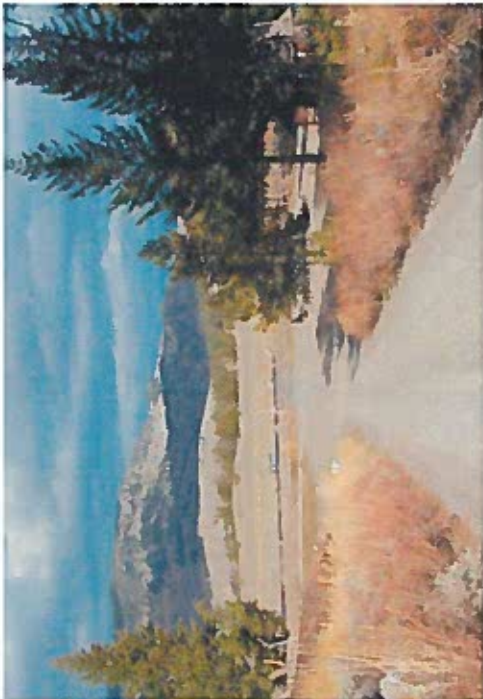
The corral operations and staging area remain obscured from lodge views and do not interfere with distant views to the valley (Shapins 2004).

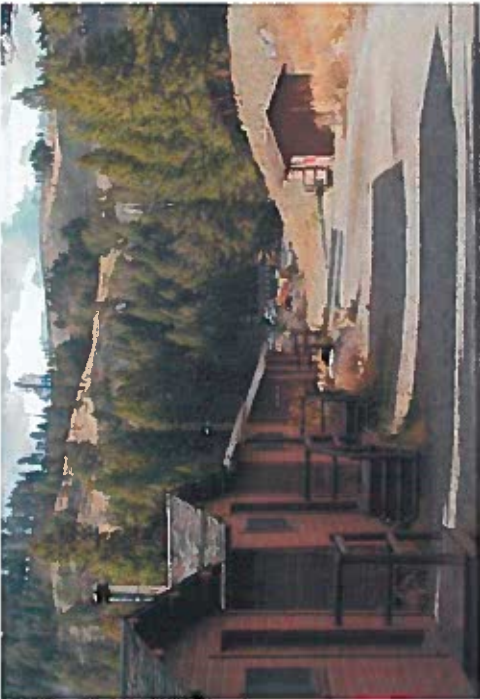
A network of informal footpaths and gravel drives reflect the historic circulation system in the cabin area (Shapins 2004).

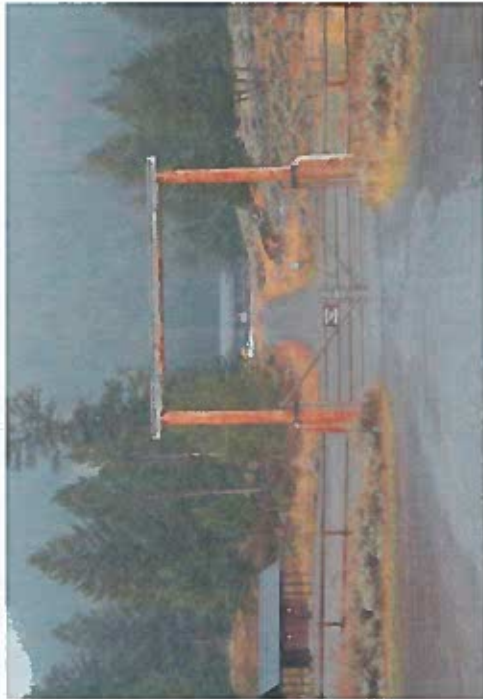
The lodge is set back from the road, located behind a natural vegetative screen. This log gateway frames a direct vista of the lodge, but was erected after the period of significance (Shapins 2004).
