# Yellowstone National Park

## Tatanka Complex and Maple Fire

### BURNED AREA EMERGENCY REHABILITATION PLAN

### BURNED AREA REHABILITATION PLAN

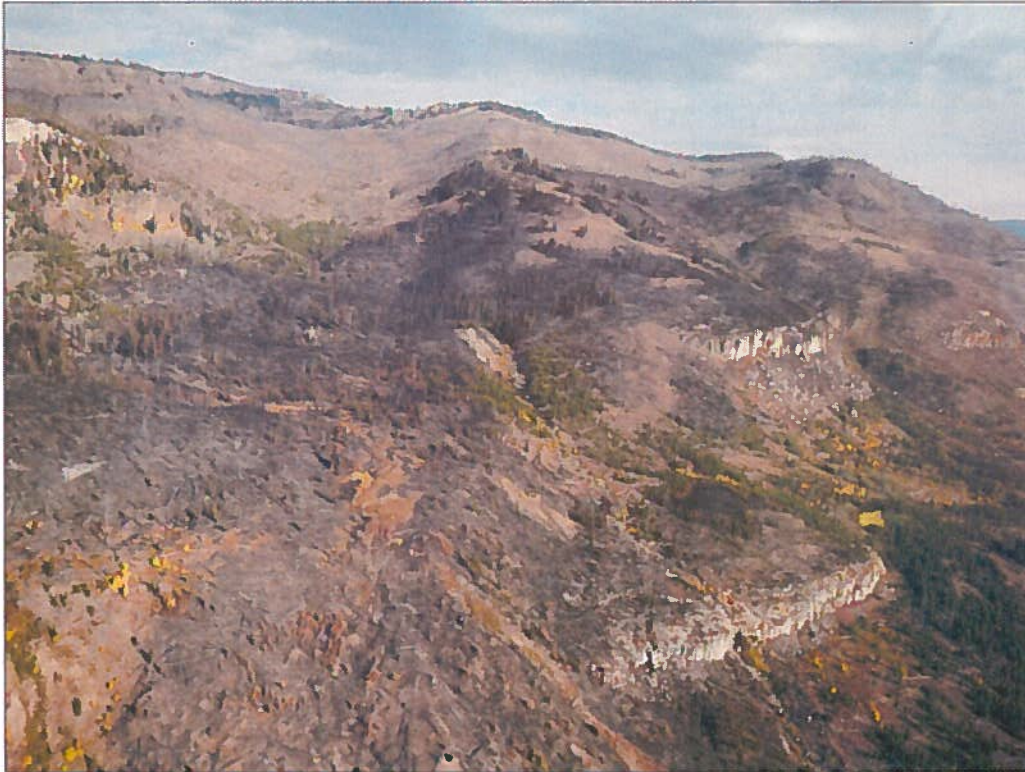
Figure 1: Burned area on the Buffalo fire.

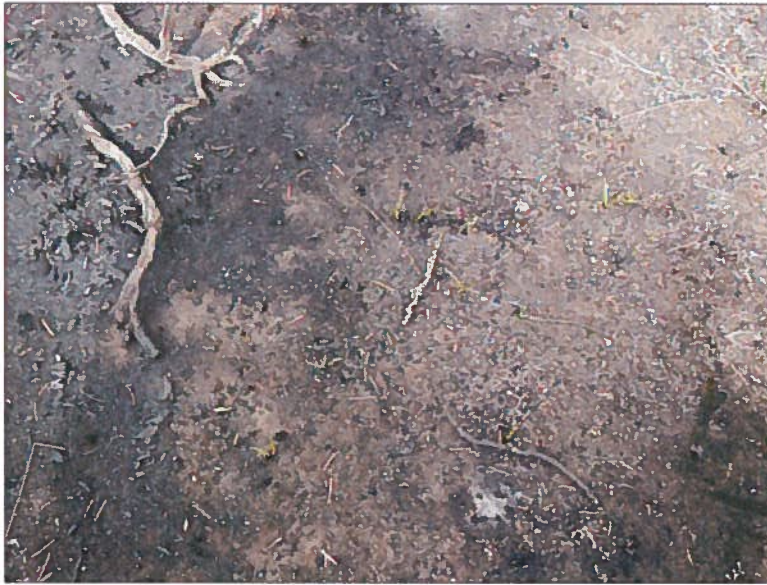
Several precipitation events have occurred over the fire areas prior to the time of this assessment. During very limited ground observation of the Maple Fire burned area along the West Entrance Road, unconsumed twigs and re-sprouting grasses were observed (Figure 7). A reconnaissance flight showed that logs remain unconsumed by fire within the Buffalo Fire burned area (Figure 8).

Figure 7. Organic matter and grasses resprouting.

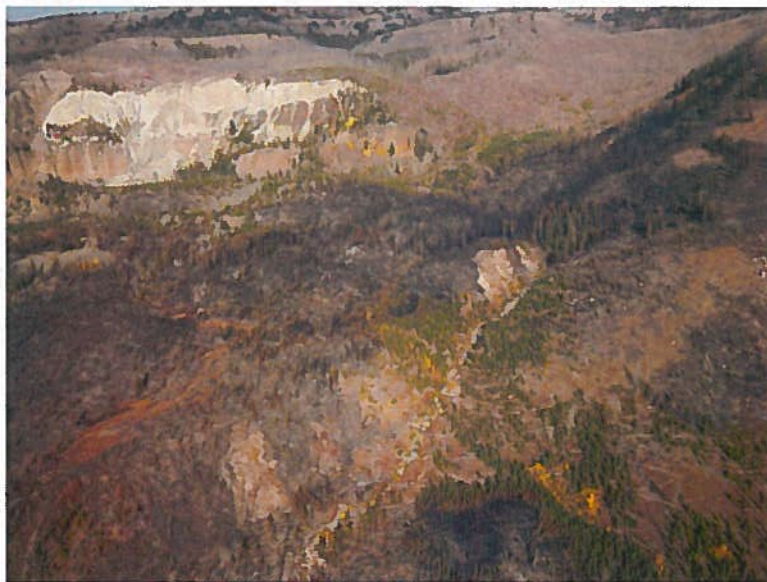
Figure 8. Unconsumed woody material as seen from a helicopter.

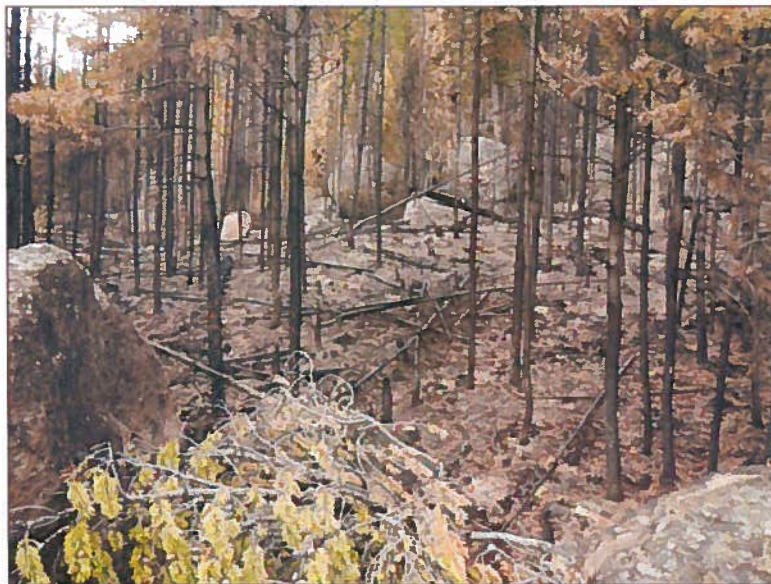
An assessment of burned hillslopes, a small burned unnamed catchment, and culverts that drain these areas at the West Entrance road was conducted by the Hydrologist. An example of one of these burned hill slopes is shown in Figure 9. With the amount of singed pine needles on the ground already, and the needles that have yet to be cast, a fair amount of natural erosion control is already in place. Several of these culverts at the road need attention (Figures 10 and 11), floatable debris is present in the immediate inlet area, and enough sediment is currently present to prohibit some of these culverts from functioning properly.

Figure 9. An example of a burned hillslope along the West Entrance Road.

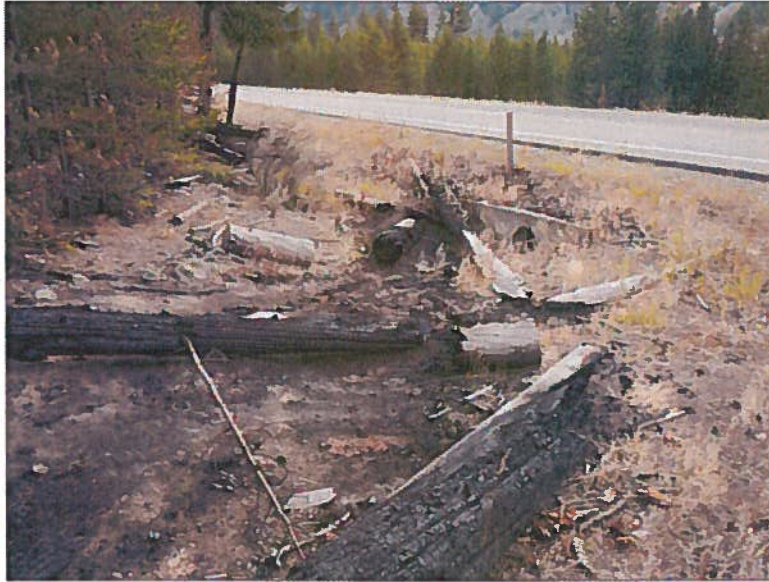
Figure 10. Floatable woody debris adjacent to a culvert.

The Maple fire burned a 2.1 mile section of road east of Seven Mile Bridge on the West Entrance road. There are three culverts on this stretch of road, which may clog with burned debris (i.e., burned logs) and sedimentation due to the close proximity of the burned slope above them. Removal of this sedimentation and fire debris is critical to stabilize the road to ensure the busiest road in the park remains open. The park is requesting funding to do periodic sedimentation removal caused by the burned slope above the culverts that may pose a threat to the life and safety of the visitors using the road if not cleared. This effort will require one equipment operator, for one pay period, for one year.

The park is requesting funding to do periodic sedimentation and debris removal around culverts caused by the Maple fire that may pose a threat to the life and safety of the visitors using the road if not cleared. This effort will require one equipment operator, for one pay period, for one year. See spreadsheet for estimate details.

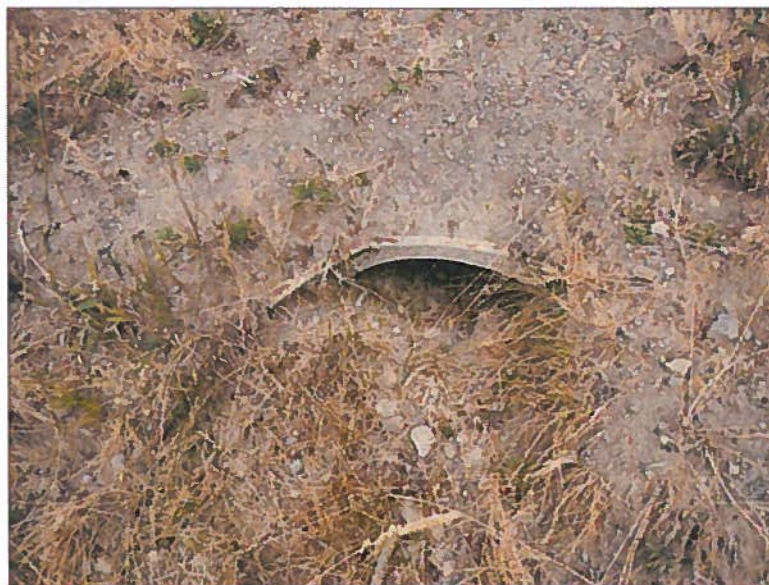
Figure 11. A plugged culvert along the West Entrance Road.

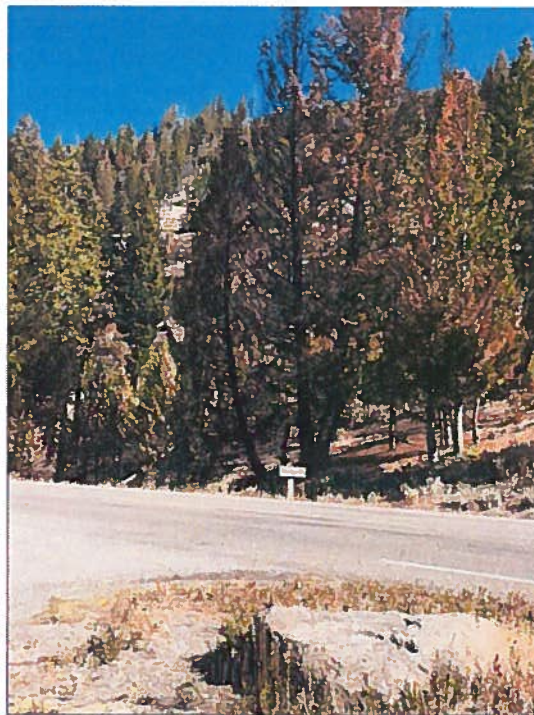
The Maple fire burned a 2.1 mile section of road east of Seven Mile Bridge on the West Entrance road. The West Entrance road is the park's busiest road, and therefore closing the road is not possible to deal with the trees killed or damaged by the fire. The park is requesting funding to assess the hazard trees and remove any threatening the life and safety of the visitors using the road. This effort will require six biological science technicians, one pay period, for one year.

Figure 17. Maple fire disturbance along roadside where hazard tree mitigation is needed.

NPS crews will survey and remove hazardous trees that were scorched and will likely die overwinter along 2.1 miles of the West Entrance Road corridor. This effort will require six seasonal biological science technicians for one pay period for one year. See spreadsheet for estimate details.

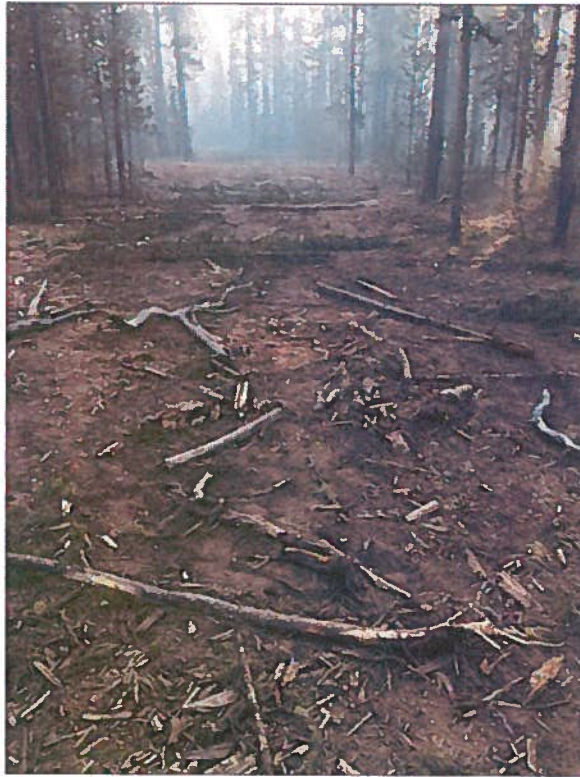
Invasive plant species concerns are focused on the Maple fire due to its close proximity to West Yellowstone, and known invasive species such as berteroa (*Berteroa incana*), yellow toadflax (*Linaria vulgaris*), spotted knapweed (*Centaurea stoebe*) and St. Johnswort (*Hypericum perforatum*). The park is proposing to assess invasive species in the fuel treatment area along the boundary due to management actions (use of heavy equipment to create a contingency line) and the known infestations within close proximity (100 feet) of the equipment use area. Known patches of Canada thistle (*Cirsium arvense*) have infested stretches of the Madison River floodplain adjacent to the burned West Entrance Road corridor, and will require treatment from spreading into the fire perimeter. Other areas of concern where assessments would take place include the Buffalo fire in burned sagebrush meadows which are in close proximity to established cheatgrass (*Bromus tectorum*) populations, and burned portions along the Fawn Pass trail with known invasive plant populations.

Figure 18. Fuel treatment along boundary of park on Maple fire where heavy equipment was used in close proximity to invasive species infestations.

If assessments show an increase of invasive species within these areas, the park will chemically or mechanically treat the invasive species, reducing them to pre-fire/treatment levels. Chemical treatment would be followed by reseeding with native seed collected locally. Treatment would be consistent with the park's Exotic Plant Management Plan (2013). NPS employees would monitor, and if needed, chemically or mechanically treat invasive species, reseeding with native grasses in bare soil areas over the next year. These efforts will require six seasonal biological science technicians for two pay periods each.
