# Inventory of Coastal Engineering Projects within Assateague Island National Seashore

Natural Resource Report NPS/NRPC/GRD/NRR—2015/914

February 2015

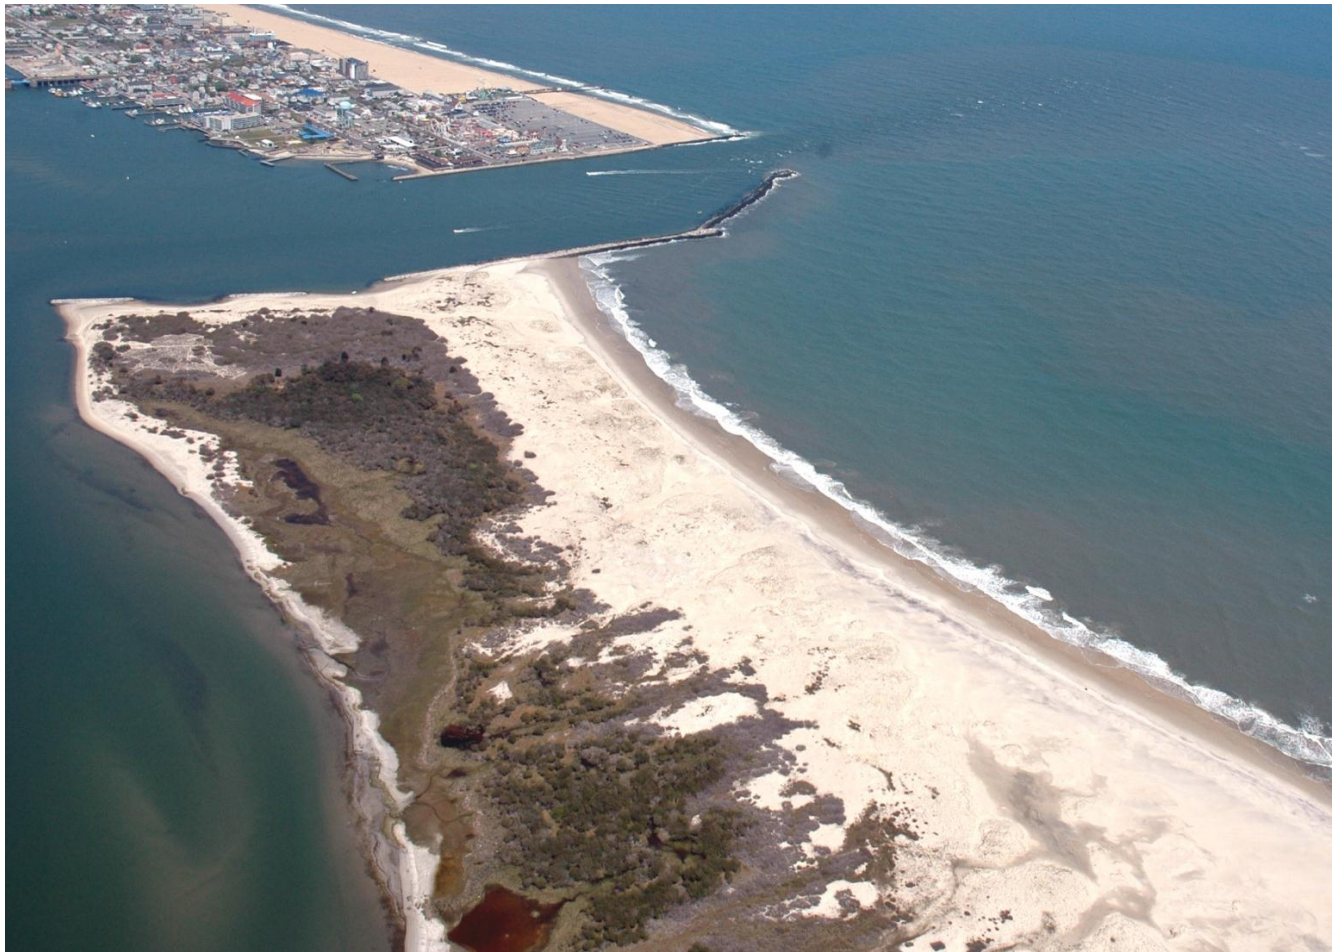
**ON THE COVER**

Ocean City Inlet jetty on the north end of Assateague Island, Maryland, on 12 May 2006.  
Photograph by: Jane Thomas, IAN Image Library ([www.ian.umces.edu/imagelibrary/](http://www.ian.umces.edu/imagelibrary/))

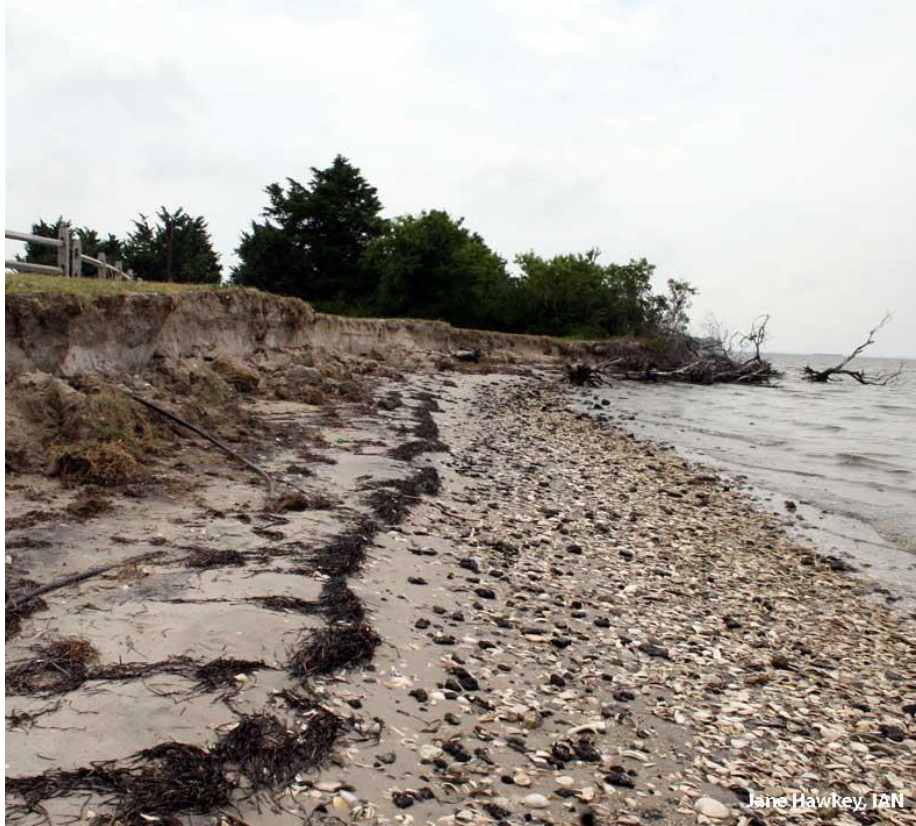
**Figure 7.** The shoreline along Bayside Peninsula continues to erode. Image by Jane Hawkey, IAN Image Library ([www.ian.umces.edu](http://www.ian.umces.edu)).

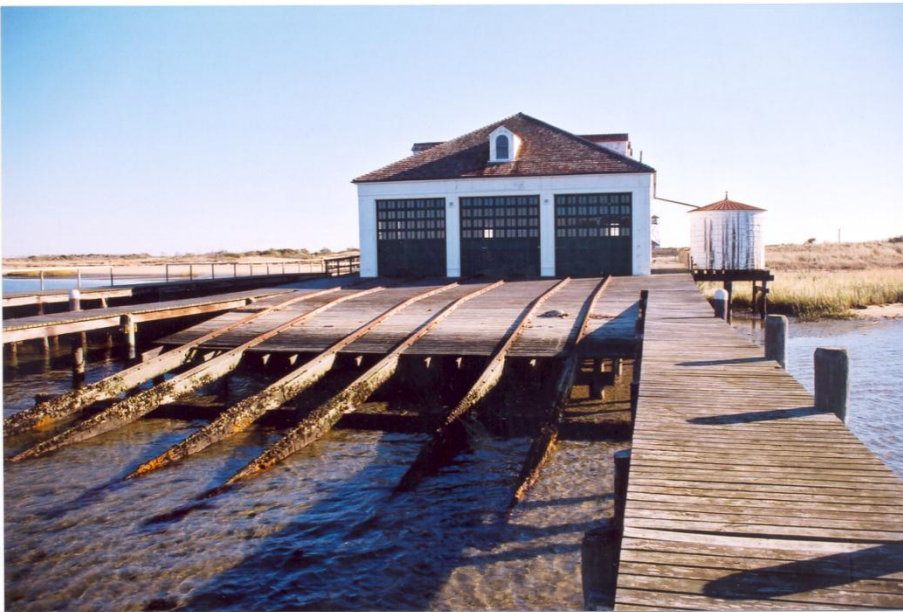
**Figure 8.** The boathouse and dock of the historic Assateague Coast Guard Station on Toms Cove Spit, Virginia. Image from Phillips (2007).

The historic Assateague Coast Guard Station on Toms Cove Spit in Virginia was established in 1922 and decommissioned in 1967 (Phillips 2007). The complex includes a boathouse (Figure 8) that was built in 1938-1939 north (bayward) of the station house. The boathouse (#11 and #12 Figure 4C) was built on wooden pilings and had an attached wooden pier dock and a launchway with steel tracks sloping from the boat doors into the water. The understructure of the boathouse and the pier were repaired in 1993 (Phillips 2007). The pilings rise 1.5 to 2.1 m (5 to 7 ft) above the sand and are exposed at low tide (Phillips 2007).

The pilings supporting the Coast Guard Boathouse and associated piers likely cause some interference with local hydrodynamics, including dissipating wave energy. Piers in excess of 30 m (100 ft) can have a number of impacts on wetlands and the habitats they support including shading of wetland vegetation and submerged aquatic vegetation that lies beneath the structures; barriers for trash and debris during large storm events; potential for the structures to break up and become debris during large storm events; and changes to the composition of marsh-dependent birds that use the area for feeding and other habitat (Cain et al. 2009).

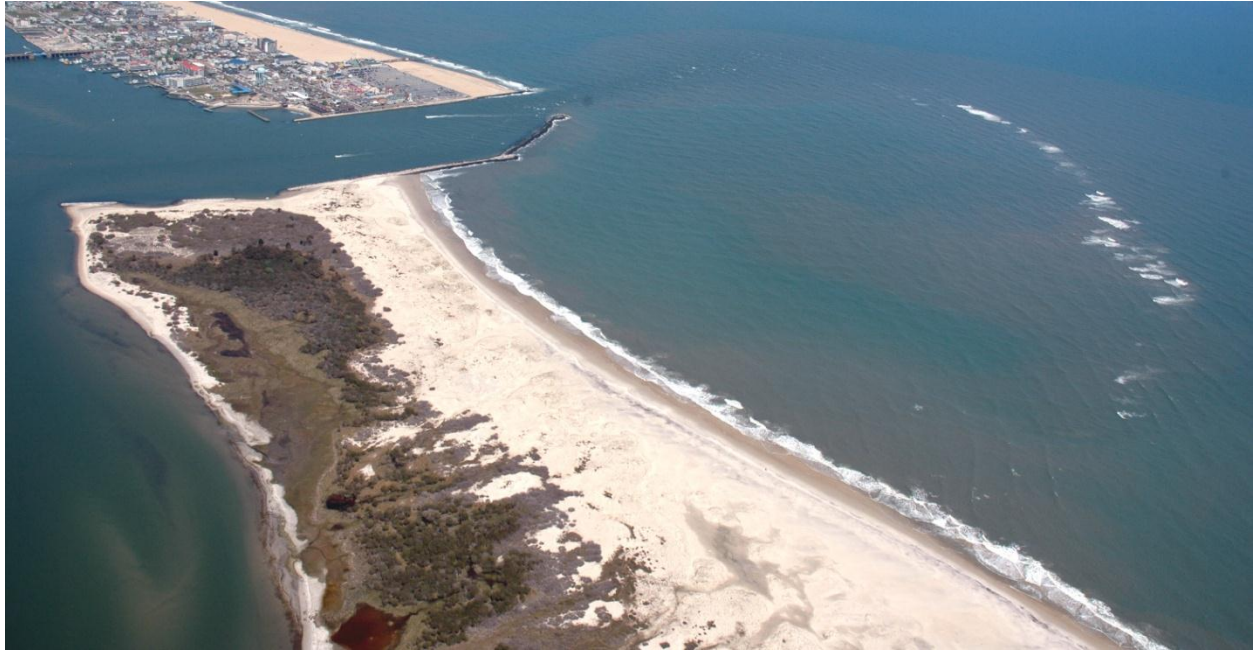
**Figure 9.** The ebb tidal delta of Ocean City Inlet curves to form an attachment bar that meets the Assateague Island shoreline; the large bathymetric feature is delineated by breaking waves. Fenwick Island (Ocean City) is visible at the top of the image, and Assateague Island is in the center of the image. Photo date 12 May 2006. Image by Jane Thomas, IAN Image Library ([www.ian.umces.edu](http://www.ian.umces.edu)).

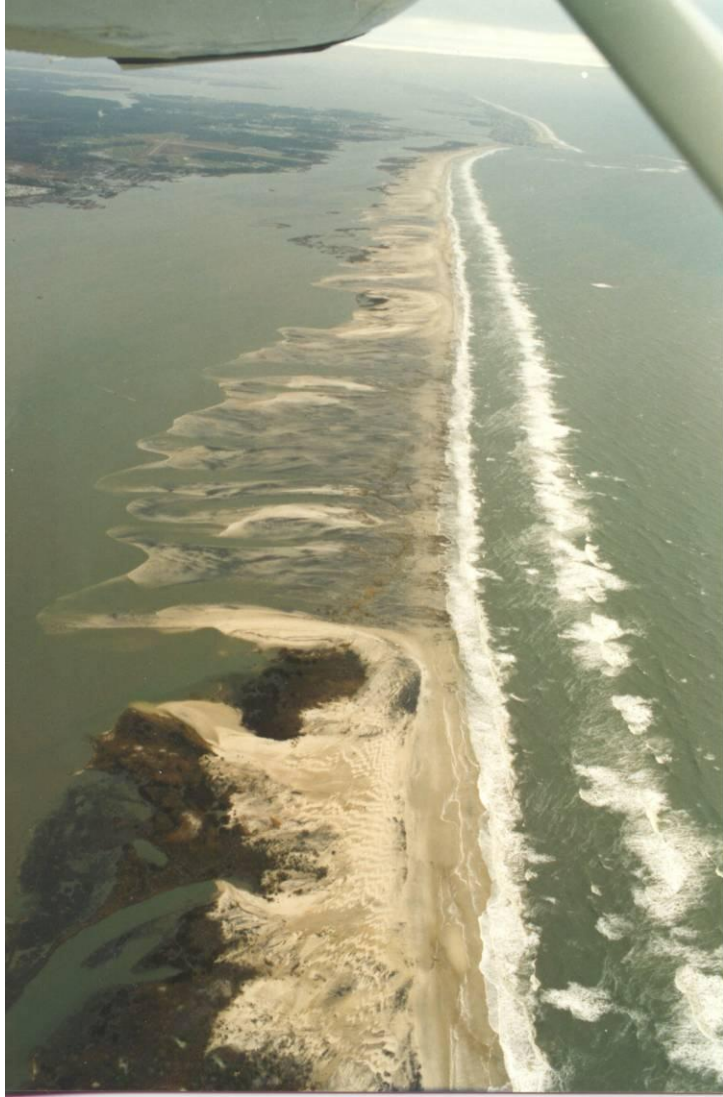
**Figure 11.** Two northeaster storms in 1998 caused sustained overwash that created a large overwash fan and uncovered relict backbarrier peat along the shoreline and within the island's interior. Image from Assateague Island National Seashore.

The sediment reduction has lowered the island's elevation and increased its vulnerability to overwash and storm surge. These changes allowed a strong northeaster in March 1962 to breach the North End in two places, one separating the south jetty from Assateague Island and another breaching the island approximately 2 km south of the inlet (Rosati 2005). Overwash and dune erosion accelerated over the next few decades. After a series of strong storms during the period 1991–1998, the North End overwashed up to 20 times per year, with well-defined overwash channels and mean elevation lower than 2.5 m (8.2 ft) NGVD29 (USACE 1998). During two northeasters in early 1998, a 2.4-km- (1.5-mi-) long area experienced sustained overwash that created a large overwash fan and uncovered peat along the shoreline and within the island's interior (USACE 1998) (Figure 11). These events led to the development of the North End Restoration Project described in the previous section.

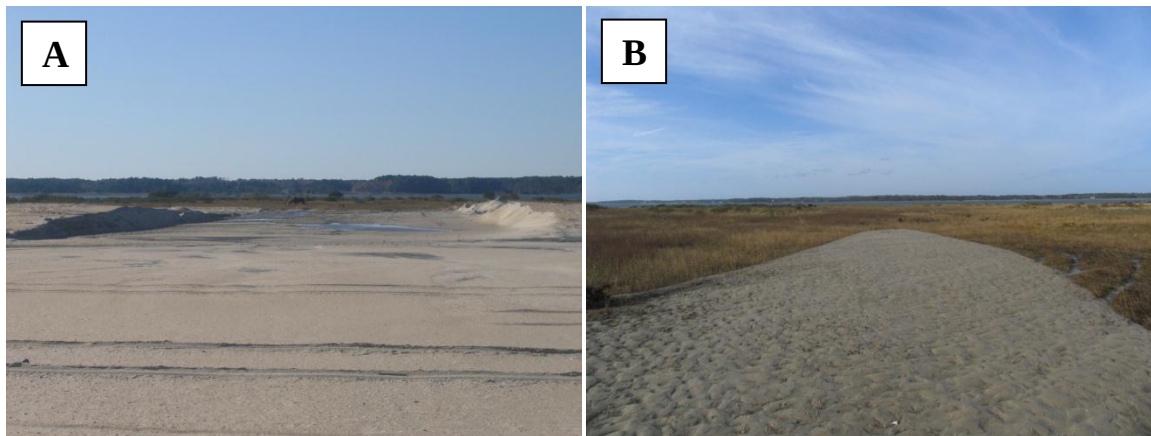
**Figure 12.** The constructed foredune was modified to restore overwash processes. A) Notches were dug in 2008 and 2009. B) As of 2011, the notches continued to allow overwash during storm events. Images from Assateague Island National Seashore.

The constructed foredune that was built in 1998 to prevent breaching, and fortified in 2002 as part of the short-term North End Restoration project, did not behave according to modeled predictions due in large part to three unexpected conditions:

1. The dredged sediment used in construction had a larger proportion of coarse-grained materials, including gravel, than did the native sediments. Through wind winnowing, this coarse fraction blankets most of the foredune surface, limiting the ability of the underlying sediments to be mobilized during wind and storm events.
2. Post-construction meteorological conditions were much calmer than the modeled storm conditions; a multi-year period of calm weather followed the 2002 sediment placement. As a result, shoreline erosion was also unexpectedly low, so the sediment protected the constructed foredune for longer than anticipated.
3. The long-term restoration effort, involving mechanical sand bypassing to the nearshore, began earlier than expected so the shoreline had not eroded as far westward as expected before the longshore sediment transport volume increased (Schupp et al. 2013).

An additional recommendation related to the North End Restoration project addresses the constructed foredune. The project design intent is for overwash restoration to sustain the availability of foraging habitat, but future foredune modifications may be necessary to maintain or increase overwash processes and piping plover habitat in the project area (Schupp et al. 2013).

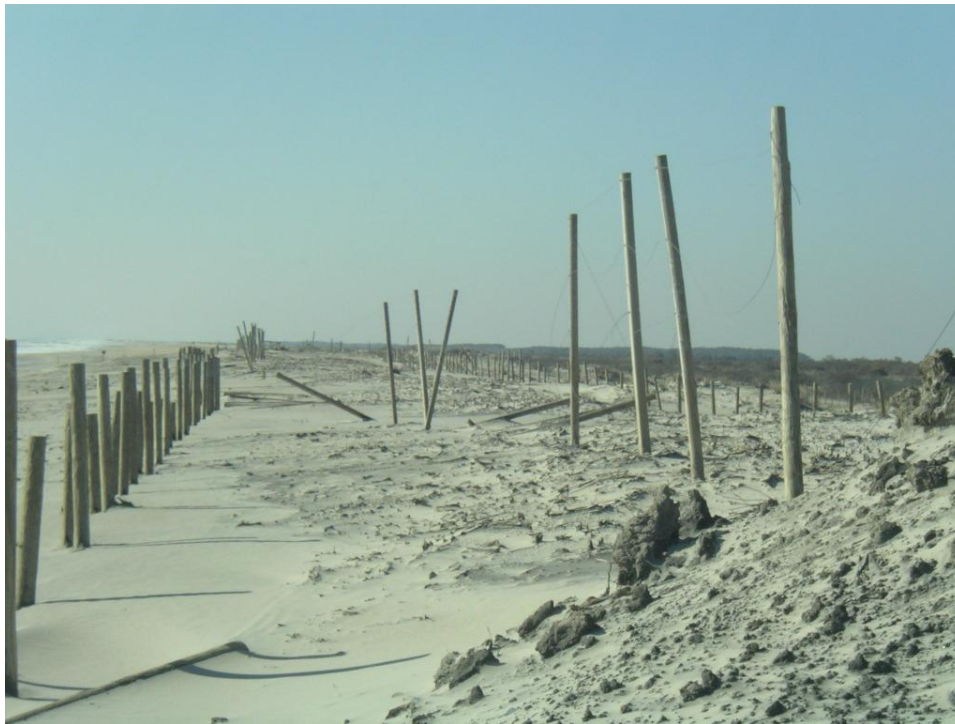
**Figure 13.** Fencing posts and other materials (e.g., fencing wire) are often buried through wind-transported sand, and later exposed by erosional events along the beach. Image from Assateague Island National Seashore.

Efforts to stabilize or fortify the artificial dune have included importing sediment, building sand fencing, grass planting, and fencing to protect the dunes from foot traffic and horses. Imported sediment may introduce exotic species and sediment that is incompatible with the beach environment. Both recent and buried fencing is sometimes uncovered and uprooted during erosive storms, leaving debris on the beaches that may include recreational hazards such as wire and nails (Figure 13).
