# Status of Climate and Water Resources at Montezuma Castle and Tuzigoot National Monuments

## *Water Year 2016*

Natural Resource Report NPS/SODN/NRR—2017/1551

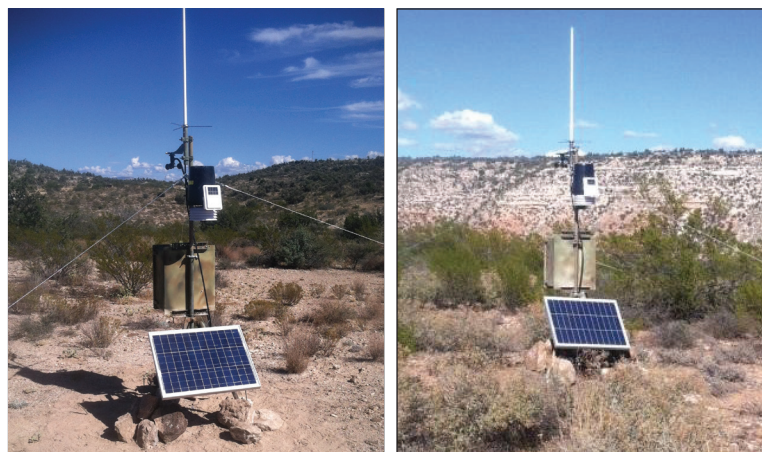
Figure 2-1. The Davis real-time weather stations at Montezuma Castle (left) and Tuzigoot (right) national monuments. Data are available through [www.climateanalyzer.org](http://www.climateanalyzer.org).

In 2014, the Sonoran Desert Network (SODN) established Davis weather stations at both units of Montezuma Castle NM, and at Tuzigoot NM to provide real-time weather conditions (Figure 2-1). All three stations are linked to the NOAA Citizen Weather Observer Program (CWOP) and accessible through [www.climateanalyzer.org](http://www.climateanalyzer.org). See the SODN climate monitoring protocol (Hubbard et al. in prep) for details on methods and data handling.

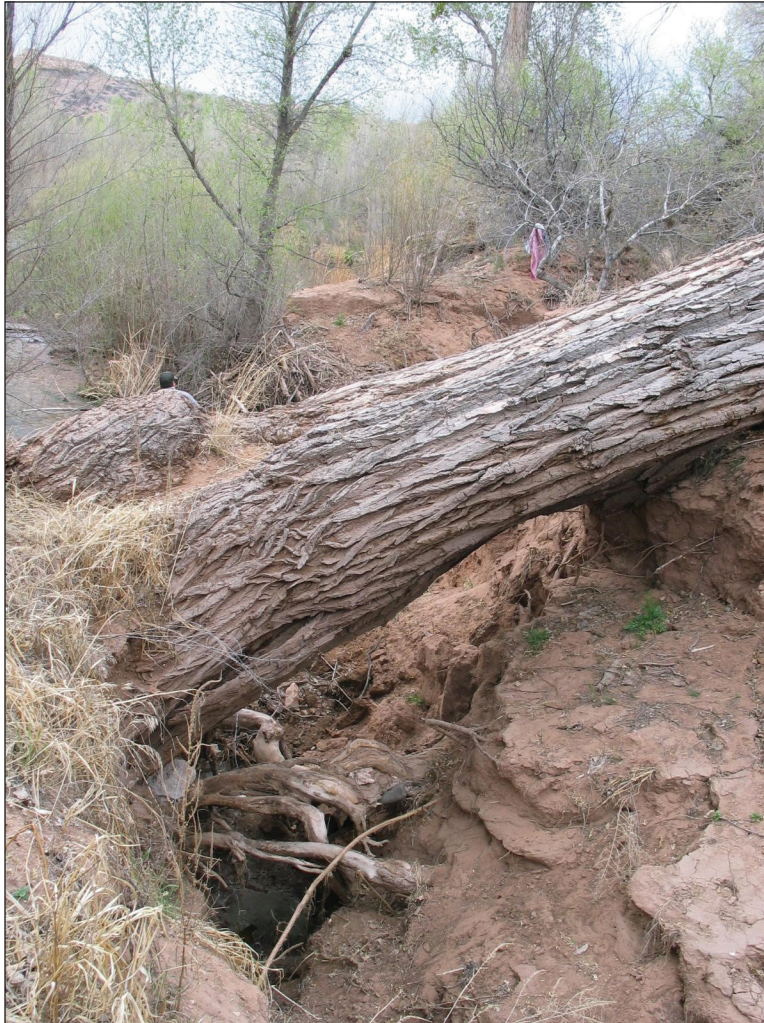
Figure 2-11. Channel cutting along the Tavasci outflow ditch following heavy rain, Tuzigoot NM. NPS photo.
