PART I  
HISTORIC STRUCTURE REPORT  
FOR

THE DUNKARD CHURCH

Antietam National Battlefield Site

Robert L. Lagemann  
Historian (Park)  
May 25, 1960  
62 Pages

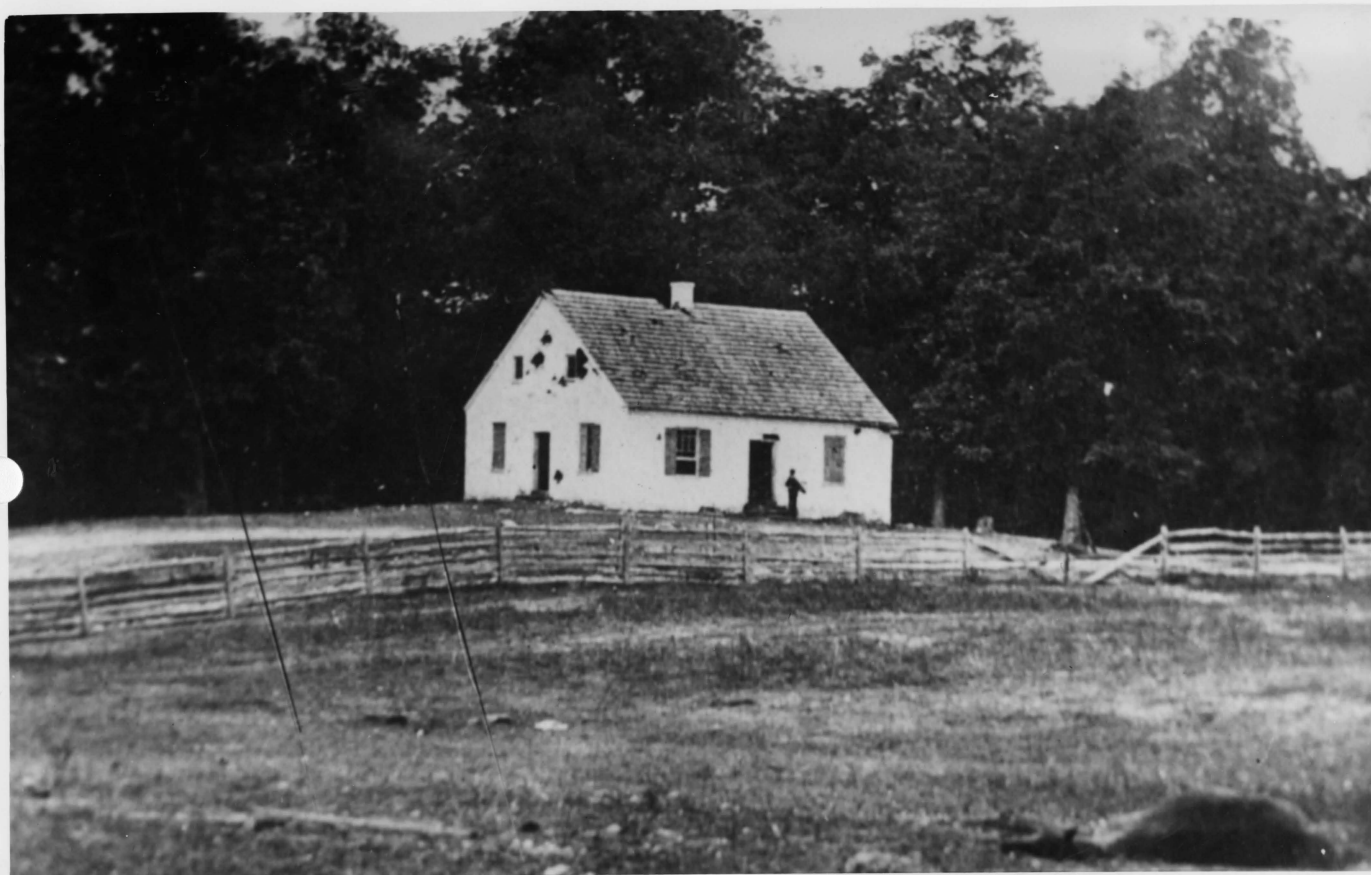
Photograph No. 1. The most widely known Brady photograph of the Dunkard Church, showing the post-and-rail fence along the Hagerstown Pike east of the church and the West Woods behind the church. Note artillery damage in the south gable.

1. (Photo #1, this report) The best known Brady photograph of the Dunkard Church, showing the post-and-rail fence in the foreground and the West Woods in the background.
2. (Photo #12) Brady photograph of the church, with dead soldiers in the foreground.
3. (Photo #7) Unknown photograph taken between 1864 and 1885, showing the repaired church.
4. (Photo #8) Unknown photograph, dated 1885.)
5. (Photo #9) Unknown photograph, taken after the installation of the War Department plaque in the 1890's.

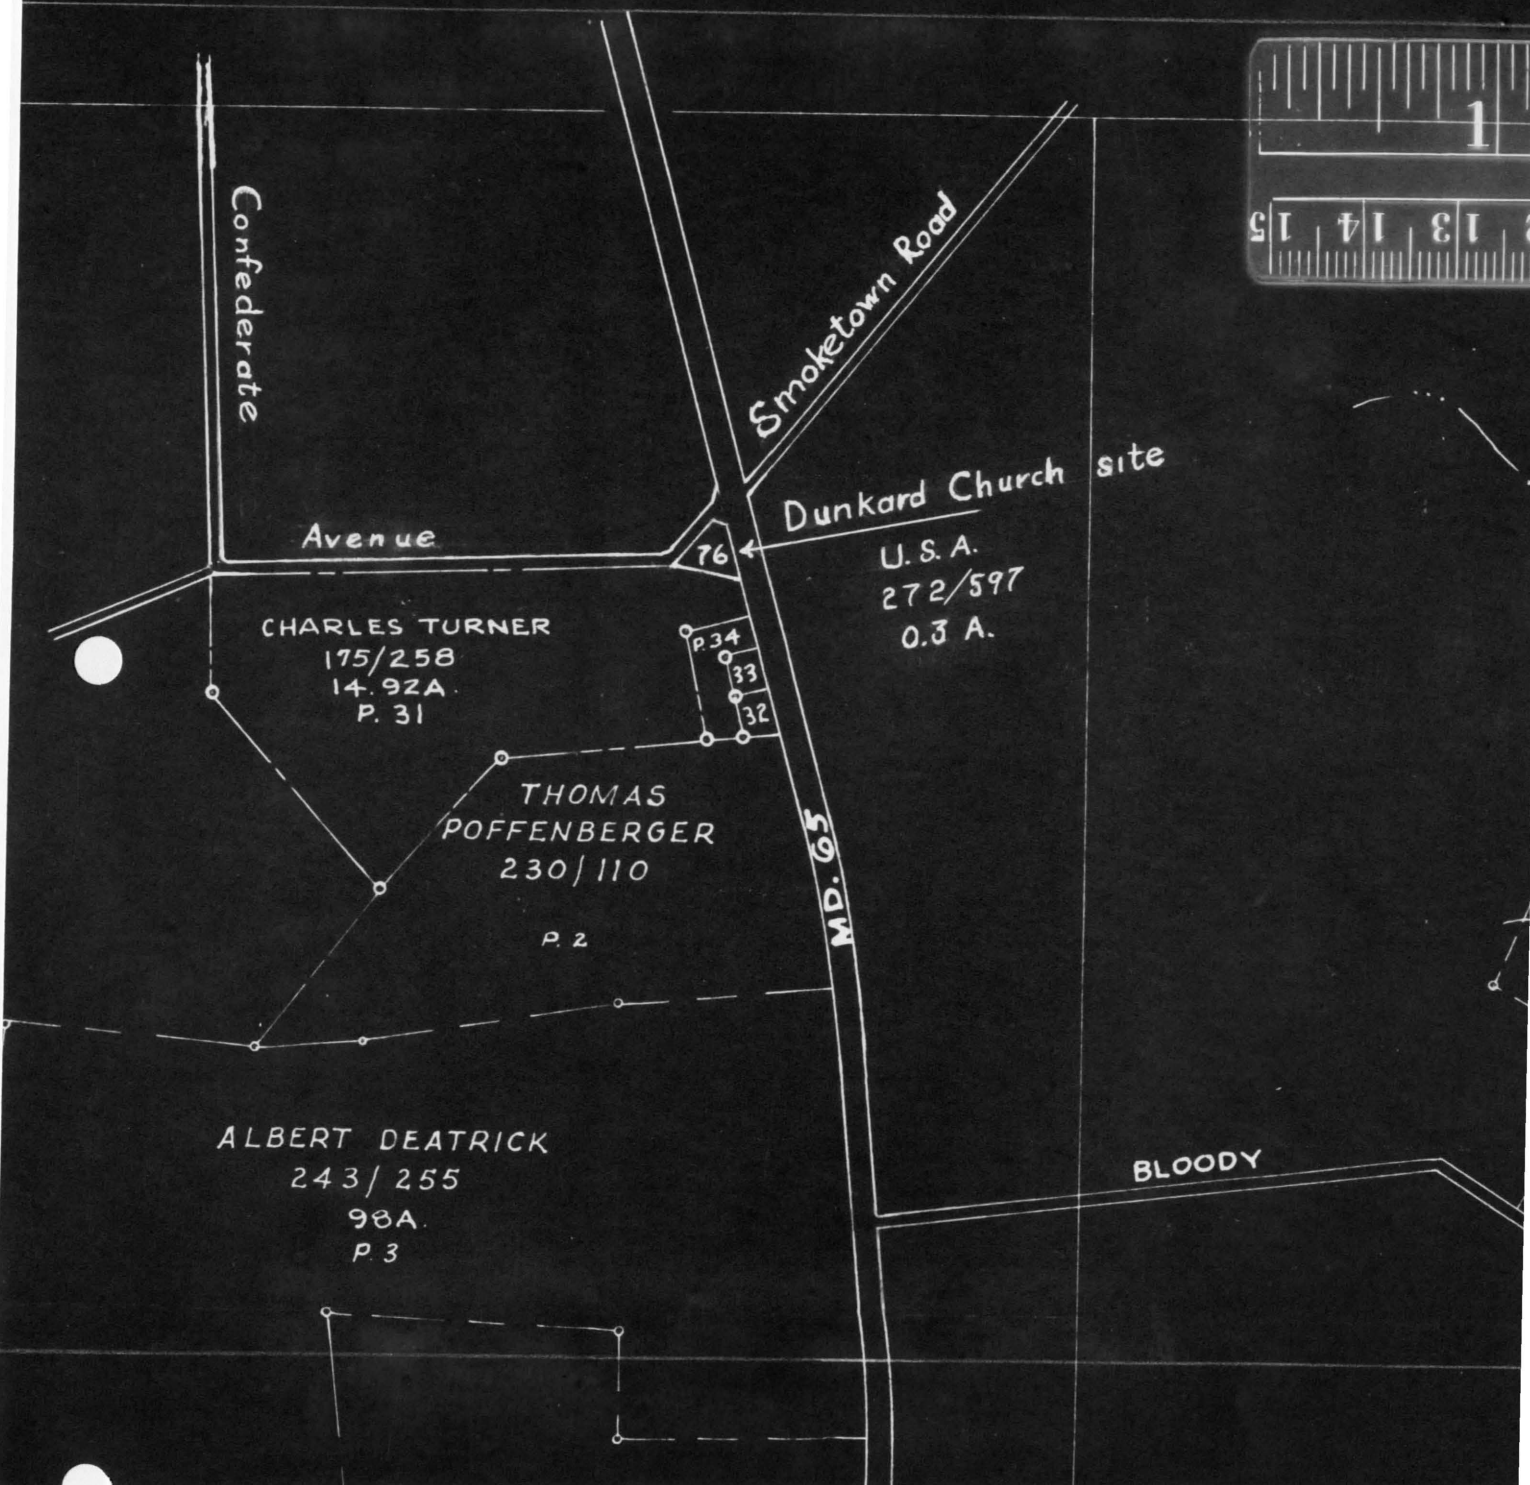
Maryland State Tax Map, Washington County, No. 76.  
Scale of original map is: one inch equals 600 feet.

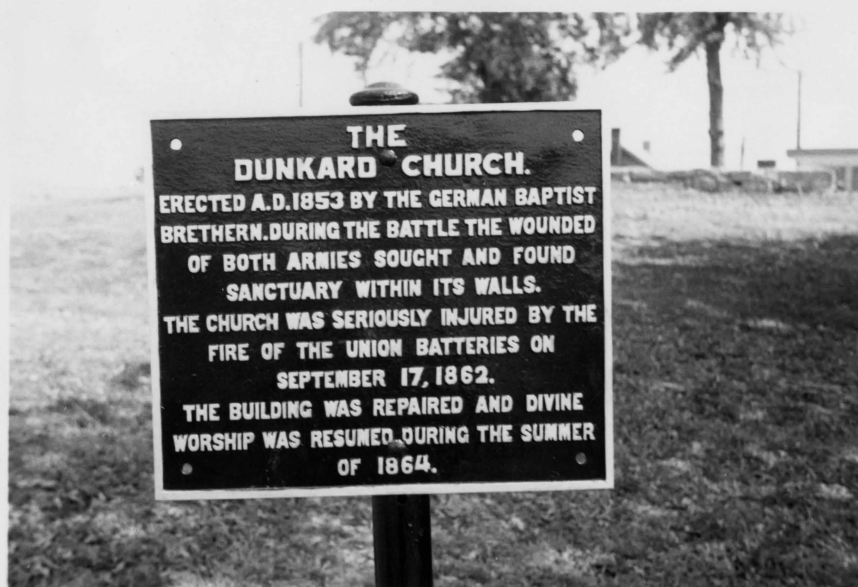
Photo No. 4. Cast iron plaque, originally set into east wall of Dunkard Church; now mounted on an iron pipe, facing Confederate Avenue, on north edge of the church site.

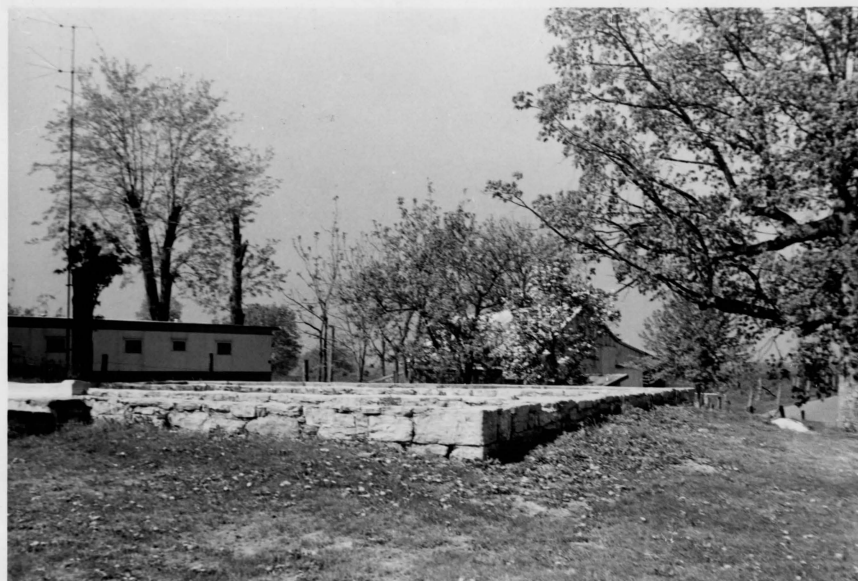
Photograph No. 5 . The remaining foundation of the  
Dunkard Church, as seen from the east. The four  
parallel walls run north to south and are approxi-  
mately nine feet apart.

The average width of these field stone walls is  
eighteen inches, except for the westernmost wall which  
is twenty-one inches wide. Their height, measured at

the four corners from ground level to wall top is: SE corner, 6"; NE corner, 20"; SW corner, 16"; NW corner, 19". The upper surfaces of all six foundation walls are approximately level with each other. The westernmost wall is partially covered by a thin layer of cement through which protrude four 1/2" threaded bolts. This addition to the original masonry was made by Mr. Charles Turner in order to anchor the frame dwelling which he erected there in 1928. All of the foundation walls have been capped in places with patches of cement, placed there to protect the old walls from further weathering and to keep the stones bound together. The latest of this periodic maintenance "patching" was applied May 10, 1960.

Near the center of the eastern and southern walls, on their exterior sides are slabs of field stone which were used as the entrance steps to the church's two doors. The lower stone at the south end is partially covered by earth, while earth has eroded away from the lower stone on the east side and has left one corner of it unsupported. As shown in the left of Photograph No. 5, a cut stone door sill has been placed on top of the eastern foundation wall, in line with the steps. This cut stone sill was definitely not a part of the original structure. This stone was originally cut to replace a damaged sill in the Park Headquarters Building in the National Cemetery,

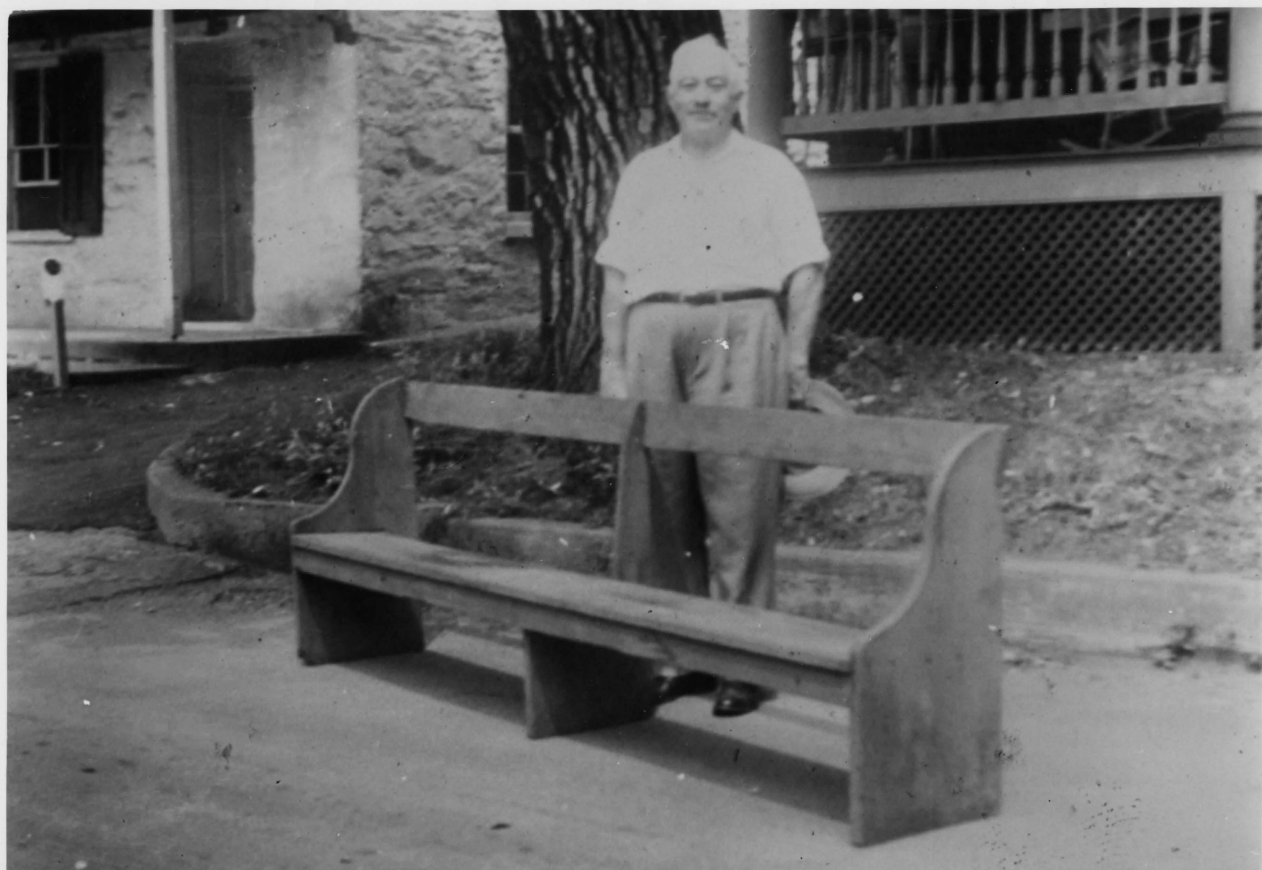
Photograph No. 6. Mr. Elmer G. Boyer, with one of the Dunkard Church benches he has salvaged and stored in Sharpsburg. (Photo by Tuckerman, 1951.)

In an interview with Mr. Boyer, May 13, 1960, at his residence in Sharpsburg, he stated he still has all the artifacts stored in his barn and garage. He has declined a number of offers by private individuals to purchase some of these materials because he hopes they will be some day incorporated in a restored Dunkard Church. In fact, he has been paying insurance on them these several years in the anticipation of seeing such a restoration in his lifetime. Although Mr. Boyer permitted a visual inspection of the materials stored in his barn, he did not welcome a suggestion that they be measured that day. Knowing that Mr. Boyer has recently suffered two strokes, Supervising Architect Franzen, Harpers Ferry National Monument, and I did not press the matter. Therefore, the following information on the physical aspects of the church itself contains several statements which I have<sup>26</sup> tentatively accepted without further proof.

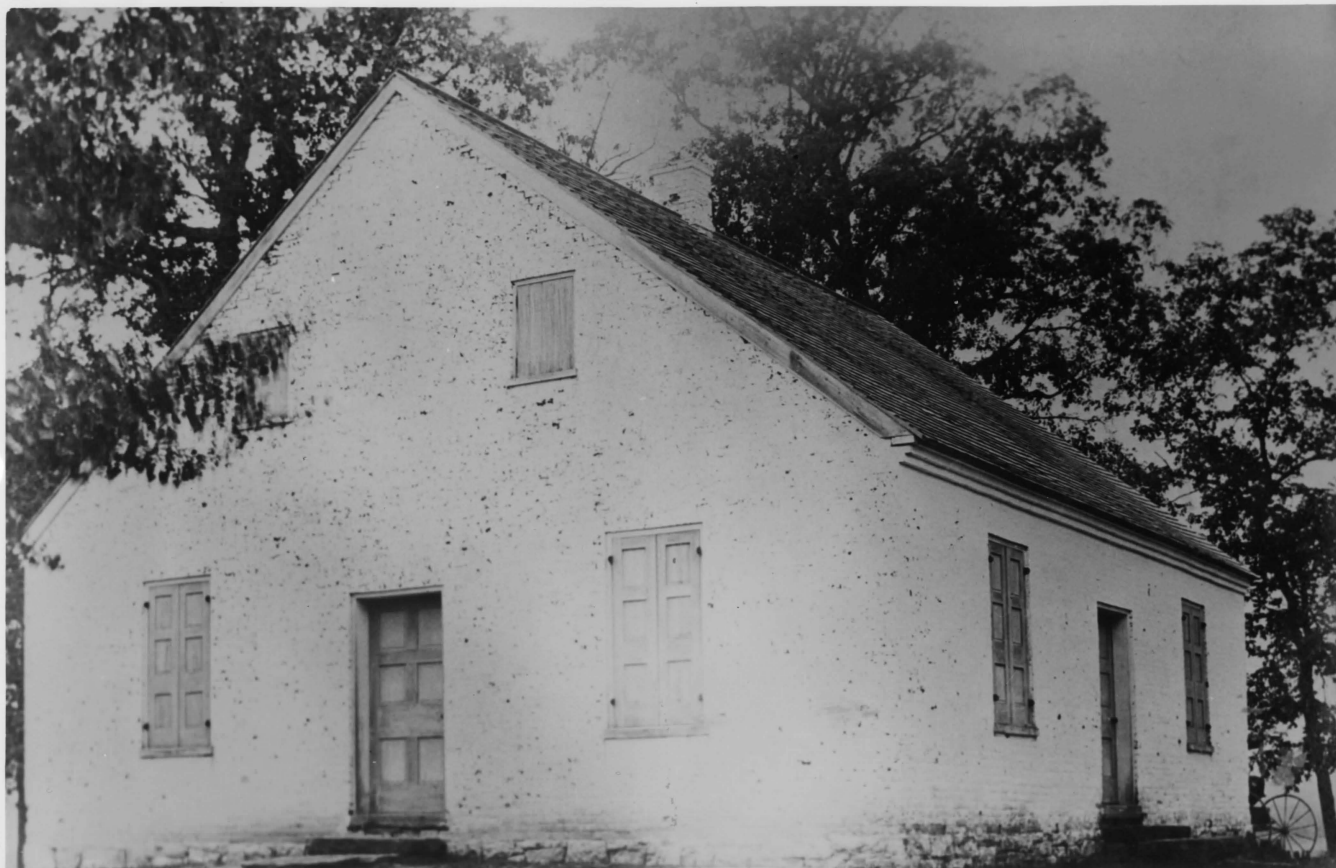
Photograph No. 7. The Dunkard Church, after the battle damage had been repaired. Exact date unknown; between 1864 and 1885. South and east walls are shown.

The gable windows in the south wall were 13' 6" above the top of the foundation. Their position in the wall with relationship to the roof line can be determined by a study of a photograph showing the south wall. It will be apparent from a Brady photograph that most of the battle damage occurred in the gable of the south wall, about level with these attic windows. The exterior dimensions of the gable window frames were 28 x 38 $\frac{1}{2}$  x 1 3/4 inches. The top of the frames was about 6' 6" below the roof ridge. Each gable window had a single shutter, made of plain boards, and hinged at the west edge of the window opening.

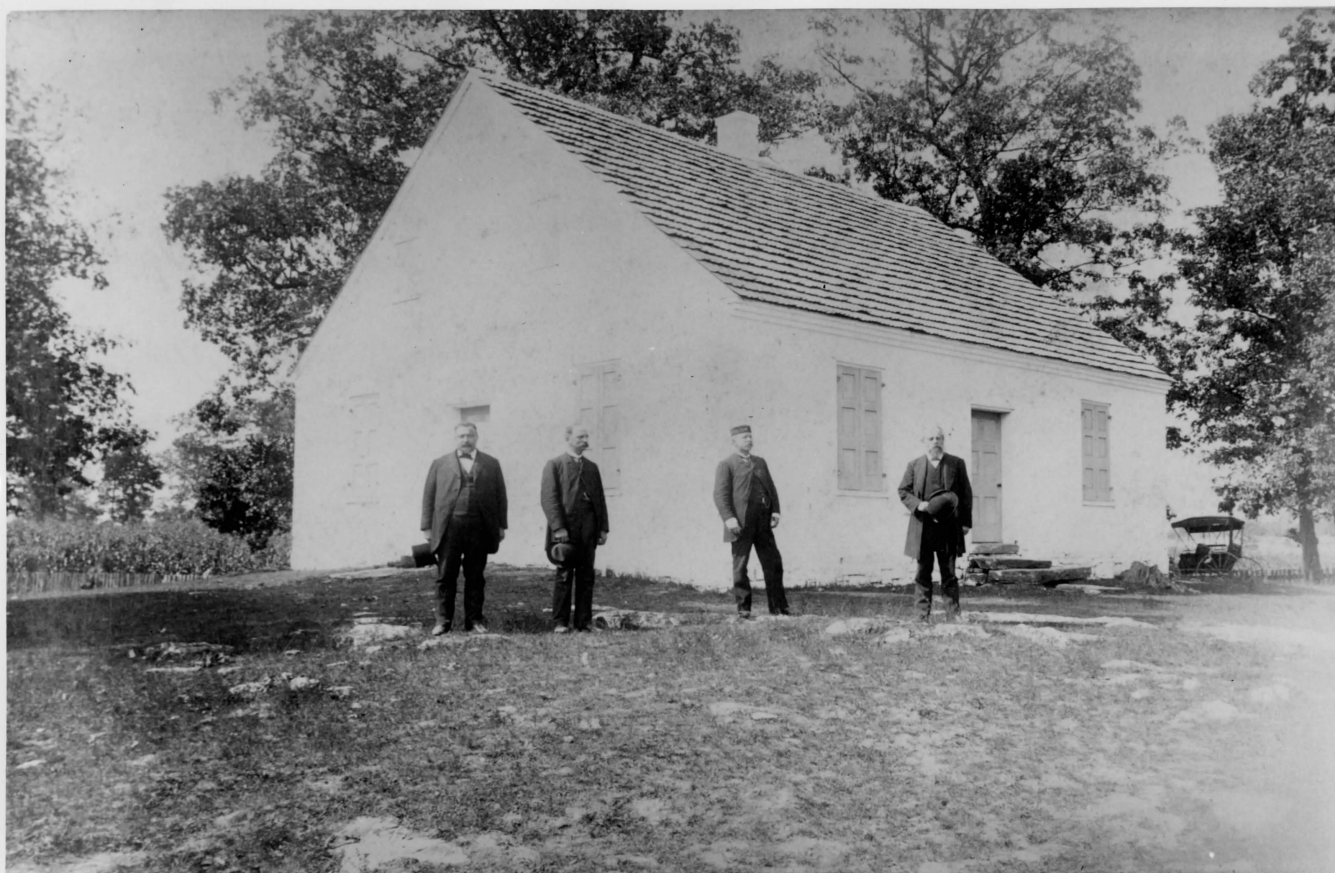
Photograph No. 8. The south and east sides of the Dunkard Church as they appeared in 1885.

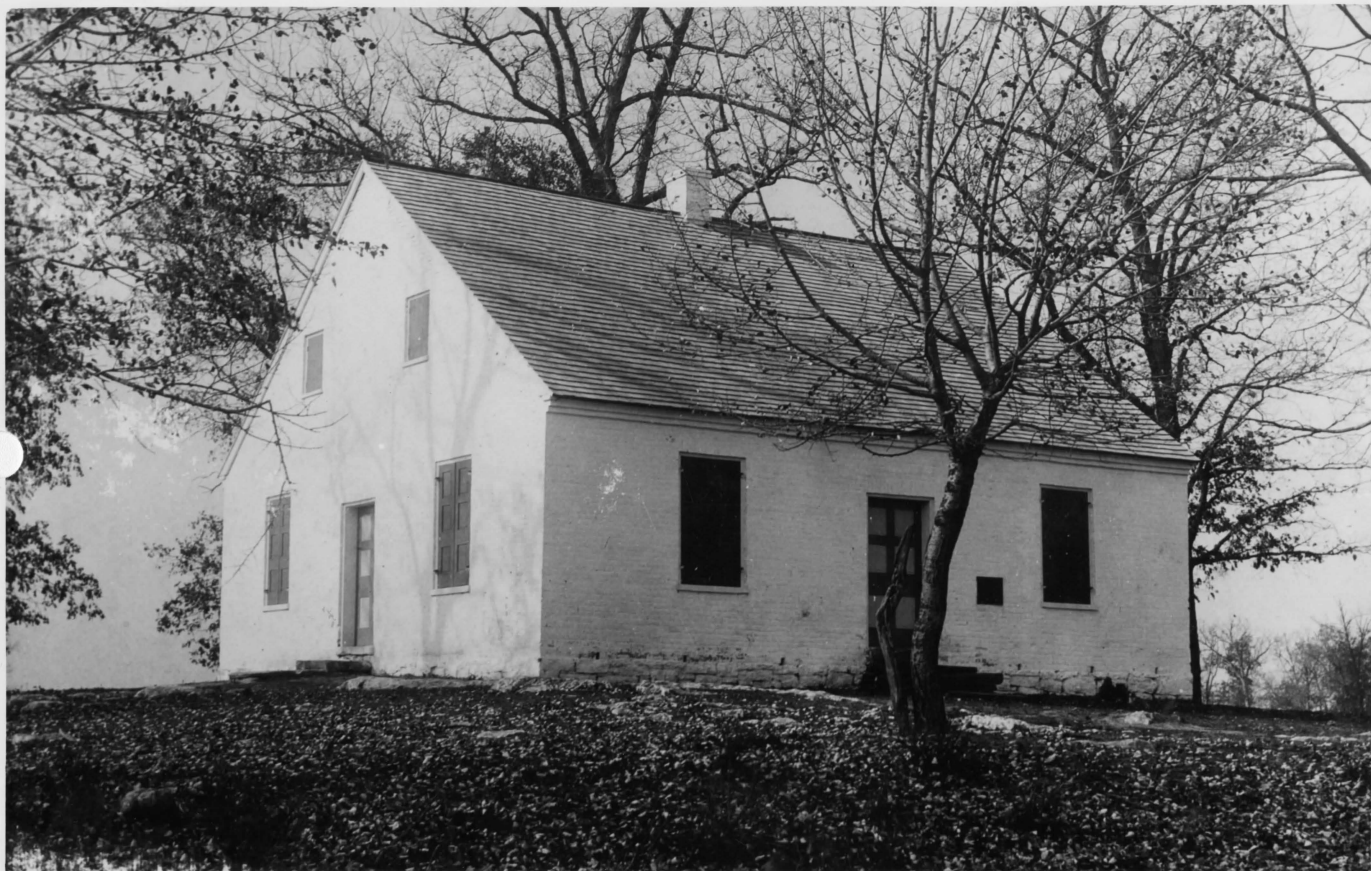
Photograph No. 9. The Dunkard Church, looking west from the Hagerstown Pike, after the War Department plaque had been mounted in the east wall; probably taken after 1905.

There is no evidence that any alterations were made in the building between this time, 1863-64, and its destruction by storm in 1921. During the 1890's, when the U. S. War Department was marking Antietam Battlefield with cast iron tablets, one iron tablet, 15" by 18", was mounted on the outer wall, to the right of the main door. This minor modification of the exterior is evident in photograph number 9 of this report.

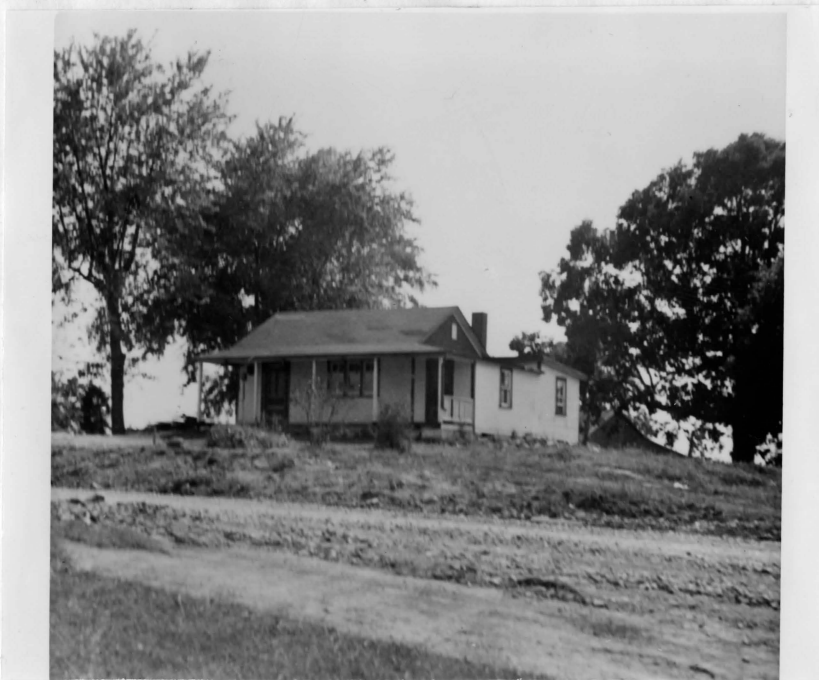
Photograph No.10. The frame dwelling erected on the Dunkard Church foundation in 1928, and occupied until 1951.

A one story frame dwelling was built upon the original foundation in 1928. This structure was in turn used as a filling station in the early 1930's, by the same owner, and then re-converted into a residence during the succeeding decade.

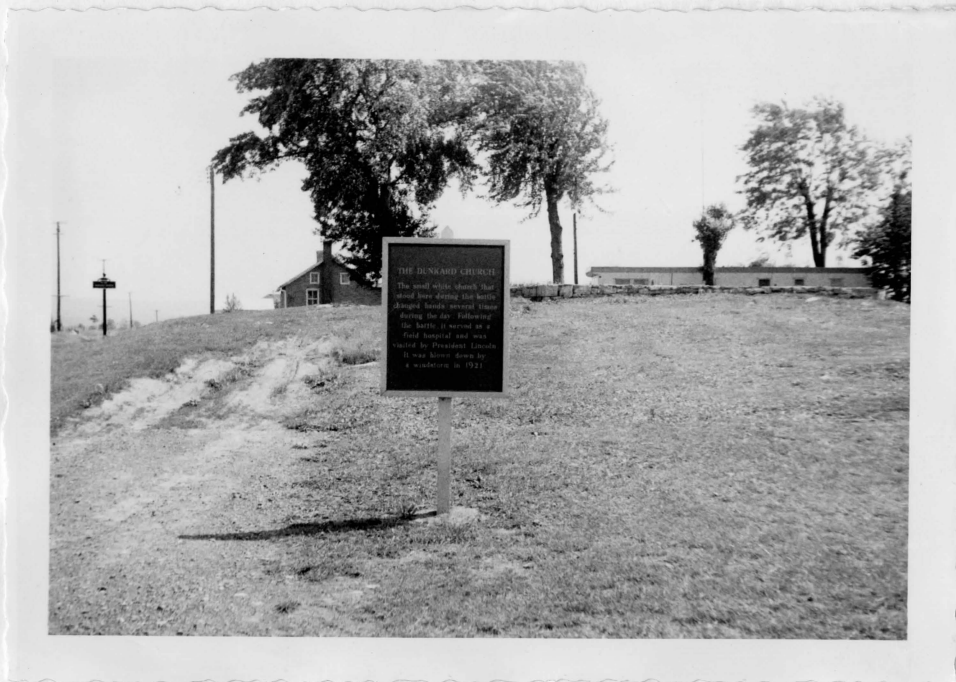
Photograph No.11. "Scotchlite" sign installed in 1959.

again as they had been in the middle 1920's. Since the National Park Service acquired the site as a gift in 1952, the foundation has remained bare and untouched, except for the minor maintenance work mentioned in the preceding part of this report. In 1959 a reflectorized "Scotchlite" sign, 32" by 40", was installed immediately behind the center of the east foundation wall, facing the highway. In February 1960, this sign was relocated at a point near the NE corner of the plot, directing the visitor's attention to the bare site, as he drives towards Sharpsburg on Maryland Route 65. (This is one of ten such modern signs on the Self Guided Tour Route on the Battlefield today.)

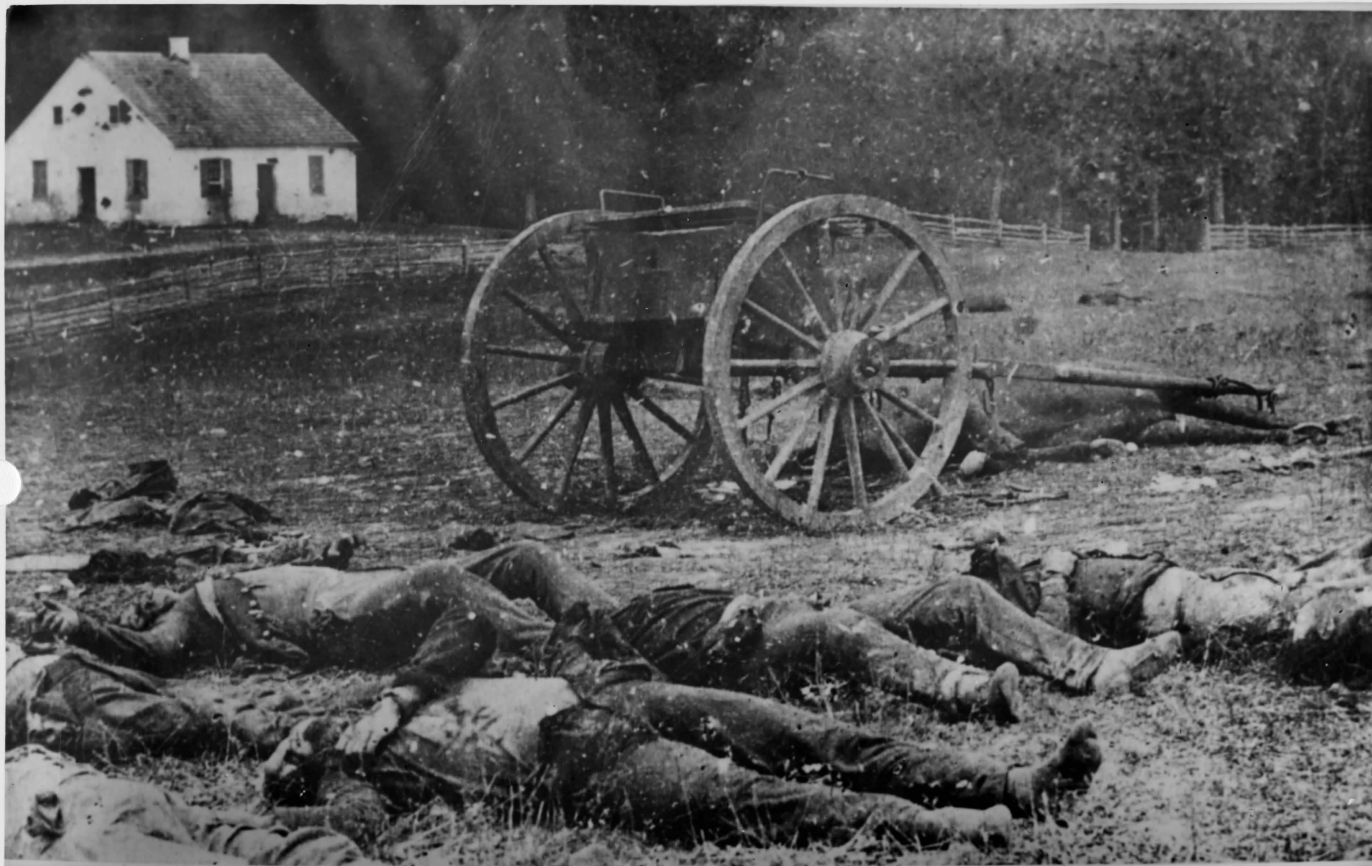
Photograph No. 12. Brady photograph of the Dunkard Church taken shortly after the battle of September 17, 1862.

in its white-washed walls. Several artillery projectiles had also smashed into its walls. The roof, too, had a multitude of holes in it. A section of the ridge pole just south of the chimney had been shot away. At some time during the morning a number of heavy shells from the Union 20-pounder Parrotts east of the Antietam, aimed at J. E. B. Stuart's light horse batteries on Nicodemus Hill about a mile NW of the church, fell short of their long range target and exploded in the south gable wall of the Dunkard Church.
