# Water Quality Monitoring for the Rito de los Frijoles and Capulin Creek in Bandelier National Monument

## *2014 Summary Report*

Natural Resource Data Series NPS/SCPN/NRDS—2017/1133

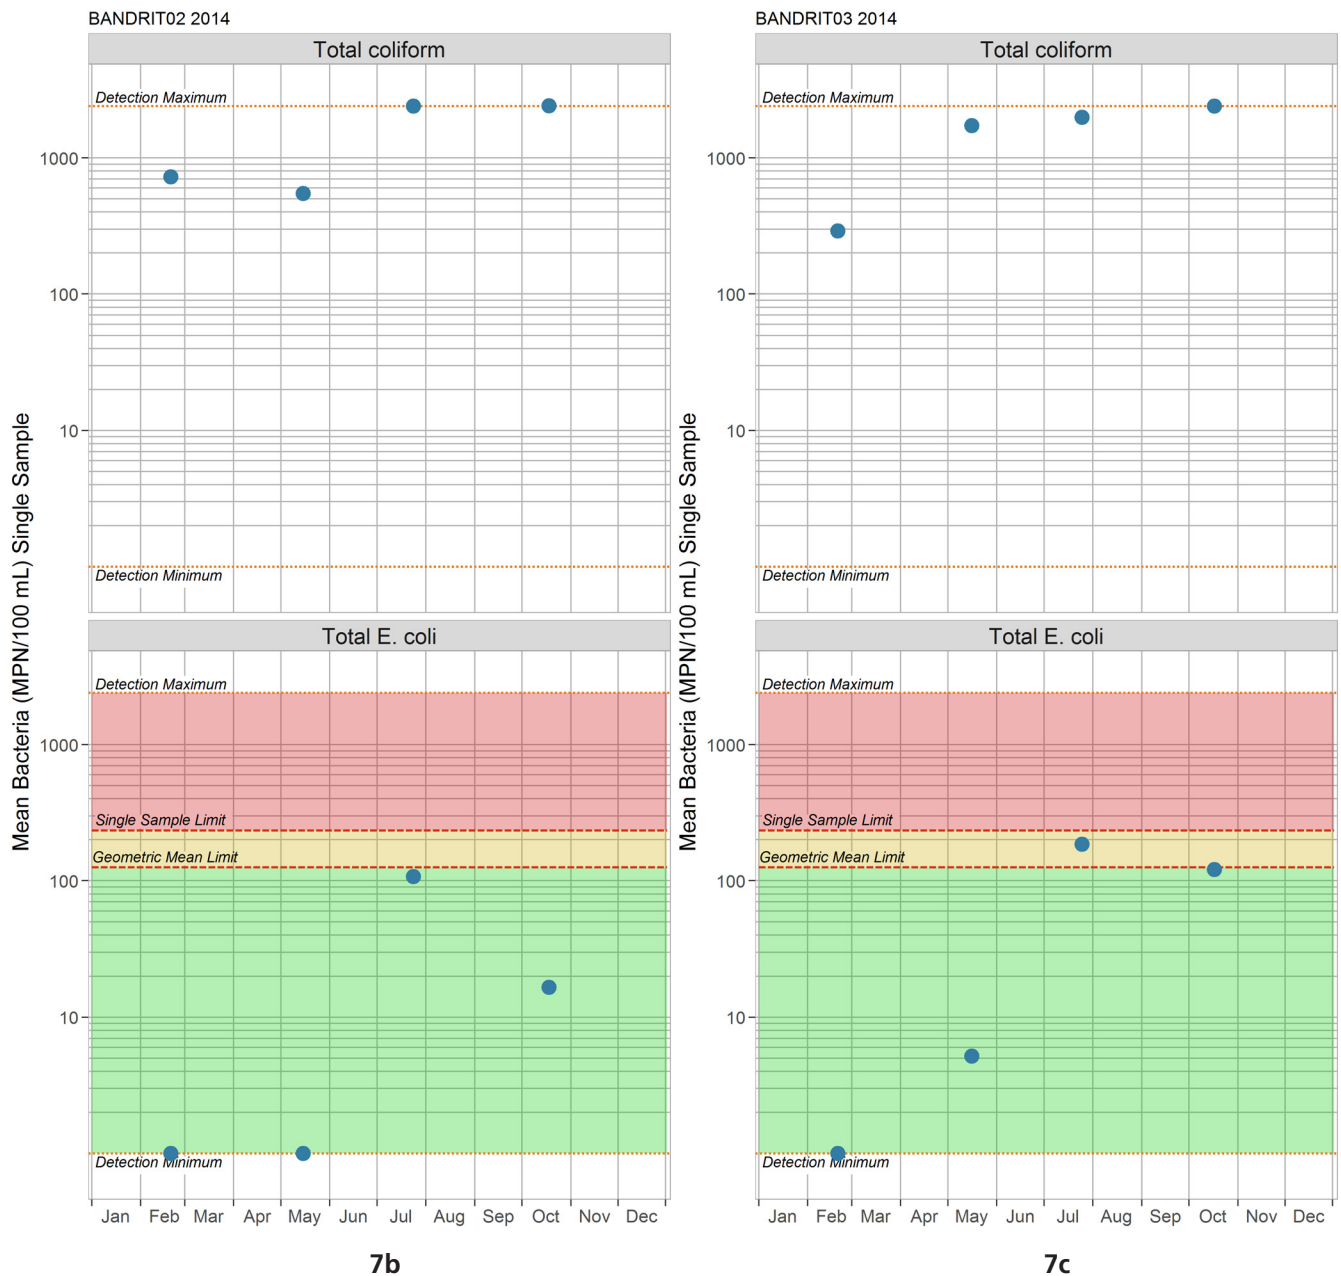
**Figure 7a**  
See caption next page.

Figure 7. Total coliforms (top) and *E. coli* (bottom) in samples collected from RIT01 (7a), RIT02 (7b), and RIT03 (7c) on the Rito de los Frijoles in Bandelier NM, 2014. *E. coli* results were <1 MPN/100 mL in the following samples: RIT01, 11/17/13 and 2/20/14; RIT02, 2/1/13, 5/22/13, 2/20/14, 5/15/14; RIT03, 2/2/13 and 2/20/14.

Bacteria results from RIT01, RIT02, and RIT03 in 2014 are plotted in Figure 7. Numeric results with dates and times for 2014 are presented in Appendix B. Four samples were collected at each site. Total coliforms include bacteria that are both vegetative and fecal in origin, and are indicators of the presence of all coliform groups of bacteria. While there are no surface water quality criteria for total coliforms, they are used in drinking water testing to indicate contamination from an outside source. Total coliforms were highest at RIT01; results ranged from 1400 to greater than 2400 MPN/100 mL and three of the four samples exceeded 2400 MPN/100 mL, which is the upper limit of the IDEXX test. At RIT02, the range was 550 to greater than 2400 MPN/100 mL. At RIT03, the range was 290 to greater than 2400 MPN/100 mL. At both these sites, one sample exceeded 2400 MPN/100 mL.
