THE WARD HOUSE  
BLOODY LANE  
ANTIETAM NATIONAL BATTLEFIELD  
near, Sharpsburg, Maryland

prepared for  
Virgil Leimer  
Superintendent  
Antietam National Battlefield

11 May 1981

by  
Douglass C. Reed  
Preservation Associates, Inc.  
Box 202  
Sharpsburg, Maryland

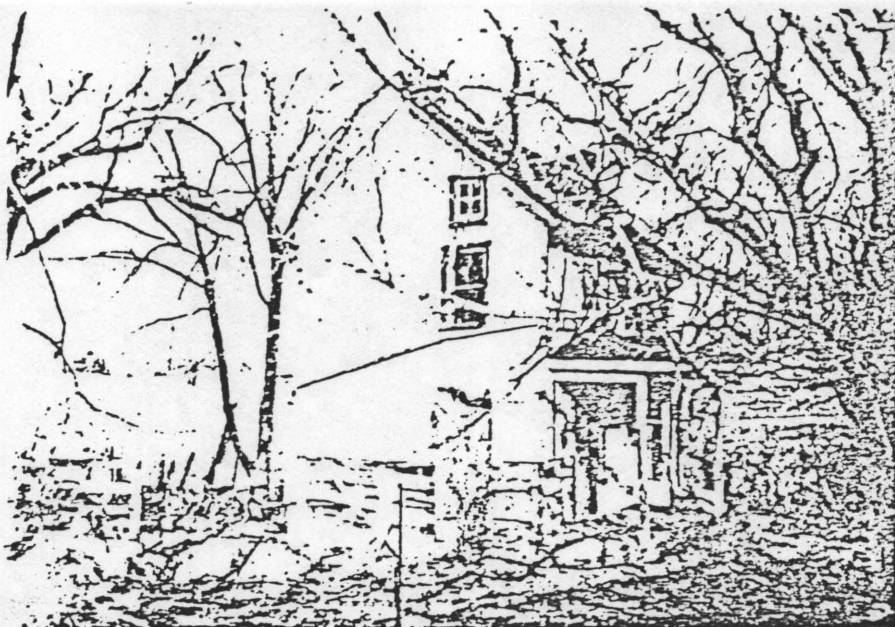
Plate 4

View looking east. Two first floor windows are covered by plywood.

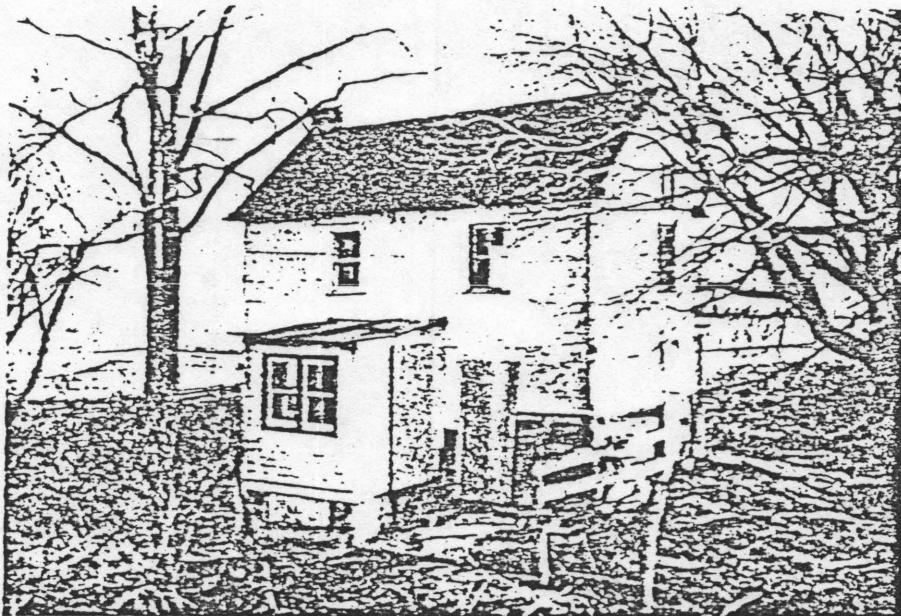
Plate 9: North corner, northeast elevation and small room addition with plywood over rear entrance.

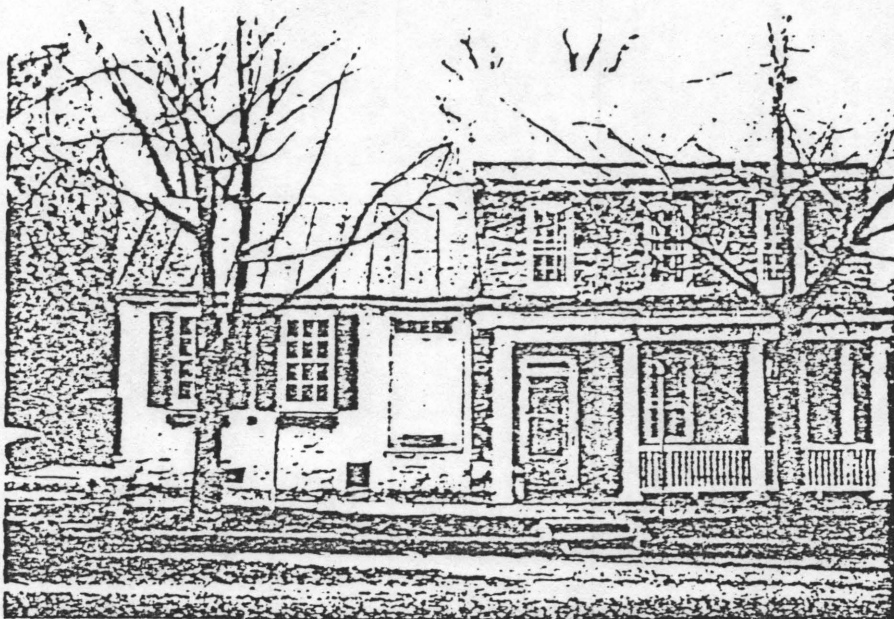
Plate 14: M. Howell Davis House, 201 W. Main St., Sharpsburg, Md. ca. 1850 post and log addition to stone house.

Also, the front elevation shows only a modicum of formality. Though it is a typical three bay, window-door-window arrangement, there is no equal spacing between the bays and the openings of the first floor do not align with those of the second. It seems that Ward was more concerned with the interior function than the exterior arrangement. The three other log buildings exhibit more formal and neater principal facades than the Ward House. (refer plates 14 and 15 on page 27).

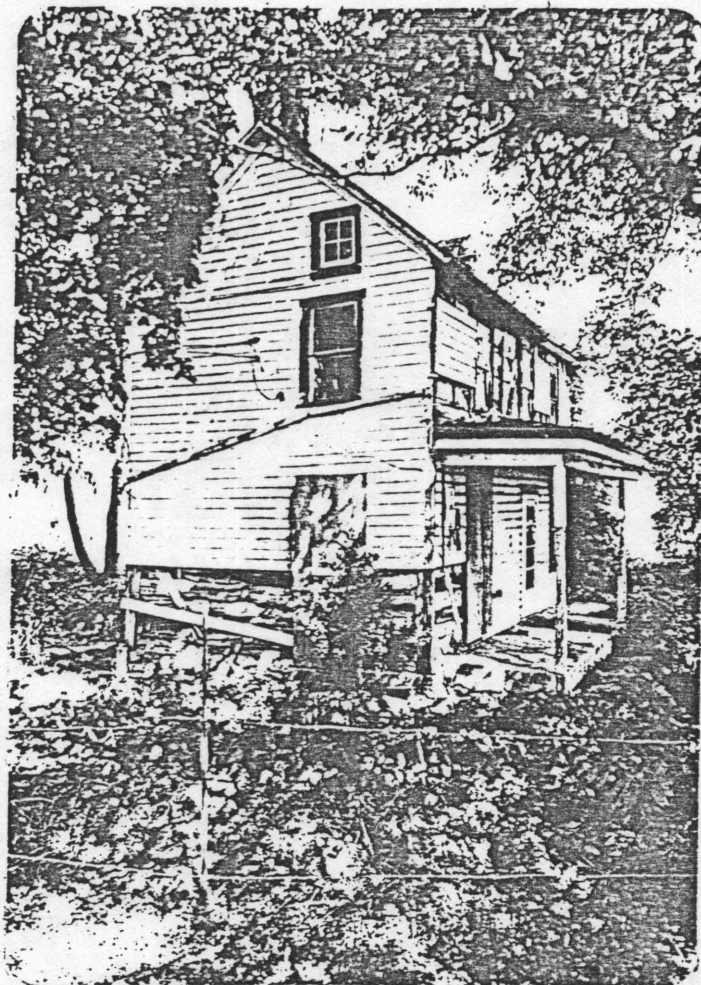
General view of Ward-Lohman log house, looking east and plan of first floor showing locations of following photographs
