# Wildlife Friendly Fence Project on Craters of the Moon National Monument and Preserve 2009-2017: Final Report

Todd C Stefanic      2017

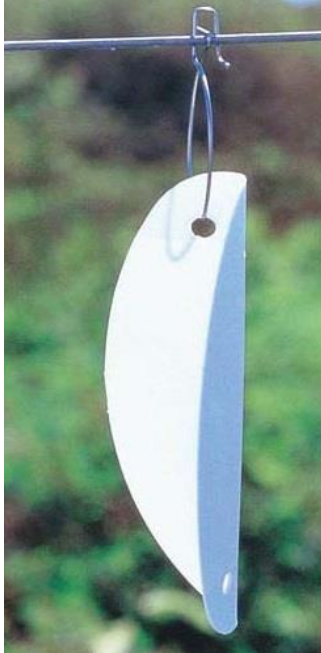
**Figure 5. Fence Flag**

This fence design was modified slightly by using smaller fence markers (white vinyl siding trim cut into ~3" strips and covered with chrome reflective tape) (Figure 6). It took some experimentation to find a fence marking system that would work. Originally, Fence Flags (Figure 5) were used but it was found that the wind blew them to the nearest T-post or they slid down the wire if the fence was on a slope. Moving them to the barbwire also proved ineffective because the cattle chewed on them and pulled
