**Project Title: Impoundment Restoration Evaluation and Sediment Elevation Monitoring**

Final Project Report

September 2017

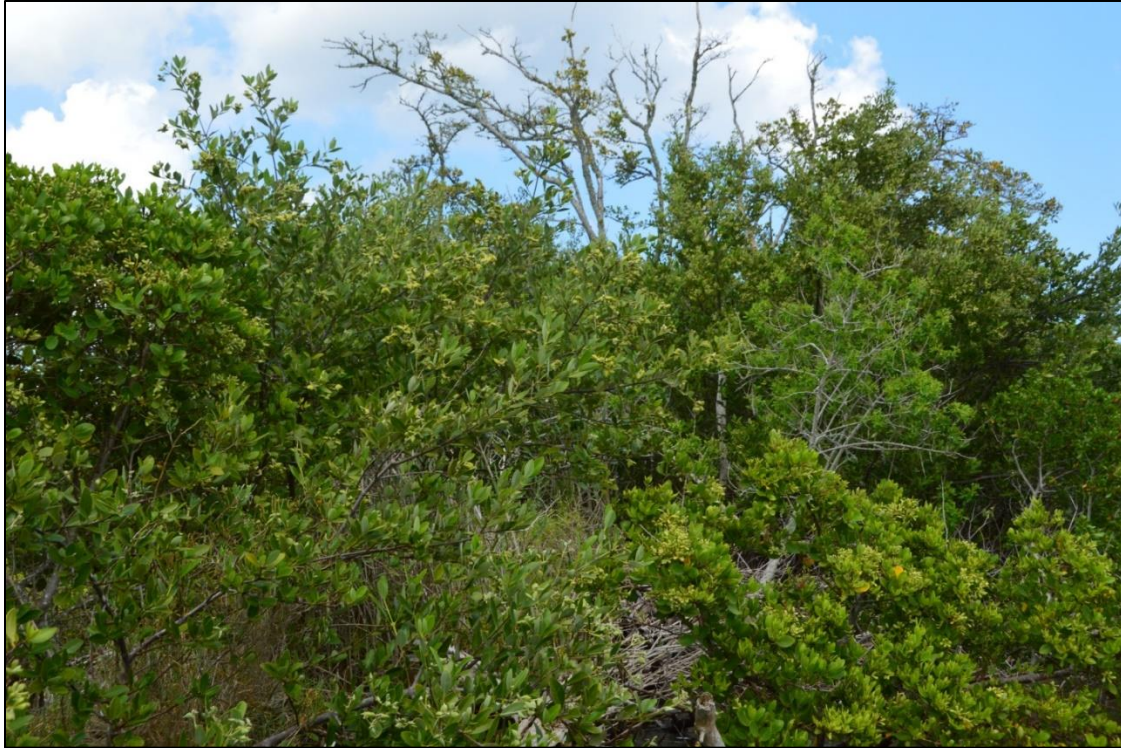
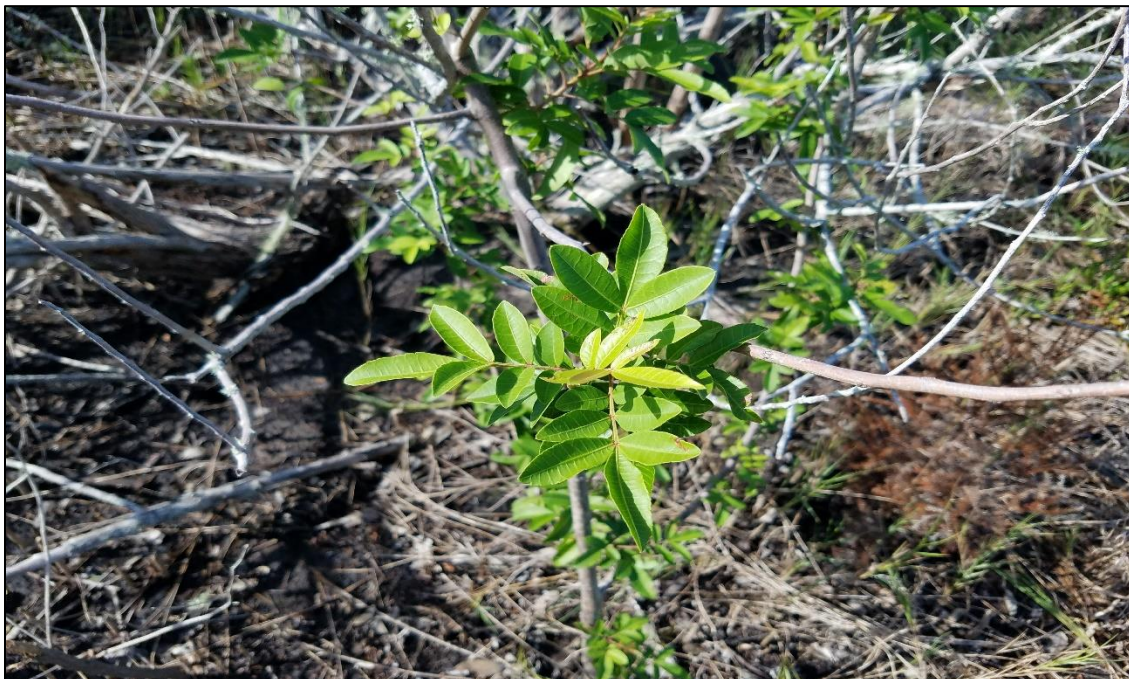
a) C-21CS

b) D-12S2

Figure 3. The overall distribution and abundance of Brazilian pepper at restored mosquito impoundments was low, however, some impoundments (C-21CS (a), D-12S2 (b)) had scattered trees remaining on the restored wetland.

All sites monitored in summer 2017 were not inundated at time of data collection, however, soil moisture was over 90% for all sites and times since restoration (Table 2). Soil salinities ranged between 20.1 ppt and 42.2 ppt, with the lowest observed salinities at the C-12D impoundment in the Banana River sites (Table 2). Maximum change in elevation ranged between 9 cm and 25 cm, with the greatest change observed at D-12S2 sites restored during 2004. This was also the only restored site during this monitoring period to have Brazilian pepper in the restored area (Figure 3).

Increases in percent cover occurred through new recruitment as well as expansion of initial colonizers, particularly *Sarcocornia perennis* and *Batis maritima*, which continue to be found at all restored impoundments and natural wetlands. Increased densities and sizes of mangroves were also observed at all impoundments and restored wetlands, with *Avicennia germinans* being the most common mangrove species at all monitored sites (Figure 9). In general, species richness tended to be highest in the early stages of recovery (0-5 years) and showed a decreasing trend as time since restoration increased (Figure 10). Restored impoundments with longer recovery times had high abundances of medium (75 cm to 125 cm) and large (> 125 cm) mangroves and the common halophytes, *S. perennis* and *B. maritima*, whereas impoundments with shorter recovery times had a greater variety of species, including halophytic grasses (*Distichlis spicata*, *Spartina alterniflora*), succulents (*Sesuvium portulacastrum*), and small shrubs (*Borrichia frutescens*). The only non-native species observed at restored impoundments was Brazilian pepper. C-21CS, C-20B, T-18B, D-12S4, T-37B and T-35 had Brazilian pepper growing in the interior wetlands; however, Brazilian pepper was only observed in the restored wetland area of C-21CS, D-12S2, and D-12S4 (Figure 3).

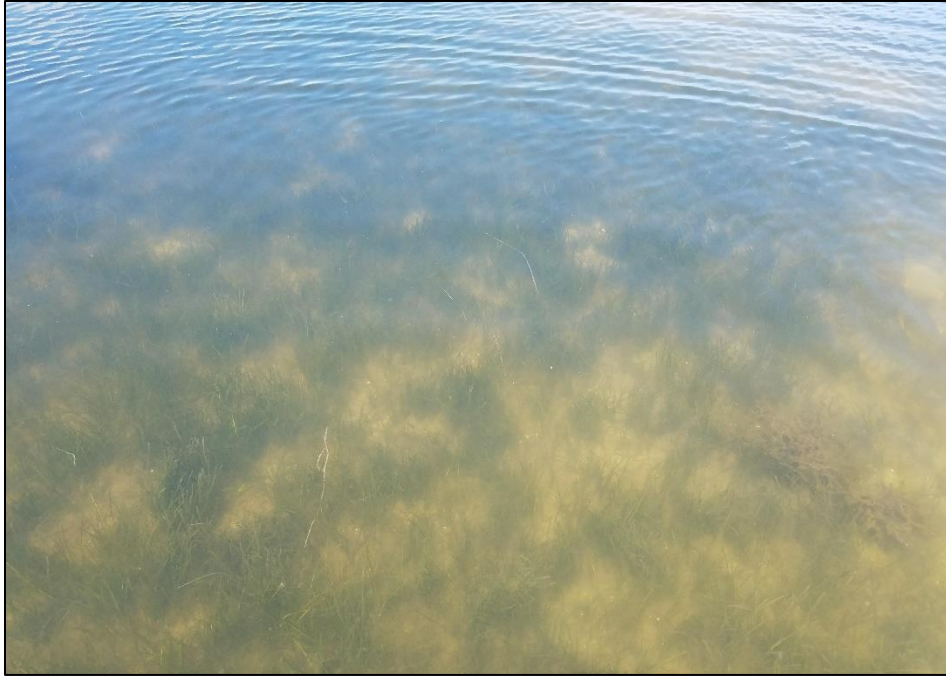
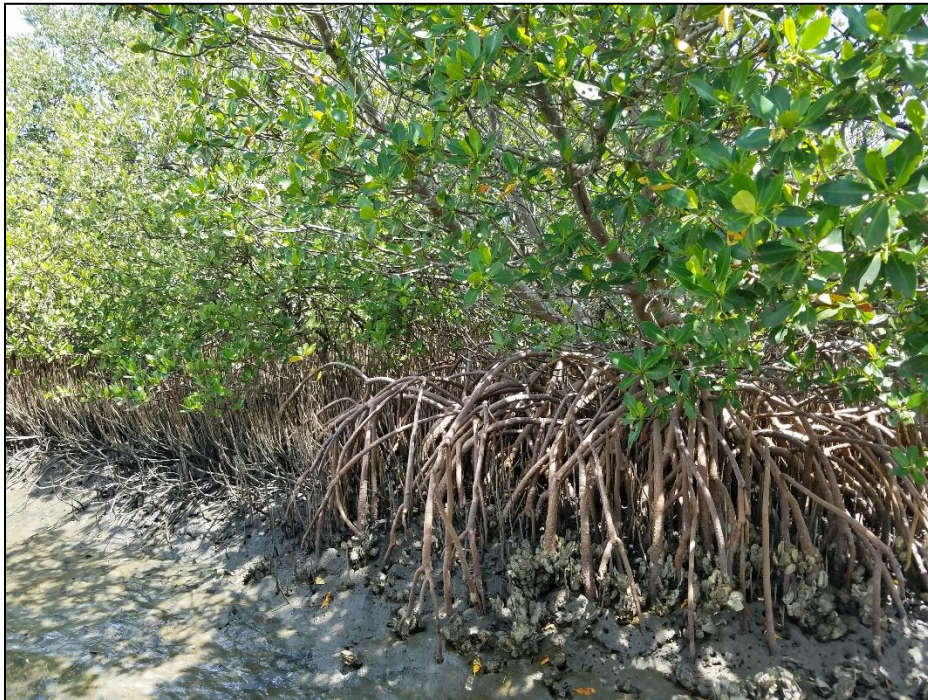
a) Seagrass near T-39S

b) Oysters attached to mangrove roots along shoreline of C-8

Figure 6. Mosquito impoundment restoration has also benefitted habitats adjacent to wetlands, including seagrass (a) in the southern region of our monitoring area and oysters (b) in the northern region.

In the subtidal zone, seagrass was observed along the shoreline of twelve of the restored impoundments (D-12S, T-42, D-12N, T-41, T-43, T-45, V-1, V-2, V-5, C-21CN, T-39S, T-37B) and three control wetlands (V, D-12S, D-12N) (Figure 6a). Mean percent cover of seagrass ranged from 13% (D-12N) to 100% (V-2). In addition to seagrass along the estuarine shoreline of restored wetlands, we also observed seagrass in the remnant borrow ditches at V-impoundments and D-12S impoundments, with percent cover ranging from 25% to 55%. Oysters were observed at one natural wetland (D-12N) and two restored impoundments (D-12N, C-8) in the lower intertidal zone and attached to red mangrove roots at the shoreline (Figure 6b).

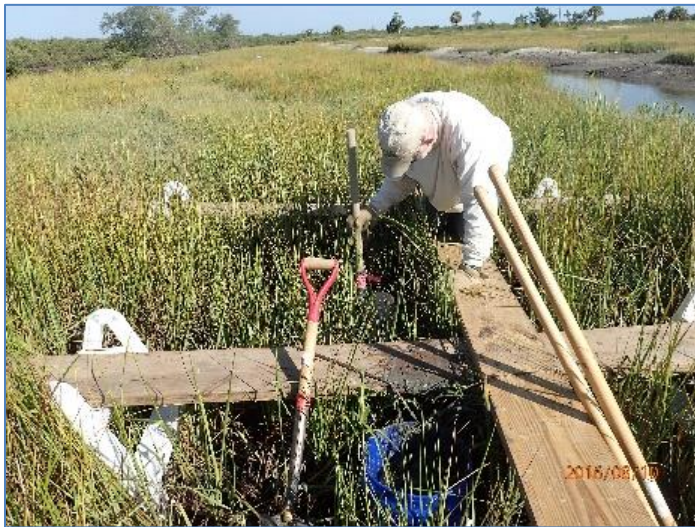
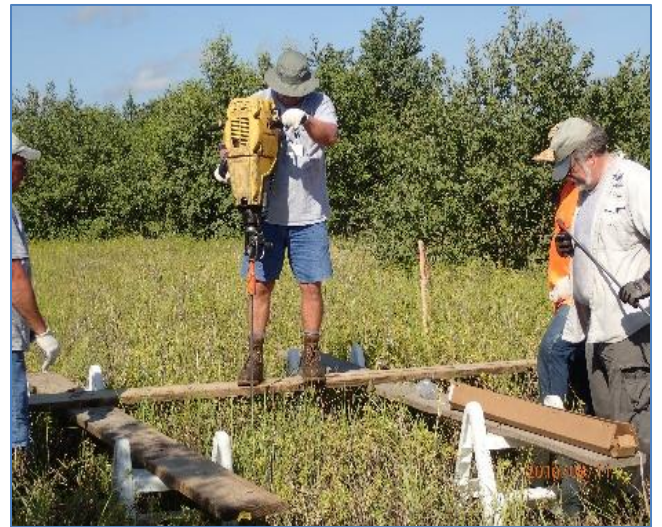
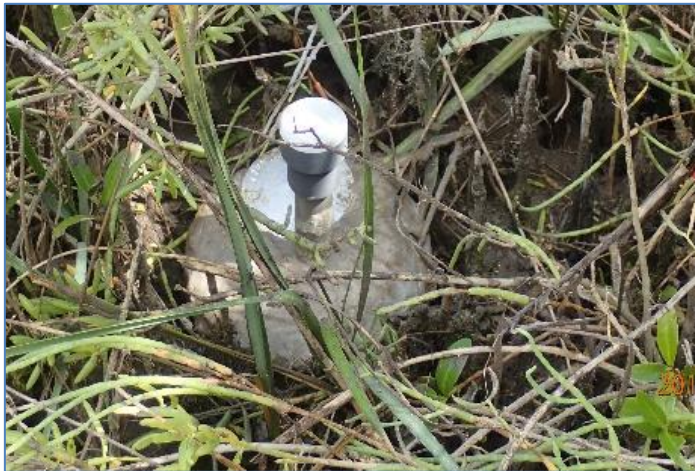
Figure 12. New SET stations were installed in the Marine Discovery Center restored wetland and in adjacent natural wetlands.

Six new SET stations using updated methodology were installed near the restored marsh at Marine Discovery Center in New Smyrna Beach in August 2016 (Figure 12). Three stations were installed on the isolated island within the restored marsh at the Center and three stations were installed in adjacent unimpacted marshes near restored marsh. Initial readings were completed in fall 2016 and first reading was completed in summer 2017.
