# United States Department of the Interior

February 2018

To: Kevin Doniere, Landscape Architect, Alaska Regional Office  
From: Peter Sharpe Ph.D., PWS, Hydrologist, Northeast Region  
Subject: Wetland Delineation Report for Travel, Ghiglione Bridge Replacement, Denali National Park & Preserve

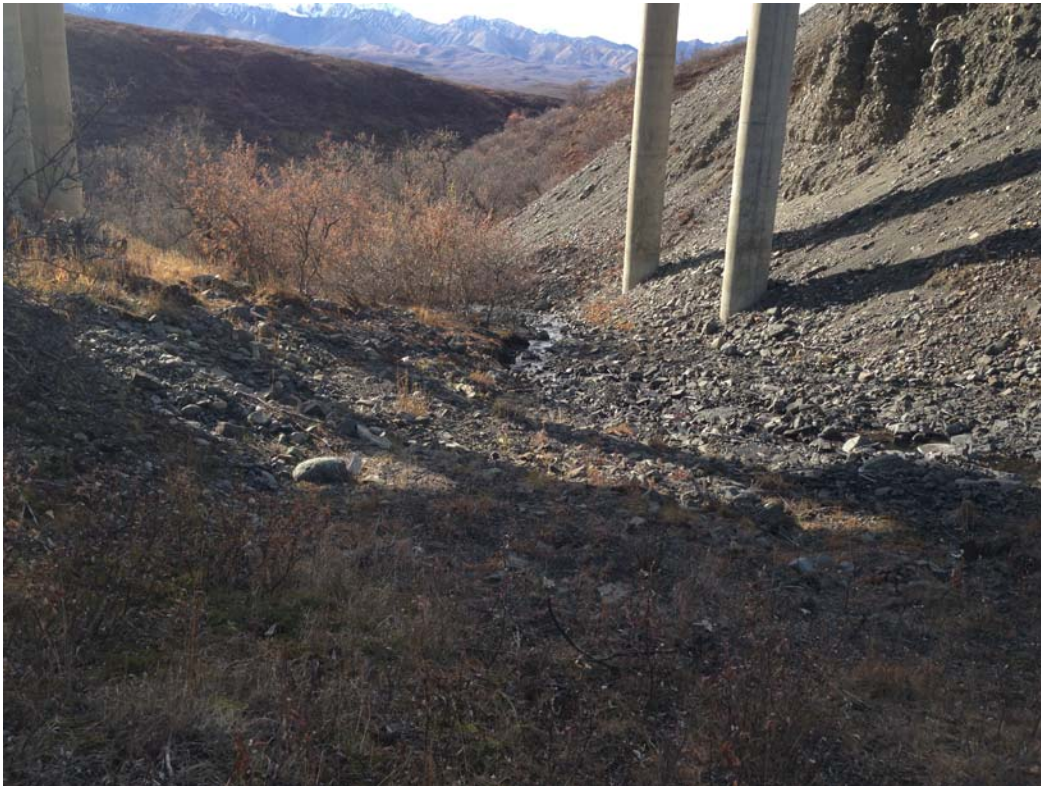
Photograph 1. Photo looking south at the mapped riverine wetland feature and a pair of the existing bridge supports of the Ghiglione Bridge at DENA. September 2017

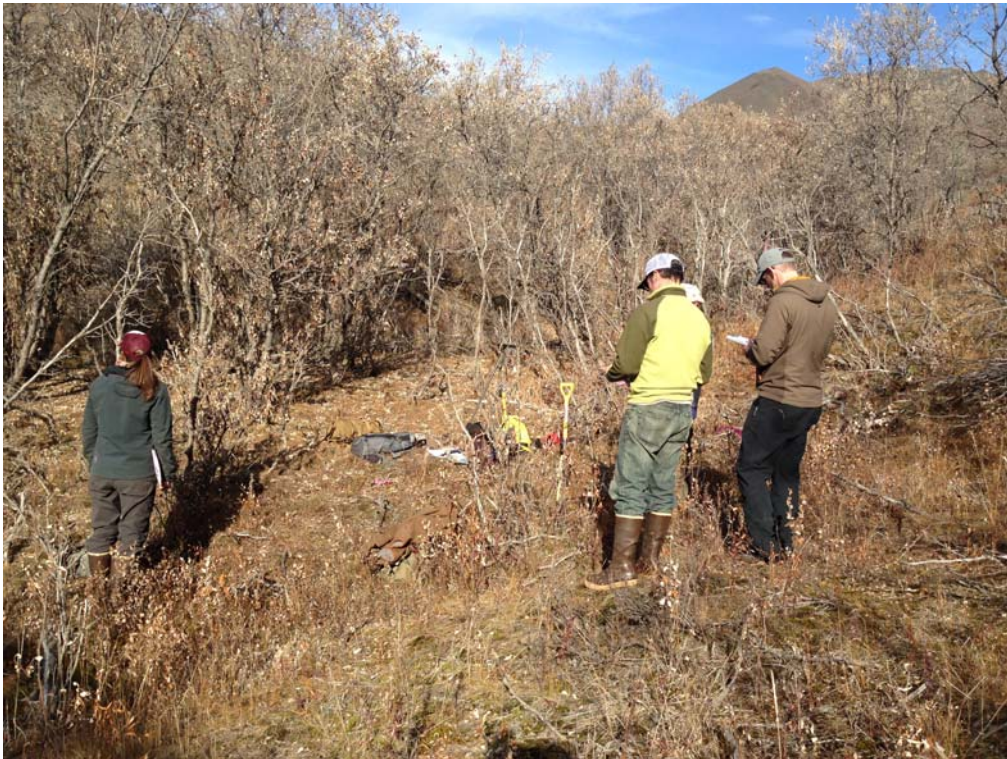
**Wetland 1 (Size – 0.02 ac):** This wetland ecosystem lies within the eastern floodplain of the mapped riverine (waterway) system which flows beneath the Ghiglione Bridge on its southwesterly path to the East Fork of the Toklat River. Site soils were extremely stony and appeared to be generally consistent with the USDA soil survey mapping data which listed this area as having Alpine Lower Mountain Slopes and Fans with Discontinuous Permafrost (7V1). The sites overall plant community also generally conformed to the Boggs et al. (2001) vegetation classification of the Low Shrub-Sedge Landcover Class. Within the Cowardin et al. (1979) classification scheme this wetland is considered characteristic of a scrub-shrub, broad leaved deciduous, seasonally flooded/saturated (PSS1E) habitat. Groundwater within the upper 12 inches of the wetland test pit was observed and appeared from field observations to be comprised of subsurface stream flow from the adjacent riverine feature. Wetland soils were low value/chroma (10YR 2/1) but problematic and determined to be indicative of low organic-carbon content based on the USACE Alaska Regional Supplement protocol. Given the

proximity of this site to the adjacent riverine system (Photo 2), as well as, it's topographic position within the landscape this wetland likely receives the bulk of its hydrology from a combination of flooding, subsurface water exchanges from the adjacent waterway, and some groundwater interception from the adjacent hill side. The dominant plant species observed within the wetland at the time of the investigation were *Salix alaxensis*, *Salix barclayi*, and *Equisetum arvense*.

Photograph 2 – Wetland 1 (PSS1E) view facing north. Photo September 2017 – P. Sharpe.

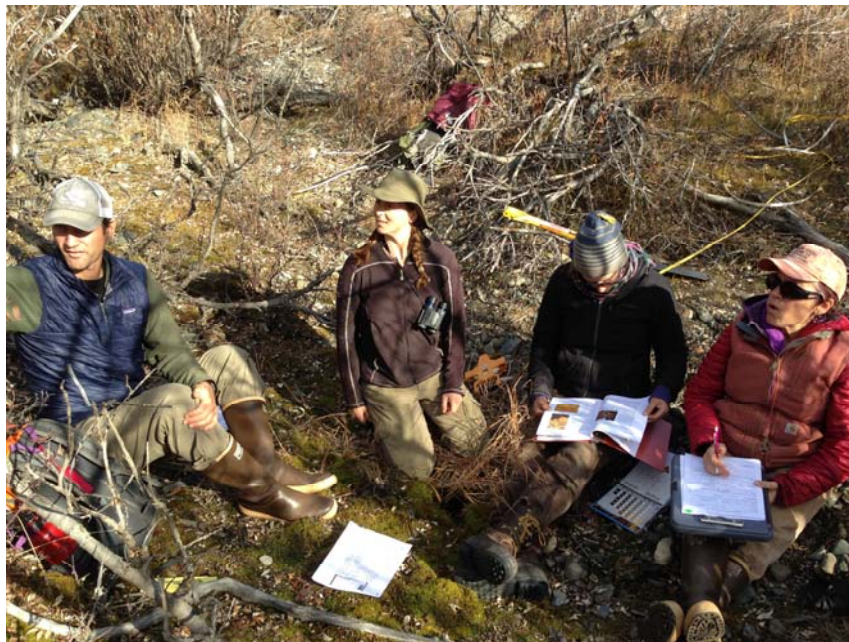
**Wetland 2 (Size – 0.03 ac):** Wetland 2 was almost the mirror image of wetland 1 in terms of size, plant community, and geomorphic position. As shown on Fig.1 this site lies within the western floodplain of the mapped riverine tributary to the East Fork of the Toklat River. Wetland 2 soils were less stony compared to wetland 1 with textures ranging from sandy loams to sandy clay at deeper depths (6-16 inches). Like wetland 1 - the sites overall plant community also generally conformed to the Boggs et al. (2001) vegetation classification of the Low Shrub-Sedge Landcover Class and shared the same Cowardin et al. (1979) class (PSS1E). Saturation and a high groundwater table were also observed within the wetland test pit, however, it appeared that the source of water was primarily from groundwater sources rather shallow sub-surface flows from the adjacent riverine system as in wetland 1. Soils within the 6-16 inch layer were gleyed (GLEY 1 3/N) but deemed problematic due to low organic-carbon content based on the USACE Alaska Regional Supplement protocol. The dominant plant species observed within the wetland at the time of the investigation were *Salix alaxensis*, *Salix barclayi*, and *Equisetum scirpoides*.

Photograph 3 – Wetland 2 (PSS1E) view is northeast looking at the wetland and its primary survey team. Photo Date September 2017 – P. Sharpe.

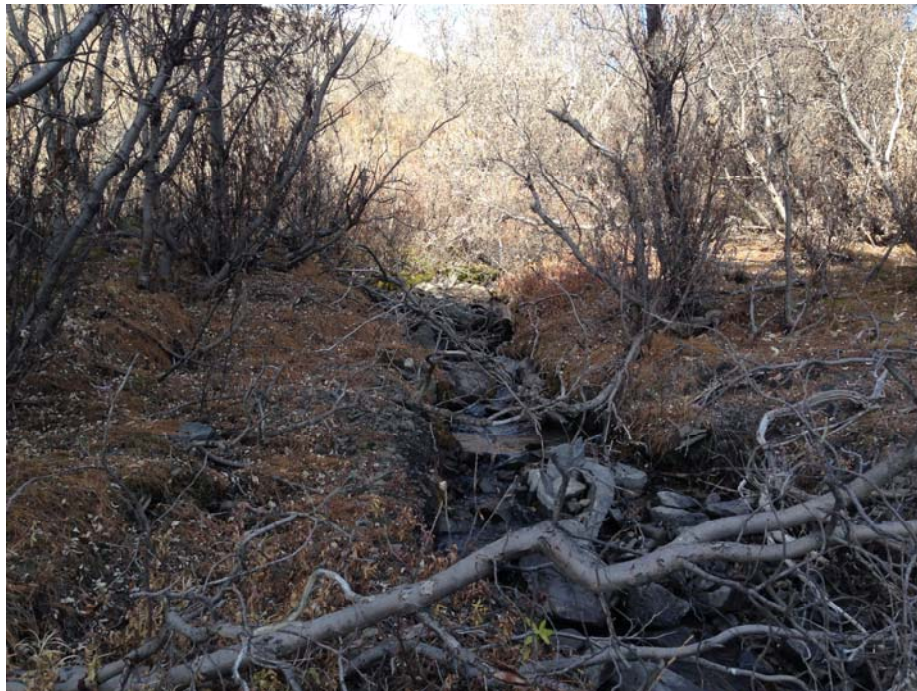
Riverine wetlands as defined in Cowardin et al. (1979) includes all wetlands and deepwater habitats contained within a channel unless that wetland is dominated by trees, shrubs, or persistent emergents, emergent mosses, or lichens or is contained within water possessing ocean derived salts in excess of 0.50 ppt. Cowardin et al. (1979) further defines the definition of a channel as “an open conduit either naturally or artificially created which periodically or continuously contains moving water, or which forms a connecting link between two bodies of standing water. “The mapped riverine feature within the Ghiglione Bridge study area was an unnamed tributary to the East Fork Toklat River.

This feature exhibited characteristics of a riverine, intermittent, stream bed system (R4SB). The flow regime of the waterway was determined based off of the presence of a defined bed and banks, natural channel substrates, and the lack of two or more obligate aquatic taxa at the time of our survey. Additional support for an intermittent stream flow determination came from NWI data which also listed this system as intermittent. The waterway is a first order stream originating approximately 0.93 miles north of the project area. This aquatic feature displays evidence of a high gradient system with substrates primarily comprised of cobble, gravels, and smaller boulders. This waterway appears to be generally stable with little or no signs of incision or anthropogenically driven erosion except within the vicinity of the existing bridge where it appeared as if periodic depositions of bridge embankment fill materials erode into the floodplain and stream system (see Photos 1 and 3).

Photograph 3 (P3) – Unnamed tributary to the East Fork Toklat River (R4SB) view is north looking upstream at the system and its riparian zones September 2017 – P. Sharpe.

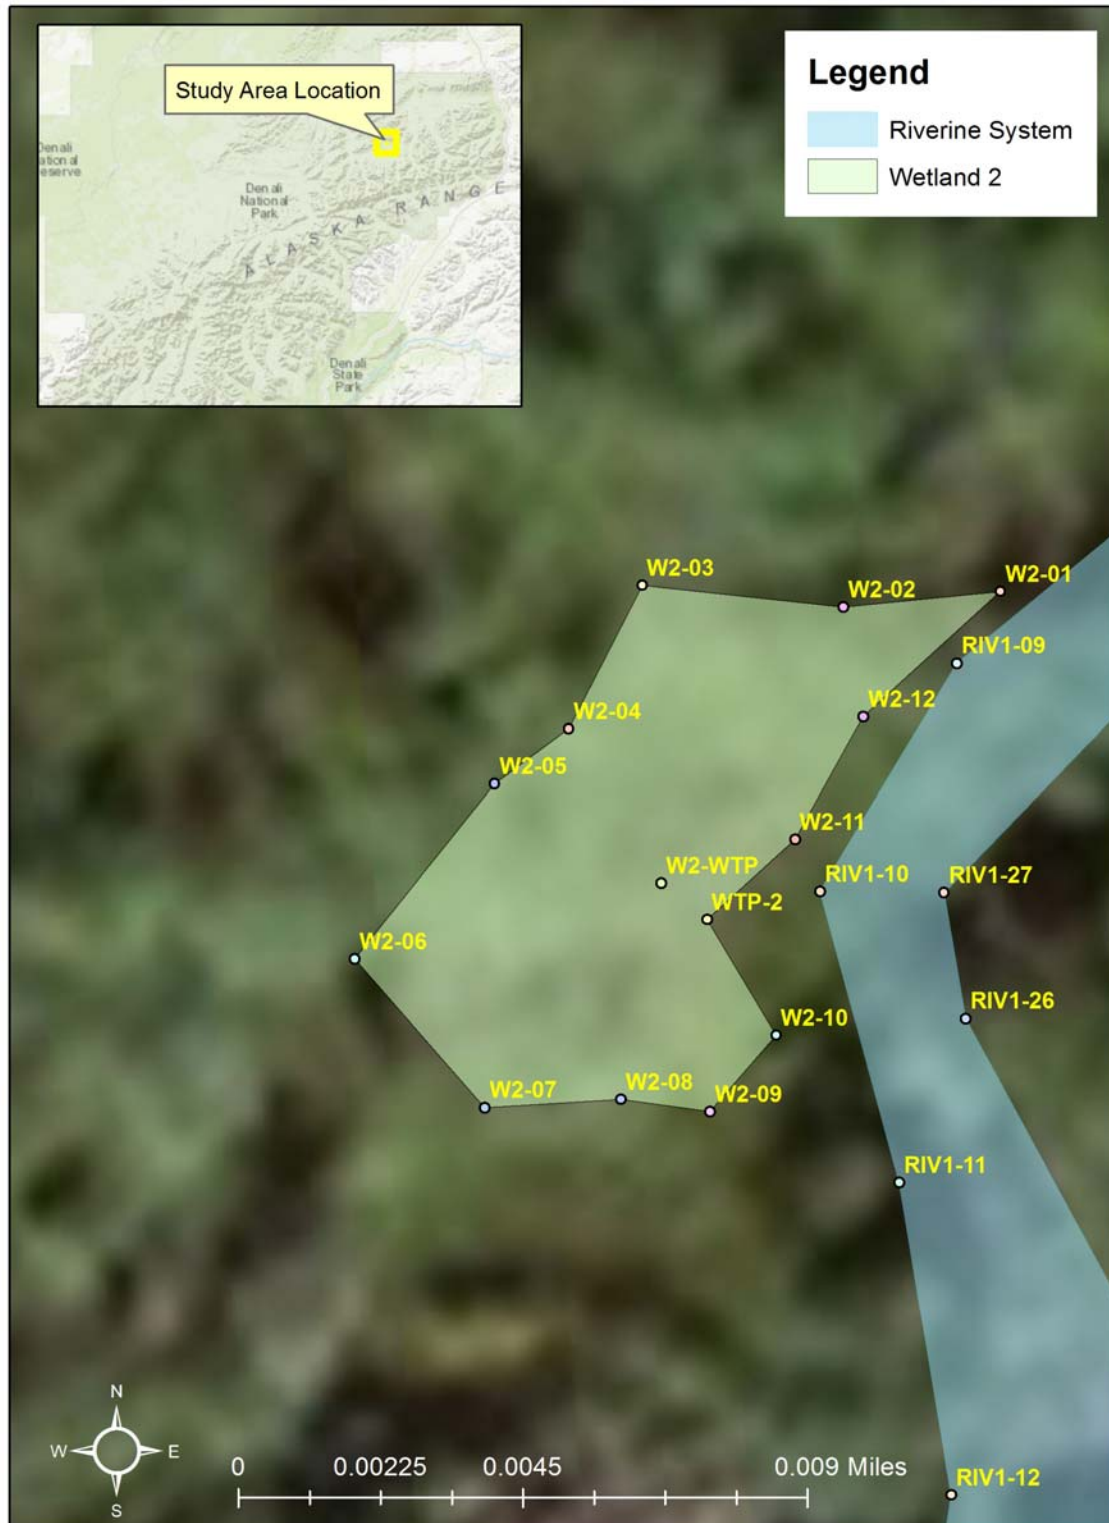
Wetland-2 showing boundary points, and wetland test pit/vegetation data collection locations (WTP/UTP) along with a portion of the riverine system.
