Historic Structures Report  
Parts I and II

Exterior Repainting of the  
Custis-Lee Mansion

June 1965

Prepared by the Staff  
National Capital Region  
and  
National Capital Office  
of Design and Construction

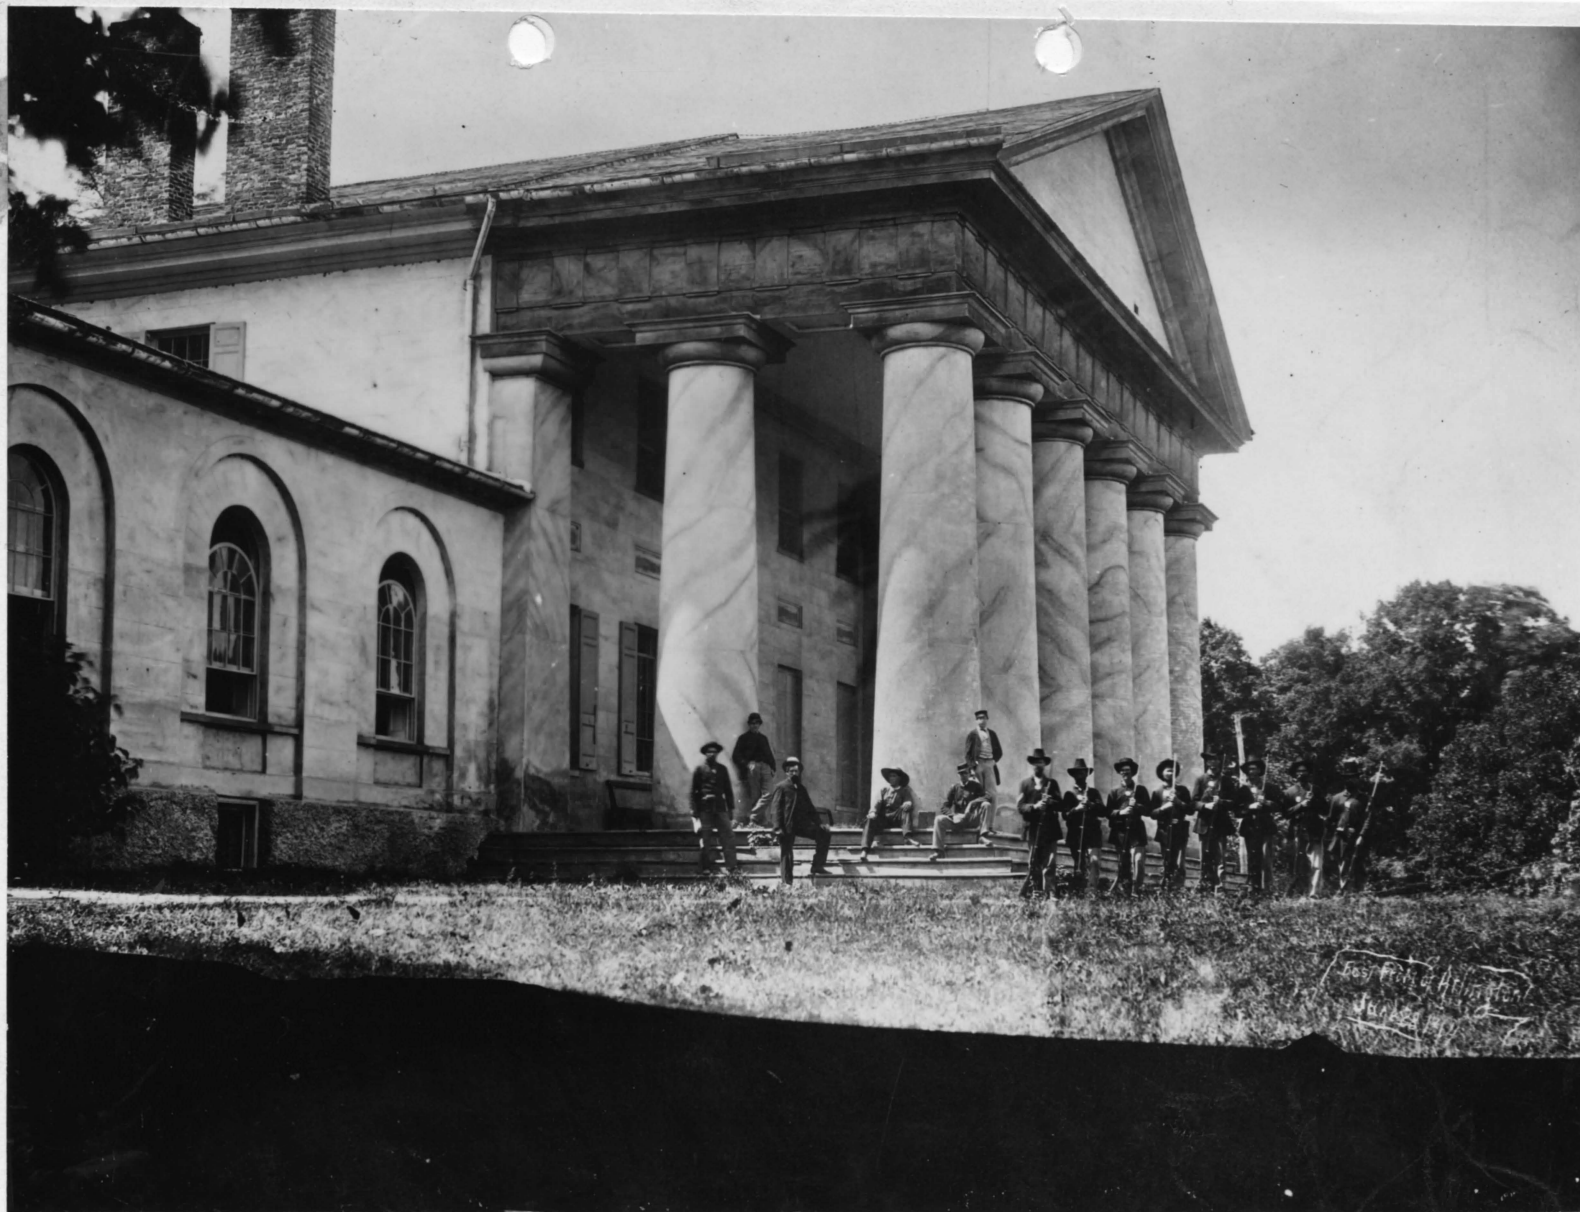
PLATE I

Arlington House from southeast. Photograph by Mathew Brady, June 28, 1864. National Archives.

Photographs taken by Mathew Brady between 1861 and 1864 constitute our most reliable evidence as to the appearance of the Custis-Lee Mansion in 1861. Definite evidence appears in three photographs taken June 28 and 29, 1864. All eight columns and both pilasters are scored twice horizontally to simulate blocks of stone. Each column and pilaster is streaked differently in each simulated drum. (See Plates I & II). The capitals of the columns and pilasters are also marbled, but their general hue is darker than the columns. The wooden entablature and cornice of the portico is also of this darker color streaked to look like stone. This treatment of the cornice ends shortly after the cornice joins the main portion of the building. There is no trace in the photographs, shown in earlier drawings of the mansion, of rusticated stucco in the pediment of the portico.

Custis' painted panels on the east front of the mansion, under the portico, are still clear in the 1864 photographs. It also appears that the rusticated stucco of the entire east front, wings included, was streaked with a contrasting color to simulate freestone. Similar sandstone and limestone was commonly used in imposing buildings such as the White House and the Capitol. If Custis intended to imitate them, then the background hue of the east walls were probably a slightly tan shade of off-white, with darker brownish-gray streaks. The 1864 photographs also hint at this treatment being used on the stuccoed sides of the center portion of the mansion, perhaps on the sides of the north and south wings, but probably not on the conservatory portion of the south wing.

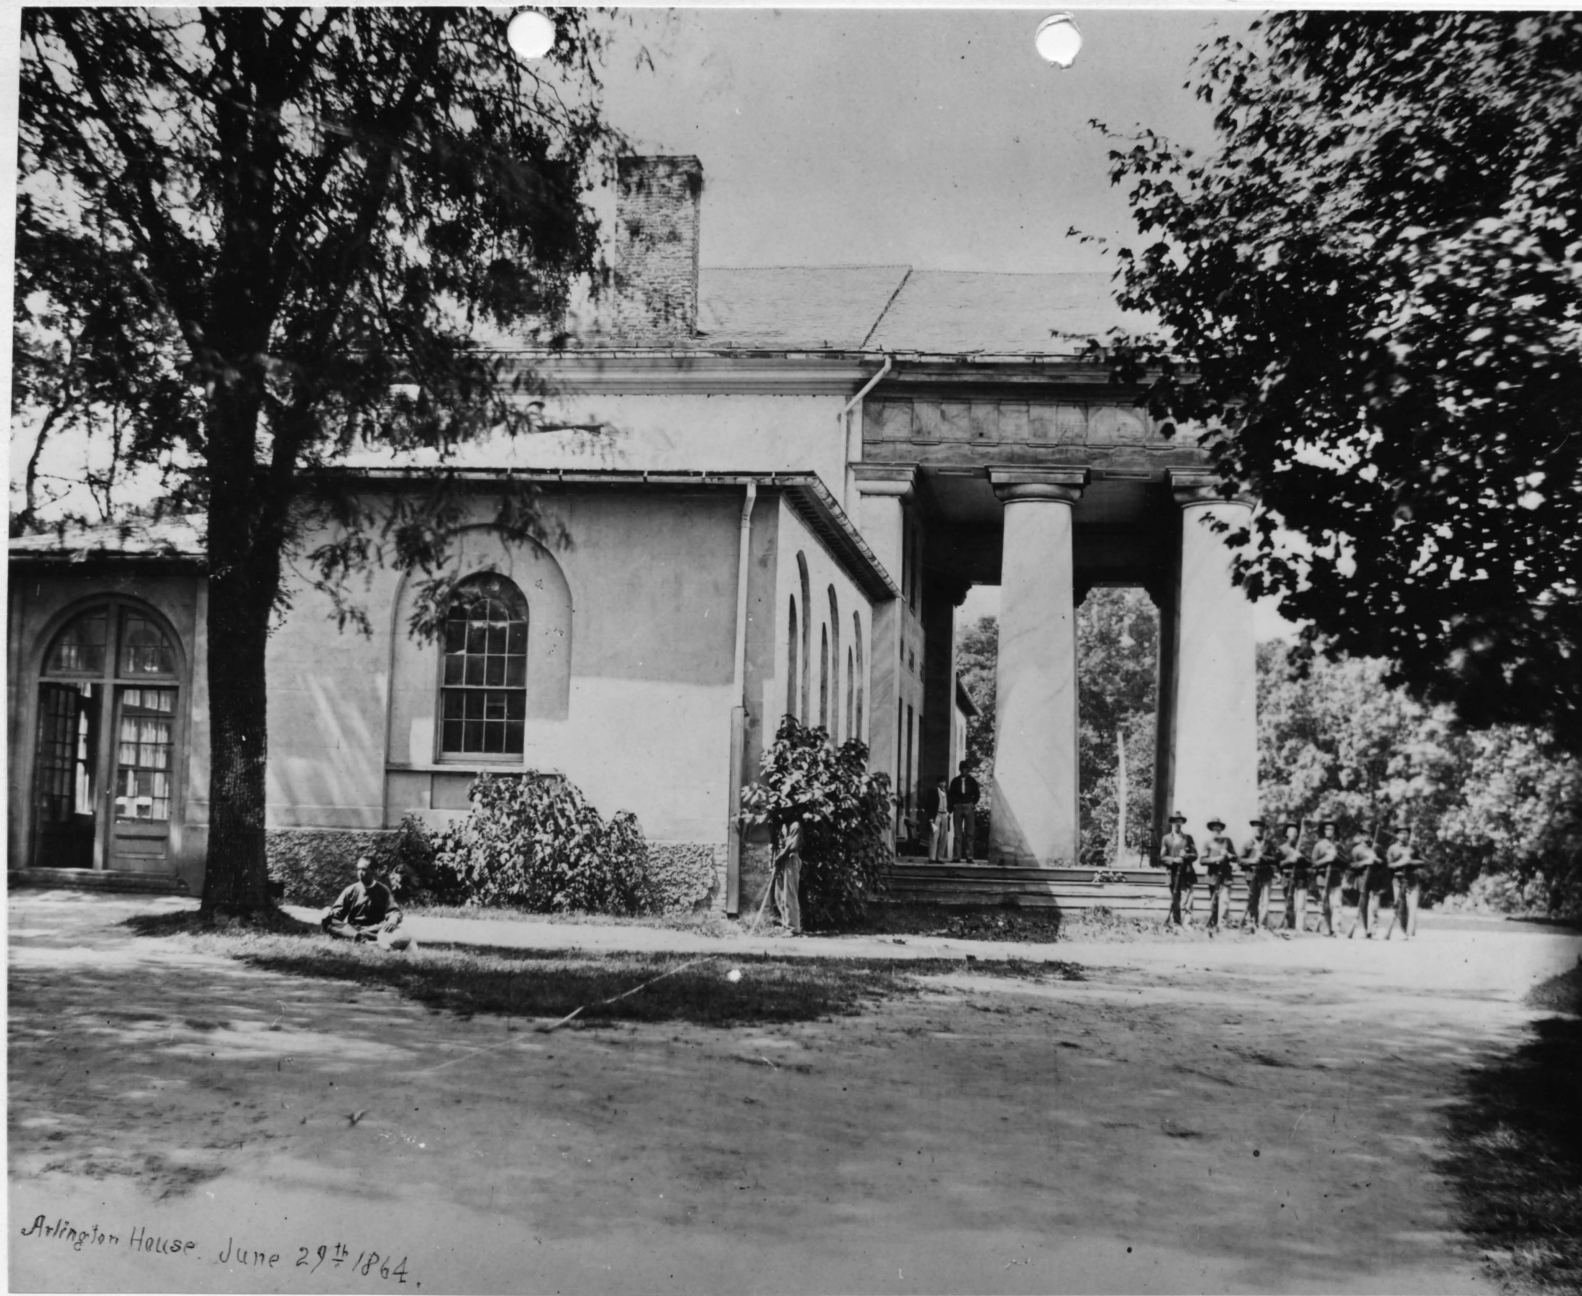
PLATE II

Arlington House from south. Photograph by Mathew Brady, June 29, 1864. National Archives.

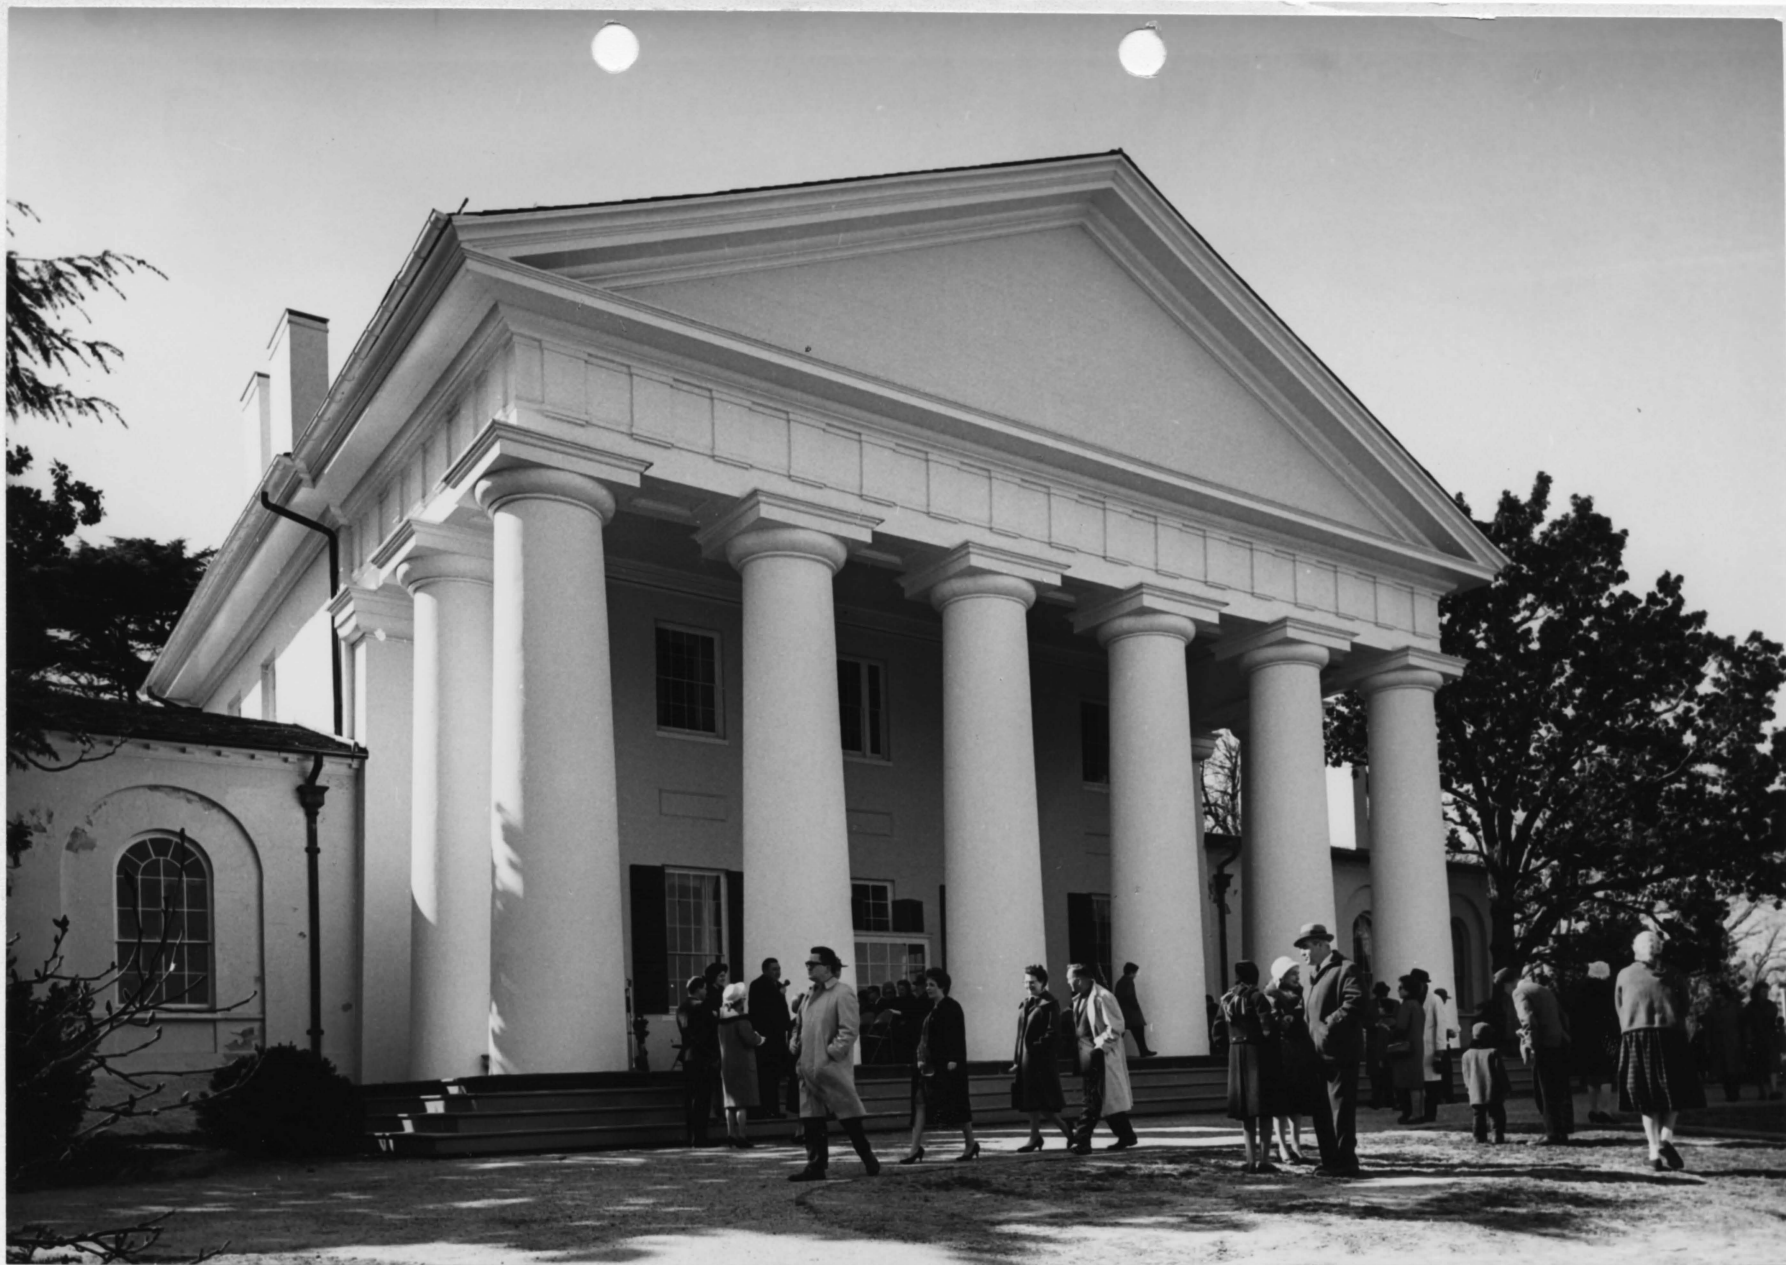
PLATE III

Custis-Lee Mansion, east front, March 1962. Note peeling paint on south wing. NPS photograph.

These conditions prevailed until the War Department began the restoration of the structure in 1928, under the authority of the act of March 4, 1925. Officers of the Quartermaster Corps collected information and began the work. A former Arlington servant, "Uncle Jim" Parks, told them that the building may have been painted with "a sort of whitewash" with yellow trim, but his recollection was questioned.<sup>7</sup> Still, the War Department did not change the cream and white colors of the mansion. These colors have remained until recently, when the surface was sandblasted. (See Plates III, IV, and VI.)

Prior to the fall of 1964, the exterior of the Custis-Lee Mansion had many thicknesses of blistering, cracking and peeling paint. The only satisfactory method for applying fresh paint was determined to include removal of the old paint. Samples of the old paint were taken by the National Capital Office, Design and Construction, of the National Park Service to the Federal Bureau of Investigation Laboratory for analysis and to establish a permanent record of what was removed. The F.B.I. Laboratory Report No. PC-82537 H.B., dated October 5, 1964, resulted. The physical evidence thus gathered, when weathering chemical and pigment changes are considered, allows that the off-white base color suggested by old photographs and documentation is reasonable.

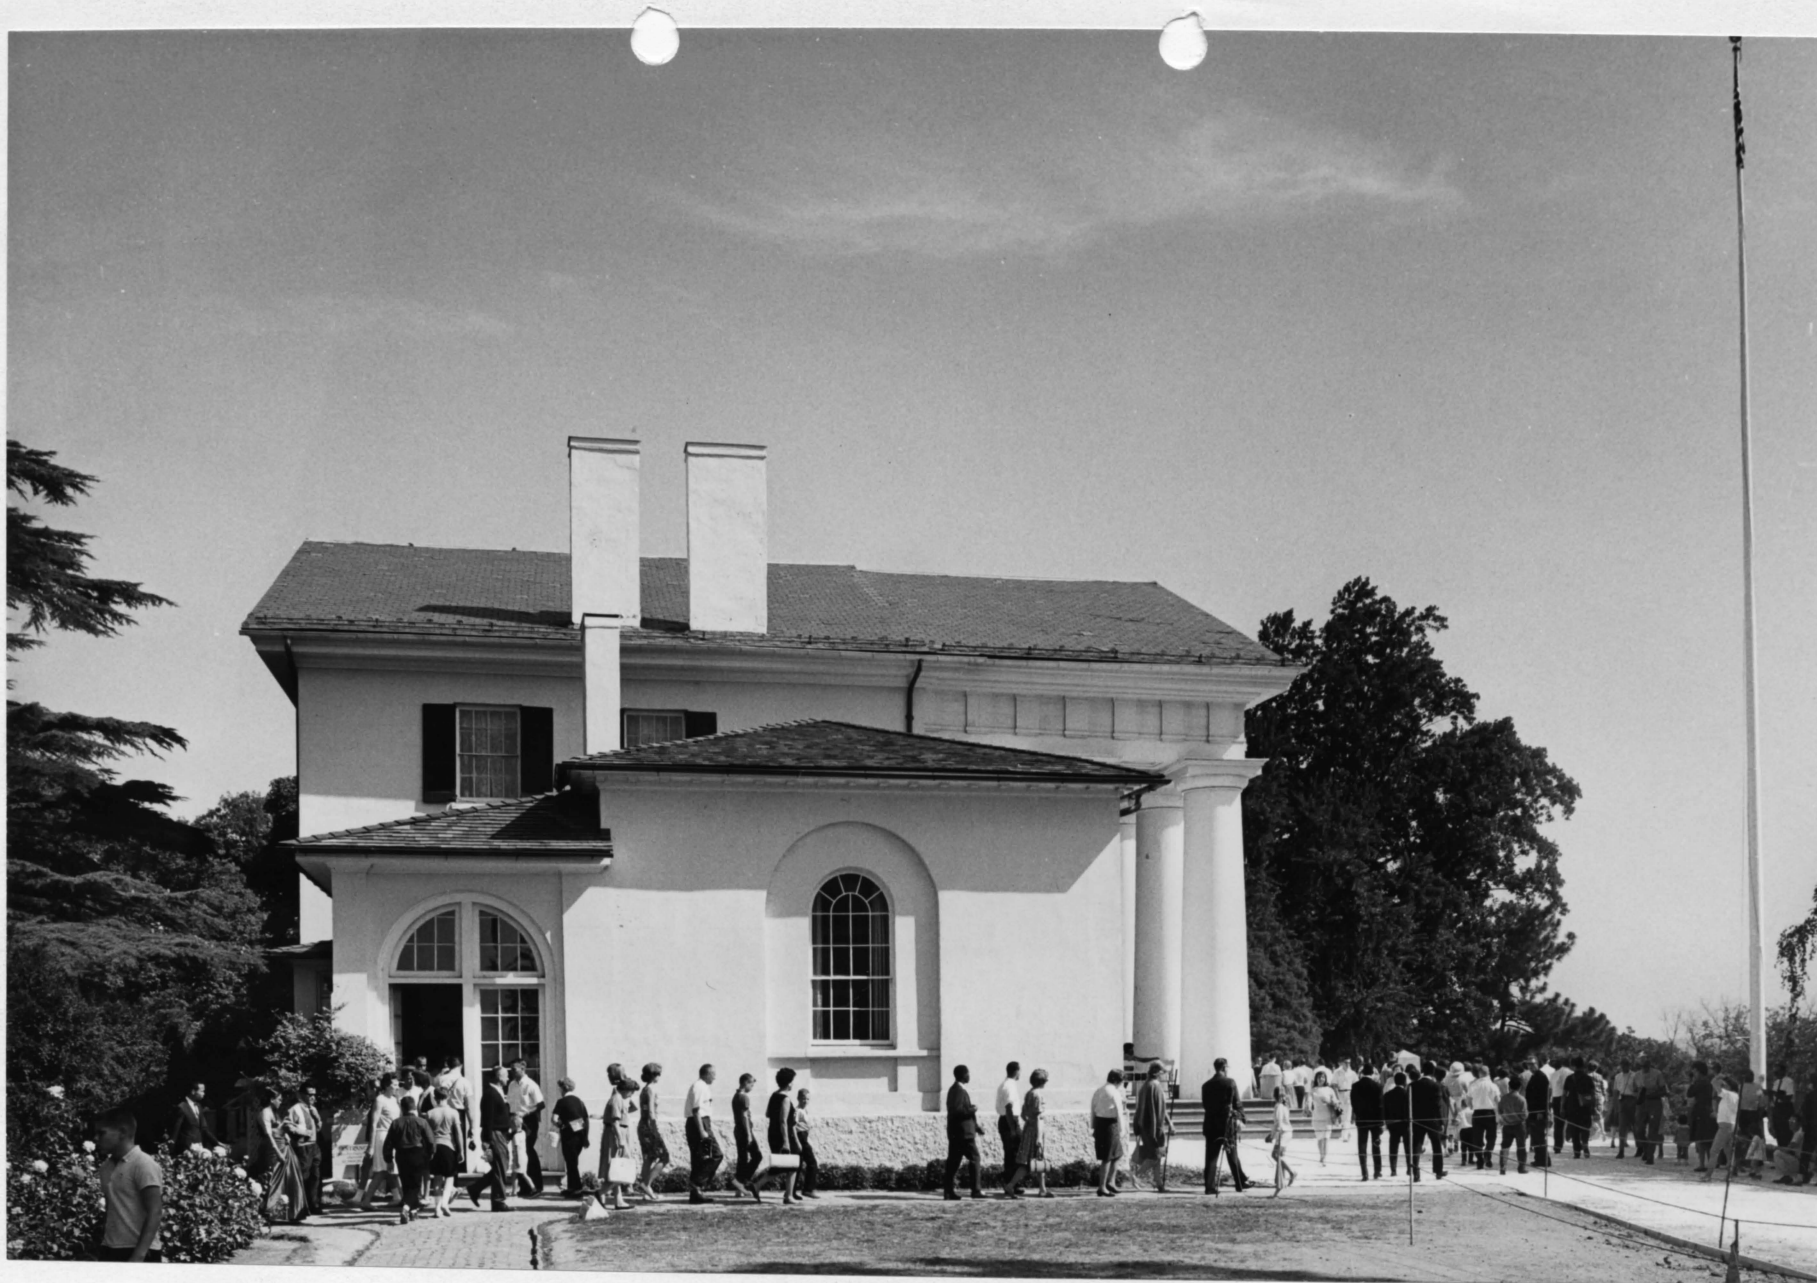
PLATE IV

Custis-Lee Mansion from south, August 1964. Exterior appearance before current project. NPS photograph.

Attention should also be given to the fact that the chimney and the West central face of the mansion were exposed brick during the period of 1861-64, the period of restoration. The present plaster surfaces in these areas are incorrect historically. (See Plates, IV, V, & VI).

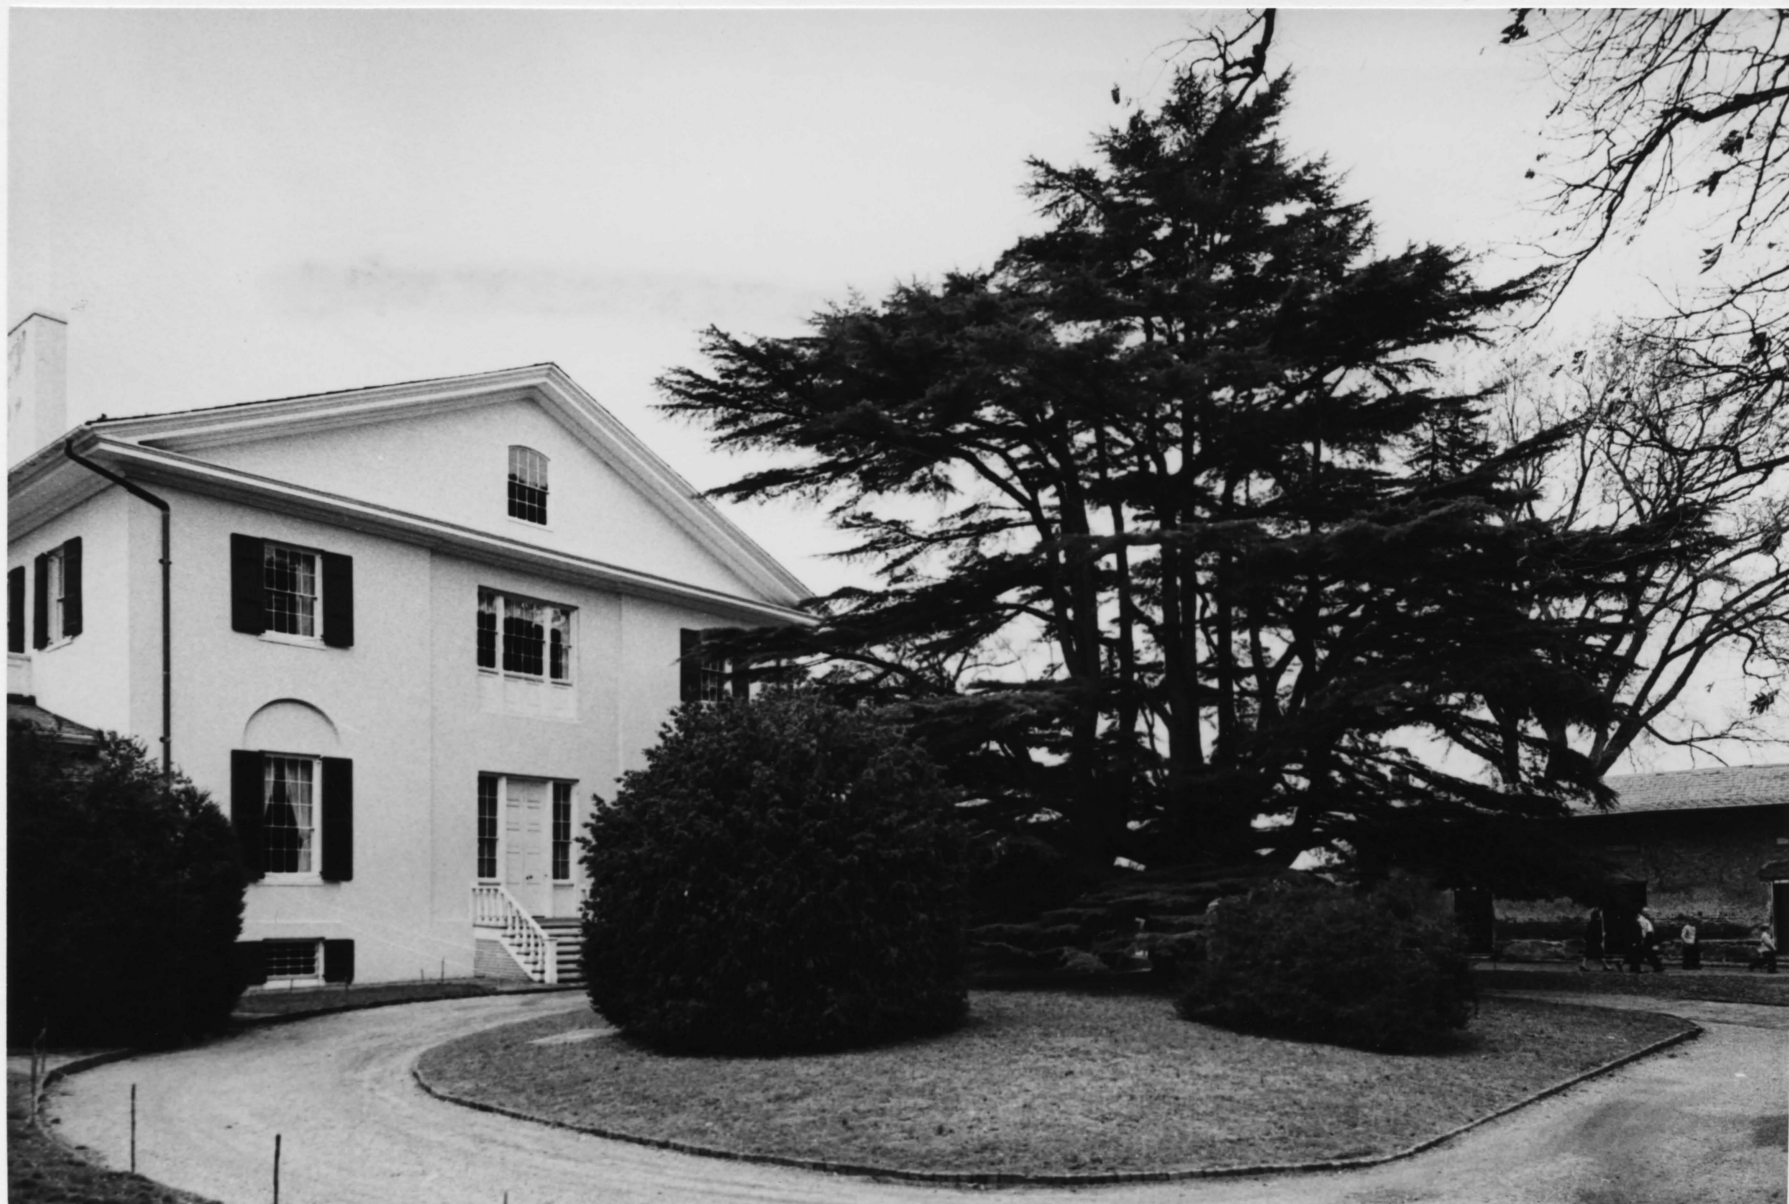
PLATE V

Custis-Lee Mansion, west front, 1959. Existing conditions before current project. NPS photograph.

The finish plaster on the central Western front of the mansion, which is of questionable authenticity, was found to be in good condition, requiring only painting to be kept in excellent condition.

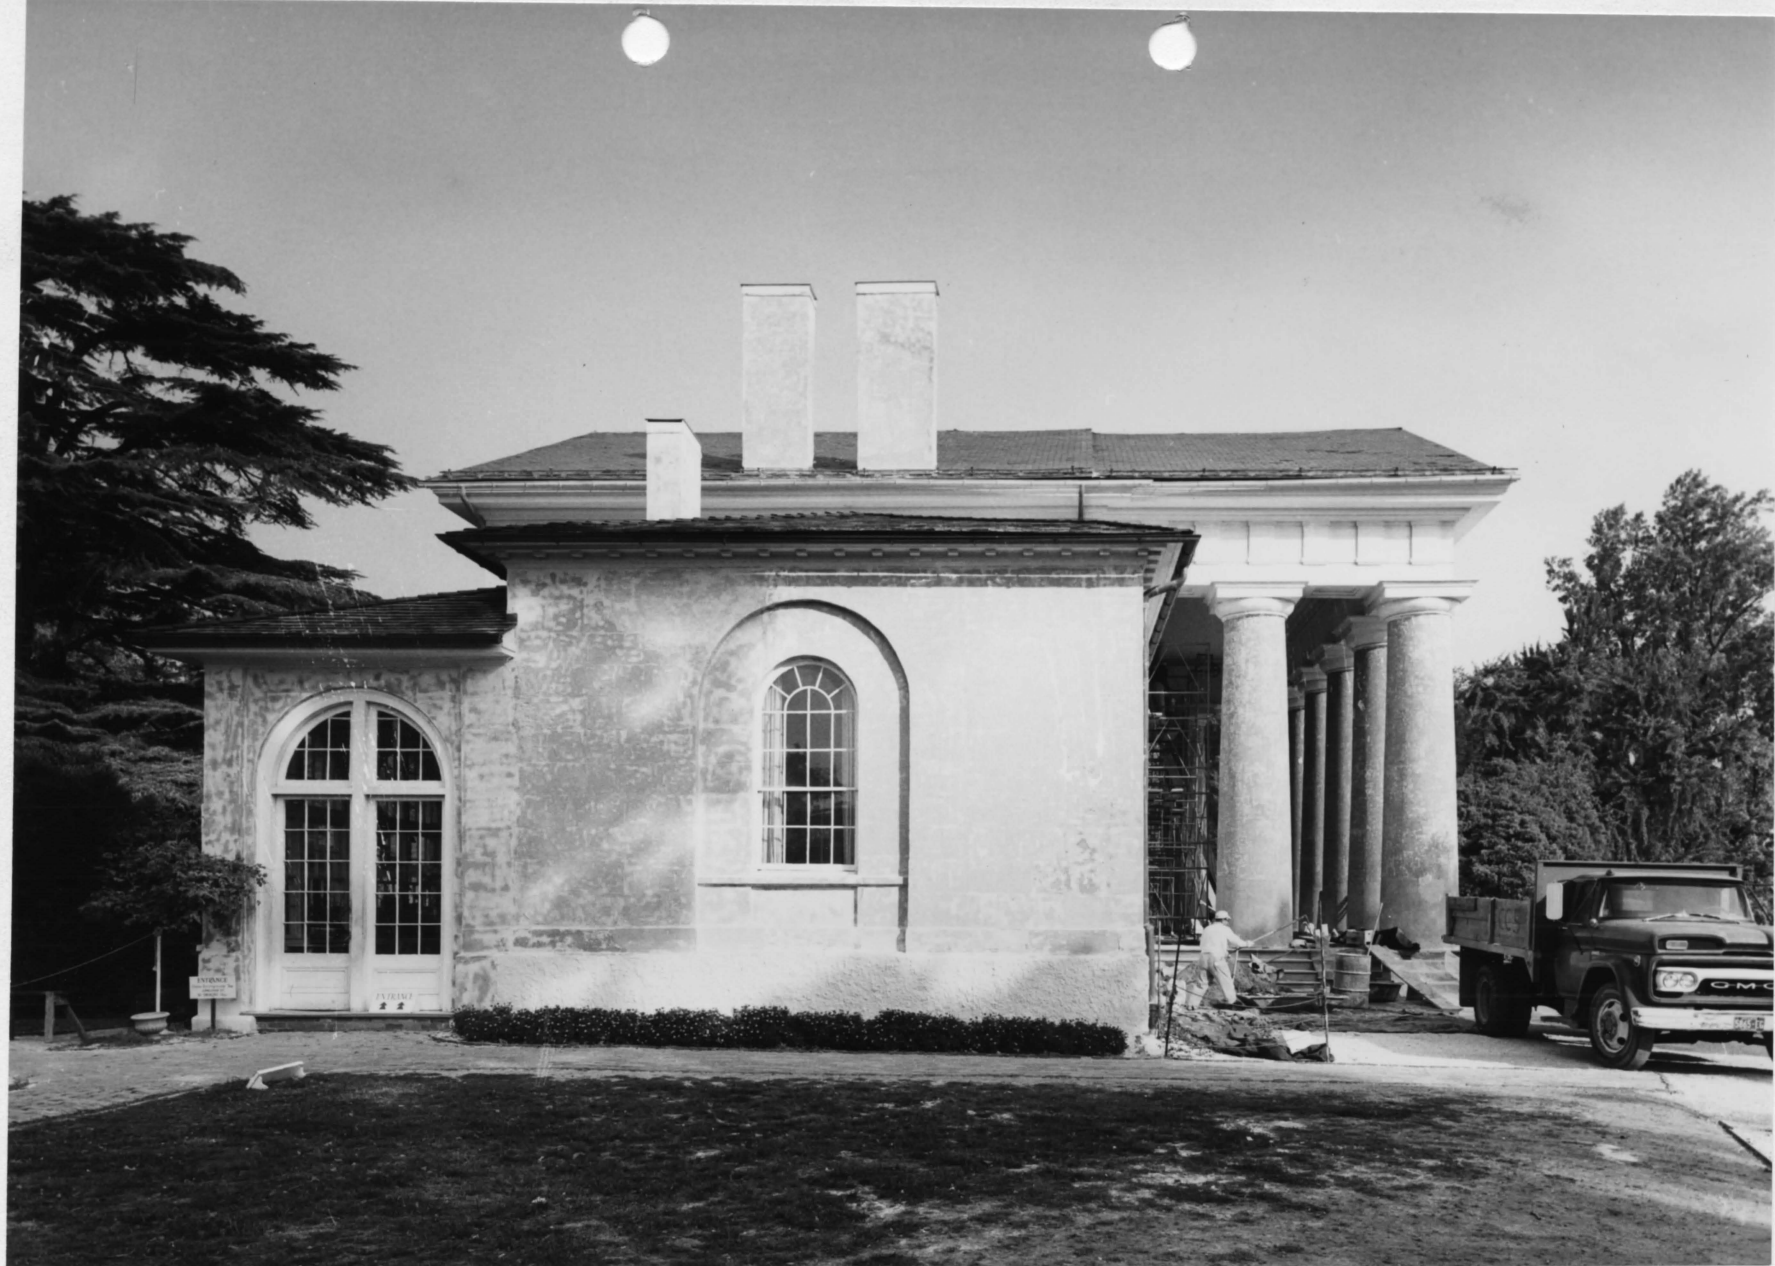
PLATE VI

Custis-Lee Mansion from south - October 23, 1964. After sandblasting exterior. NPS photograph.

During September and October of 1964, the entire exterior surface of the Custis-Lee Mansion was lightly sandblasted to remove blistering paint and loose cement. The surface exposed by the sandblasting was in such poor condition and such a conglomeration of patches that the work of lathing and plastering was undertaken.

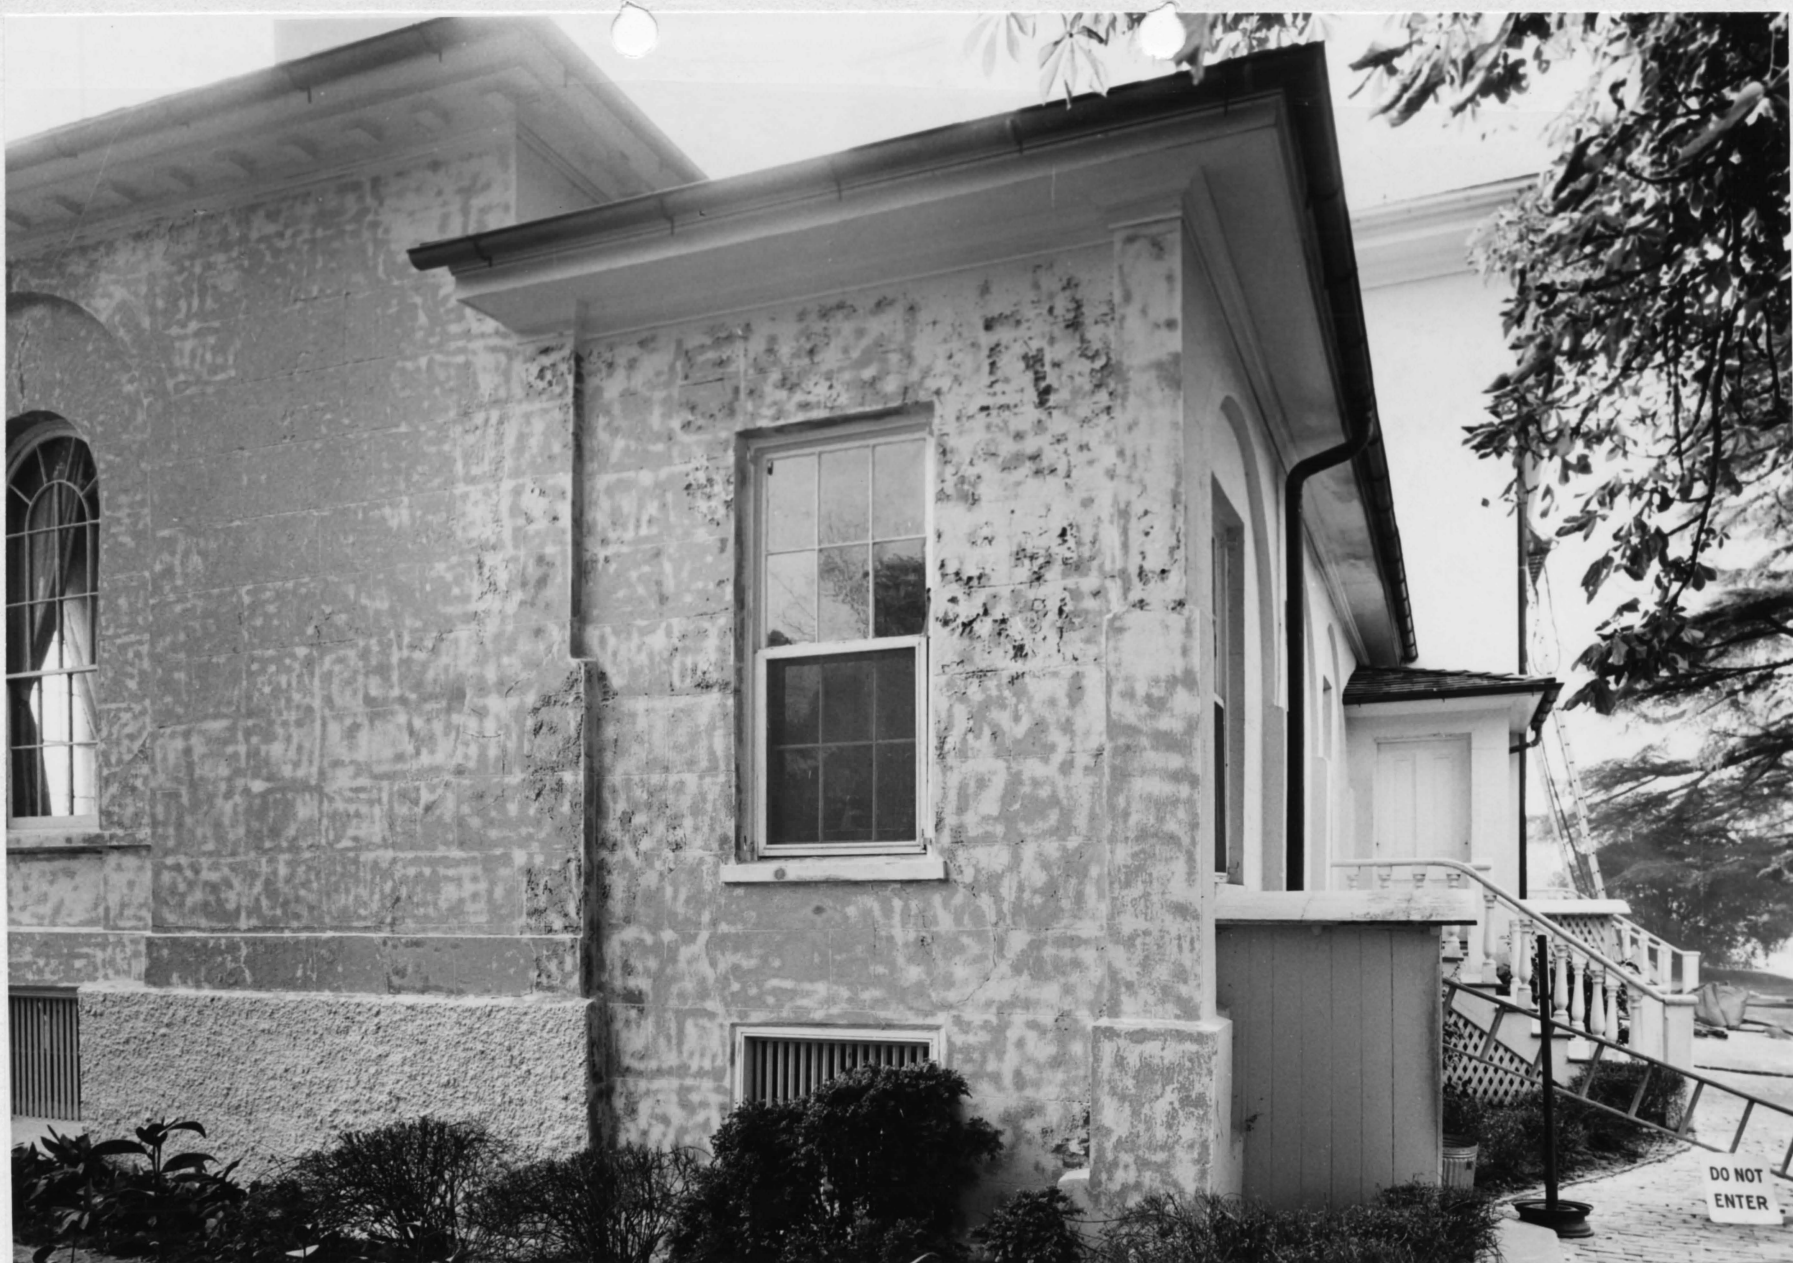
PLATE VII

As paint was removed in sample areas, the plaster beneath proved to be a patchwork of original stucco and later cement patches, a fact that was obvious due to spottiness and textural irregularities seen through the paint. (Plate VIII) What was not known, however, was the condition of the bottom coat of stucco. This was found to be deteriorated or "rotted" to such an extent that it would crumble when exposed. (Plate VII) Such conditions would not give sufficient bond

to any but the most temporary patch. All areas on the East, South and North sides of the structure were found to be in the same dangerous condition. Dangerous in the fact that the conditions would aggravate the already serious water leakage problems as well as constitute a real hazard to visitors from the falling plaster.

Custis-Lee Mansion, northwest corner, October 23, 1964. Note deteriorated stucco. NPS photograph.

It was the opinion of masonry experts from the National Capital Region, Operation and Maintenance section that the insufficient bonding properties of the old finish would require the use of flat, unribbed, expanded metal lath and new plaster, scored identically to the old.

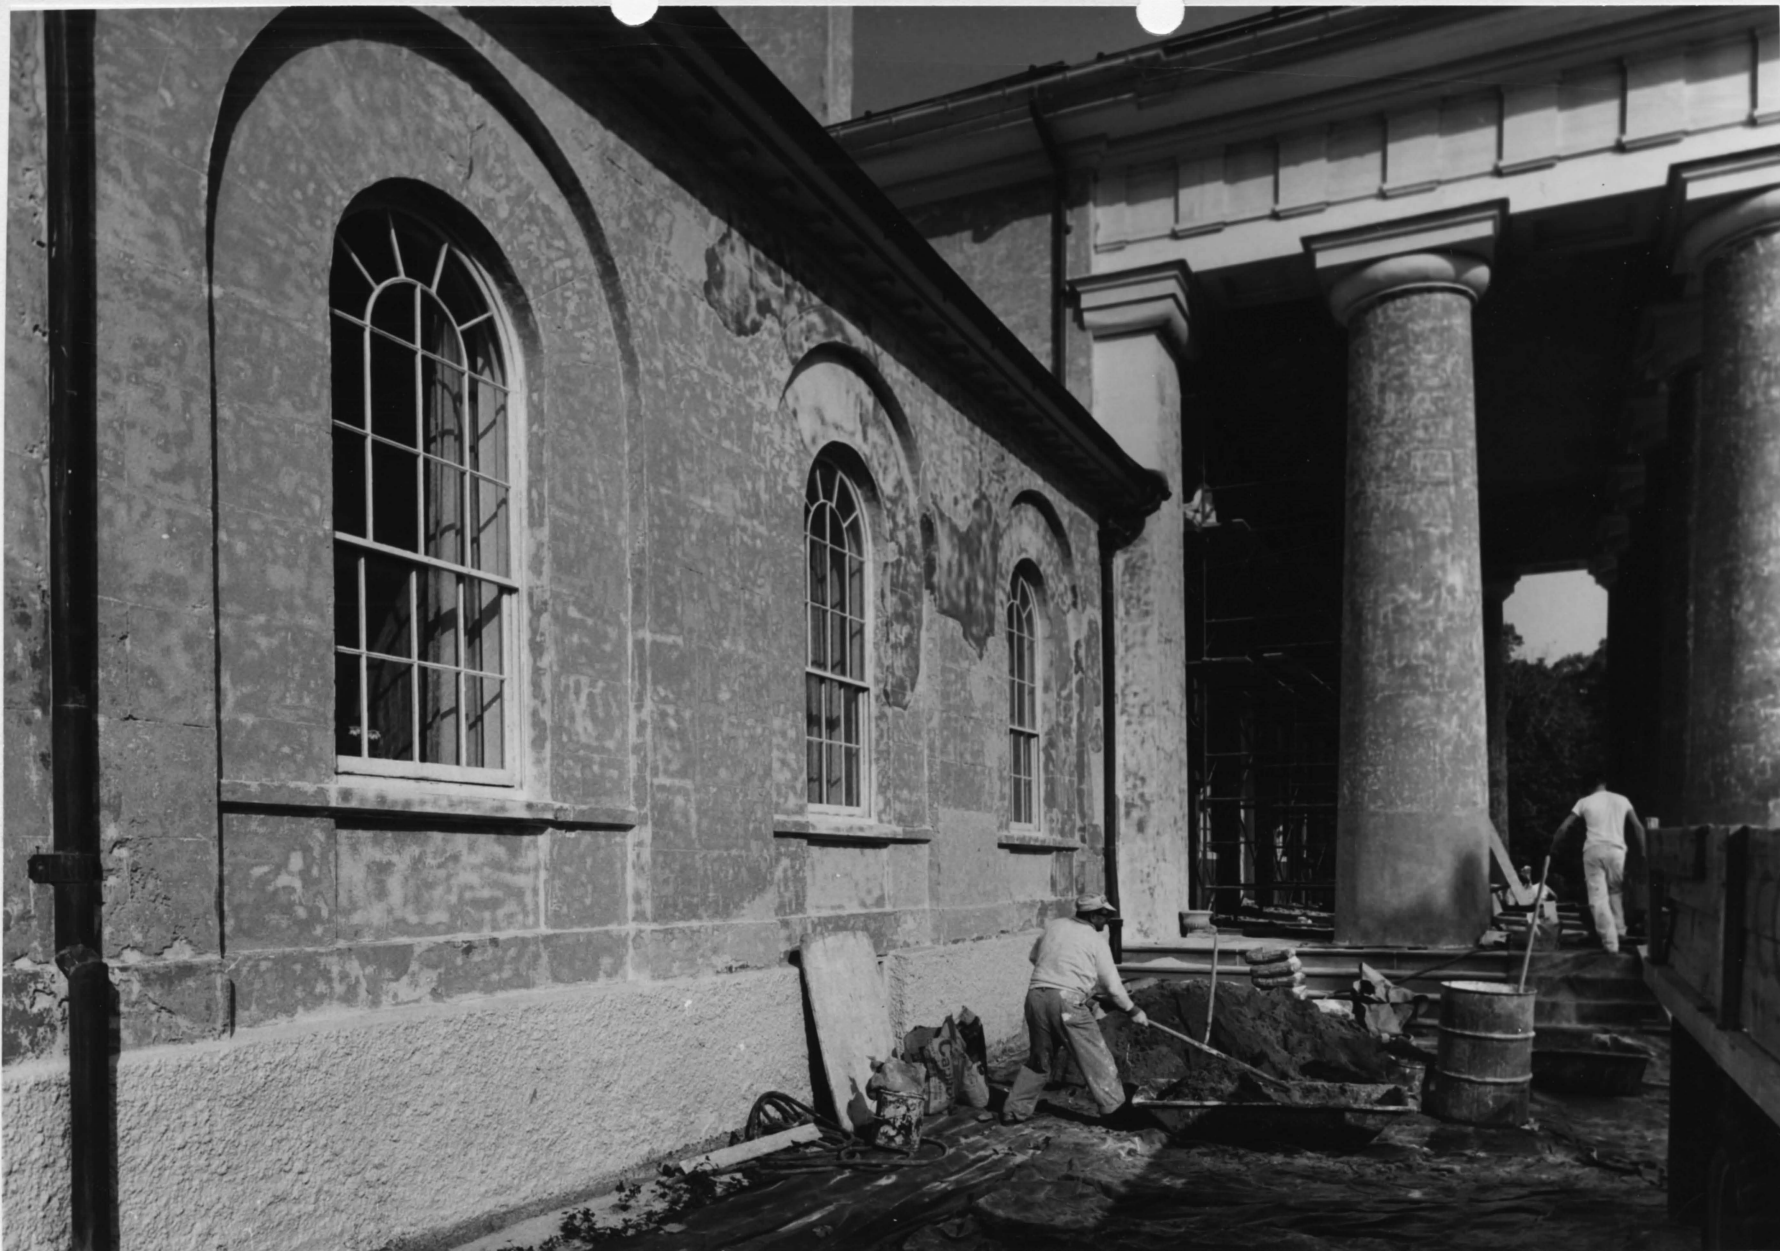
PLATE VIII

Gustis-Lee Mansion, south wing and portion of portico. Note patches and deteriorated stucco. NPS photograph.

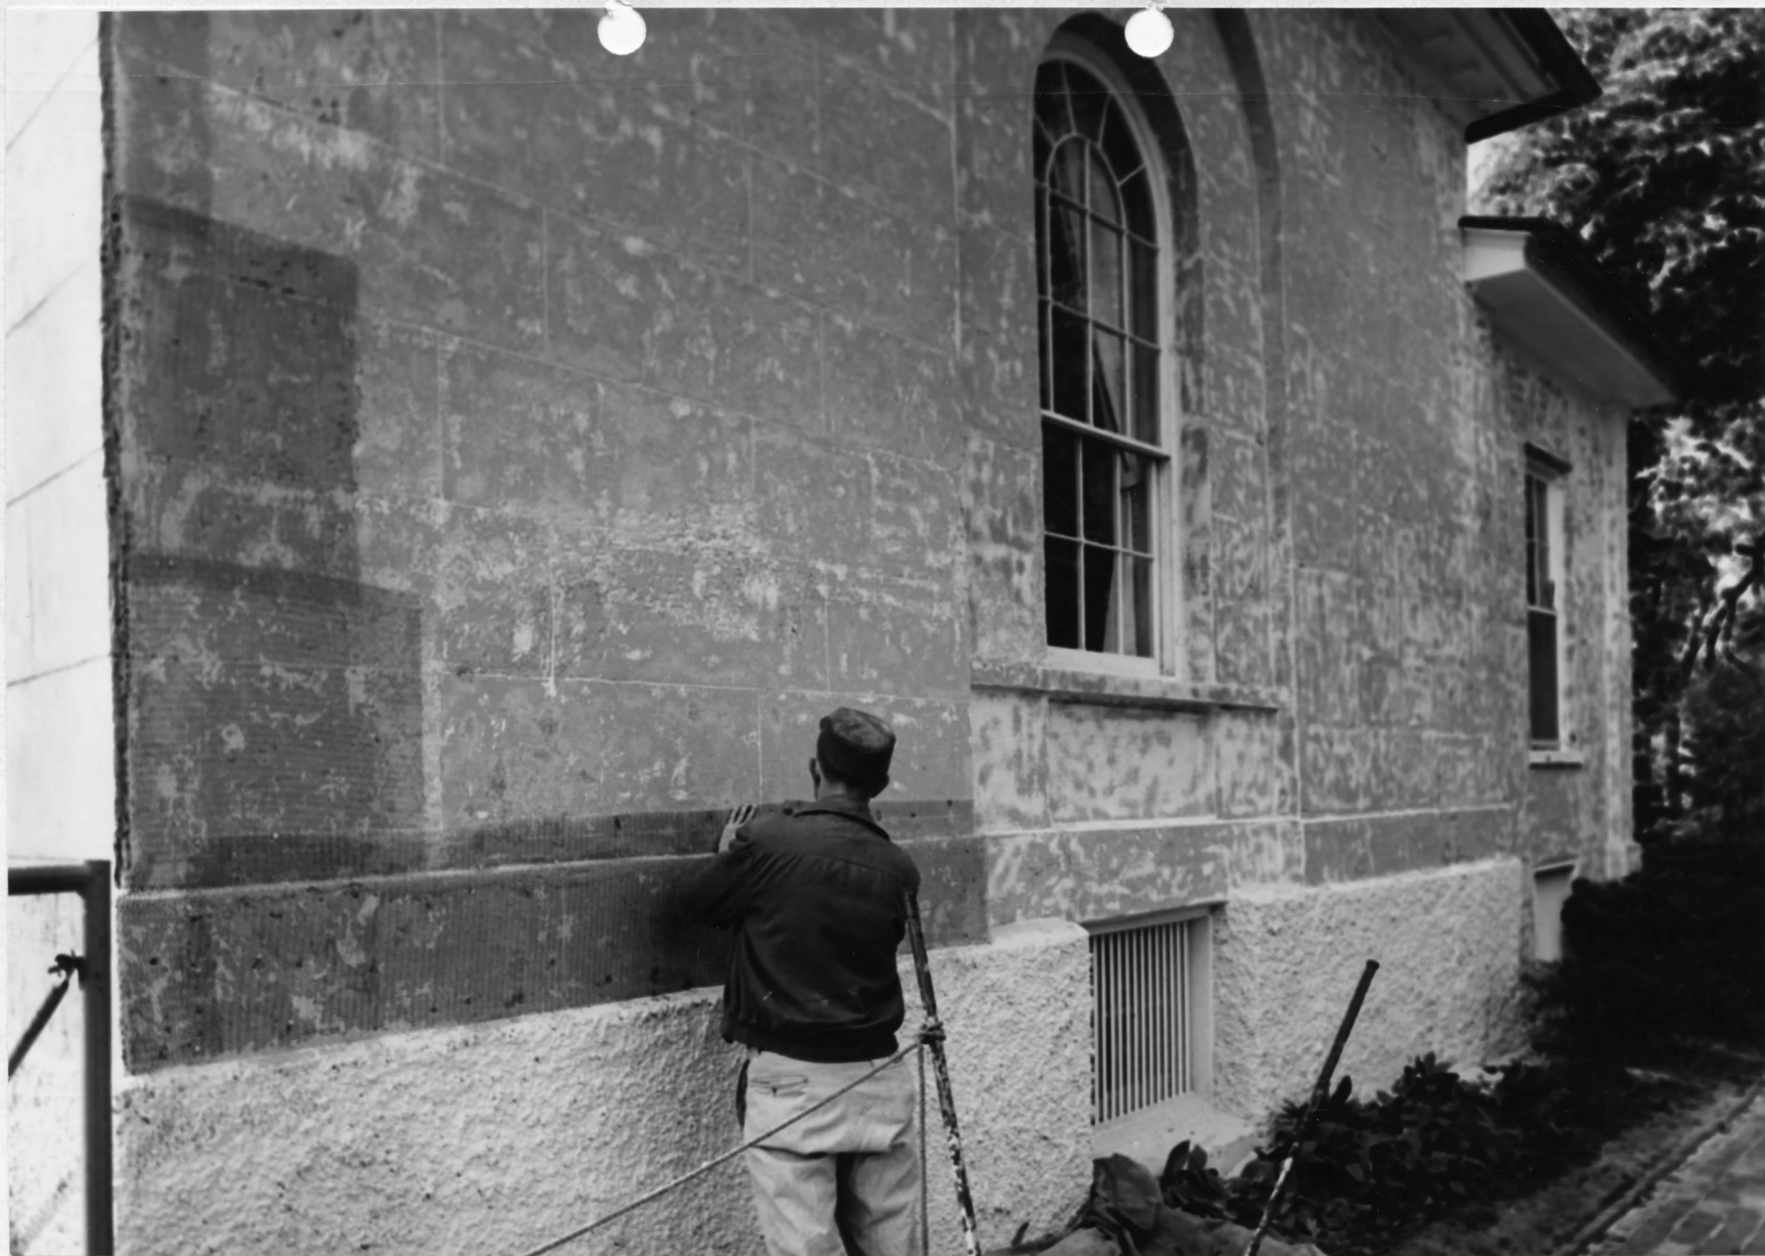
PLATE IX

Custis-Lee Mansion, October 23, 1964. Installation of metal lath preparatory to restuccoing. NPS photo.

Expanded wire ribless metal lath was anchored to the surface except for the west central front and the columns of the east portico. The lath was deep anchored with nails into the masonry. (Plate IX).

On top of the lath a rough and a finish coat of waterproof cement was installed. A surface identical to the original was completed, thus giving a waterproof surface which covered the remains of the original, without obliterating it. The surface was then set to "cure" until spring, 1965. The exterior was scheduled to be painted an off-white with waterproof paint manufactured by Re-Nu-It of New York.
