April 2018

## Memorandum

Subject: Wetland Delineation and Watershed Analysis Report for Travel, Pin Oaks and Whitehill boundary sections of Petersburg National Battlefield (PETE)

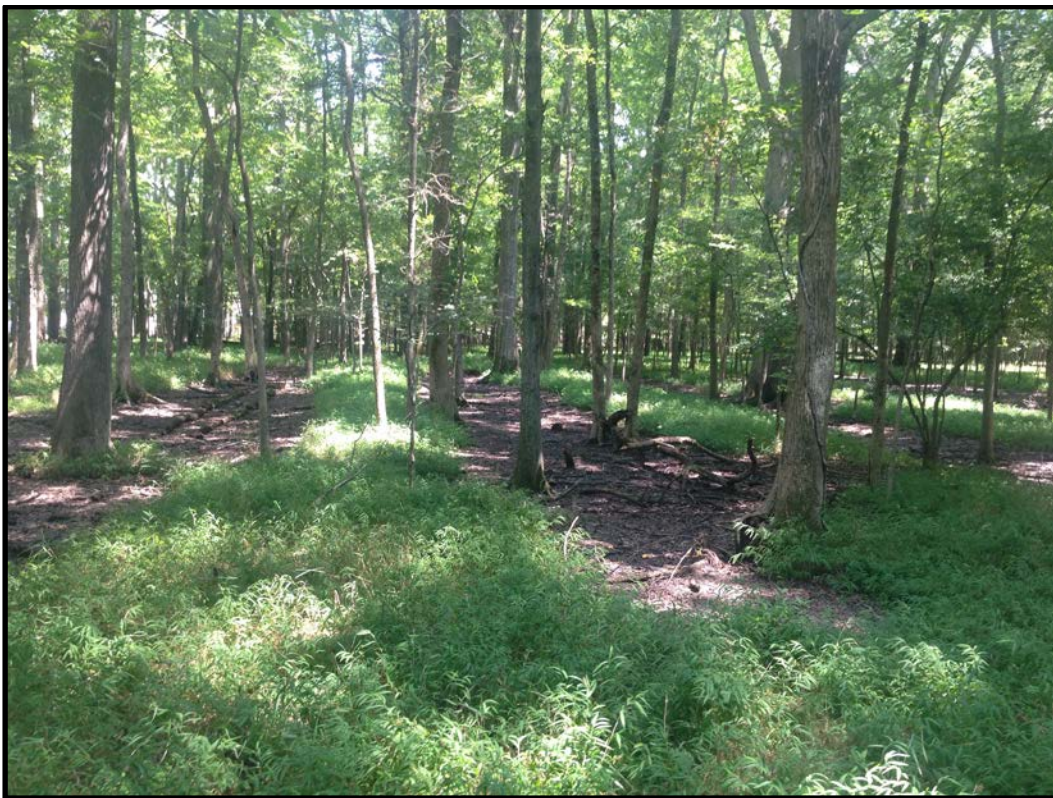
Photograph 1 (P1). Photo looking Northeast at Wetland 1 and a few of the CCC era drainage features which bisect the habitat within the study area boundary at PETE. August 2018

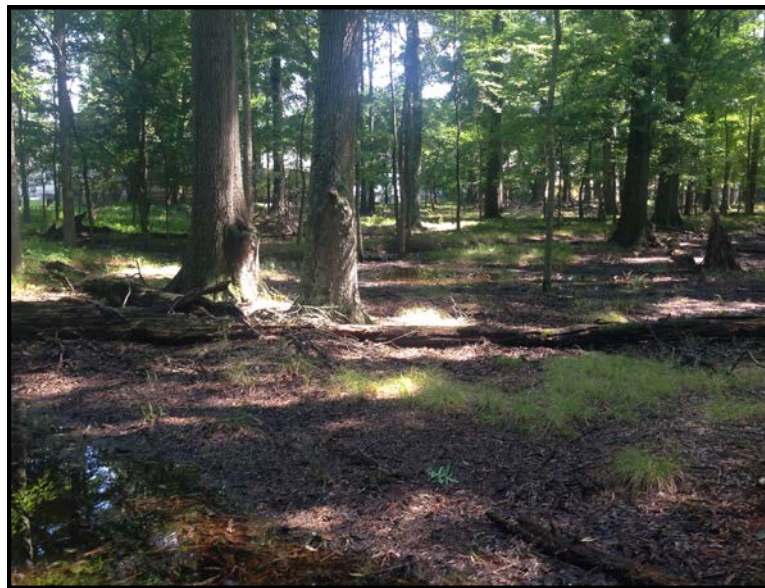
Photograph 2 (P2) – Wetland 1 (PSS1E) view facing north.  
Photo September 2017 – P. Sharpe.

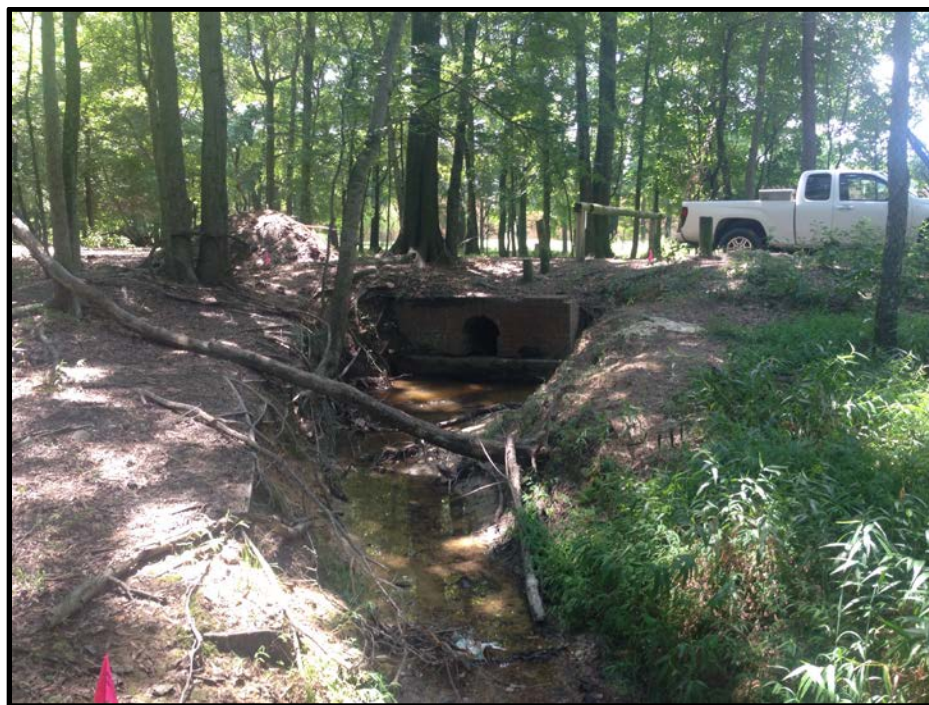
The riverine feature mapped in August 2017 and shown in Photograph 3 below exhibited characteristics of a riverine, intermittent, streambed, mud system (R4SB5). The flow regime of the waterway was determined based off of the presence of a defined bed and banks, natural channel substrates, and the lack of two or more obligate aquatic taxa (i.e. fishes or benthic macroinvertebrates) at the time of our survey. Additionally an assessment of basic hydrologic condition following the methodology described in Fritz et al. (2006) was conducted post-hoc. This unnamed riverine feature is a first order drainage to the Appomattox River originating out of a stormwater culvert at the north western limit of the study area (Figure 3 – “Origin”). This aquatic feature displays evidence of a low gradient system with substrates primarily comprised organic material and mud, with surface water present, but exhibited no signs of visible flow

Photograph 3 (P3) – Mapped riverine wetland system shown on NPS lands view is southeast looking upstream at the system and its riparian zones September 2017 – P. Sharpe.

during this survey. Indications of incision and erosion were observed, however, it appeared as if the system had stabilized with respect to the flow control points (culverts) shown in Photographs 3 and 4. Obligate aquatic taxa were not observed, however, numerous adult green frogs (*Rana clamitans melanota*) were seen utilizing the small pool directly below the culvert outflow in Photograph 3.

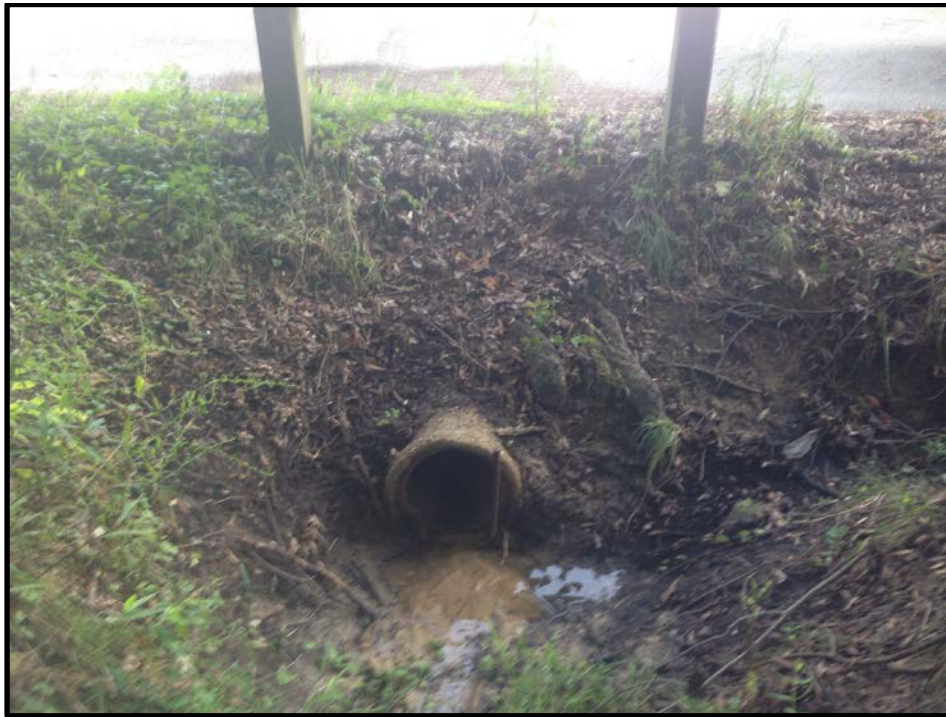
Photograph 4 (P4) – 12 inch RCP which serves as the only visible outlet for the 85.52 acre watershed system draining to this point. View is northwest August 2017 – P. Sharpe.

These calculations, coupled with the evidence of a large forested wetland ecosystem (Wetland – 1) occupying lands rated as having low levels of hydric soil components (5B Emporia Sandy Loam), no historic National Wetland Inventory Designation (see Appendix A mapping), and public, as well as, NPS observations of severe flooding in this area lend support to the theory that the existing culvert (Photograph 4) is improperly sized to convey stormwater offsite.

With the aforementioned information as context I recommend that the PETE staff consider the construction of a low (3-4 feet high) berm system that runs along the northern boundary of Wetland-1 between the Whitehill Development and the NPS lands. The berm system would

need to be designed and built such that overland flows were captured and retained within NPS lands while providing minimal impact to the existing viewshed from the adjacent neighborhood. The berm would also serve as a simple restoration tool to alleviate the influence of the numerous ditches which currently bisect this wetland system (see Photograph 1 and Fig. 3). Engineering design work and coordination with the City of Petersburg would still need to be conducted, as well as, compliance with NPS cultural resource staff, and the Norfolk District of the U.S. Army Corps of Engineers to ensure that this solution doesn't adversely impact cultural resources/landscapes located on-site and ensure Clean Water Act compliance.
