# Rainbow Bridge Vibration Risk Assessment

## *Ambient Vibration Testing and Computer Modeling results for Rainbow Bridge*

Natural Resource Report NPS/RABR/NRR—2018/1617

Jeffrey R. Moore

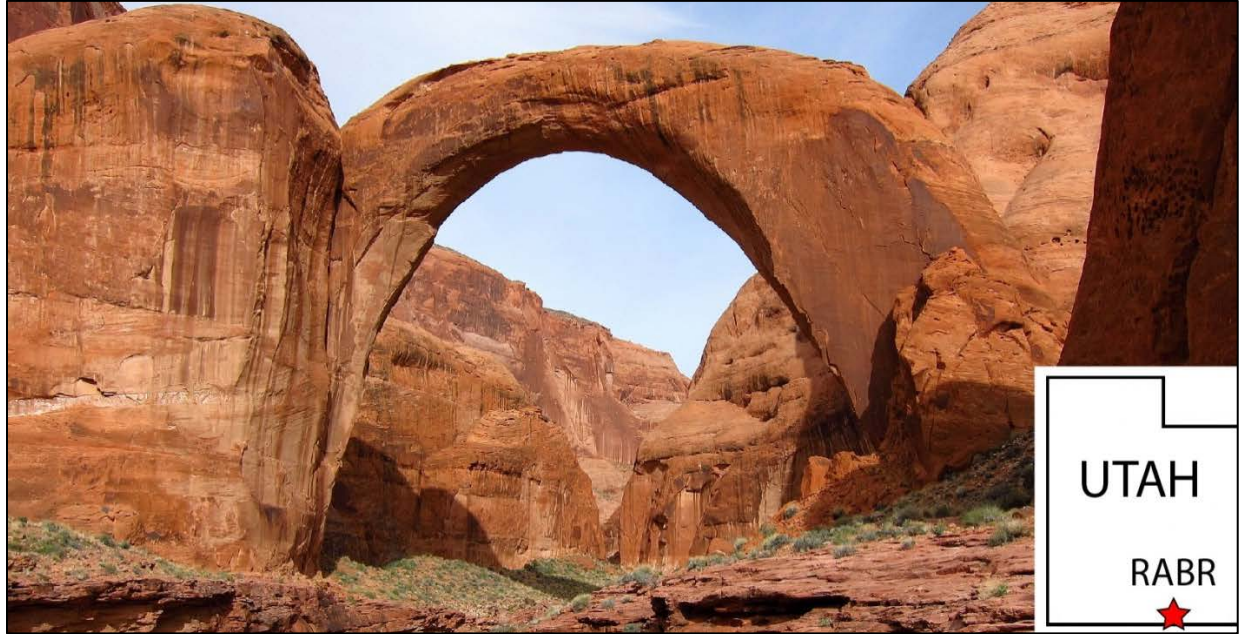
Rainbow Bridge as seen from the trail looking westward. Inset is the general location of Rainbow Bridge National Monument (RABR) in the State of Utah.

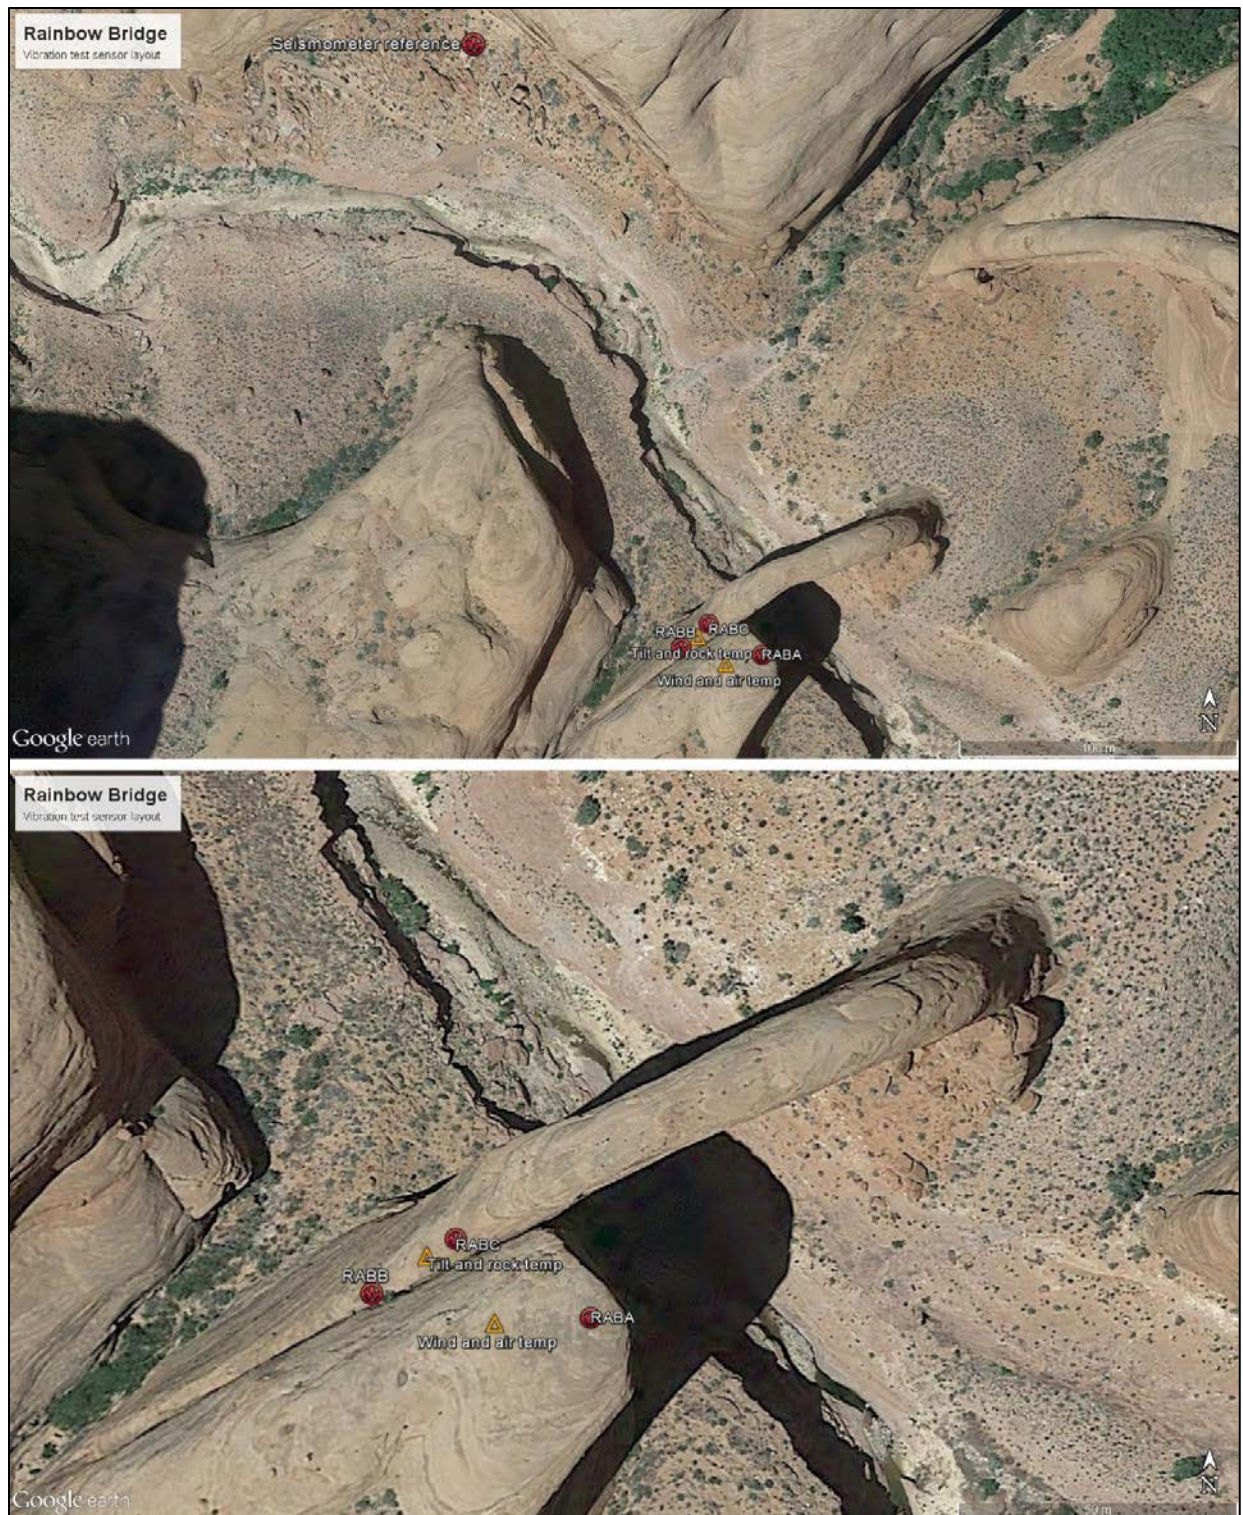
**Figure 1.** Overview of sensor locations on and around Rainbow Bridge. Reference seismometer is RABD. RABB and RABC are 12.5 m apart on the bridge; RABA is on the adjoining knoll. (Google Earth).

The layout of sensors is shown in Figures 1 and 2. Meteorological conditions at the time of the test were predominantly sunny with fair temperatures and calm winds during the day, with strong winds early in the evening settling to calm winds overnight and early morning (Figure 3).

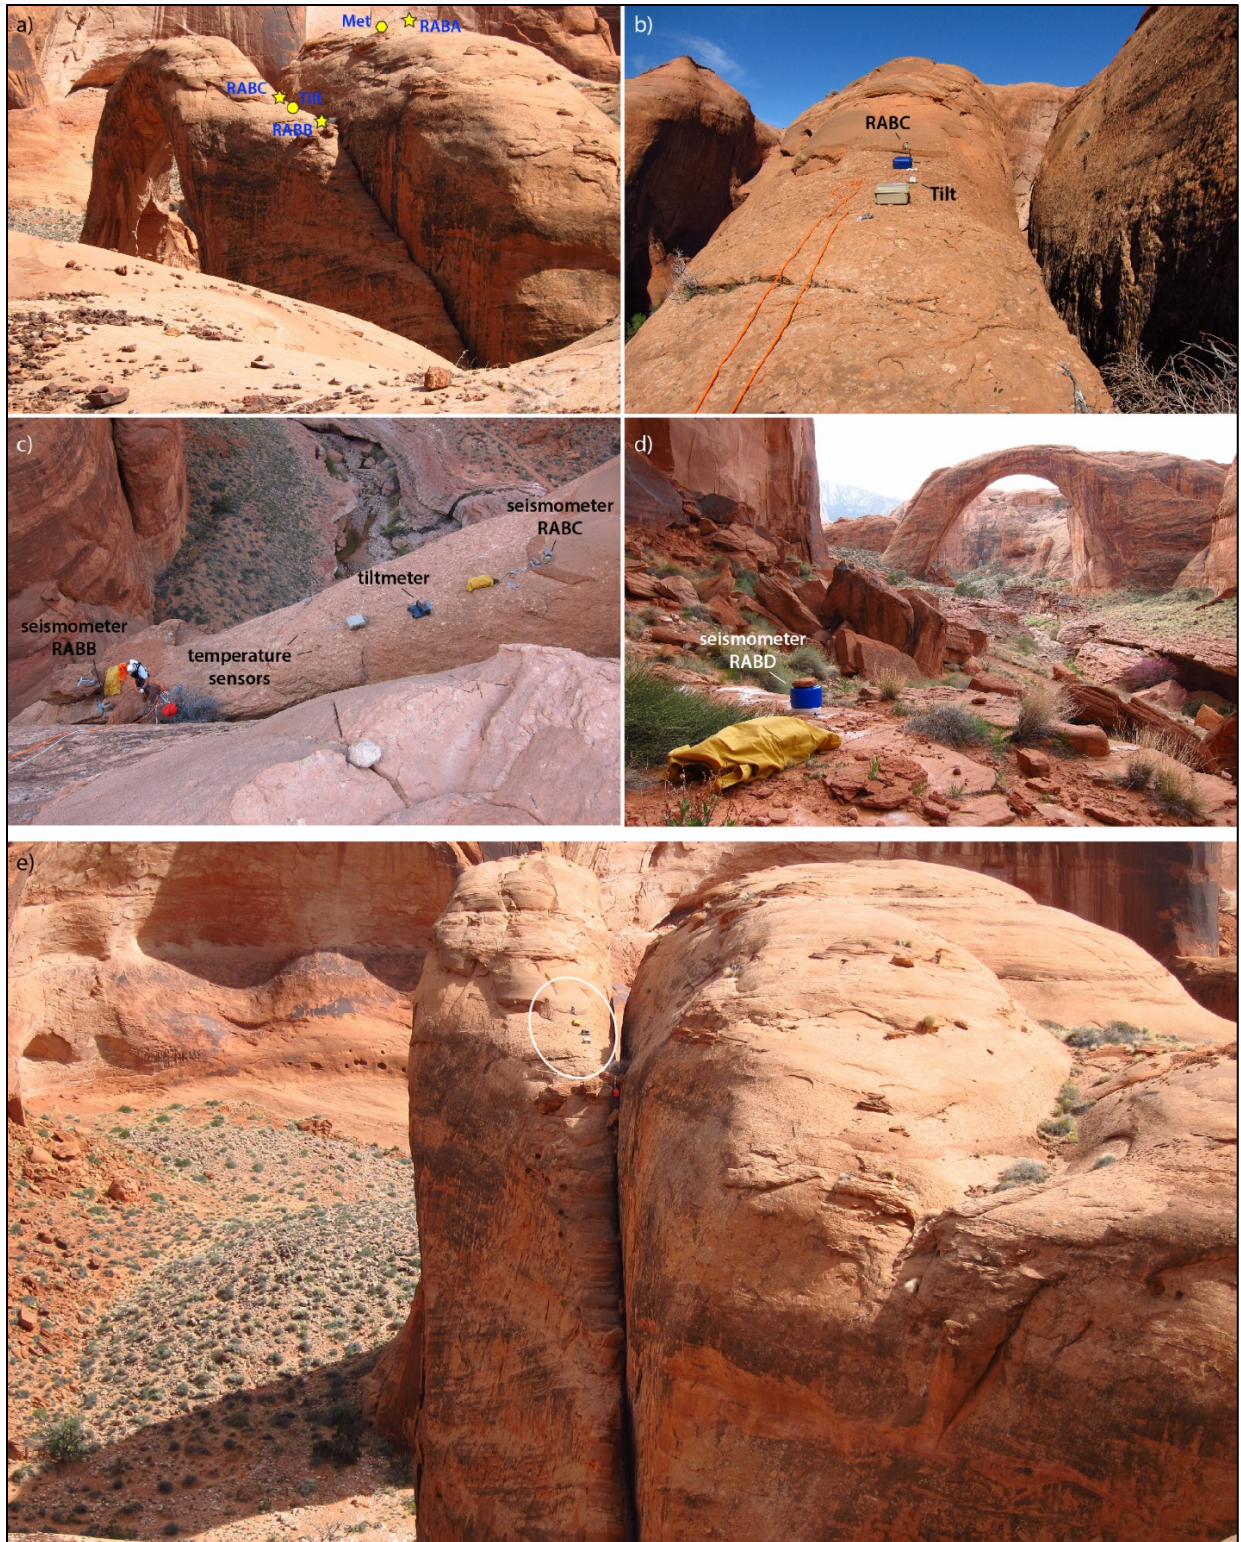
**Figure 2.** a) Layout of sensors on and around Rainbow Bridge, b) close-up view of sensors on bridge, c) different sensors on bridge under respective covers, d) reference seismometer 220 m from bridge. e) Overview of sensor cluster on Rainbow Bridge (view along trend of the bridge at  $\sim 065^\circ$  azimuth).

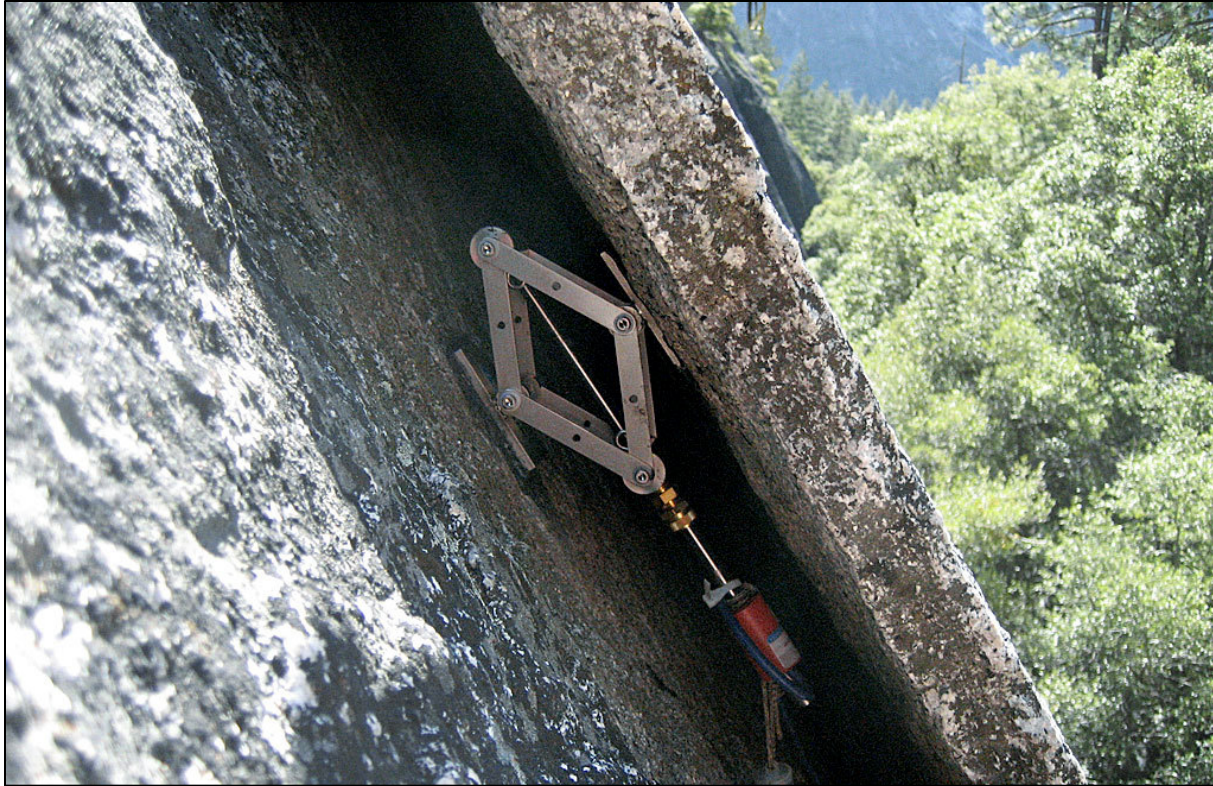
**Figure 30.** Vibrating wire scissor-jack crackmeter (image: Geokon Inc.) installed in a crack in Yosemite.

In-situ monitoring of crack displacement (i.e. opening and closing) is an essential measurement in most landslide hazard investigations. The author has used several such systems in different configurations in past studies to monitor crack displacement and landslide movement. Modern crackmeters based on vibrating wire sensors are inexpensive and accurate, and the technology is well-established. Most, however, require permanent mounting using anchor bolts on either side of a crack, which is technically feasible in some areas of Rainbow Bridge but might be intrusive for the sensitive rock structure. Moreover, such an instrument should be well-hidden at Rainbow Bridge so as not to be visible to visitors. In light of these considerations, and after field reconnaissance, I recommend use of a new type of crackmeter, a so-called scissor-jack meter. The device, shown in Figure 30, consists of a vibrating wire displacement sensor attached to a spring-driven jack, and is placed inside a narrow crack and glued to the crack walls. The sensor was developed by USGS and NPS personnel for use in Yosemite National Park (Collins and Stock, 2016). Since it is placed inside a crack, it is nearly invisible from most viewing angles, and it features the same sensor as well-established crackmeters, sensing crack aperture changes of  $<0.05$  mm. Such an instrument once installed operates continuously, attached to a small field data logger (Figure 30) that stores readings on-site until data retrieval. Continuous crack opening data would allow us to measure the response of the crack to short-term environmental conditions, e.g. thermal cycles, as well as identify any long-term opening trends. I would propose to place one scissor-jack crackmeter within the broad crack on the south-western abutment of Rainbow Bridge (Figure 31). Preliminary modeling shows that the bridge tends to pull away from the adjoining knoll under gravity, with key tensile resistance provided by the adhered portions of this abutment. As this crack continues to elongate, the overall tensile strength is reduced, and cumulative deformation of the bridge could result in localized and potentially eventual global failure. A single crackmeter measurement provides a good starting point to assess any long-trends in global deformation (or lack thereof), without large costs or intrusive installations. A suitable position within the crack would need to be identified through future field assessment, i.e. where the crack is narrow enough for the scissor-jack meter, but wide enough to be accessed for installation. The sensor would be installed on rappel from the adjoining rock knoll south of the bridge. Data stored on site could be retrieved at intervals of twice per year (for example), and batteries checked and changed as needed. Solar power is likely not required.
