# Status of Climate and Water Resources at Casa Grande Ruins National Monument

*Water Year 2016*

Natural Resource Report NPS/SODN/NRR—2018/1629

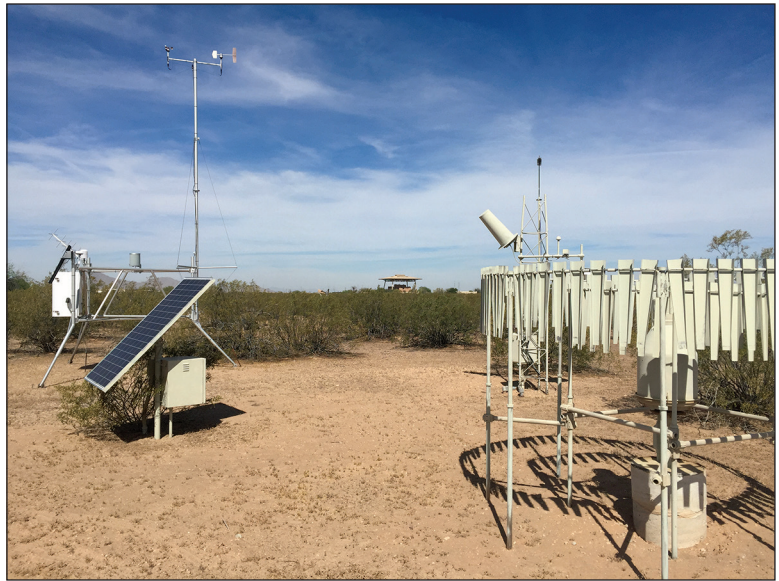
Figure 2-1. Three weather stations at Casa Grande Ruins National Monument: (1) A remote automated weather station, shown at left, (2) a high-precision regional climate reference network station, shown at right, and (3) the NOAA Cooperative Observer Program station, located near the Great House (seen in background).

The monument also contains two recently established climate stations: a remote automated weather station (RAWS), installed in 2014; and a Regional Climate Reference Network station, installed in 2011 (Figure 2-1). Both are maintained and operated by the National Park Service Sonoran Desert Network. In combination with the excellent, long-term, NOAA COOP dataset, these stations provide a unique opportunity to study climate and weather patterns in the Sonoran Desert.

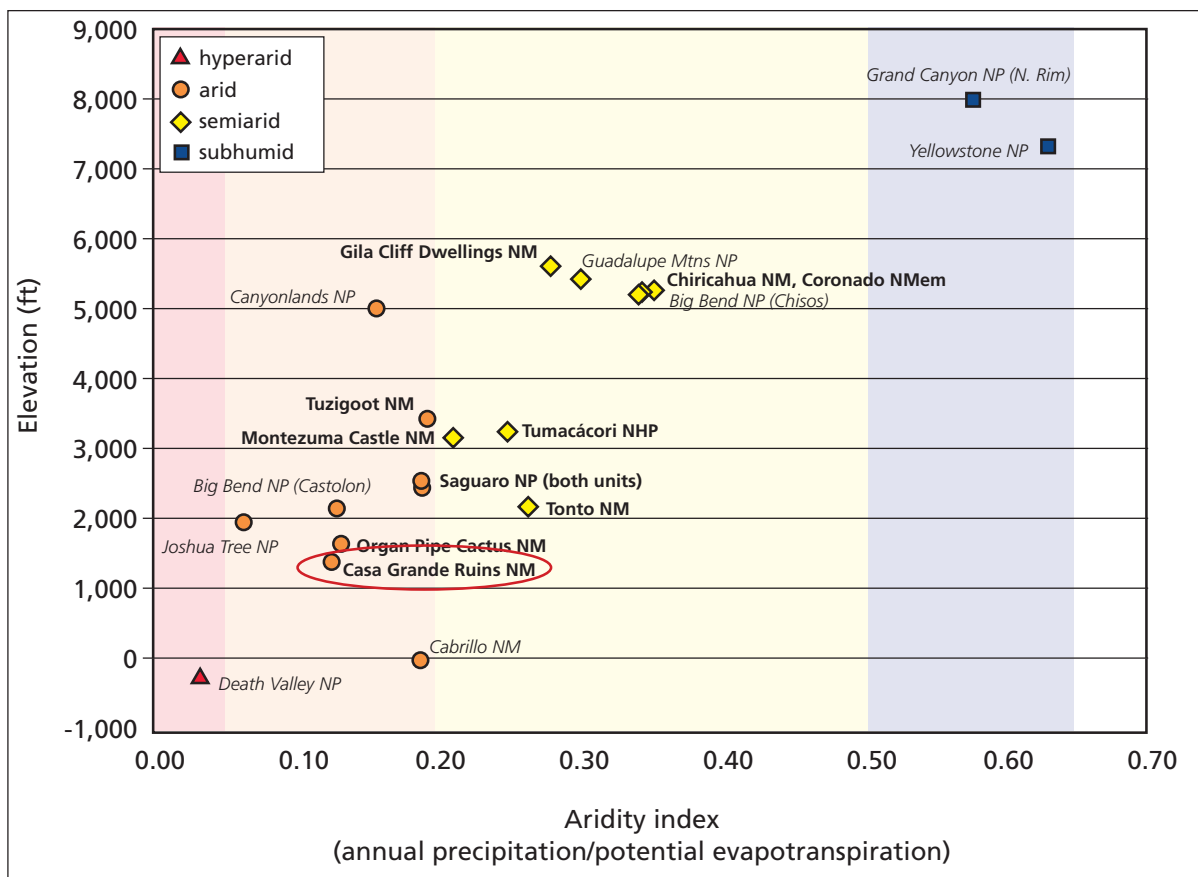
Figure 2-2. Aridity index vs. elevation of selected southwestern national parks, including Casa Grande Ruins National Monument. Figure from Hubbard and others (in prep).

An aridity index (UNEP 1992), based on long-term average annual precipitation relative to average annual potential evapotranspiration, can be a useful tool for contrasting the

local climate of national parks (Figure 2-2). Used globally to classify climate zones, aridity index seeks to answer the question, “How dry is dry?” (Tsakiris and Vengelis 2005). Using the period of record (1906–present), the climate of Casa Grande Ruins NM is classified as “arid.”

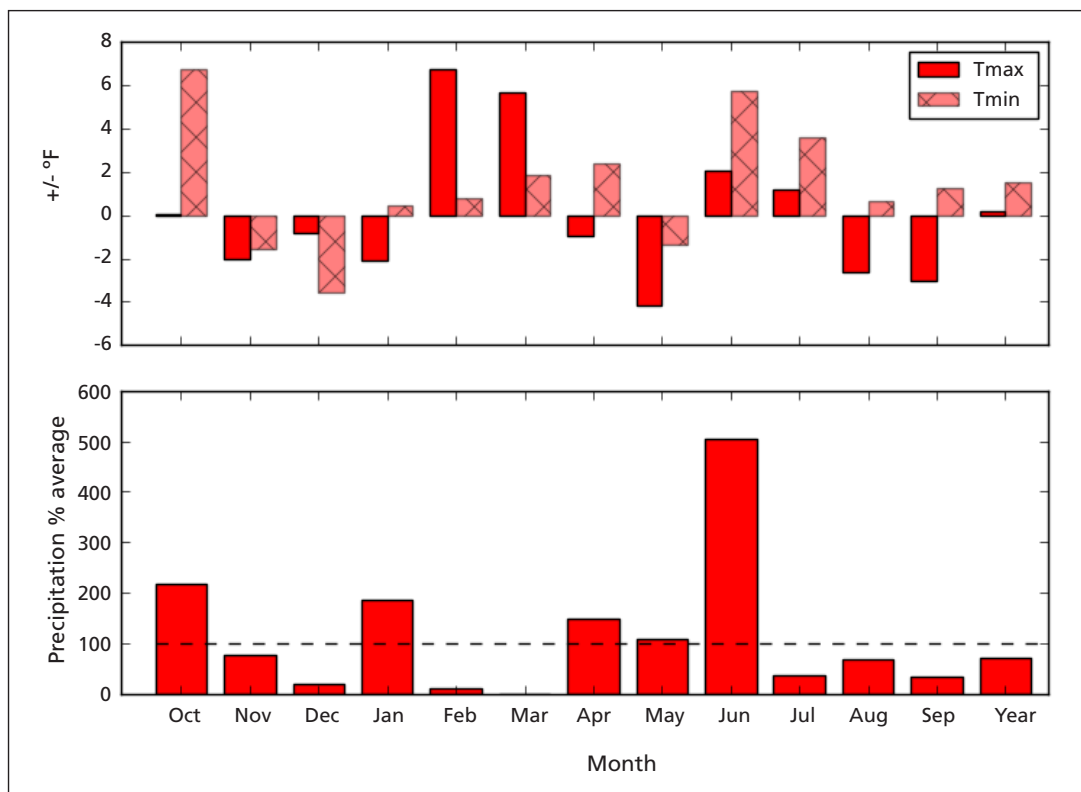
Figure 2-3. Departures from 30-year (1981–2010) normal minimum and maximum air temperature and precipitation, Casa Grande Ruins National Monument, WY2016. Graphics generated by climateanalyzer.org.

Precipitation was below normal (74%, -1.4") for the fall and winter of WY2016, although October and January were somewhat wetter than normal (Figure 2-3). Very little precipitation fell during December, February, and March, which are typically among the monument’s wettest months. Air temperatures were generally below normal (-1 to -4°F) from November through January, whereas minimum and especially maximum air tem-

peratures soared in February and March relative to 1981–2010 normals (Figure 2-3).

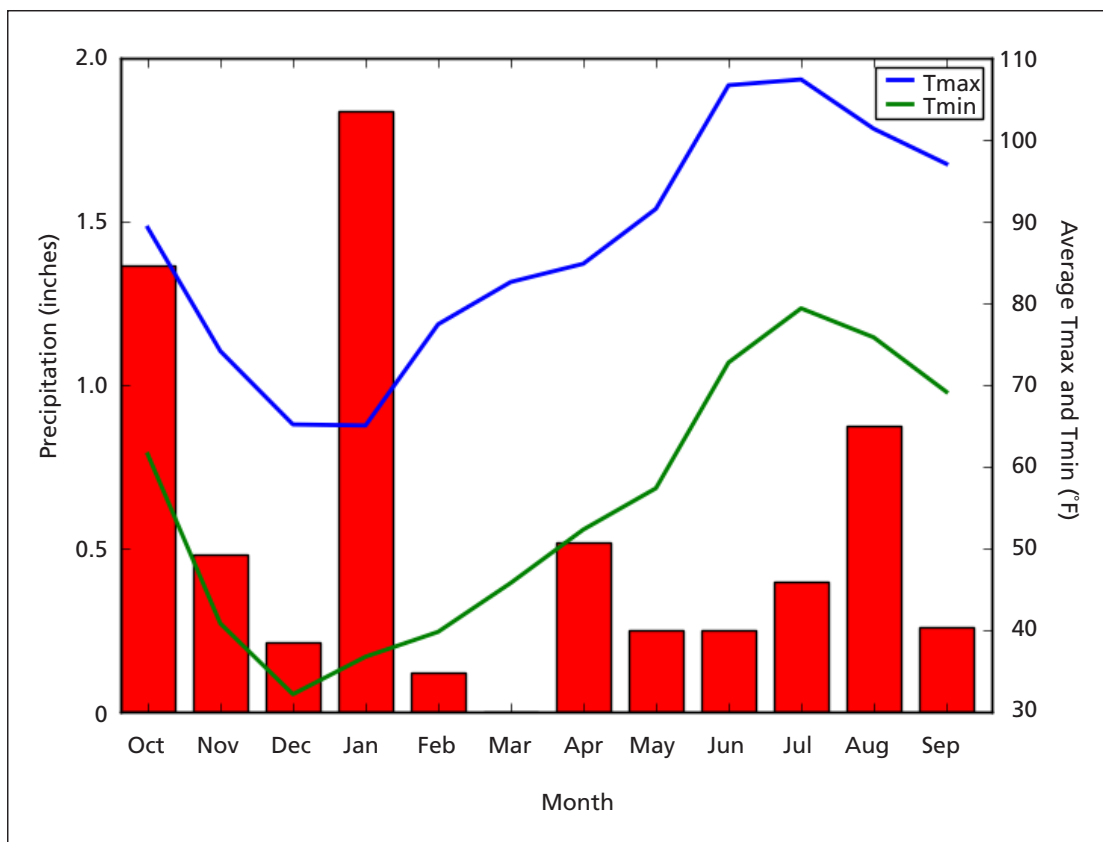
Figure 2-4. Climogram for Casa Grande Ruins National Monument, WY2016. Graphics generated by climateanalyzer.org.

Precipitation for spring and early summer of WY2016 was above normal—particularly during June, when monthly precipitation was about five times normal (0.25" vs 0.05"). Almost no rain falls in June during most years (Figure 2-4). In combination with below-normal rainfall in July–September, the overall warm-season precipitation total was greatly below (68%, -1.21") 1981–2010 normals. Minimum air temperatures at the monument were generally above normal throughout the warm season. Maximum air temperatures were above normal in early summer, followed by more mild maximum air temperatures throughout the rest of the monsoon season.

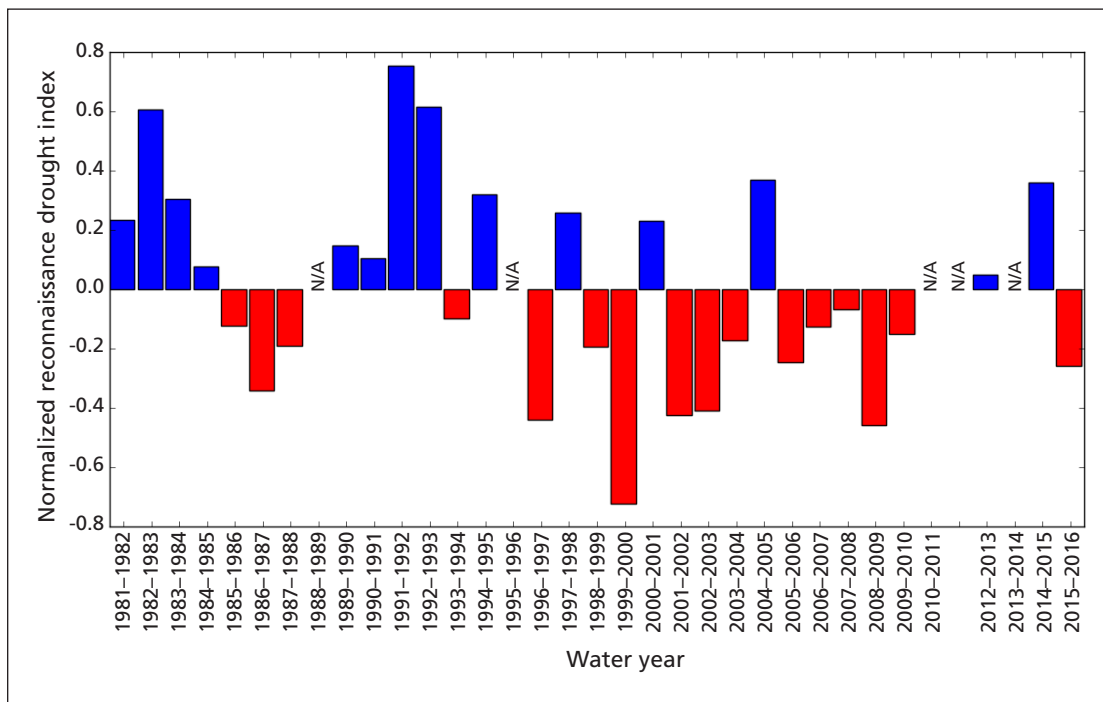
Figure 2-5. Reconnaissance drought index for Casa Grande Ruins National Monument, water years 1981–2016. "n/a" = insufficient data to generate reliable RDI estimates. Graphics generated by www.climateanalyzer.org.

Reconnaissance drought index (RDI; Tsakiris and Vangelis 2005) is a measure of drought severity and extent relative to long-term climate, based on average precipitation to average potential evapotranspiration over shorter periods of time (seasons to years). RDI for Casa Grande Ruins NM reflects the extended regional drought since 2000 (Figure 2-5), with brief recoveries in WY2005, 2013, and 2015, followed by much more xeric conditions in WY2016. The five-year moving mean of total annual precipitation from 1981 to 2016 (Figure 2-6) suggests that recent wet years prior to WY2016 have brought a slight precipitation surplus. However, results may be skewed due to missing data.

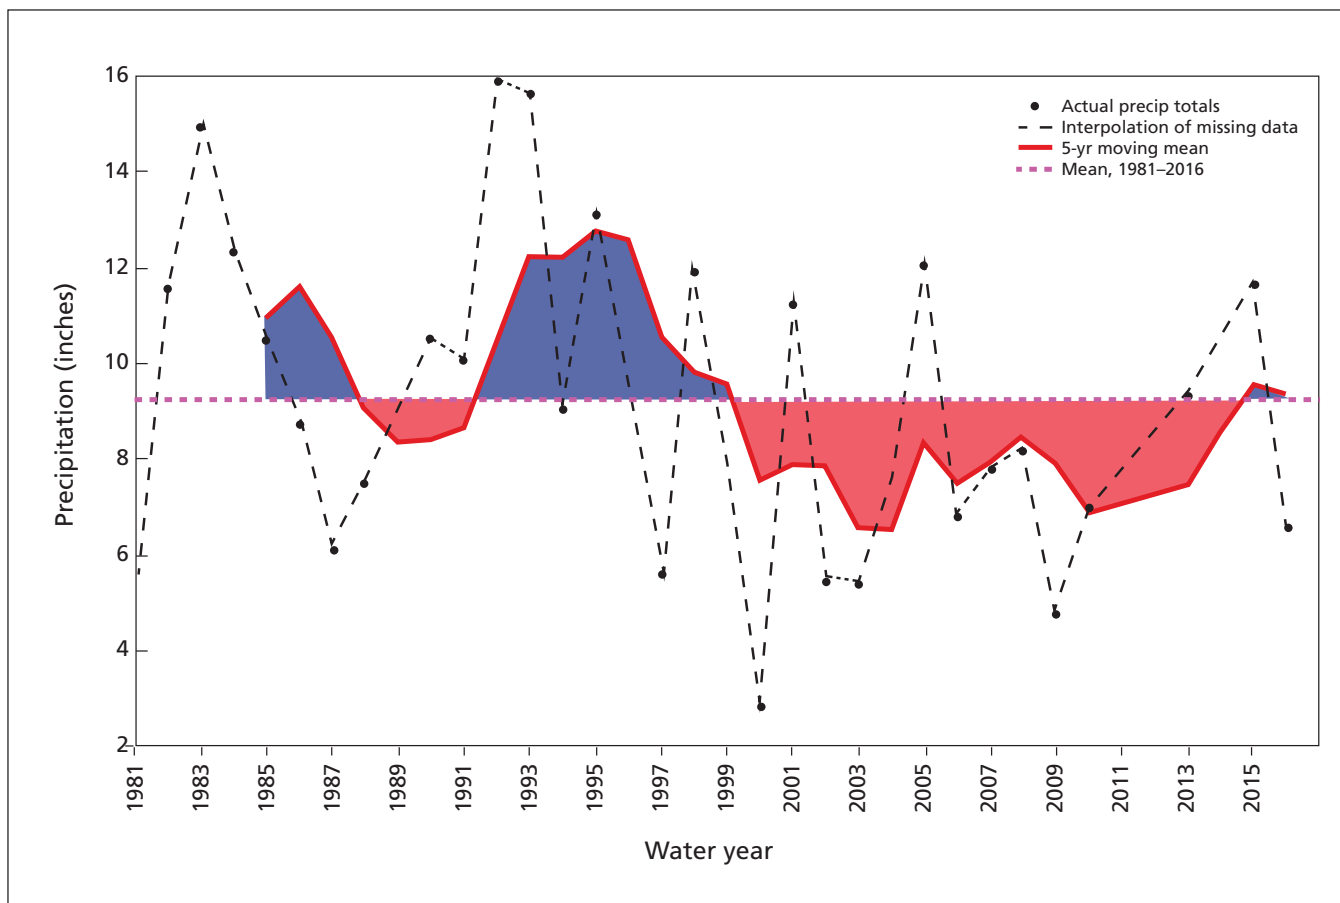
Figure 2-6. Five-year moving mean of annual precipitation, Casa Grande Ruins National Monument, 1981–2016. The moving mean (solid red line) is based on a timeseries with 14% (5 of 36) missing values, and includes the current year and previous four years. Missing years are linearly interpolated (dashed grey lines). Graphics generated by climateanalyzer.org.

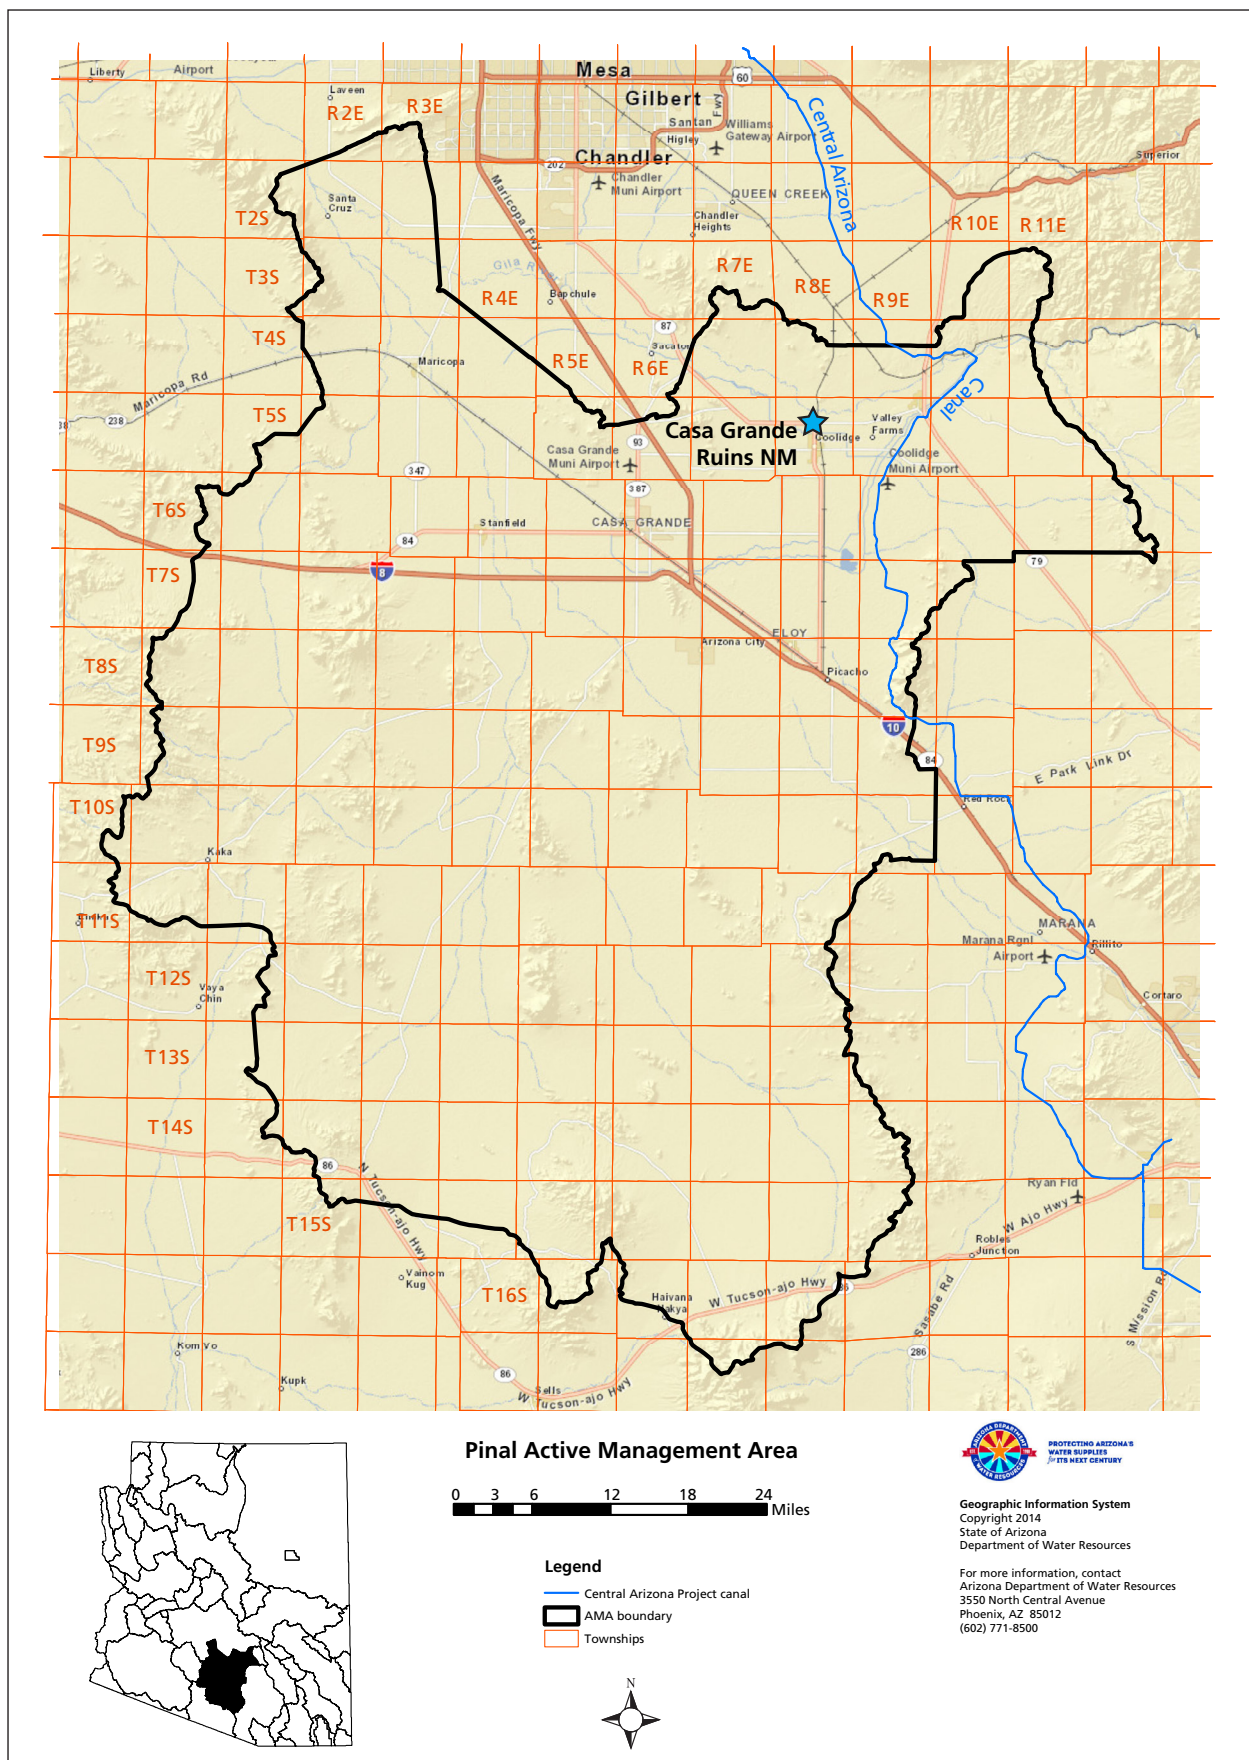
Figure 3-1. Map of Pinal Active Management Area (ADWR 2014).

Casa Grande Ruins National Monument is located in the northeast quadrant of the Pinal Active Management Area (AMA, Figure 3-1; figures start on page 11) and in the north-central section of the Eloy groundwater sub-basin (Figure 3-2). The Eloy groundwater subbasin occupies a pair of hydrologically connected structural depressions formed by the relatively impermeable bedrock of the surrounding mountains and pre-Basin and Range sedimentary rocks (Hammett 1992). The bedrock depressions are filled with 800 to more than 1,000 feet of sediments, including sequences of coarse and fine-grained sediments in the area around the monument (Richard et al. 2007). Measurements in the early 20<sup>th</sup> century indicated that water-level elevations were similar for both shallow and deep wells around the subbasin (Hammett 1992). This indicates horizontal and vertical hydrologic connectivity within the basin. Under those conditions, significant differences in water-level elevations between wells are the result of localized pumping or recharge, which occurs through underflow into the basin; streambed infiltration from the Gila River during flood events; and, to a lesser extent, recharge from the surrounding mountains.

ure 3-1) in 1987 resulted in reduced groundwater pumping in irrigation districts near the canal, including the Hohokam and the Central Arizona Irrigation and Drainage districts (Corkhill 2012). This reduction had a significant influence on groundwater levels in the basin. Outside of CAP service areas, groundwater levels generally declined, such as in the San Carlos Irrigation and Drainage District, adjacent to the monument, and other non-irrigation-district agricultural areas (Corkhill 2012). The slow dissipation of a groundwater mound formed after flooding of the Gila River was a second factor in groundwater-level changes at wells located near the Gila River during this period.

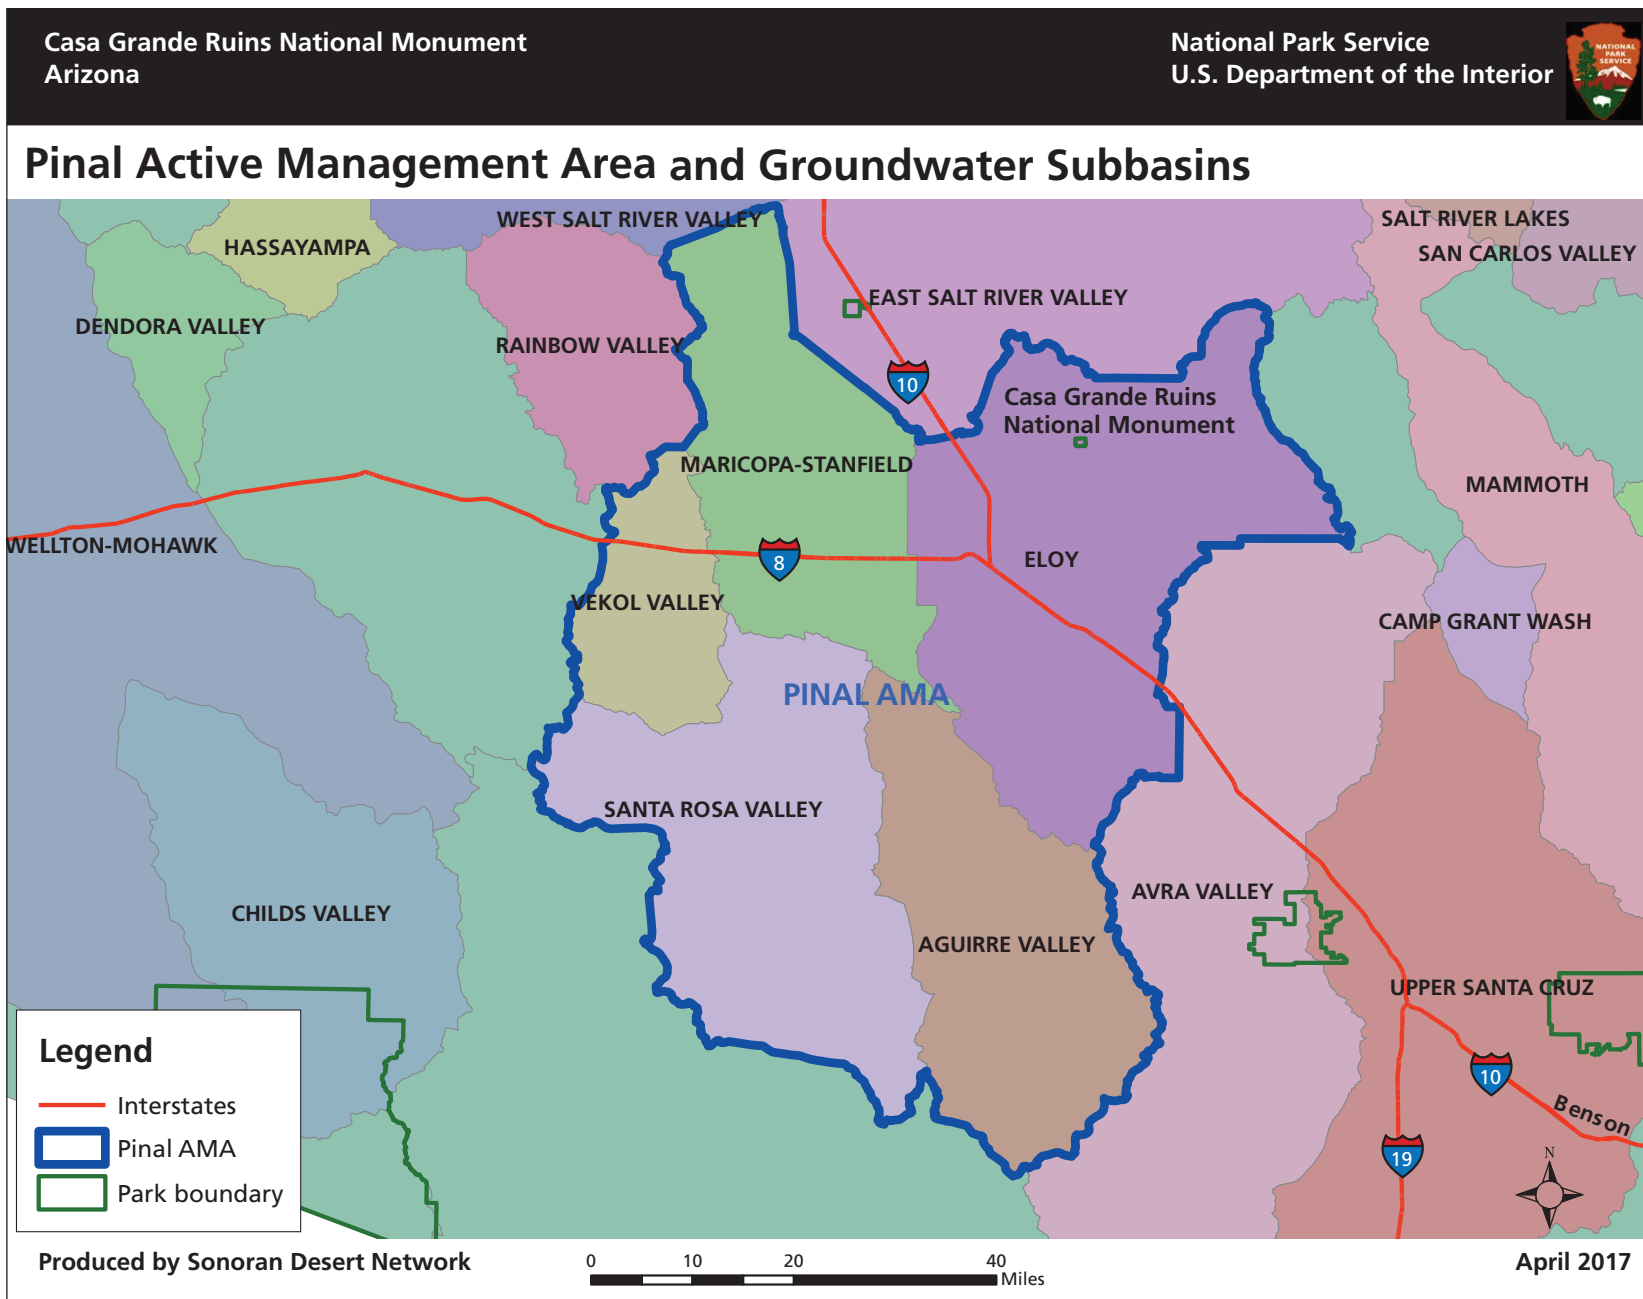
Figure 3-2. Active Management Areas and groundwater subbasins around Casa Grande Ruins National Monument.

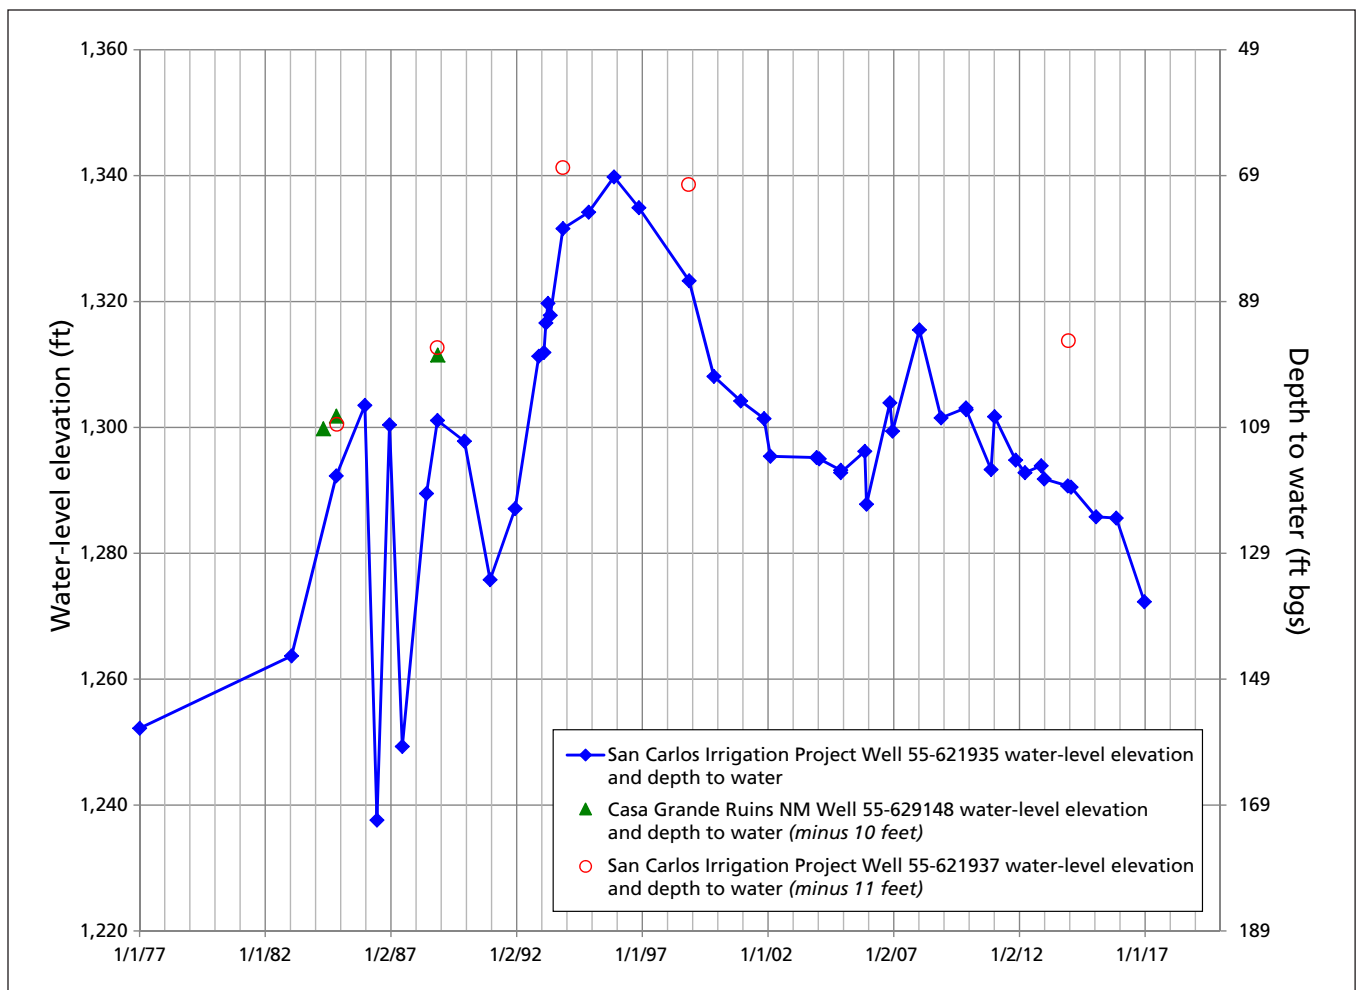
Figure 3-3. Water-level elevation and depth to water at and near Casa Grande Ruins National Monument. Wellhead elevation for well 621935 is 1,409 feet. Wellhead elevation for well 629148 is 1,419 feet, so 10 feet should be added to the scale shown on the right y-axis to obtain the correct depth. Wellhead elevation for well 629937 is 1,420 feet, so 11 feet should be added to the scale shown on the right y-axis to obtain the correct depth.

Water levels at selected wells in the monument area are monitored by the State of Arizona Department of Water Resources (ADWR). Figure 3-3 shows water-level elevations measured at three wells in and near the monument. Well 629148, located inside the monument boundary is 180 feet deep and believed to be a former water supply. Wells 621935 (820 feet deep) and 621937 (1,110 feet deep) are owned by the San Carlos Irrigation Project (SCIP). Figure 3-4 shows the locations of these wells. SCIP well 621935, an ADWR index well, is monitored annually by the state.

Figure 3-3 shows that water levels between the monument well and SCIP well 621937 are very similar, despite significant differences in the total depths of these wells. The historical water-level record documented in Figure 3-3 reflects substantial groundwater-level increases attributed to infiltration from the Gila River following the major regional flood years of 1983 and 1993, and, to a lesser extent, 2007 (Figure 3-5). Groundwater levels in the Eloy subbasin decline between high flow events on the Gila River. Differences between the wells at and adjacent to the monument and the ADWR index well, located about 1.4 miles from park headquarters, are attributed to pumping at the index well.

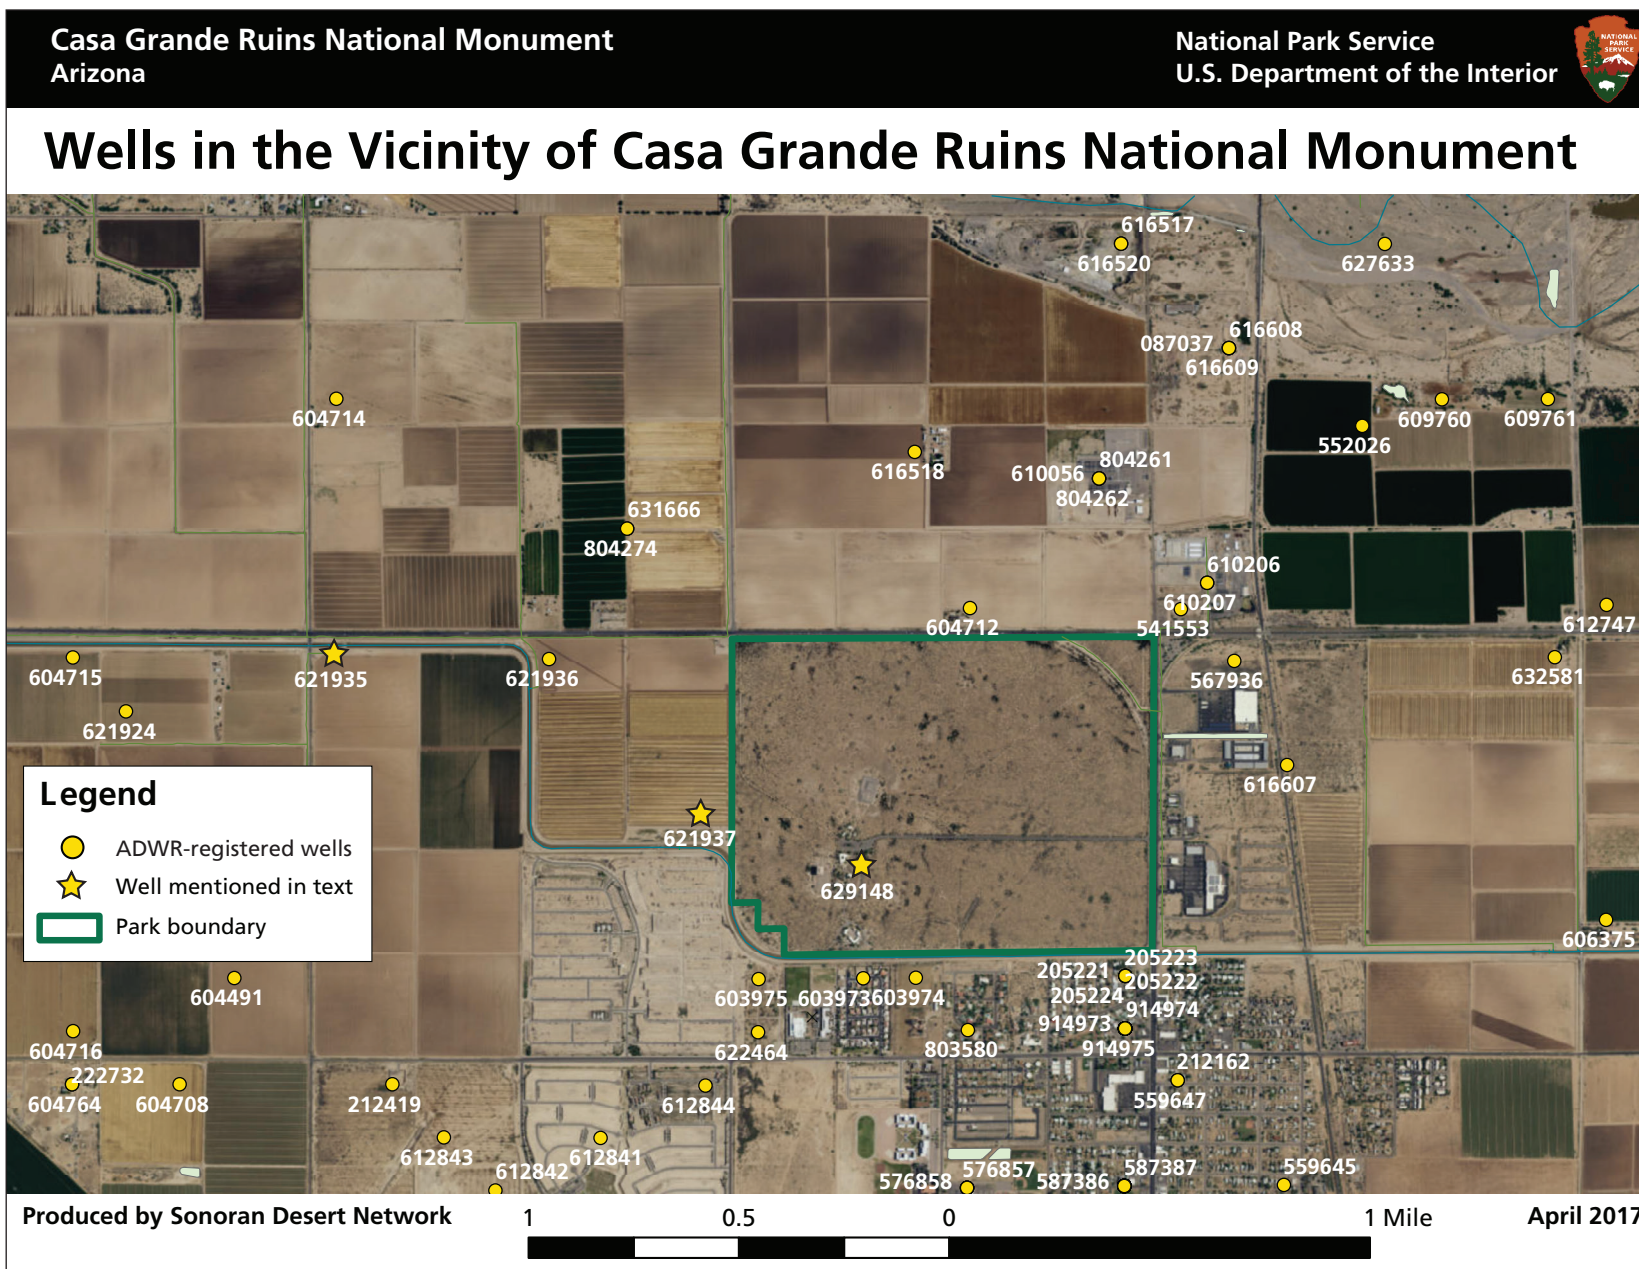
Figure 3-4. Location and state registry numbers for wells in the vicinity of Casa Grande Ruins National Monument.

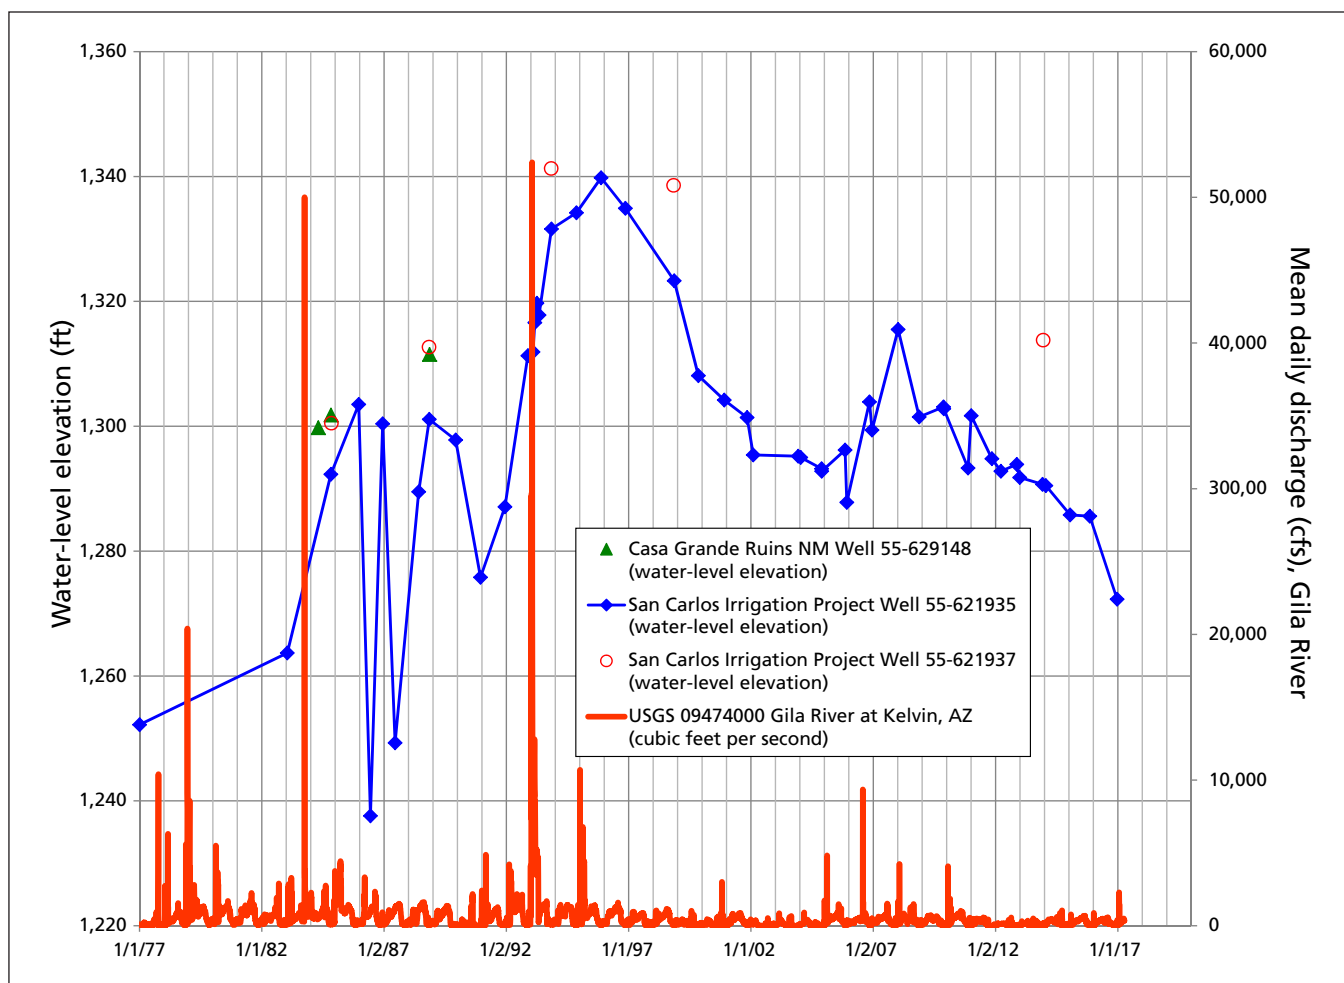
Figure 3-5. Gila River mean daily discharge at Kelvin, Arizona, and water-level elevation in and around Casa Grande Ruins National Monument, 1977–2016.

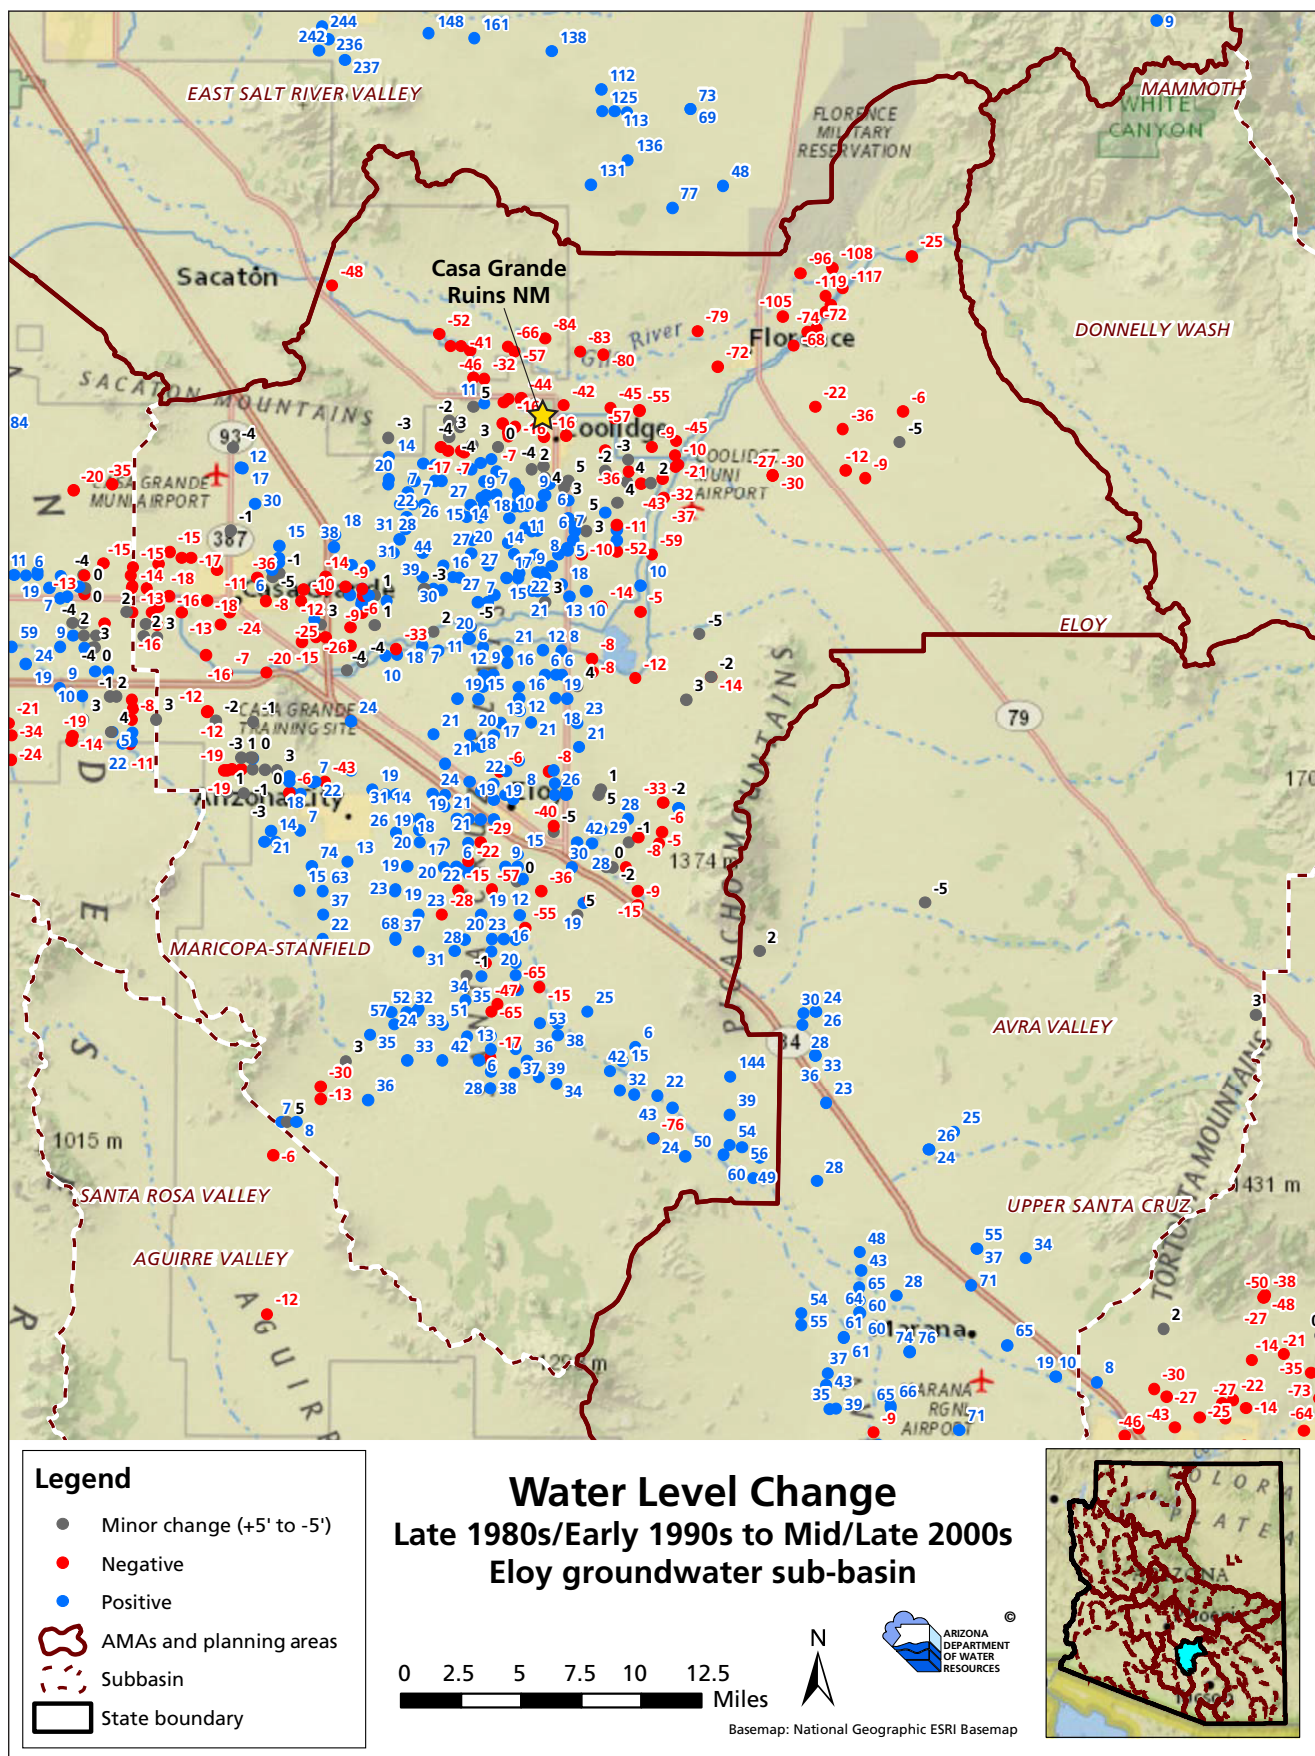
Figure 3-6. Water-level change in the Eloy groundwater subbasin (Corkhill 2012).

Figure 3-6 maps water-level changes in the Eloy subbasin between the late 1980s/early 1990s and the mid/late 2000s (Corkhill 2012). The introduction of water from the Central Arizona Project (CAP, shown in Fig-

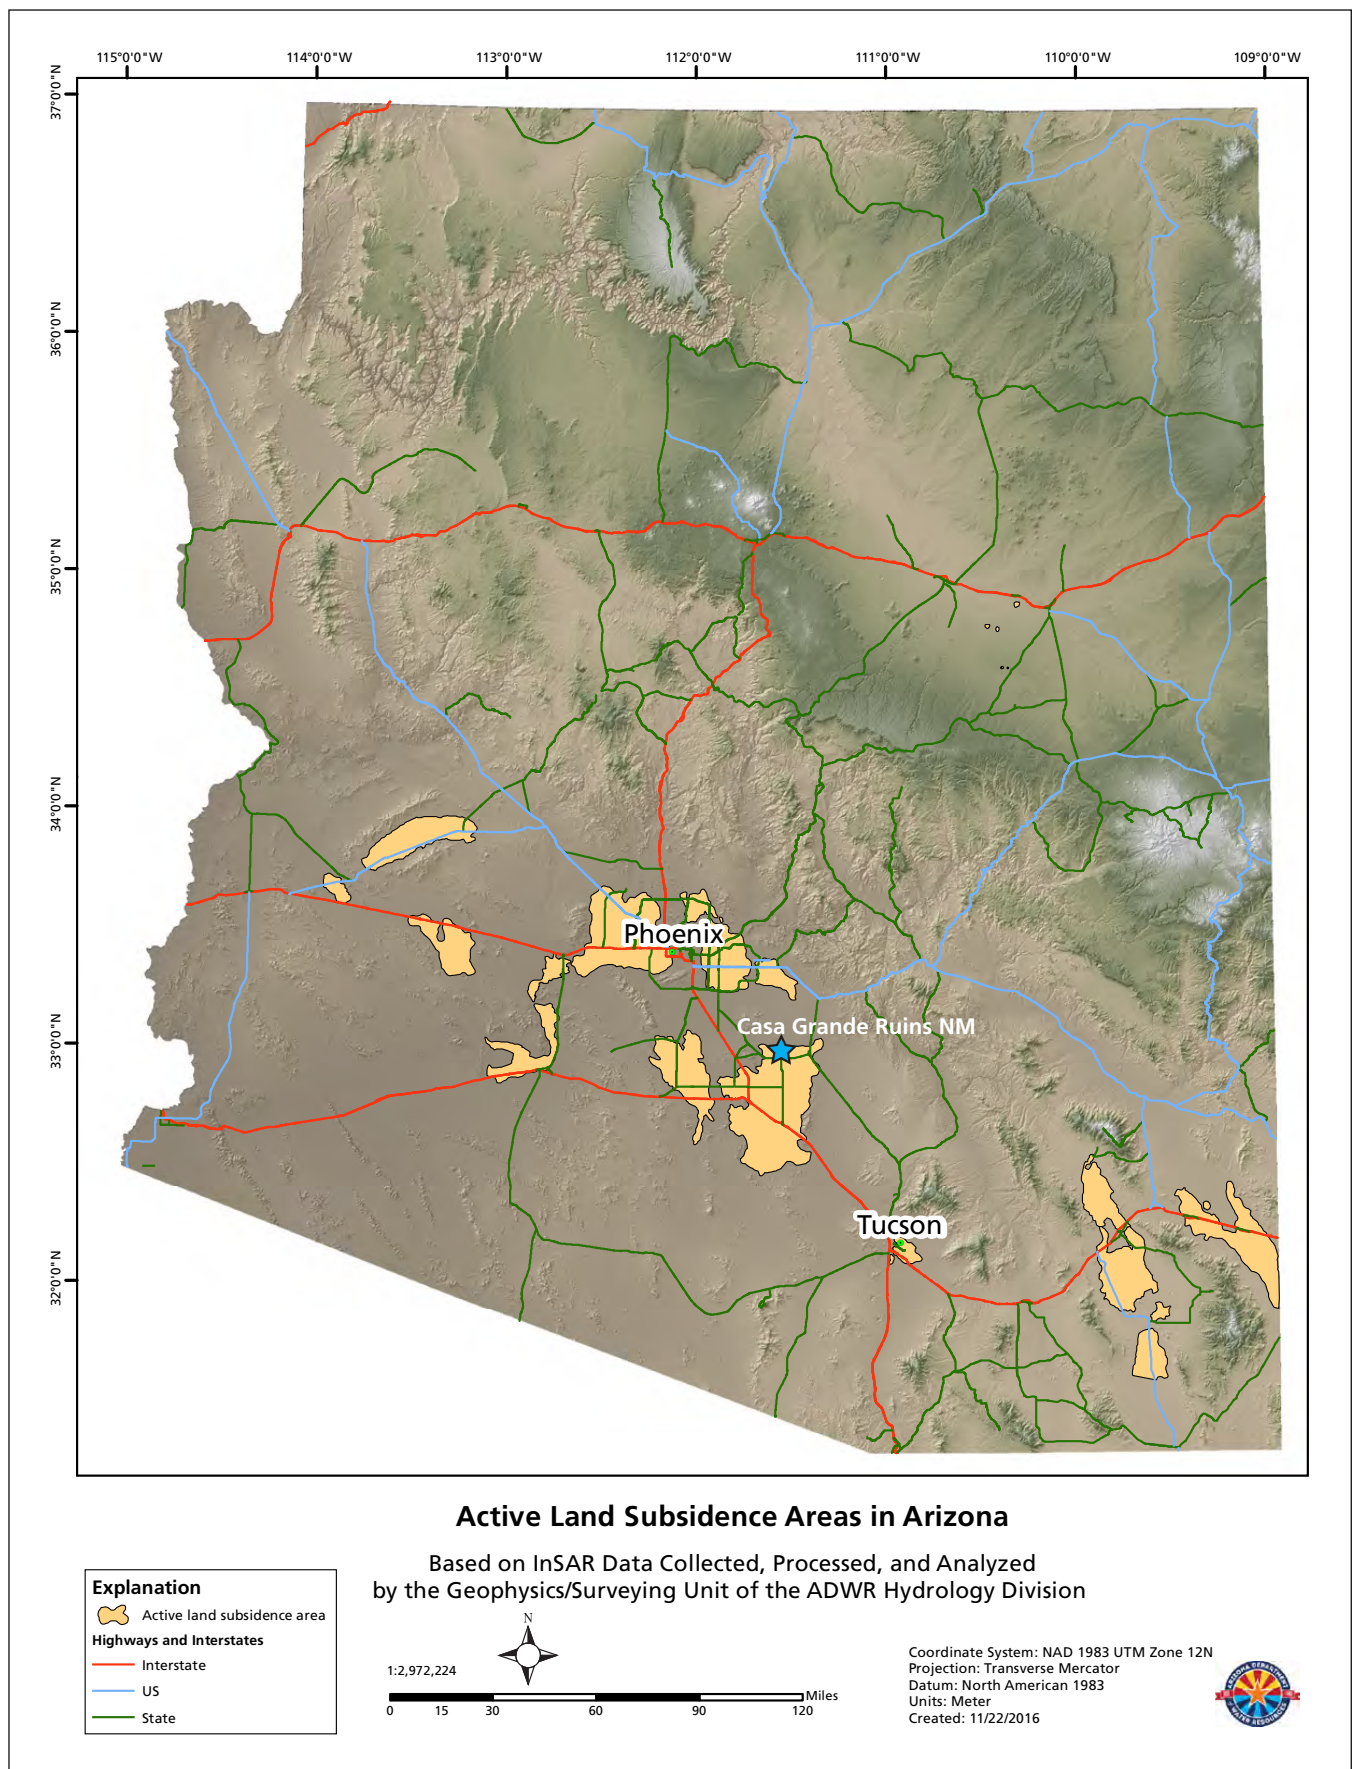
Figure 3-7. Areas experiencing active land subsidence in Arizona (ADWR 2017b).

Long-term declines in groundwater levels throughout Arizona have resulted in areas of land subsidence (gradual collapse, fissuring or slumping), as shown in Figure 3-7 (ADWR 2017b). Subsidence occurs in areas where deep basins filled with alluvial sediments are dewatered, especially where compressible and plastic fine-grained materials are present. Land subsidence is not reversible. Casa Grande Ruins NM is located near the northern end of the Picacho-Eloy subsidence feature (Figure 3-8). Figure 3-9 illustrates subsidence measured between 2010 and 2016, together with traces of known earth fissures in the subbasin (ADWR 2017b). Additional
