# Status of Climate and Water Resources at Casa Grande Ruins National Monument

*Water Year 2016*

Natural Resource Report NPS/SODN/NRR—2018/1629

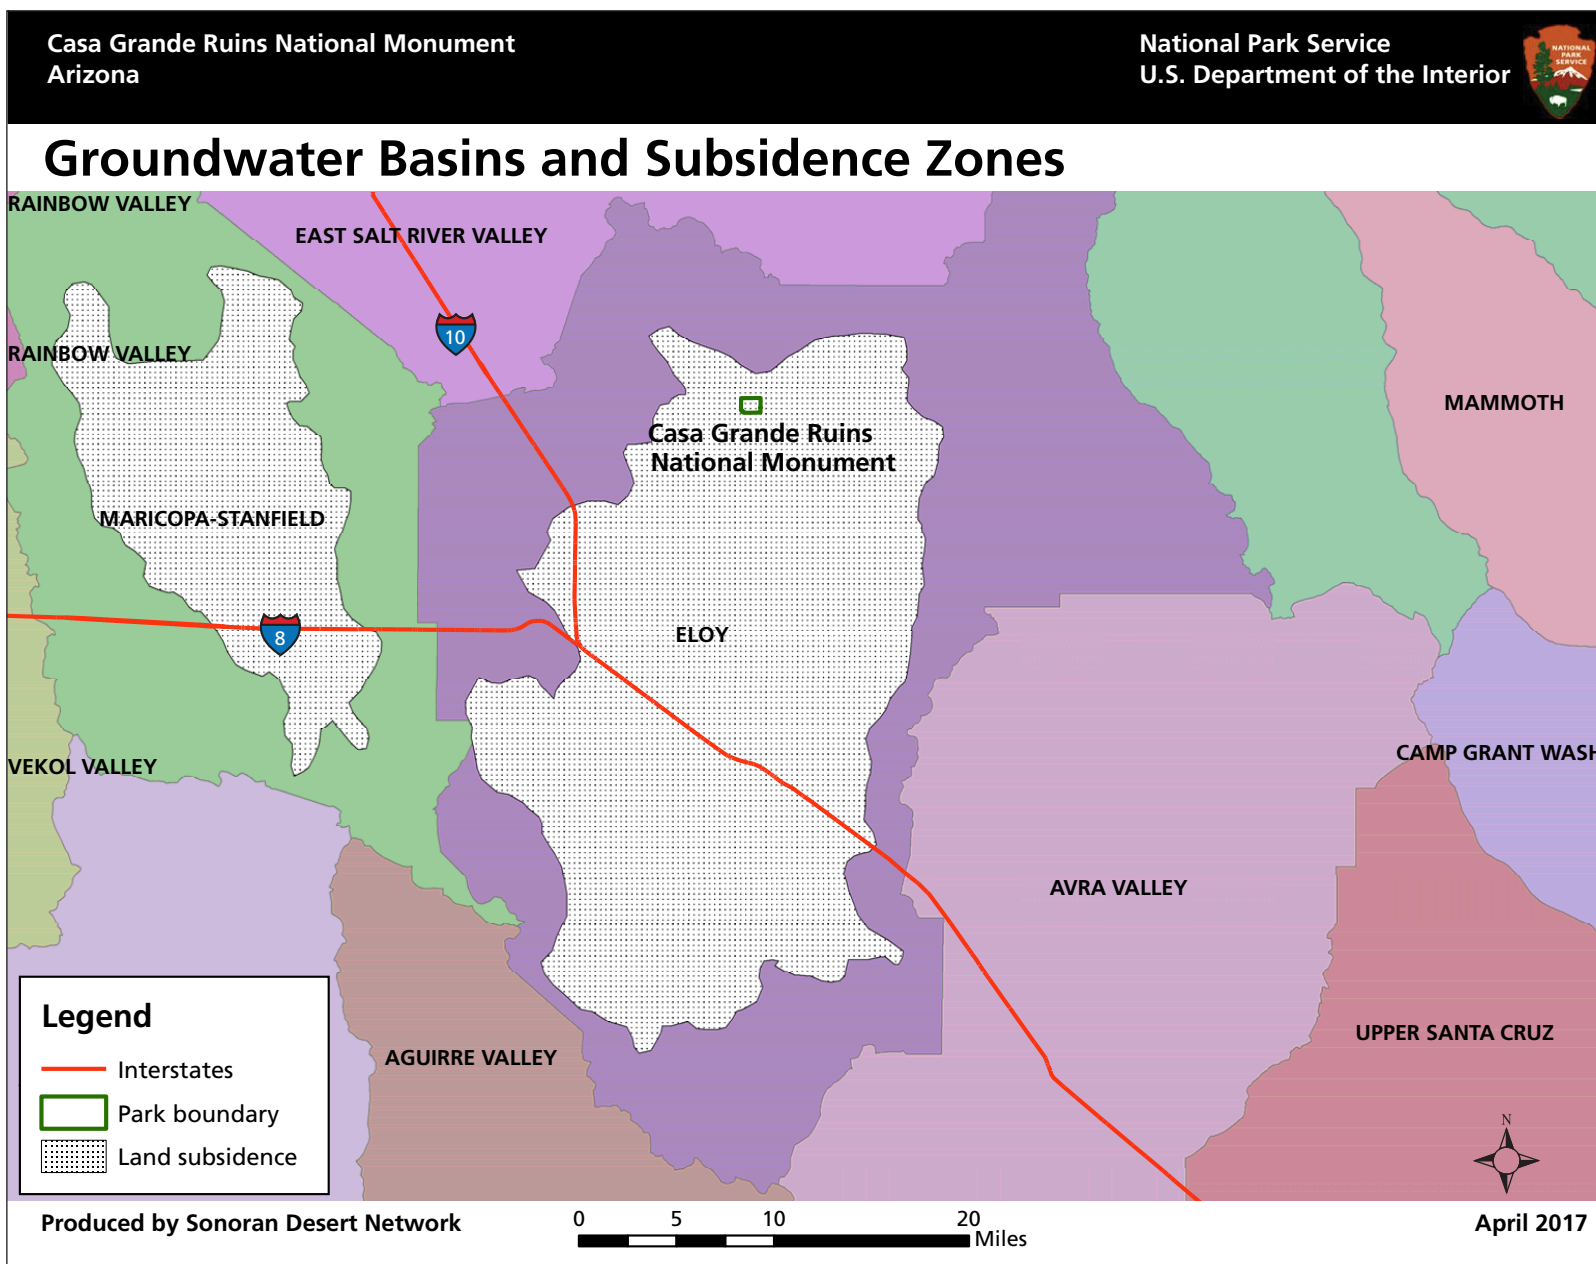
Figure 3-8. Groundwater subbasins and areas experiencing subsidence at and near Casa Grande Ruins National Monument.

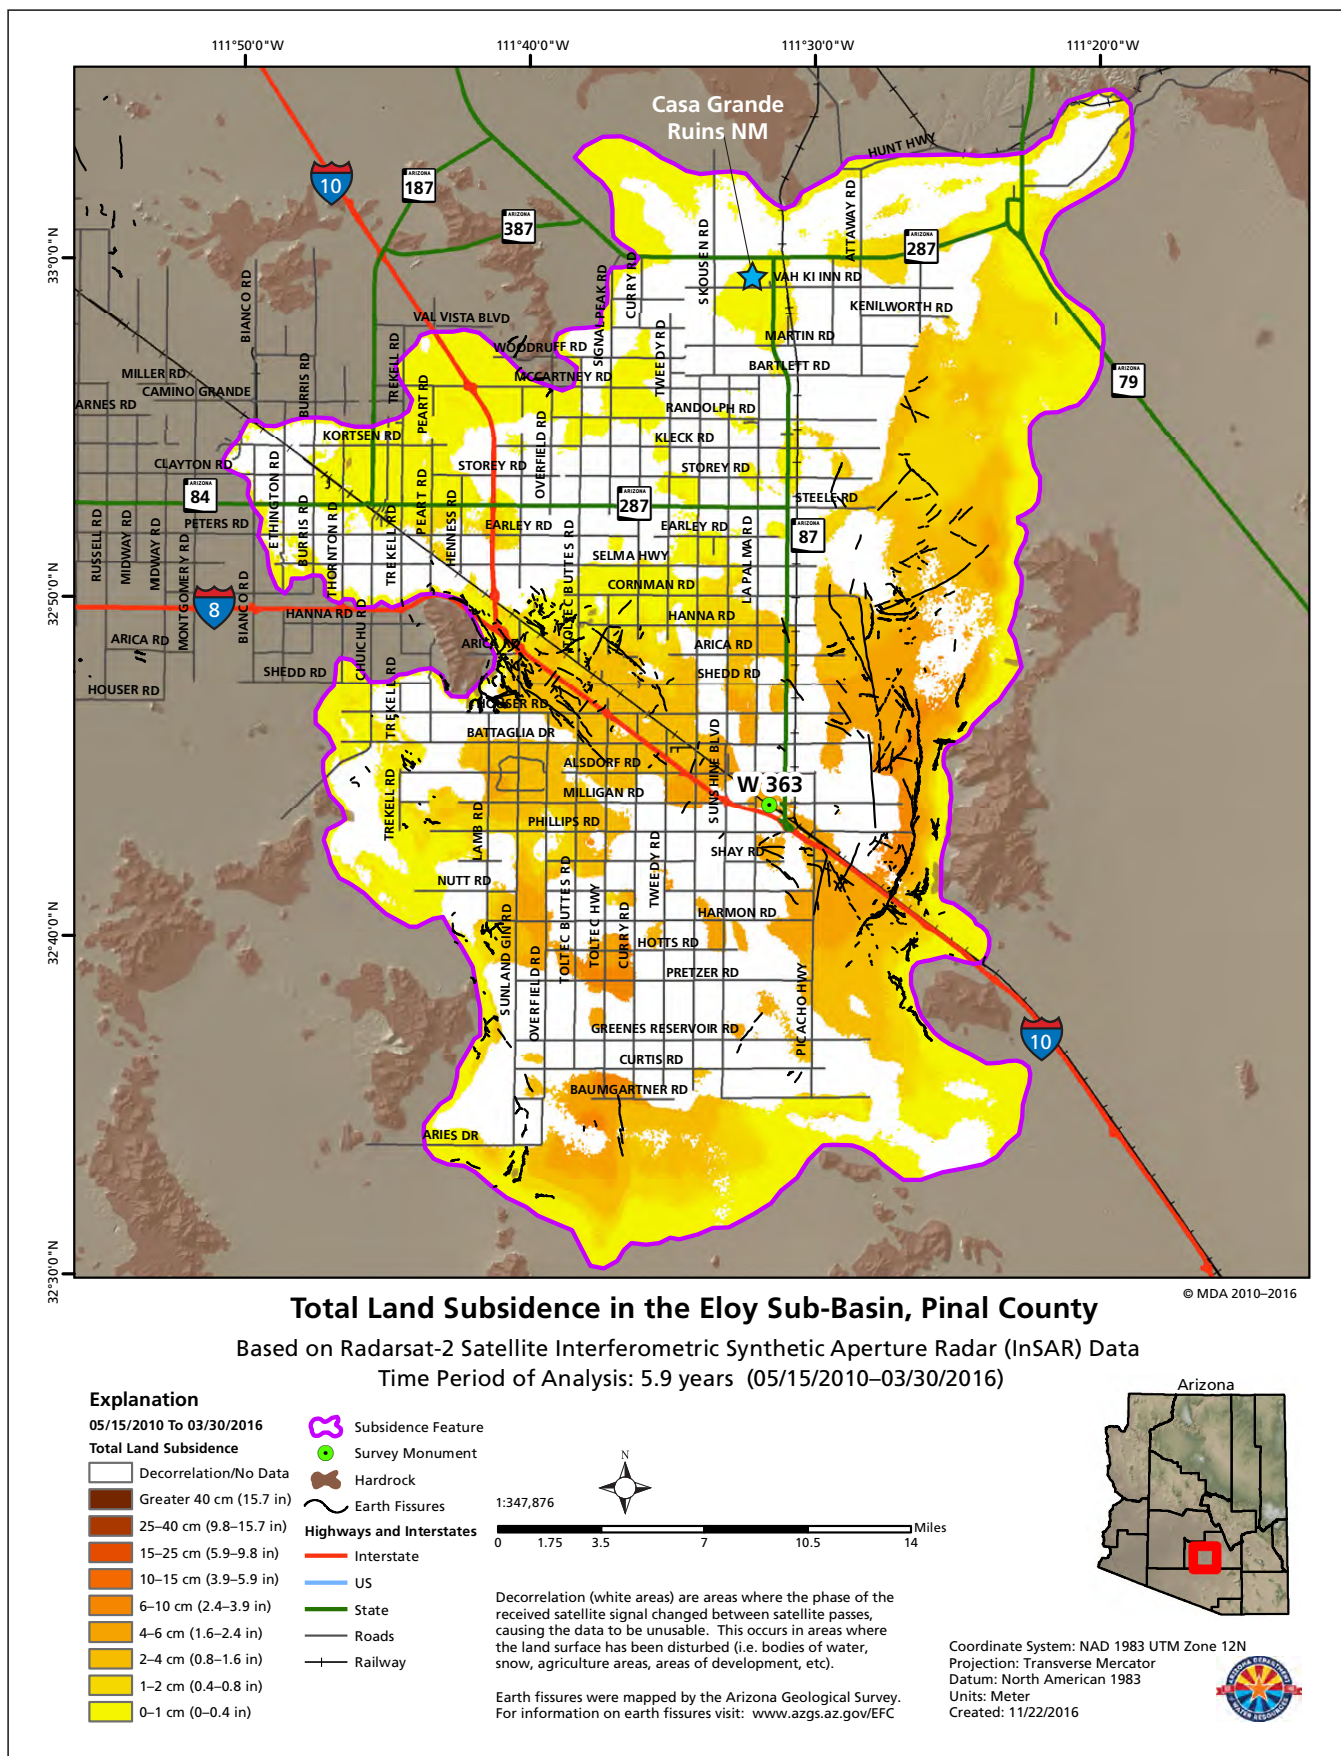
Figure 3-9. Land subsidence and earth fissures in the Eloy subbasin (ADWR 2017b).

Long-term declines in groundwater levels throughout Arizona have resulted in areas of land subsidence (gradual collapse, fissuring or slumping), as shown in Figure 3-7 (ADWR 2017b). Subsidence occurs in areas where deep basins filled with alluvial sediments are dewatered, especially where compressible and plastic fine-grained materials are present. Land subsidence is not reversible. Casa Grande Ruins NM is located near the northern end of the Picacho-Eloy subsidence feature (Figure 3-8). Figure 3-9 illustrates subsidence measured between 2010 and 2016, together with traces of known earth fissures in the subbasin (ADWR 2017b). Additional

information about this subsidence feature and maps of measured subsidence in the area from 2004 through 2016 may be found at <http://www.azwater.gov/AzDWR/Hydrology/Geophysics/PicachoEloySubsidence.htm>. The Eloy subbasin has the dubious distinction of harboring the greatest number of earth fissures in the state, mostly clustered along the central eastern and central western parts of the subbasin (AGS 2016).
