# Historic Structure Treatment Record

## Repair Wirth Hall Basement Windows and Doorways Stephen T. Mather Training Center

PMIS #183498A  
Historic Preservation Training Center  
National Park Service  
Frederick, MD

April 2014

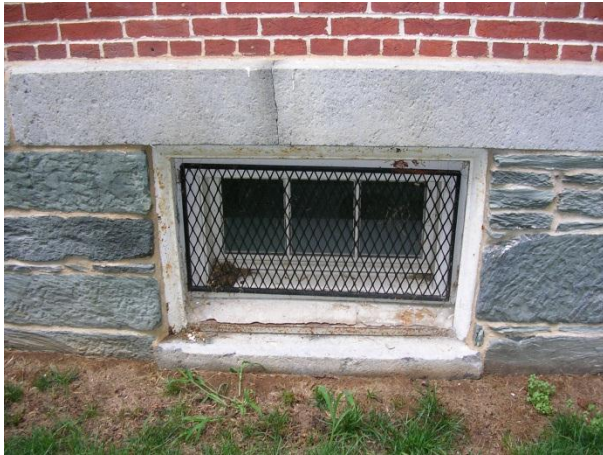
Figure 1 : An example of the window conditions prior to the preservation work completed by the HPTC wood crafting team.

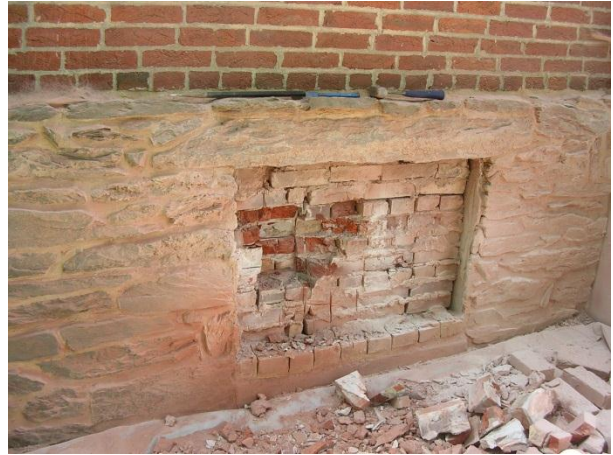
Figure 2 : Some of the window openings had been bricked over. Here, the HPTC wood crafting team begins to open up one of these window openings.

Next, bricked over window openings were opened. Four to five layers deep of brick courses were discovered. Whole bricks were saved and given to park maintenance; the remaining brick debris was removed from the site and disposed of.

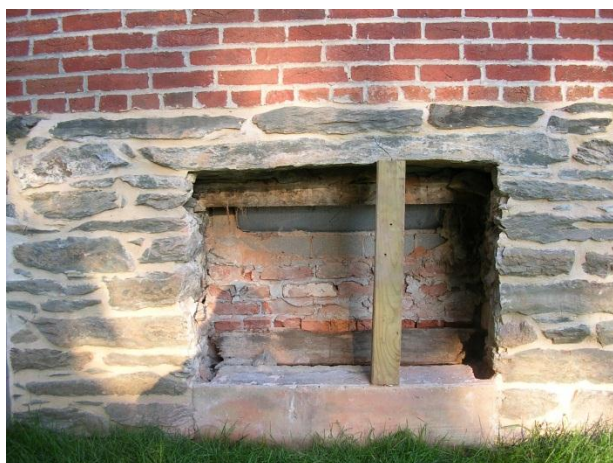
Figure 3 : When opened, four to five layers of brick courses were discovered. Whole bricks were saved and given to park maintenance; the remaining debris was disposed of.

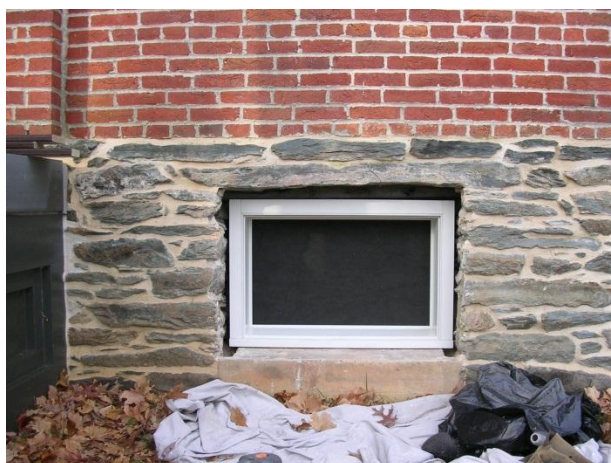
Figure 4 : The window sash were taken to HPTC's Jenkins shop facility for abatement and repairs before being reinstalled in their respective openings. Above, a repaired sash is reinstalled.

At the Jenkins shop, the glazing and paint on the windows was removed. Any broken or missing glass was then replaced and all windows were glazed using Sarco glazing putty. The pulleys that had been removed from the window jambs were cleaned; all the paint was removed from the face plate and wheel, the faces were wire brushed clean, and a coat of Rust-O-Leum clear lacquer was applied. The window sash were then primed with oil based primer, sanded, and received two finish coats of latex exterior paint and re-installed.

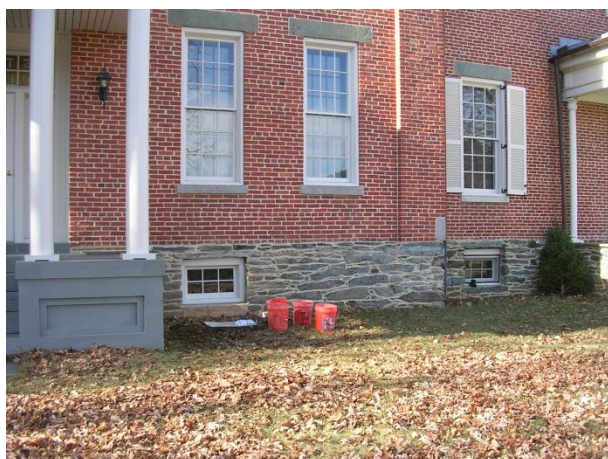
Figure 5 : A completed sash installation

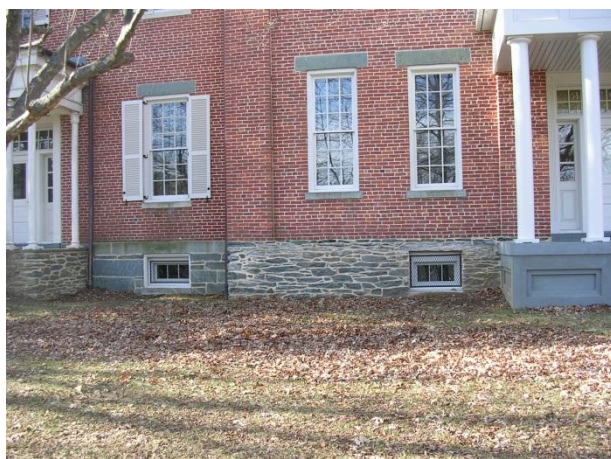
Figure 6 : Final window unit repairs. Once the window units were replaced, the stainless steel mesh panels were reinstalled.

The stainless steel mesh panels were powder coated jet black by High Tech Coatings, Inc. and then transported to the site for installation.

Stainless steel, (powder coated black) metal screens were installed over 12 window units.

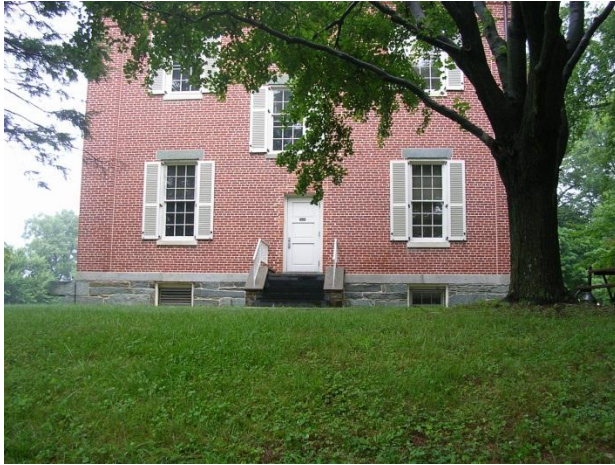
Figure 7 : The HPTC wood crafting team also worked on the doorways of the Wirth Hall. Pictured above is a doorway that has been wet scraped and sanded to remove any flaking or failing paint; primed with Benjamin Moore alkyd primer; wiped down with deglosser; and painted with Benjamin Moore semi-gloss latex paint to matching the existing paint.

All deteriorated wood components on the door units were repaired with either epoxy or a wood Dutchman and then wet scraped and sanded to remove flaking or failing paint. The intact paint was feathered out and the doors were then primed with Benjamin Moore penetrating alkyd primer, wiped down with deglosser, and painted with Benjamin Moore semi-gloss latex paint to match the existing Wirth Hall color. The center batten on the west elevation door was replaced due to deterioration and mismatched repairs on the bottom. Additionally, a new door sweep was installed on door 6 and a new door threshold was installed on door 2.

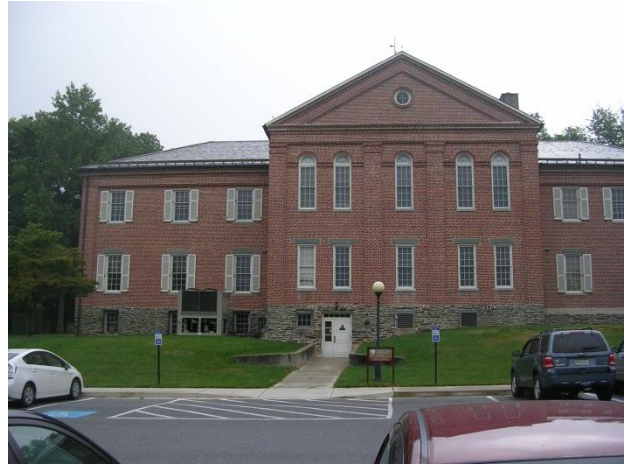
Figure 8 : Similarly, this image pictures another door that was treated using the same process as the door in figure 7.
