# 526 Auburn Avenue Martin Luther King, Jr. National Historic Site Historic Structure Report

# Historic Structure Report

May 2017

The purpose of this historic structure report (HSR) is to document the construction history and current condition of 526 Auburn Avenue, Atlanta, Georgia, in the Martin Luther King, Jr. National Historic Site (MALU) and to provide recommendations for the building's treatment and use. This HSR will guide the National Park Service in the stewardship of this historic resource.

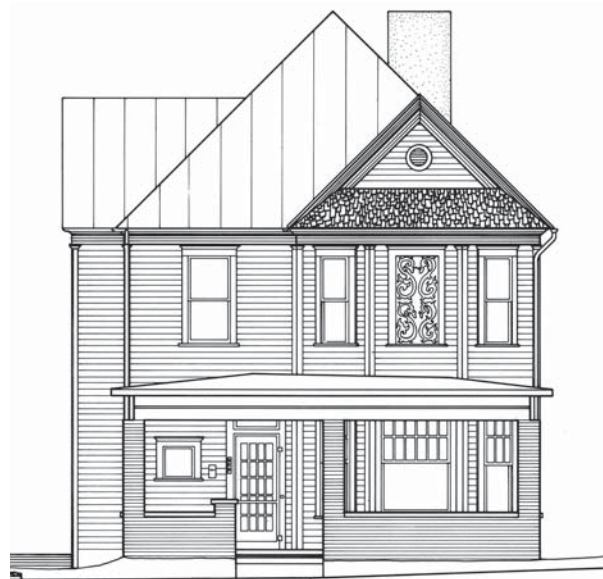
**Figure 30.** Historic American Buildings Survey (HABS) drawing prepared in 1985 showing 518, 522, and 526 Auburn Avenue. Note the brick wall and posts on the porch at this time.

and these drawings document the house prior to many of these changes. The preparers of the HABS documentation recorded drawings of the facades along the block as well as a full drawing set to document the existing conditions at 526 Auburn Avenue<sup>147</sup> (Figure 29 and Figure 30).

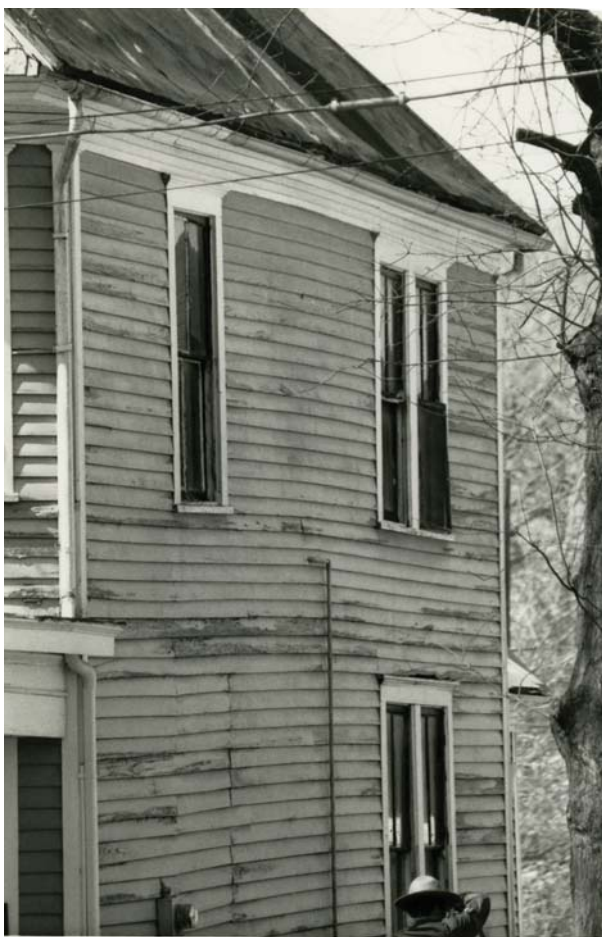
**Figure 31.** Undated (c. 1985) photo of the east facade of 526 Auburn Avenue prior to exterior improvement project.

Not long after this recordation, the NPS commissioned work for rehabilitation including selective demolition and upgrades to the structure. The rehabilitation project included improvements to the exterior, including removal of deteriorating siding and of non-historic porch features (Figure 31 and Figure 32). The NPS proposed replacement of historic fabric in-kind, replacement of missing historic fabric, and the addition of non-historic elements for stabilization. Work included "carpentry, millwork, finish hardware, glass and

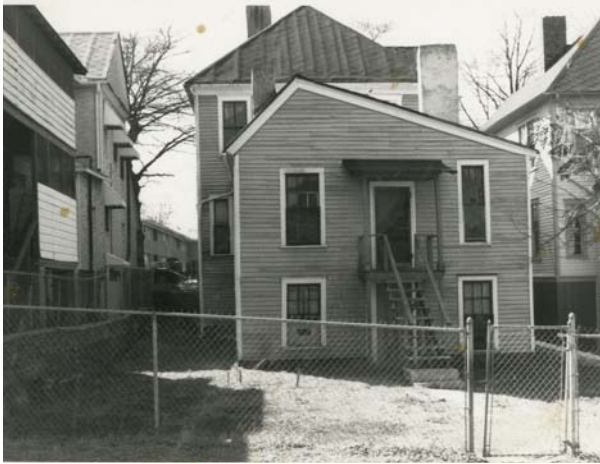
**Figure 33.** Undated photo of north facade prior to restoration efforts

glazing, roofing, finishes, paint; wood doors, window sashes and porch railings and posts; miscellaneous metals, gutters and downspouts, concrete footings, systems and fire stairs (Figure 33).<sup>148</sup> The project commenced in 1988. Ms. P.C. Barlow received the contract for “Preservation House Work” for this rehabilitation work.<sup>149</sup> *Appendix A, Sheet A-03* depicts the first floor plan of the building after the implementation of interior changes.

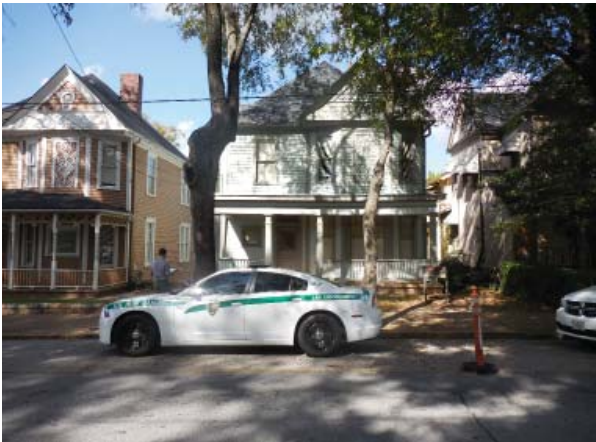
Figure 35. South elevation.

Located on the north side of Auburn Avenue west of Howell Street and fronted by an exposed aggregate concrete sidewalk, the house faces south (Figure 35).

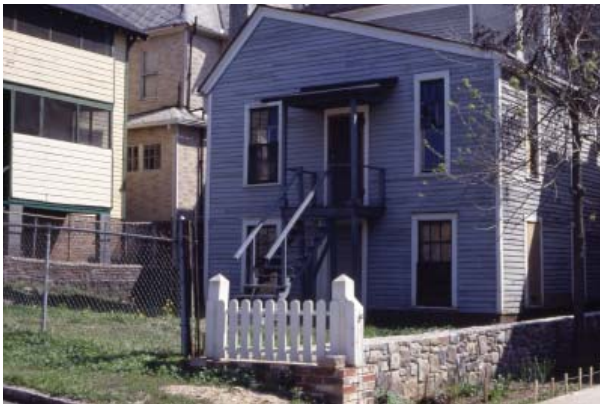
**Figure 37.** North elevation, oblique view (MALU Archives, Slide 526882, April 1985)

of the house. A low stone retaining wall separates side and rear yards of 526 and 522 Auburn Avenue (Figure 37). A stacked-stone wall is located alongside 530 Auburn Avenue and 54 Howell Street. The east and west yards include lawn areas. HVAC condensing units are set on-grade in the east side yard.

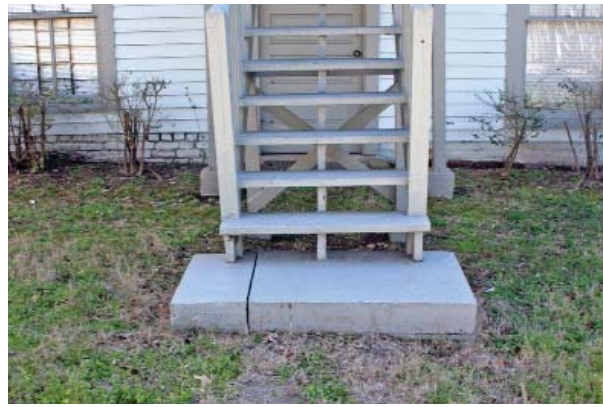
**Figure 38.** North elevation, rear steps, concrete pad and pavers.

Old Wheat Street is the northern border of the rear lawn area. There is no sidewalk. A poured concrete slab acts as a footer for the wood stairs leading to the main level from the rear yard (Figure 38). Remnants of hexagonal pavers leading north from the stair, existing in 1985 photographs of the site, remain (Figure 39 and Figure 40). There are privet hedges (*Ligustrum sinsense*) along the north elevation of the house.

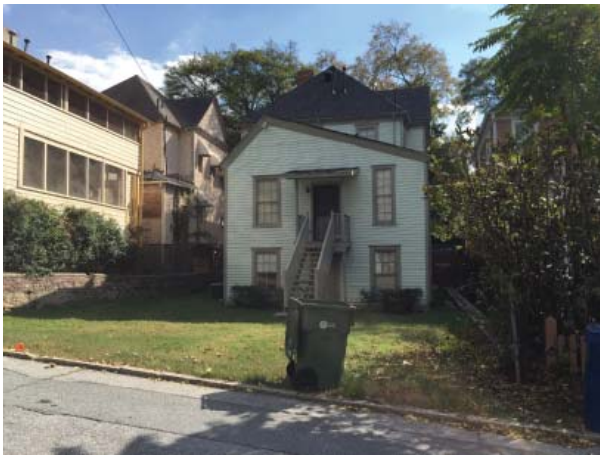
**Figure 39.** North elevation.

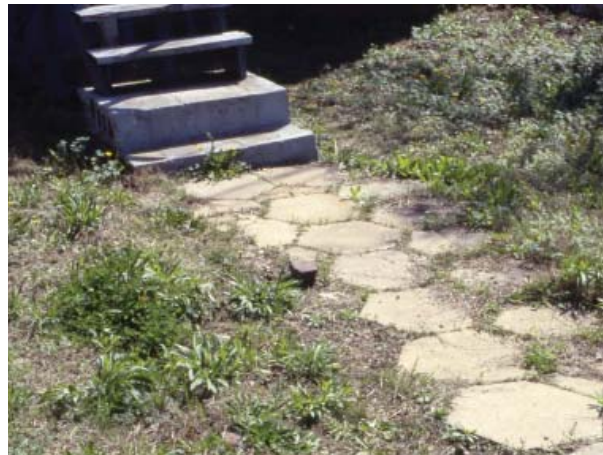
**Figure 40.** North (rear) yard, hexagonal pavers (MALU Archives, Slide 526866, April 1985)

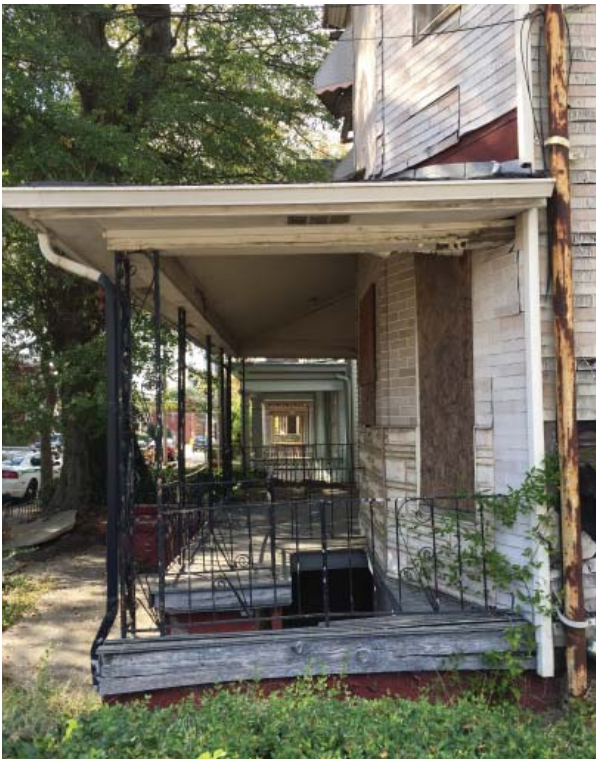
**Figure 41.** Prototype houses, front porches along Auburn Avenue.

the 500 block of Auburn Avenue.<sup>157</sup> The prototype design is Queen Anne in form, massing and room configuration, and stock elements include stair, door, and window designs, primary and secondary baseboards, picture moldings, fireplace mantels, door and window casings, and crown moldings. The design lent itself to creation of a distinctive appearance for each address (Figure 41). Simple modification of exterior elements such as shingle cut and pattern, gable vents, door and window designs, and porch columns and balustrades, create a visual contrast and blending of architectural styles along this block of Auburn Avenue (Figure 42). Minor modifications to interior floor plans further personalized the utility of each prototype house.<sup>158</sup>

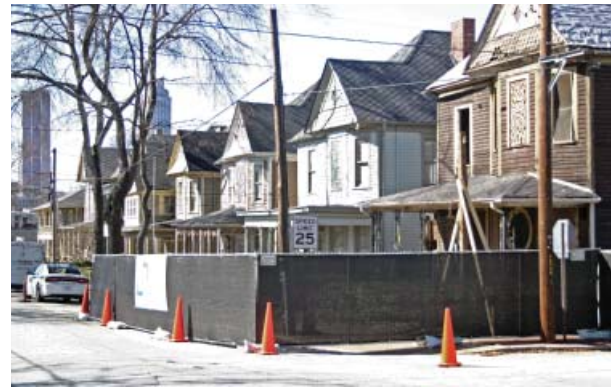
**Figure 42.** Prototype houses along Auburn Avenue.

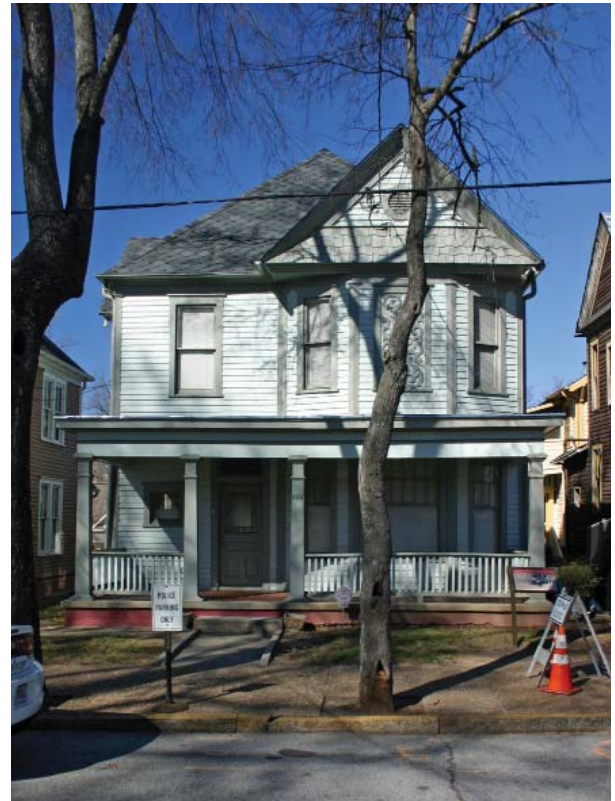
**Figure 43.** South elevation.

A two-story house with basement, it includes a primary main block with a one-story north wing. Roof forms vary, with a tall hipped roof with projecting gables on the south and west elevations covering the main block. An asymmetrical gabled roof sits atop this roof. Hexagonal asphalt composite shingles cover both roofs.

The full-width, hipped roof porch dominates the primary south elevation fronting Auburn Avenue (Figure 43). Wood posts and balusters are not original, as photographs dating to the 1980s and 1985 HABS drawings and photos indicate brick columns and a low brick wall at the Entry Porch

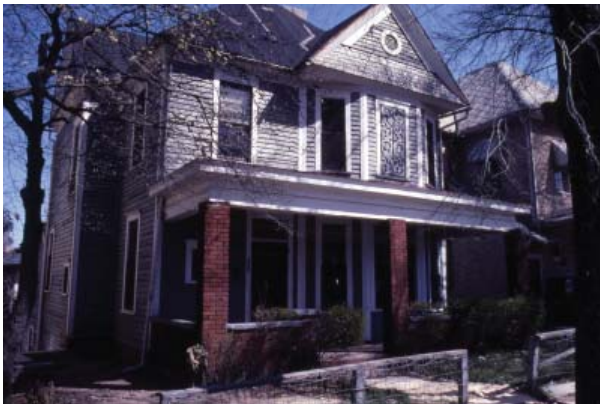
**Figure 44.** South elevation (MALU Archives, Slide 526879, March 1985)

(Figure 44). A single concrete step leads up to the concrete porch deck with a quarry tile inset. Stucco covers a brick wall below the concrete deck on all elevations of the Entry Porch.

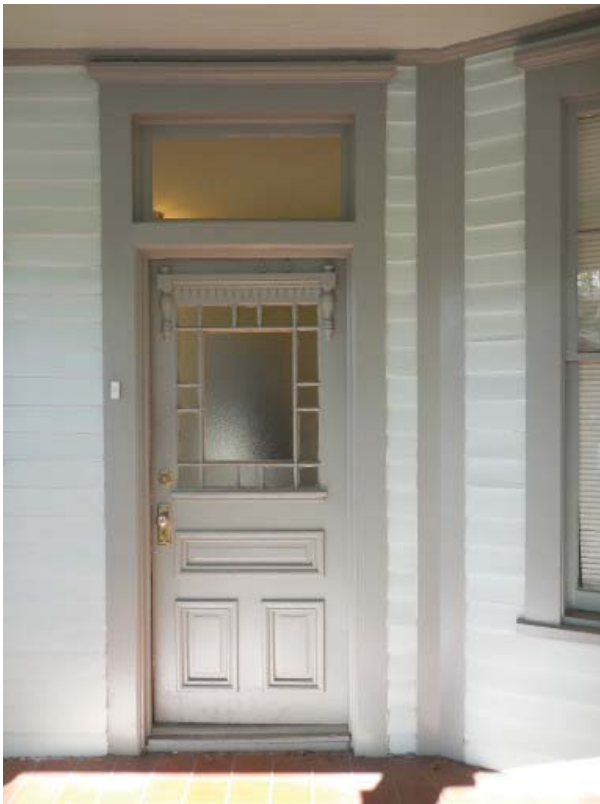
**Figure 46.** Front Door.

Windows vary in type and size, and are asymmetrical in placement. The typical window type is a two-over-two double-hung wood window (Figure 45). Notable variations include the twelve-over-one windows of the projecting front bay and the one-over-one windows immediately above on the second floor. To the west of the front door is a single fixed-sash window. A variety of window types are found on the north wing. A round wood vent is centered in the upper gable. The three exterior doors are varied in design, and the NPS installed the elaborate front door with a frosted glass light after 1985 (Figure 46).

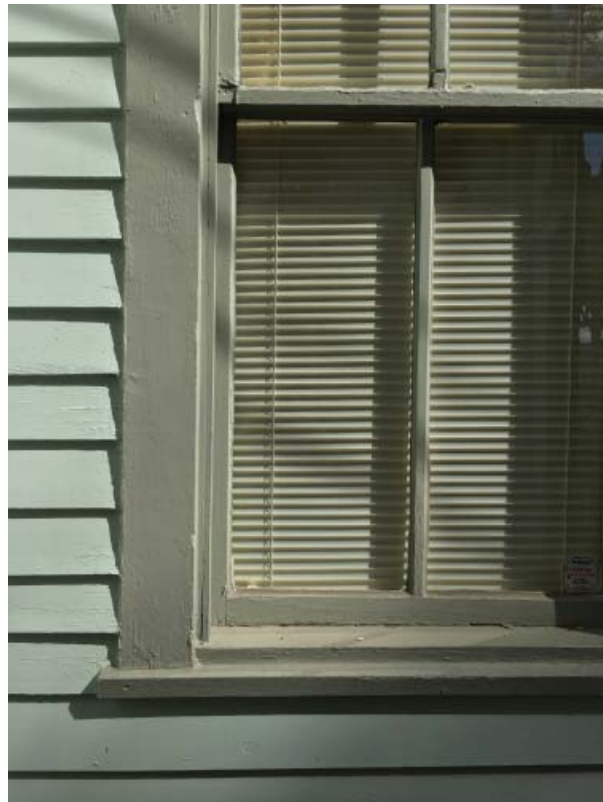
**Figure 45.** Typical window, exterior view.

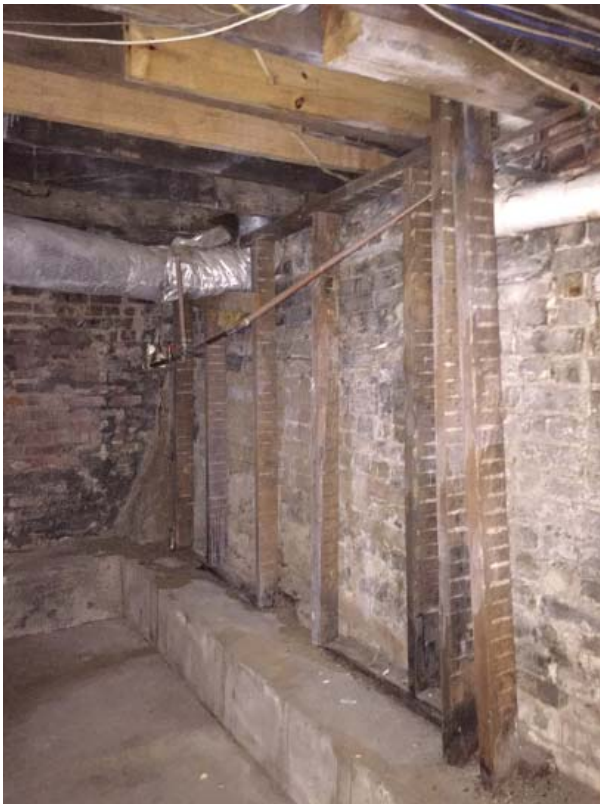
**Figure 49.** Southwest corner of basement.

The south portion of the full height basement is buried below grade and the portion to the north is above grade. The full height basement walls are stone or brick. Construction includes a concrete slab-on-grade throughout and concrete bulkheads at the base of the stone or brick retaining walls (Figure 49). At a point, approximately 10'-0" north of the south face of the building, there are site retaining walls that tie into east and west basement walls, allowing the grade outside to drop approximately 6'-0" south-to-north.

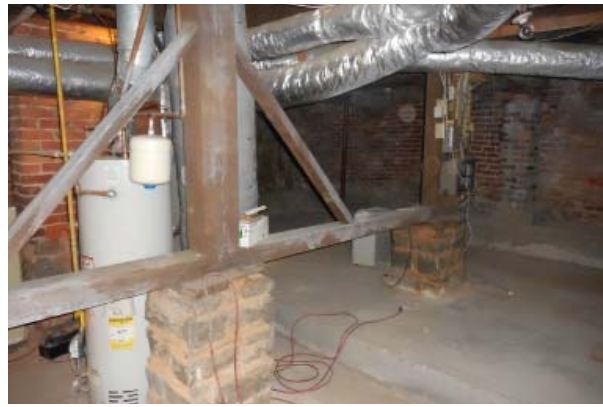
**Figure 50.** Wood support frame under bearing wall running North-South.

The floor joists and interior bearing walls from the floors above are supported in the basement by a system of timber beams. These beams are just below the floor level and bear on timber columns that bear on low timber beams approximately 3'-0" above the basement floor. The low beams of the truss bear on stone piers. The piers have extensive deterioration of the mortar resulting in some loss of stone material. This wood framing system includes wood kicker bracing (Figure 50 and Figure 51) that is part of the lateral load resisting system. In several locations the owners removed portions of the low wood beams during renovations (Figure 52 and Figure 53).

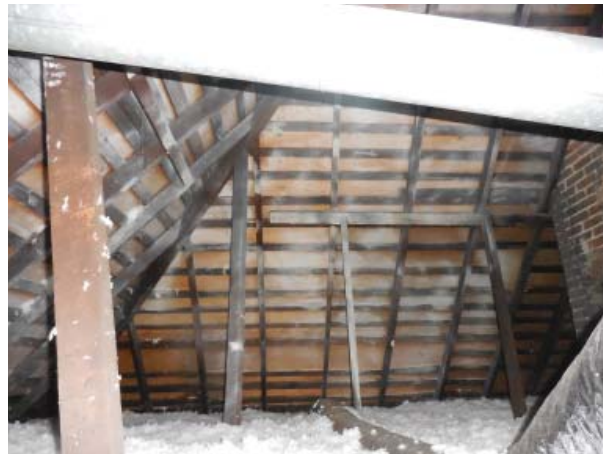
**Figure 56.** Roof framing in attic.

The roof is a gable and hip roof made of rough-cut rafters covered with horizontal battens that supported the original roofing. At some point, plywood sheathing was added on top of the battens. The rafters are braced by mid height knee walls kicking down to the framing below. The rafters connect to a ridge, hip beams and live valley beams that bear on support posts bearing on wall framing below (Figure 56). The roof system cantilevers over the wall of the bay at the south face of the building below to form an overhang.

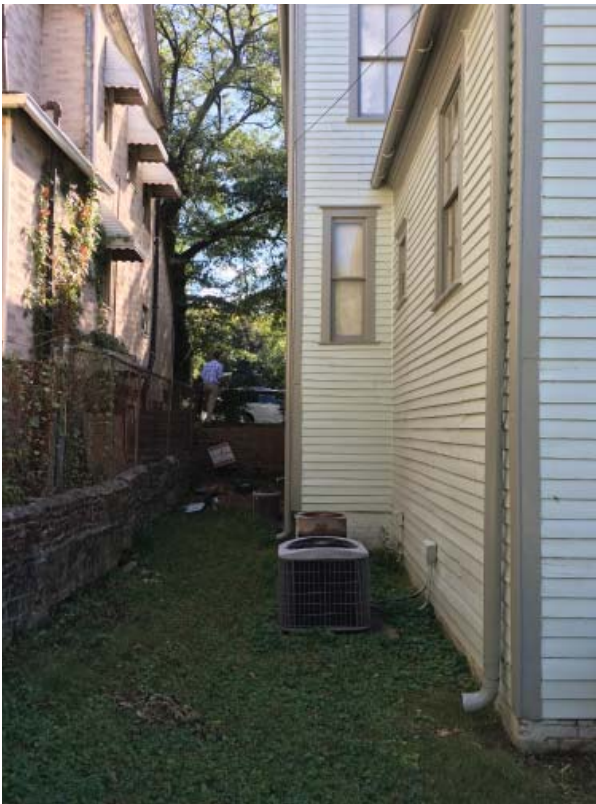
Figure 57. East Side Yard.

and air conditioning to spaces on all levels via insulated ductwork routed below the main floor and above the second floor in the attic. Condensing units are located on grade in the east side yard, (Figure 57) and air-handling units are located in Unfinished Room 004 (and in the attic) (Figure 58).

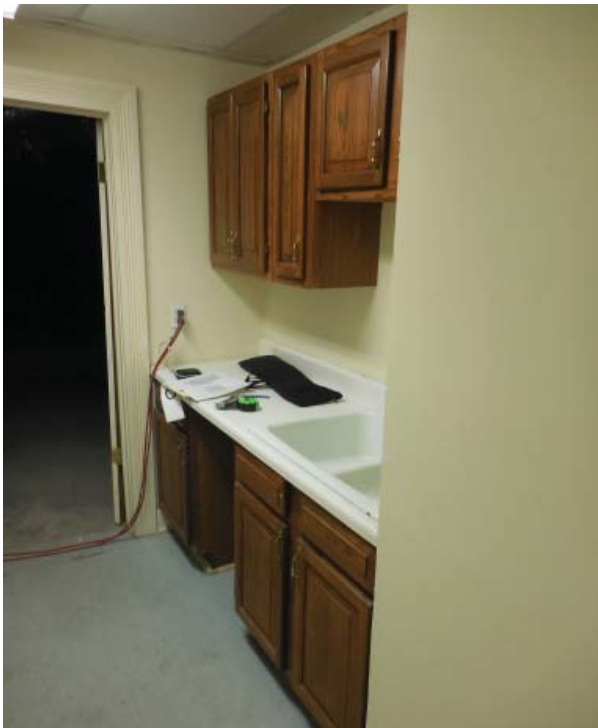
**Figure 60.** Hall 002 view toward southwest.

A plastic laminate countertop located in Hall 002 includes a double-bowl kitchen sink (Figure 60).

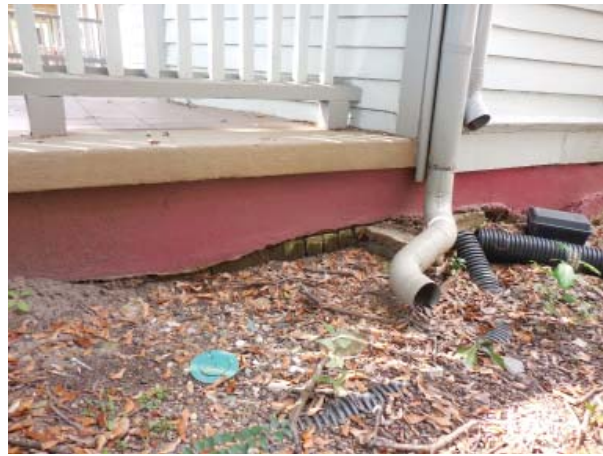
**Figure 61.** West elevation.

Six-inch diameter round metal gutters are located on the north, east, south and west sides of the main hipped roof and on the east and west sides of the gabled north wing, and the front porch is served by an internal gutter and two downspouts. Four and six-inch diameter downspouts direct rainwater to adjacent roofs and down to grade. Downspouts are connected to a subsurface drainage system (operation unconfirmed) at locations on the east and west elevations via flexible plastic connections, which are disconnected at the southeast corner of the house (Figure 61). Other downspouts release rainwater directly to grade. All gutters and downspouts are painted.

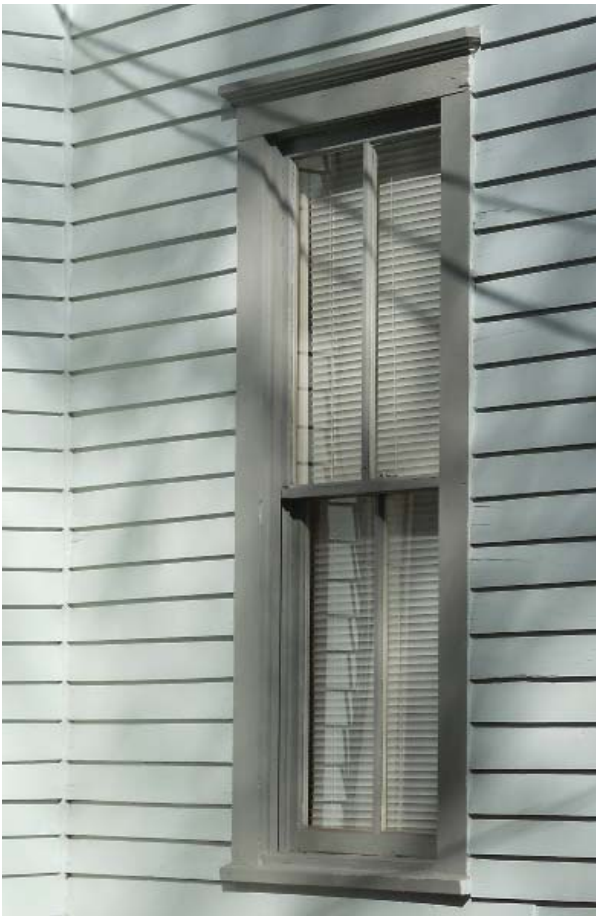
**Figure 62.** Typical double-hung window.

Typical window types include two-over-two double-hung wood windows that measure

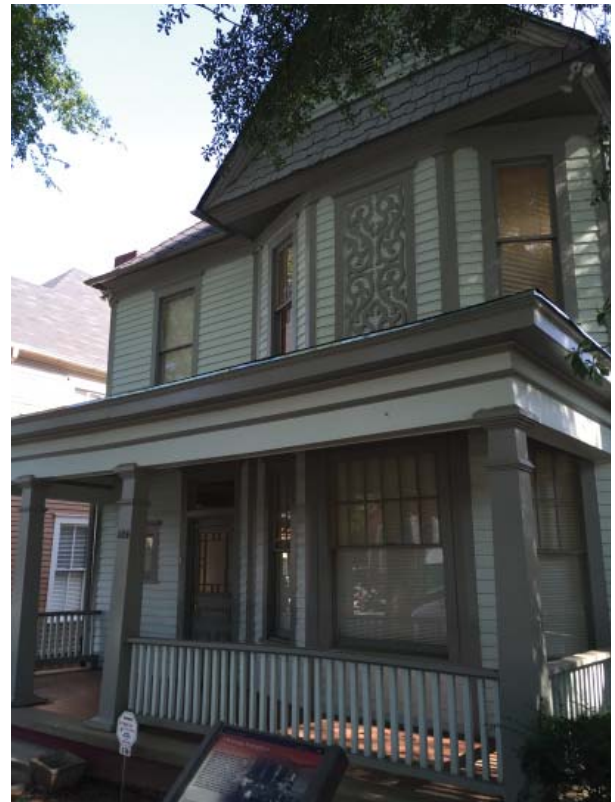
**Figure 63.** South elevation.

six-over-one double-hung windows. At the second floor, immediately above, two one-over-one double hung windows, each measuring approximately 2'-0" wide by 5'-9" tall, flank a solid bay panel with decorative wood scrollwork (Figure 63).

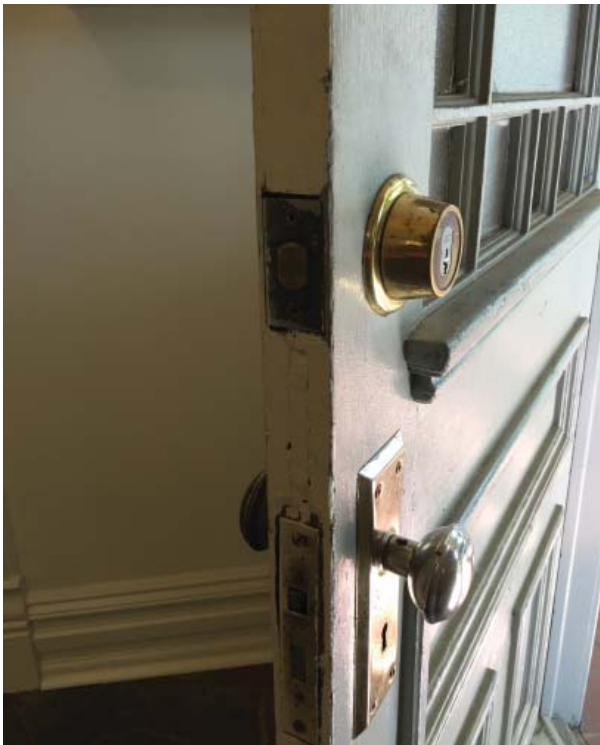
**Figure 64.** Front door.

The front entrance (south elevation) includes an original single-light transom, original wood casing and trim. This solid wood door of mortise and tenon construction measures 3'-0" wide by 7'-0" tall by 1 3/8" thick. A frosted glass half-light includes a large pane surrounded by smaller individual panes. It is topped with applied wood trim including two turned wood spindles and applied trim at the sill. A single, horizontal raised wood panel and two vertical panels are framed by wood trim. Hardware includes a mortised brass knob and

escutcheon plate with opening for skeleton key, a modern mortised brass deadbolt lock, three 4" brass butt hinges, and a hydraulic closer mounted on the interior face of the door and frame. While the mortised construction of this door suggests an early 20<sup>th</sup> or late 19<sup>th</sup> century date of manufacture, this door differs in appearance from the front door shown in HABS drawings dating from 1985.<sup>162</sup> It is not possible to confirm if this door is original to the house with available evidence (Figure 64).

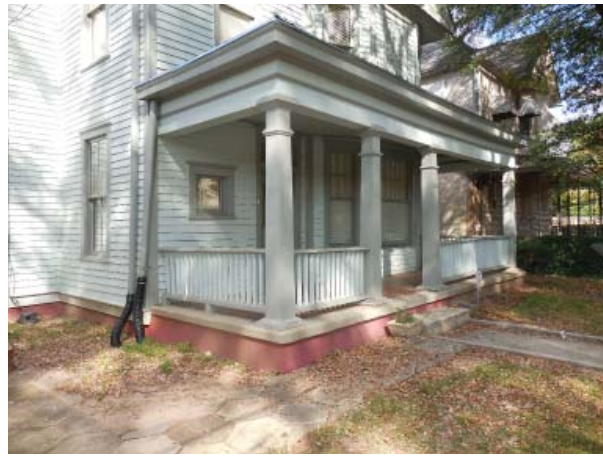
**Figure 65.** Entry Porch, Oblique View toward east.

The full-width, hipped roof Entry Porch located on the south elevation is original to the house, however HABS documents and historic photographs from the mid-1980s indicate that the wood porch posts and balustrades were added since 1985. A single concrete step leads to the front porch (Figure 65). The porch is paved with quarry tiles, present in 1985 photographs (Figure 66).

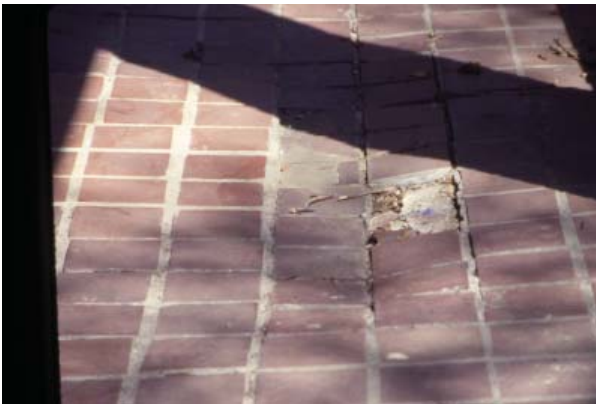
**Figure 66.** Entry Porch, quarry tile pavers (MALU Archives, Slide 526898, April 1985).

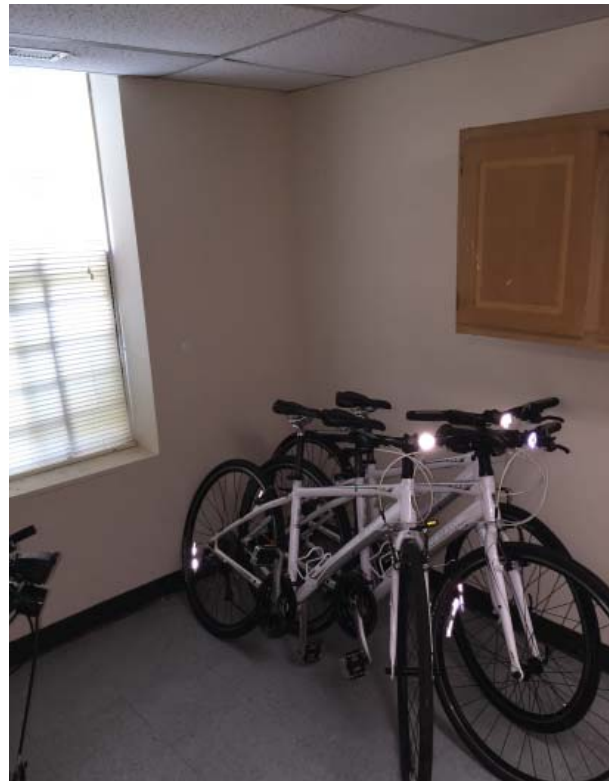
**Figure 67.** Storage Room 001 view toward northeast.

This 17'-11" by 8'-5" room has a 10'-0" ceiling height, remodeled after 1985 and again as part of a 1994 project (Figure 67). A 3'-0" wide by 7'-0" tall wood-cased opening connects the room to Hall 002. Constructed in 1988-1989, mechanical and plumbing chases are located along the full width of the east and west of the space. To the east, a chase was created with wood studs and ½" thick gypsum thick wallboard; to the west, double stud walls with gypsum wallboard finish create a chase. A spiral metal stair, installed in 1994, serves as the only interior connection between the Basement and First Floor.

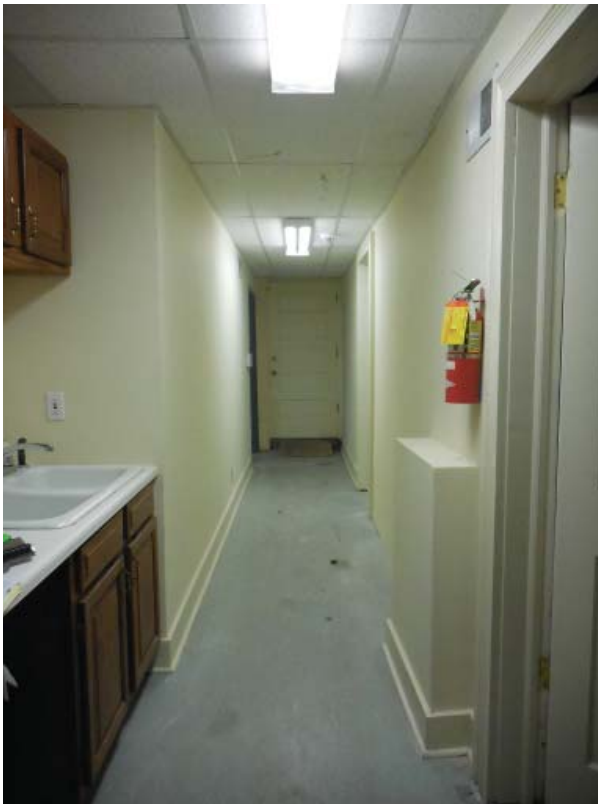
**Figure 68.** Hall 002 view toward north.

The central basement hall (Figure 68) runs north to south and measures 3'-9" by 25'-0" with a ceiling height of approximately 8'-0." The central hall provides access to the backyard via a single door to the north and connects to Storage Room 003 and Unfinished Room 004 via doors and a 3'-0" wide by 7'-0" tall cased wood opening connects to Storage Room 001. Existing conditions differ from those shown in the 1985 HABS drawings and indicate the room's expansion to the south and separation from Unfinished Room 004.

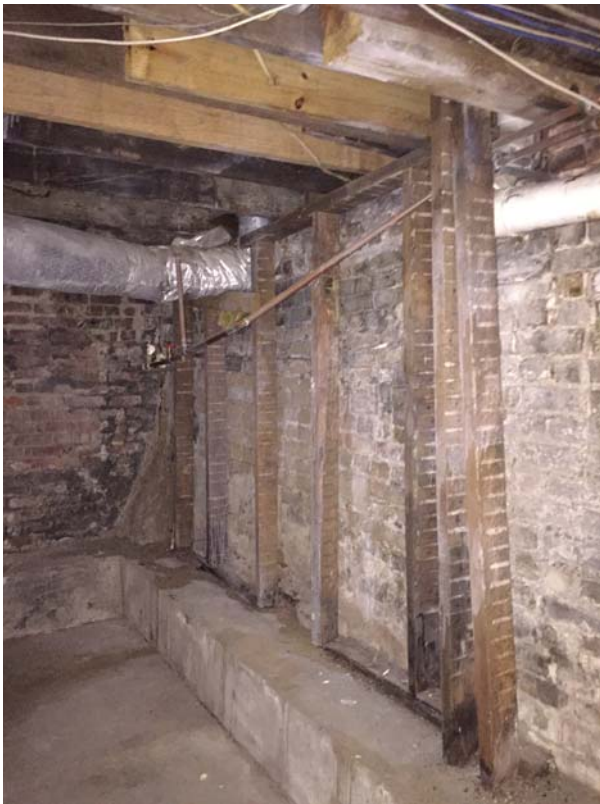
**Figure 71.** Unfinished Basement view toward southwest.

The brick retaining walls located at the south end of the room are in good condition. There is evidence of water infiltration, however, no indication of active leaks was observed. Wood studs located at a short section of retaining wall at the south end of the west appear to be recycled from other locations due to plaster markings, and may indicate that an additional wall finish once existed at this location (Figure 71).

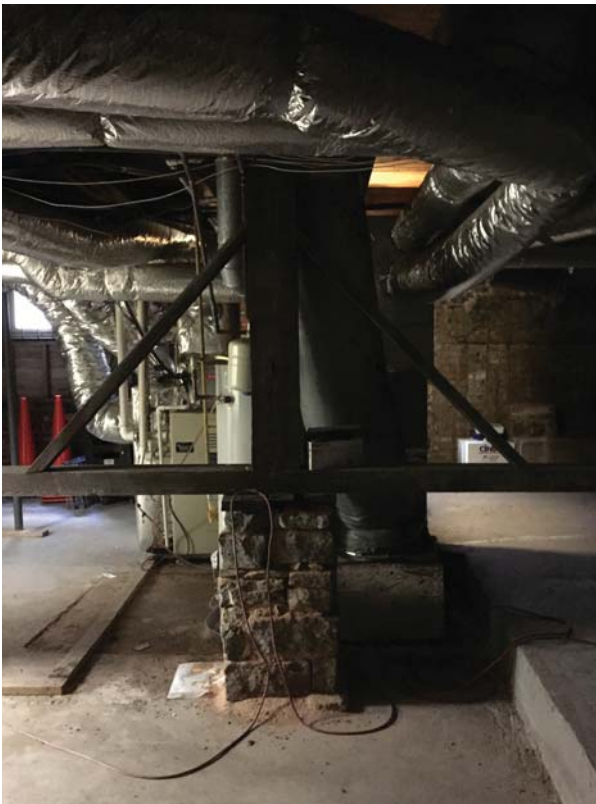
**Figure 73.** Unfinished Room 004 view toward east.

Structural shoring and bracing has been installed in this space. These features are described under Physical Description and Condition Assessment: Structural.

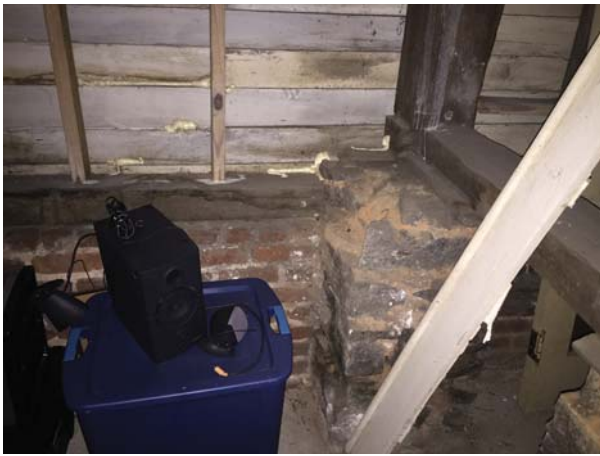
**Figure 74.** Unfinished Room 004 view toward west.

Foam sealant has been applied to the interior of wood weatherboards along the west wall, likely as an attempt to reduce air and water infiltration. Although not evident, openings in wood weatherboards might allow insect and rodent entry (Figure 74).

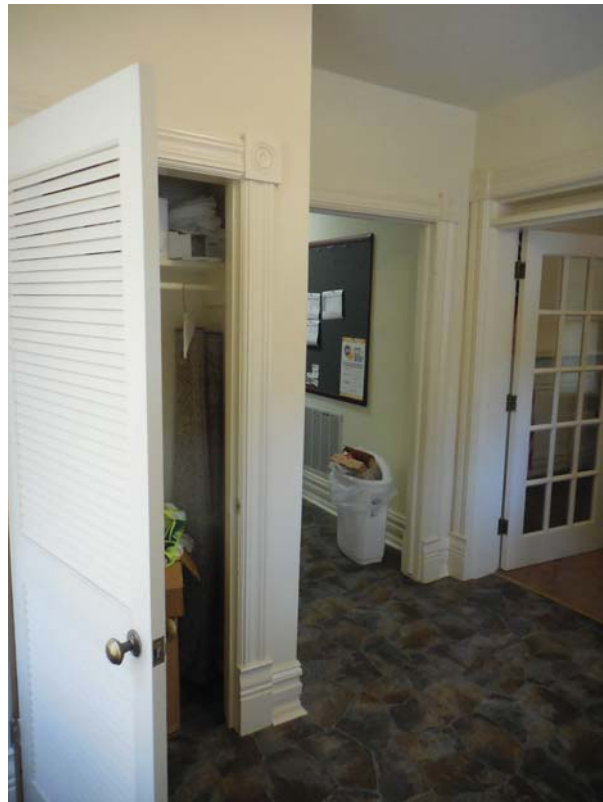
**Figure 75.** Entry Hall 101, view toward north.

The doorway on the west wall provides access to Room 102. This pair of modern 3'-5 ½" wide by 6'-10 ½" tall fifteen light wood doors is set within a frame taller than the doors which has been modified with an intermediate horizontal 2 × wood member to accept the door's height, creating a small 5 ½" false transom above the door (Figure 75).

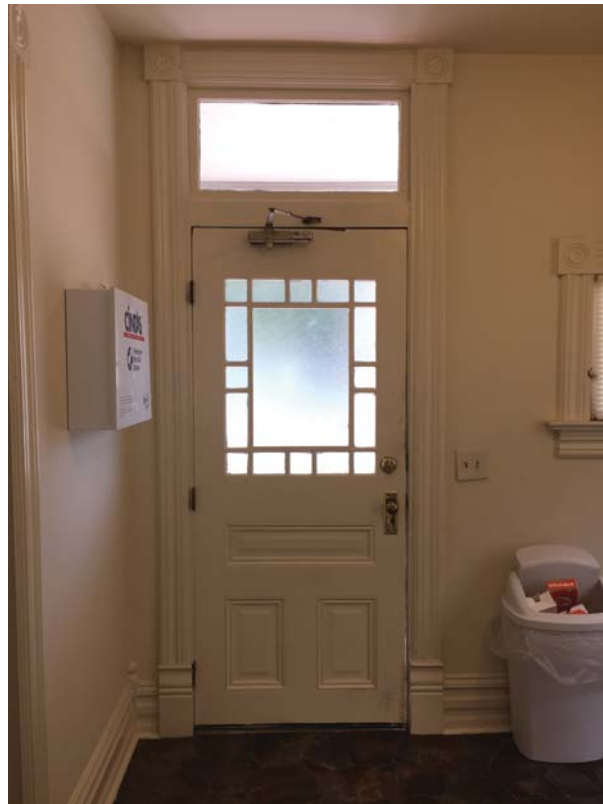
**Figure 76.** Entry Hall 101 view toward south.

There are three doorways in this room. An exterior doorway of indeterminate date is located on the south wall (Figure 76). The interior wood casing, corner rosettes and plinth is 5" wide and matches door casings found throughout the main

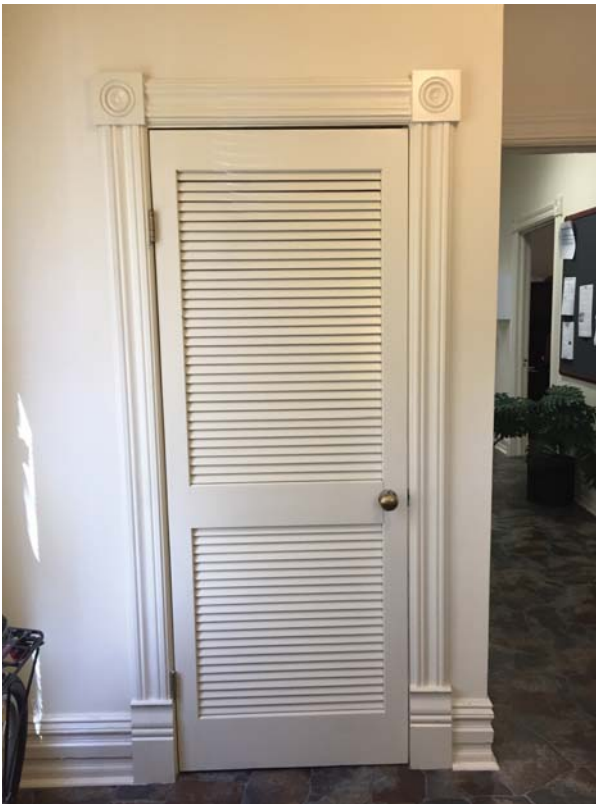
**Figure 77.** Entry Hall 101 oblique view toward northeast.

modern 2'-6" wide by 6'-8" tall louvered wood door provides access to the closet, and its wood casing, corner rosettes and plinth replicate profiles found elsewhere in the house (Figure 77).

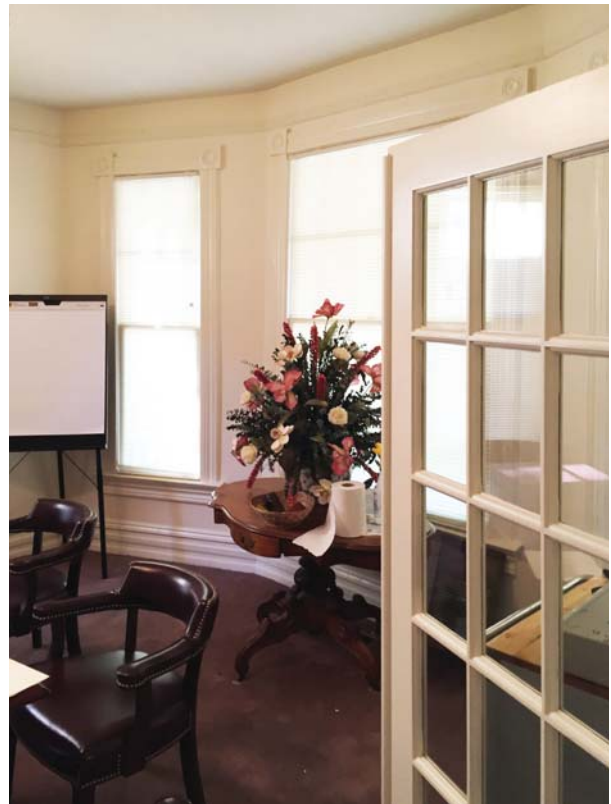
**Figure 78.** Room 102 view toward southeast.

This 14'-6" by 14'-0" room maintains its original configuration with a projecting bay to the south (Figure 78). The room is connected to the entry hall via a pair of doors to the west (Figure 79). Notable changes that have occurred since 1985 include: removal of grates, hearth and mirror from the fireplace and installation of a gypsum wallboard closure over the firebox; relocation of hearths between Rooms 102 and 104; and removal of a doorway to the west of the fireplace (Figure 80).

A 2 ¼" tall painted wood picture rail is located on all walls of the space (Figure 78).

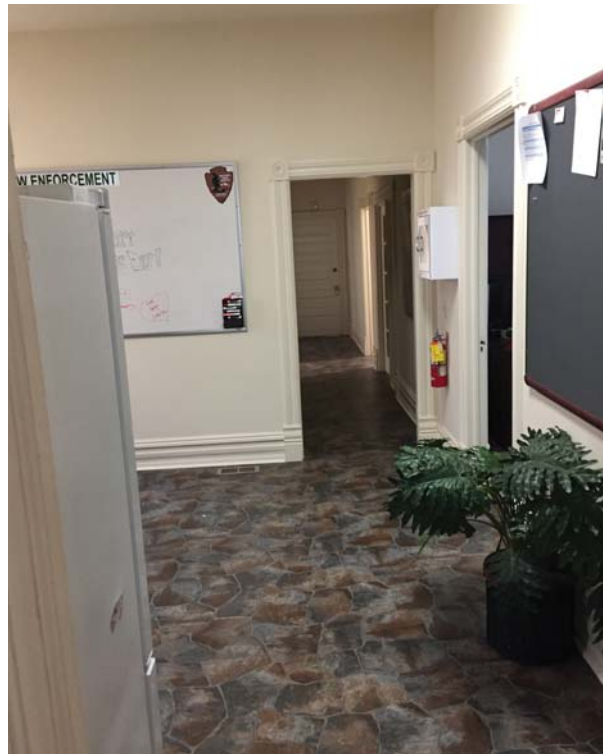
**Figure 81.** Stair Hall 103 view toward north.

Both this double-height 13'-5" by 15'-0" room and its winding stair maintains their original overall configurations, based on 1985 HABS drawings. The room is connected to Hall 105 to the north (Figure 81) and Entry Hall 101 to the south via cased wood openings. A doorway connects to Room 104 to the east.

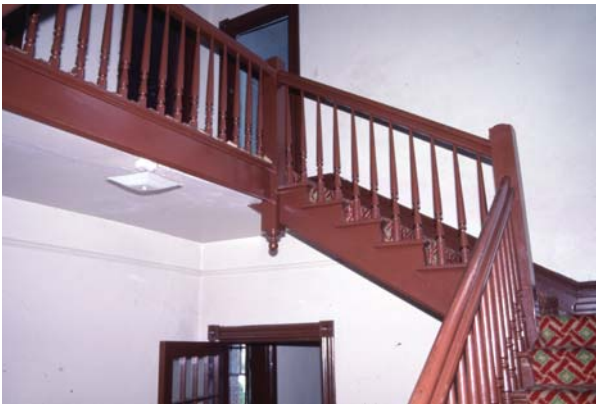
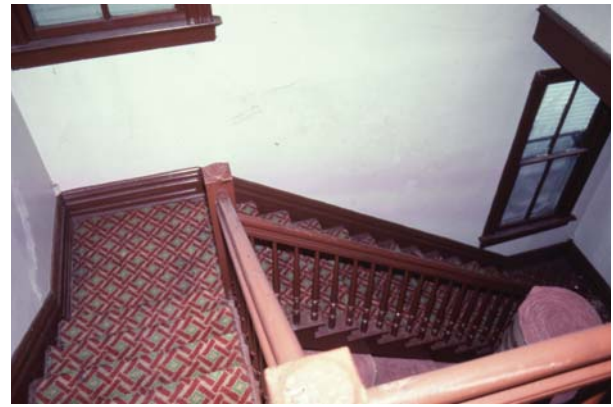
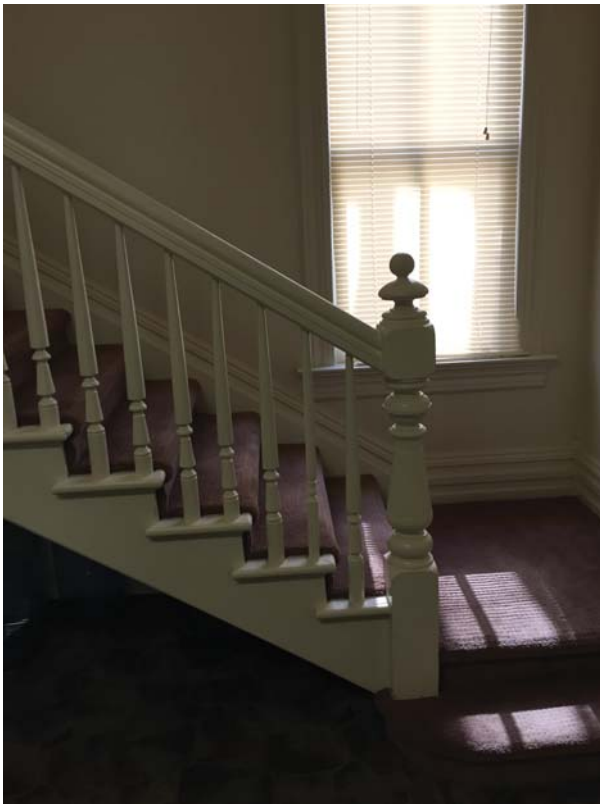
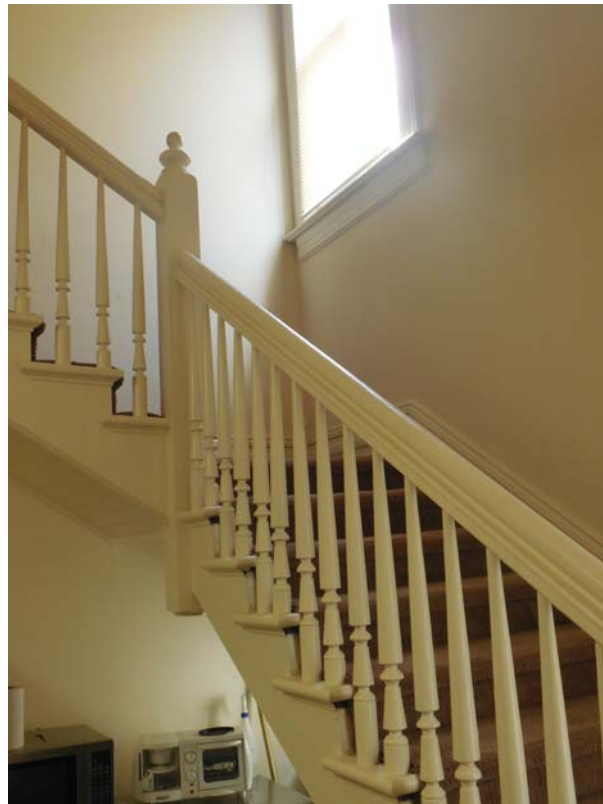
The existing stair maintains its original plan configuration, wood turned spindles, solid wood newel posts, balusters, carpet-covered wood treads and risers, and other miscellaneous wood trim,

as shown in photographs taken prior to the 1980s remodeling projects (Figure 82, Figure 83, Figure 84, and Figure 85).

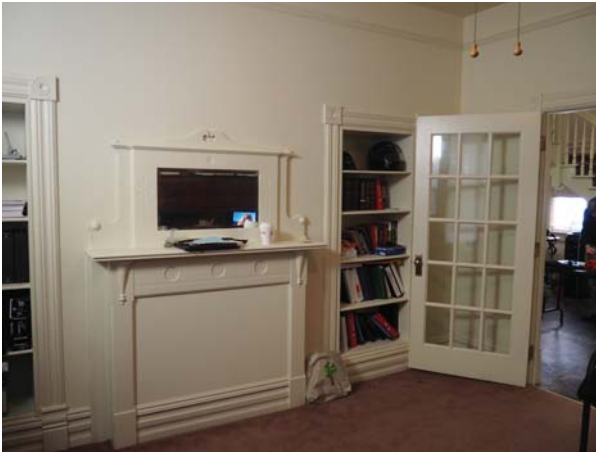
**Figure 87.** Room 104, view toward south.

This 14'-10" by 14'-4" room generally maintains the overall configuration as shown in 1985 HABS drawings. Changes that have occurred since 1985 include removal of grates, hearth and mirror from the fireplace and installation of a gypsum wallboard closure over the firebox, relocation of hearths between Rooms 102 and 104 (Figure 86), the removal of doors to the east and west of the fireplace, and the installation of bookshelves in existing doorways on the south wall (Figure 87). The room is connected to Stair Hall 103 through a single door to the west.

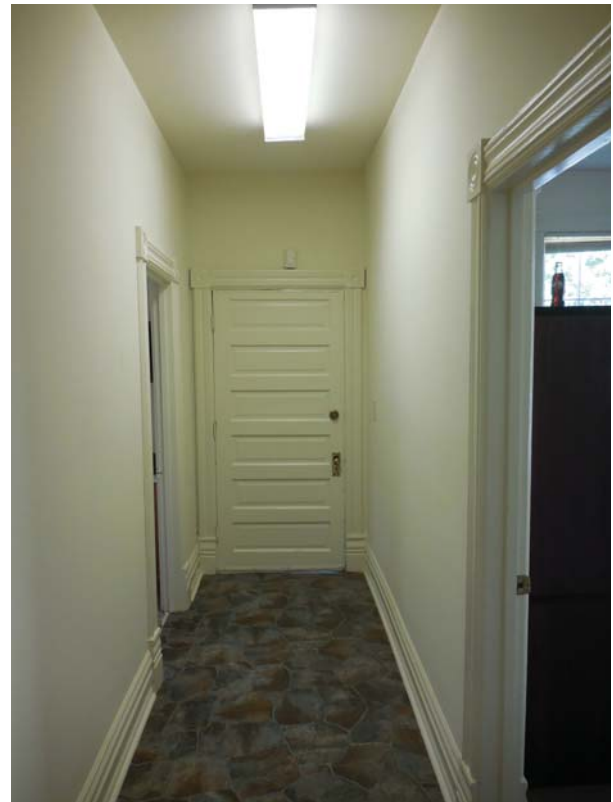
**Figure 88.** Hall 105 view toward south.

Five doors and a cased opening provide access to the north yard, Stair Hall 103 to the south as well as Storage 106, Storage 107, Bath 108, Office 109, and Stair Hall 110 (Figure 88). The wood casing, corner rosettes and plinth replicate original profiles found elsewhere in the house.

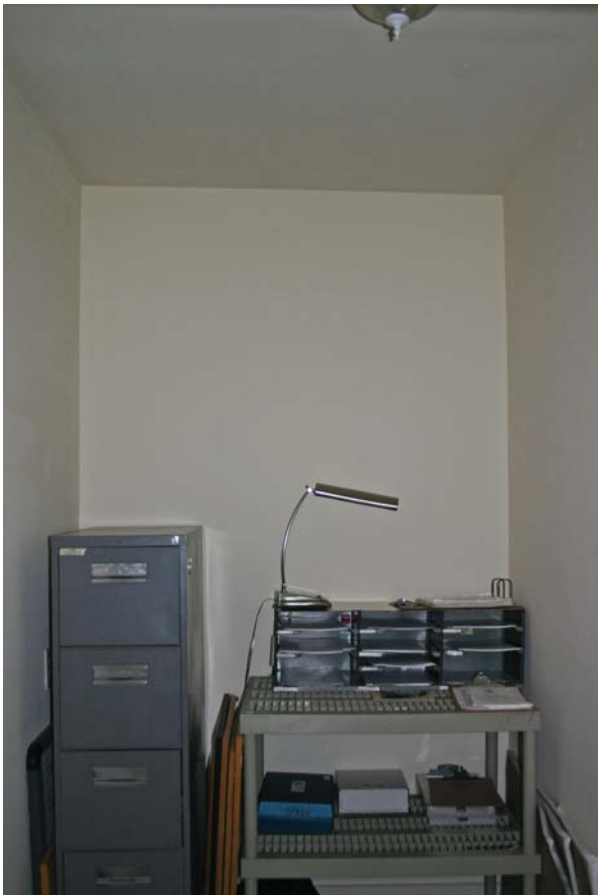
**Figure 89.** Storage 106.

This rectangular 9'-0" by 5'-2 1/2" room connects to Hall 105 via a cased wood opening (Figure 89). This space is roughly the size and shape of a bathroom shown on 1985 HABS drawings. No plumbing fixtures remain.

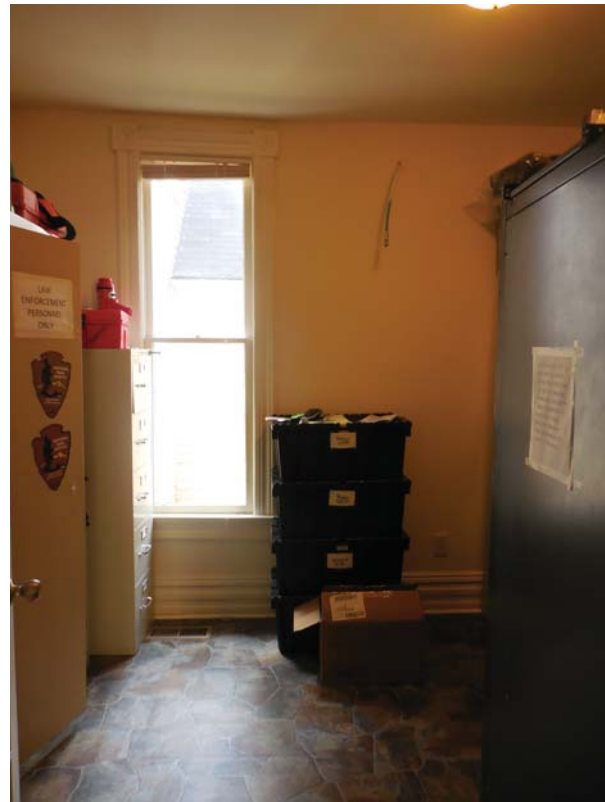
**Figure 90.** Storage 107 view toward west.

This rectangular room measures 9'-0" by 10'-1 ¾" and is connected to Hall 105 via a single door. The existing use is storage (Figure 90). 1985 HABS drawings indicate that this area has been reconfigured to accommodate the adjacent room, Bath 108.

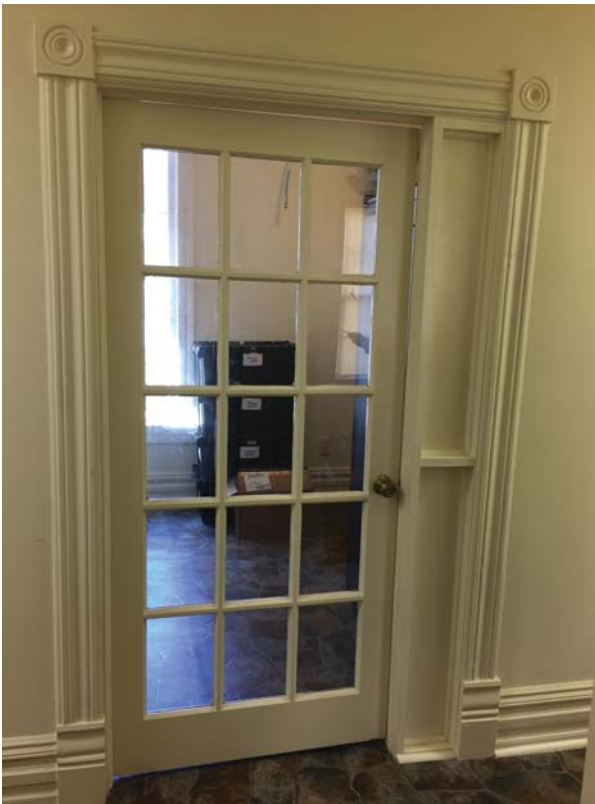
**Figure 91.** Hall 105 view toward east toward Storage 107.

A single modern full-light (divided into 15 panes) door measuring 3'-0" wide by 6'-8" tall leads into Storage 107. The opening for this door has been modified to accommodate relocation of the door to the south with the addition of a 2 × wood frame and solid plywood panel added to the north of the door opening. This work likely dates to the 1994 remodeling project (Figure 91).

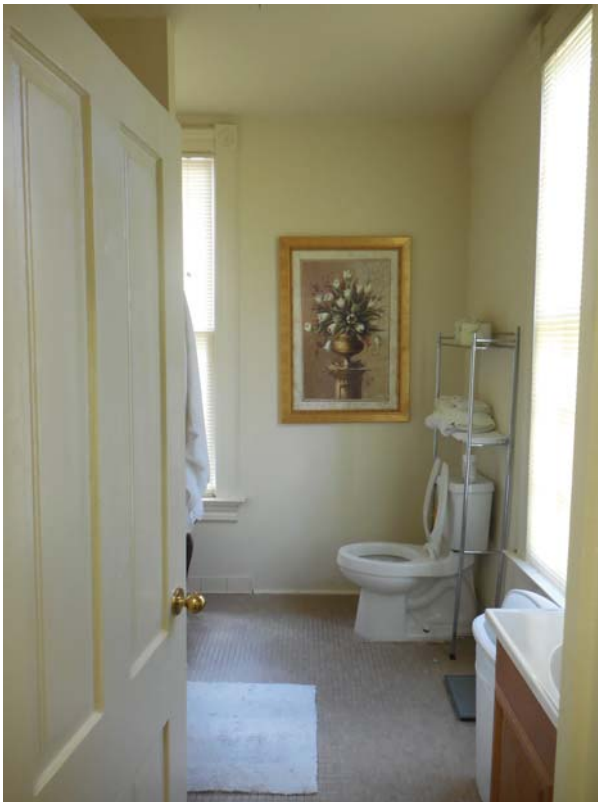
**Figure 92.** Bath 108 view toward west.

This rectangular 7'-6" by 9'-0" bathroom is connected to Hall 105 with a single door (Figure 92). HABS drawings prepared in 1985 indicate that this space was reconfigured as part of the 1988-1989 remodeling project. Work at that time included removal of an existing fireplace, wall and closet and construction of new wall to accommodate the new bathroom layout.
