# 526 Auburn Avenue Martin Luther King, Jr. National Historic Site Historic Structure Report

# Historic Structure Report

May 2017

The purpose of this historic structure report (HSR) is to document the construction history and current condition of 526 Auburn Avenue, Atlanta, Georgia, in the Martin Luther King, Jr. National Historic Site (MALU) and to provide recommendations for the building's treatment and use. This HSR will guide the National Park Service in the stewardship of this historic resource.

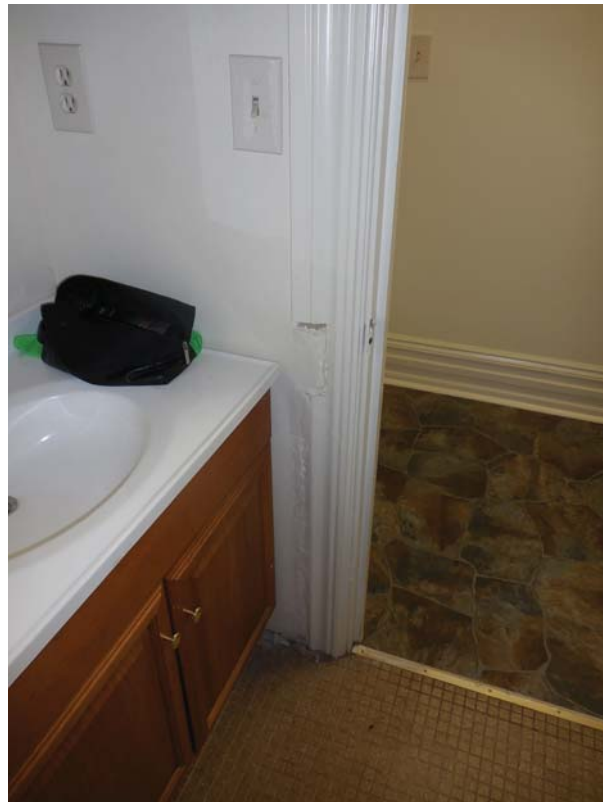
**Figure 93.** Bath 108 vanity.

Modern plumbing fixtures include a bathtub; a vanity base cabinet with integral cast countertop and lavatory (Figure 93); and a modern toilet.

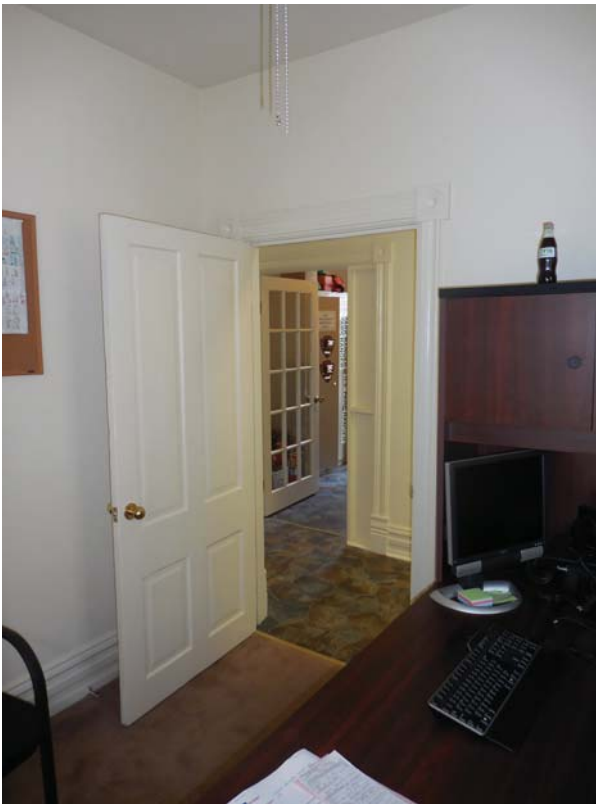
**Figure 94.** Office 109 view toward west.

currently serves as an office (Figure 94). Two doors provide access to Hall 105 and an adjacent closet. This space roughly maintains the configuration of the Kitchen space shown in HABS drawings prepared in 1985.

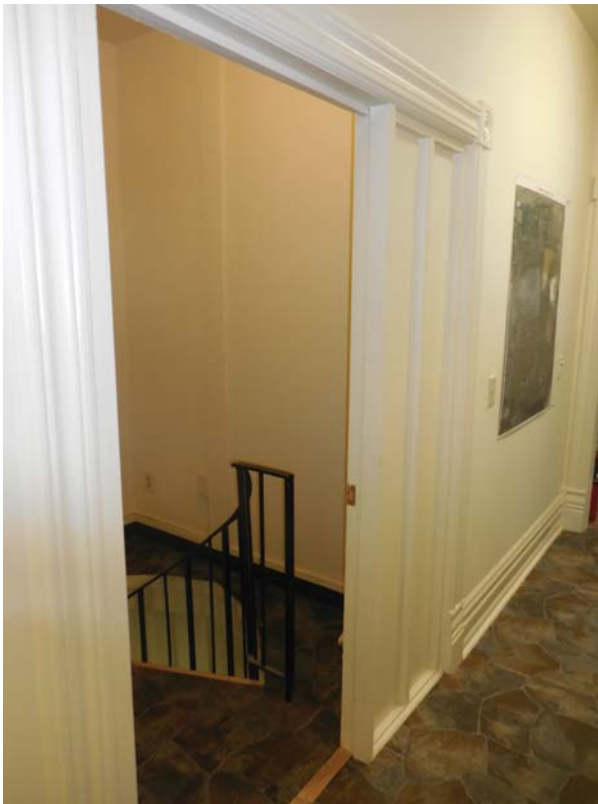
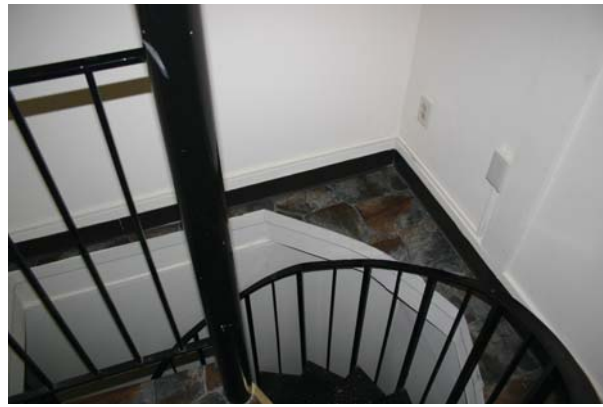
This 6'-5" by 5'-10" room connects the first floor to the basement via a painted welded metal spiral stair installed in 1994 (Figure 96 and Figure 97). A

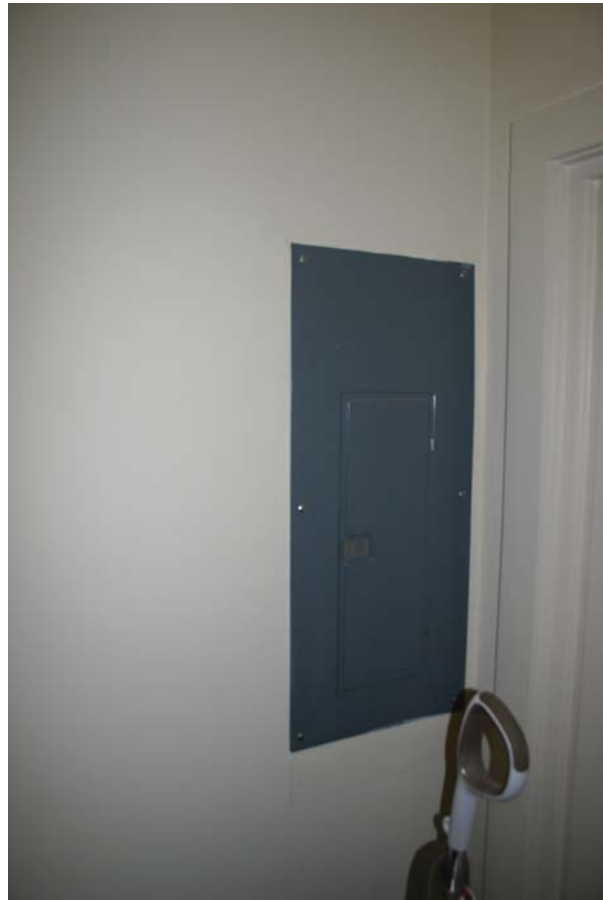
**Figure 98.** Electrical panel, Stair Hall 110.

The electrical panel for the house is located on the south wall (Figure 98). A single, modern surface-

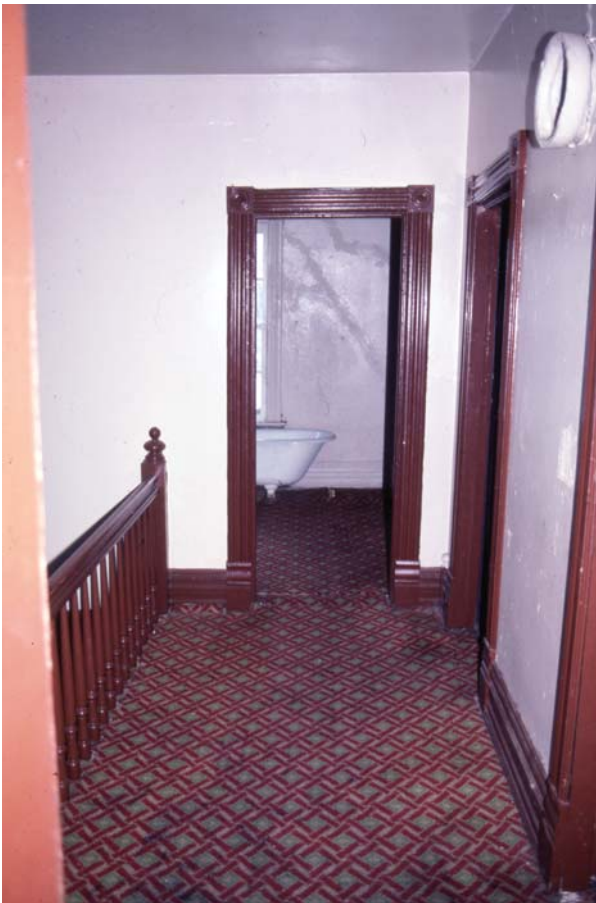
**Figure 99.** Stair Hall 201 landing (MALU Archives, Slide 526\_06, April 1985).

This double-height 13'-5" by 15'-0" room generally maintains its original configuration as shown in HABS drawings and historic photographs (Figure 99). The room is connected to Office 204 to the north and Office 202 to the south via two doors in original locations. A 1988-1989 remodeling project included the removal of two doorways and modification of the north wall to accommodate a new closet serving Office 204.

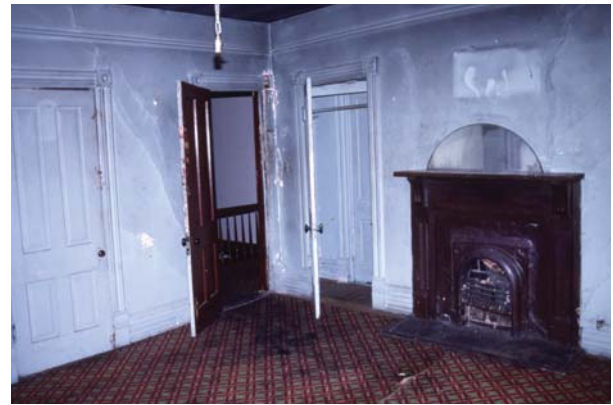
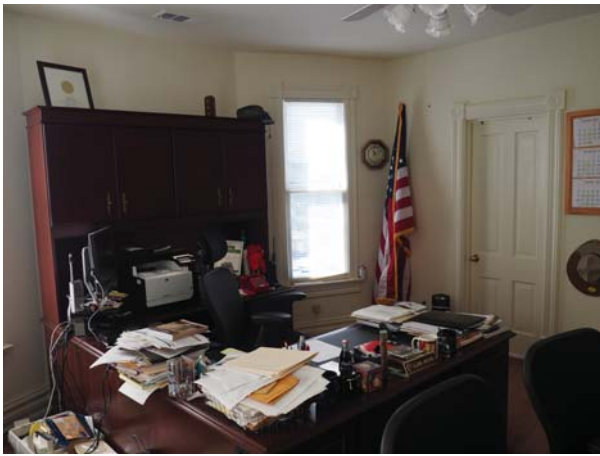
This square room with projecting bay measures 14'-6" by 15'-11". The original fireplace location on the north wall is covered by gypsum wallboard and the hearth and surround, as shown in HABS drawings and photographs (Figure 100) has been removed since 1985 (Figure 101).

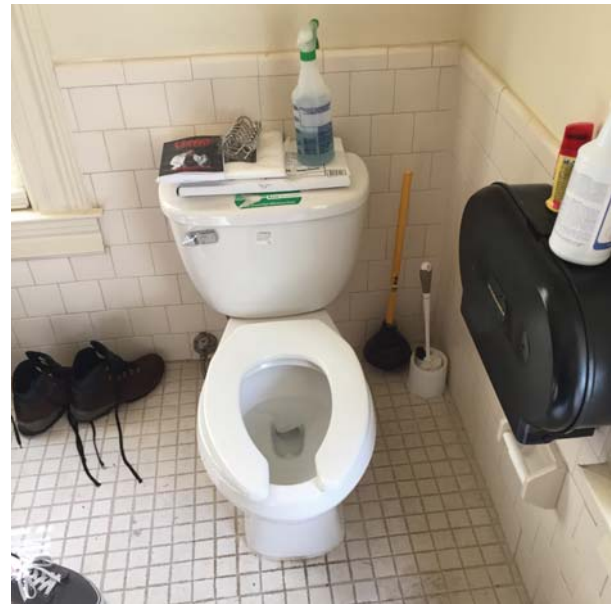
Figure 103. Bath 203, modern toilet.

Modern plumbing fixtures are located in the room, including, a molded acrylic shower unit, a vanity base cabinet with integral cast countertop and lavatory, and a toilet (Figure 103).

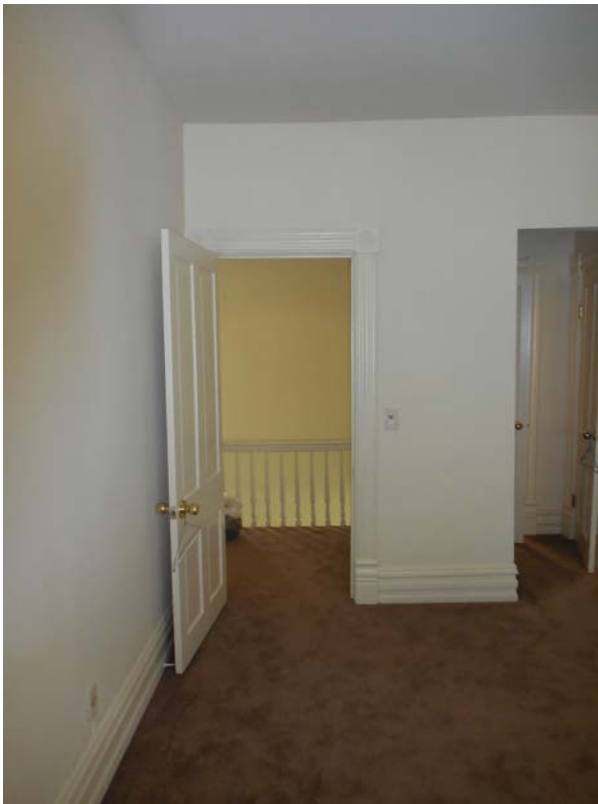
**Figure 104.** Office 204 view toward west toward Stair Hall 201.

A four-panel 3'-0" wide by 6'-8" tall wood door provides access to Stair Hall 201 (Figure 104). This mortise and tenon constructed door is in the original location with modern door hardware. Modern louvered wood doors provide access to

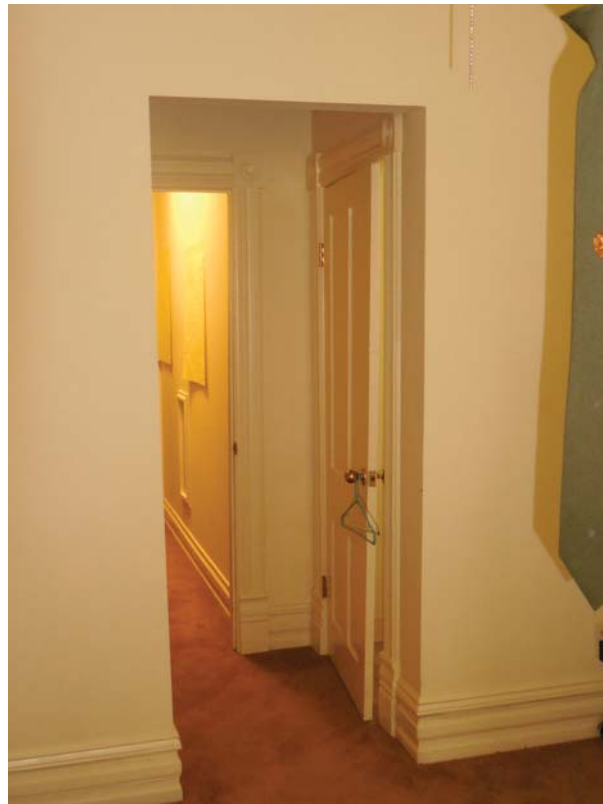
**Figure 105.** Office 204 view toward west.

Access to two adjacent closets is through an opening to a vestibule shared with Bath 205 (Figure 105). A second original closet, as shown in

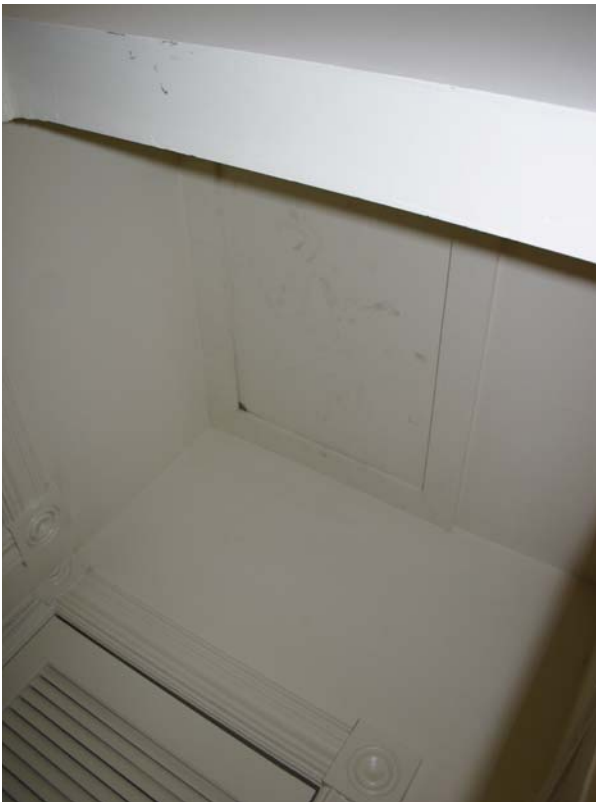
**Figure 106.** Office 204, attic access panel.

A plywood attic access panel is located in the ceiling above this space (Figure 106).

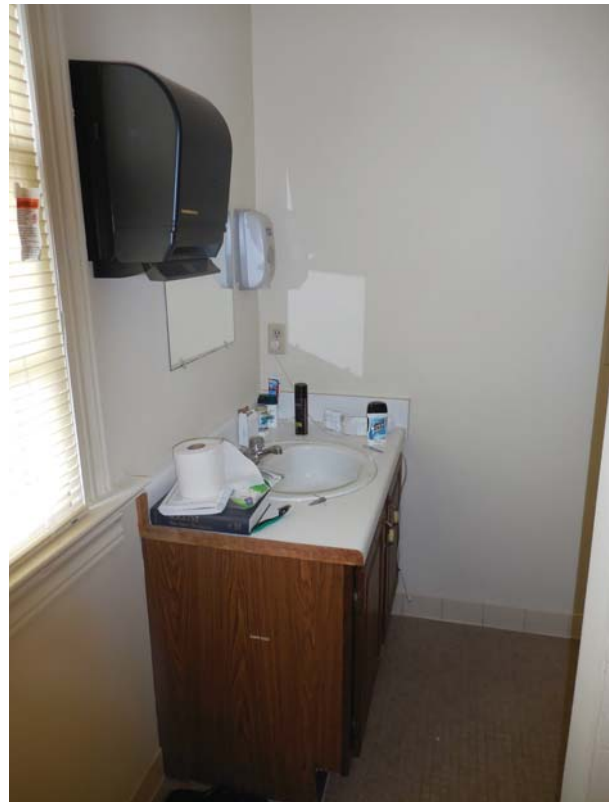
**Figure 107.** Bath 205 view toward east.

This modern bathroom measures 8'-7 1/2" by 5'-7 1/2". A single door provides access from Office 204 (Figure 107). This space has been significantly reconfigured since 1985.
