# Double-Shotgun House 480 Auburn Avenue

Martin Luther King, Jr.  
National Historical Park

## Historic Structure Report 2018

2018  
Historic Structure Report  
Double-Shotgun House  
480 Auburn Avenue  
Martin Luther King, Jr. National Historical Park (MALU)

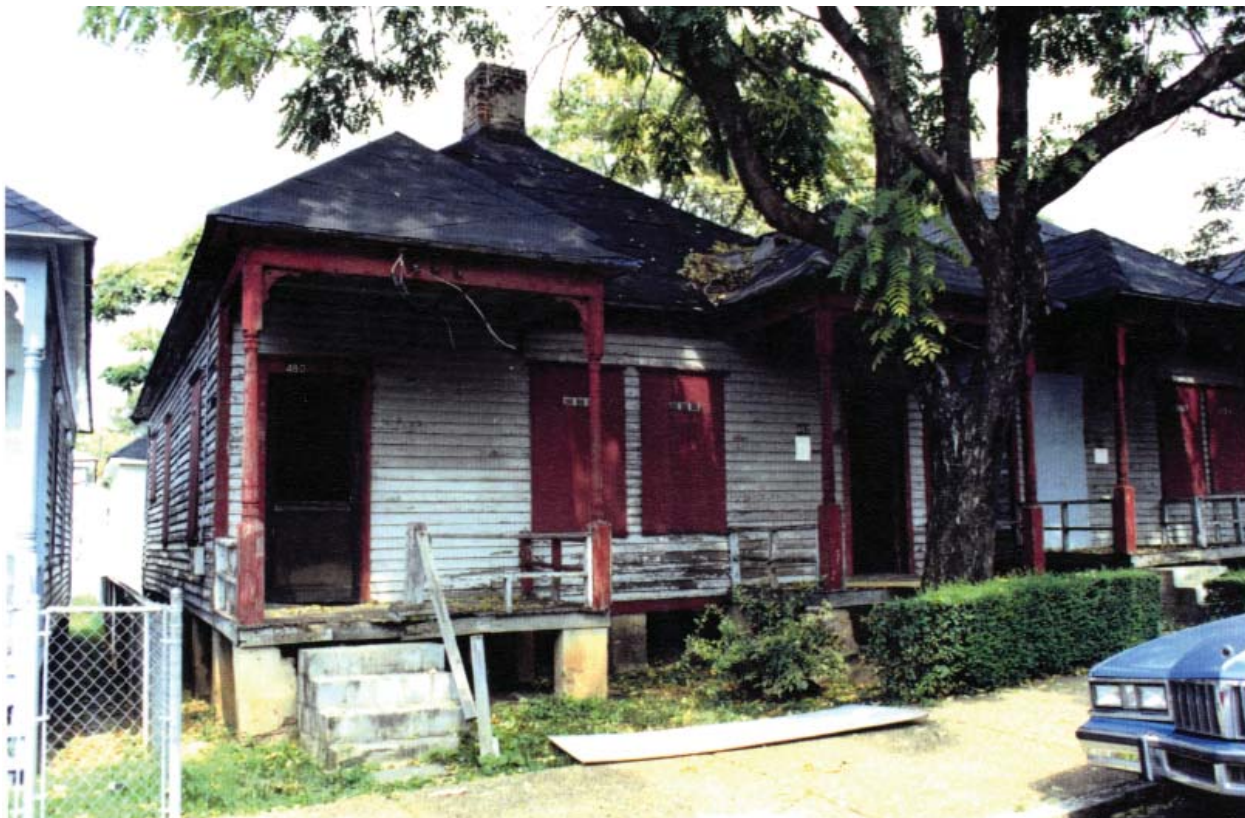
**Figure M2.** Double shotguns at 480 (left) and 484 Auburn Avenue in 1991. Each entrance has its own hipped-roof porch, and all roofs are sheathed with roll roofing. Note central chimney that served two fireplaces in each residence. (MALU collection of 2005-2010 photographs)

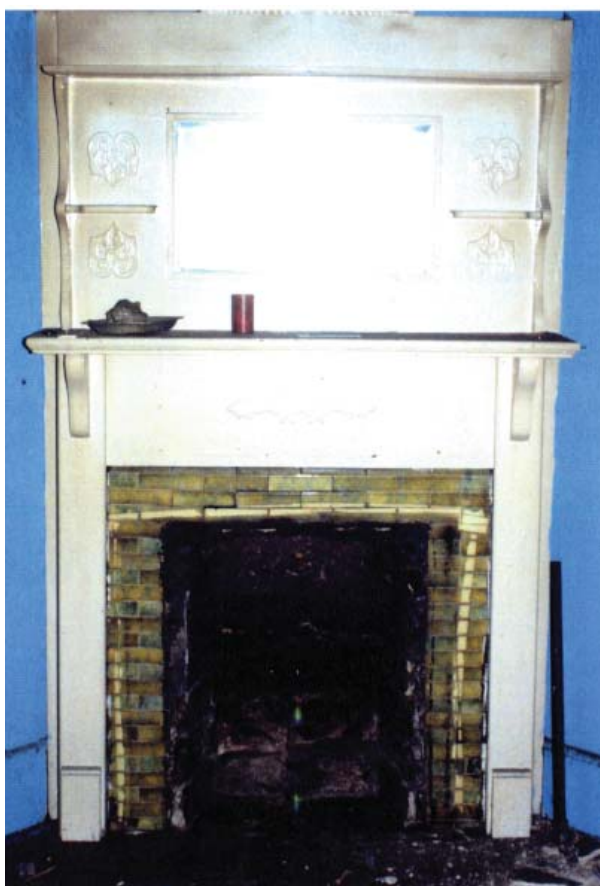
**Figure M3.** Corner mantelpiece in one of the front rooms of neighboring 484 Auburn, photographed in 1991. The mantels in 480 were similar. The mantel, its upper shelves, and the firebox with tile surround are in place, as well as the board floor, baseboards and plaster walls. (Historic Structure Assessment Report, 1991)

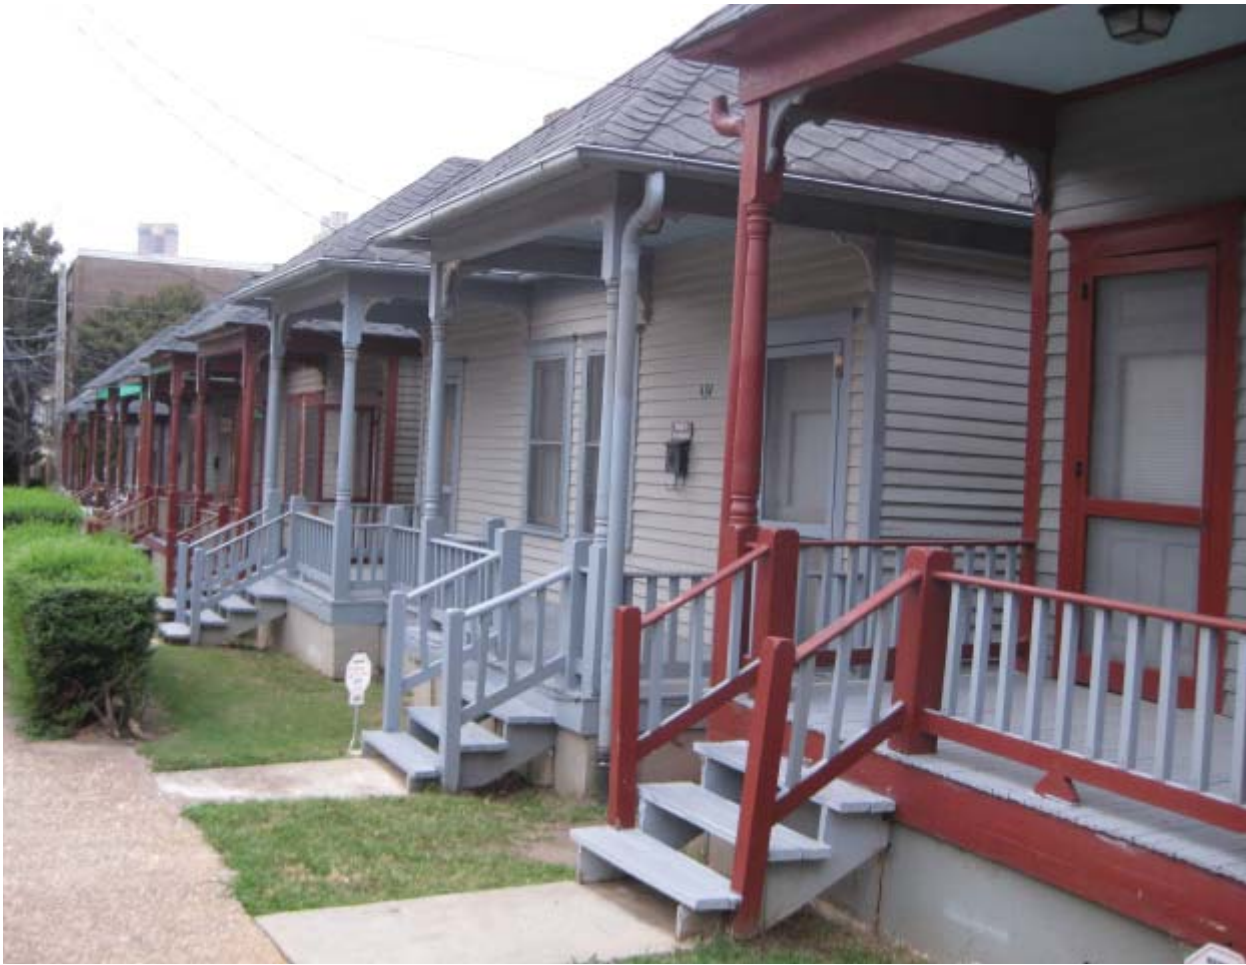
**Figure M4.** The row of 1905 double shotguns facing Auburn Avenue, each with its two hipped-roof entrance porches, now connected. The third house from the right, with red trim, is 480 Auburn. (JKOA 2016)

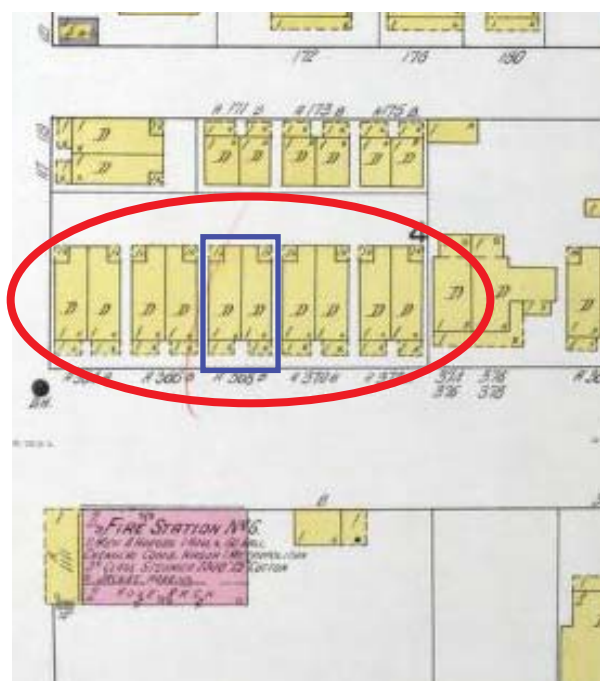
**Figure B3.** Sanborn map of 1911 showing the row of shotgun houses facing Auburn Avenue. Blue rectangle identifies current-day 480 Auburn. It is the westernmost of the three houses bought by Mattie Mays in 1905 and sold together thereafter. The one-story double shotguns contain two side-by-side dwelling units, each with a separate front porch and an inset corner back porch. In 1911, all roofs were wood shingle.

10 feet in height, with shingled roof, 4"-by-8" girders, 2"-by-8" joists with 14-inch spans, and 8 feet between supports.<sup>68</sup> The five structures facing Auburn Avenue were built first (*Figs. B2-B3*).

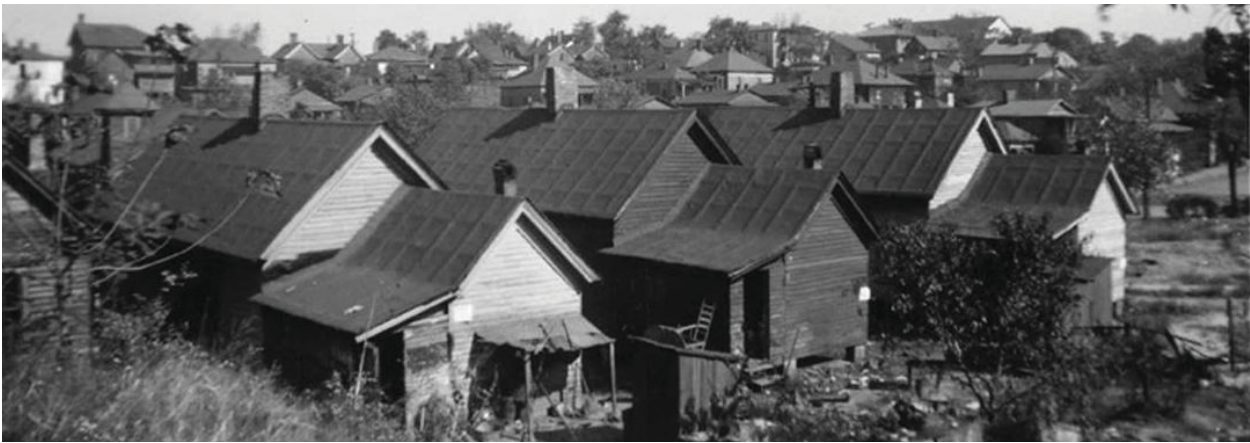
**Figure B8.** Roll roofing covers houses in this ca. 1940 photograph. Photographs taken during the period of significance of the Birth-Home Block show a preponderance of roll roofing in African-American neighborhoods, and the 1995 CLR reports roll roofing still evident on many Auburn buildings. (Atlanta History Center)

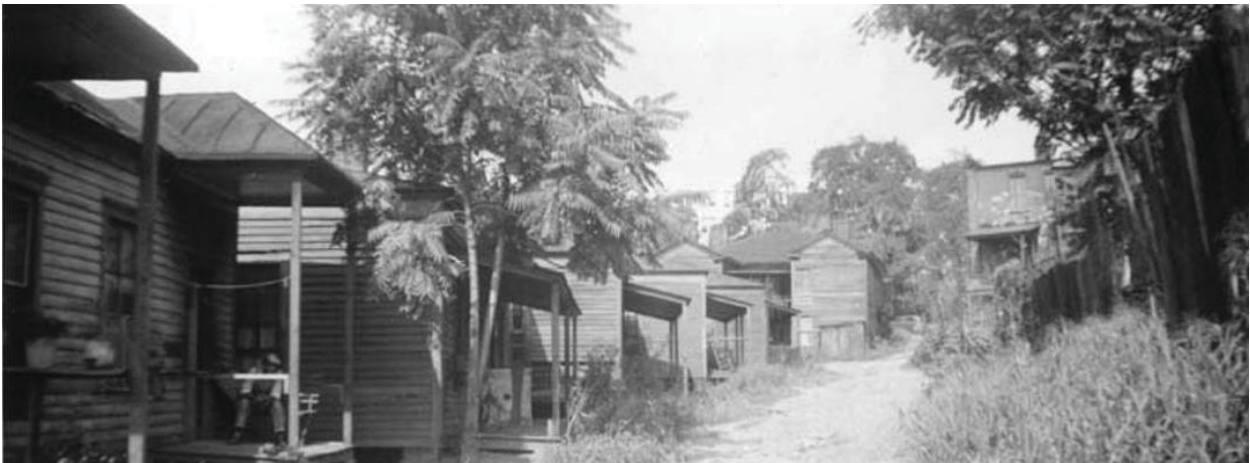
**Figure B9.** Double shotguns on Craven Alley, among the many in Atlanta destroyed for highways and the urban renewal program, photographed ca. 1940. (Atlanta Housing Authority Collection, Atlanta History Center)

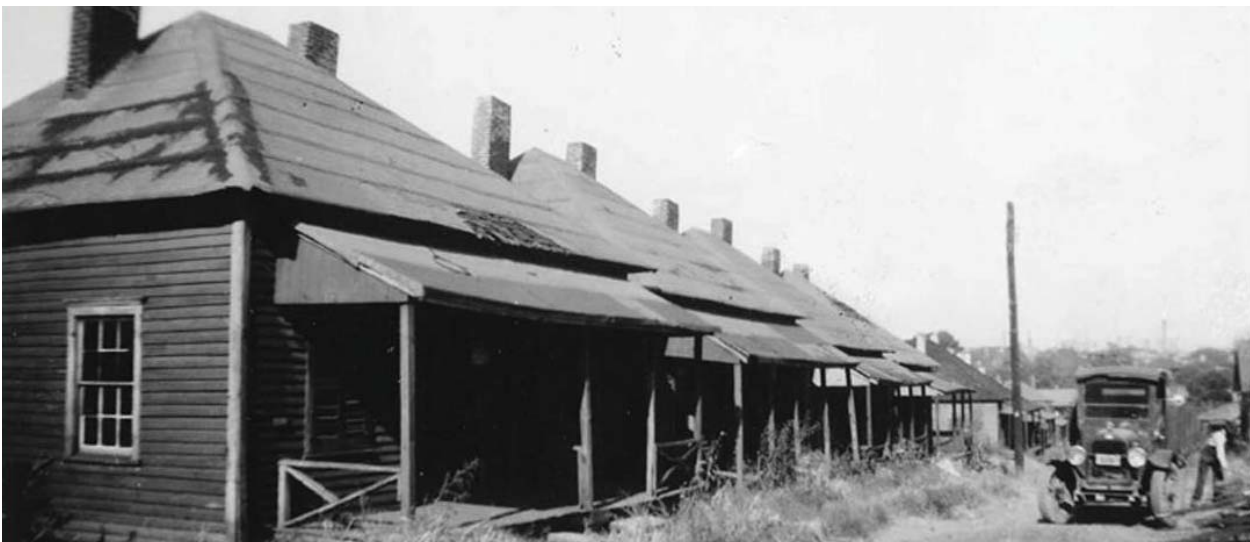
**Figure B10.** Another row of double shotguns, destroyed ca. 1940. All have the roll roofing typical of the time. (Atlanta Housing Authority Collection, Atlanta History Center)

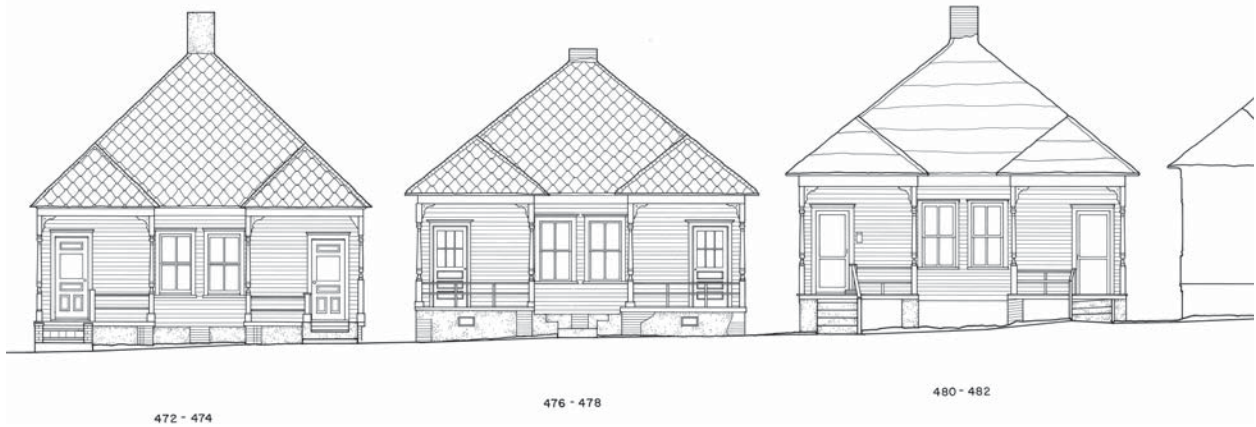
**Figure B11.** Front elevation of 480 (right) Auburn Avenue, drawn by HABS in 1985 before NPS ownership and before front porches were linked. To the left are 472-474, on the corner of Boulevard, and 476-478. (Library of Congress: HABS GA,61-ATLA,49-sheet 2)

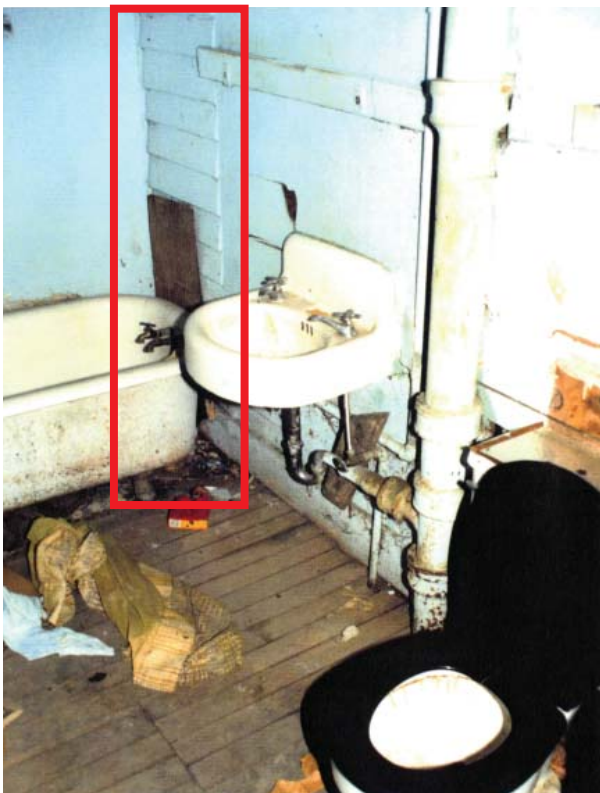
**Figure B13.** West bathroom of 480 Auburn before 1991 work, showing expansion into back porch when bathtub added. Red border outlines east exterior siding of porch and change in flooring. (HSAR)

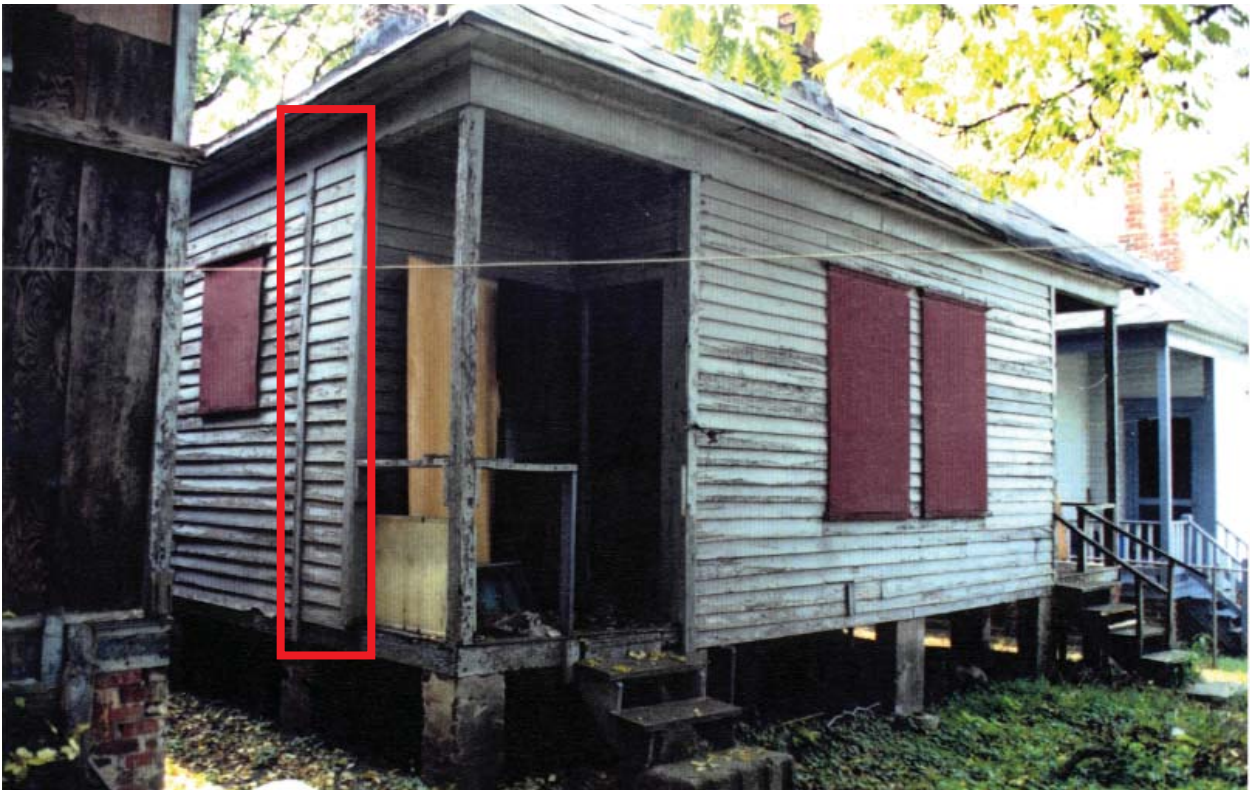
**Figure B15.** Back and east side of 480 Auburn Avenue showing similar expansion into back porch when bathtub added. A vertical board covers the seam between original and later siding. (HSAR)

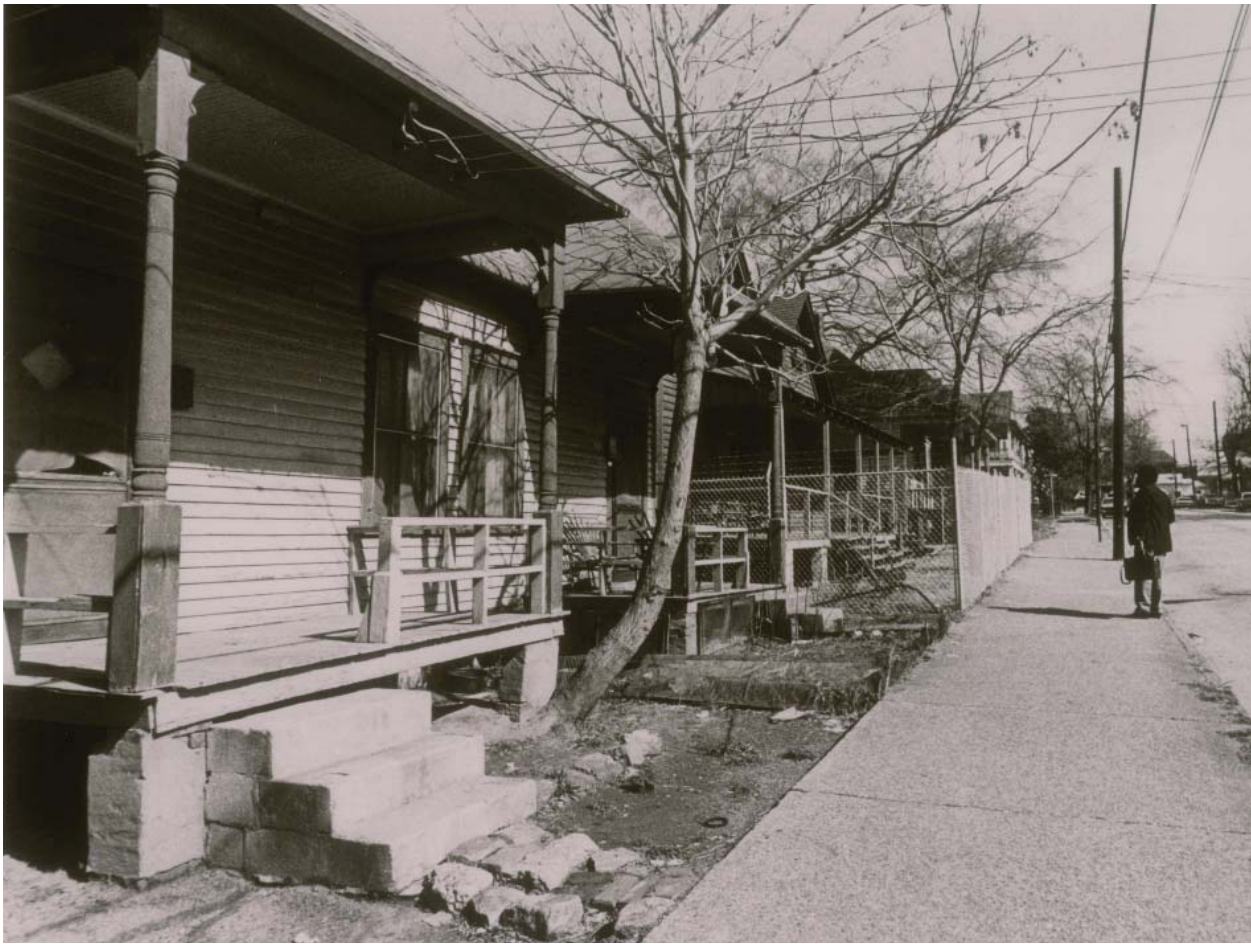
**Figure B16.** The double shotgun houses in the 1980s, or more likely earlier, showing front yards and separate porches. Undated photograph. (MALU Collection)

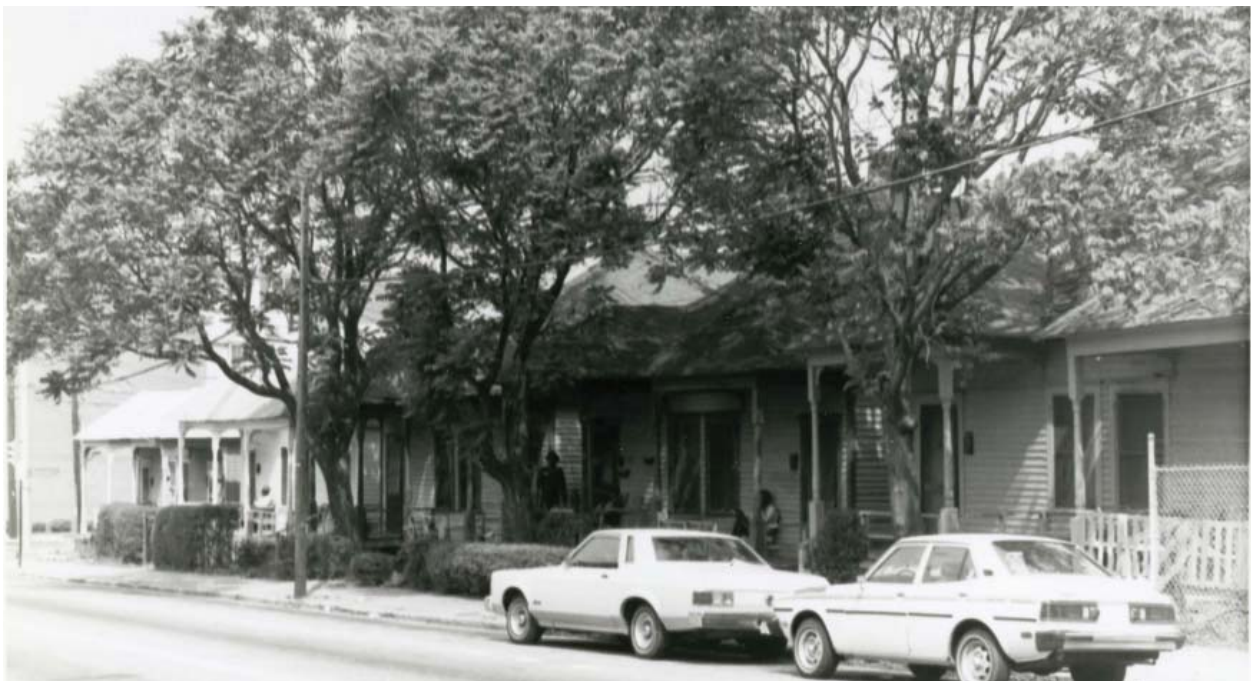
**Figure B17.** The double shotguns before porches were linked. Roofs are sheathed with roll roofing, and trees provide shade. Undated photograph. (MALU Collection)

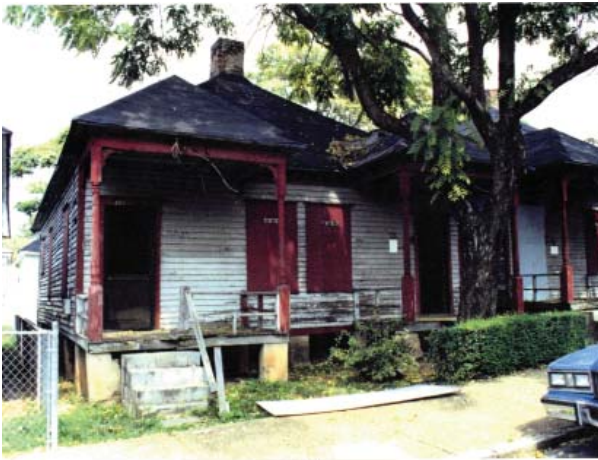
**Figure B18.** Front and west side of 480-82 Auburn Avenue in 1991 before work. To the right is 484-86. Farther right (east) and not visible is 488-90 Auburn, which was in similar condition. (HSAR)

Additional photographs in the HSARs for 480 and 484 show other interior rooms and the condition and colors of the exteriors (*Figs. B18-B22*).

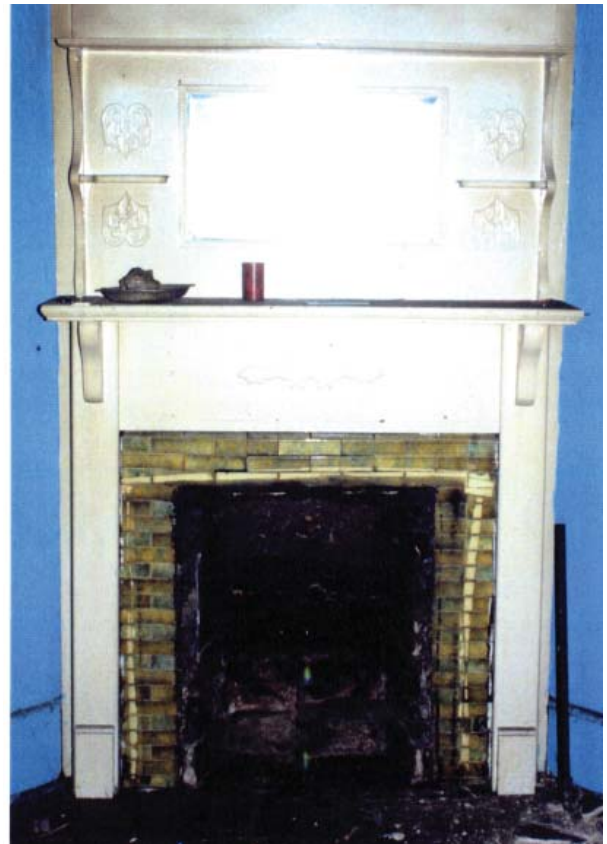
**Figure B19.** Corner mantelpiece in front room of 484 before work began, showing the mantel and upper shelves in place, firebox with tile surround, board floor, baseboards and plaster walls. (HSAR)

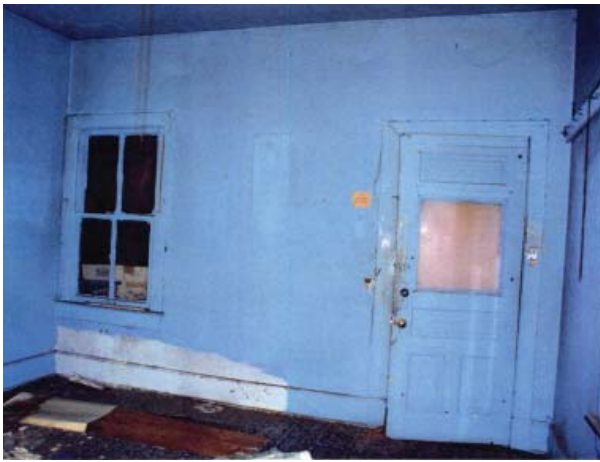
Figure B21. West front room of 484 Auburn Avenue, looking south towards the front door and two-over-two front window. (HSAR)

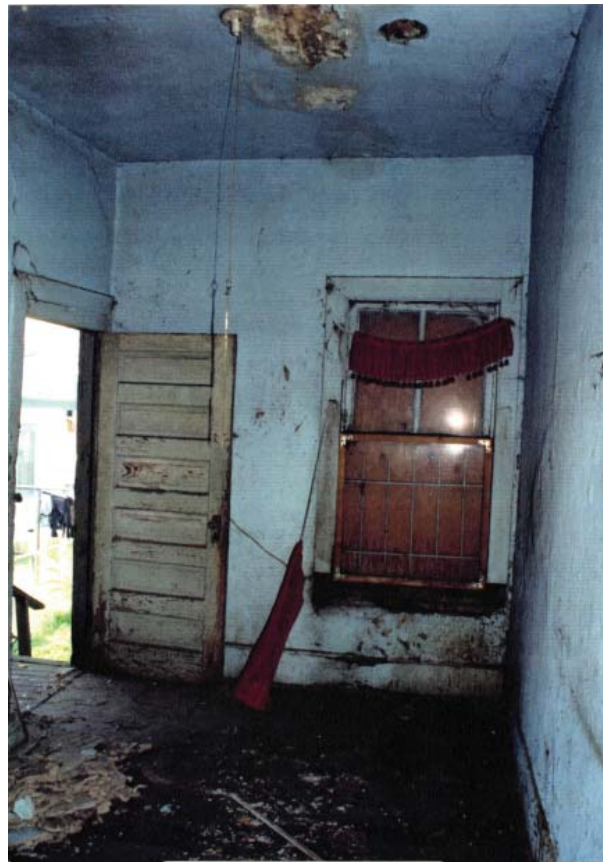
Figure B22. West kitchen of 480 before 1991 work, showing original two-over-two window and doorway to back porch. Bathroom addition is just south of the porch though not shown in this photograph. (HSAR)

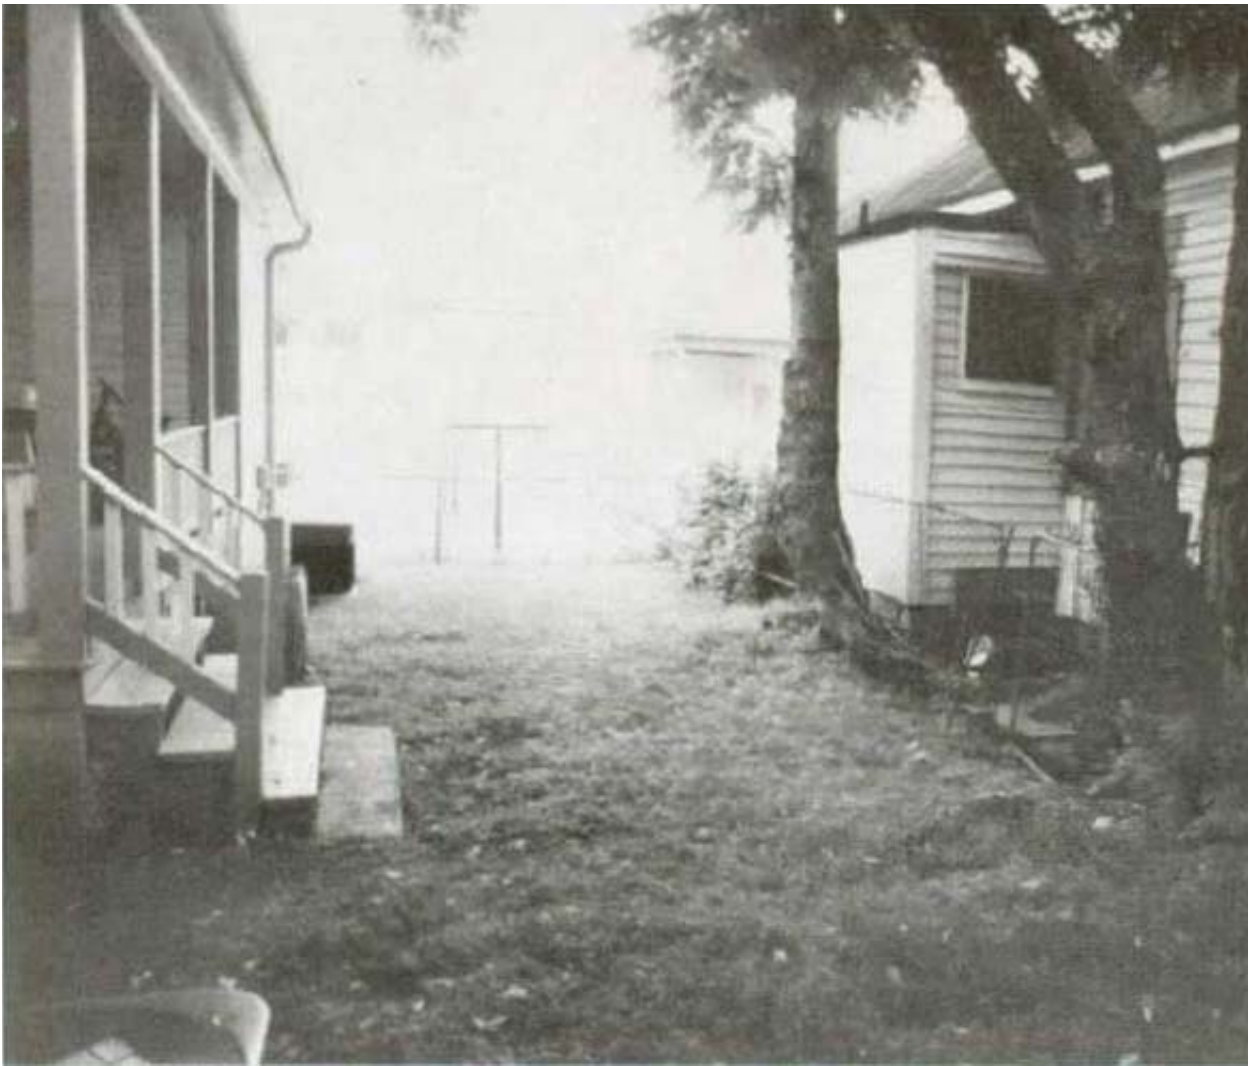
**Figure B27.** Back yard of the row of the Auburn Avenue double shotguns after the 1991 work (left), showing the new back porch addition and back stair. The distinct yards of the individual residences have been incorporated into one long open strip, no longer dirt but grassed. A clothesline remains in the neighboring yard, and trees and chain link fence identify the property line immediately behind the small shotguns facing Old Wheat Street (right), now demolished. (Lawliss, *CLR*, p. 42)

The back yards, like the back porches, were work spaces used for bathing, food preparation, and laundry. They were usually fenced and contained one or, more likely, two clotheslines for the two residences, piles of ashes from stoves, and wood piles.<sup>89</sup> The NPS rehabilitation project removed the fences and replaced the individual yards with a long swath of grass running behind the row of buildings (*Figs. B26-27*).

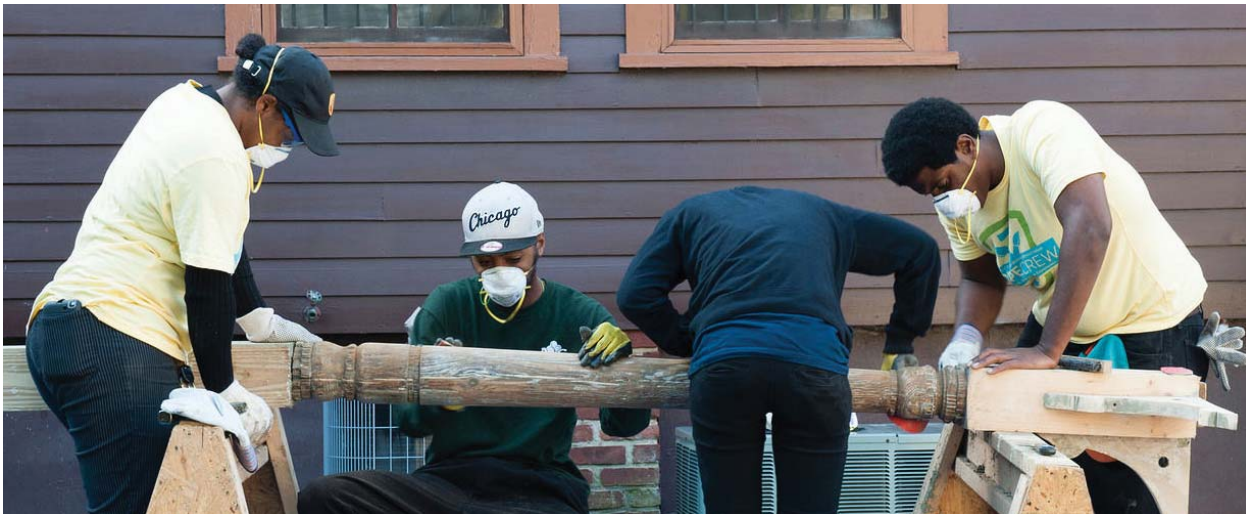
**Figure B28.** Members of the HOPE Crew sanding a turned porch post of one of the shotgun houses on Auburn Avenue. ("HOPE Crew Restores Historic Shotgun Houses in Atlanta," 6 November 2014, [savingplaces.org](https://savingplaces.org))

The Park Service funds maintenance of some houses with revenue from leasing about 30 of its historic buildings in the Park for residential use, including the shotgun houses.<sup>91</sup> The National Trust for Historic Preservation's Hands-On Preservation Experience, or HOPE Crew, assisted with the exterior painting of the shotguns as well as with work on other buildings in the Park. The group represents a collaboration among the National Trust, NPS, and the Greening Youth Foundation, a nonprofit Atlanta-based youth corps (*Fig. B28*).<sup>92</sup>

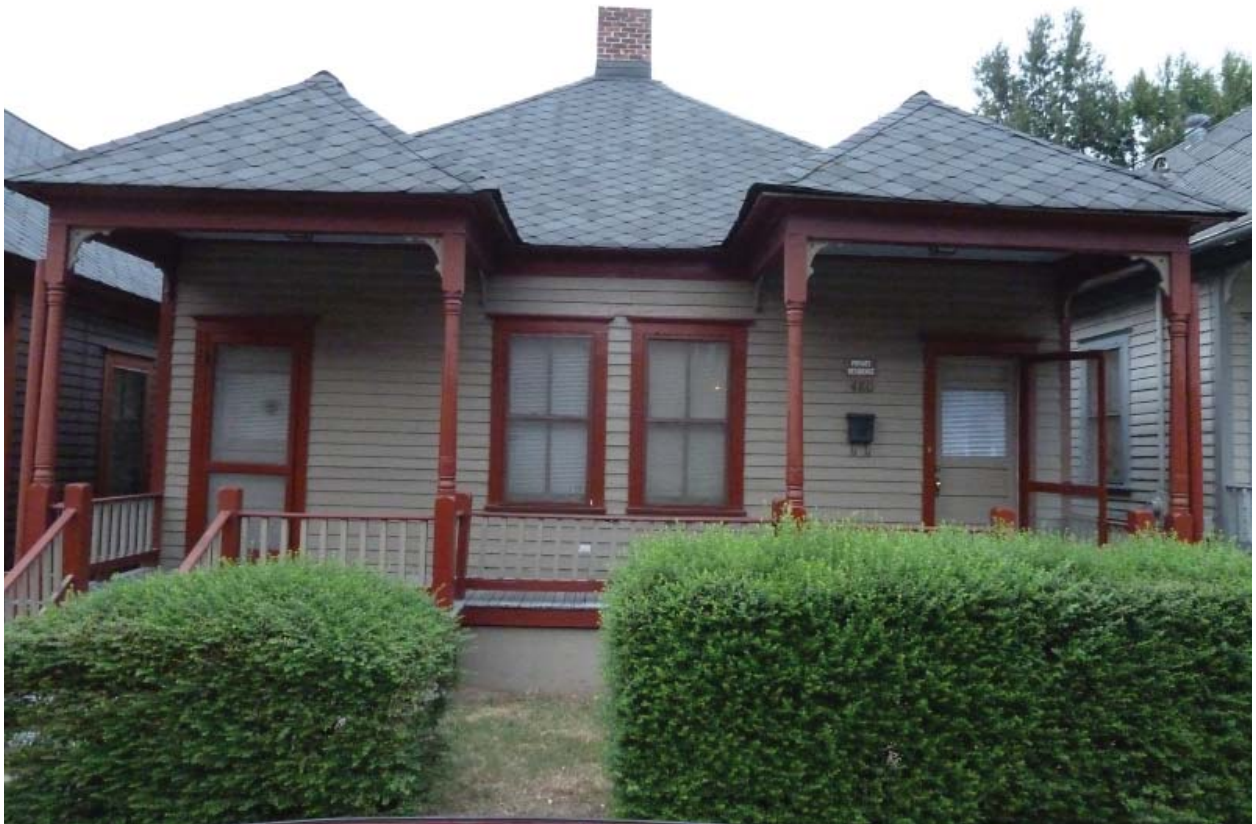
**Figure C1.** 480 Auburn Avenue viewed from south side of street. Unless otherwise specified, all photos in this section taken by JKOA in 2016.

The grassy lots of the Birth-Home Block are narrow; most of the one- and two-story residences along both sides have a shallow front yard and no side yard except where adjacent to a side street. Sidewalks are paved with dry-laid brick or concrete with exposed aggregate; gray Stone Mountain granite-block curbs separate them from the asphalt streets. Small shrubs, especially privet, are common. Some lots have fences, typically low, and some yards have mature trees, occasionally adjacent to the street. The houses are all wood frame, and the vast majority are set above grade on short masonry piers (*Figs. C1-2*).

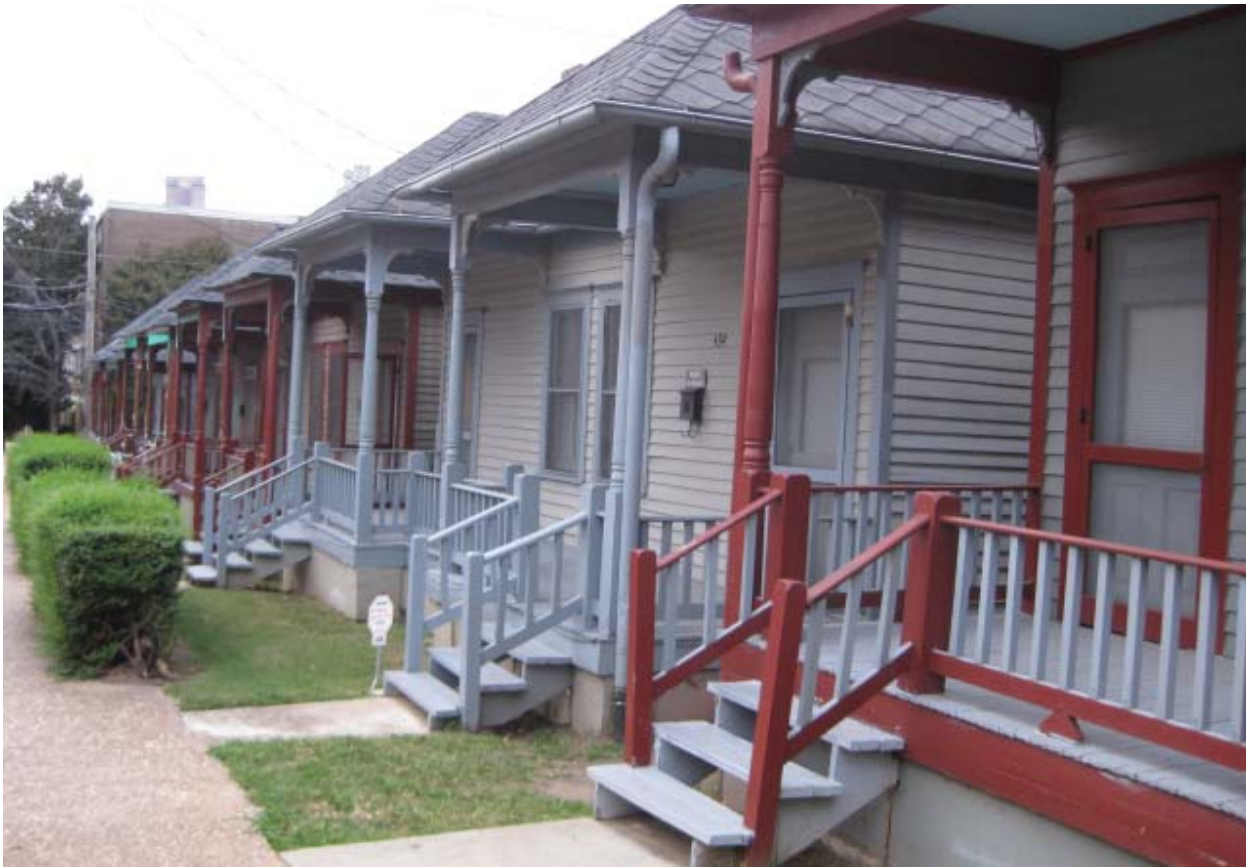
**Figure C2.** Row of five double-shotgun houses along north side of Auburn Avenue in the Birth-Home Block.

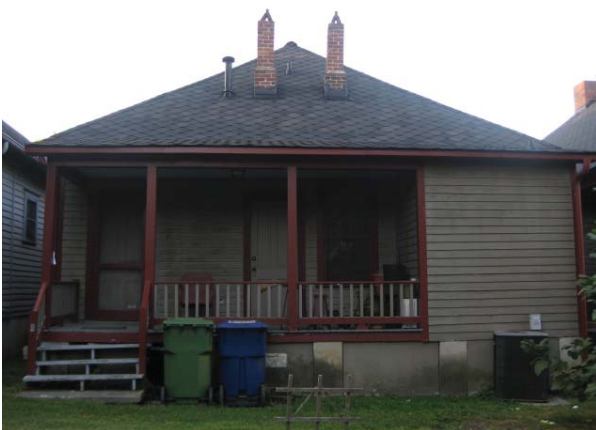
**Figure C3.** Rear facade viewed from the north.

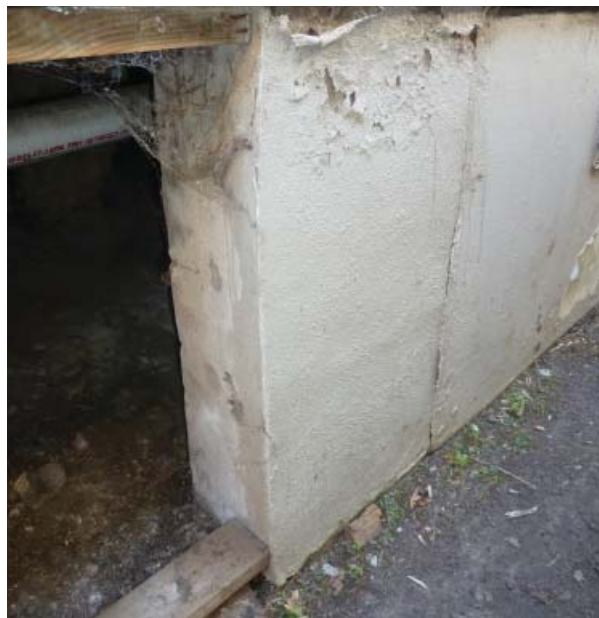
**Figure C6.** Typical stuccoed masonry foundation pier of main block and cement board infill wall. Photograph taken at 484 Auburn Avenue, where access was provided.

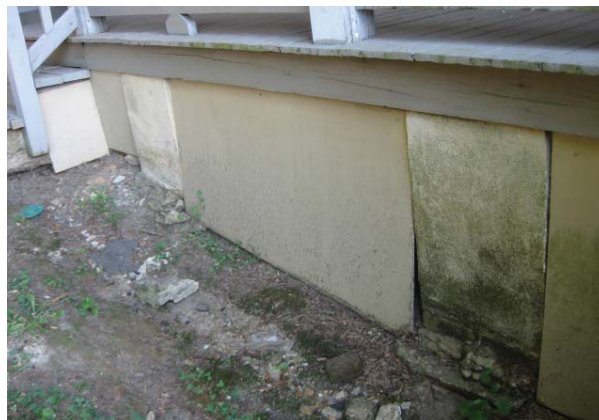
**Figure C7.** Typical stuccoed masonry foundation pier or rear addition. Photograph taken at 484 Auburn Avenue, where access was provided.

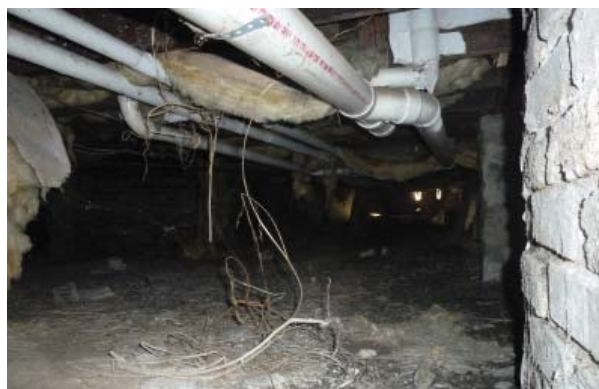
**Figure C8.** View into crawl space. Note the modern PVC plumbing lines and the modern insulation. Photograph taken at 484 Auburn Avenue, where access was provided.

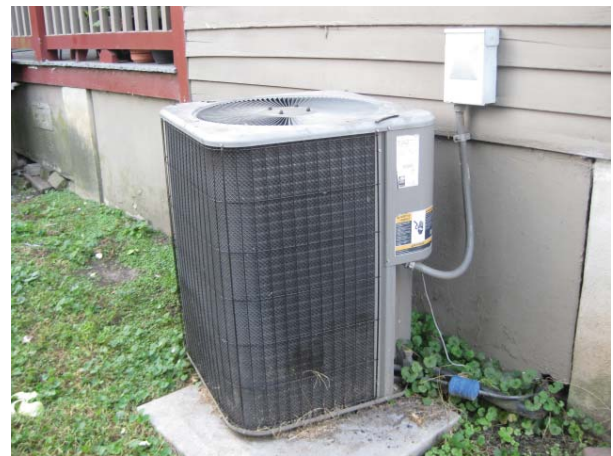
**Figure C9.** Heat pump at north side of building.

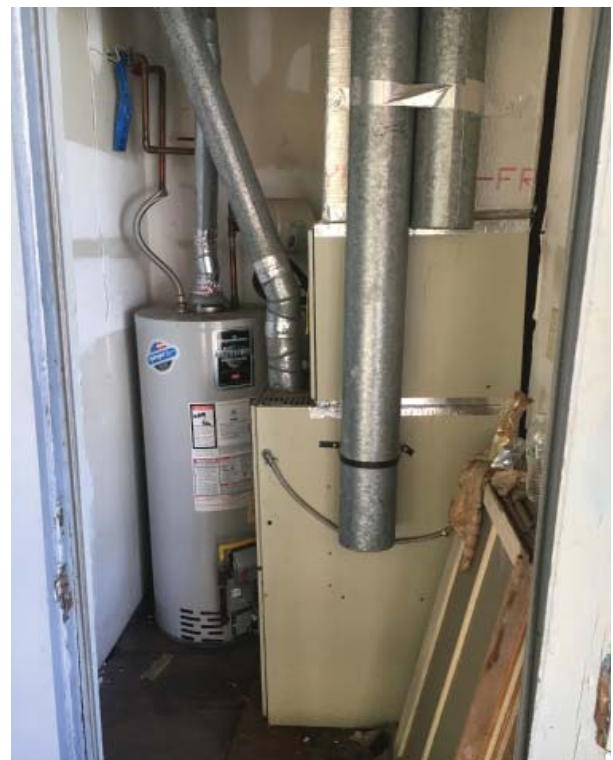
**Figure C10.** Water heater and Furnace in Room 109, the mechanical closet. Photograph taken at 484 Auburn Avenue, where access was provided.

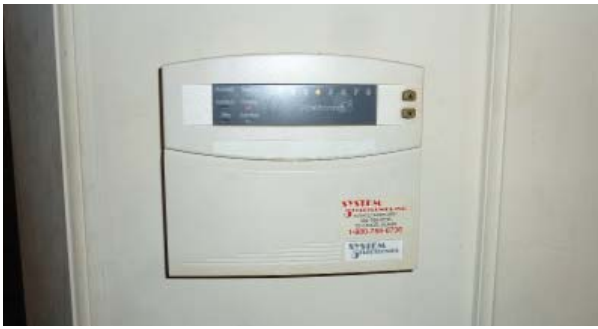
**Figure C11.** Panel box for modern security system.

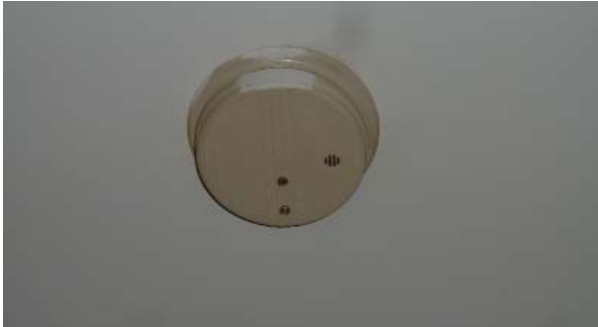
**Figure C12.** Ceiling-mounted, combination smoke and carbon monoxide detector.

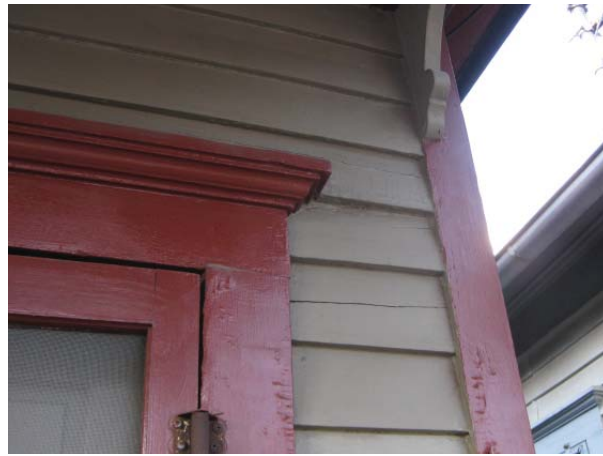
**Figure C13.** Weatherboard siding and plank cornerboards.

- Repair/replace weatherboard siding where it is damaged and pulling away from the wall surface, leaving the wall framing and interior finish exposed to water infiltration.
- The siding is of marginal quality. It is very thin and has visible knots and checks. When replaced, a higher quality of wood siding will diminish the avoidable problems of splitting and warping, and reduce maintenance costs.

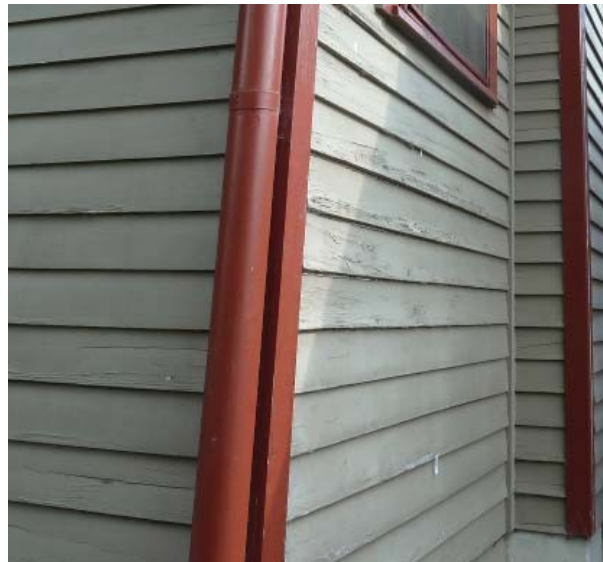
**Figure C14.** Note the checks and splitting of the siding.

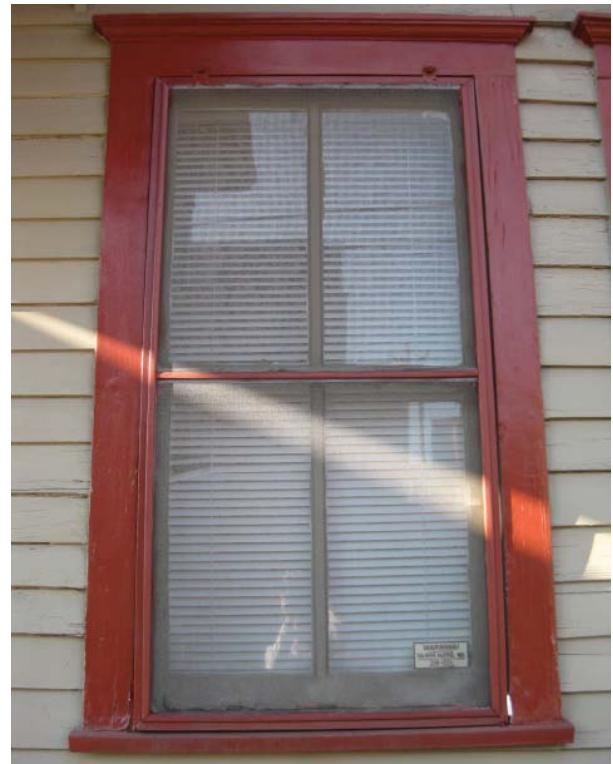
**Figure C16.** Window type one on all sides of the main block.

At the south and north elevations and in the southernmost two bays of the east and west elevations are a total of seven two-over-two-light, double-sash, wood windows measuring 2'-8" wide by 5'-2" tall. These are presumably original to the structure (*Fig. C16*). In the northernmost bays of the east and west elevations are two-over-two-light, double-sash, wood windows measuring 2'-4" wide by 2'-11" tall. These were likely added when a portion of the original kitchen was enclosed for a bathroom (*Fig. C17*). On the west wall of the 1990s rear addition is a single two-over-two-light, double-sash, wood window measuring 3'-0" wide by 3'-0" tall, that is contemporaneous to the addition (*Fig. C18*).

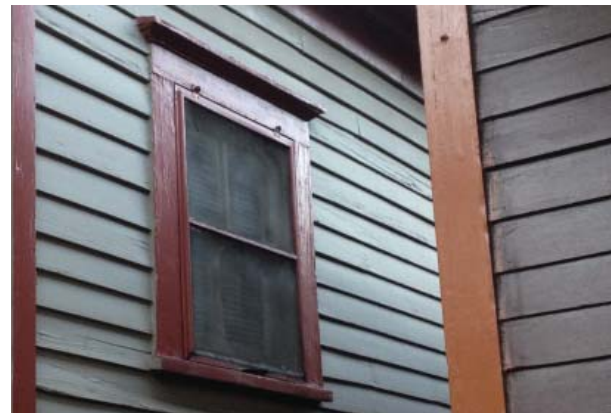
**Figure C17.** Window type two on the north portion of the east and west side of the main block. Obscured by the screen, this is a two-over-two double sash wood window.

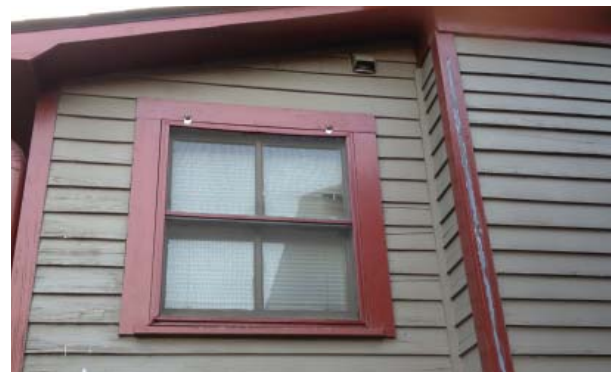
**Figure C18.** Window type three at the west side of the rear addition.

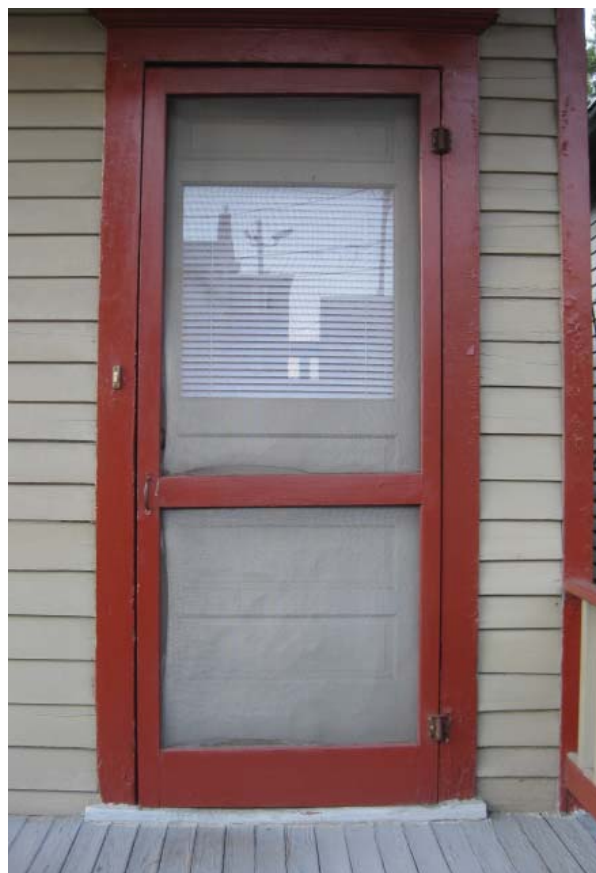
**Figure C20.** Primary entrance doorway.

The primary doorway is in the easternmost bay of the main block. Its wood door with a single light and a combination of horizontal and vertical panels is early, if not original. Measuring 7'-0" tall by 2'-10" wide by 1 1/8" thick, it is hung with two 4"-tall, brass, five-knuckle, butt hinges. Other hardware includes a rectangular brass escutcheon with a mortise lock and crimped brass doorknob and a modern brass mortise deadbolt. Panels are raised and have molded sticking (*Fig. C20*).

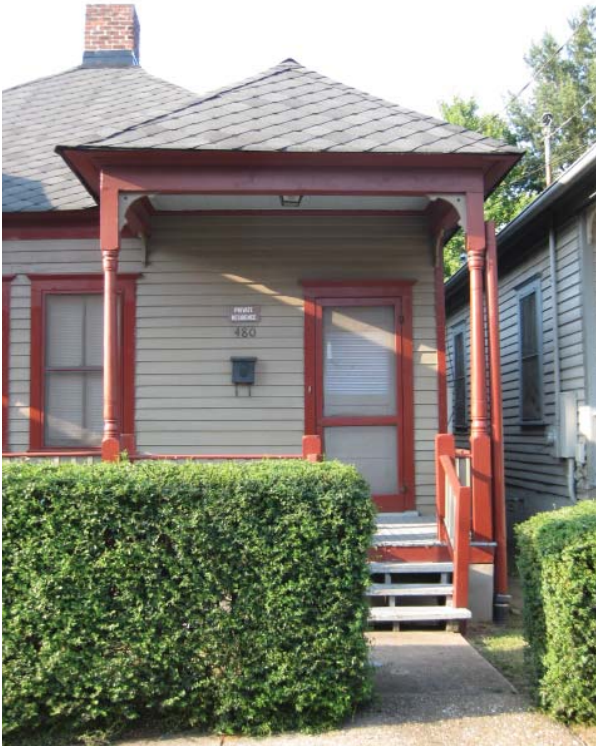
**Figure C22.** Front porch of original west unit.

measuring 13" square are set on either side of each column and where the box beam intersects with the south wall of the main block (*Figs. C22-23*).

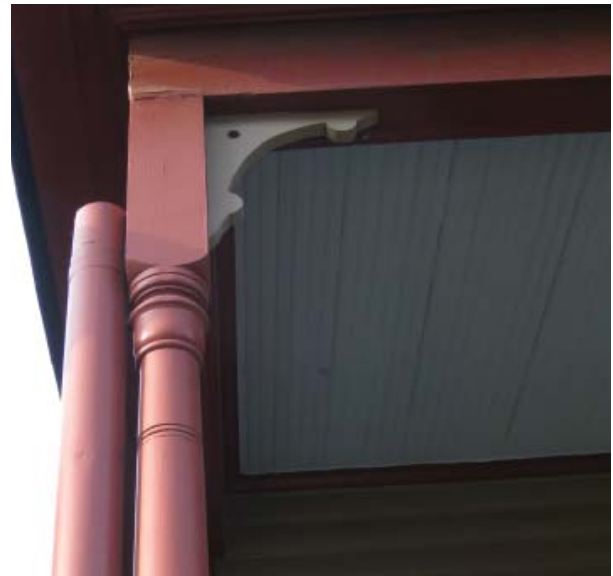
**Figure C23.** Decorative bracket and crown molding at front porch.

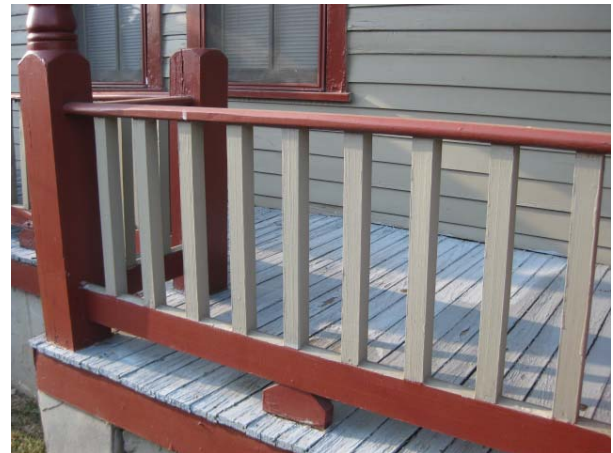
**Figure C24.** Front porch floorboards and balustrade.

The tongue-and-groove porch floorboards measure 3¼" wide by ¾" thick and run north-south. The original flooring was replaced during the 1990s rehabilitation, when the two separate porches were connected (*Fig. C24*).

A wood balustrade is composed of a rounded top rail, square balusters, and a rectangular bottom rail with a chamfered top. The top rail measures 3½" wide by 1¼" tall; the bottom rail measures 1¾" wide by 4" tall; and the balusters measure 1¾" square. At each set of steps, two newel posts at the top measure 5½" square and two at the bottom measure 3½" square. All newel posts have chamfered tops. Much of the material is modern replacement (*Fig. C24*).
