# Double-Shotgun House 480 Auburn Avenue

Martin Luther King, Jr.  
National Historical Park

## Historic Structure Report 2018

2018  
Historic Structure Report  
Double-Shotgun House  
480 Auburn Avenue  
Martin Luther King, Jr. National Historical Park (MALU)

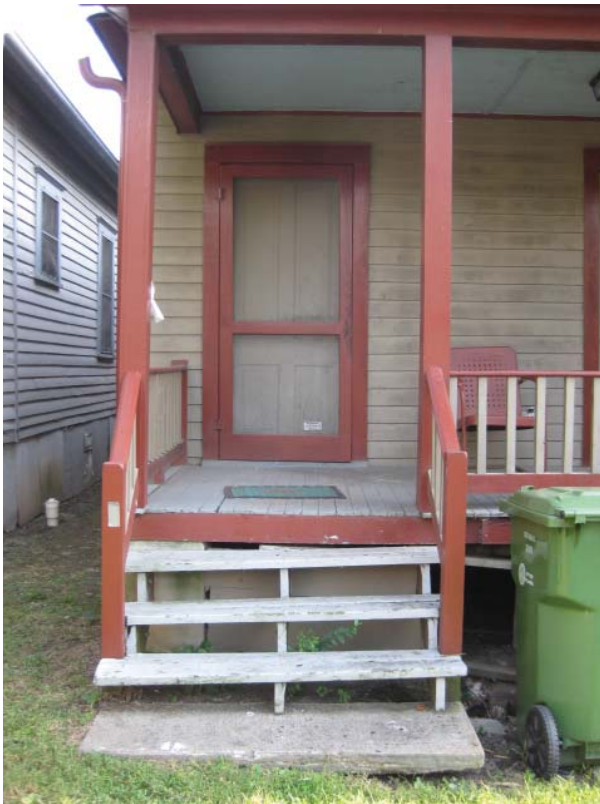
**Figure C25.** Modern rear door of combined units.

This doorway also has a two-light, wood screen door measuring 7'-0" tall by 2'-10" wide by 1" thick, hung with three 3"-tall, brass, spring-loaded hinges. Each of the two openings holds a fine wire mesh. The only other hardware is a 3"-tall metal pull. This door is a modern reproduction of the early screen doors on the front entrances.

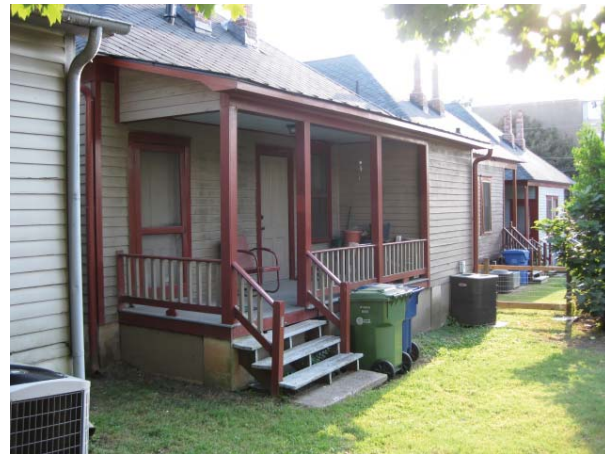
**Figure C26.** Modern back porch.

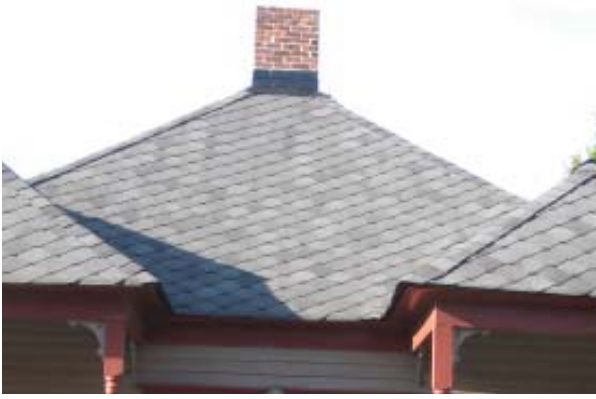
Both the hipped and shed roofs are covered in 16"-by-16" Owens Corning French Method

**Figure C27.** "French Method" composition shingle roof and front chimney.

fiberglass shingles. The ridges are shingled, and the flashing is galvanized. The 6" half-round gutters are galvanized and have 5" downspouts (Figs. C27-28).

- The current roofing material, while recently installed, is not appropriate to the period of significance. There is clear evidence that this building, like many others, was roofed with roll asphalt. At the appropriate time for replacement, roll asphalt roofing would be a more appropriate choice.
- Interior and exterior rehabilitation work introduced a variety of non-historic elements to both the exterior and interior of the house.
- Due to the current long-term tenant, cyclical maintenance has not been performed on the interior. As a result, many interior fixtures and finishes such as painted walls and carpeted floors are in need of repair and/or refinishing.

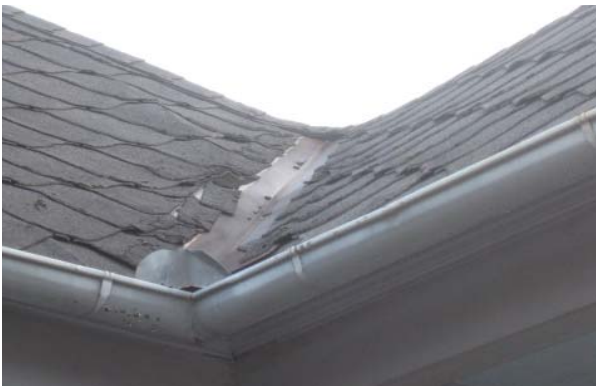
**Figure C28.** Typical valley flashing of roof. Photograph taken at 484 Auburn Ave.

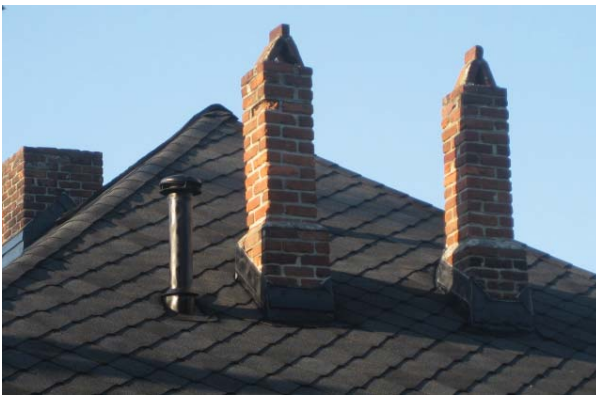
**Figure C29.** Paired rear brick chimneys with corbelled integrated cap.

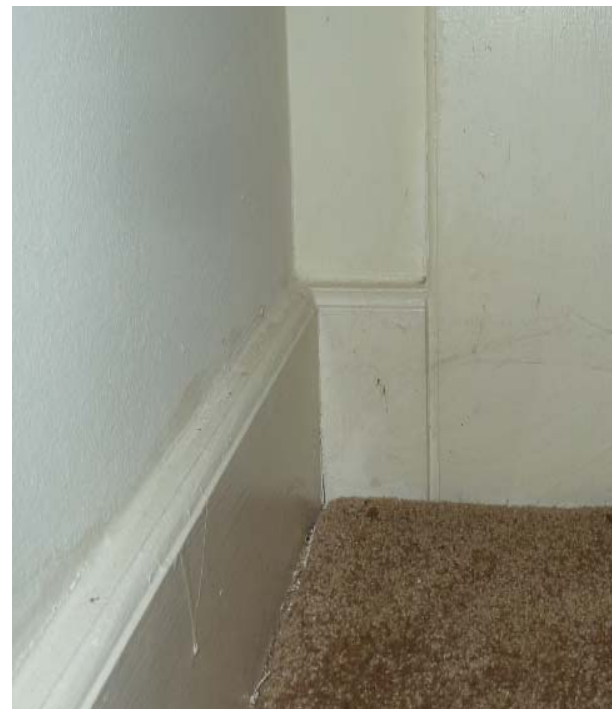
With few exceptions, the baseboards throughout the house are 5"-tall by ¾"-wide plank board with an integral ½" tall molded cap. These baseboards are modern replacement introduced during the 1990s rehabilitation (Fig. C30).

**Figure C30.** Typical baseboards.

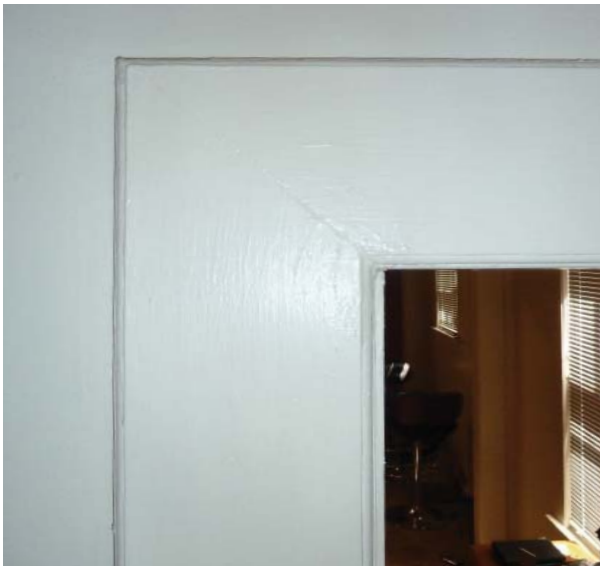
Door and window casing throughout the house is miter-cut and measures 6" wide by ¾" thick with a ¼" chamfer on each edge. The molding is a modern replacement introduced during the 1990s rehabilitation (Fig. C31).

**Figure C31.** Typical door and window casing.

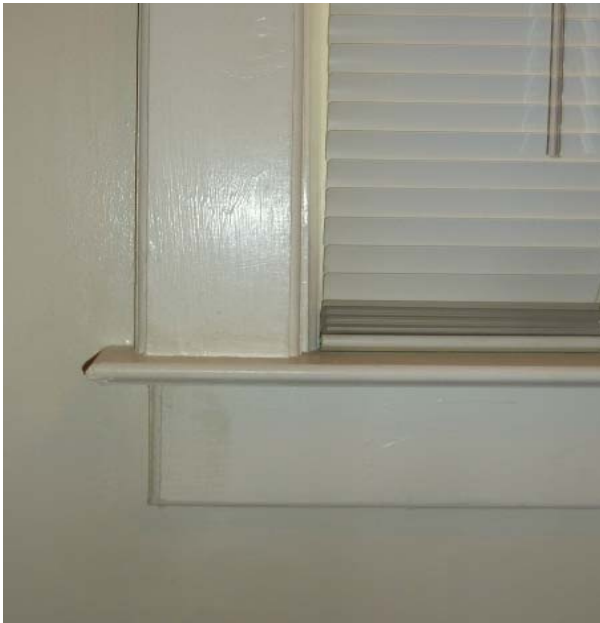
Windowsills throughout the house are ½" tall, molded, and have molded returns. Aprons measure 6" wide by ¾" thick with a ¼" chamfer on the three exposed edges. The sill and apron are both modern replacements introduced during the 1990s rehabilitation (Fig. C32).

**Figure C32.** Typical windowsill and apron.

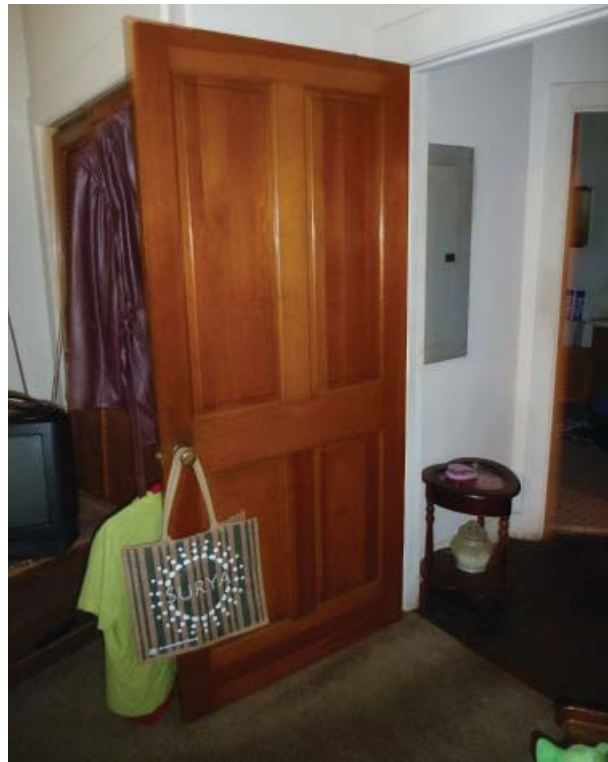
**Figure C33.** Typical interior door.

With few exceptions, interior doors measure 6'-8" tall by 3'-0" wide by 1 $\frac{3}{8}$ " thick and are hung with two 3 $\frac{1}{2}$ "-tall modern, brass, butt hinges. The four-panel wood doors have raised panels with molded sticking. Door hardware includes a 2"-diameter brass knob with a privacy lock set and a 2 $\frac{3}{4}$ "-diameter brass rosette. Doors are stained and varnished (*Fig. C33*).

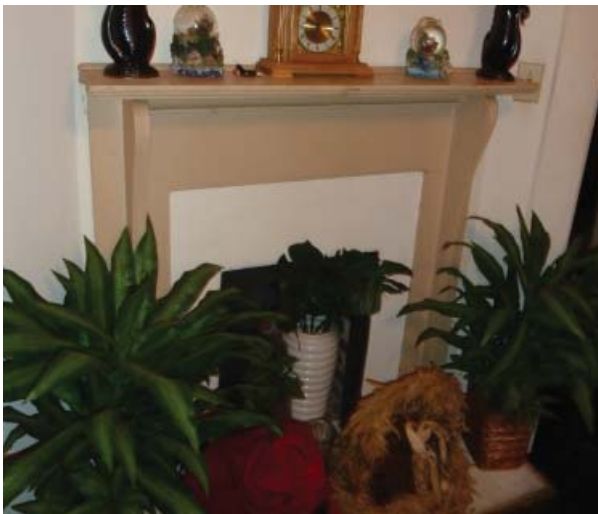
**Figure C42.** Firebox and hearth in southwest corner of Room 103.

A fireplace with a decorative cast-iron, coal-burning insert is in the southwest corner. The hearth measures 1'-0" deep by about 4'-0" wide and is laid in painted concrete. A bracketed wood mantel measuring 9¾" deep by 4'-3" wide is attached to a built-up wood surround. The fireplace is inoperable.

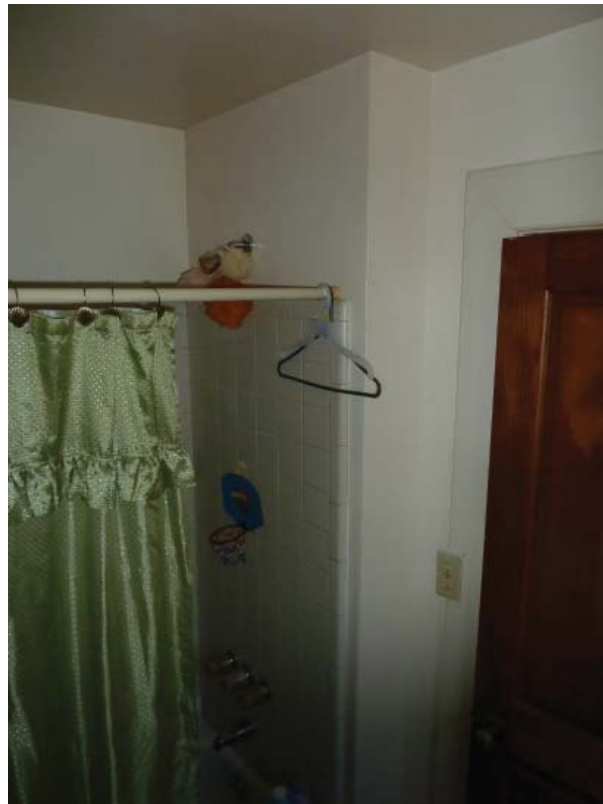
Measuring 7'-4" east-west by 5'-8" north-south, this room occupies the western portion of the rear addition. It was added during the 1990s rehabilitation (*Figs. C54-55*).

**Figure C54.** Room 110, southwest oblique.

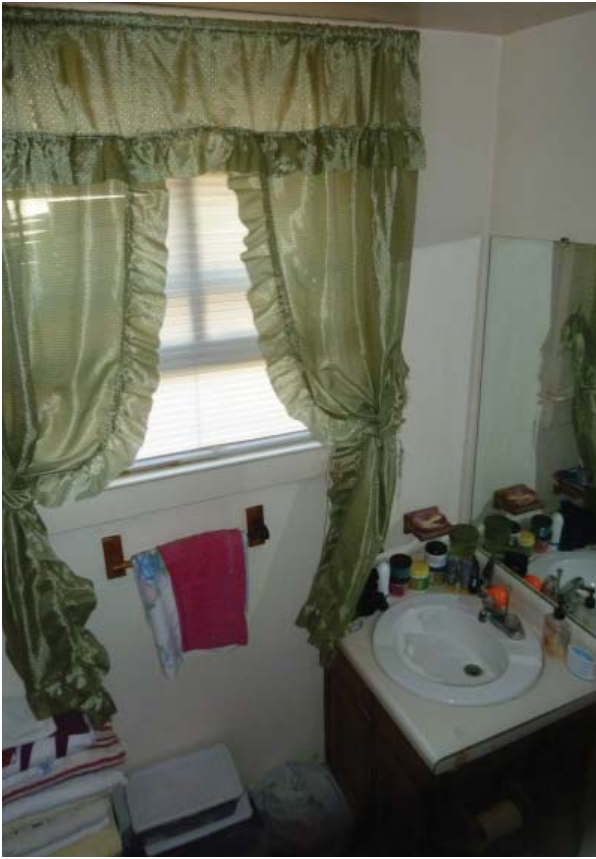
**Figure C55.** Room 110, northwest oblique.

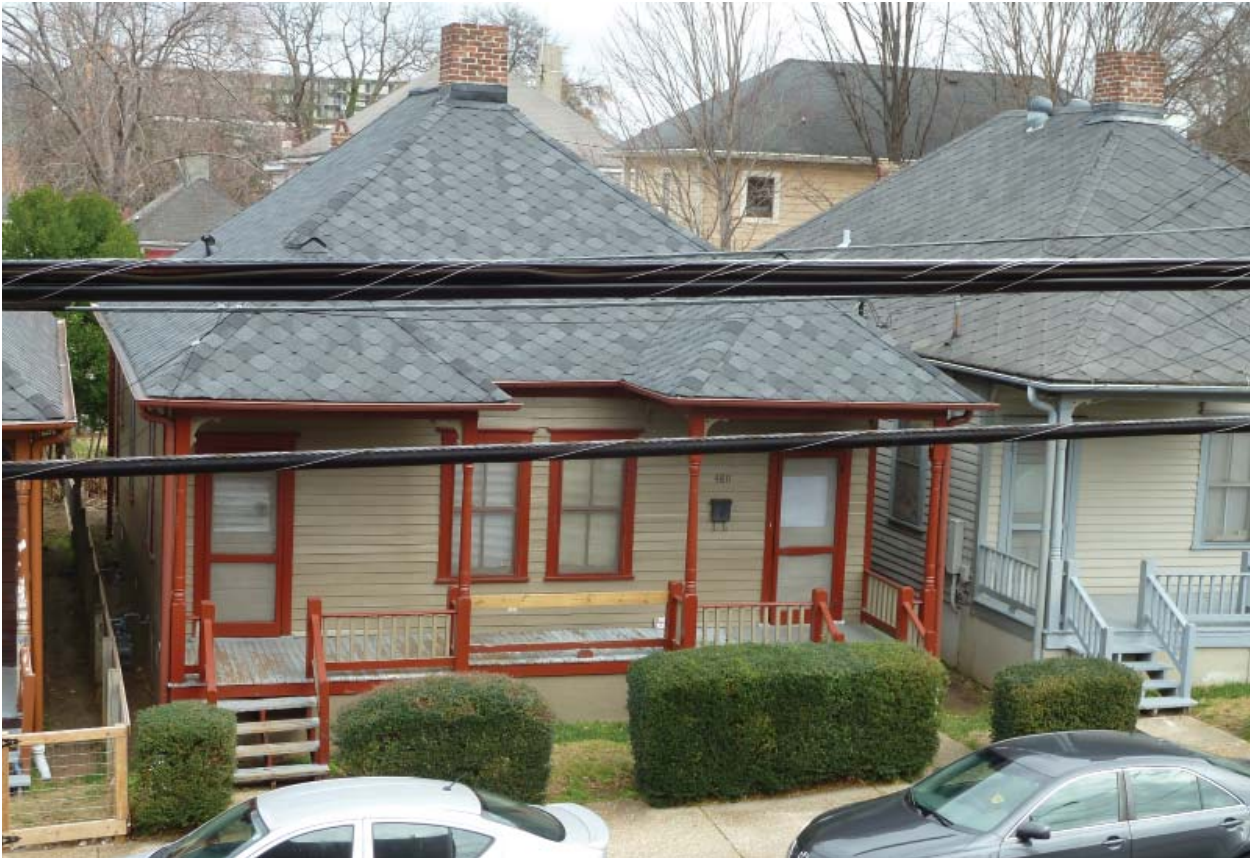
**Figure II-1.** Front (south) elevation, 480 Auburn Avenue.

The Ultimate Treatment and Use recommendations for 480 Auburn Avenue echo the treatment and use strategy of the Park's administration, its General Management Plan (GMP), and Long-Range Interpretive Plan (LRIP). All call for restoring the exteriors to their appearance during Dr. King's youth in the neighborhood (1929-1941). The Park administration agrees with the recommendations.
