HISTORIC STRUCTURES REPORT

JOHNSON FARM GROUP

Blue Ridge Parkway

January 30, 1964

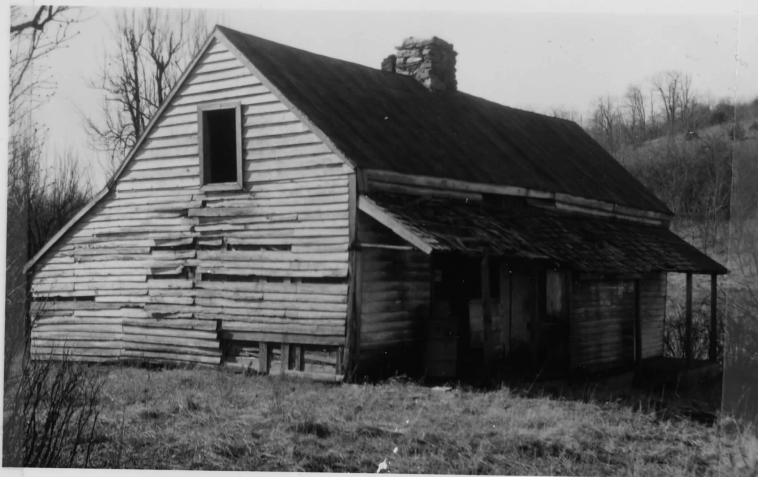
(Front)

Johnson House before removal of porch and rear addition.

House, Building No. 154 - Repair the floors, doors, porches, etc., to a condition safe for people to use. Remove an existing tin roof and replace with wooden shakes. Remove superficial siding to expose the original log structure and repair original chinking.

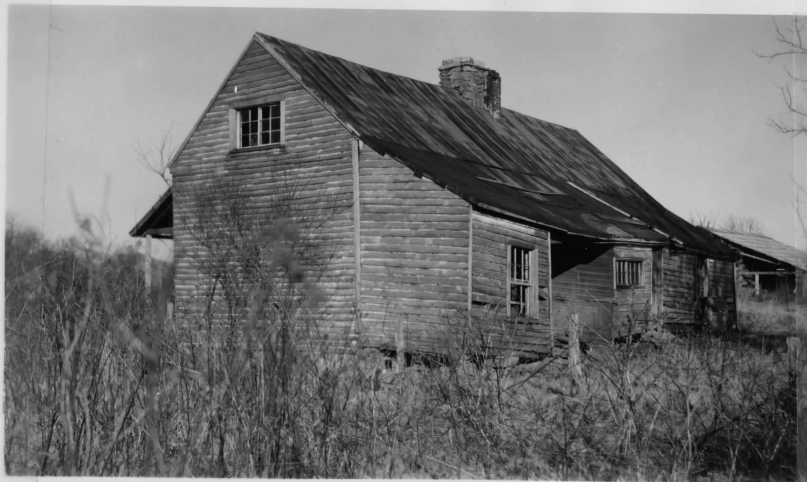
(Rear)

(The addition on rear is of relatively recent construction.)
