## **Big Heath Social Trails, 2016 - 2017**

**Charles Jacobi, Natural Resource Specialist**  
**Rebecca Flesh, Recreation Technician**  
**Karen Anderson, GIS Specialist**  
**December 2017**  
**ANP Natural Resource Report 2017 - 4**

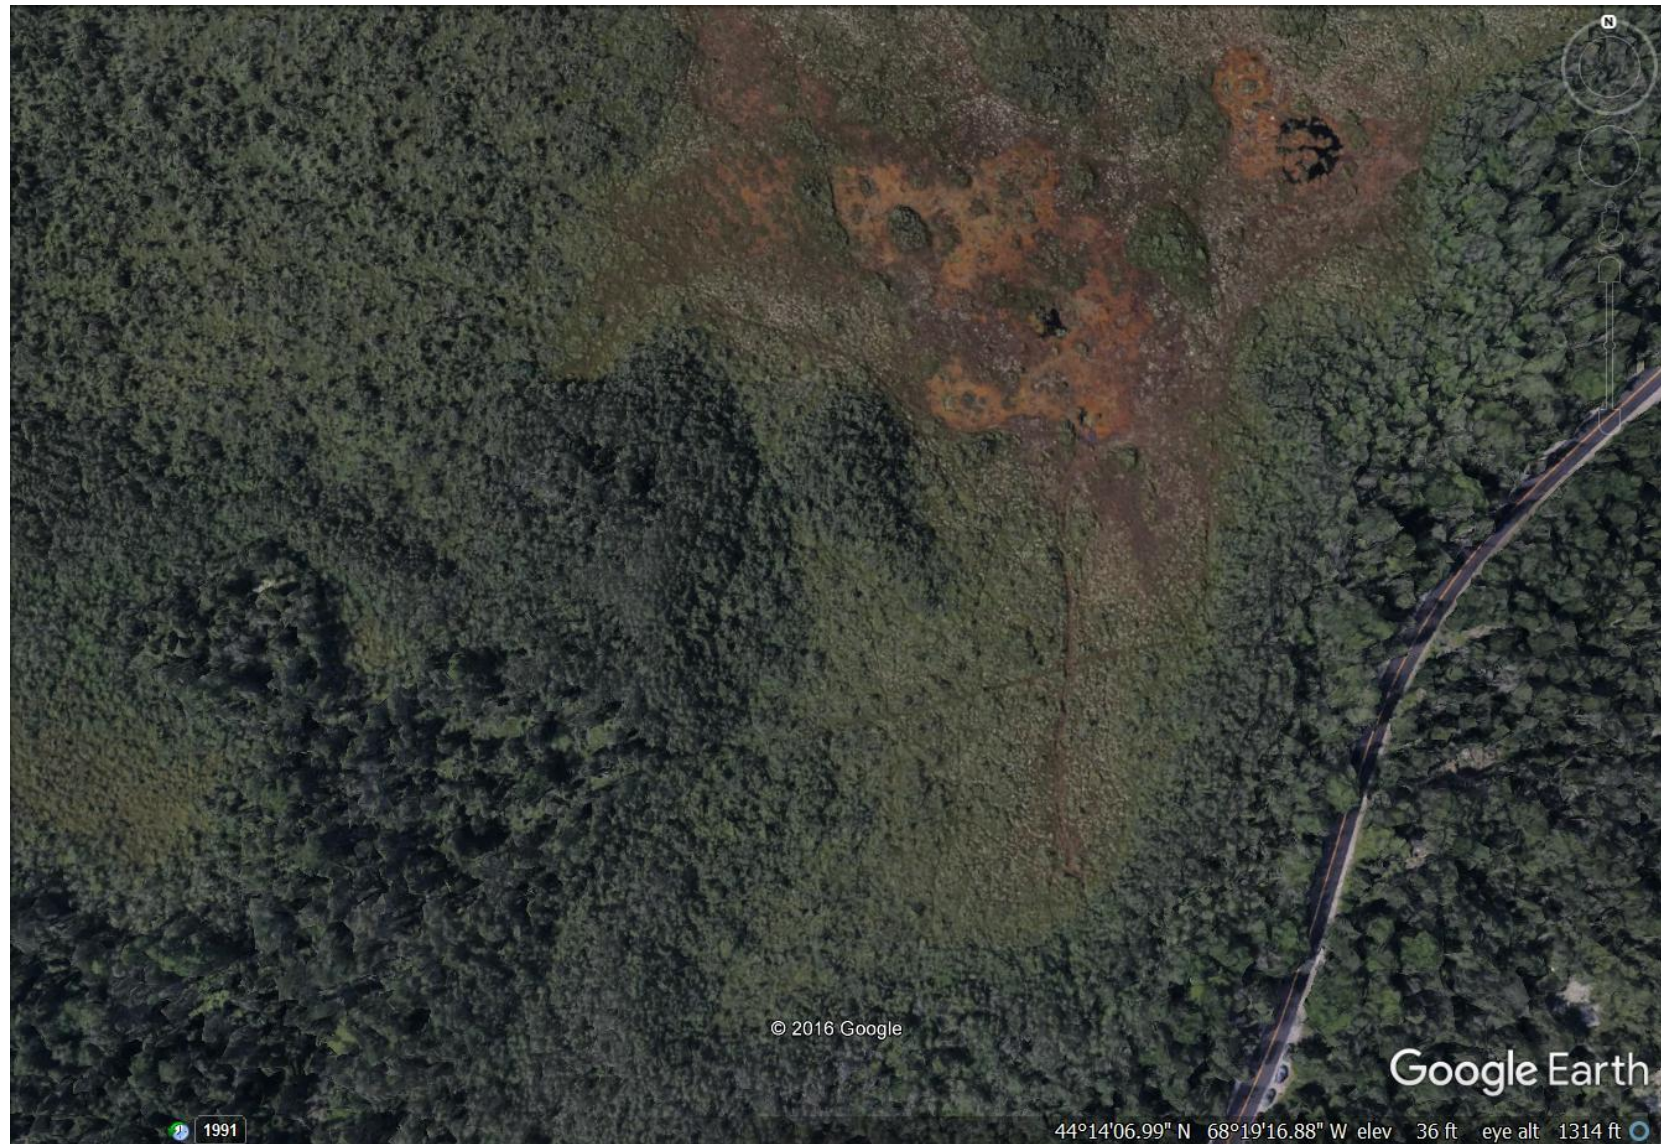
**FIGURE 7: 1991 GOOGLE EARTH IMAGE OF BIG HEATH.**

Comparing the 1986 McInness map (Figure 1), our 2016-2017 map (Figure 2), the 1991 Google Earth image (Figure 7), and the 2013 digital orthophoto (DOQQ) image from 2013 (Figure 8), it is possible to trace the history of social trails with some confidence. We do not think we found McInness Trail 1. Trail 2 from McInness looks like it is our Trail 3a, which starts from just east of the Wonderland Parking Area. Once in the heath it curves northerly ending just before a small pond. This trail shows in Figure 7 (Google Earth) as the prominent north-south linear feature. McInness Trail 3 is a trail we missed entirely first time around but mapped in late May 2017. It is our trail 3c and also the southernmost of the two east-west linear features shown in Figure 7 (Google Earth) and Figure 8 (DOQQ). It extends west and appears to go into the upland forest a good distance, but we did not try to follow or map it because of the vegetation density.

The northernmost of the two east-west lines shown in Figure 7 (Google Earth) and Figure 8 (DOQQ) is our trail 3c mapped in May 2017. We cannot determine with any confidence if this is the small segment shown on the McInness map connecting his trails 1, 2, and 3. McInness's work was focused on counting visitors, not mapping trails. Also visible on the 1991 Google Earth image and the 2013 DOQQ image (but not shown by McInness) is a linear feature that runs north up the east side of the heath along the shrub-heath edge before ending south of the largest (circular) pond shown. Our trail 5 is likely a part of this trail.

Figure 7 (Google Earth, 1991) also shows numerous faint wavy, linear features especially in the shrubby and more remote parts of the heath.

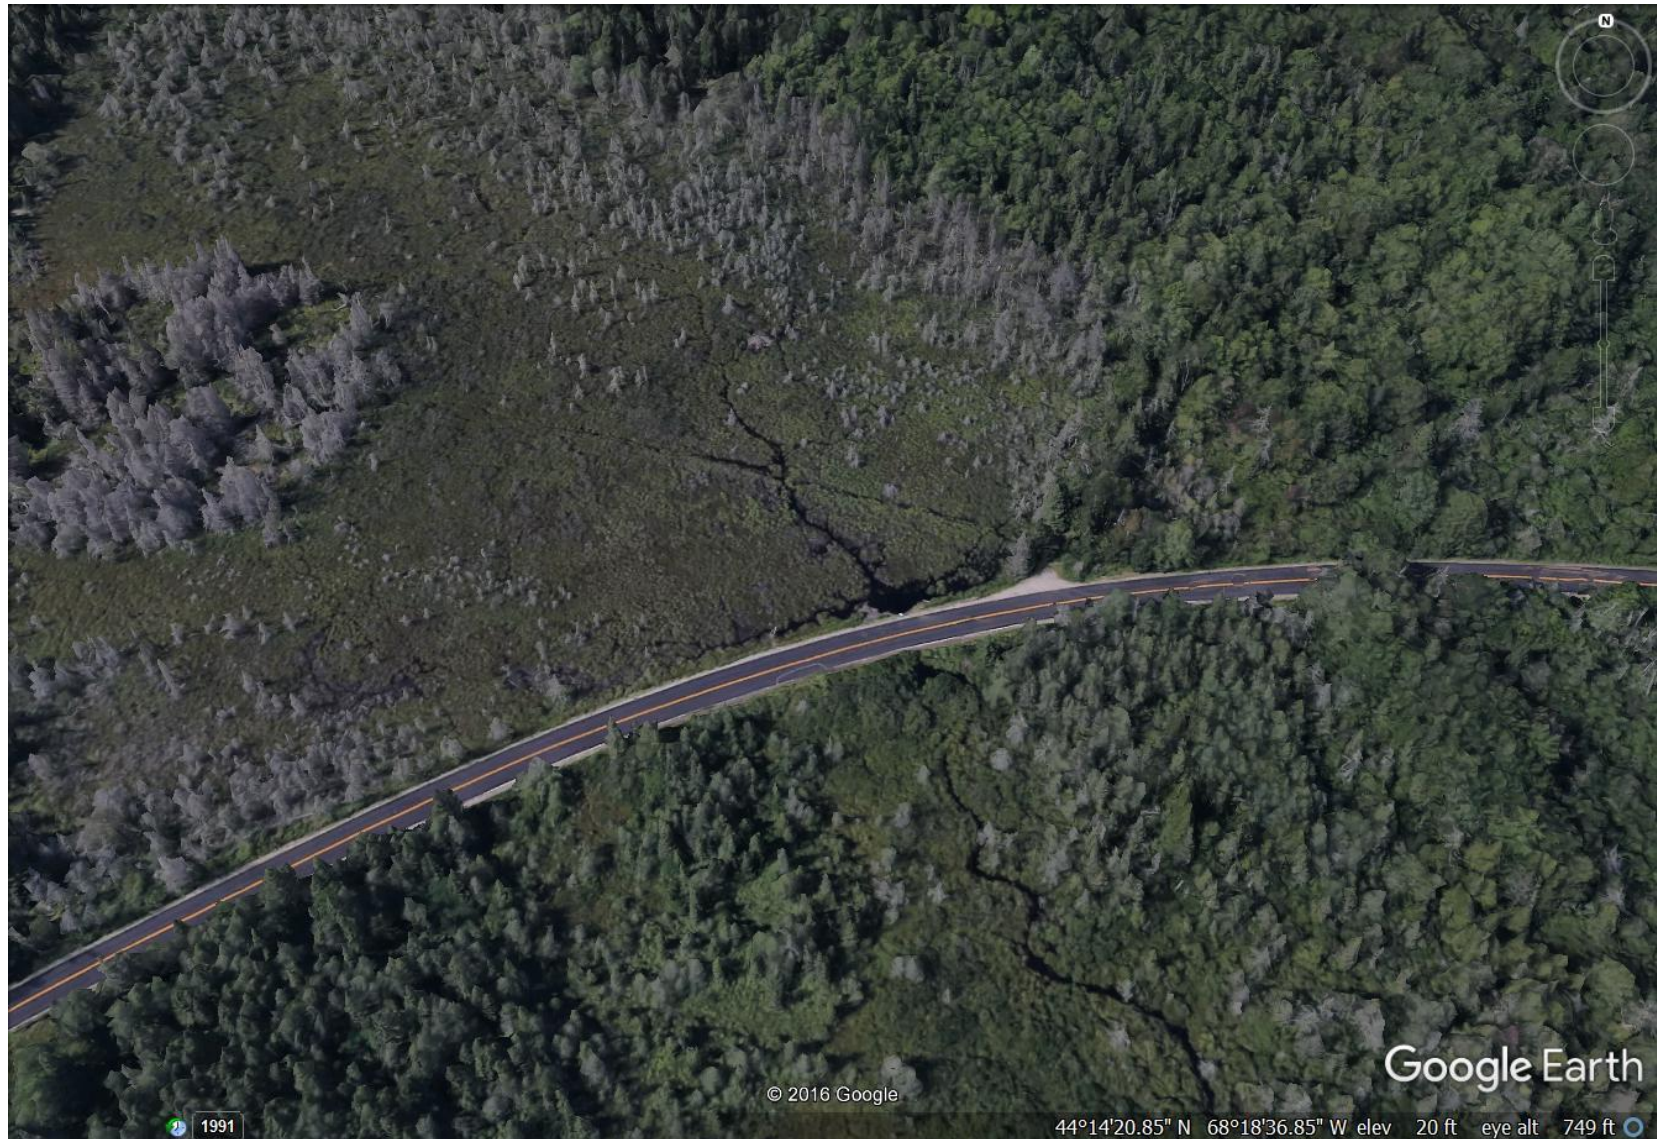
**FIGURE 10: 1991 GOOGLE EARTH IMAGE, EASTERN WETLAND CONNECTED TO BIG HEATH.**

Figure 10 (Google Earth) shows one other straight line feature and a circular feature in the wetland closest to Seawall Campground. This property was owned by the Navy for a radio substation associated with the Fabbri radio station circa 1917-1919, was then transferred to the park, then transferred back to the navy in 1942 for the same purpose during WWII, and then back again to the park after the war. The straight line feature was a power line corridor to the circular feature, which was the antenna array.

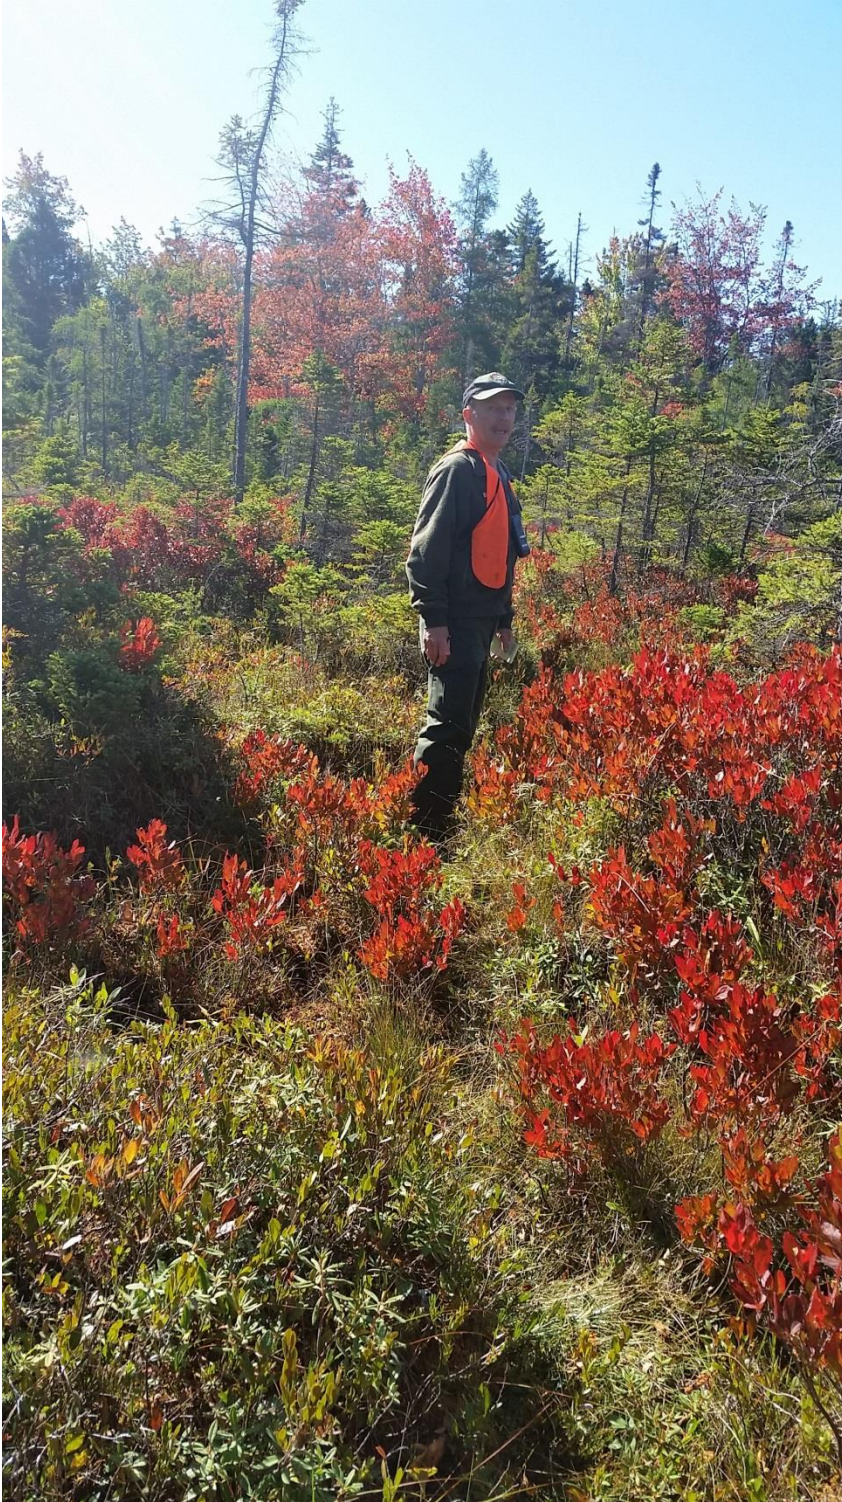
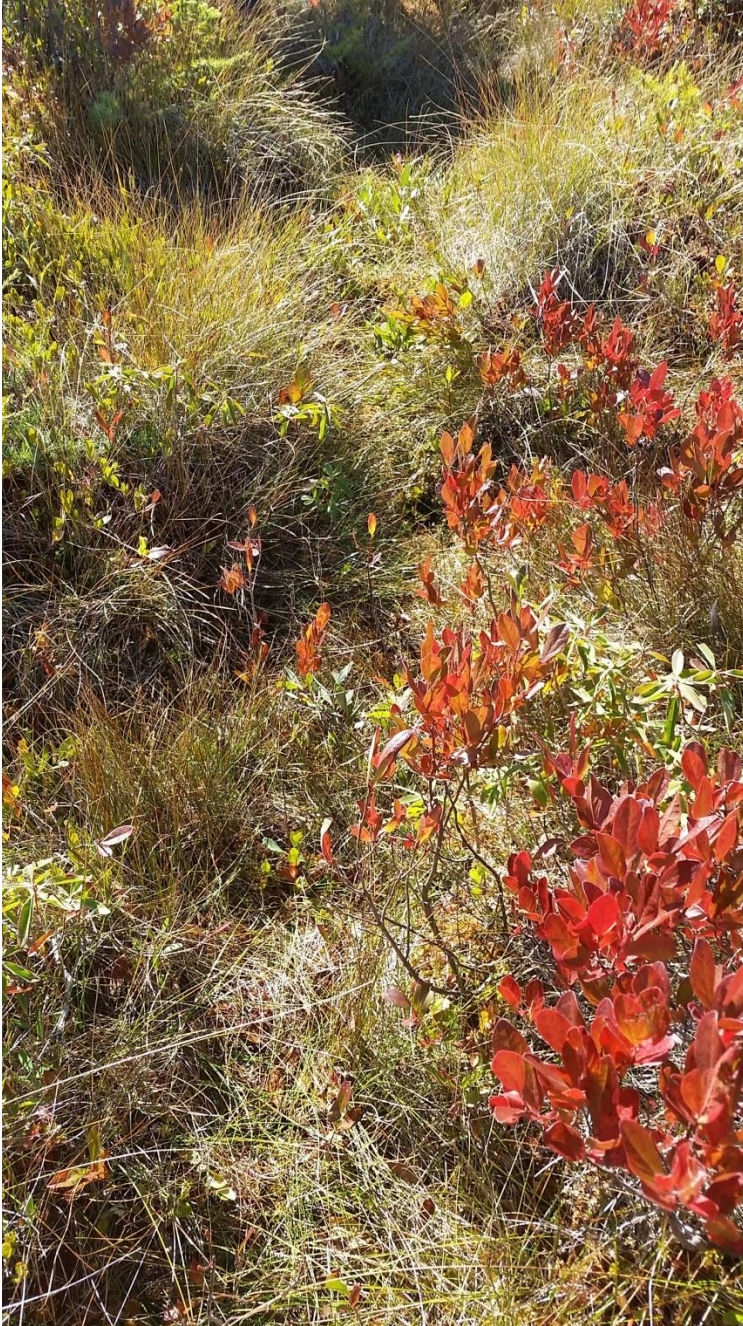
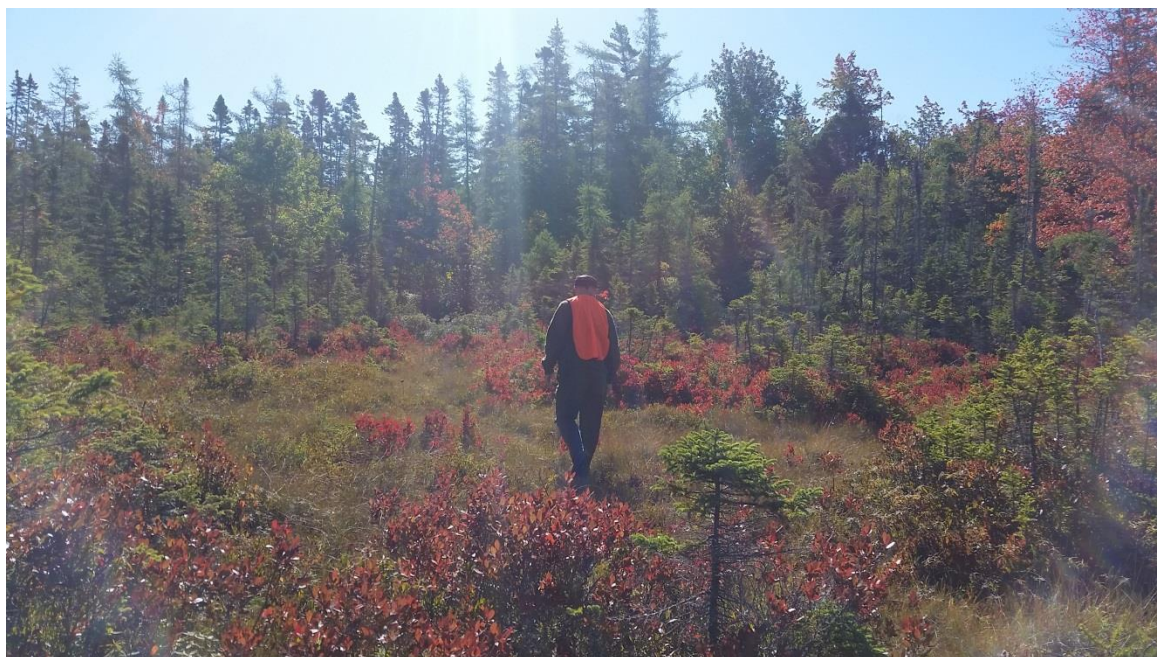
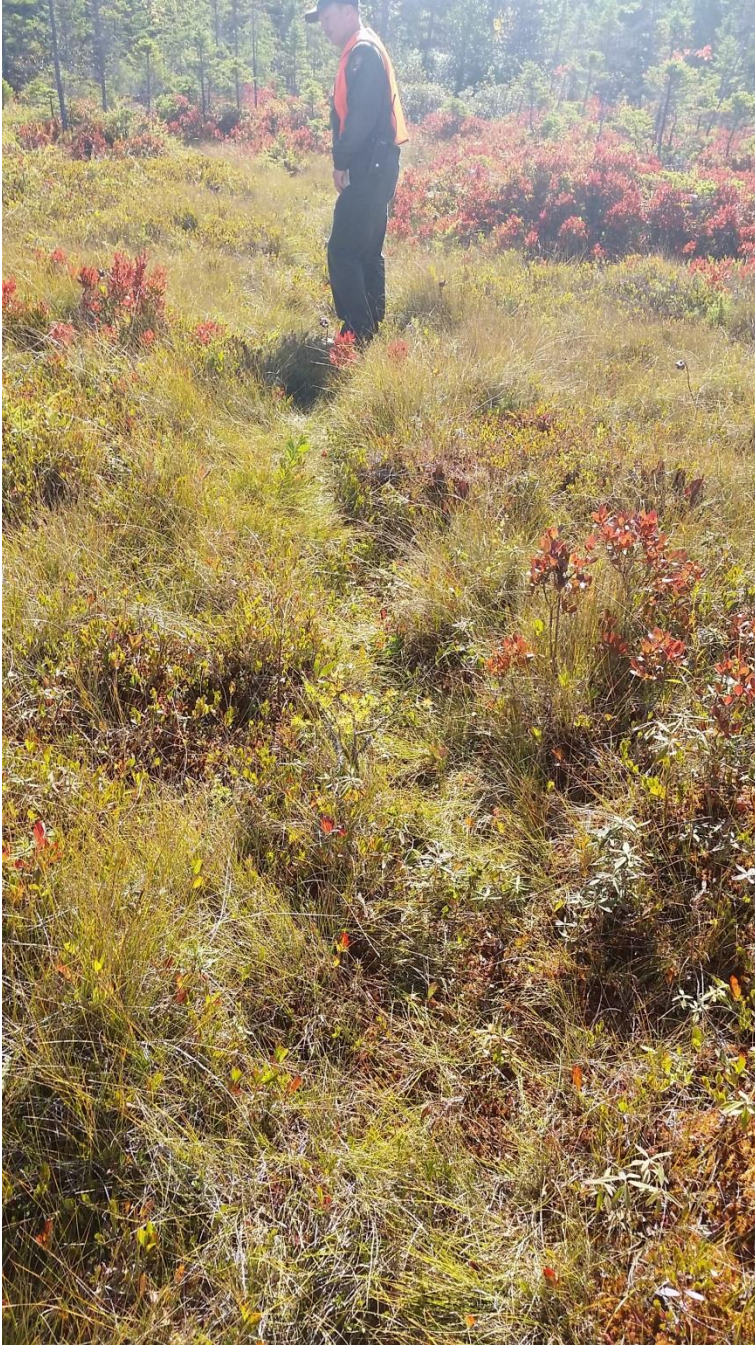
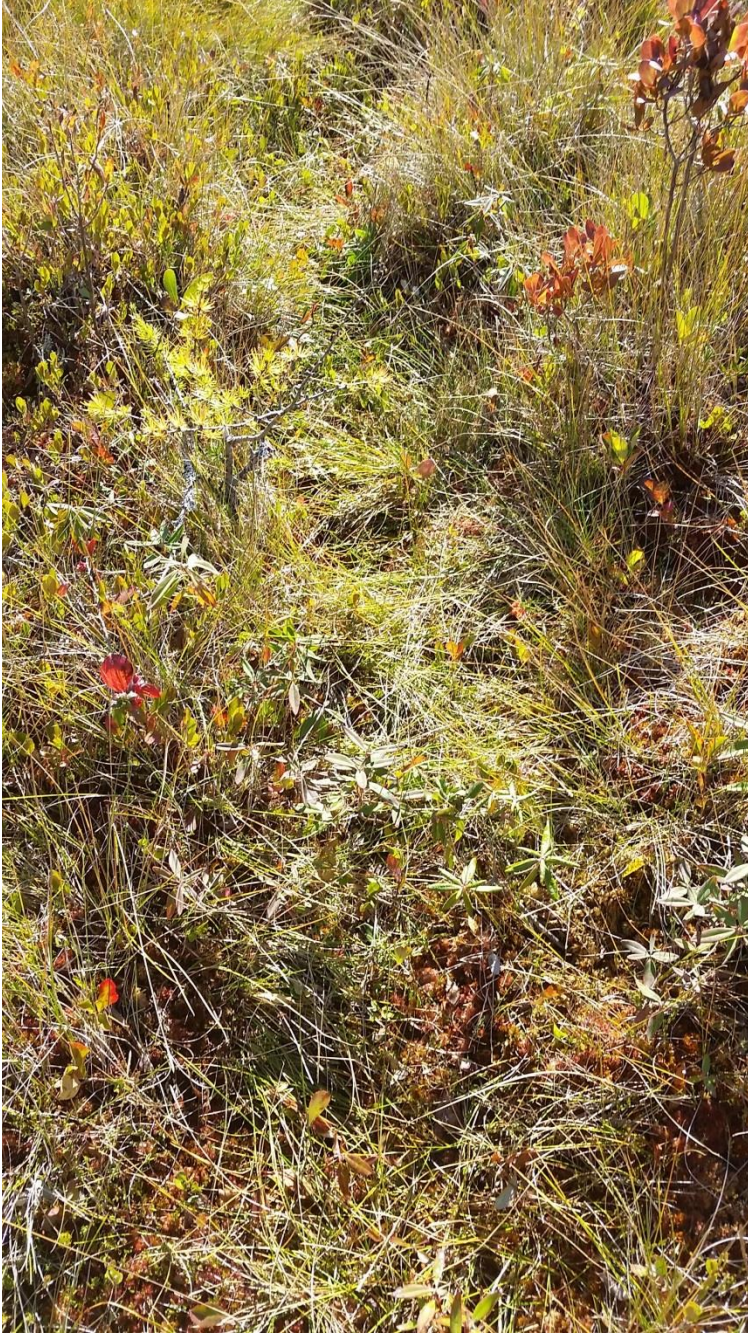
1. West of Ship Harbor parking: faint wildlife trail into upland area
2. Grassy Wetland: pitcher plants too, heavily vegetated tread, overgrown at end. A social trail.
3. East of Wonderland: social trail to Big Heath, snakes through forest then goes far out into heath; old braiding of trails evident; tread all vegetated in heath.
4. I and M Plot Route: across from small pulloff on South side of road; not very visible from road, snakes through forest and is overgrown, some blue flagging; in heath the tread is all vegetated; does not go all the way to the plot.
5. Wildlife trail: parallels southern end of heath, some old braiding, tread is all vegetated.
6. Pulloff on North side of road: very overgrown, removed pink flagging. Probably wildlife trail only now.
7. Another wildlife trail: overgrown.

Trail 2, Grassy Wetland Photo 1.

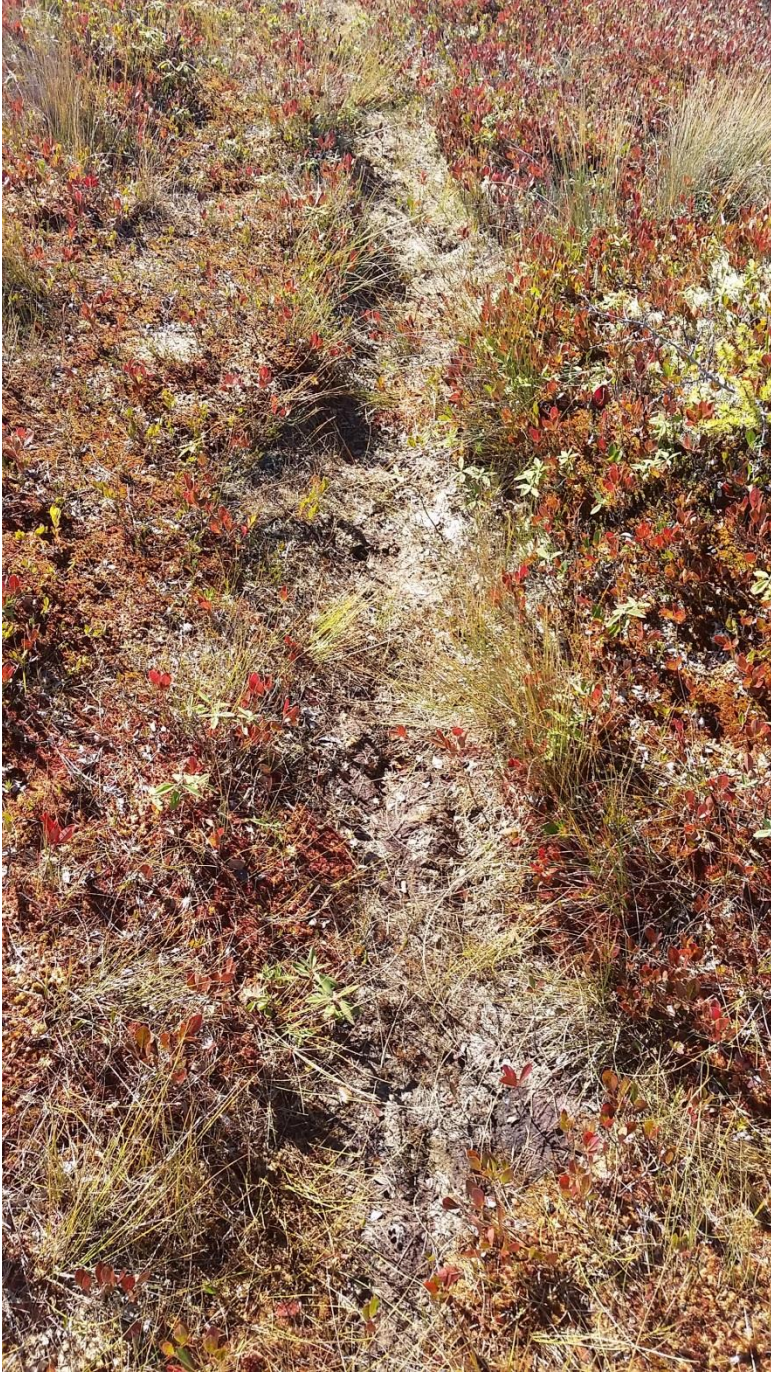
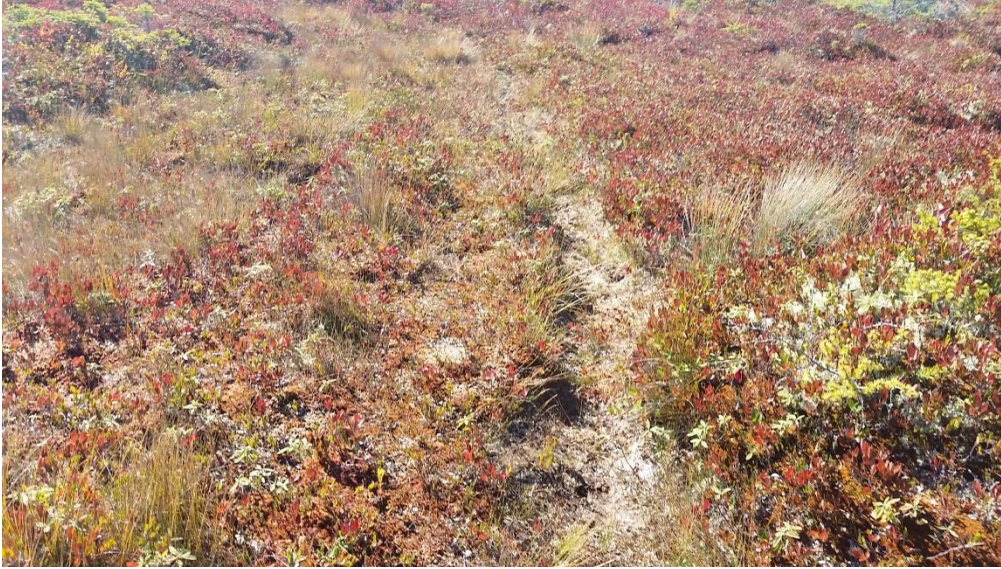
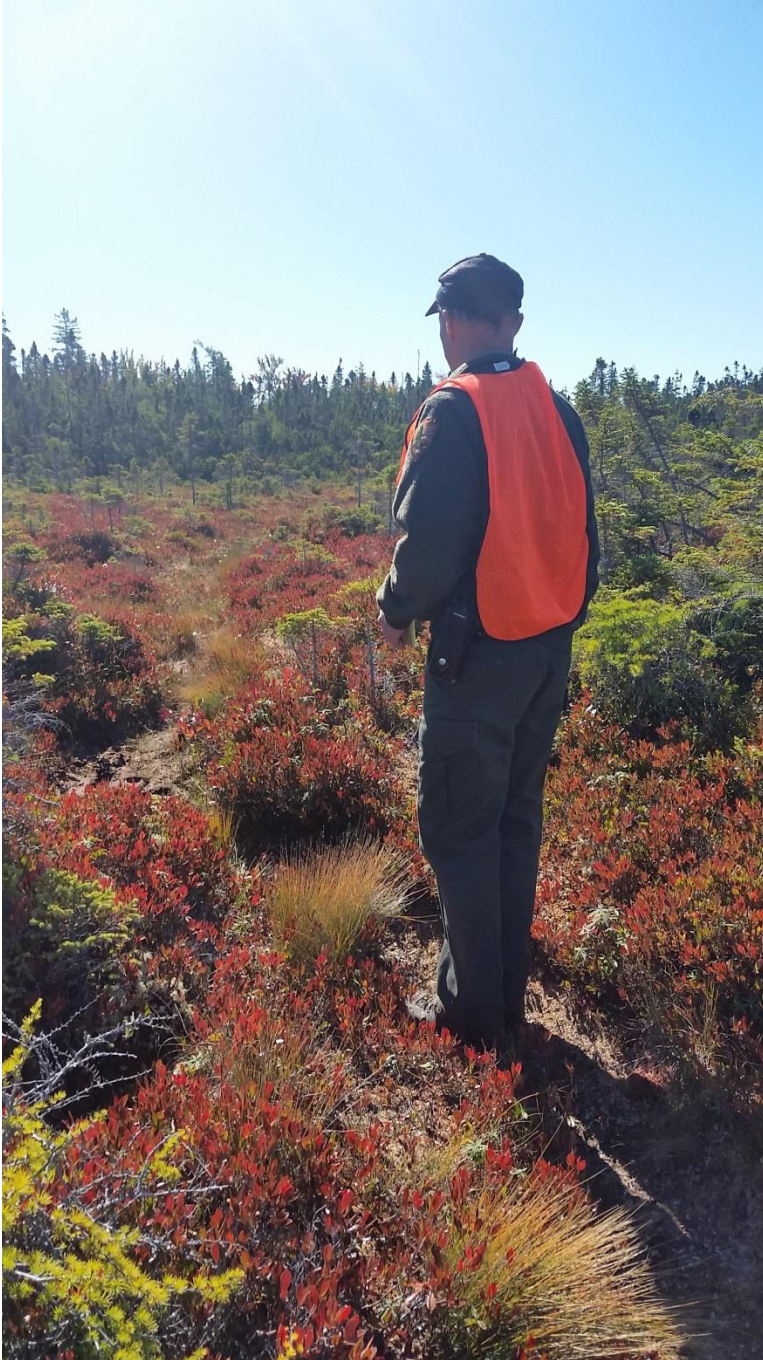
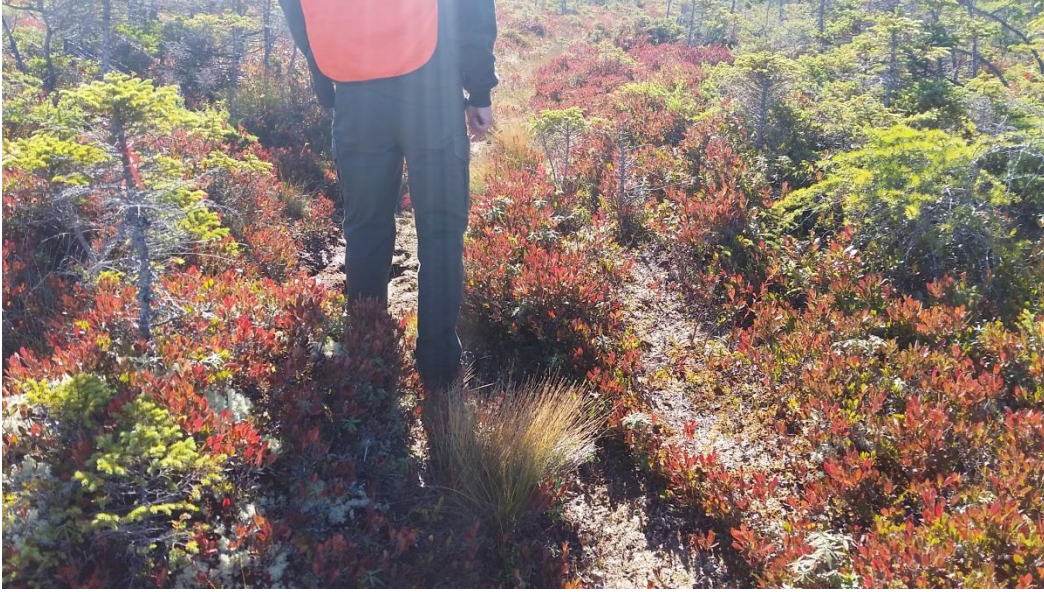
Trail 3, East of Wonderland Photo 1.
