## Archeological Investigations at the Tower Stairhall

Independence National Historical Park  
Philadelphia, Pennsylvania

by  
Paul Y. Inashima

United States Department of the Interior  
National Park Service  
Denver Service Center  
Resource Planning  
Applied Archeology Center  
Silver Spring, Maryland 20904  
1998

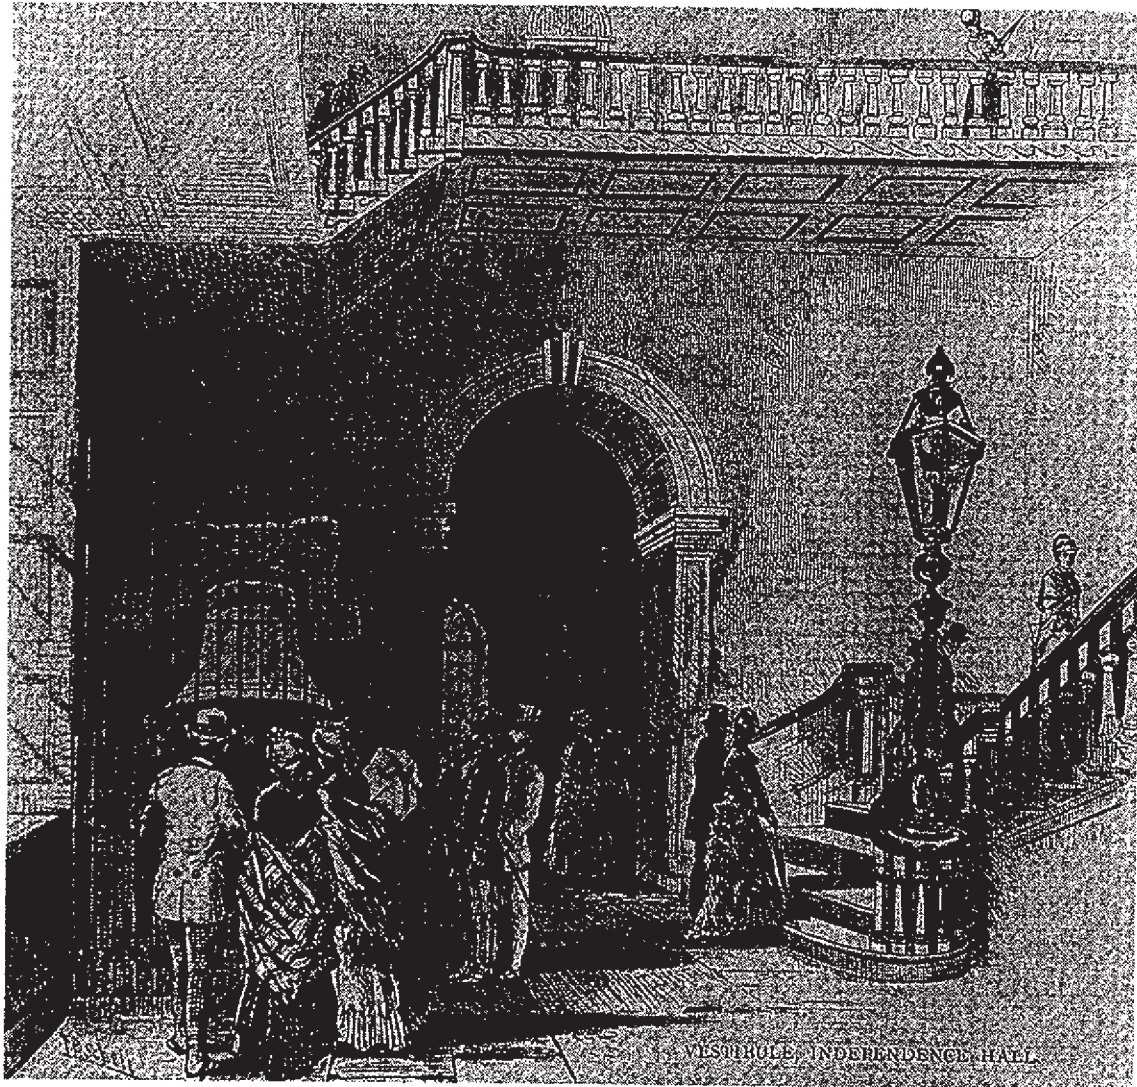
Figure 4. F.B. Schell's "Vestibule, Independence Hall" in 1875 illustrates the presence of stone paving in the Tower Stairhall and the location of the Liberty Bell in the northwest corner (Temple University Urban Archives print reproduced in Stevick 1996:51).

According to Lee Nelson (1966:1), the initial paving in the Tower Stairhall was likely brick. In 1797, the old paving was removed, and new brick pavement was laid (Nelson 1966:2). Sometime between 1818 and before 1875 (Figure 4), the brick flooring was replaced with stone (Nelson 1966:3). In 1898, soft "press bricks" were installed as replacements for the stone. In 1925, these were replaced with the brick flooring which was extant at the time of Nelson's investigations. In 1967, the 1925 paving was replaced with brick paving set on a sand bed over a reinforced concrete base (Batcheler 1989:22). It was this latter pavement which was encountered during the 1996 excavation of the new HVAC utility trench.

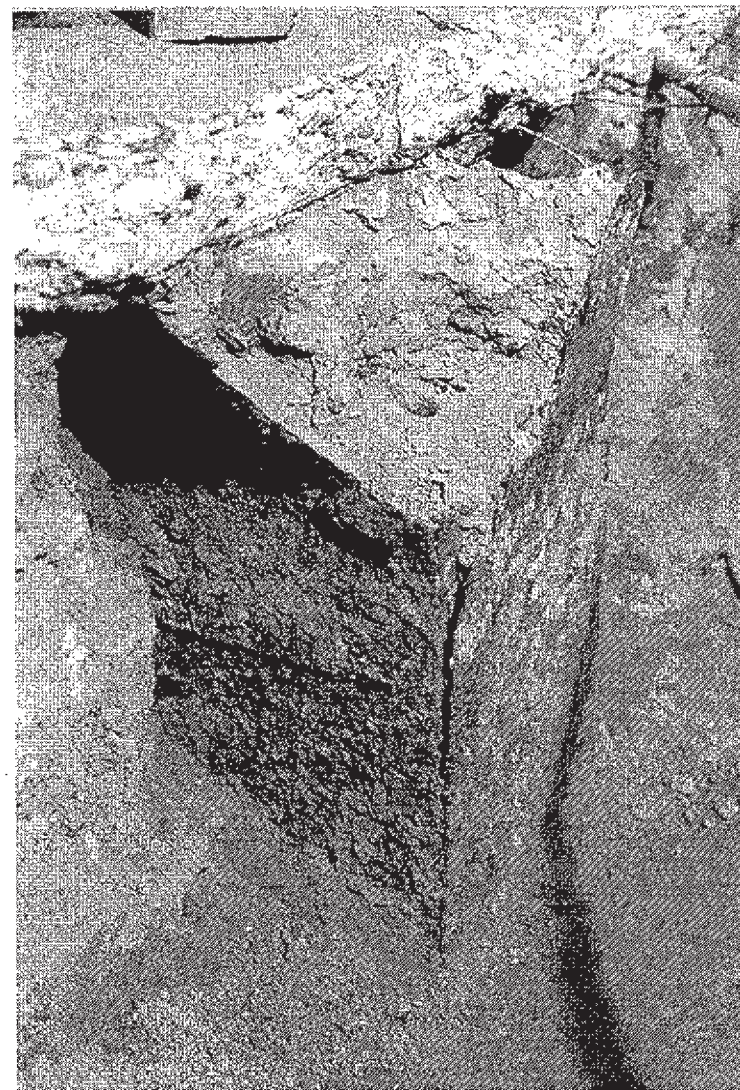
Figure 11. Detail of the truncated end of the Feature 1 metal chute, facing northwest.

The top of the truncated metal chute extended to the bottom of the 1967 reinforced concrete base and was—at that level—surrounded by a shallow basin-shaped pit. The top sides of the truncated chute had been bent to

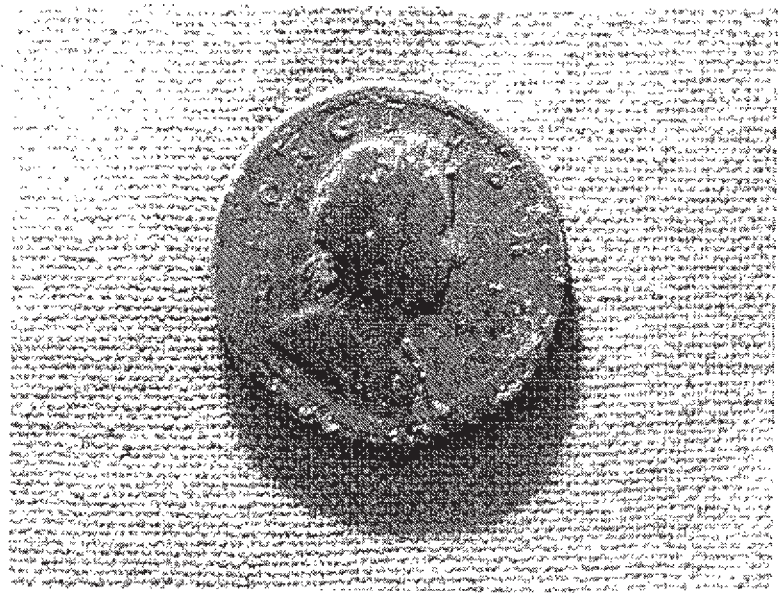
Figure 15. King George I halfpenny (obverse).

A King George I copper halfpenny (Figures 15 and 16) was found near the top of Stratum C (the historic topsoil), just south of the Central Hall builder's trench. On the coin (INDE 52876), the profile of King George faces to the right, and the text above the profile reads, "GEORGIVS REX." The reverse side depicts a crowned, seated lady facing to the left. She has a staff in her left hand and a torch (?) in her right hand. Around the edge of the reverse surrounding the figure is the label, "BRITANNIA." Below the figure is the date, "1720." King George I reigned from 1714 to 1727. A similar coin is illustrated in Ivor Noël Hume's (1978:157, Figure 59, Item 11) book, *A Guide to Artifacts of Colonial America*. A halfpenny was equivalent to 2 farthings, 1/24 of a shilling, or 1/480 of a pound.

To preclude future deterioration, the copper halfpenny was treated and stabilized by conservator, Katherine Singley. To summarize her condition report, the coin was "partially covered by an encrustation of mortar and brick dust. Patches of crystalline carbonate corrosion under the encrustation are probably due to contact with the alkaline mortar. Otherwise the coin is covered with a compact and coherent dark green patina." During the conservation treatment, the dirt and encrustation were removed by mechanical cleaning. Then, a 10% to 15% solution of formic acid was applied locally for final cleaning. The compact green patina was retained, and the coin was treated under vacuum with 3% benzotriazole in ethanol. The piece was dried and lacquered. The adhering mortar was retained as a separate sample and was returned along with the coin to the park.

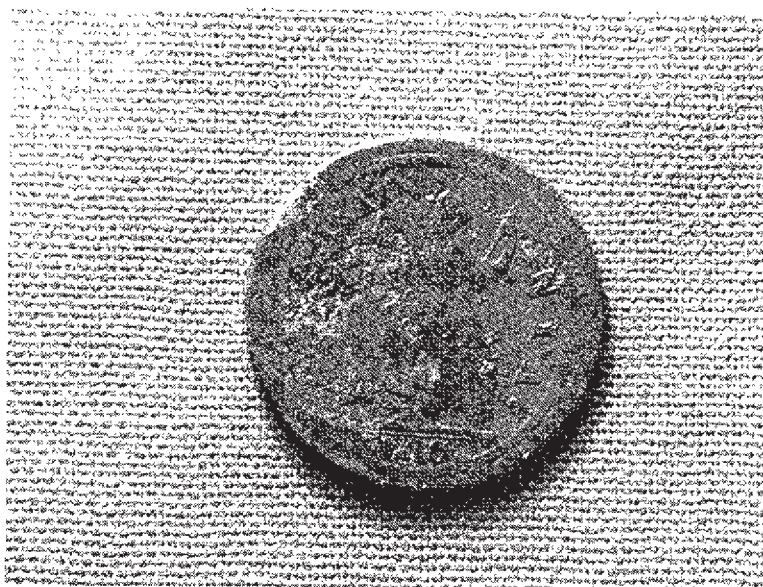
Figure 16. King George I halfpenny (reverse).
