RESTORATION OF THE  
BISHOP WHITE HOUSE

Independence National Historical Park  
Architectural Data Section

PART II, SUPPLEMENT I, ILLUSTRATIONS

Prepared by  
Architects Norman M. Souder and George L. Wrenn  
March 1961

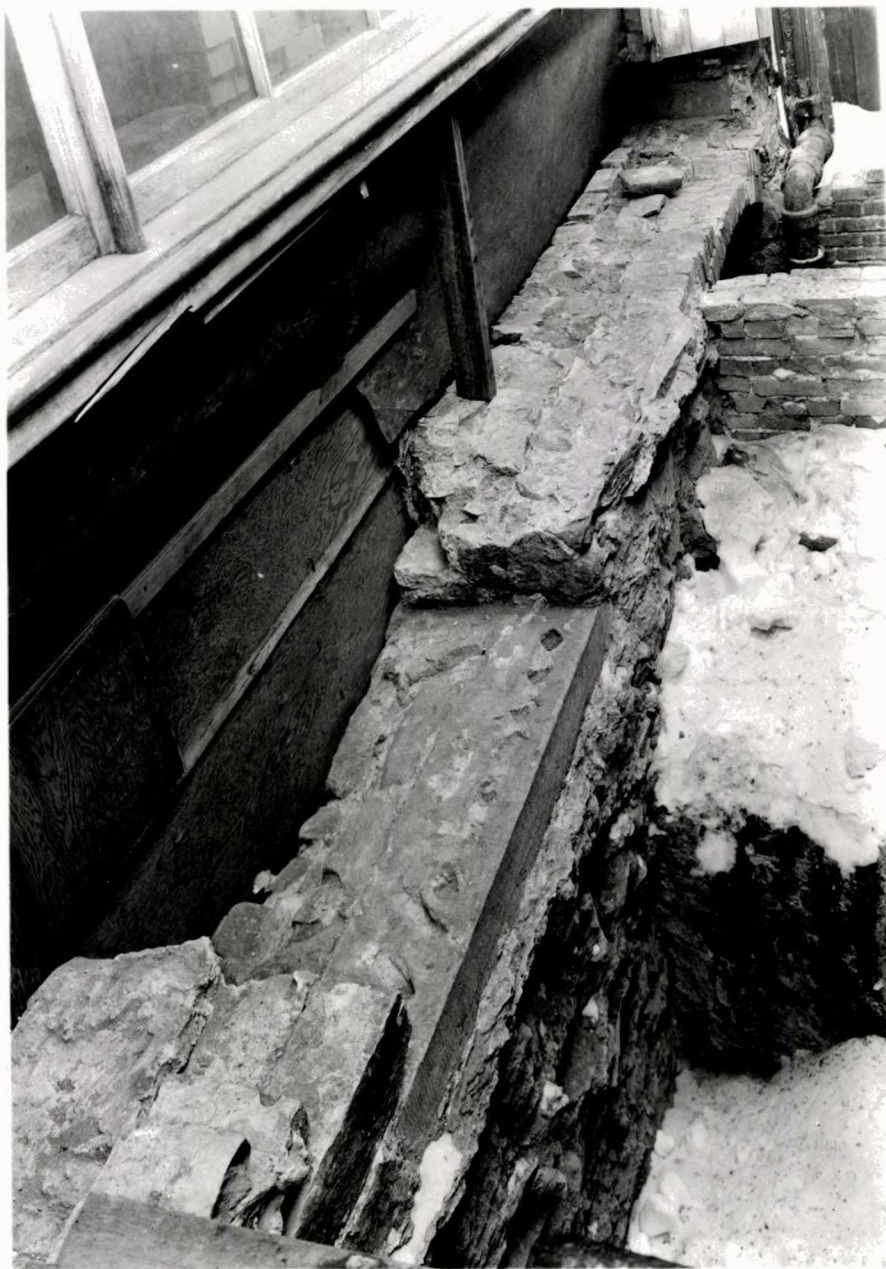
ILLUSTRATION NO. 5

Front wall: remains after removal of Walnut Street sidewalk. Original stone window sill remaining in the front of the building at the basement level. The holes in the sill formerly held iron bars. The rough area in the stonework below the sill indicates the area of the wall formerly below grade (masonry laid up from inside of basement excavation). At the top right can be seen the base of the basement entrance bulkhead. See page iv.

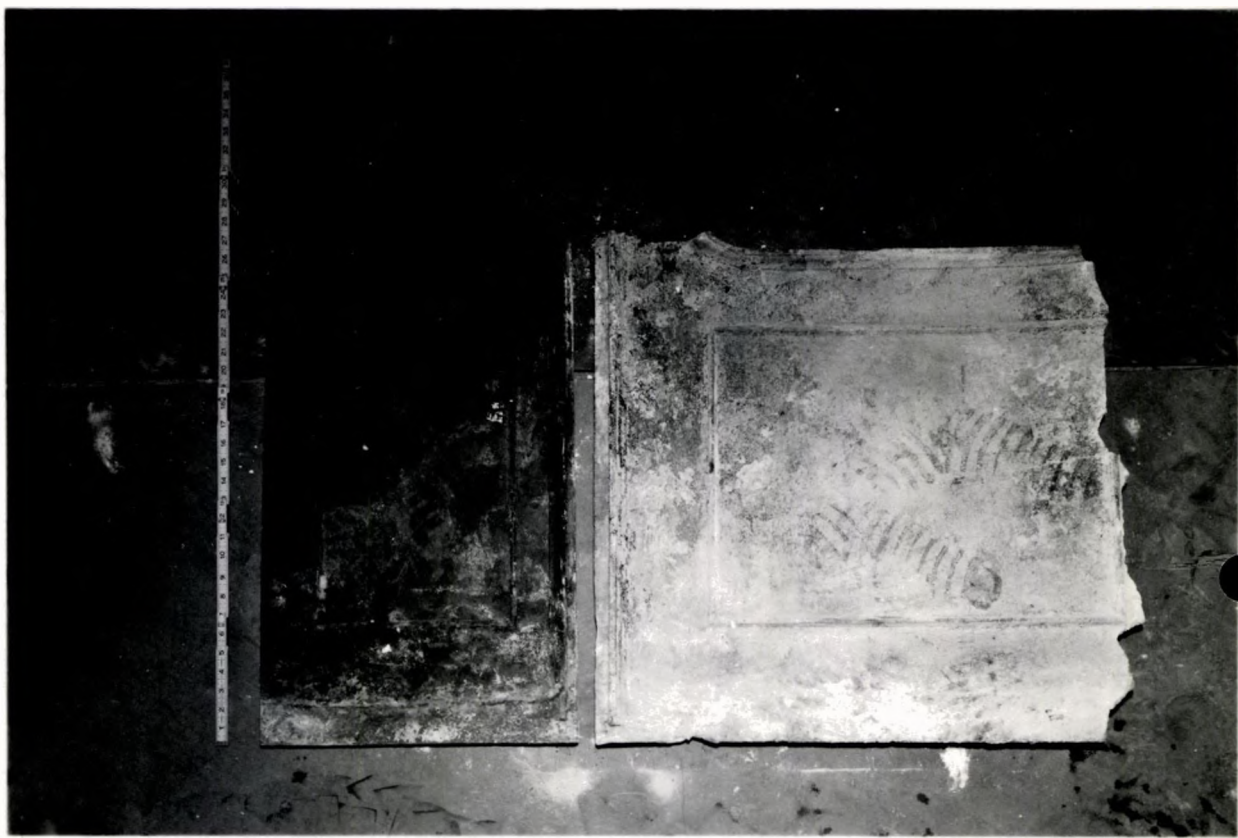
ILLUSTRATION NO. 4

Back and jamb plates removed from the base of the fireplace at the second floor level. See Illustration No. 3 for location of plates prior to removal. These plates are very similar to those found in Old City Hall which date from 1791. See page 111.

When the modern ceiling of the first floor was removed we found back and jamb plates from a fireplace reused as supporting members to the southern-most chimney at the second floor level. These are not yet accessible for examination. The fireplace and

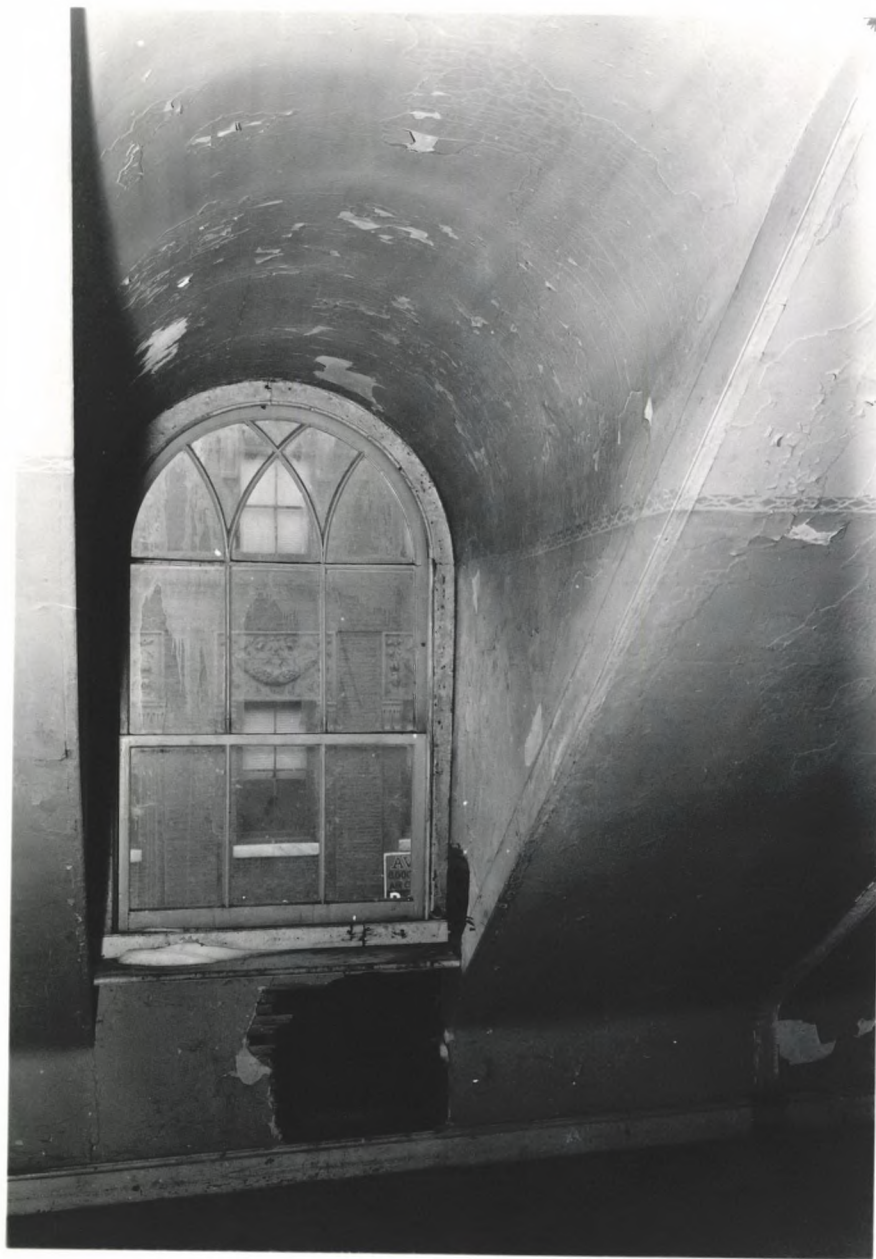
ILLUSTRATION NO. 14

Dormer consoles shown in Articles of the  
Carpenters Company... Philadelphia, 1786, unpagged,  
courtesy of the Carpenters' Company Library. See  
page 4.

Philadelphia dormer consoles exist at the Powel House, Cliveden, and Mount Pleasant. Whether any here or elsewhere are original is questionable as their position on the roof is one that encourages rot. They may, however, be considered typical of Philadelphia dormer consoles.

The illustration from the Articles of the Carpenters' Company, 1786, while contemporary with the building of the Bishop White House, does not conform in profile to those of the 1859 photograph of the house. A console more closely resembling the Bishop's was on the first United States Mint, built in 1792 and now destroyed, Seventh Street north of Market Street near Sugar Alley, the first building ever owned by the U.S. Government. Two good photographs of this are enclosed. It is considered imperative to conform to the shape of those in the 1859 Sachse photograph of the Bishop White House, using an eighteenth century spirit and technique indigenous to this city.

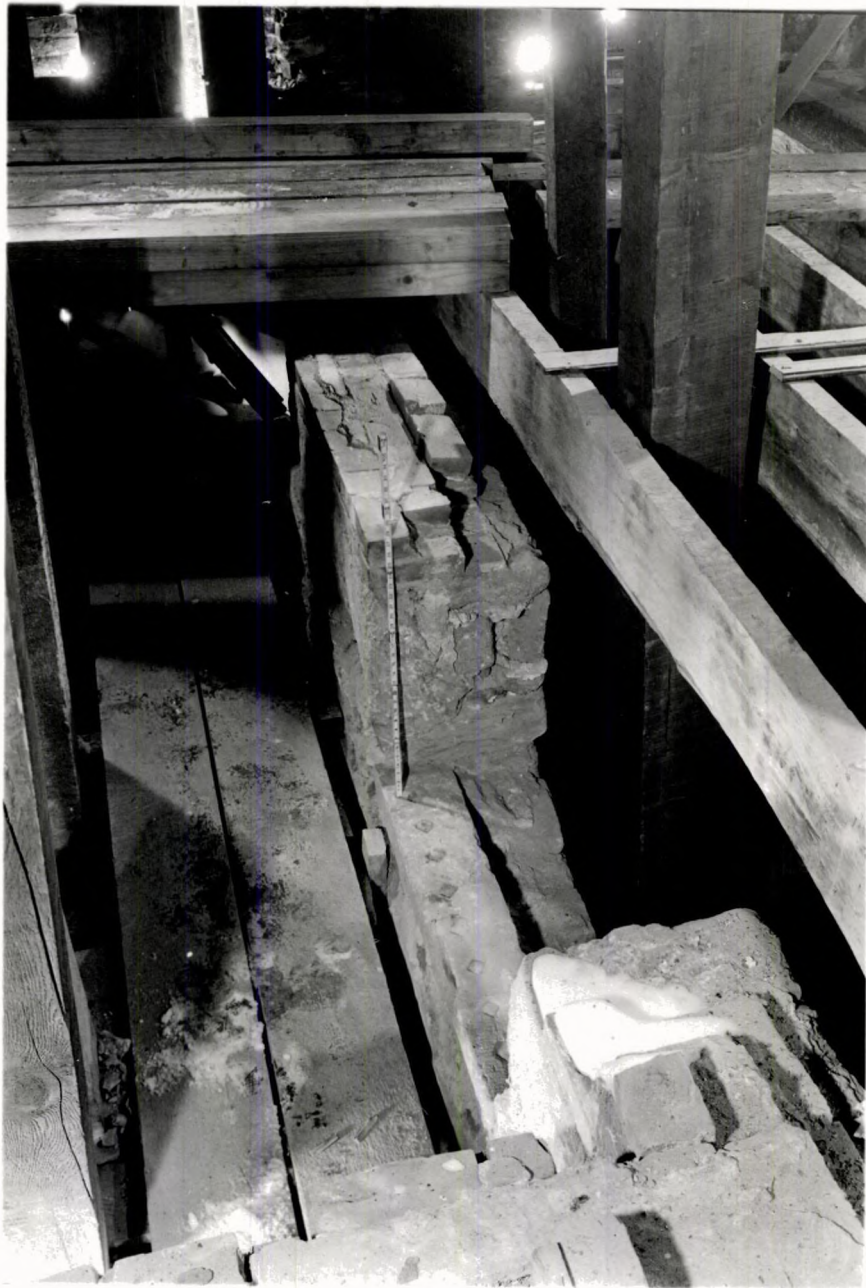
ILLUSTRATION NO. 18

The remains of the rear wall of the front building. Here, the two stone basement window sills are intact with holes for iron bars. The face of brick nearest the rule marks the face of the exterior wall.

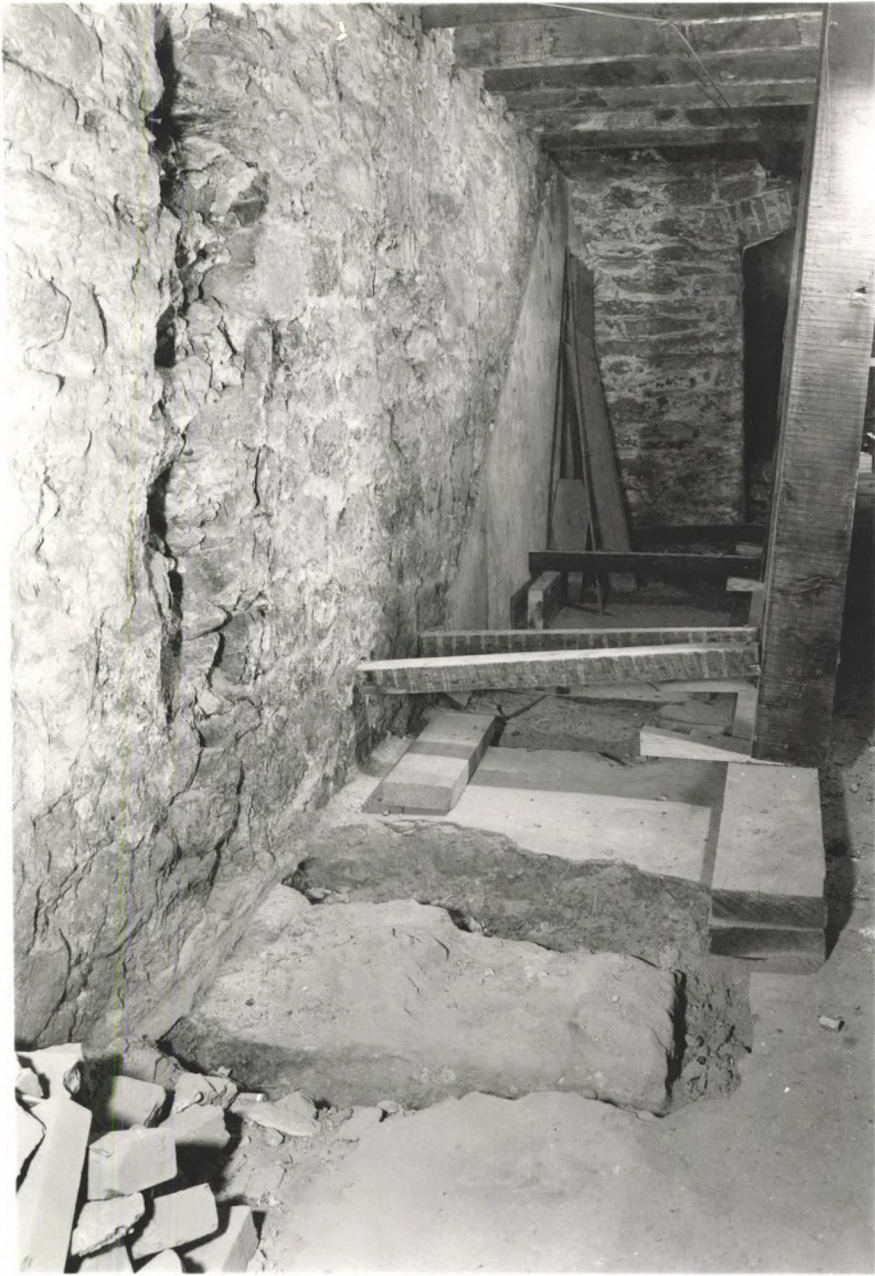
ILLUSTRATION NO. 17

The rough area in the wall at the left and the footings below the present basement floor level indicate the location of the wall between the front section of the house and the piazza--a continuation of the rear wall of the house.

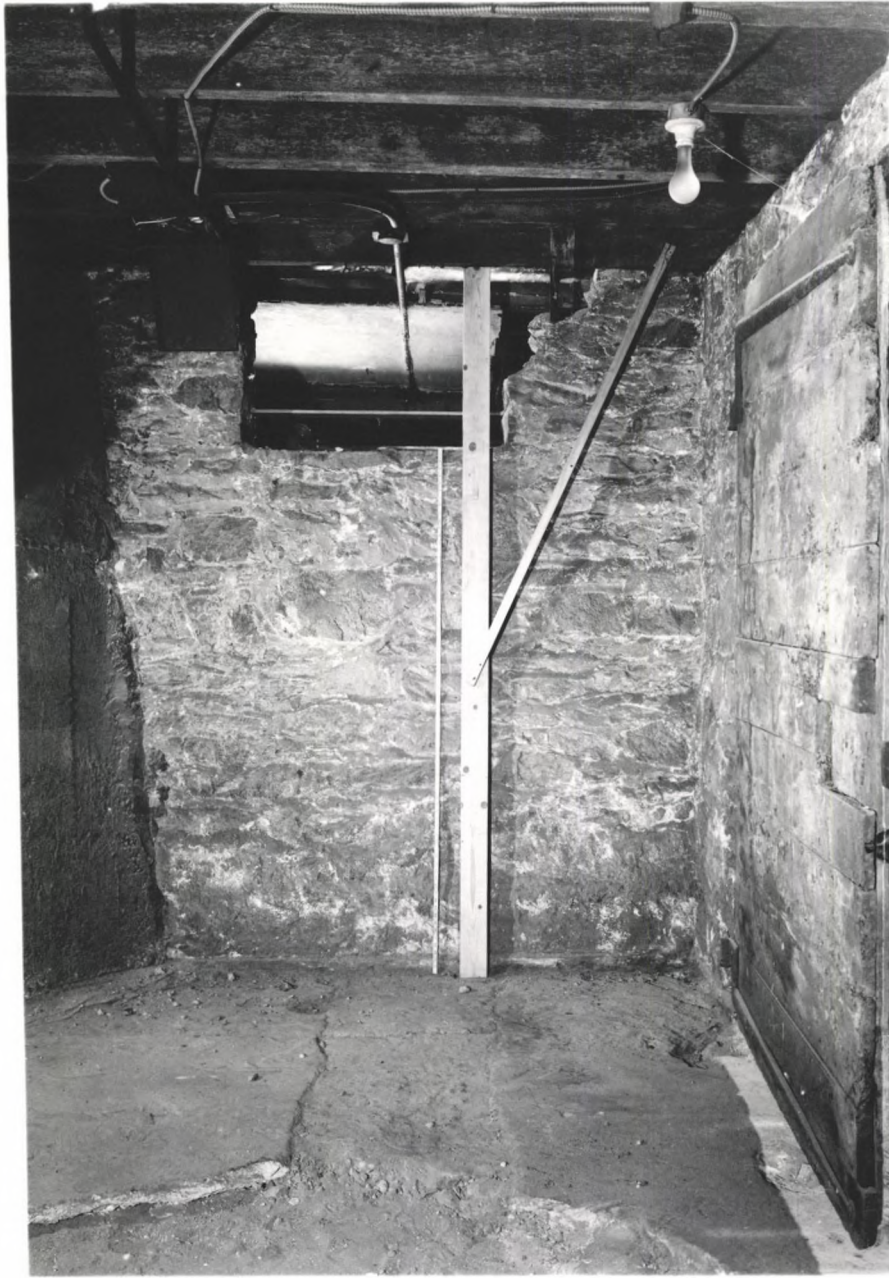
ILLUSTRATION NO. 16

Basement interior window opening. One horizontal bar is still in place. A vertical 2" x 4" was placed in the photograph to indicate the point on the floor above where the masonry jamb to a double door between parlors would occur. See page 6.

This is good reasoning and probably quite correct; however, it would be well to investigate the double doors at 239 Pine Street (1795) and the Wharton House (prior to 1796).

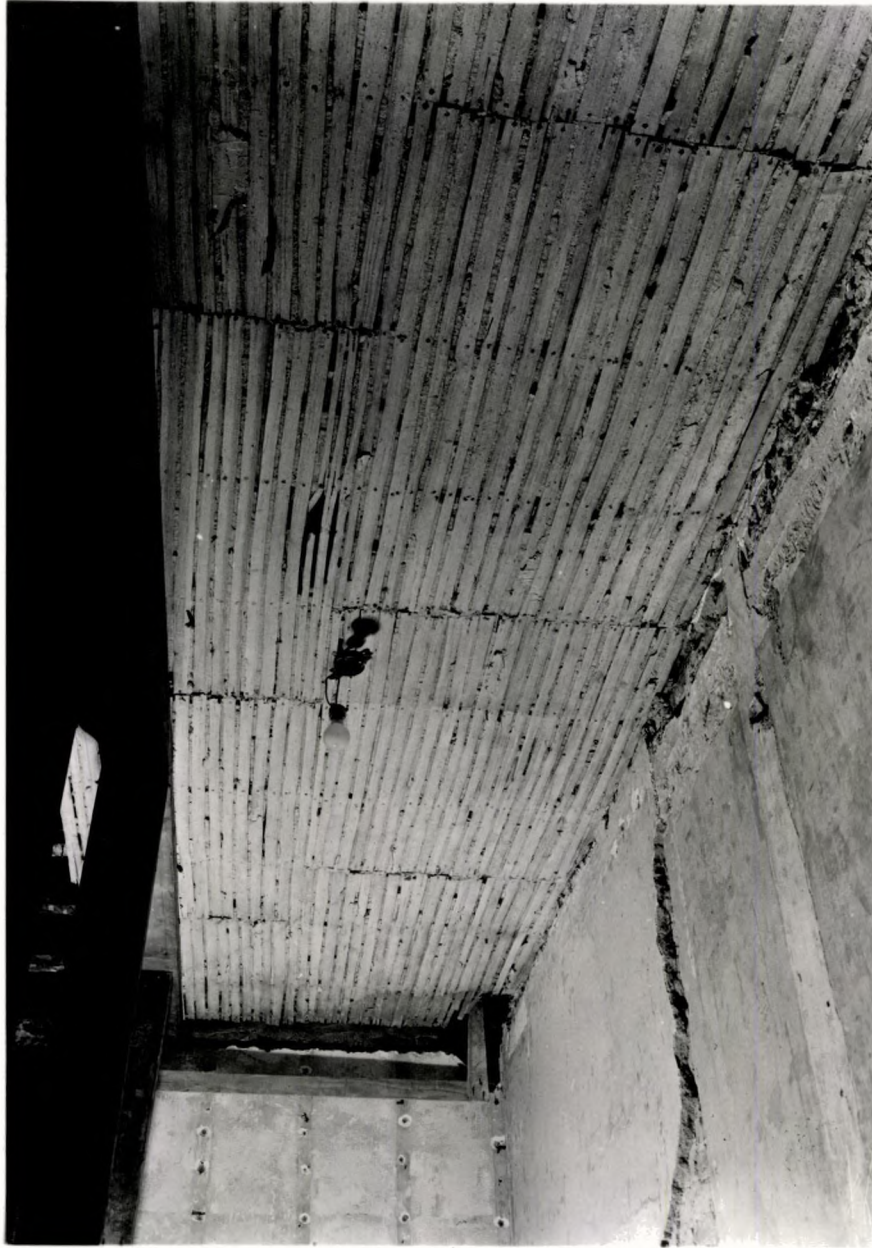
ILLUSTRATION NO. 15

The ceiling of the first floor entrance hall. The split lath is original and shows no break; indicating the absence of a vestibule when the house was built. A later vestibule was added-- shown by the light line across the lath to the right of the light bulb. See page 5.

Probably the vestibule shown in the 1858 insurance survey was in the house during the Bishop's occupancy but not at the building of the house. If the plaster on the ceiling was original, it is a pity so much of it had to be removed for purposes of investigation. Would not a narrow longitudinal strip have sufficed?
