Historic Structures Report  
on  
Fling House  
319-321 Walnut Street  
Independence National Historical Park

Independence National Historical Park  
Philadelphia, Pennsylvania

June 1960

Historic Structures Report, Part 1  
Fling House (319-321 Walnut St.)  
Bldg. No. B61

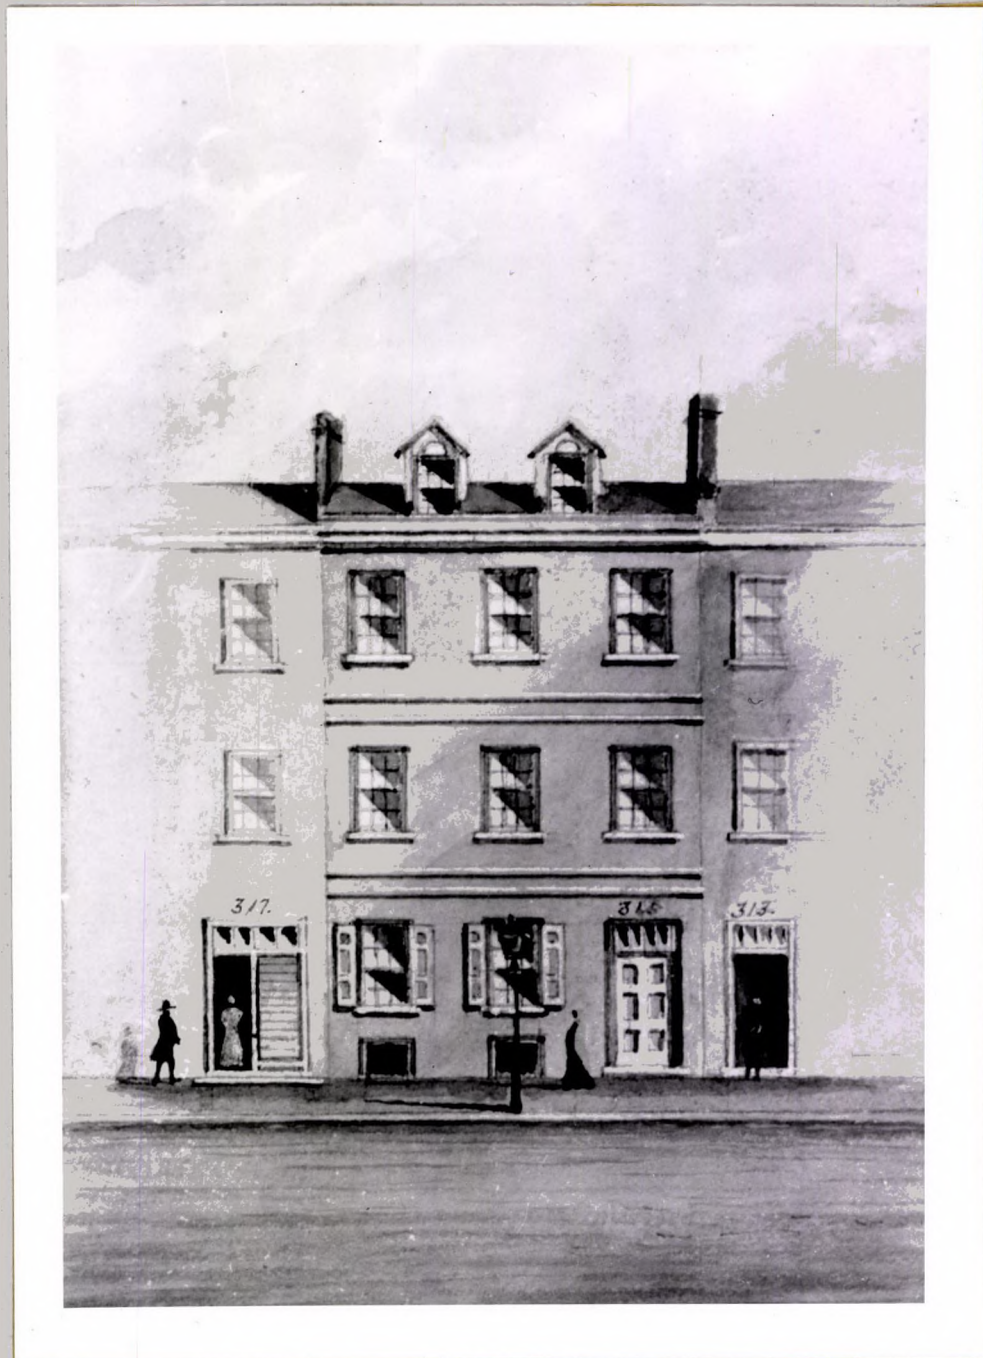
The McIlvaine and Fling Houses (315 & 317 Walnut Street), c. 1845-1850, Kennedy Collection, Historical Society of Pennsylvania. Note double doors to entry and character of windows on second and third floors of the latter.

The Fling House (Illustration No. 1), Nos. 319-321 Walnut Street, is a nineteenth century three and one half story brick building. It is located on the north side of Walnut Street between Third and Fourth Streets, the McIlvaine House, a vintage federal period residence of 1793, on one side and the Kid Houses, two residences of the 1810-1812 period, on the other. The Fling House is situated on a lot fronting 20 feet on Walnut Street and extending in depth 108 feet to Harmony Court.

By 1845 the Fling and McIlvaine Houses had been joined as one structure. The entry way to the Fling House (on the east) served the combined structures (see Illustration No. 1). The interior passageway and staircase, also on the east side of the Fling House, separated the two interiors. Doorways were opened up for each of the three stories and garret through the west wall of the McIlvaine House.

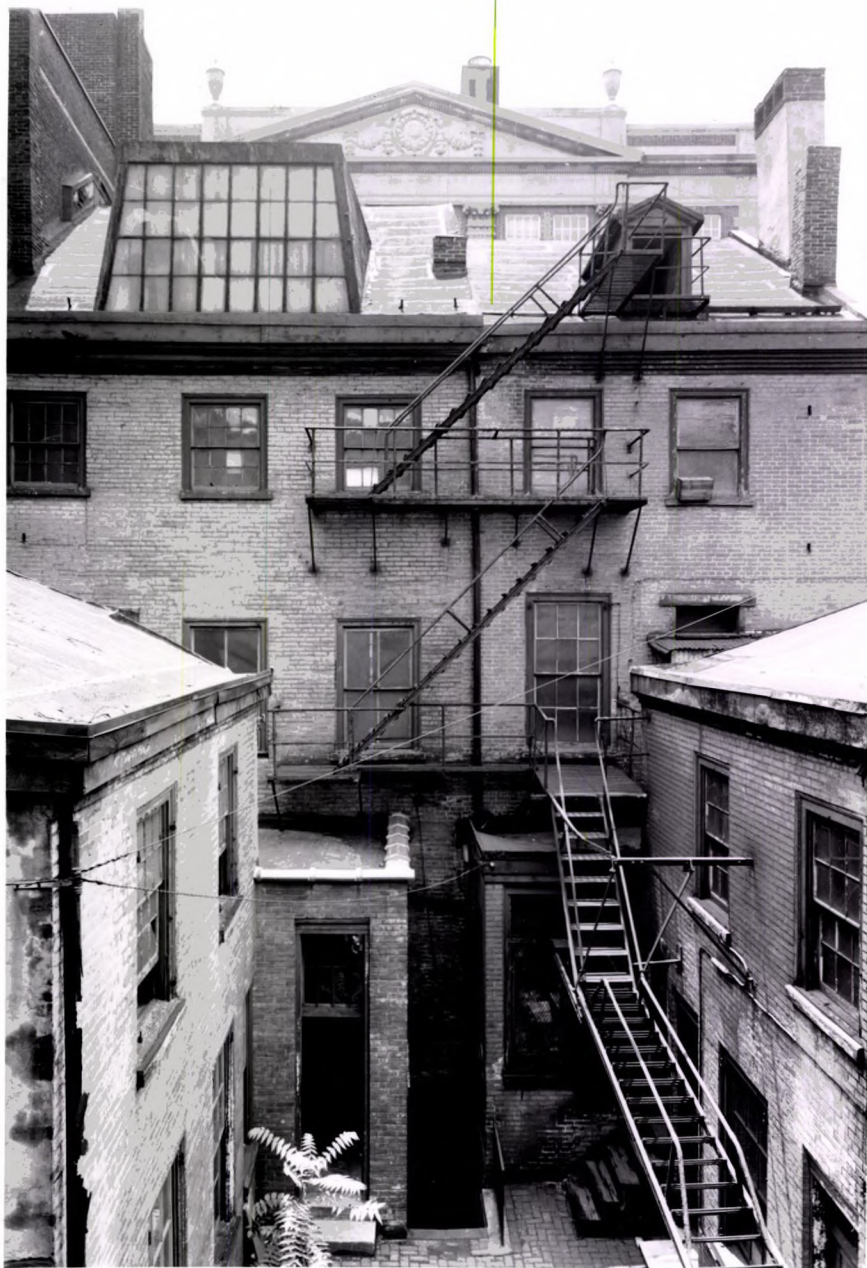
View of the rear of the McIlvaine and Fling Houses, taken in 1952. Rear building of Fling House can be seen to the right. This structure was removed in September 1959. National Park Service photo.

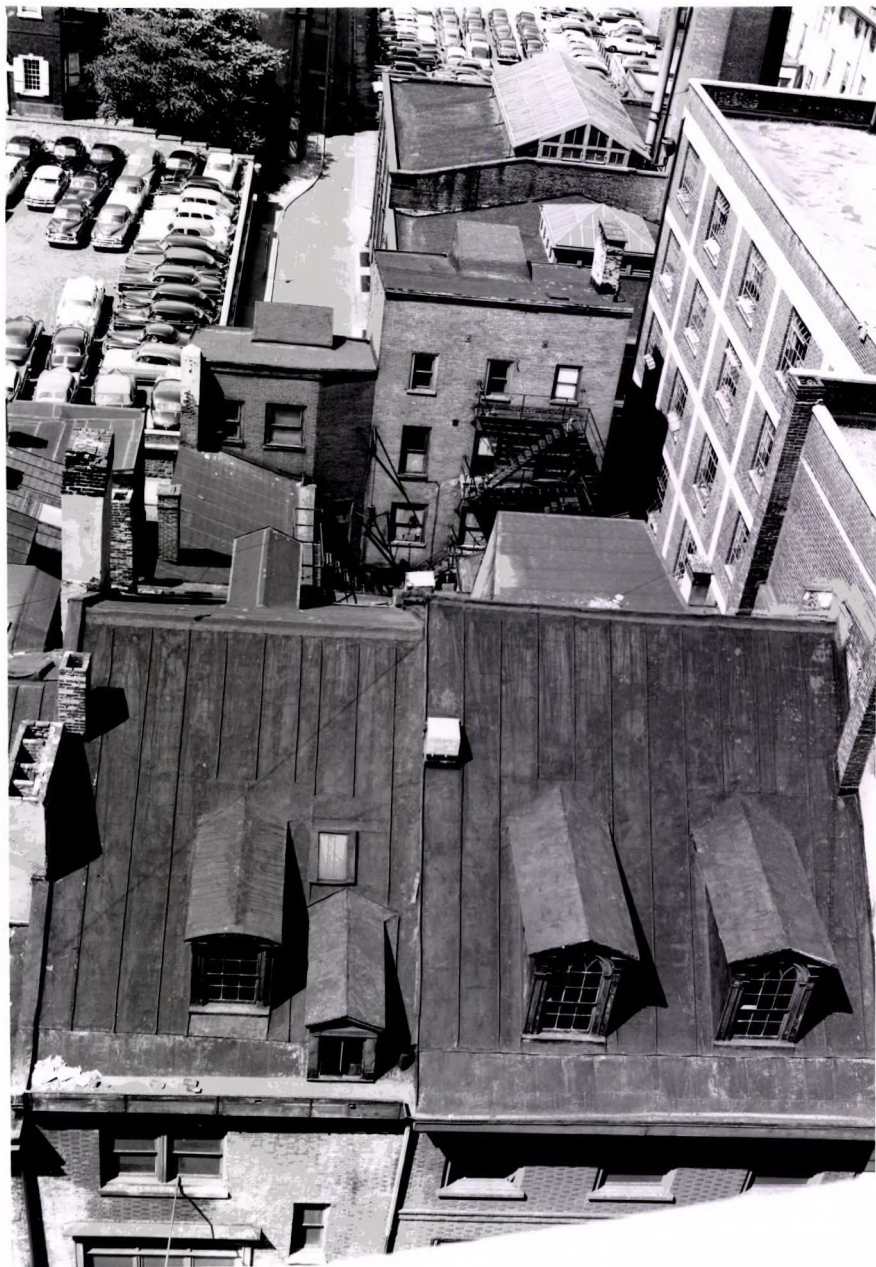
The McIlvaine and Fling Houses, looking north, in 1952. In left center is rear building of the Fling House. Further in the background are factory structures erected by Fling to house his furniture operation. These buildings were taken down in September 1959. National Park Service photo.

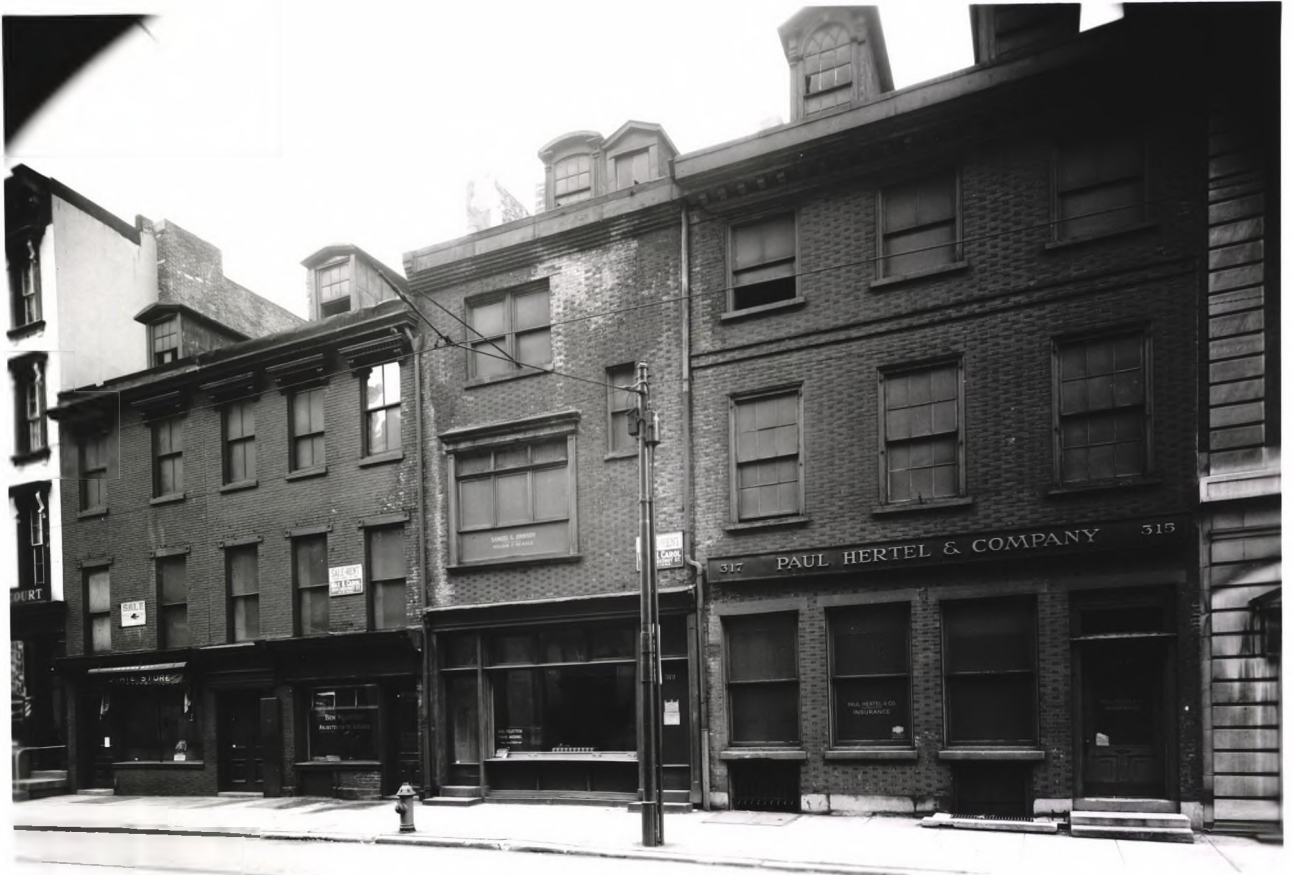
Chapter II  
Illustration No. 4

View of Walnut Street buildings taken in 1951.  
The Fling House is located in the center. Note  
difference in facade as shown in Illustration  
No. 1. National Park Service photo.

No evidence has been uncovered to indicate further alteration of the Fling House interior since 1861. However, certain changes were made to the facade. These include the installation of the plate glass store window on the lower story, the large second floor window, the substitution of a smaller window between the second and third stories for the larger windows on each floor, and addition of a dormer and doorway on the west side of the structure (see Illustrations Nos. 1 and 4).

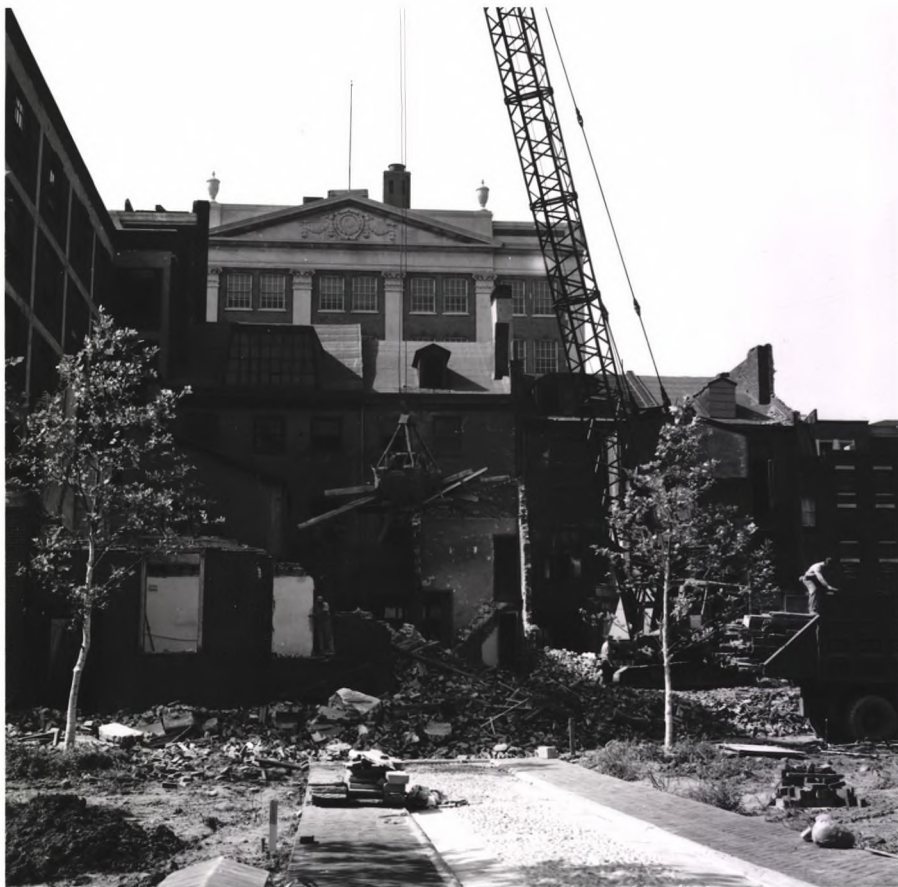
View taken during demolition of buildings  
to the rear of Fling House, September 1959,  
shows interior wall of lower stories before  
patching. National Park Service photo.

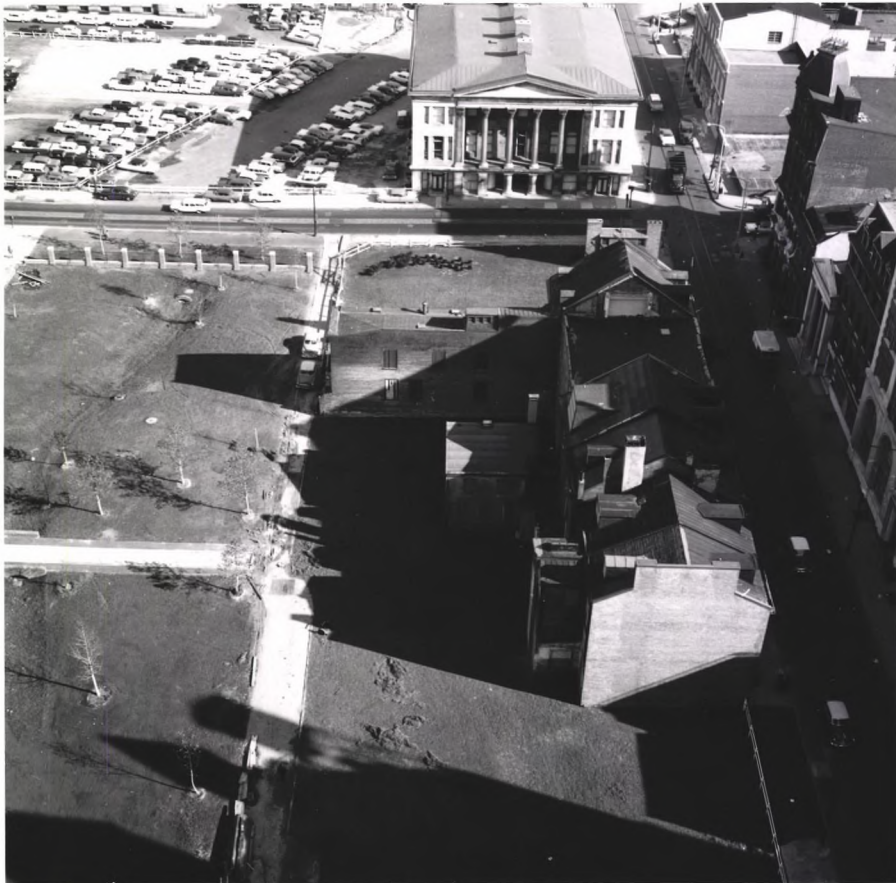
View of Walnut Street Houses, looking east,  
following demolition of back buildings and  
adjacent non-historic structures in Septem-  
ber 1959. National Park Service photo.
