HISTORIC STRUCTURES REPORT

BENJAMIN FRANKLIN TENANT HOUSE

322 Market Street

Independence National Historical Park

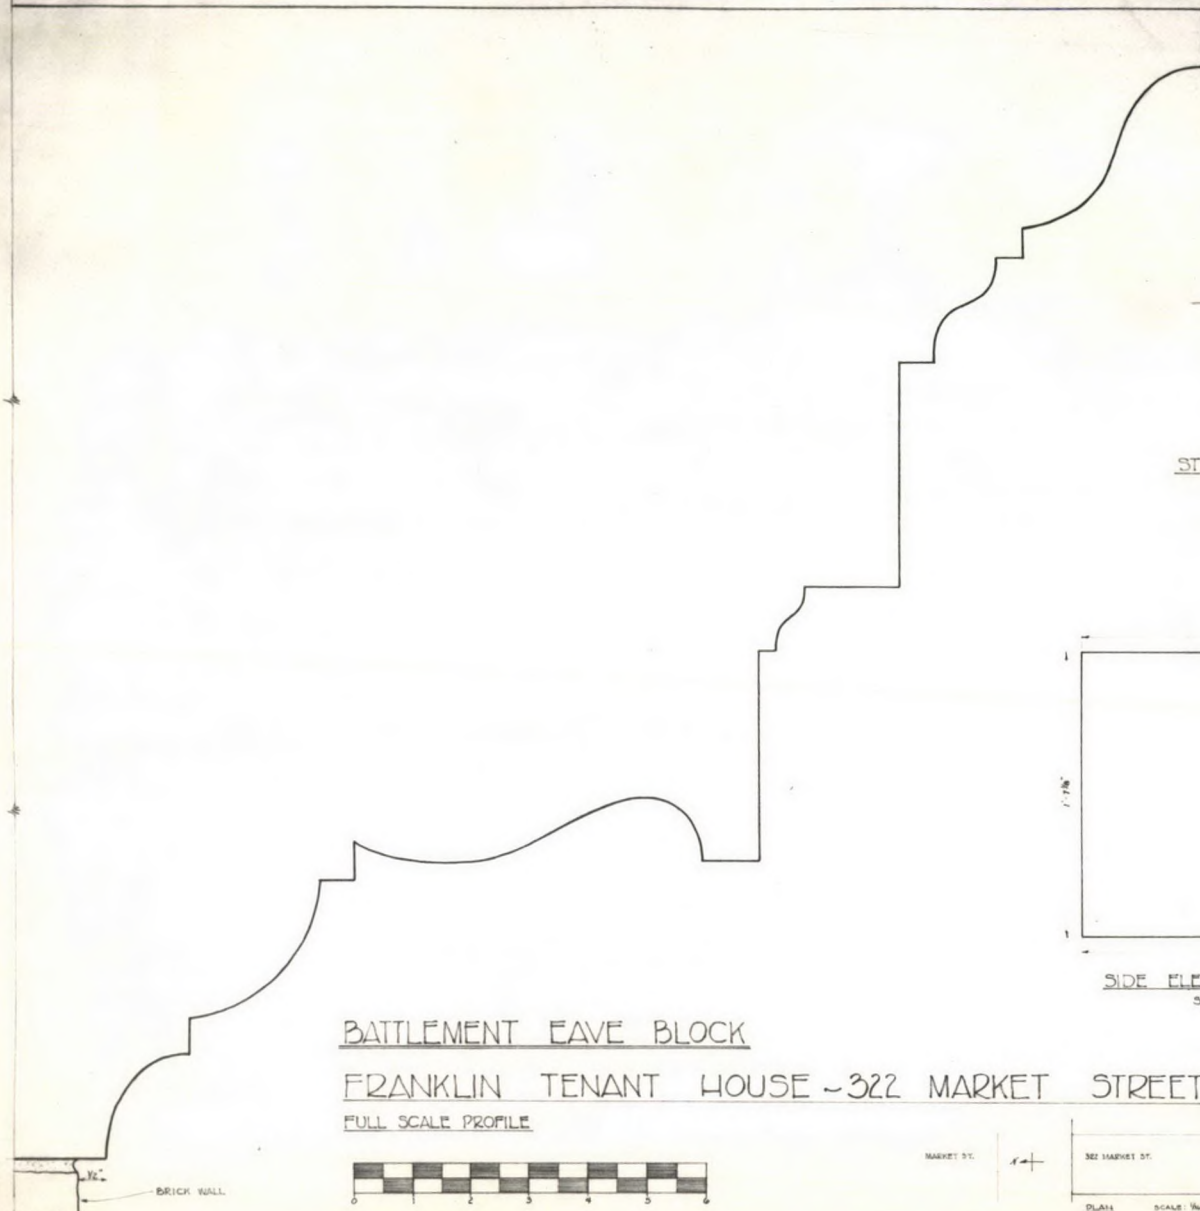
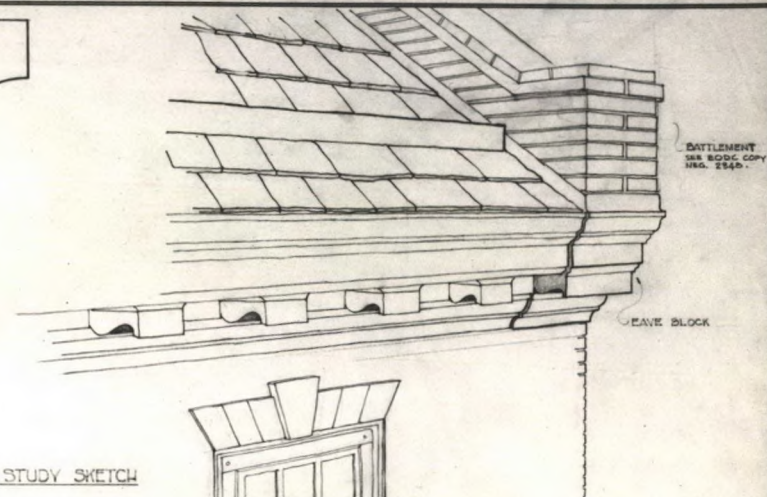
# BATTELEMENT EAVE BLOCK

FRANKLIN TENANT HOUSE - 322 MARKET STREET

FULL SCALE PROFILE

these original battlements are to be seen today. In addition we are fortunate to have found in place what is called "a battlement eave block"<sup>11</sup> (see Illustration No. 11 and Drawing No. NHP-IND 3309, sheets 6 and 7). By its corbeling action the stone block supported the extension of the battlement above the cornice. At the same time it separated the wood cornice of Franklin's house from that of the neighboring houses.

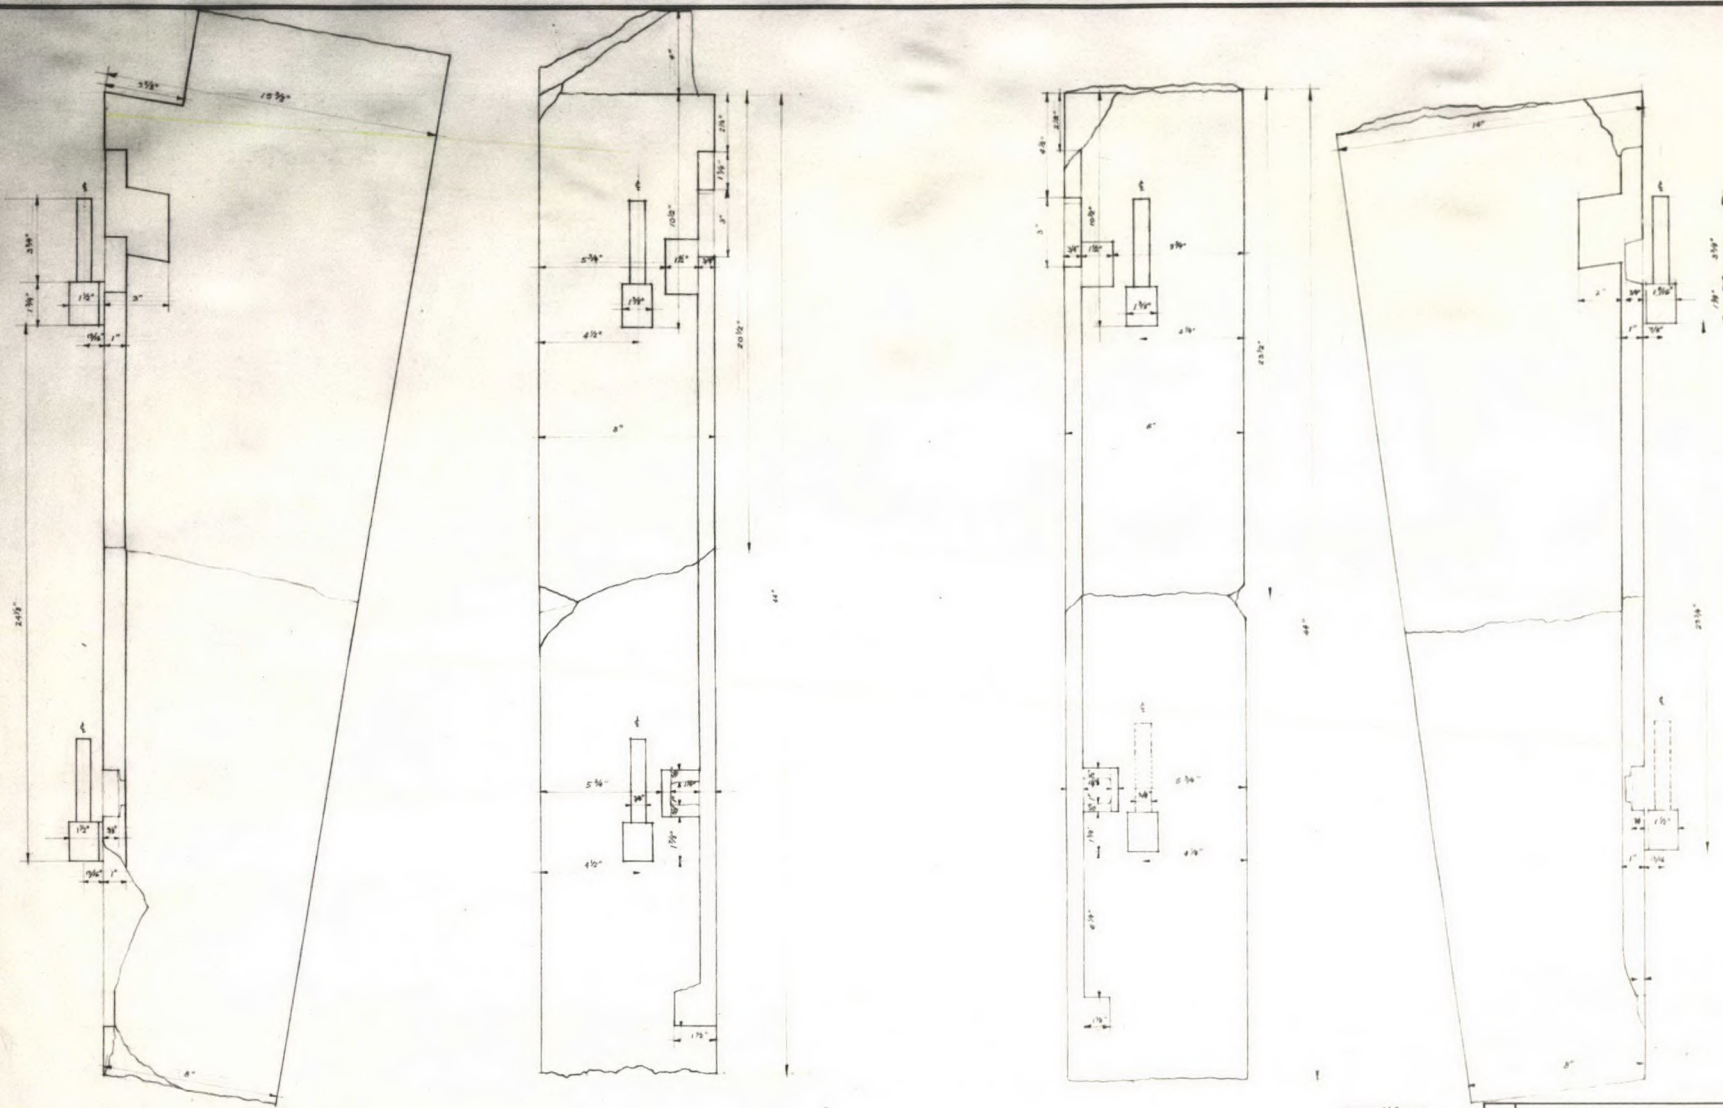
DETAIL ELEVATIONS OF STONE CHEEKS FOUND IN FILL OF BULKHEAD DATED 1788  
 STONE CHEEKS ARE POSSIBLY 18<sup>TH</sup> CENTURY

In the front of the house at the northwest corner a bulkhead door led down to the cellar. The sloping walls below grade and jambs of the original bulkhead remain. On the east jamb the slope of the original ladder is marked by remaining plaster (see Drawing No. NHP-IND 3309, sheet 6). This bulkhead when we began work was closed up (see Illustration Nos. 3, 4 and 5). In the fill we found two sets of stone monolith bulkhead cheeks (see Drawing No. NHP-IND 3309, sheets 8, 9 and 10). The

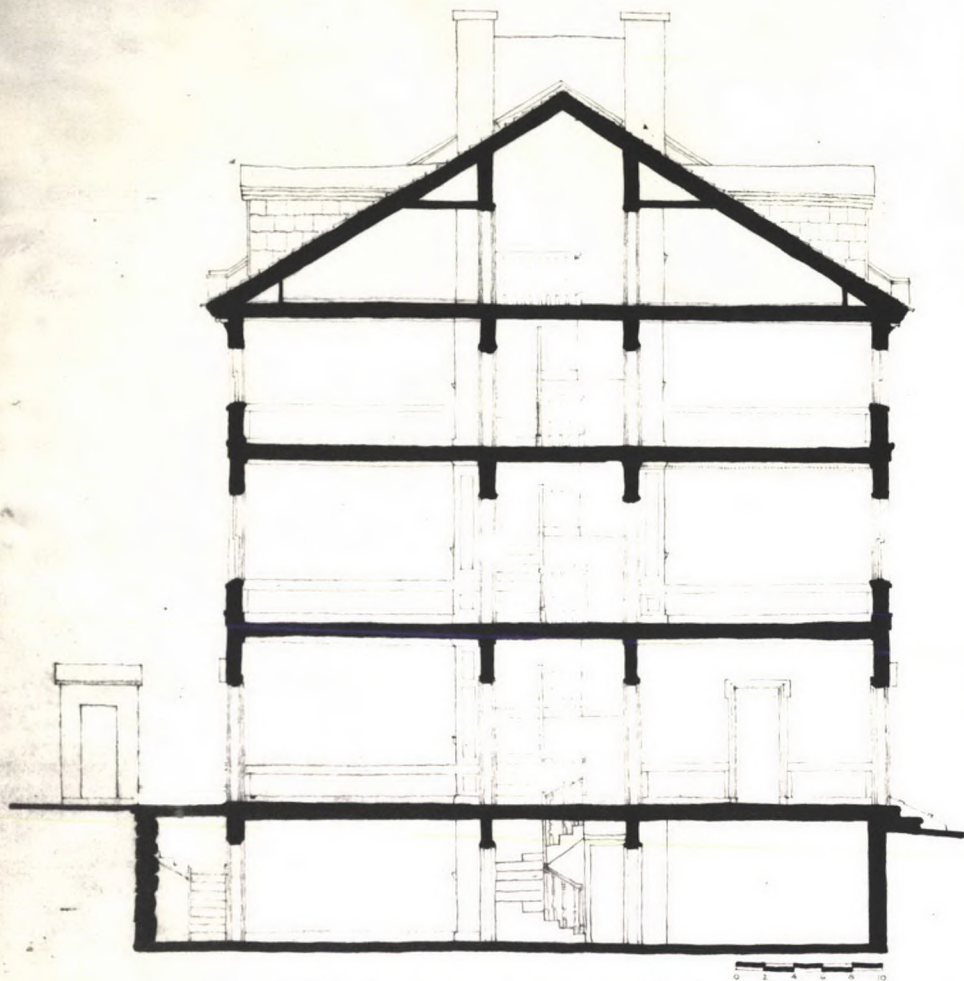
SECTION ELEVATION "B-B"  
RESTORATION STUDY OF 322 MARKET STREET  
BENJAMIN FRANKLIN TENANT HOUSE

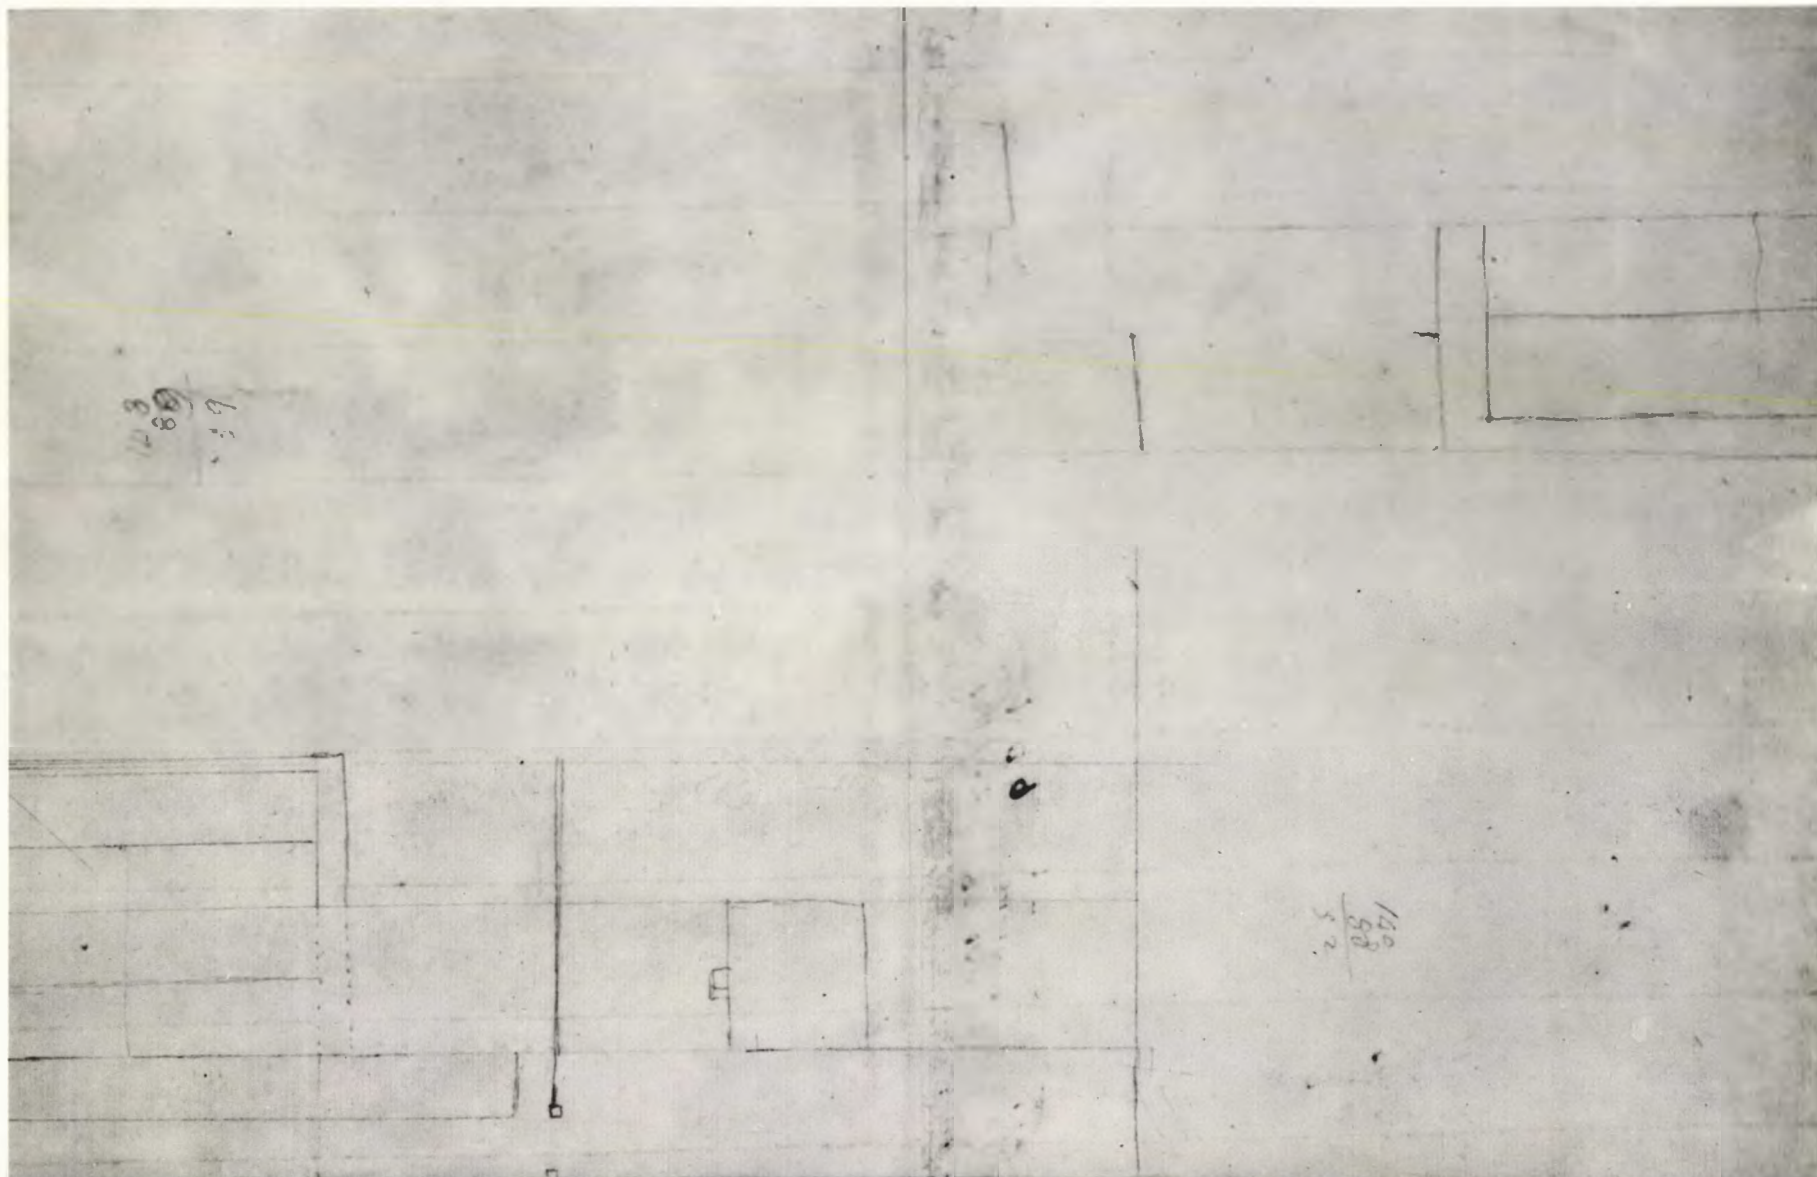
Note Franklin's square house facing a wall with two  
piers at the south end of the entrance drive from  
Market Street. This entrance in 1787 was removed  
and on this lot Franklin built the 322 Market Street  
Tenant House.

N  $\leftarrow$  JOHN READ PLAN OF FRANKLIN COURT PRE-1786, FRANKLIN PAPERS, AMERICAN PHILOSOPHICAL SOCIETY

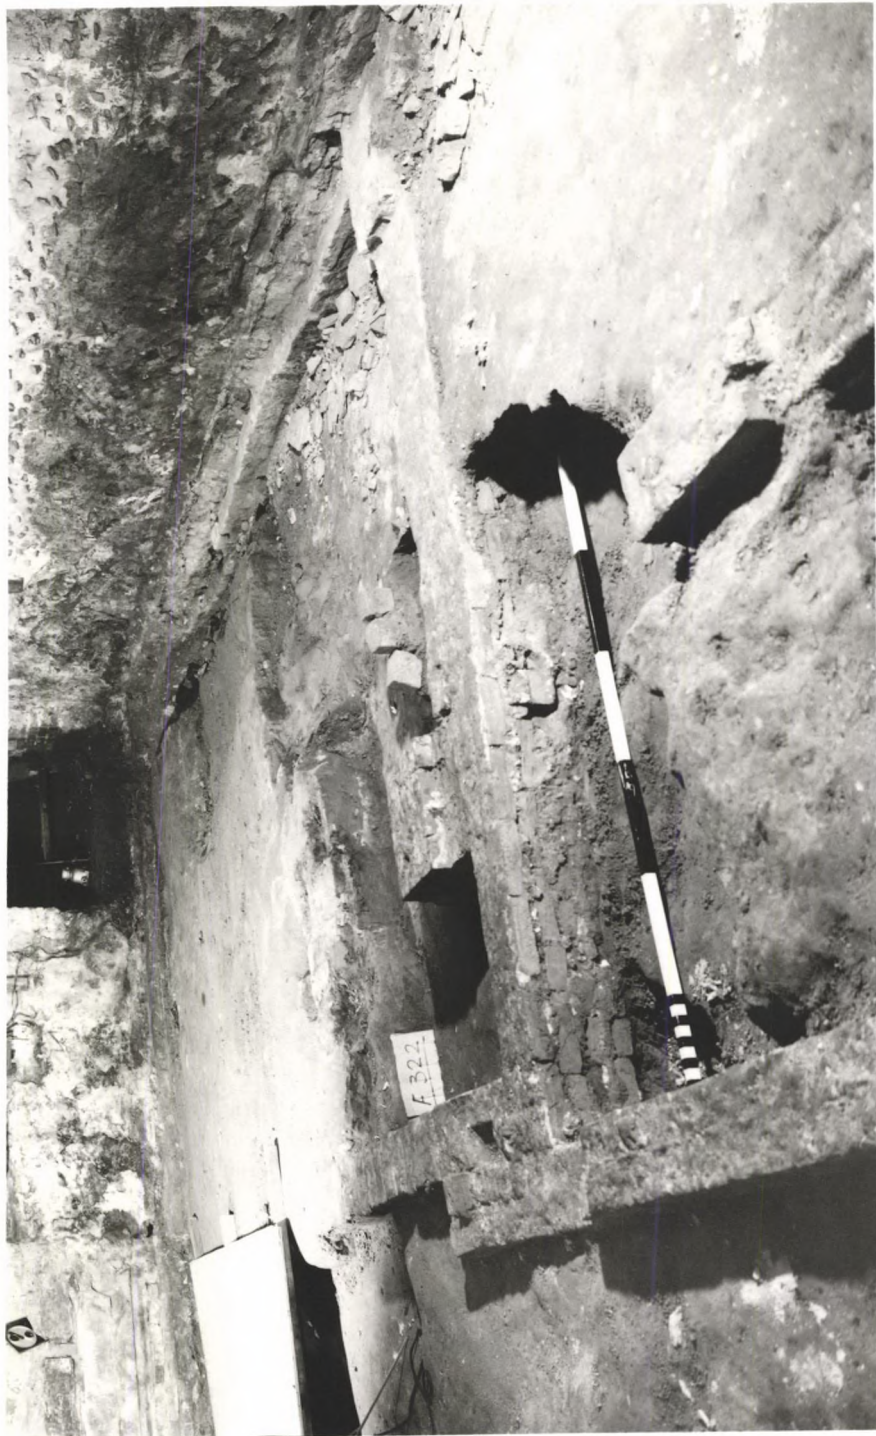
ILLUSTRATION NO. 2

322 Market Street, looking north into the area of the front cellar room. The brick foundations in the foreground are those of the wall between the north room and stairhall, as well as the north chimney piers.

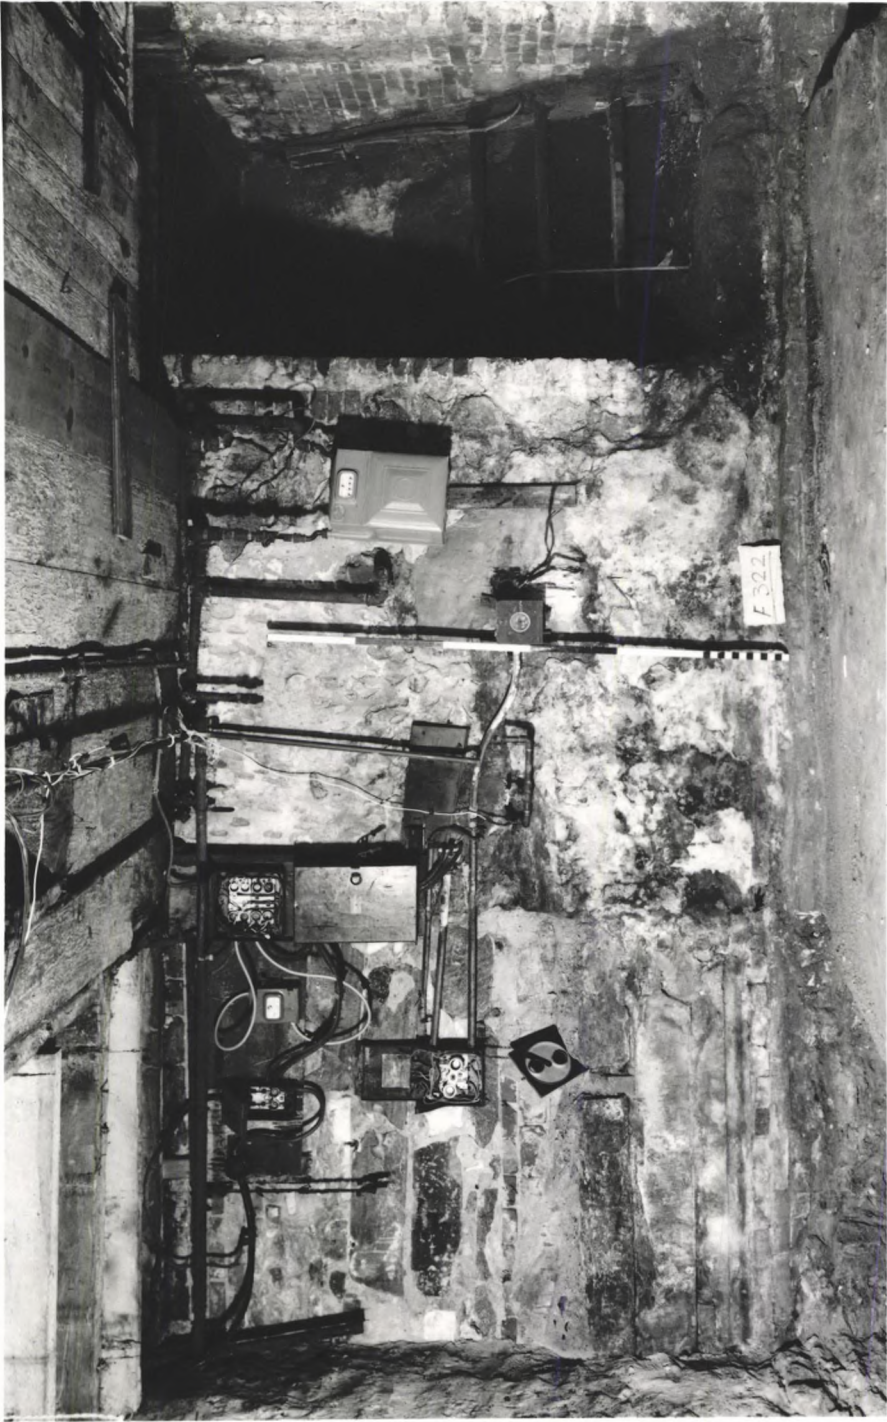
ILLUSTRATION NO. 3

Basement north wall of 322 Market Street  
before architectural investigation. Note the filled  
bulkhead at left, and the broken stonework where the  
bulkhead at right was cut through.

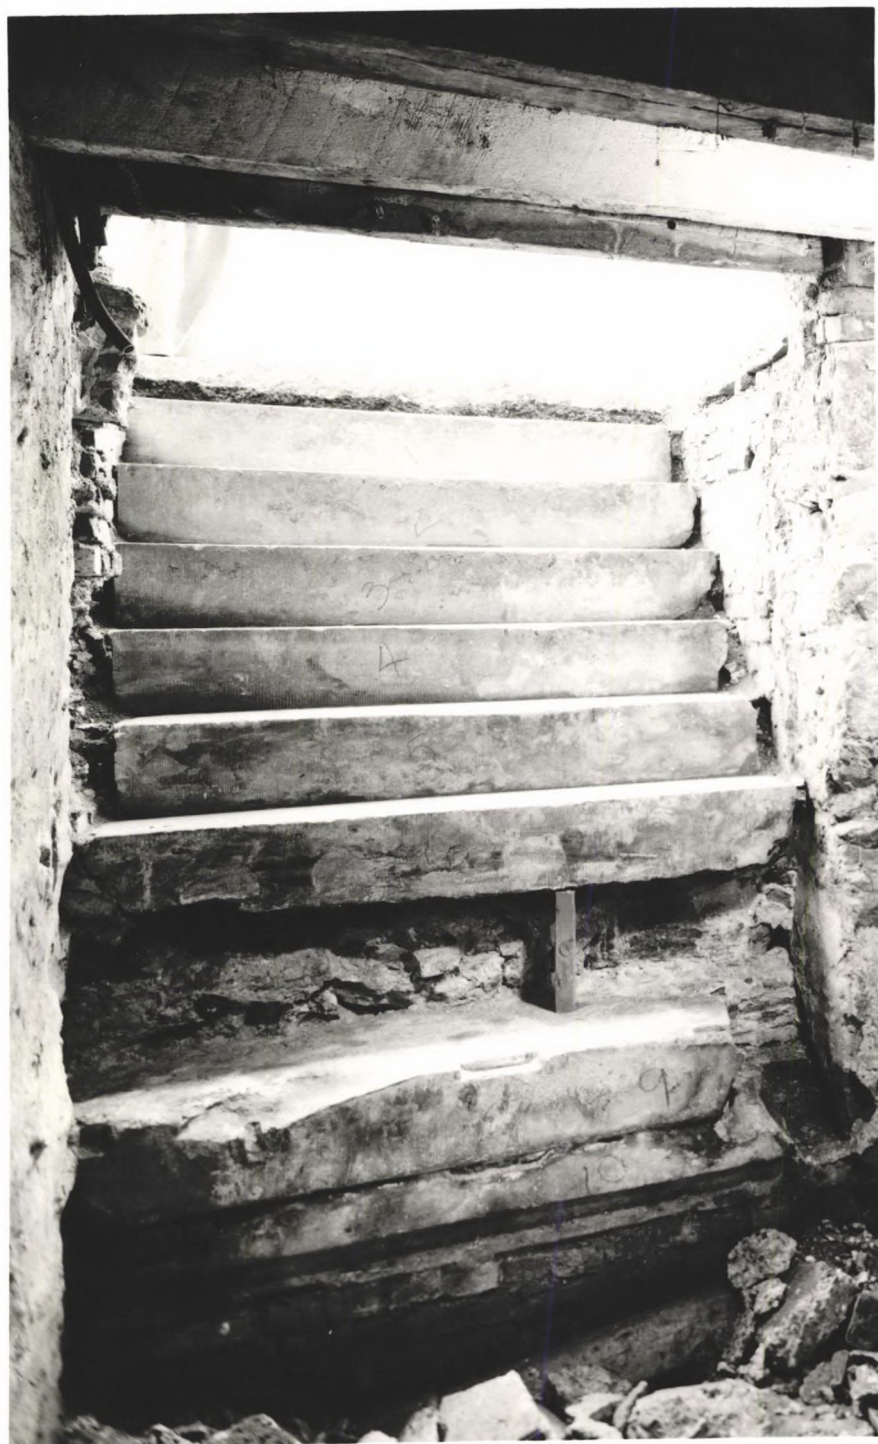
ILLUSTRATION NO. 4

322 Market Street partially excavated original bulkhead in the northwest corner. The stone steps shown were seated on rubble fill, obviously a later addition. Note that step number 9 is one of the original bulkhead cheeks.

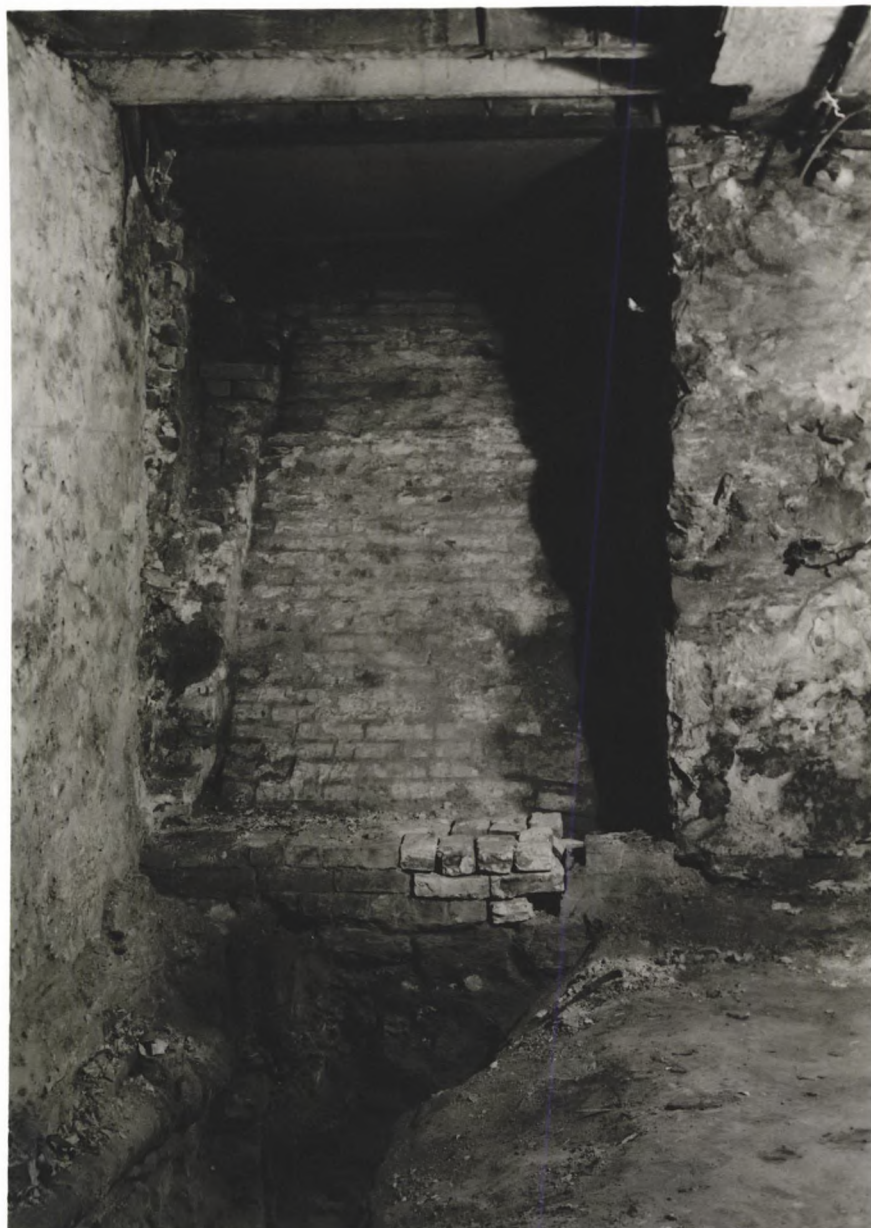
ILLUSTRATION NO. 5

322 Market Street original bulkhead completely uncovered. The brick jamb at left has been broken back, but the stone jamb at right is completely intact including a hand wrought anchor for a door frame. A heavy wood ladder rested against the brick slope for access to the street.

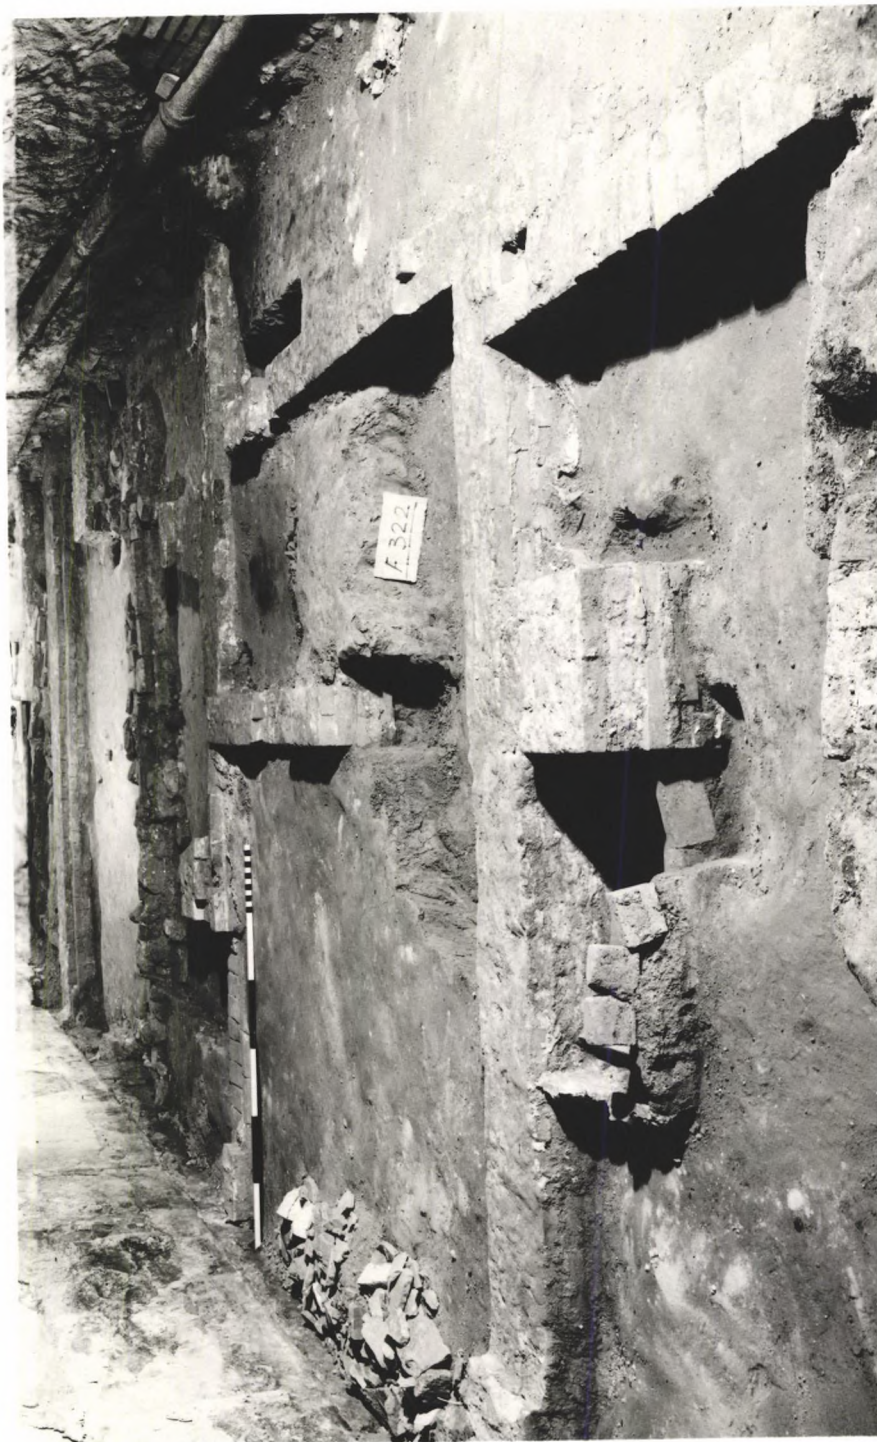
ILLUSTRATION NO. 6

322 Market Street looking south into the area of the cellar stairhall. In the foreground are the north room chimney piers and what may be to their left an ash hole backing up against the north stairhall wall. Beyond are two short north-south walls which may have been the footings for the stairway and closet partitions. Beyond the horizontal measure stick are the worn sill bricks of the door between the stairhall and kitchen.

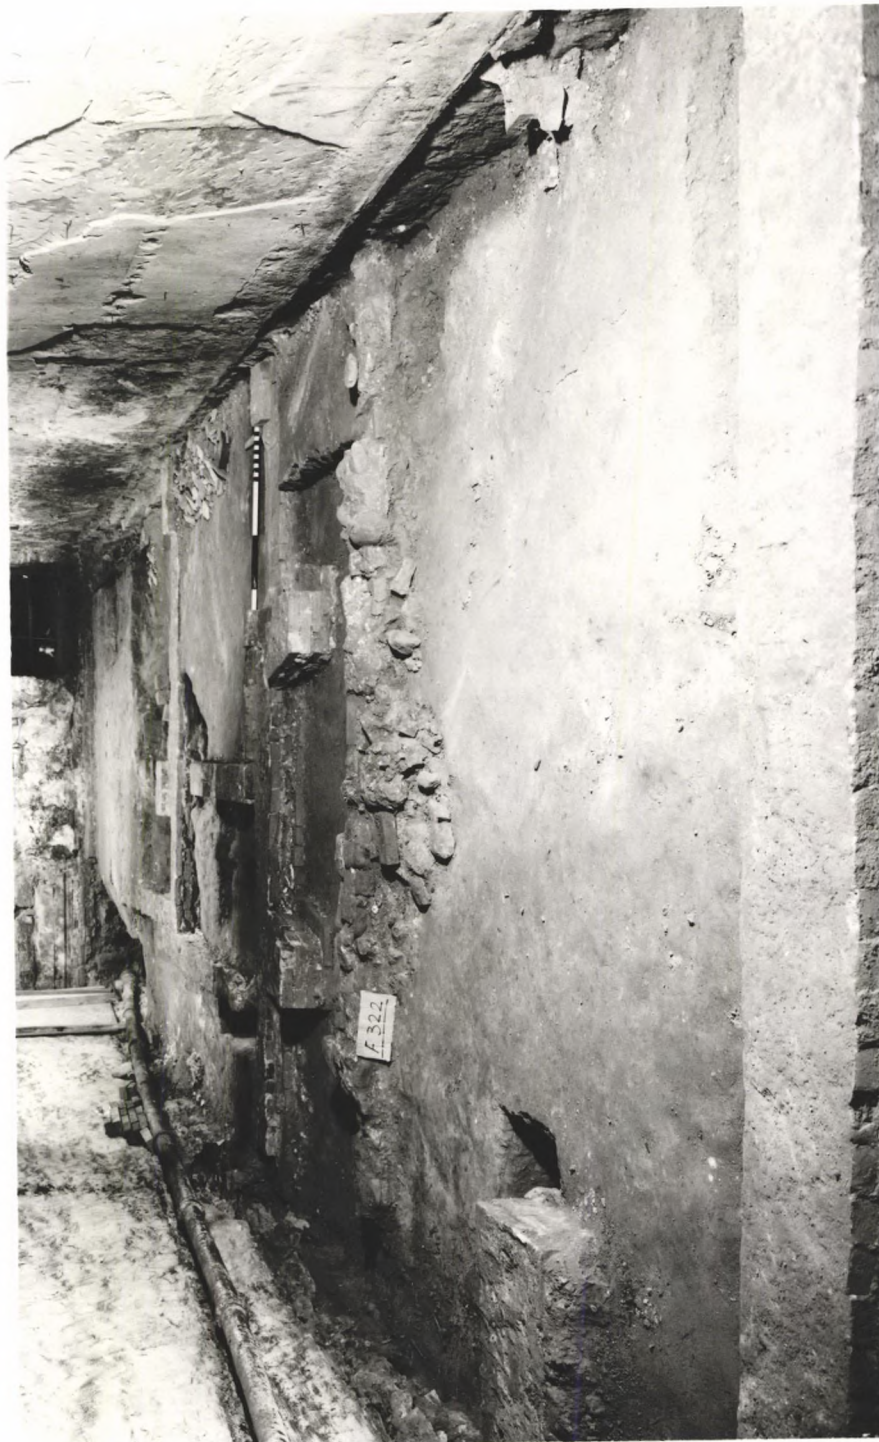
ILLUSTRATION NO. 7

322 Market Street looking north into the area of the cellar kitchen. The foundation of the south exterior wall is in the immediate foreground, and the kitchen fireplace is centered beyond the unidentified rubble.

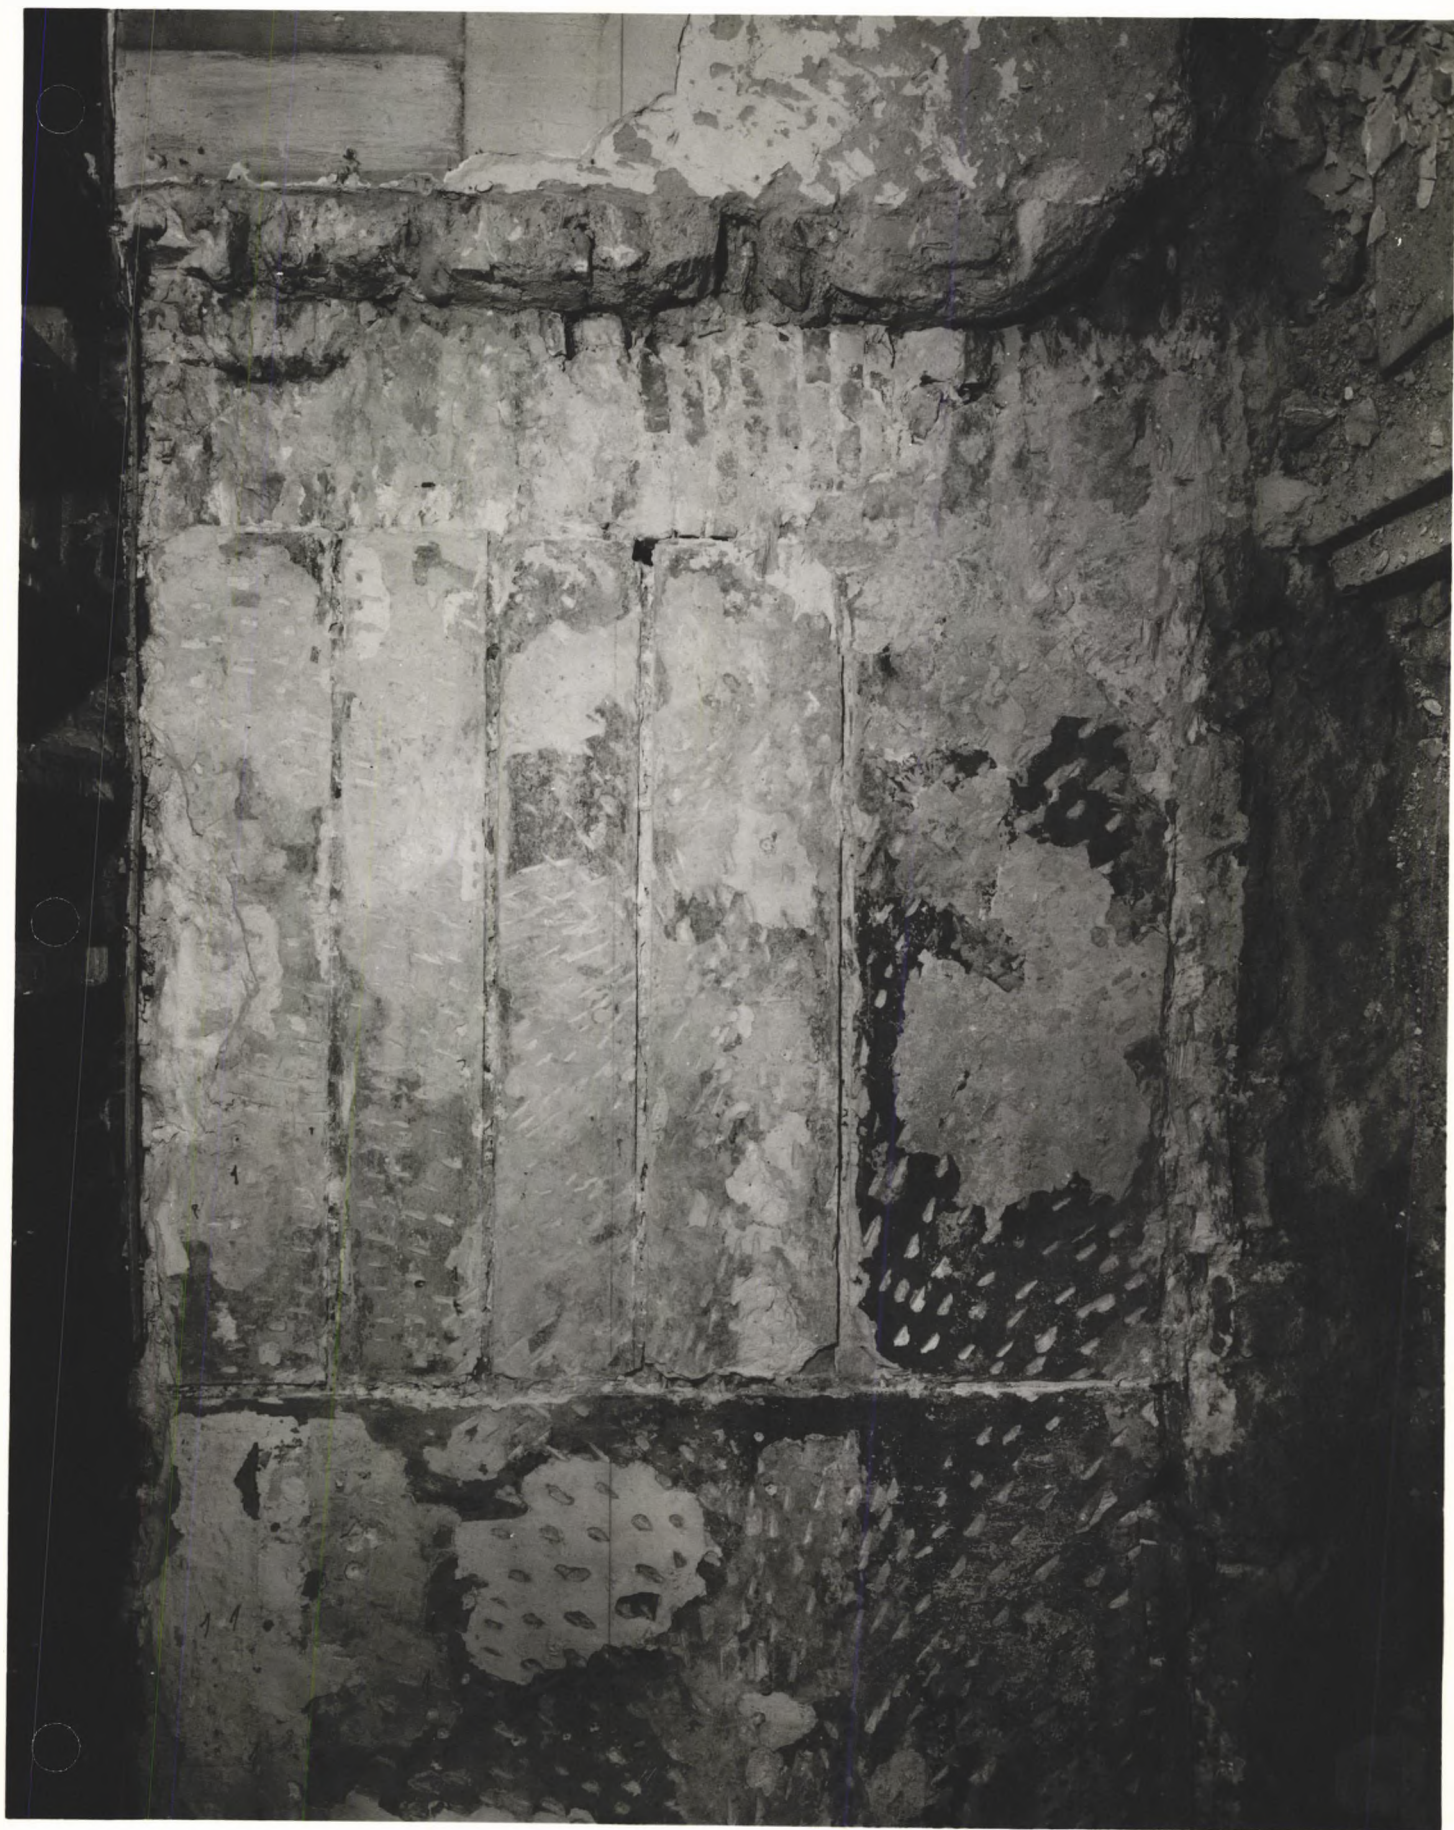
ILLUSTRATION NO. 8

322 Market Street cellar kitchen east wall.

The original plaster remains with not only the layers of paint applied over the years, but it contains the shelf and end board locations of the original kitchen dresser or cupboard.

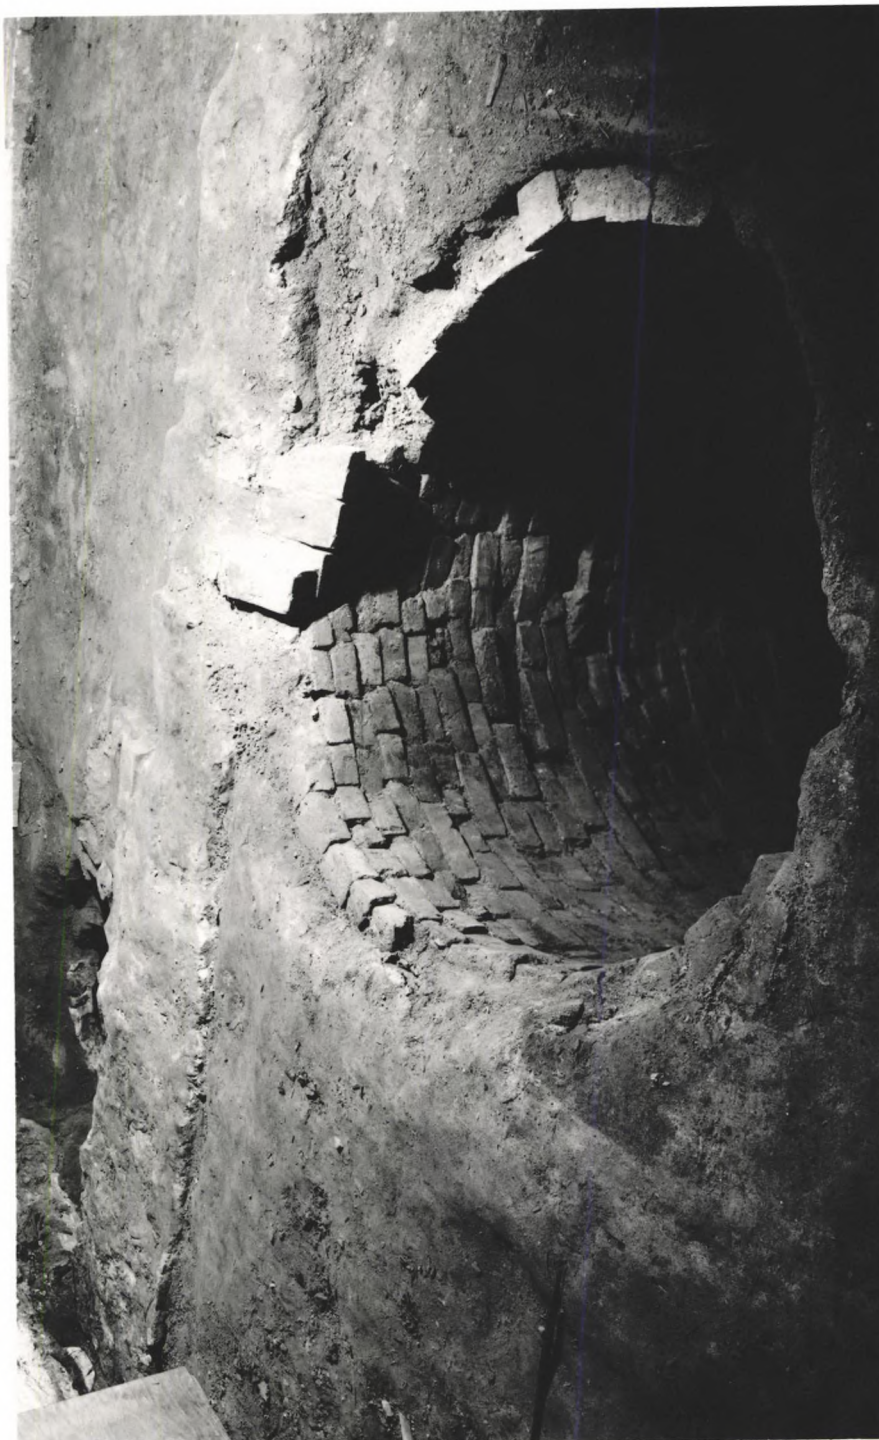
ILLUSTRATION NO. 9

322 Market Street original privy pit,  
located just to the south of the areaway outside  
the kitchen. There seem to be two drains into  
the pit. One is at the sloped bricks at the  
present top course, and the other is at the dark  
hole 10 brick courses below.

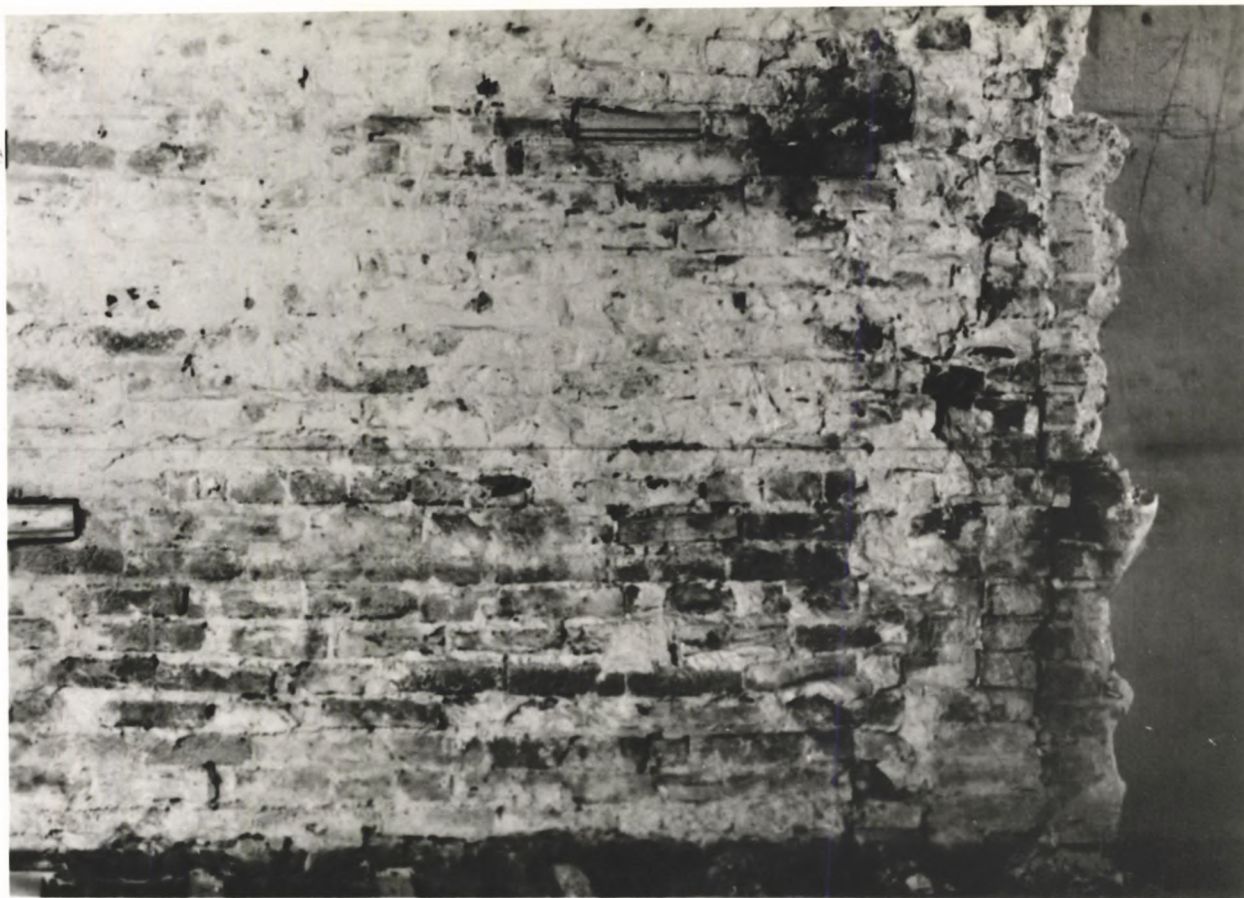
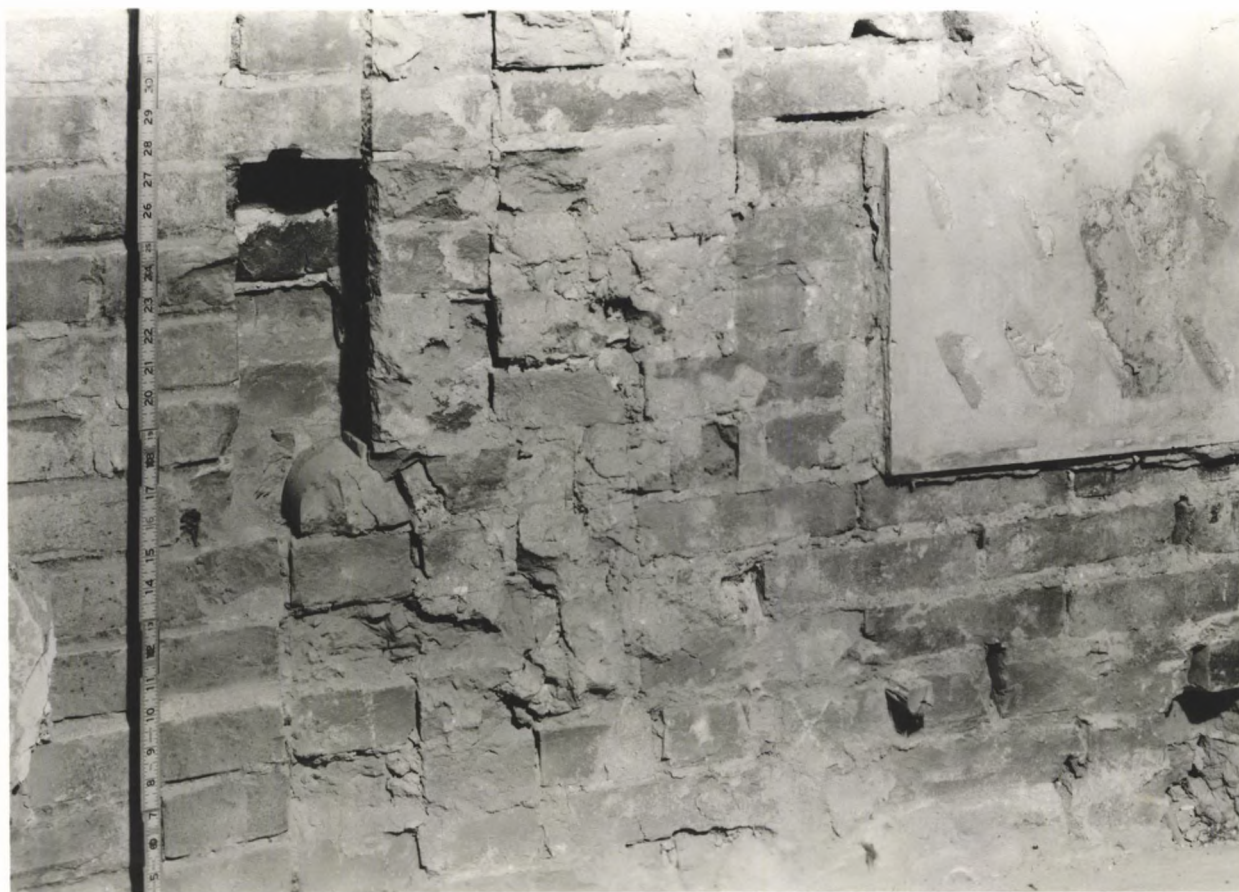
ILLUSTRATION NO. 10

Upper Photo: 322 Market Street. Remains of the  
belt course of south and rear facade  
between the second and third floors,  
as found in the east party wall.

Lower Photo: 318 Market Street. Remains of the  
moulded brick water table of the  
south and rear facade as found in  
the west party wall.

3309, sheet 6). Although the evidence for such a belt course is missing at the second floor level, it can be assumed from general practice that there were belt courses at both levels.
