HISTORIC STRUCTURES REPORT

BENJAMIN FRANKLIN TENANT HOUSE

322 Market Street

Independence National Historical Park

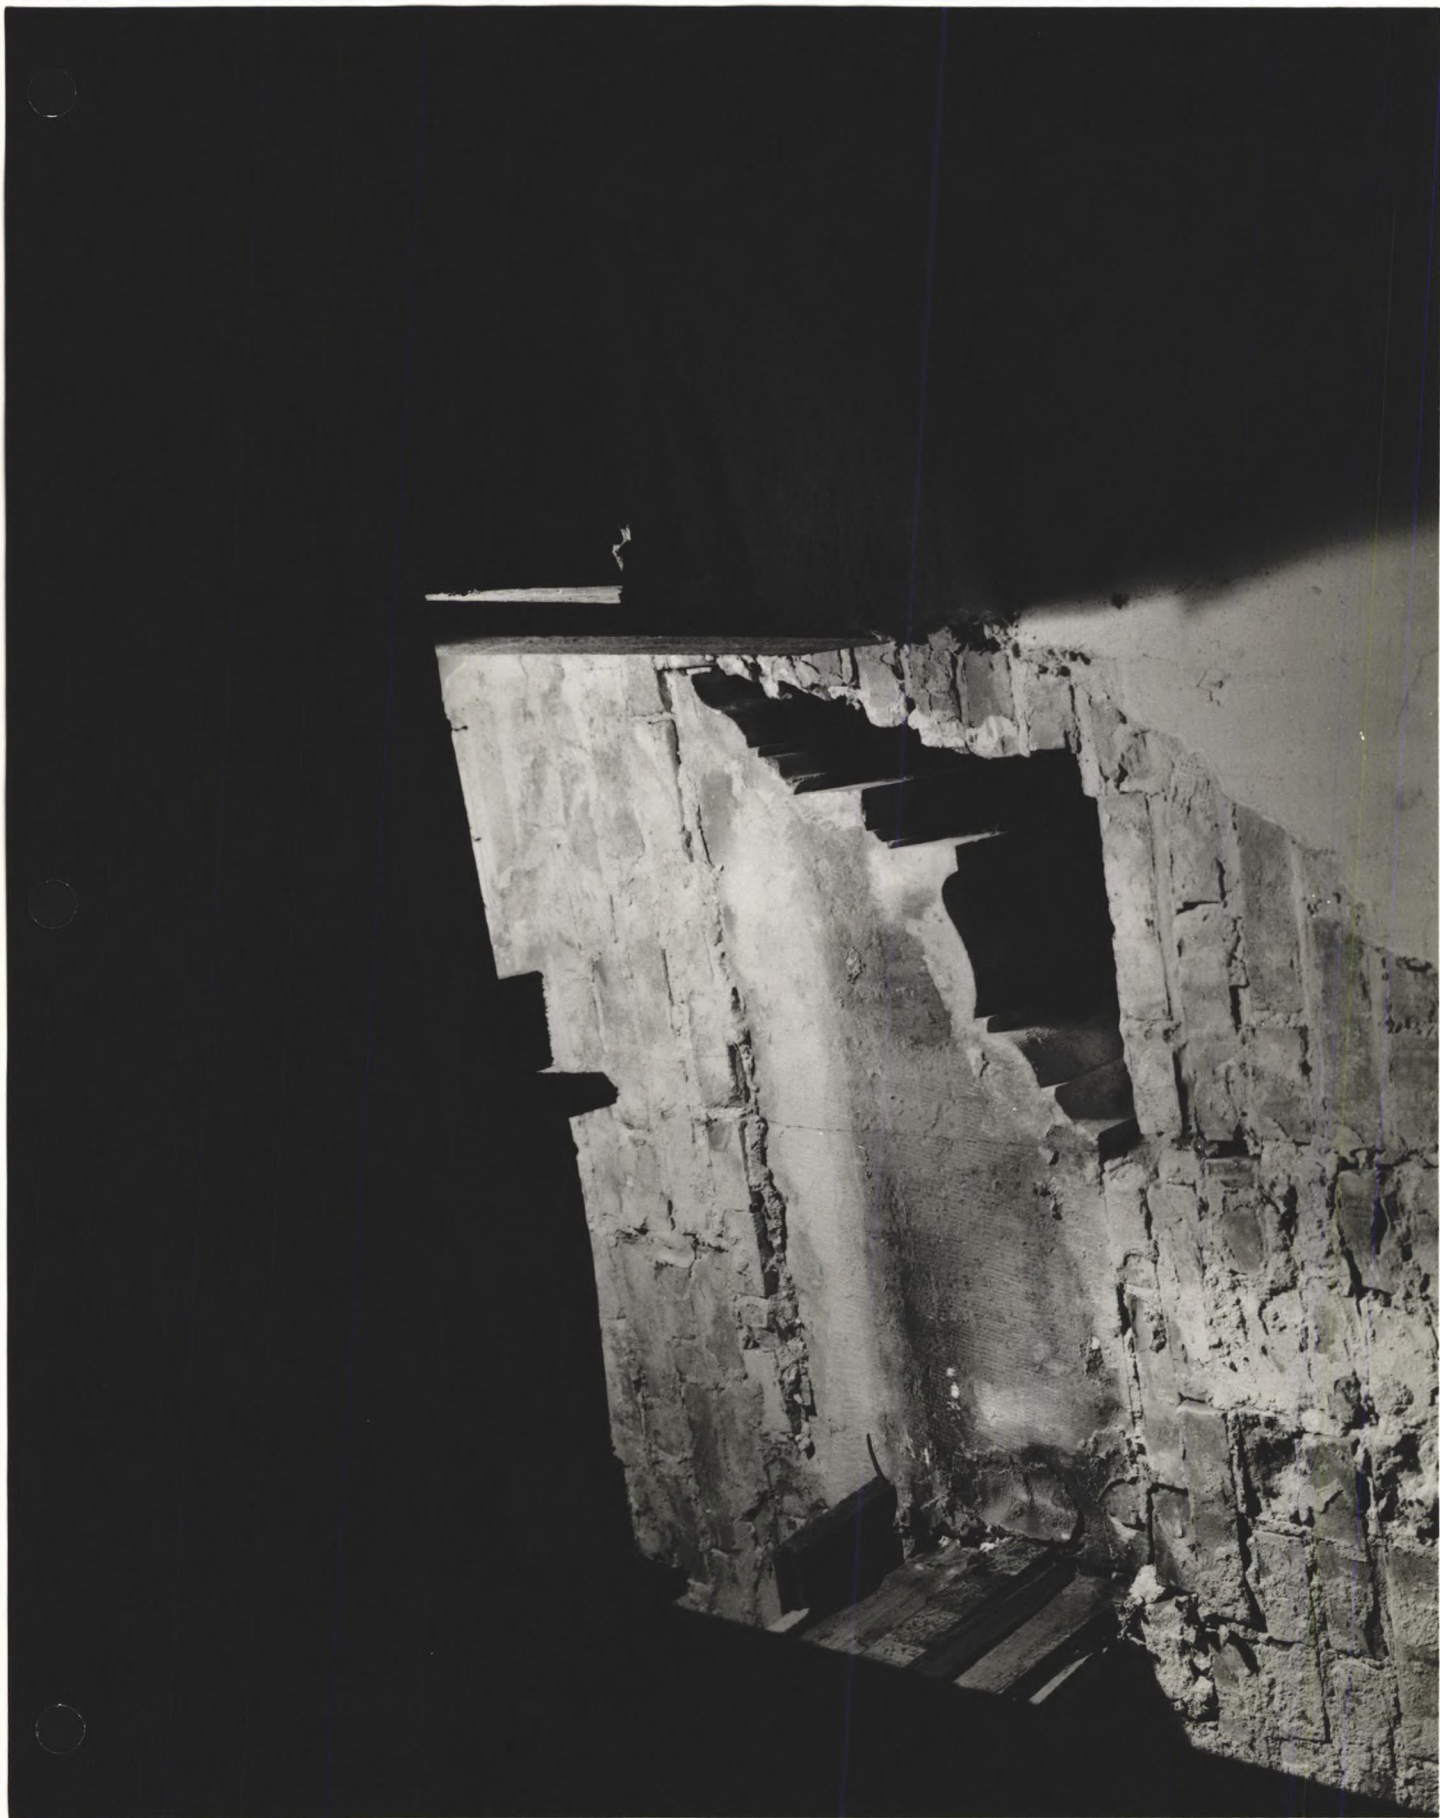
ILLUSTRATION NO. 11

322 Market Street. "Battlement eave block"  
found in the east party wall at the south exterior  
facade line. The corbelling action of this stone  
block supported the fireproofing brick battlement  
walls above. The main cornice profile is repeated  
in the eave block to receive the butt end of the  
cornice.

these original battlements are to be seen today. In addition we are fortunate to have found in place what is called "a battlement eave block"<sup>11</sup> (see Illustration No. 11 and Drawing No. NHP-IND 3309, sheets 6 and 7). By its corbeling action the stone block supported the extension of the battlement above the cornice. At the same time it separated the wood cornice of Franklin's house from that of the neighboring houses.

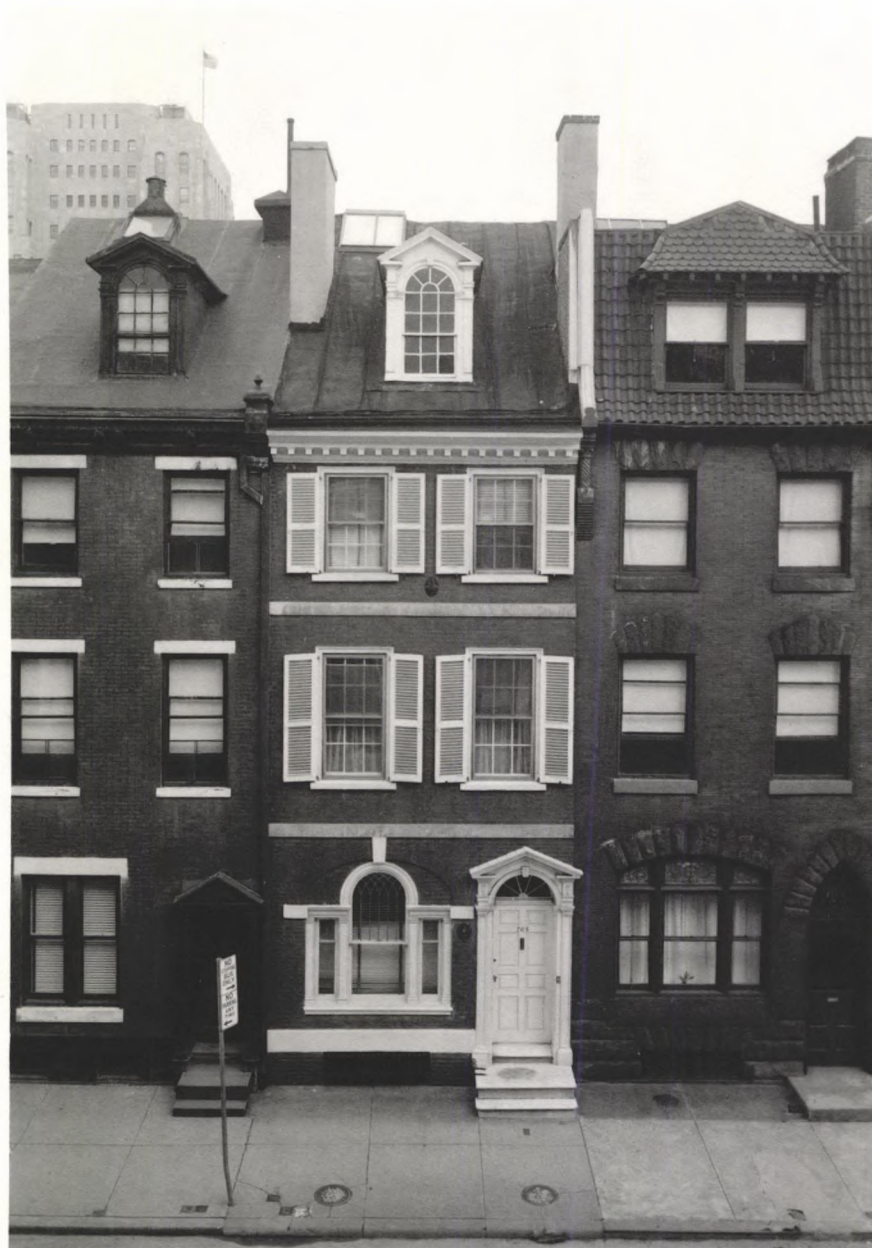
ILLUSTRATION NO. 12

705 Spruce Street ca. 1795-7 front facade.

With exception to the marble belt courses, modern Palladian window and louvered shutters, this facade is good precedent for that of 322 Market Street. Note the original frontispiece, plank front window frames, the absence of window lintel treatment, modillion cornice, dormer and skylight.

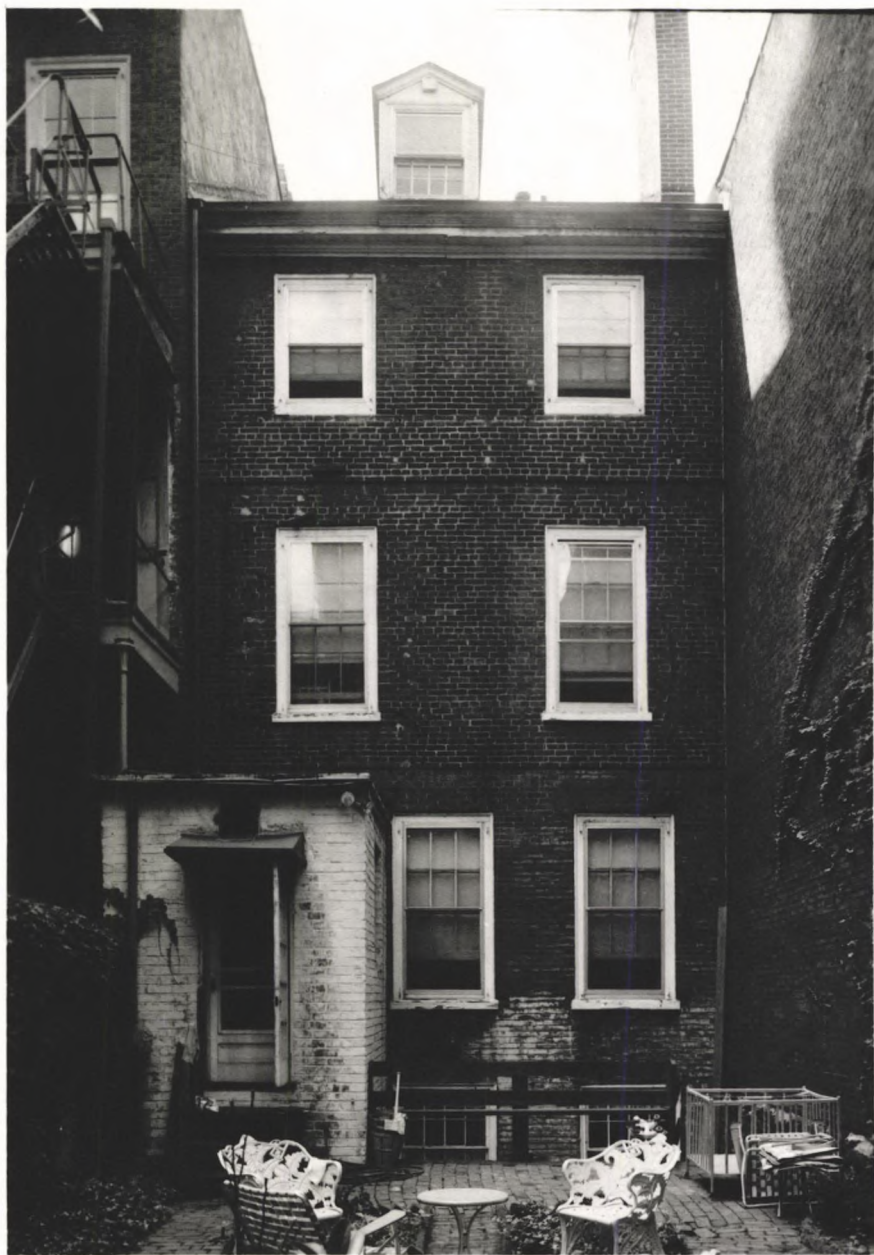
ILLUSTRATION NO. 13

705 Walnut Street ca. 1800-1801. The rear facade, shown here, in this house has less architectural refinement than the front facade. This was not the case in the Franklin Tenant houses. The detail to note in this photograph however, is the position of the cellar and first floor windows to allow for doors opening onto the areaway and a "bridge" over the areaway.

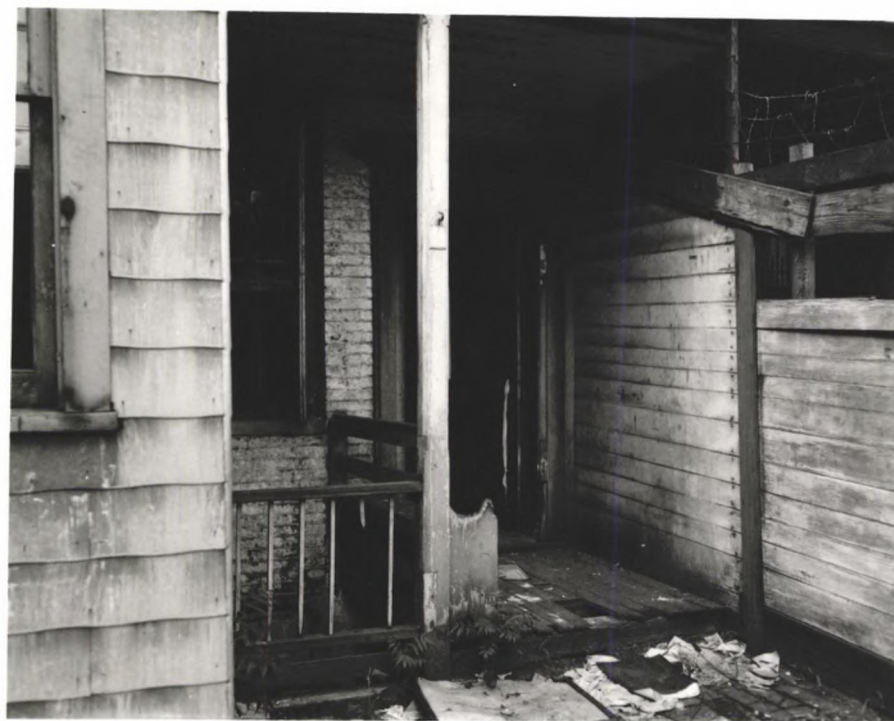
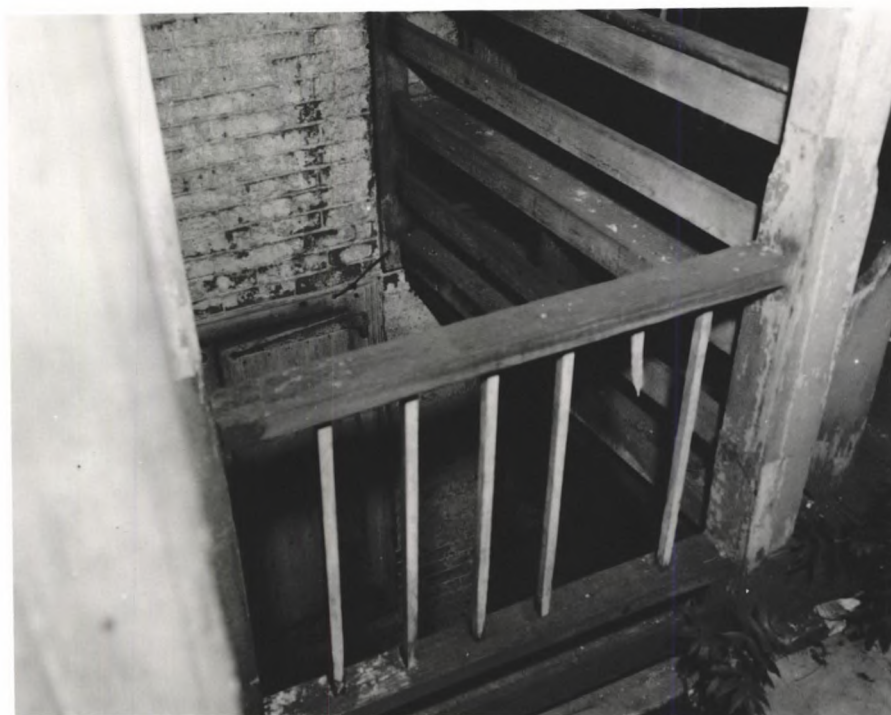
ILLUSTRATION NO. 14

629 Spruce Street rear, showing a door opening from the first floor rear room onto a "bridge" over the cellar areaway, exactly the same situation as was in 322 Market Street. The porch above and shed to the left seems to be a recent addition.

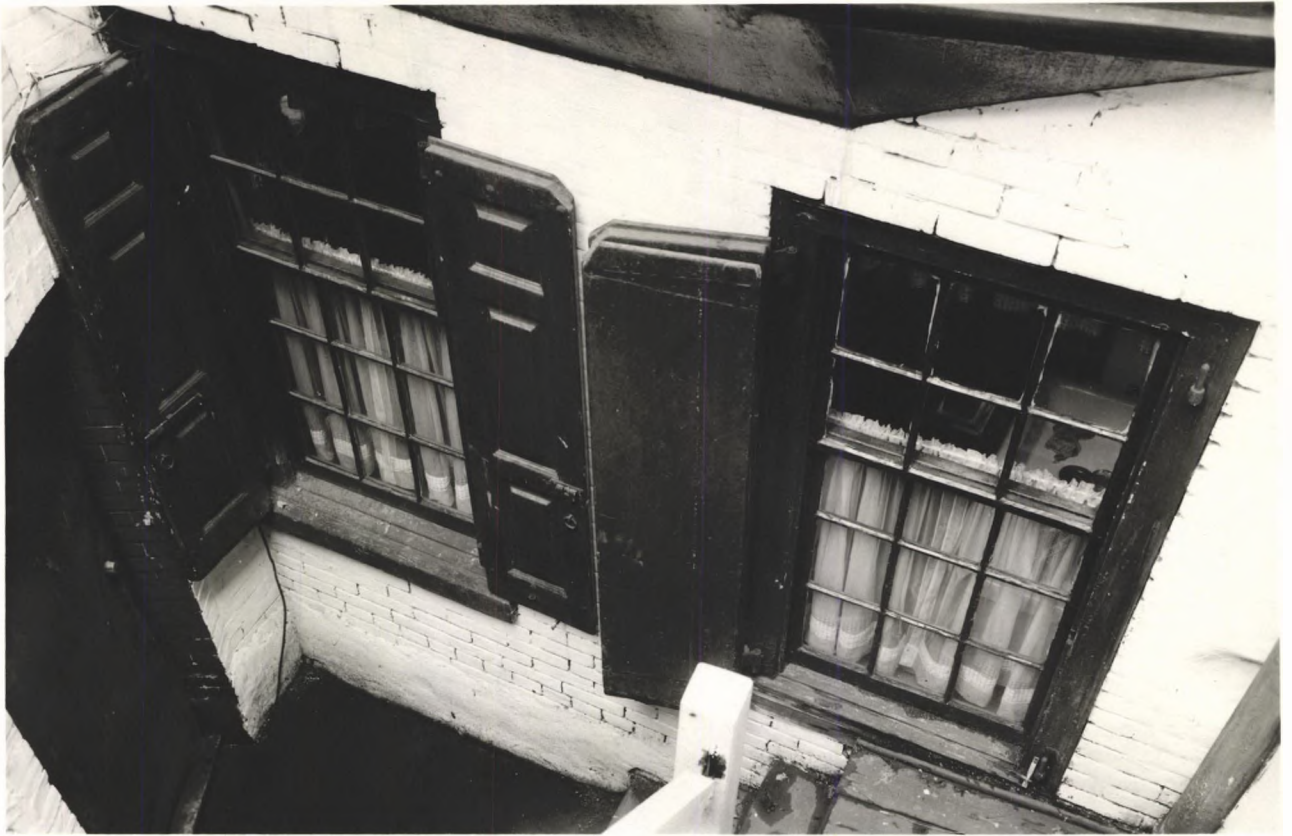
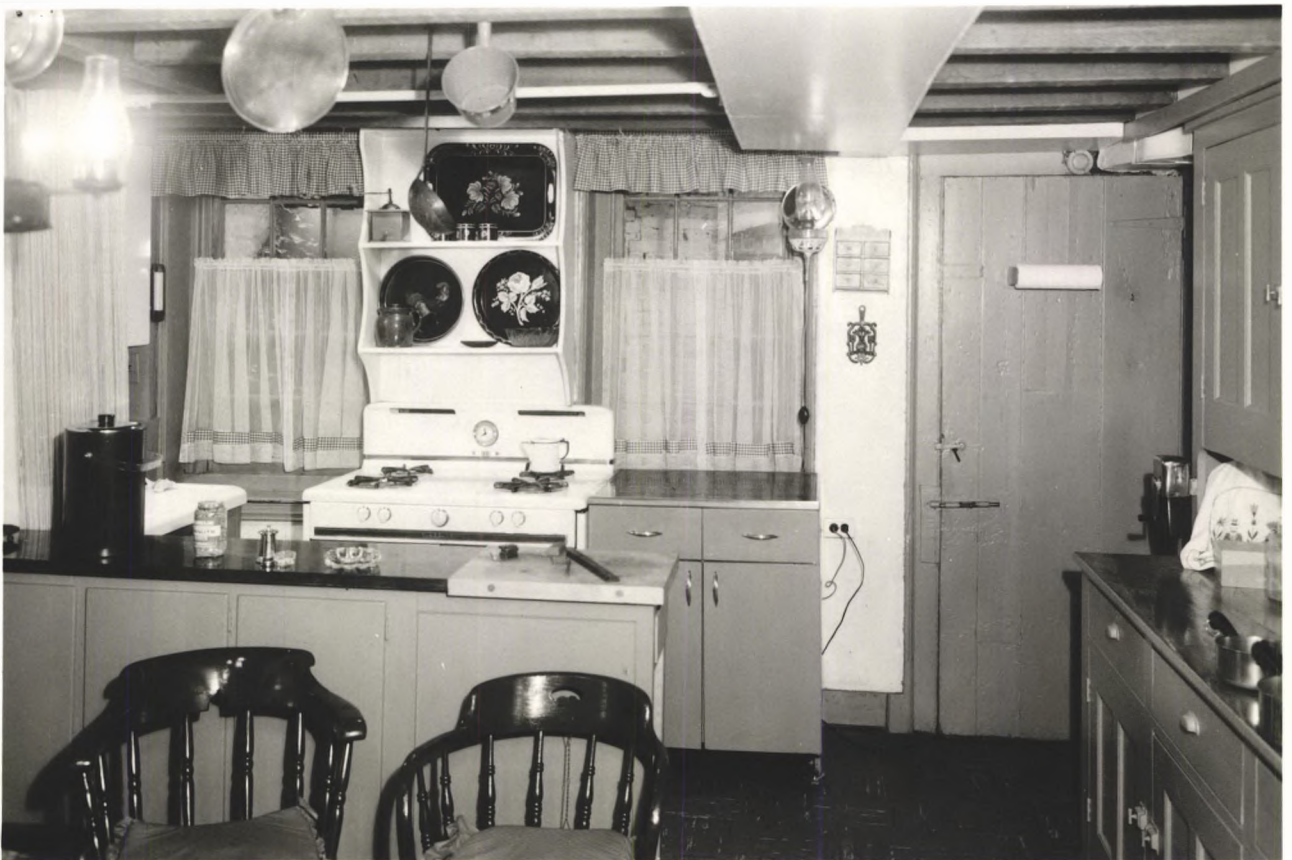
ILLUSTRATION NO. 15

705 Spruce Street ca. 1795-7

The Lower view is inside the cellar kitchen looking toward the door and windows which open onto the areaway undoubtedly the same distribution of openings as was in 322 Market Street. Note plaster stains on the ceiling joists, evidence that the kitchen ceiling joists originally were not exposed, but as is suggested for 322 Market Street, the kitchen ceiling was plastered below the joists.

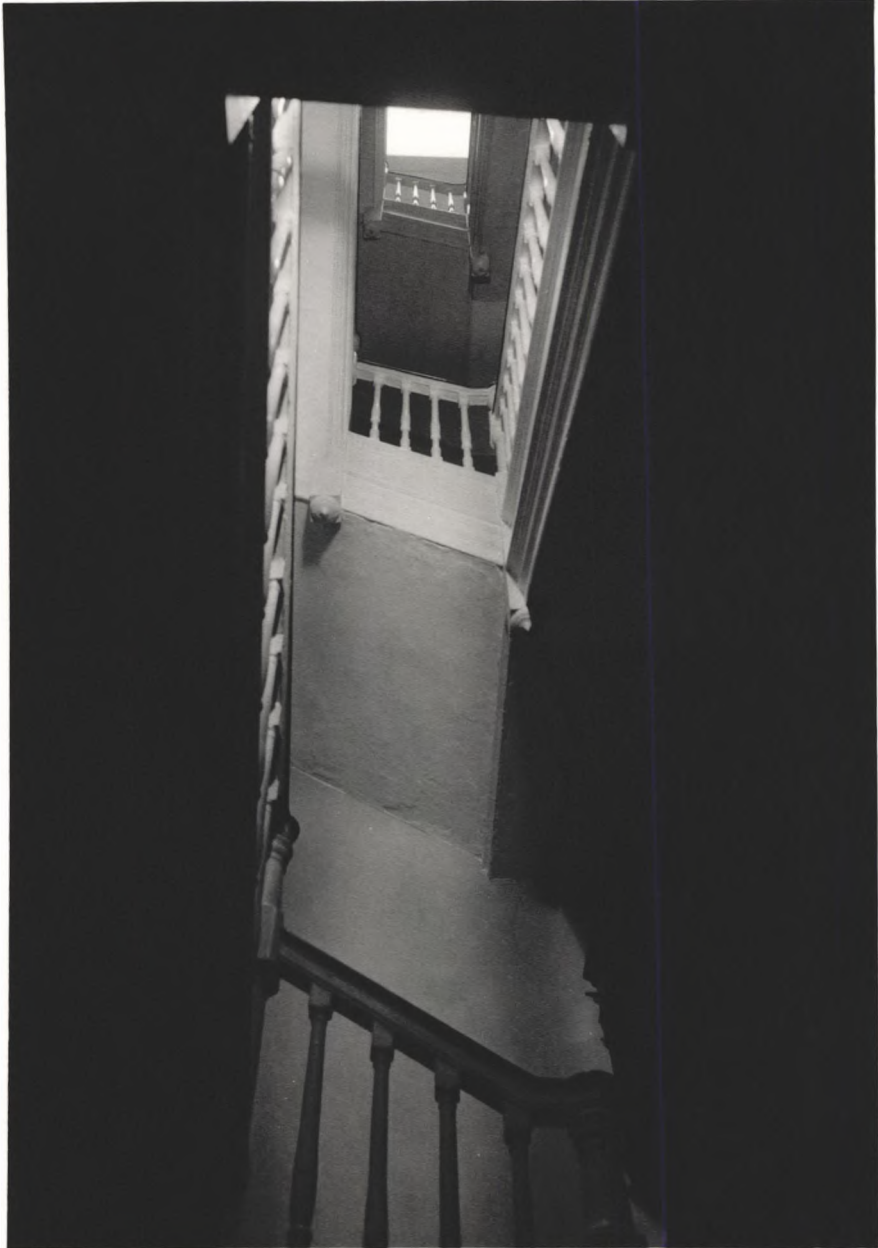
ILLUSTRATION NO. 16

705 Spruce Street ca. 1795-7 interior  
stairhall lighted by a skylight in the roof.

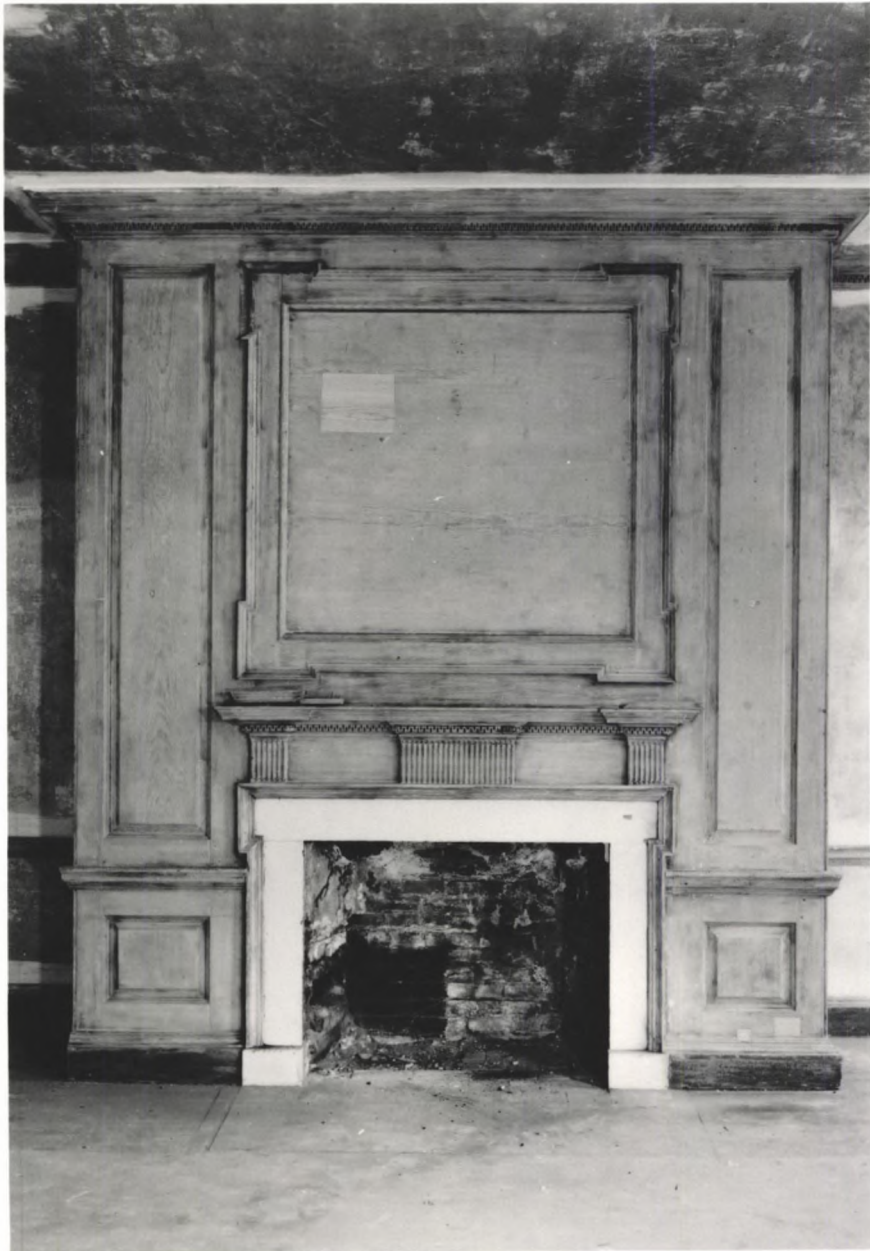
ILLUSTRATION NO. 17

336 Spruce Street, second floor front room,  
built 1788-1796. This feature is described in the  
Philadelphia Contributionship Survey #2777-8, October  
6, 1796.

The wood paneled finish of the chimney breast is  
precedent for 318 Market Street and thus also for the  
third Tenant house, 322 Market Street.

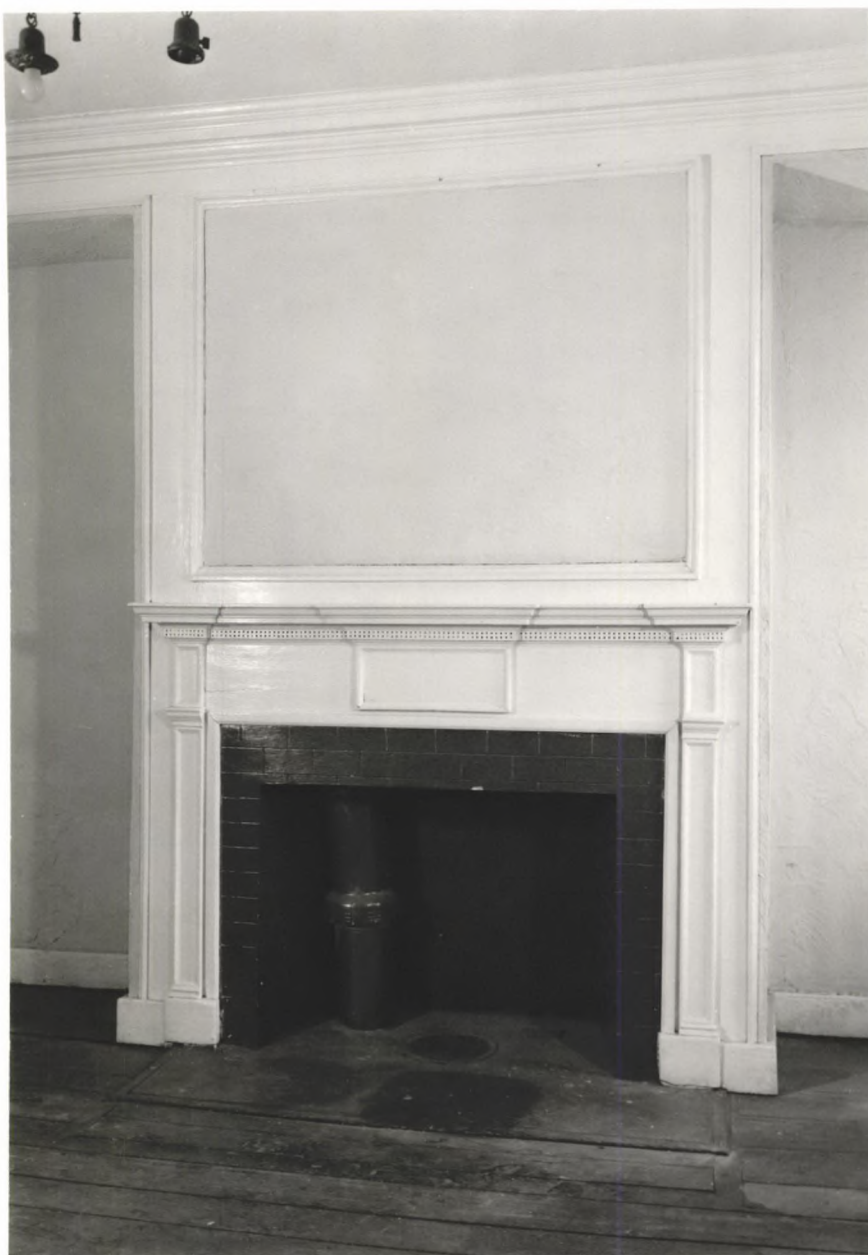
ILLUSTRATION NO. 18

310 Cypress Street, ca. 1796, first floor front room chimney breast with a plaster landscape panel such as is mentioned in the insurance survey for the Benjamin Franklin Tenant houses at 316 and 318 Market Street.

The survey for 322 Market Street, the third Franklin Tenant house, omits mentioning plaster landscape panels. They must have been in use as all three houses are so closely alike. Furthermore, omissions in insurance surveys are more the rule than exception, for the survey for this house, 310 Cypress Street also neglects to mention this plaster landscape panel.

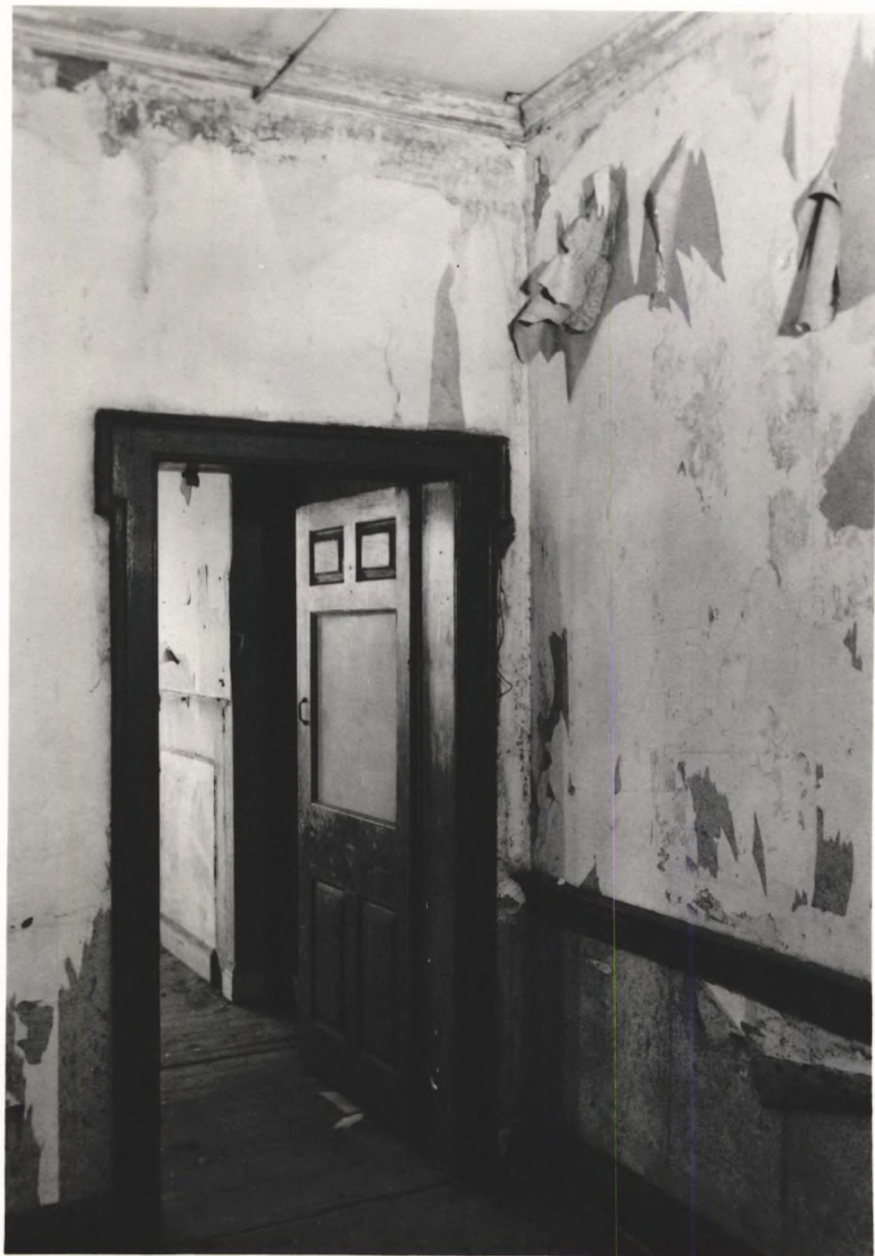
ILLUSTRATION NO. 19

421 South Second Street, Thomas Harper House, ca. 1788, from the back room into a front parlor. Note the wood cornice, dog-eared single architrave at the paneled door in a brick partition. The doors, leading to the front and rear rooms from the stairhall of 322 Market Street were probably of this detail. Note also the chair rail and baseboard precedents.

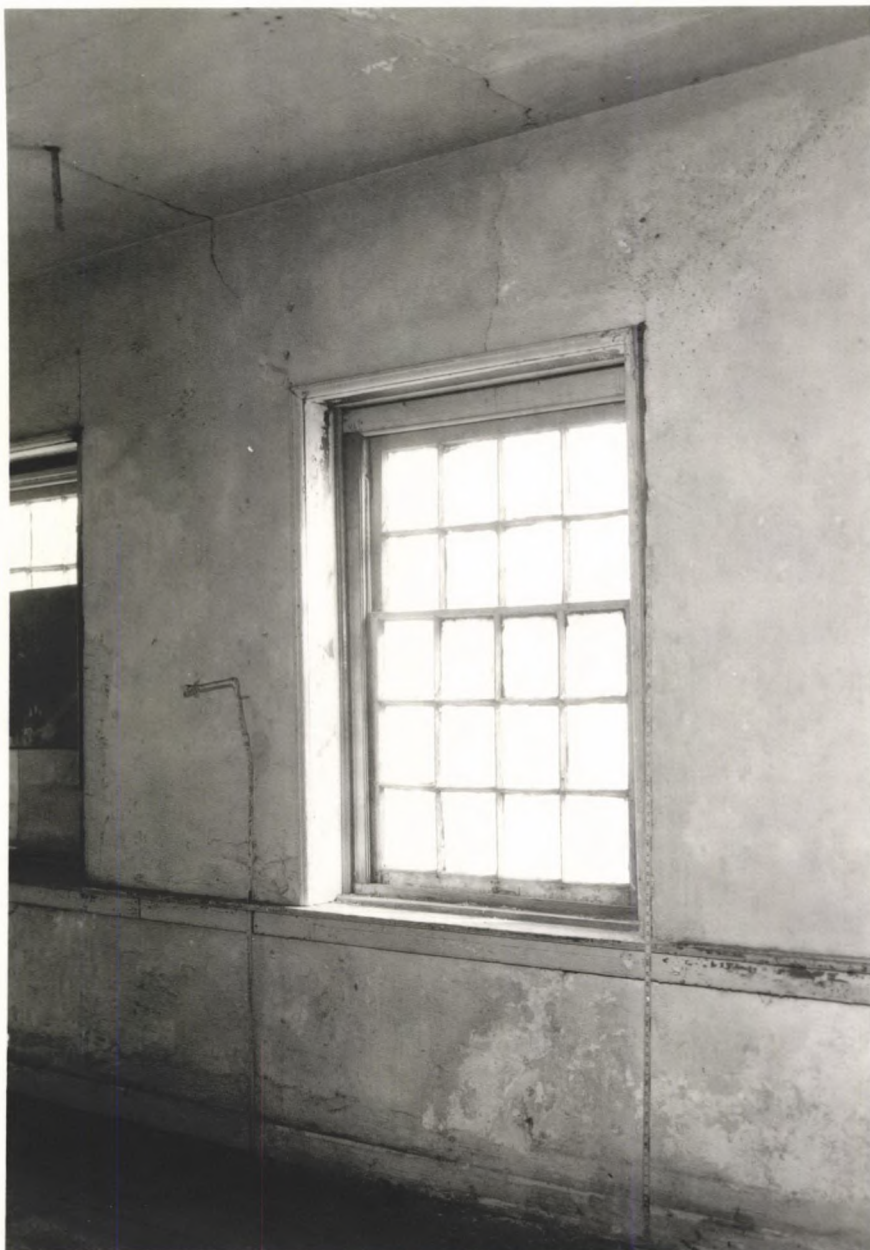
ILLUSTRATION NO. 20

421 South Second Street, The Thomas Harper House, ca. 1788, third floor, southeast room. Note the absence of cornice, low ceiling height, single moulding at the cased window and the single profiles of the chair rail and baseboard. Typical treatment for this less important upper floor room.

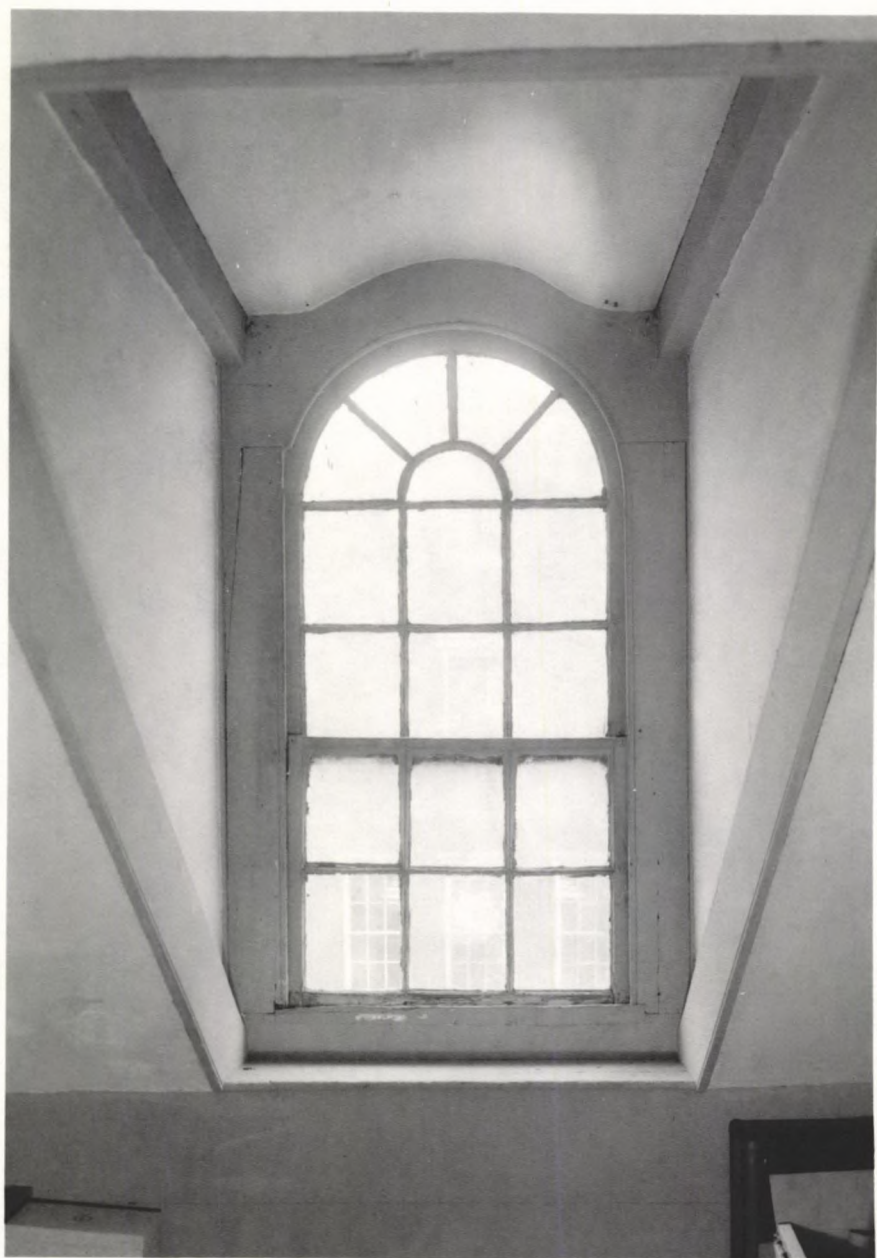
ILLUSTRATION NO. 21

705 Spruce Street ca. 1795-7. Interior  
view of the front dormer window.

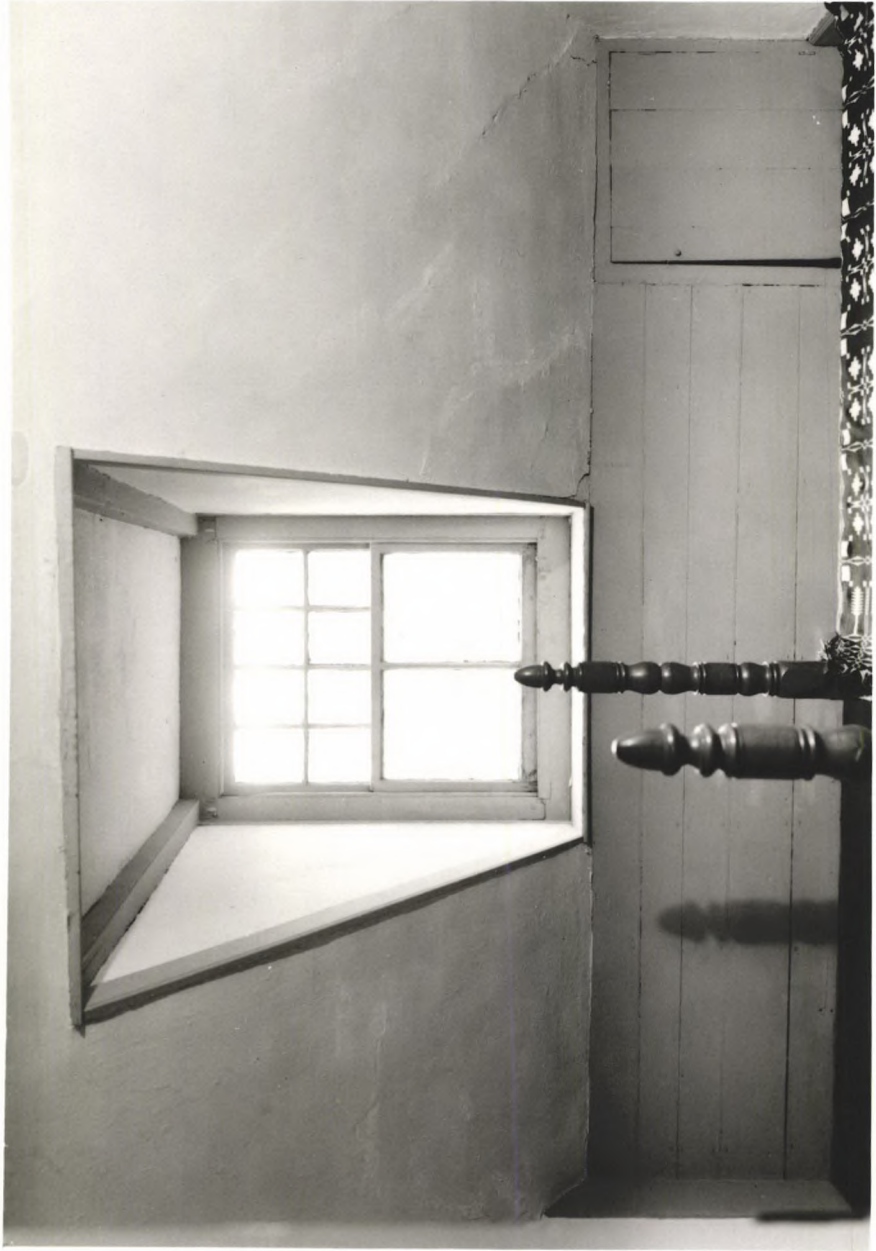
ILLUSTRATION NO. 22

705 Spruce Street, ca. 1795-7, interior  
view of rear dormer, lights 8" x 10". In this  
case the rear dormer is less elaborate than the  
front dormer. Note the horizontal board knee wall  
with a door to the eave closet.
