HISTORIC STRUCTURES REPORT

PART I, SUPPLEMENT I

YARD WALL

BISHOP WHITE HOUSE RESTORATION

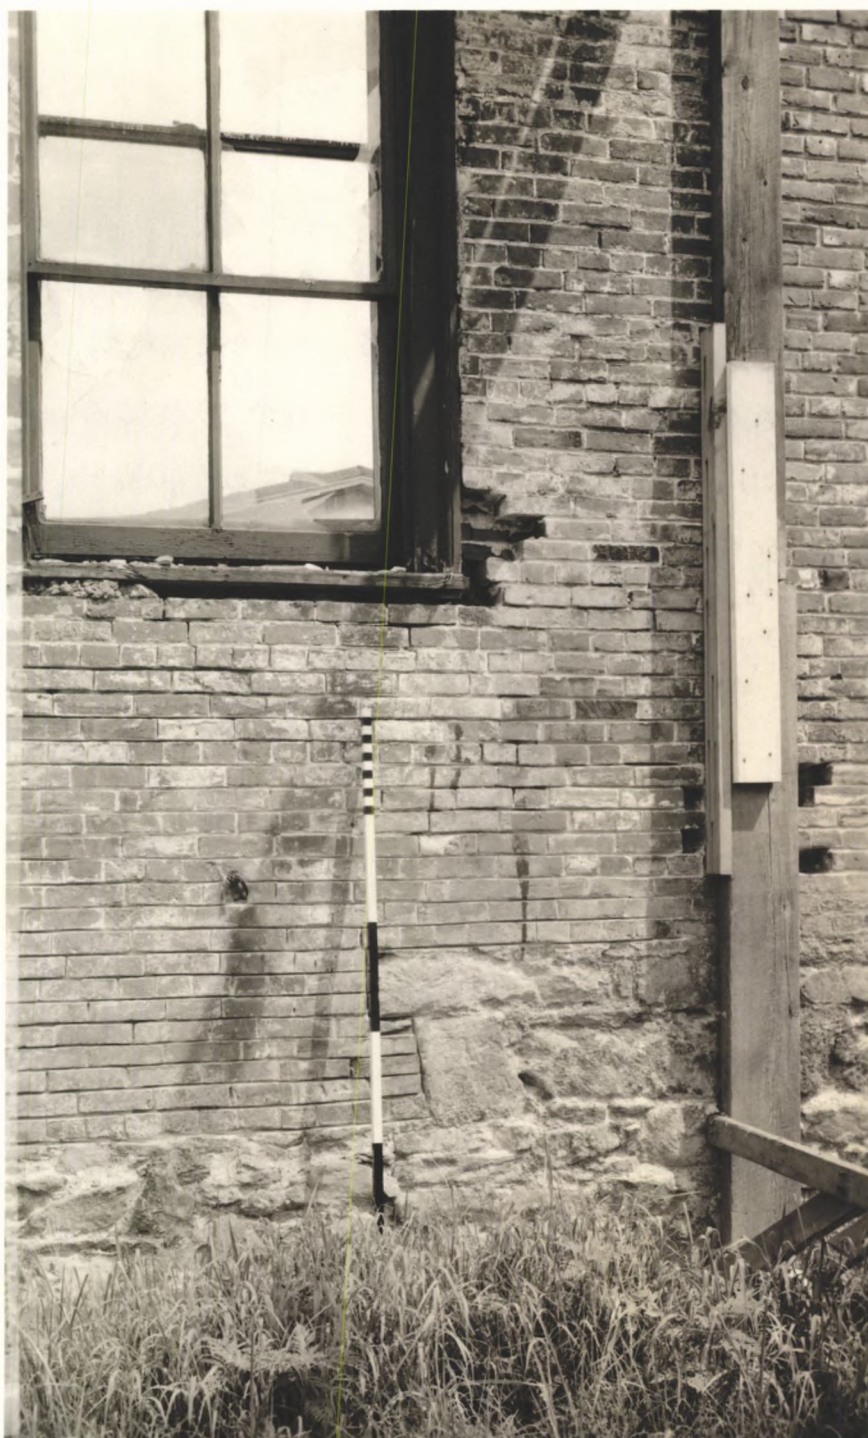
West face of west wall. The rod marks the location of the north wall of the necessary at the juncture of the garden wall. The brick on this face is continuous. Note the lowered stone foundation at the garden wall area.

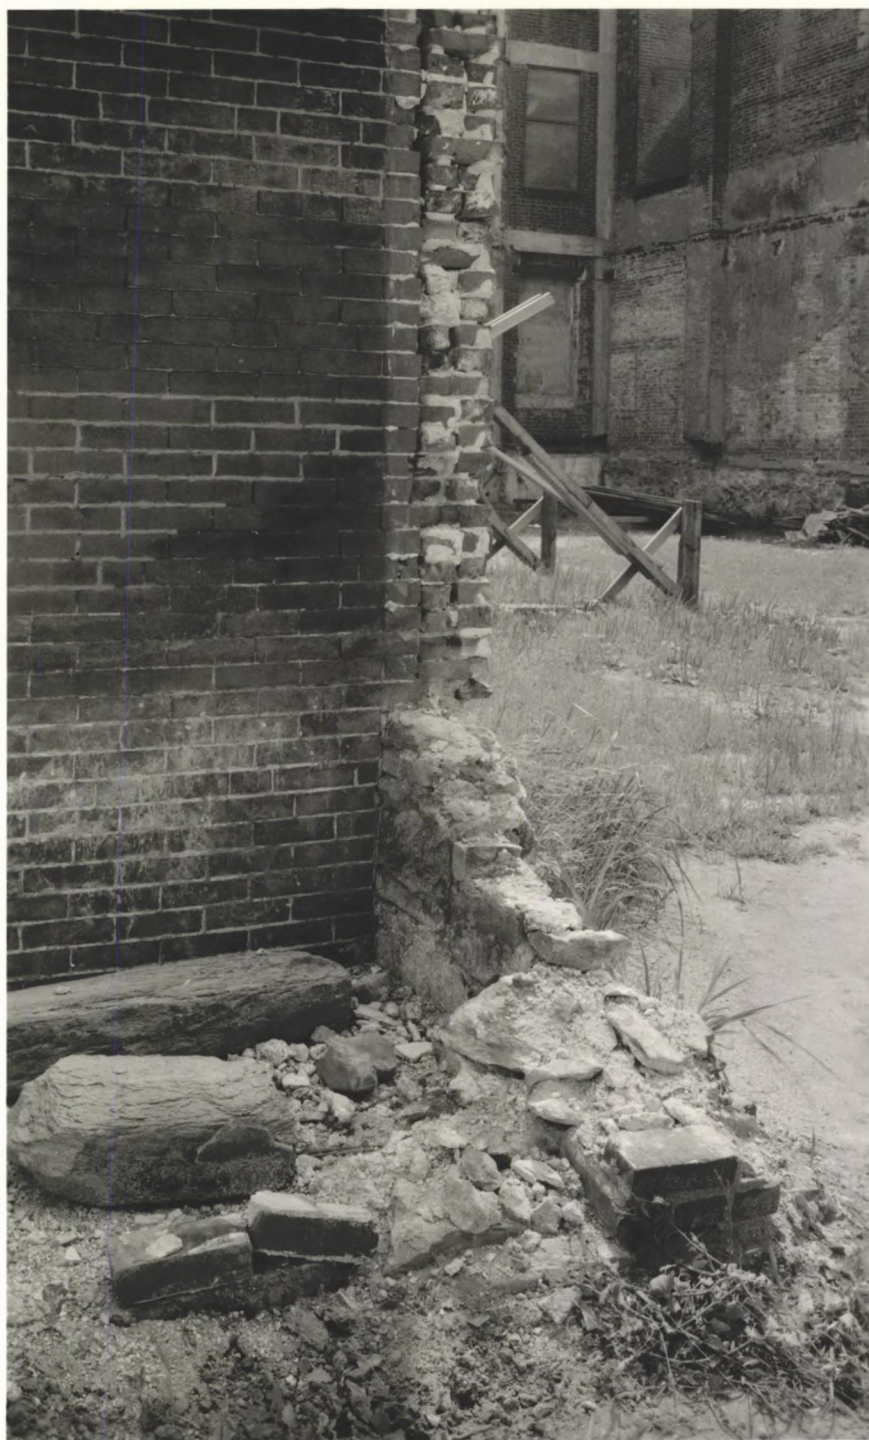
North wall at Harmony Street. The end of the wall of broken brick on the stone foundation in the center is the original garden wall with the 1880 wall abutting but not toothed into it. The bricks in the lower foreground indicate the old location of the north wall.

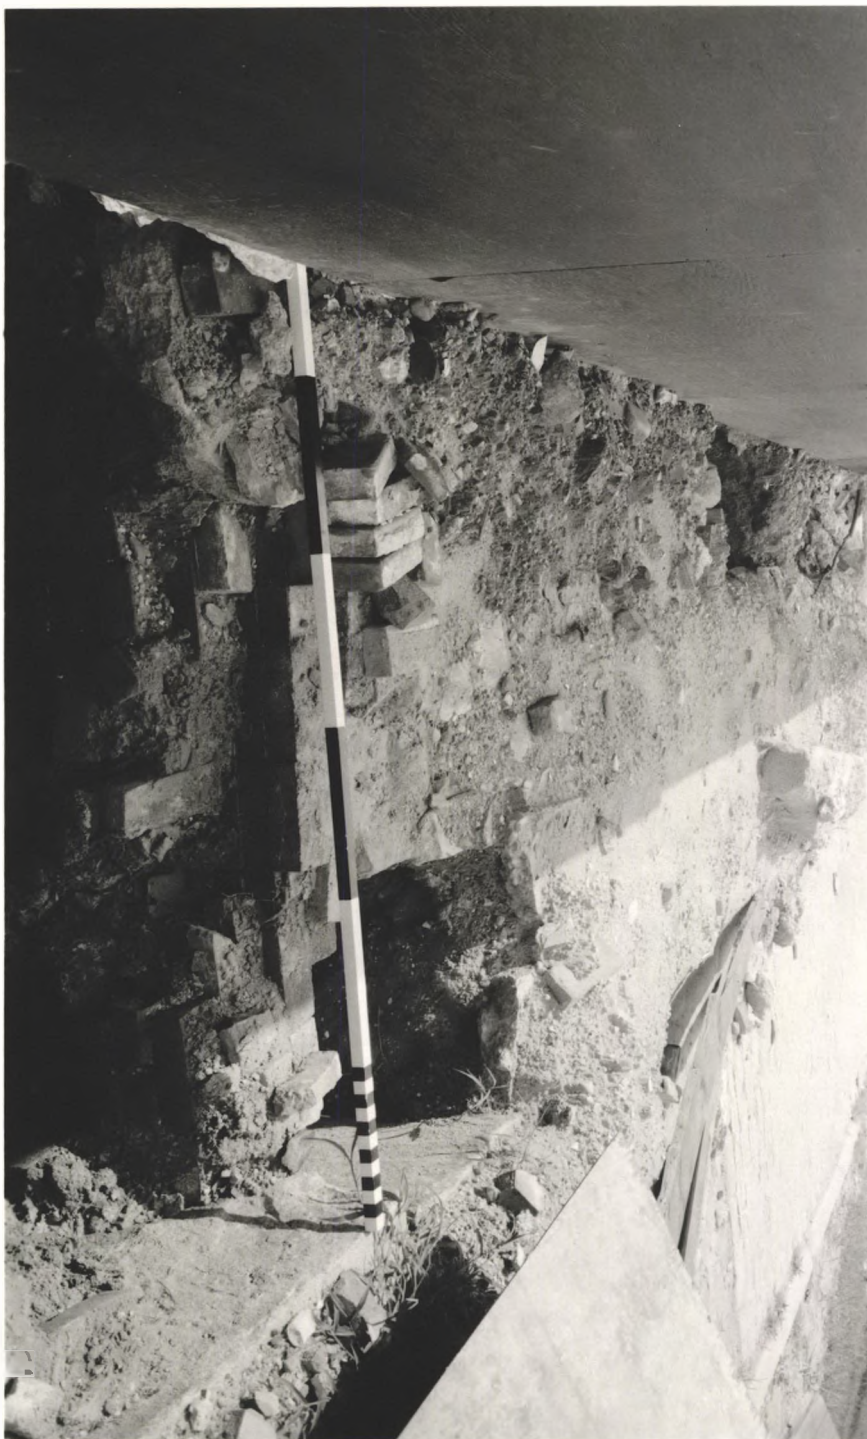
The remains of the north garden wall along Harmony Street looking north. The red marks the east boundary of the wall. The barricade shadow falls slightly to the right of the old garden wall. The dimension from the outer face of the wall to the curb is two feet.

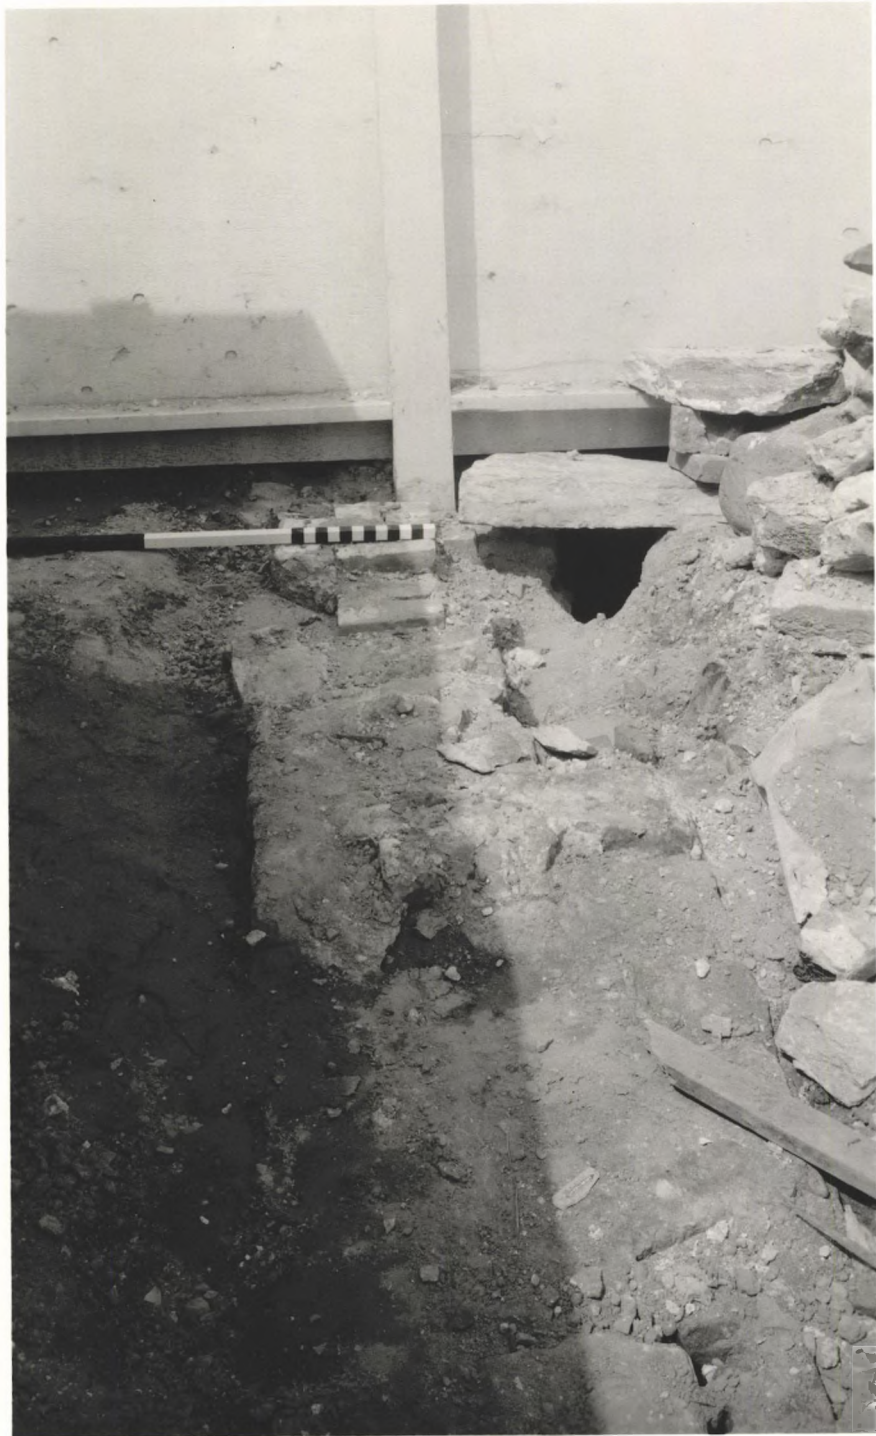
The bricks under the inch markings on the red indicate the original garden wall at the north end of the east wall. From just south of this point the old wall foundation was obliterated by party walls of later buildings.

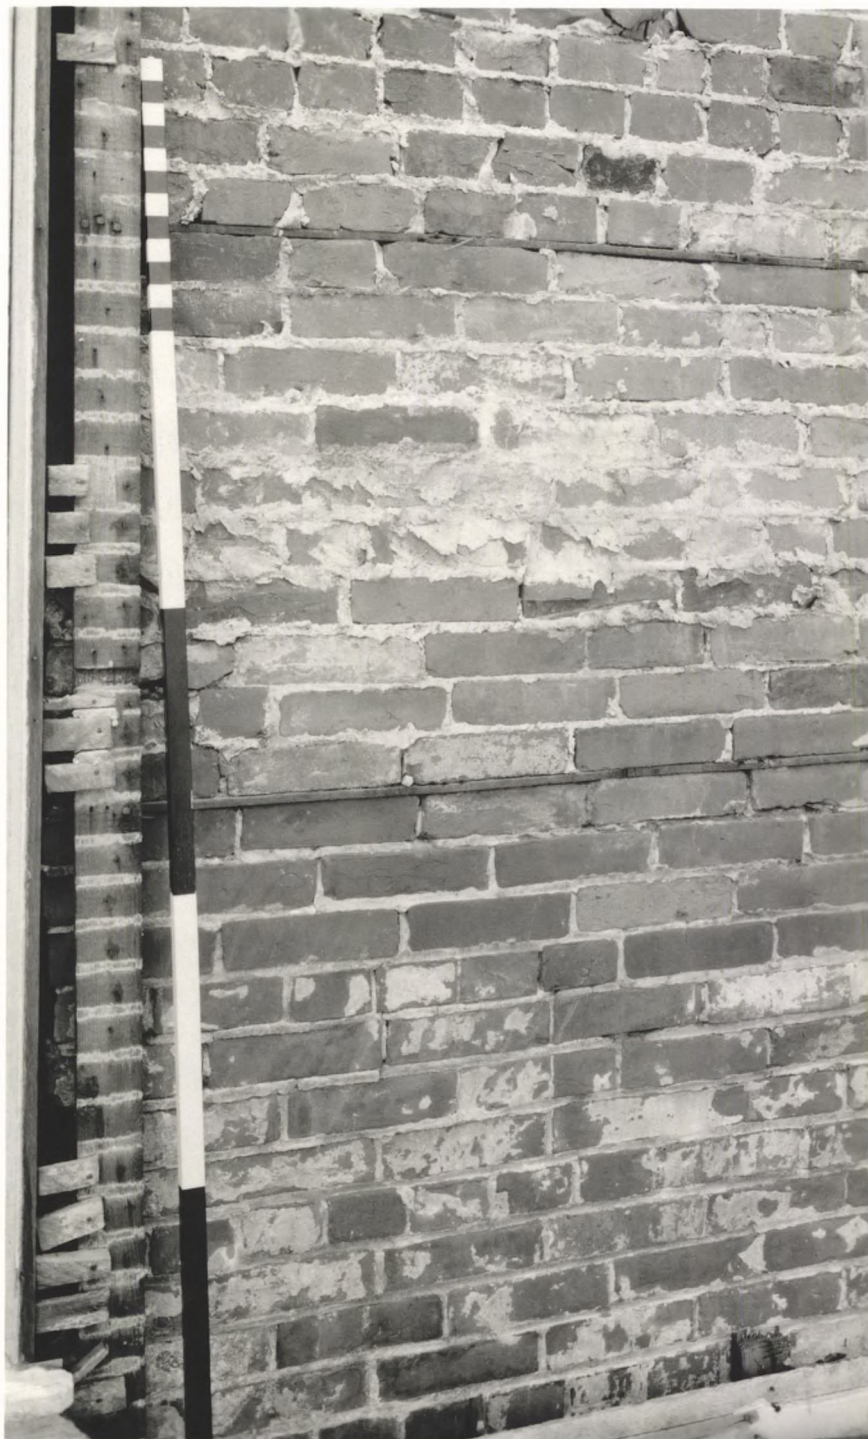
The inside face of the original garden wall shows at the lower part of the photo. The wood strip marks the change in brick and mortar--the 1880 wall was built on top of the garden wall at this point. The joints in the lower portion are finished and the part above rough. Traces of whitewash and paint remain on the garden wall portion. Due to the 1880 plaster this face of the wall was concealed until recently.

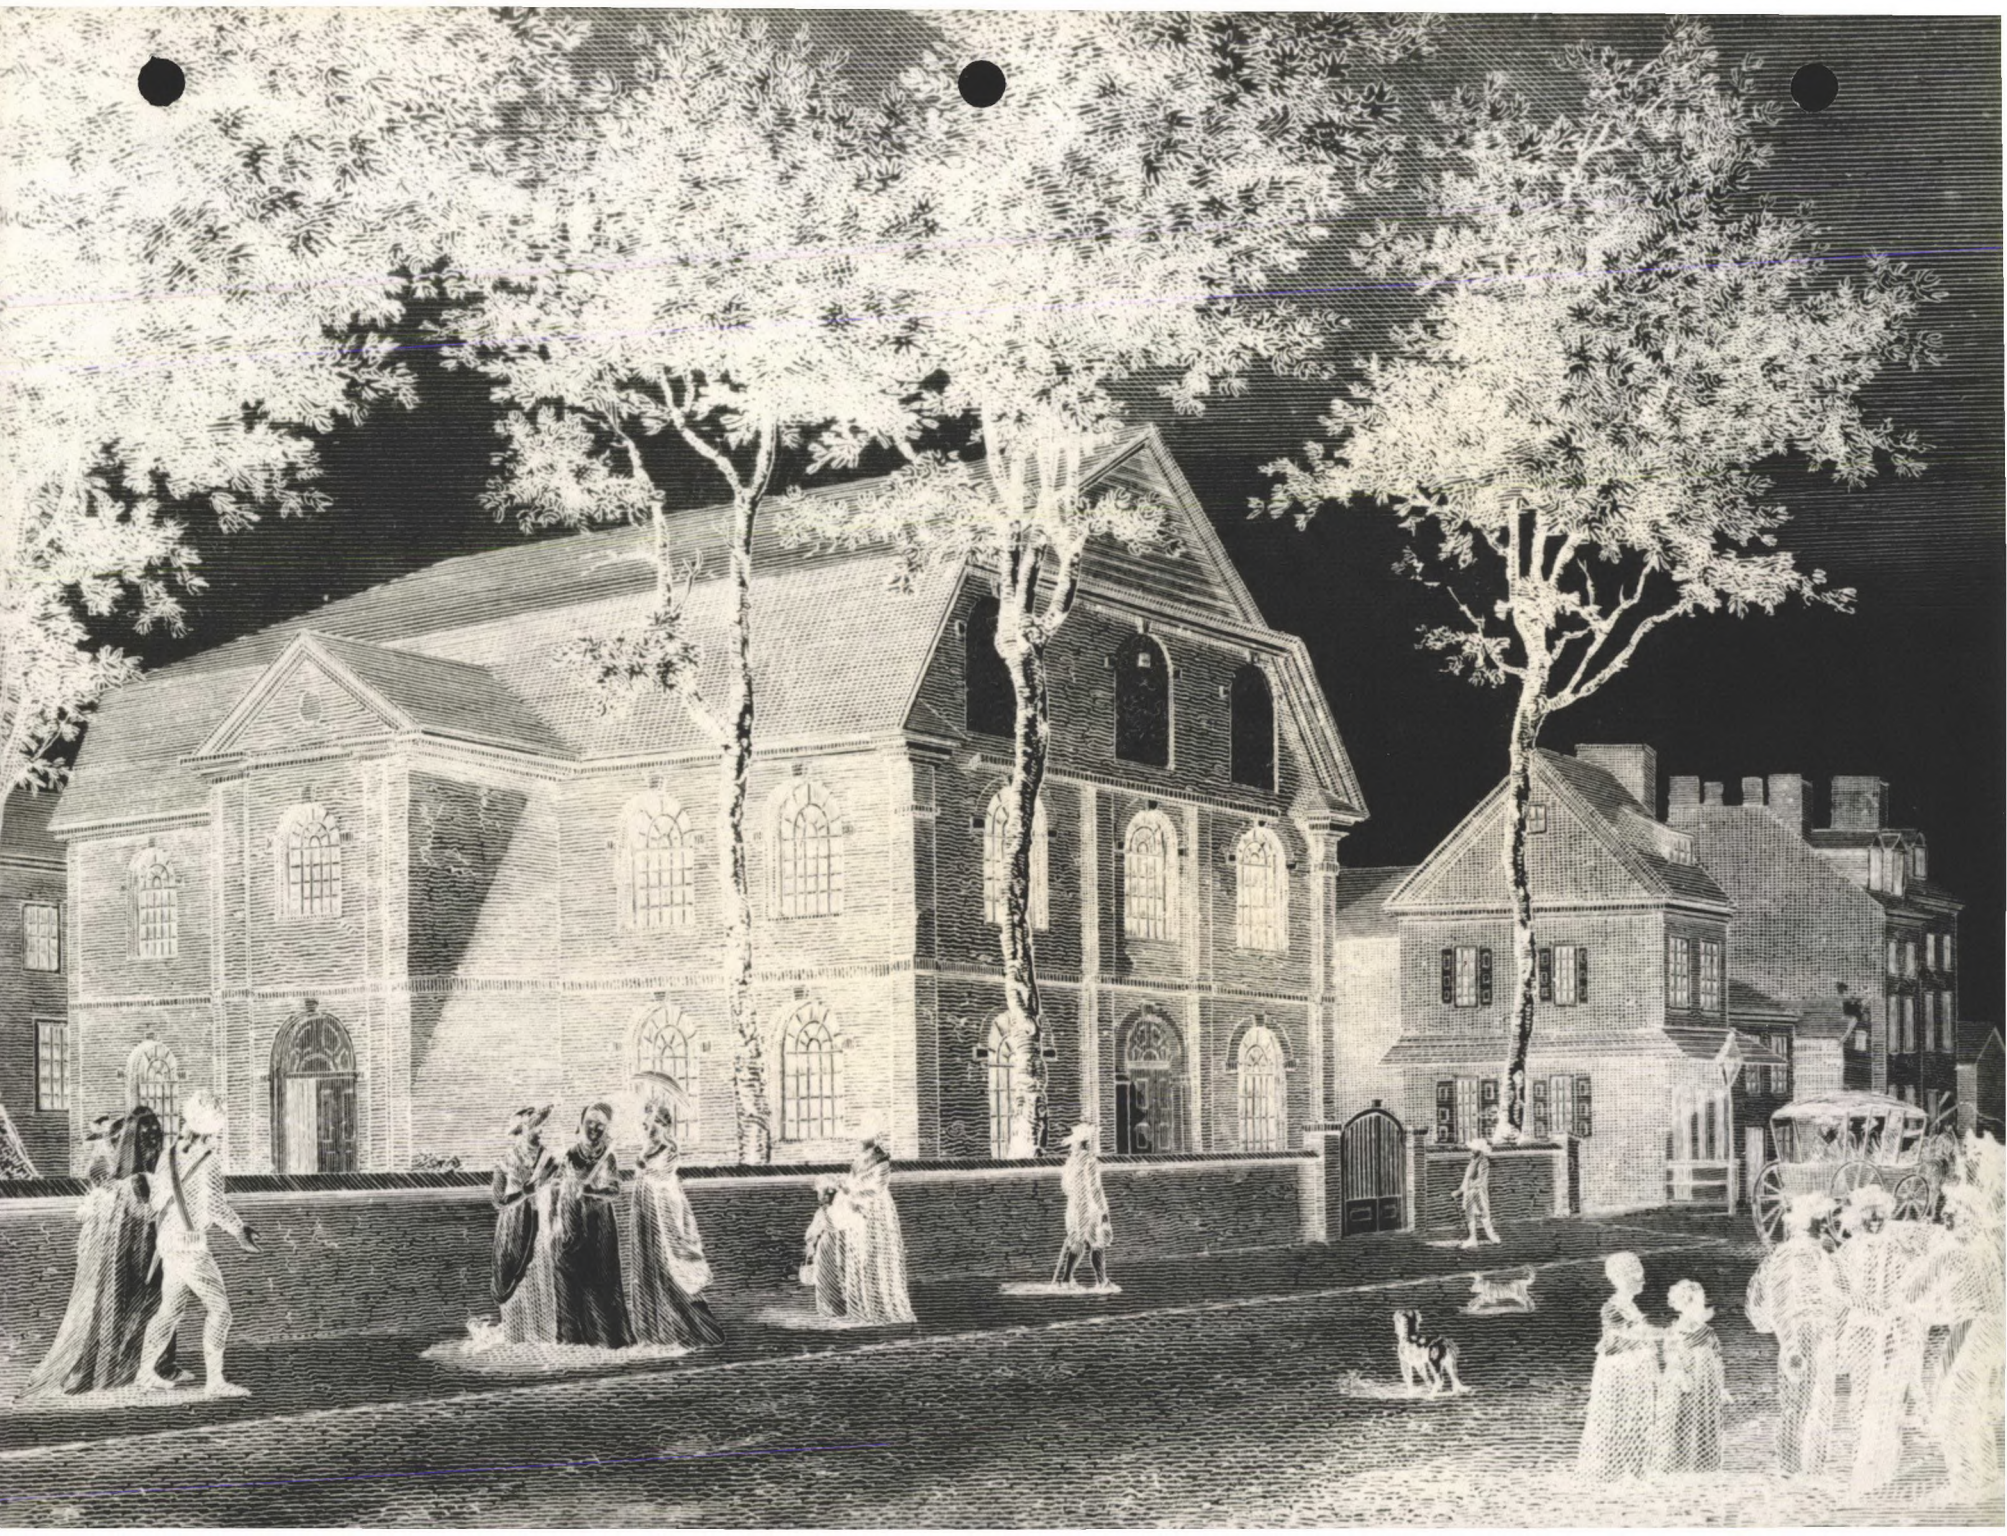
The top of the brick yard wall at the old Lutheran Church, 5th Street appears to have been covered by shingles as was the custom at that period. Reverse print of Birch print of 1800.

method of capping walls at that time. Wood shingle copings were used on church yard walls and a few pictures remain to indicate this. These are included in the accompanying photo section. This method of capping was also used extensively in the outlying areas on stone and brick walls. The remains of such treatment exists on a stone wall at the writer's farm in Chester County.

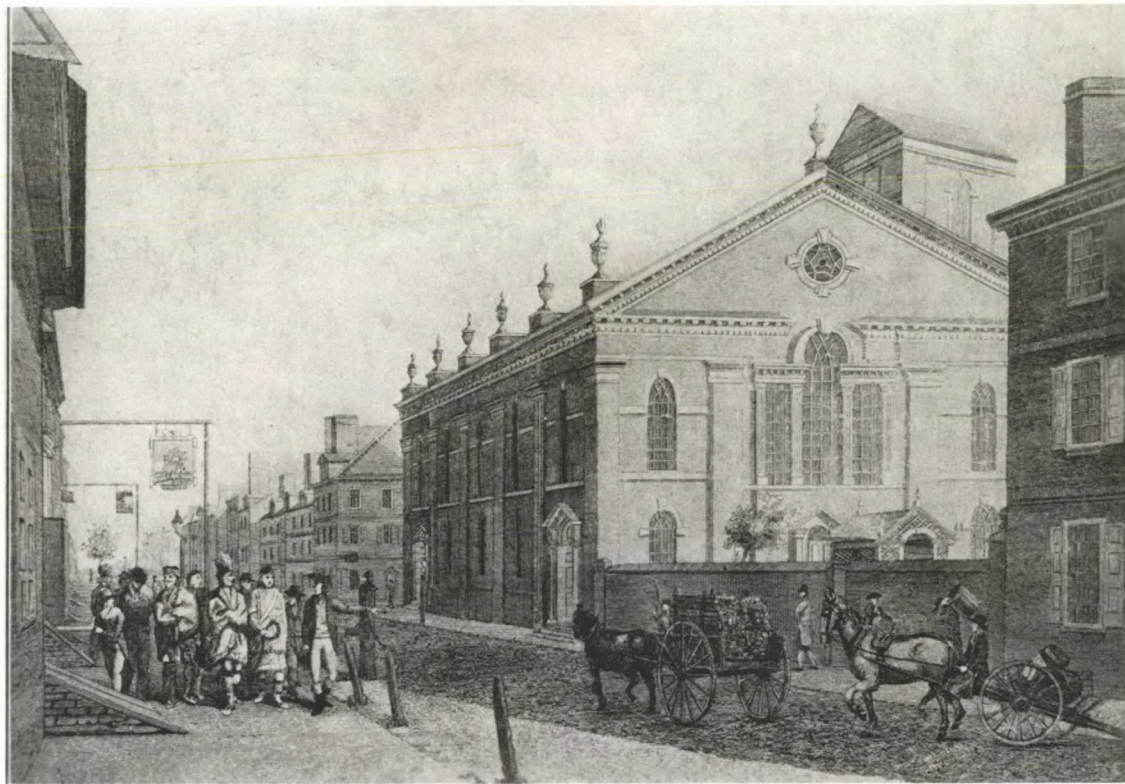
The church yard wall in this print of Old Zion Church in 1789 shows the shingle capping. Note the typical slope of the shingles at the gate opening near the center of the wall.

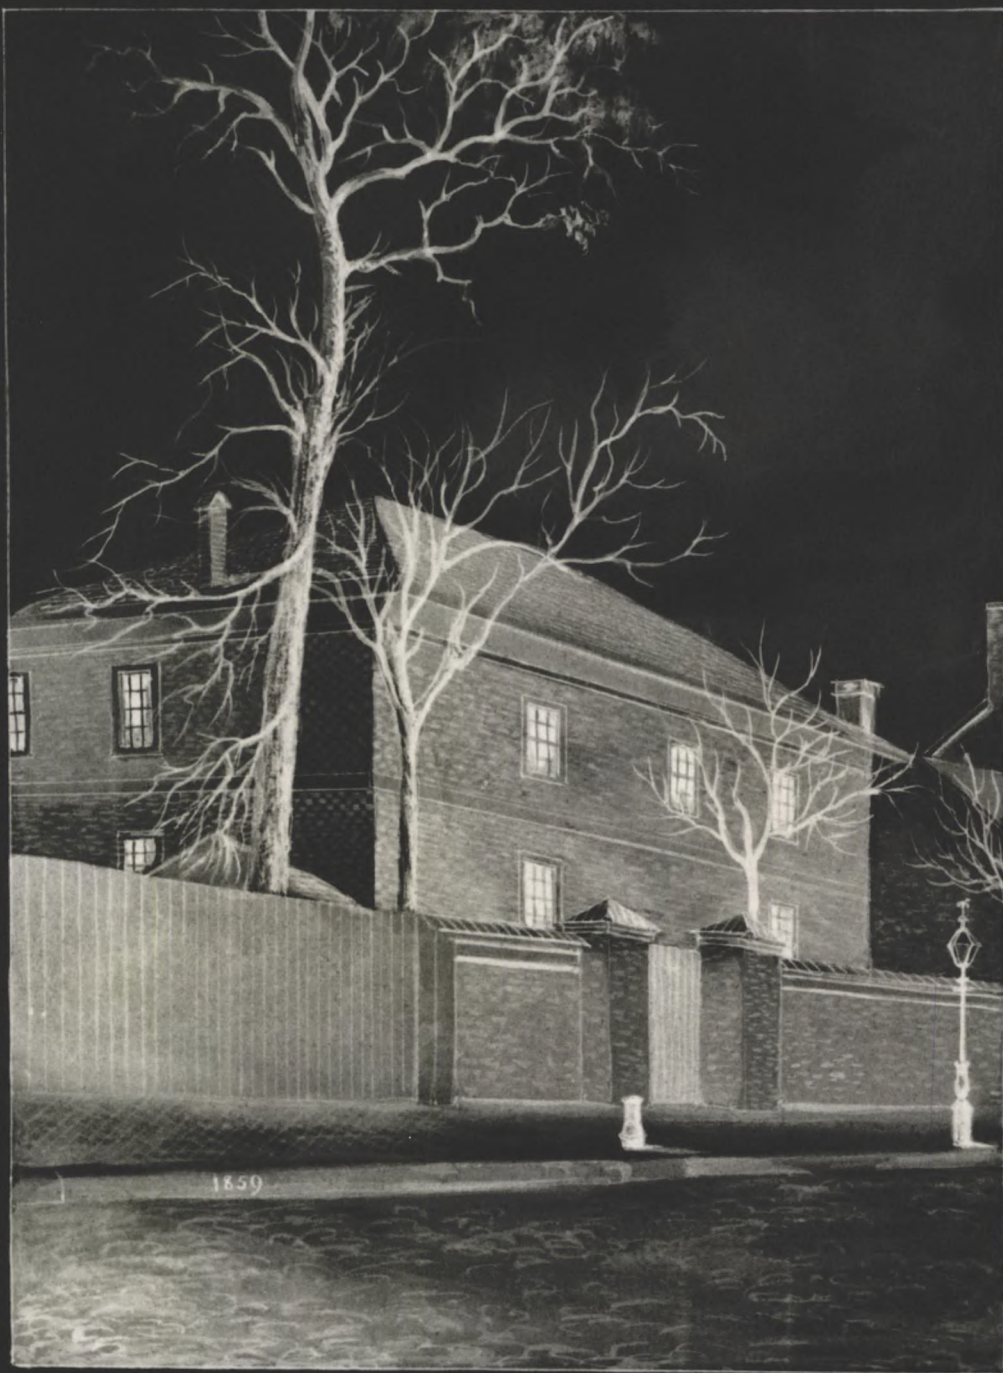
PINE STREET MEETING-HOUSE

1859 print of The Old Pine Street Meeting House  
showing the shingle top and gate posts. It is  
proposed that the yard wall at the Bishop White  
restoration be similarly finished as in this  
and the foregoing prints.
