INTERIM HISTORIC STRUCTURES REPORT

EAGLE TYMPANUM, PORTICO,

FIRST BANK OF THE UNITED STATES

PART II

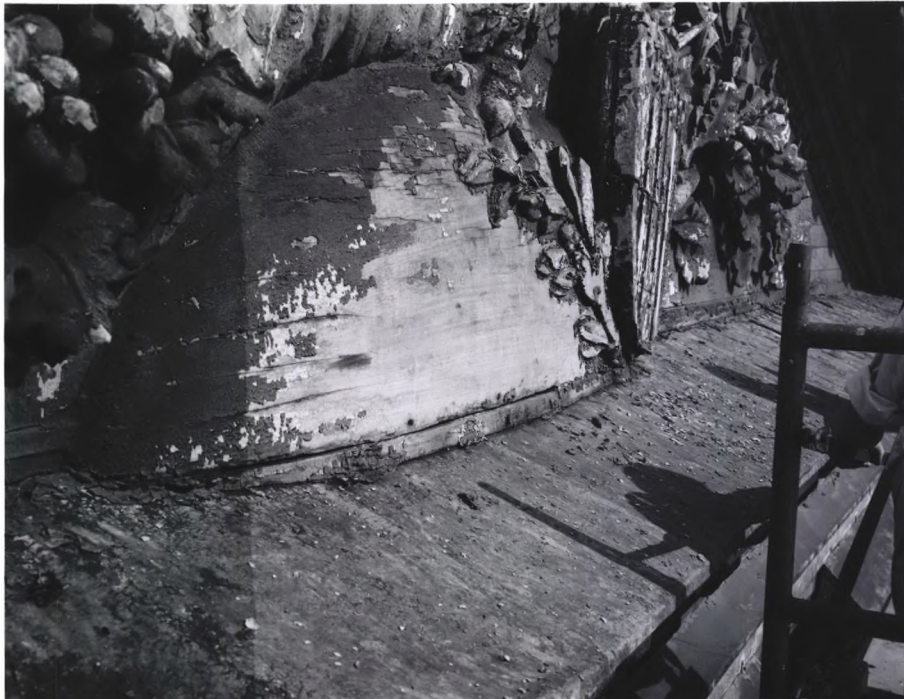
Chapter VI  
Figure 5

The carving is made of a number of pieces of solid mahogany, except for the bottom strip of the globe which is pine. This strip appears to be original, but may have been added after the tympanum was put in place, in order to make the protruding bottom edge of the globe conform to the slope of the horizontal pediment roof. See Figure 5.

dampness can be held, the wood has developed the soft, easily penetrated characteristics of beginning rot. The most serious places of this type of damage are in the right shield shelf, in the back shield-form at the bottom tip, in the bottom pine board of the globe, and in the weather strip to the right of the shield. See Figures 5, 7 and 8. Also, notably in the globe, the areas of wood which have been long exposed to the weather, because of their location and consequent loss of paint, have developed splits and checks. See Figure 5.

4. To test wood for rotting in the weathered areas, and to treat it with an impregnating and preserving agent, or to replace it if it has decayed beyond cure.
