Historic Building Report  
on  
Philadelphia (Merchants') Exchange  
Third and Walnut Streets  
Independence National Historical Park

Independence National Historical Park  
Philadelphia, Pennsylvania

May, 1988

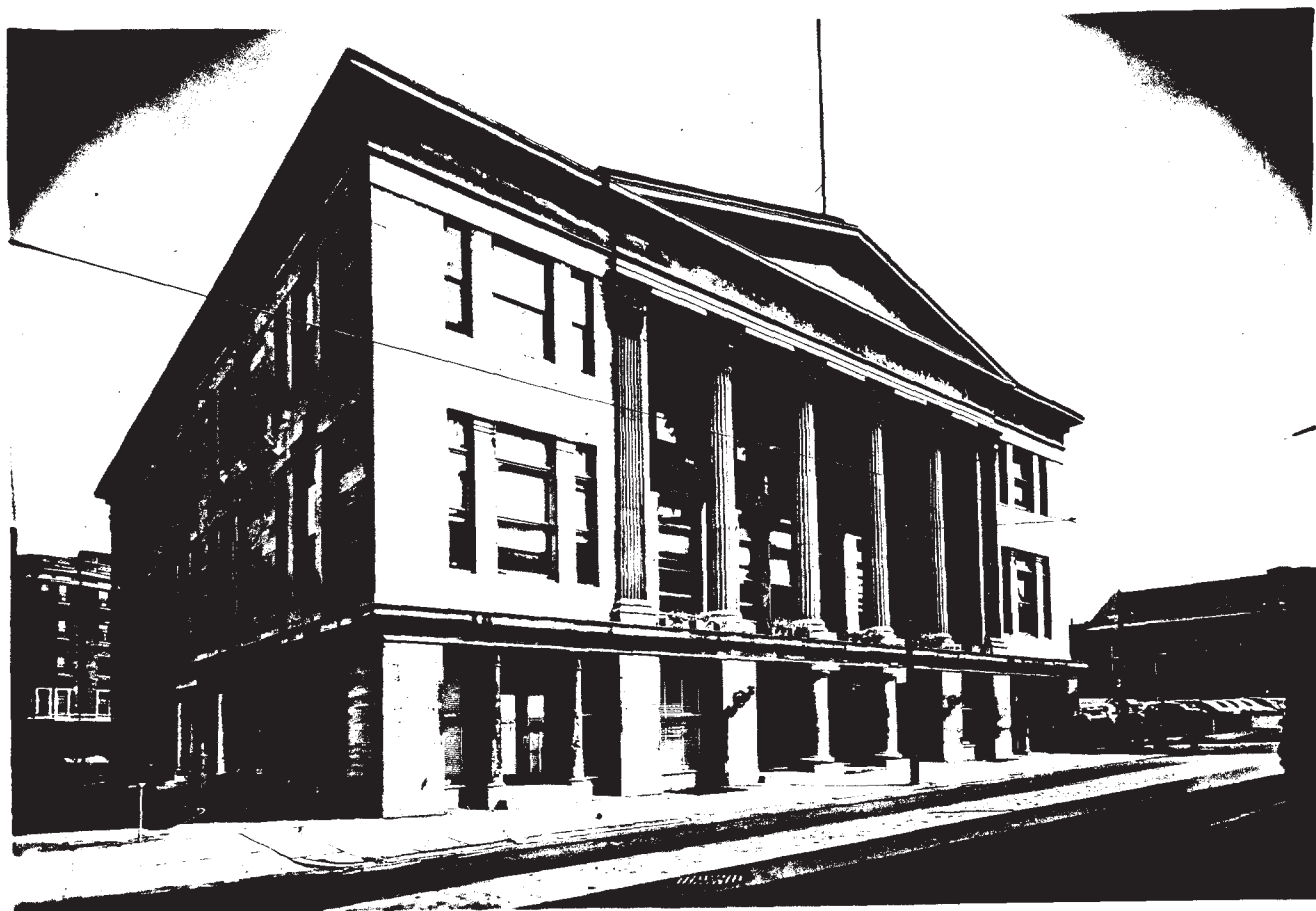
**Chapter XII**  
**Plate No. 4**

**View of west facade on Third Street, 1954.**

Sometime between 1869, and 1890, the east doors were replaced by more ornate doors, and the small lights of glass in windows were replaced by large panes of glass (see Plate Nos. 3 and 4).

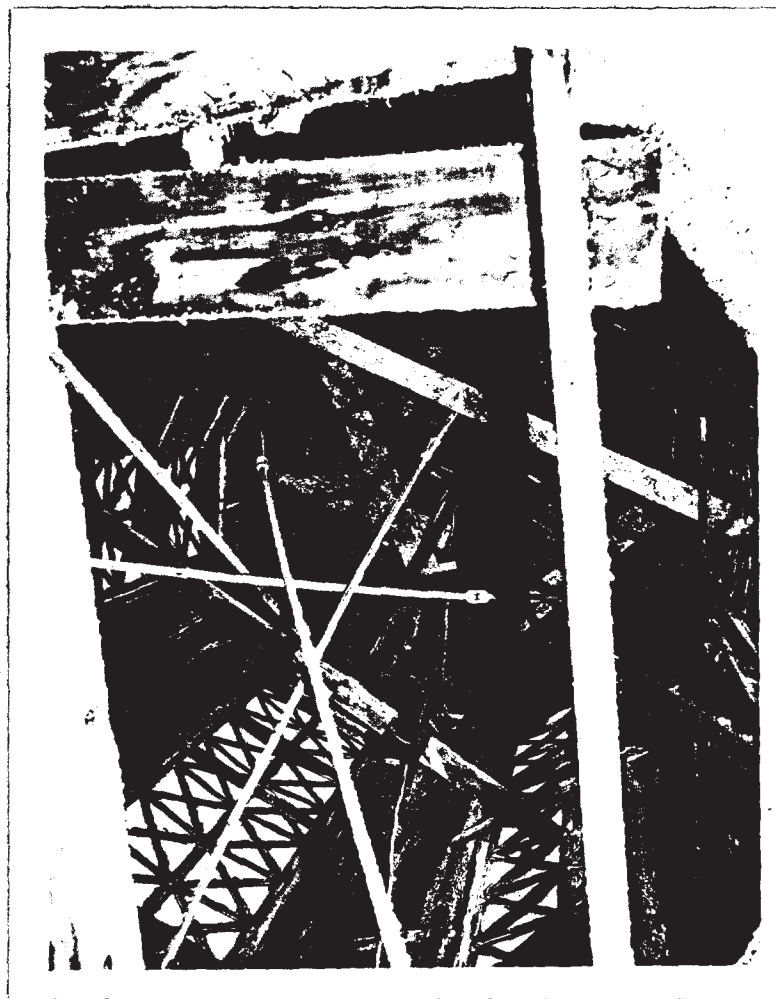
Interior view of the existing Hickman tower  
looking up to the roof showing methods of  
framing and bracing.

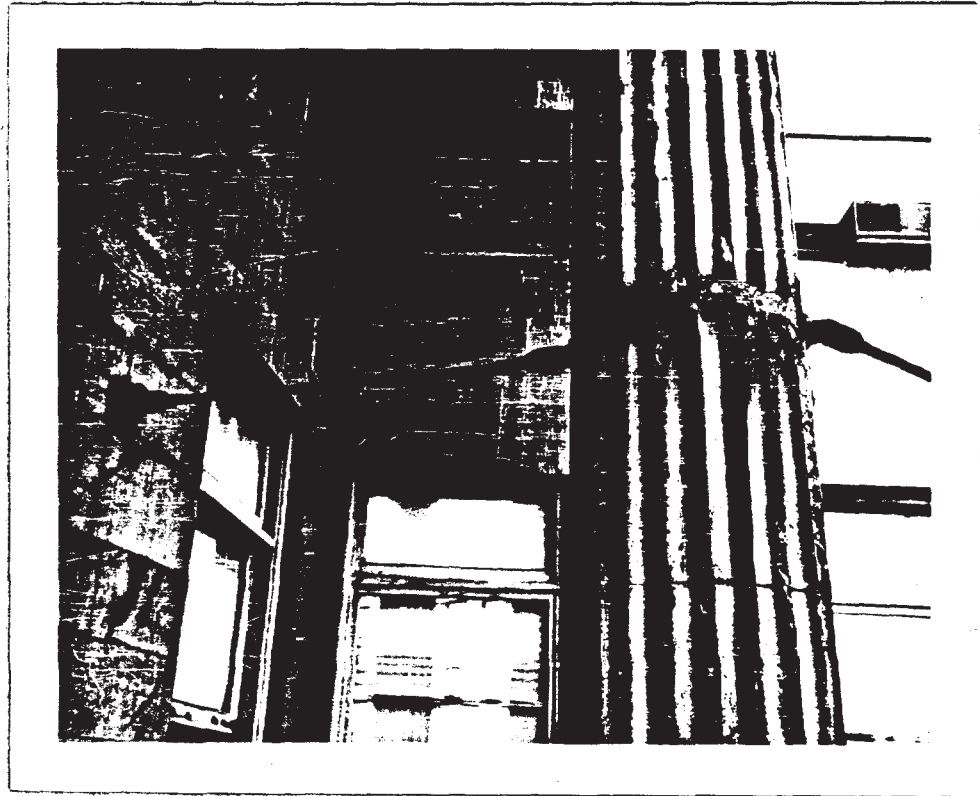
Detail showing how roofs of the produce sheds were  
anchored to the columns and wall of the east portico.

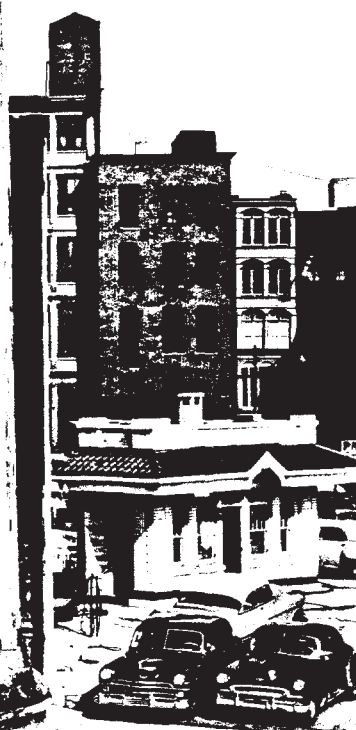
Detail showing mutilations of columns caused by  
the construction of the produce sheds and also the  
disintegration of the columns due to weathering  
and the effect of acids in the air.

Detail showing mutilation of portico floor  
resulting from the construction of the produce  
sheds.

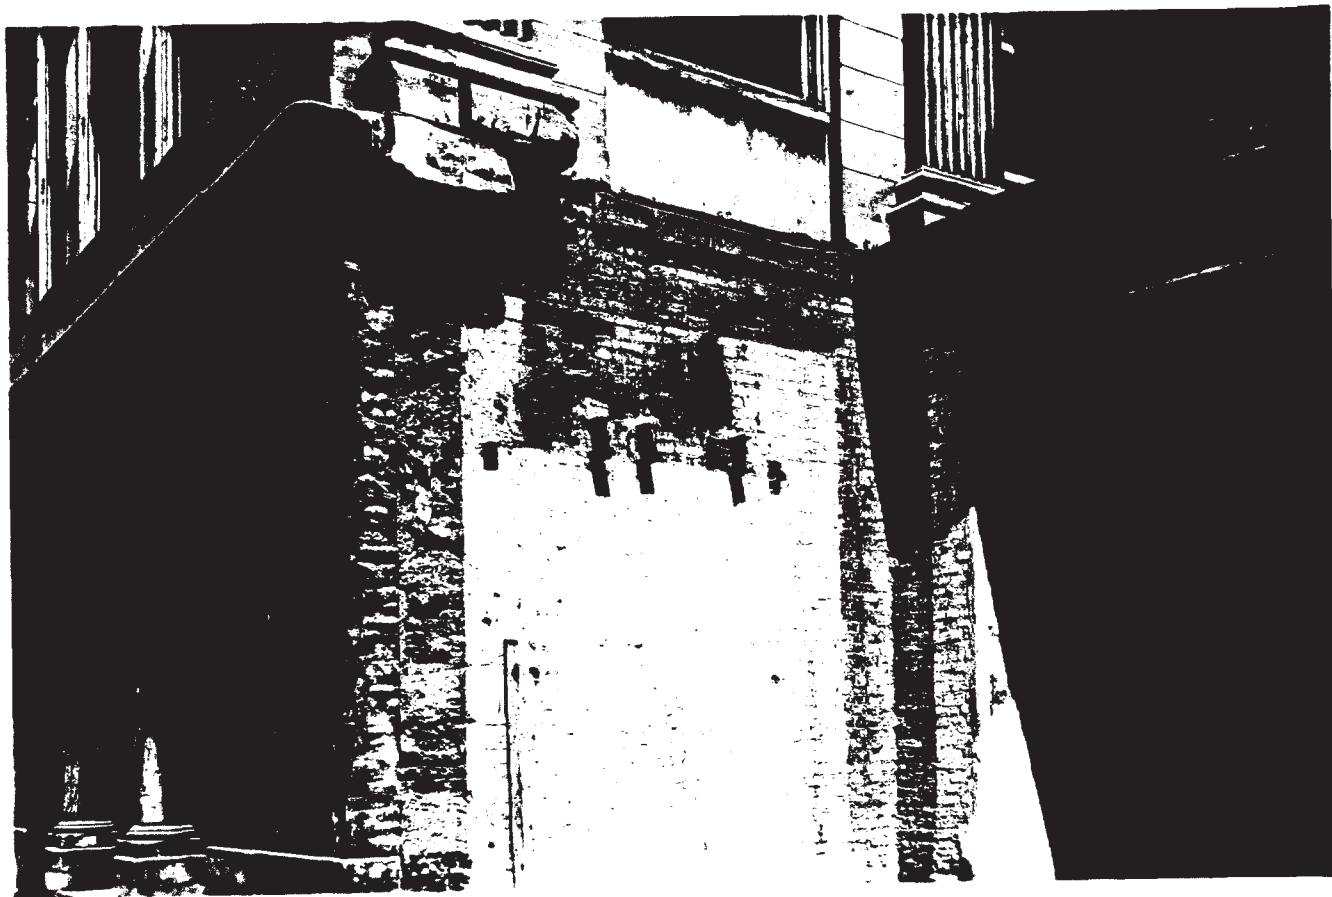
Detail at south staircase after the removal of  
the produce sheds.

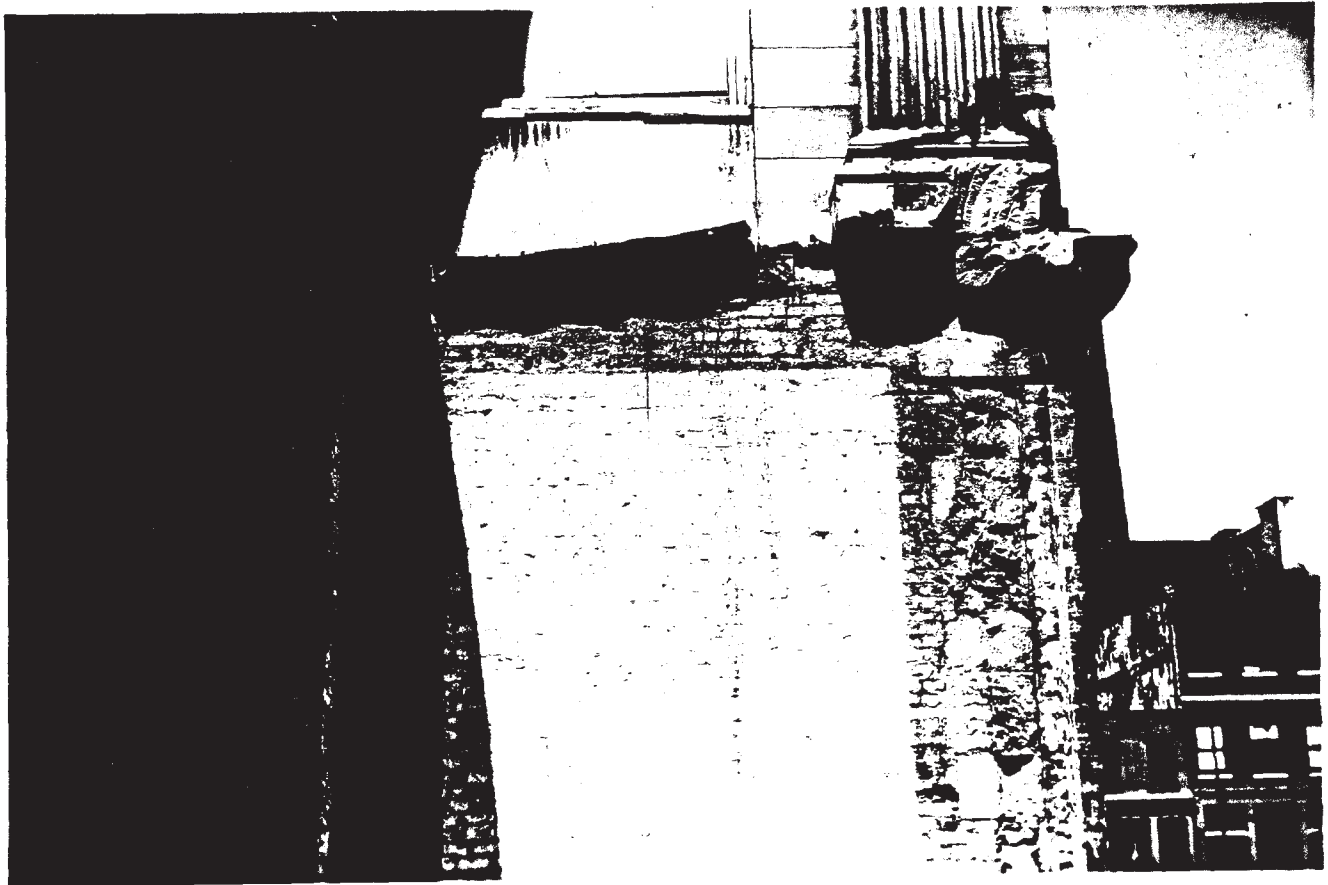
Detail at north staircase after the removal of  
the produce sheds.

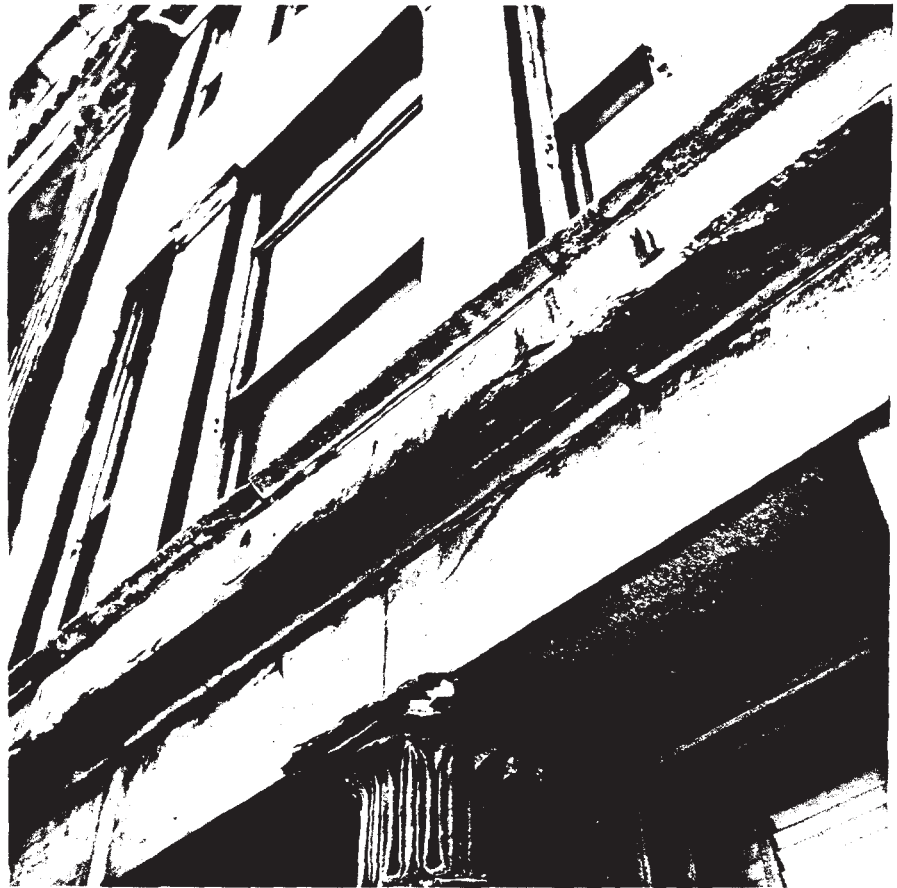
Detail of Walnut Street cornice at second floor showing effects of weathering on the drips and water table. This condition exists around the entire building.

The elements have eroded the soft Pennsylvania blue marble facing of the exterior walls until large sections of water tables and drips have disintegrated, permitting water to run down the walls and seep into the masonry joints (see Plate Nos. 21 and 22). Where layers of soot and dust adhere to the marble they form a wick which absorbs and holds acids from the air and intensifies their corrosive action. Over the years this has resulted in the disintegration of

large areas of the marble surfaces (see Plate Nos. 23 and 24). Suitable materials and methods must be found to clean and seal the exceptionally soft marble without destroying the surface and architectural details. The eroded water tables and drips must be re-established.

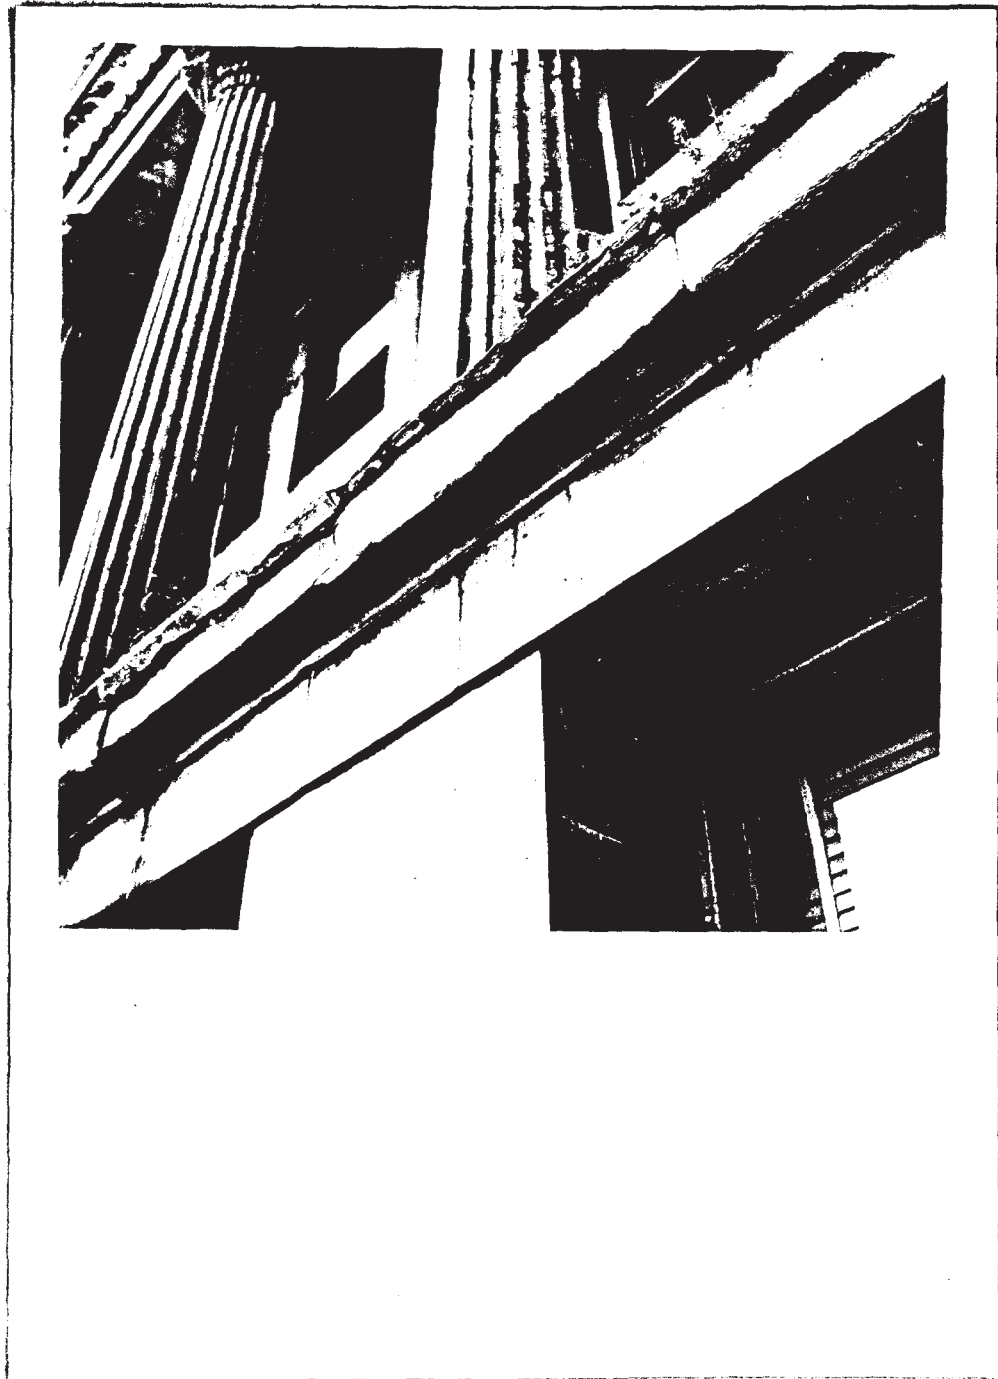
Detail of Third Street cornice at second floor.  
The condition of the main cornice at the roof  
is in similar condition.

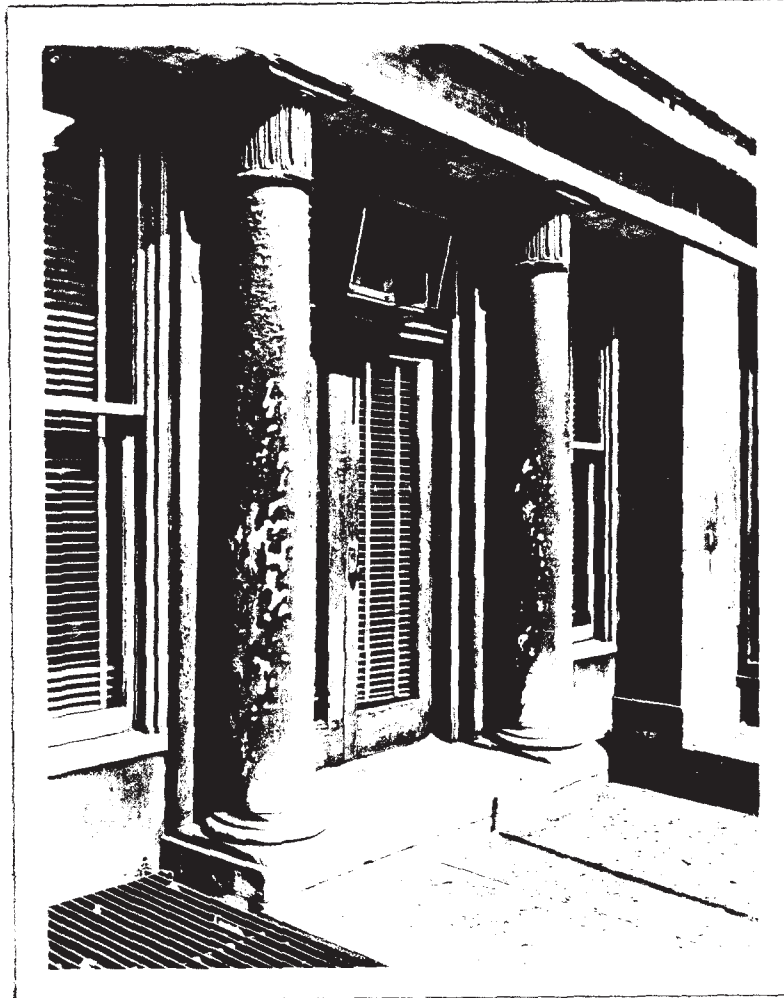
Columns along Walnut Street showing effect  
of dust and acid on the marble surfaces.

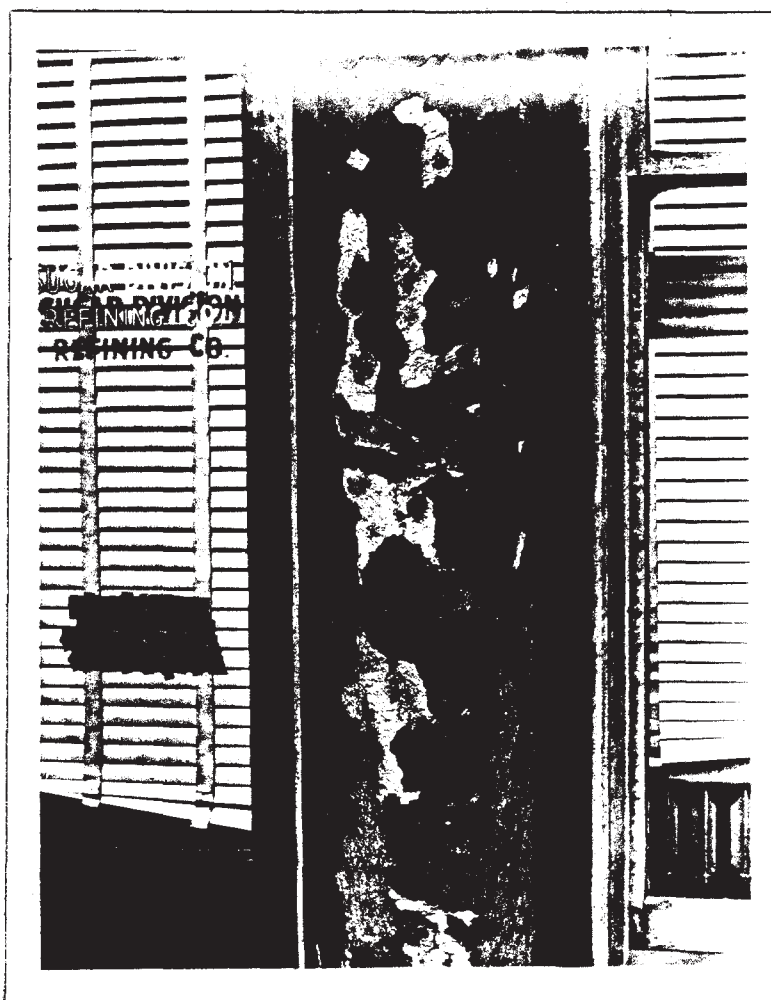
Detail showing effect of acid absorbed by  
soot and dust adhering to the marble surfaces.  
The effect is so extensive and deep that the  
surface frequently forms large blisters which  
crumble when pressure is applied.

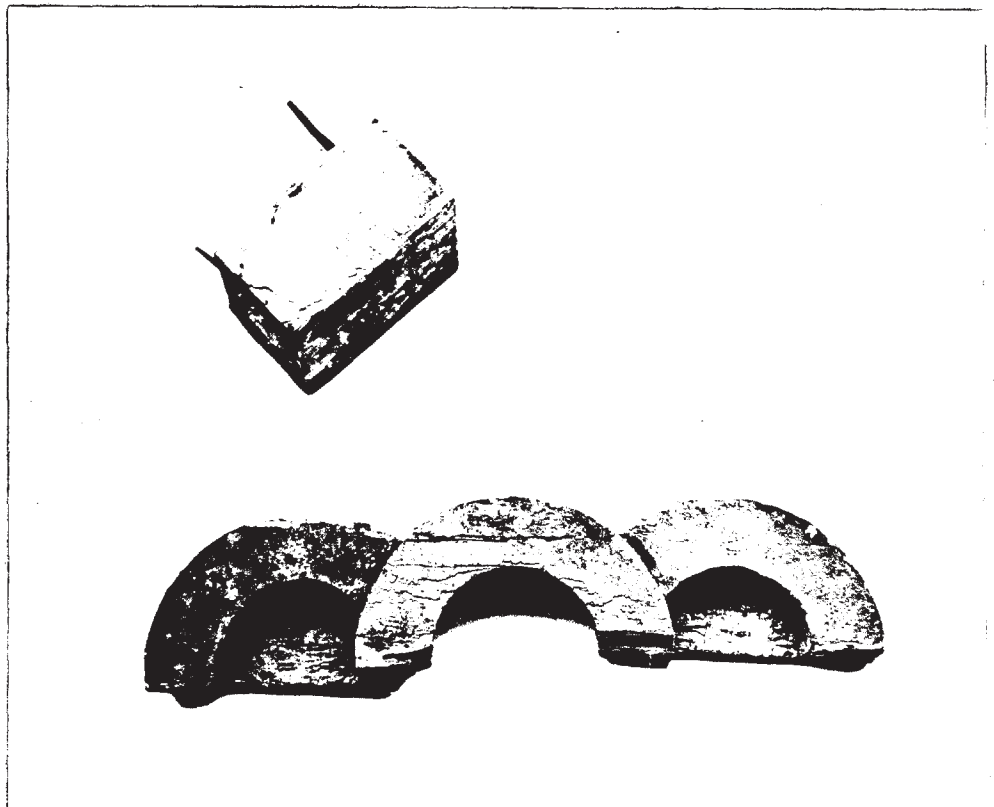
Detail of dentil and tripod ornament from  
the original Strickland lantern found while  
investigations were being made of the building.  
This view shows front elevation of portion of  
the brazier.

The tripod decorative element in the intercolumniation area of the tower is the only decorative part of the tower based on actual physical evidence (Record Book, p. 41; see Plate No. 37). The top part of one of these pieces, as well as a dentil from the original tower (see Plate Nos. 49 and 50), was found this summer in the dead space between the east rotunda soffit area and the roof. Not only was this of incalculable aid in determining an accurate reconstruction of this element, but the subtle curve of the rear of the piece determined without question the original circumference of the tower (see Plate No. 50). Thus a check was possible on the circumference previously determined by the 1/4" blowup of the 1849 photograph which was found quite accurate with this later dimension.
