HISTORIC STRUCTURES REPORT, PART II  
on  
PHILADELPHIA (MERCHANTS') EXCHANGE  
INDEPENDENCE NATIONAL HISTORICAL PARK  
JULY 1960

**HISTORIC STRUCTURES REPORT, PART II**  
**OR**  
**PHILADELPHIA (MERCHANTS') EXCHANGE**  
**INDEPENDENCE NATIONAL HISTORICAL PARK**

**July 1960**

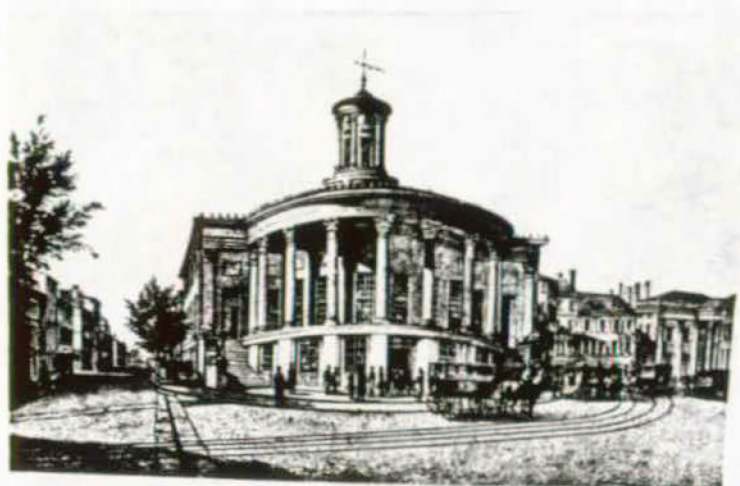
THE MERCHANTS' EXCHANGE, 1840  
Print Lit Entry 323

View of the Philadelphia Exchange in 1840,  
engraved by J. T. Bowen. Photo taken from  
Nicholas Wainwright, Philadelphia in the  
Romantic Age of Lithography.

Note that the center folding doors in the  
first floor rotunda are set farther back  
than are those on either side.

A comparison between Illustration No. 1, an 1840 view of the Exchange, and Illustration No. 2, a recent photograph of the building taken from the same angle as the 1840 engraving, suggests the major steps necessary to restore the building's exterior. These steps were listed in Chapter III, Section 4, page 1, of the Part I report as follows:

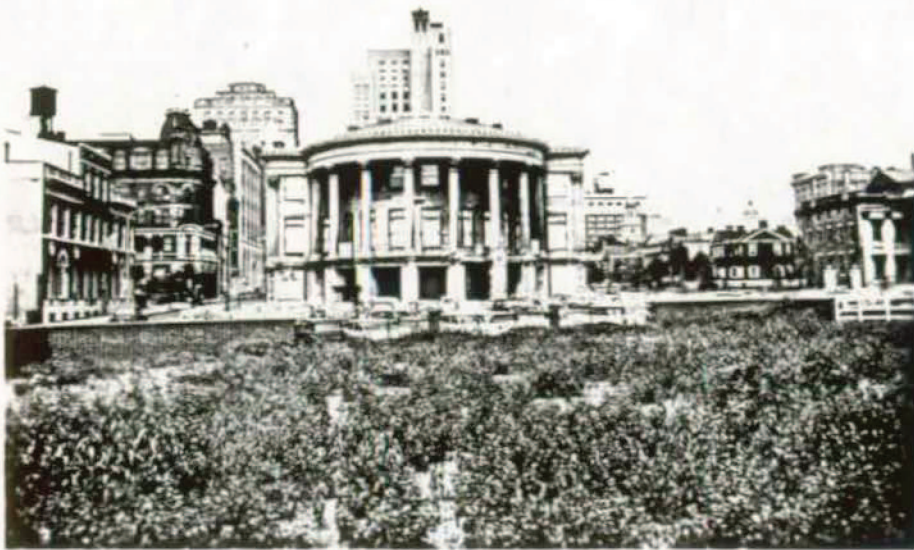
The Philadelphia Exchange today. Comparison with the 1840 engraving on the facing page shows the extent of the alterations the east facade has undergone.

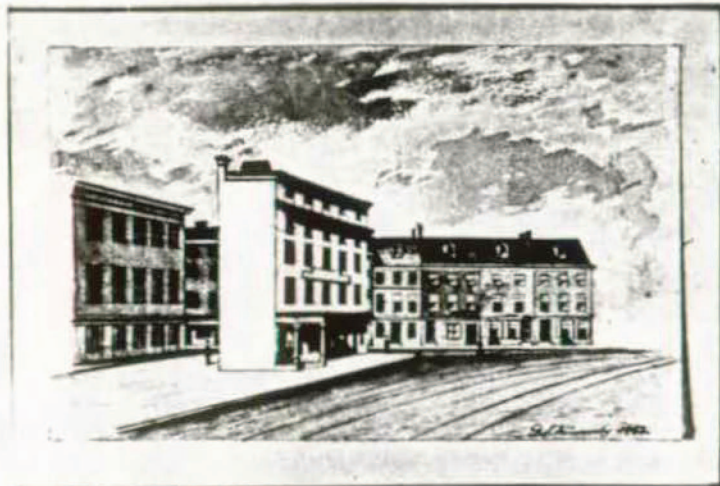
Southeast corner of Third and Dock Streets in 1852. Watercolor by D. J. Kennedy. Courtesy of Historical Society of Pennsylvania.

The north wall of the Exchange is shown at the left.

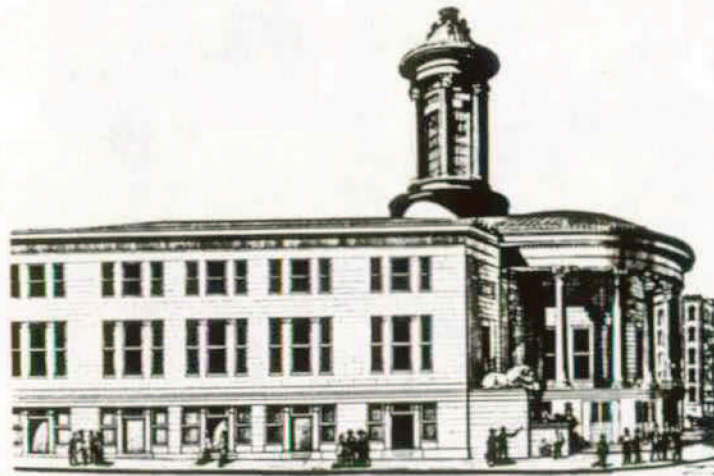
Unidentified, undated view of south wall of  
Exchange, from Shrines Commission Report.

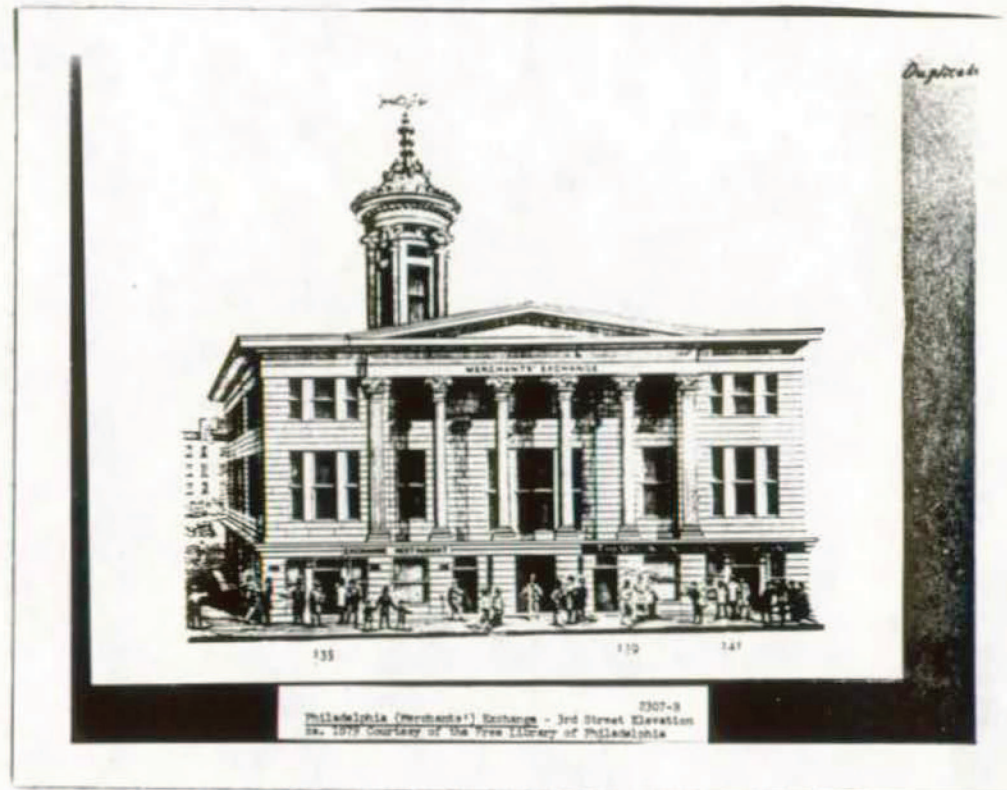
West facade of the Philadelphia (Merchants')  
Exchange, c. 1879. Courtesy of Free Library  
of Philadelphia.

Two nineteenth century views of the West (Third Street) Facade of the Exchange which were omitted from Part I are included among the illustrations of this report (see Illustrations Nos. 5 and 6). These confirm the statements made in the Interim Part II report that there were originally eight windows, four doors and a center entrance in the first floor of this

facade and that within the portico of the facade there were originally a tripartite window flanked on either side by single windows at both the second and third floors.<sup>4</sup>
