## Diagram of c.1834 Summer Beam in Attic Floor

# DETAIL OF SUMMER BEAM IN ATTIC FLOOR FRAMING (Section 2, c.1834)

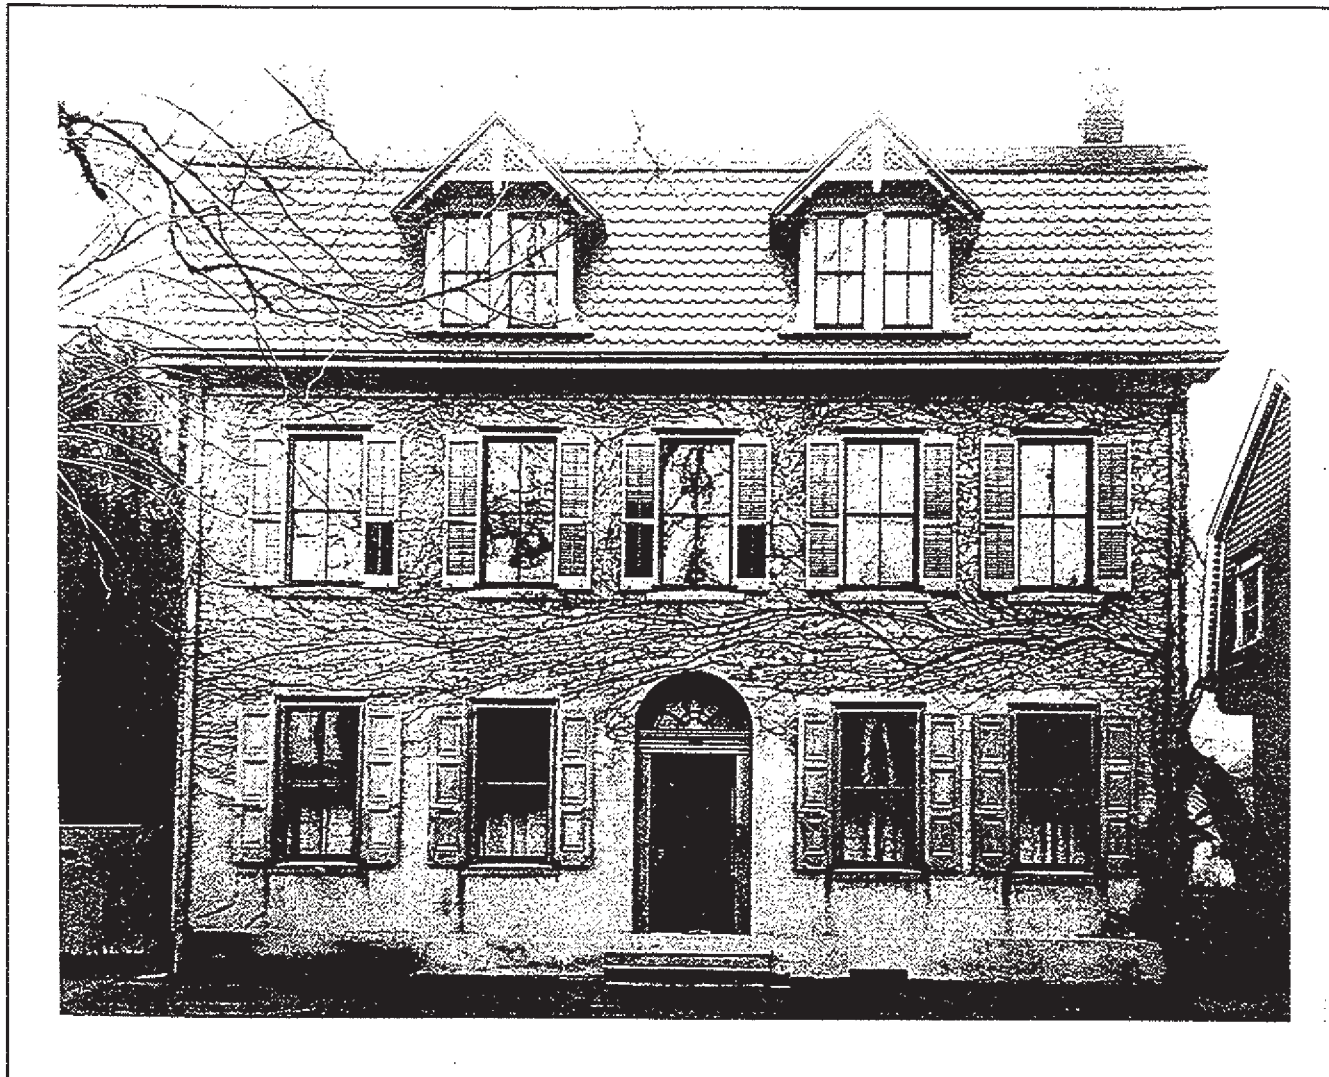
Plate 5. Historic photo showing the full east facade of the Bringhurst House as it looked in the early 20th century. This view clearly shows the full impact of the c.1895 renovation.

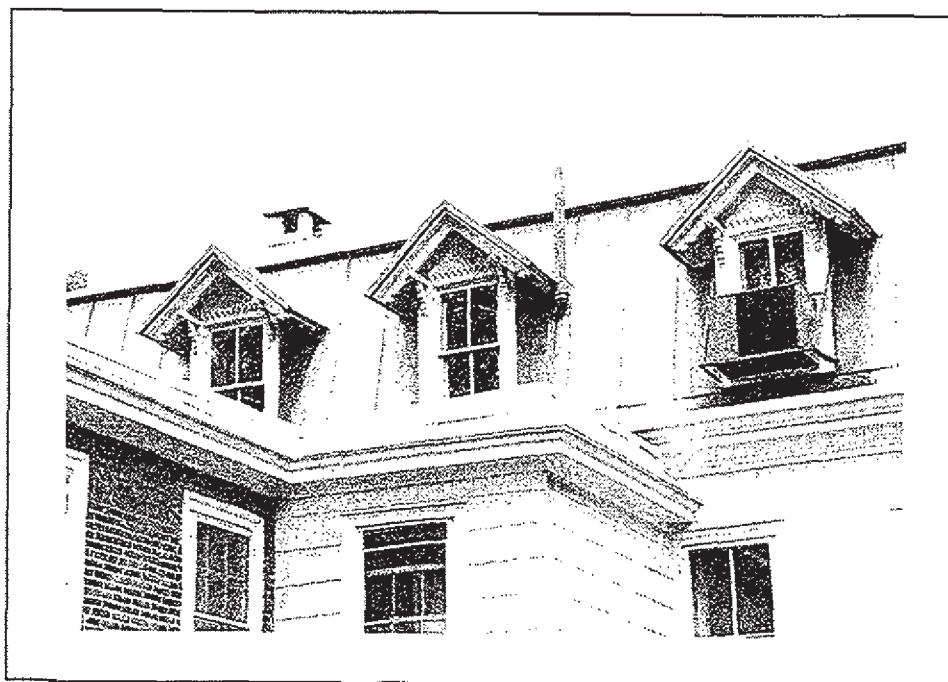
Plate 9. A detail of the c.1895 dormer windows surviving on the rear of the main roof.

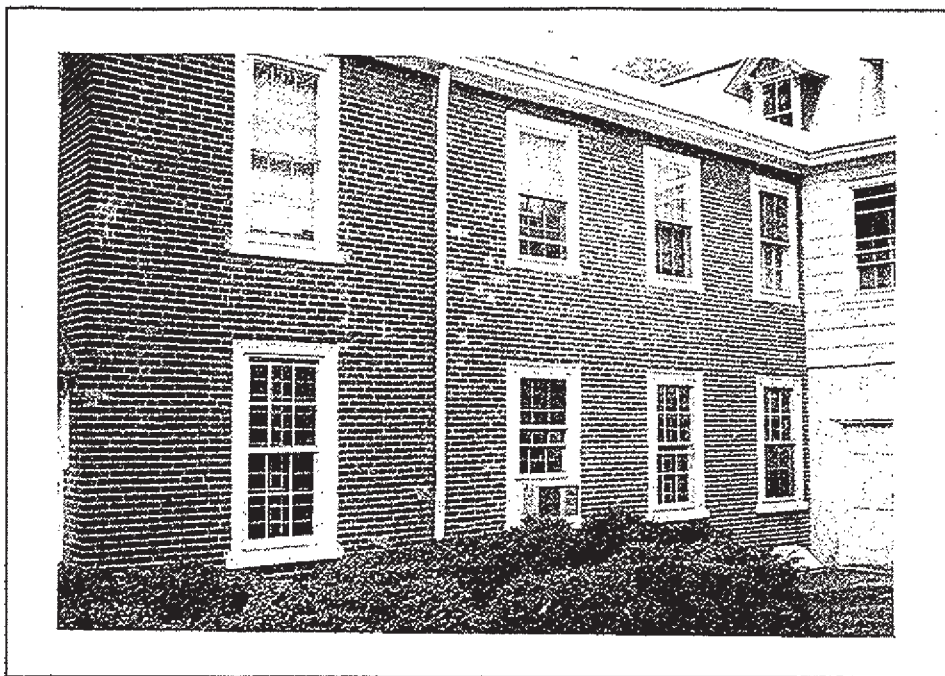
Plate 10. View of the rear extension showing Section 4 at the left of the downspout, Section 3 is to the right.  
Note the difference in the brick bonding patterns.

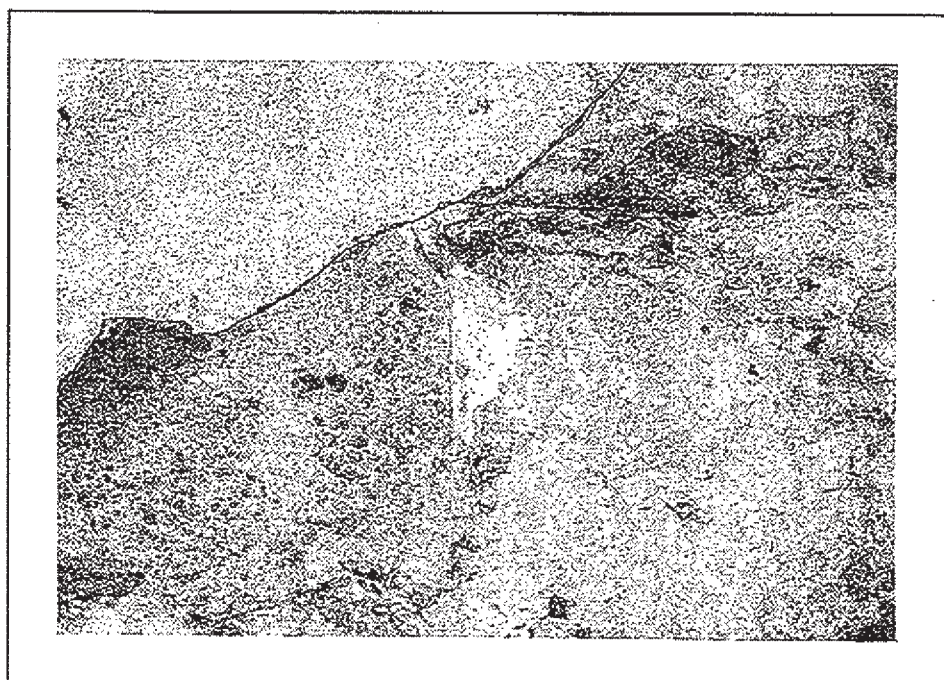
Plate 29. Cellar of Section 3, northwest corner. Detail of c.1850 stair tread in plaster of the north wall.
