**BRINGHURST HOUSE**  
**HISTORIC STRUCTURES REPORT**  
**ARCHITECTURAL DATA SECTION**

**PART II**

by  
**Thomas Clinton McGimsey**  
**Historical Architect**

Independence National Historical Park

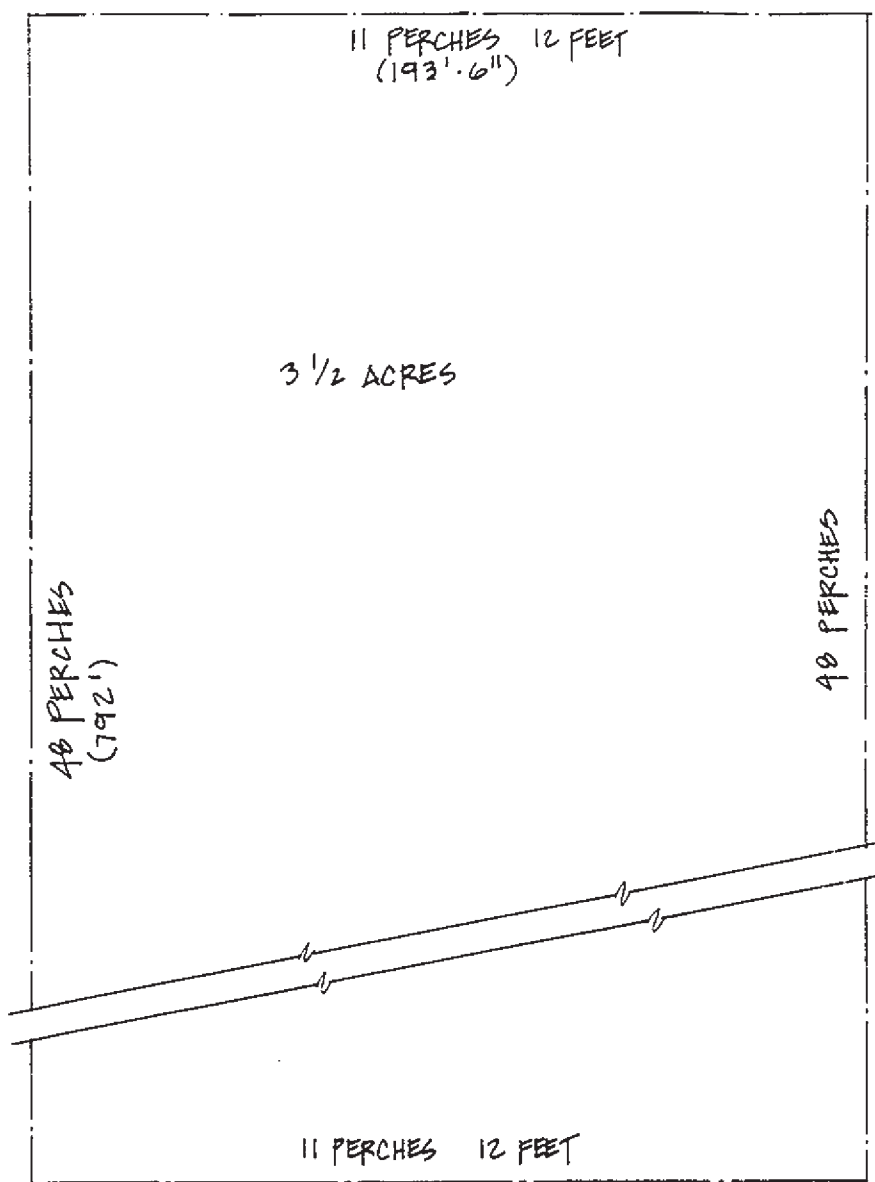
Figure 1. Plot plan of the lot purchased by George Bringhurst, Sr. in 1726.

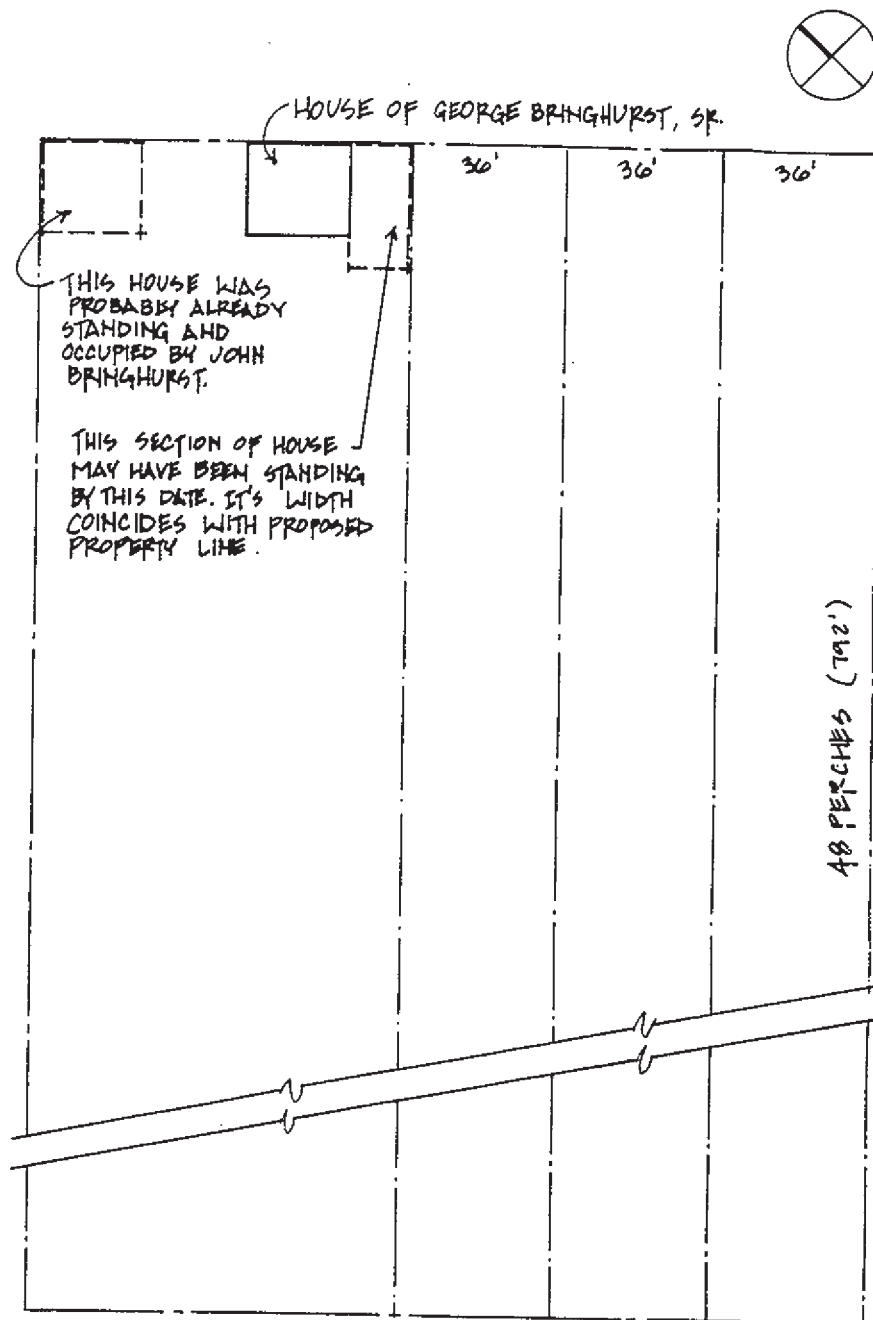
Figure 2. Plot plan of George Bringhurst's property showing location of lots offered for sale in 1751. This exact subdivision was not realized.

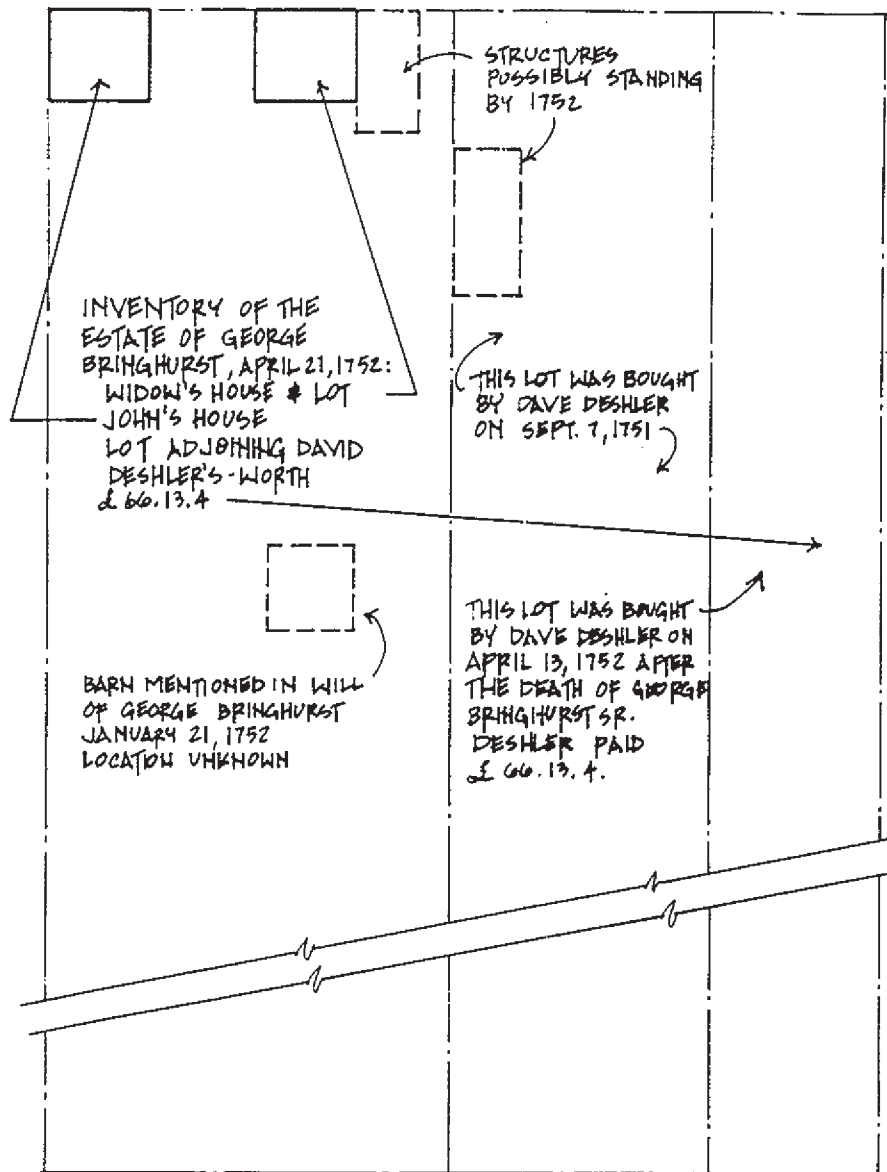
Figure 3. Plot plan showing development of Bringhurst lot soon after the death of George Bringhurst, Sr. in 1752.

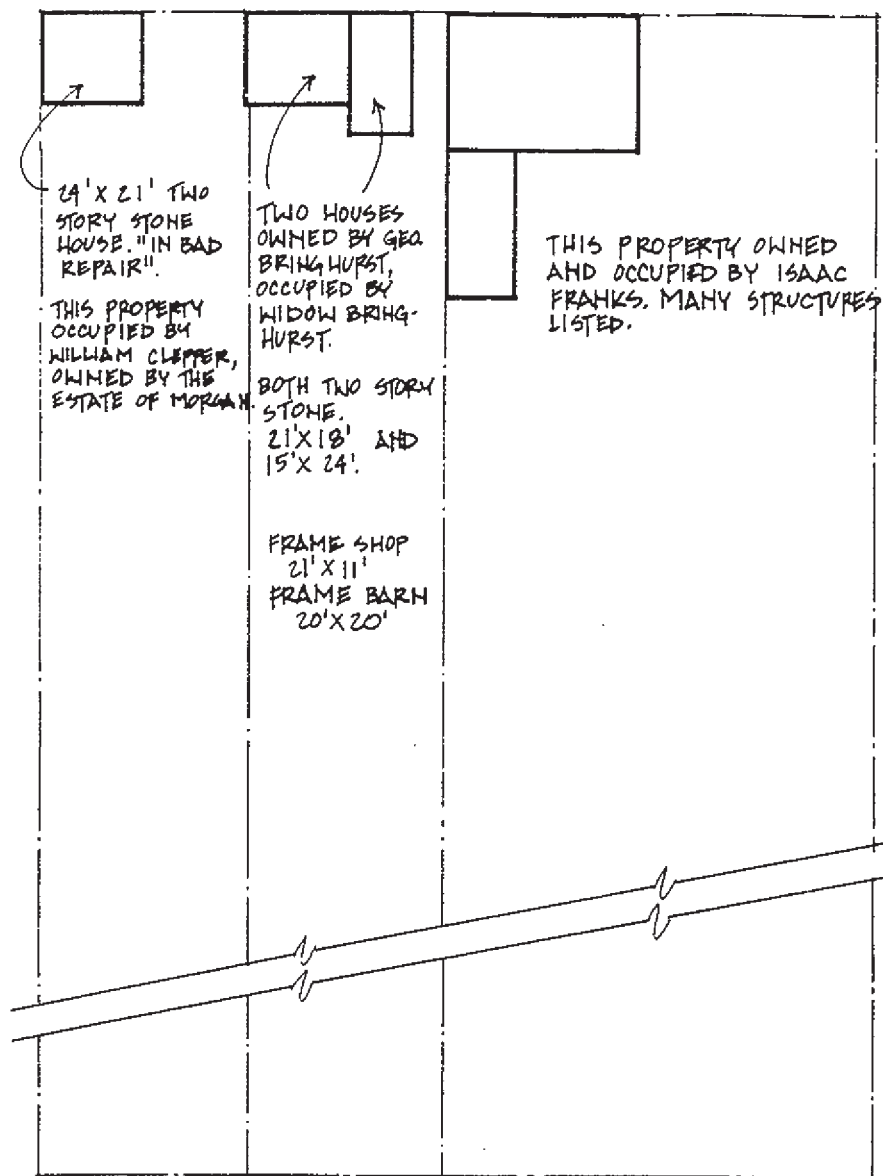
Figure 4. Plot plan of Bringhurst and adjacent properties showing structures described in 1798 U.S. Direct Tax records.

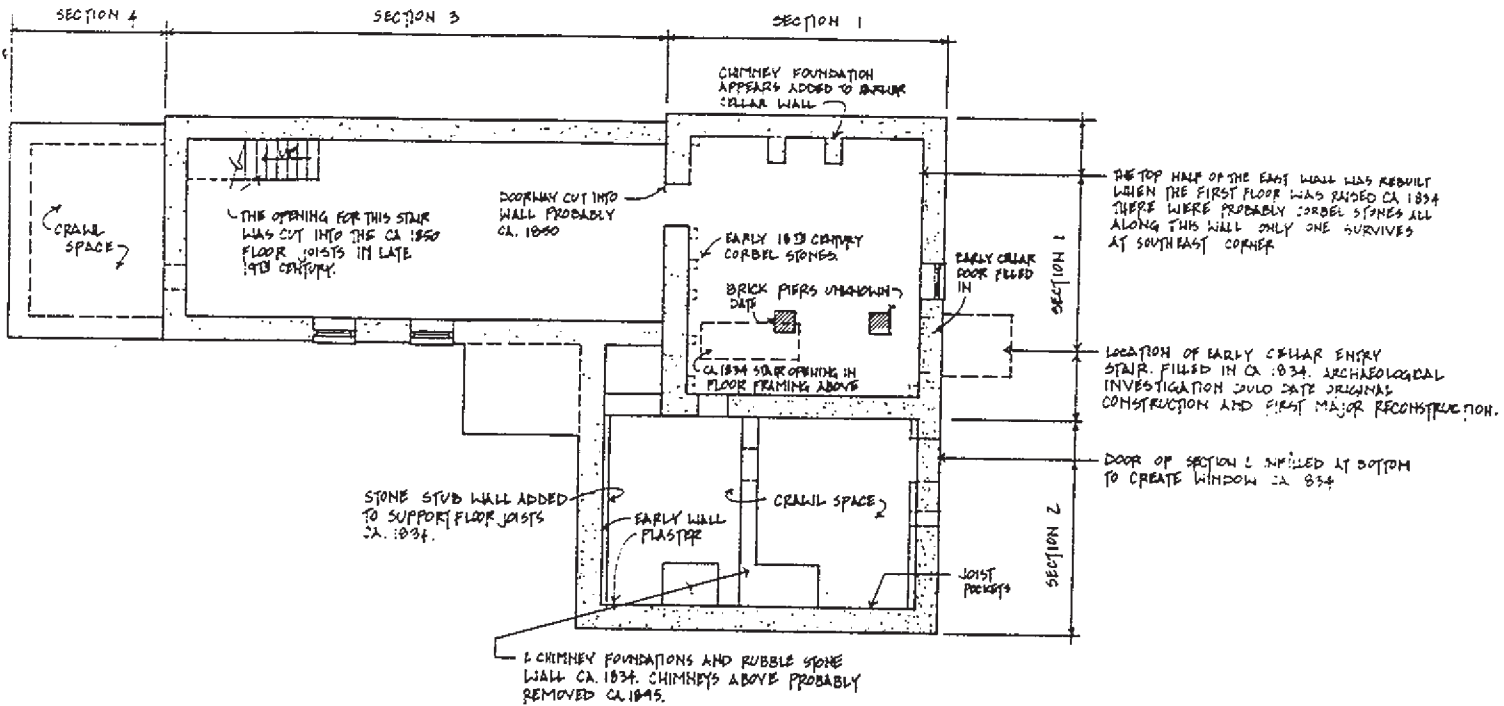
Figure 5.

## CELLAR FLOOR PLAN

Some clues to the size and location of the early house of George Bringhurst Senior can be found in the cellar below the stone eastern front of the house. On the cellar floor plan, (Figure 5), the early cellar space is labeled Section 1. This cellar room appears to have survived numerous major renovations to the rest of the house above and was almost certainly part of the house that was standing when George Bringhurst Senior died in 1752. The depth of Section 1 along the northern edge of the property coincides with the curious offset in the northern property line. The fact that the property line moves back 7" to the south around the northwestern corner of the early cellar suggests that not only was the cellar, and the house above, standing before 1763, but also that another structure or a rear kitchen wing may have existed behind the house.

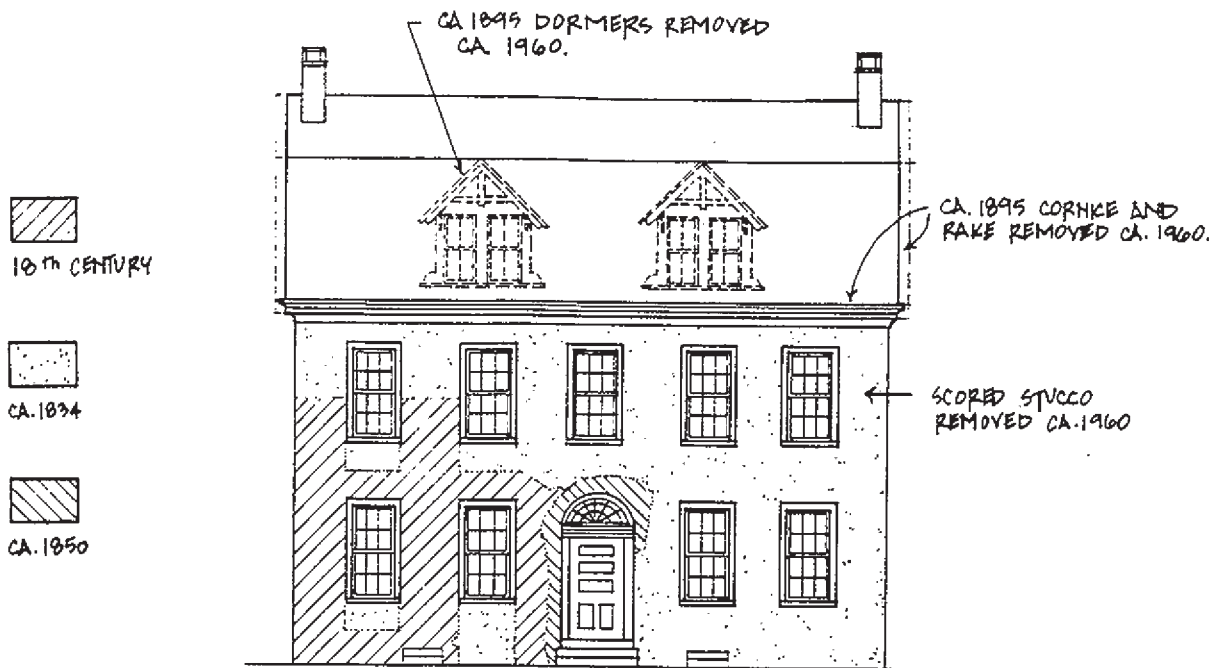
## East Elevation

Figure 10. Showing evidence of alterations

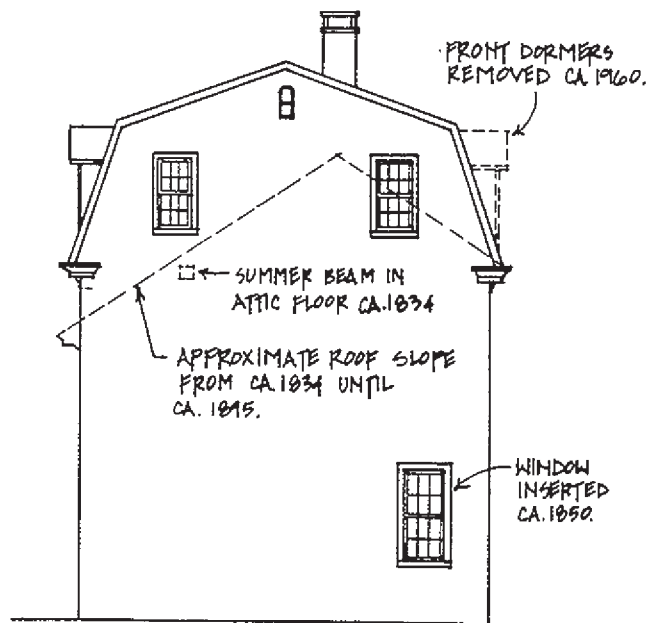
## South Elevation (partial)

Figure 11. Showing the approximate slope of the roof prior to c.1895 alterations.

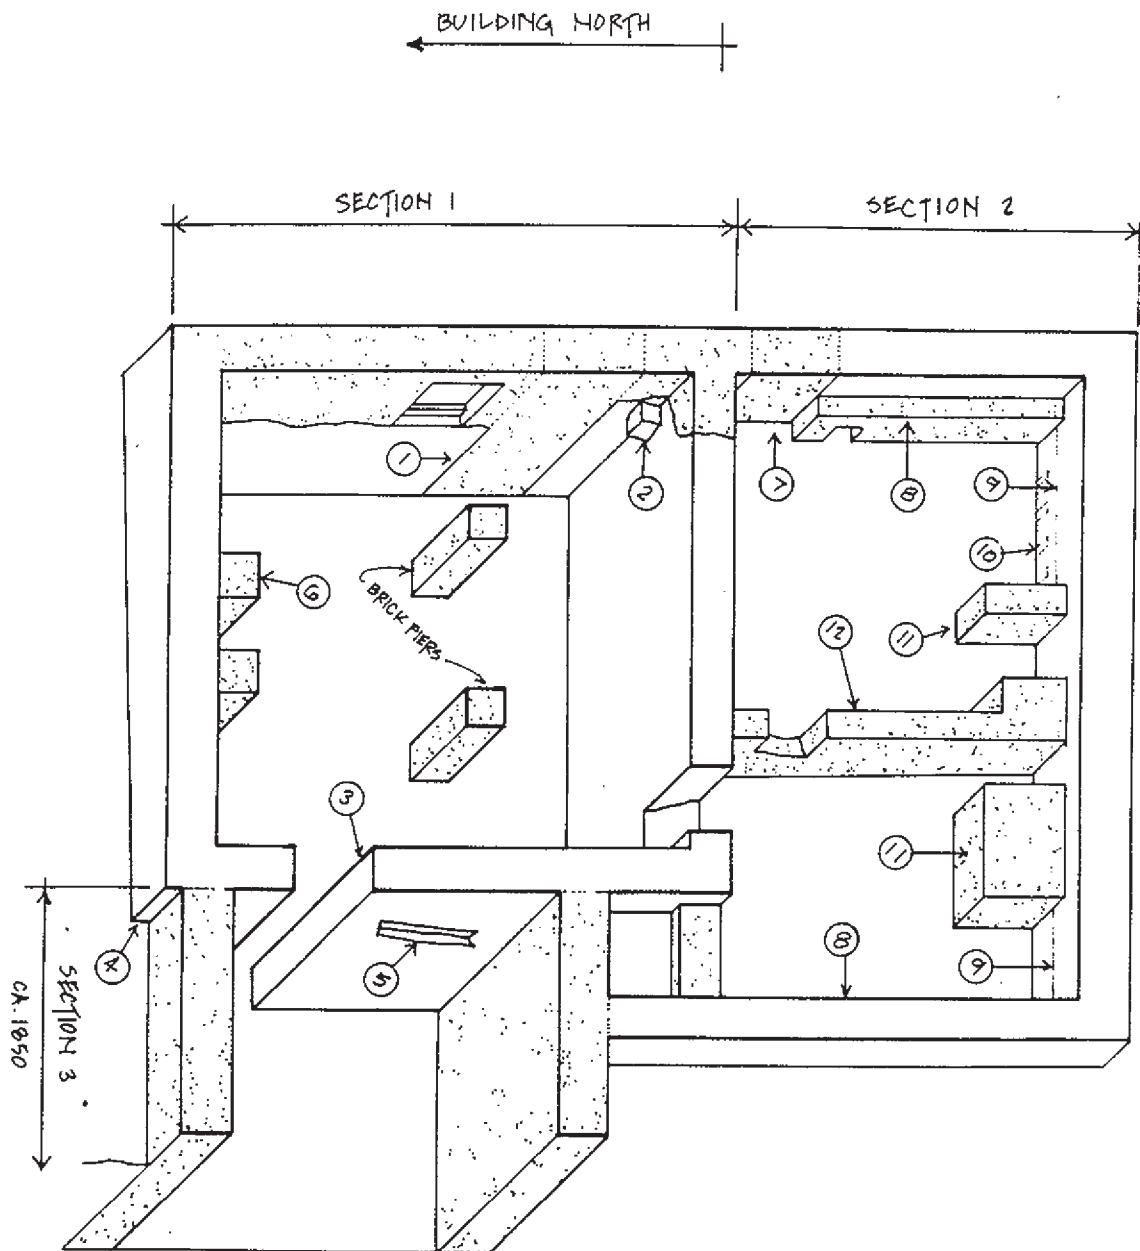
Figure 12.

# FOUNDATION DIAGRAM

4. In the northwest corner of the early foundation, the property line follows the wall around the 7" offset. This offset in the property line dates from at least 1753.

wall of this cellar room. (See Figure #12). This section of wall is the exterior of the foundation of Section 1 and resembles the springing for a large arch, possibly the foundation for a kitchen hearth. It is possible that the erection of this section entailed the total removal of a rear wing of the original house, including the kitchen. Without more physical evidence, it is impossible to fully understand the early design of this section of the house.

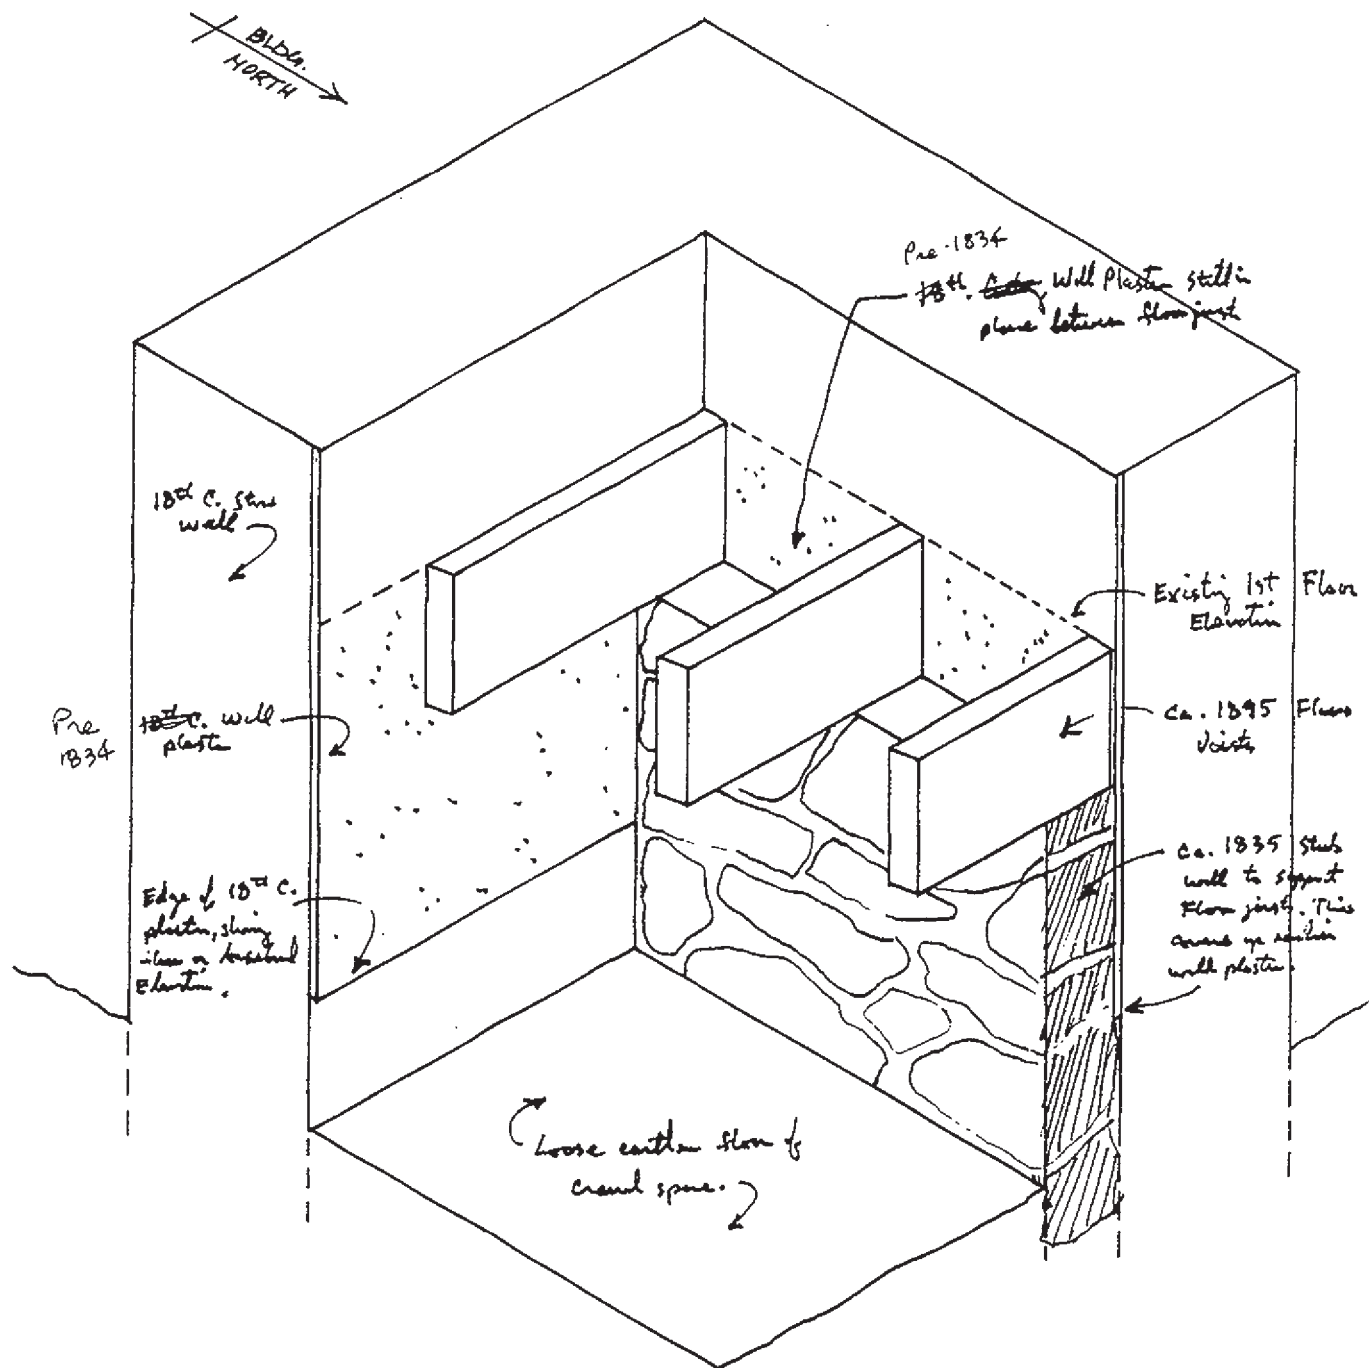
Figure 13.

# DIAGRAM OF PHYSICAL EVIDENCE VISIBLE IN THE SOUTHWEST CORNER OF THE CRAWL SPACE

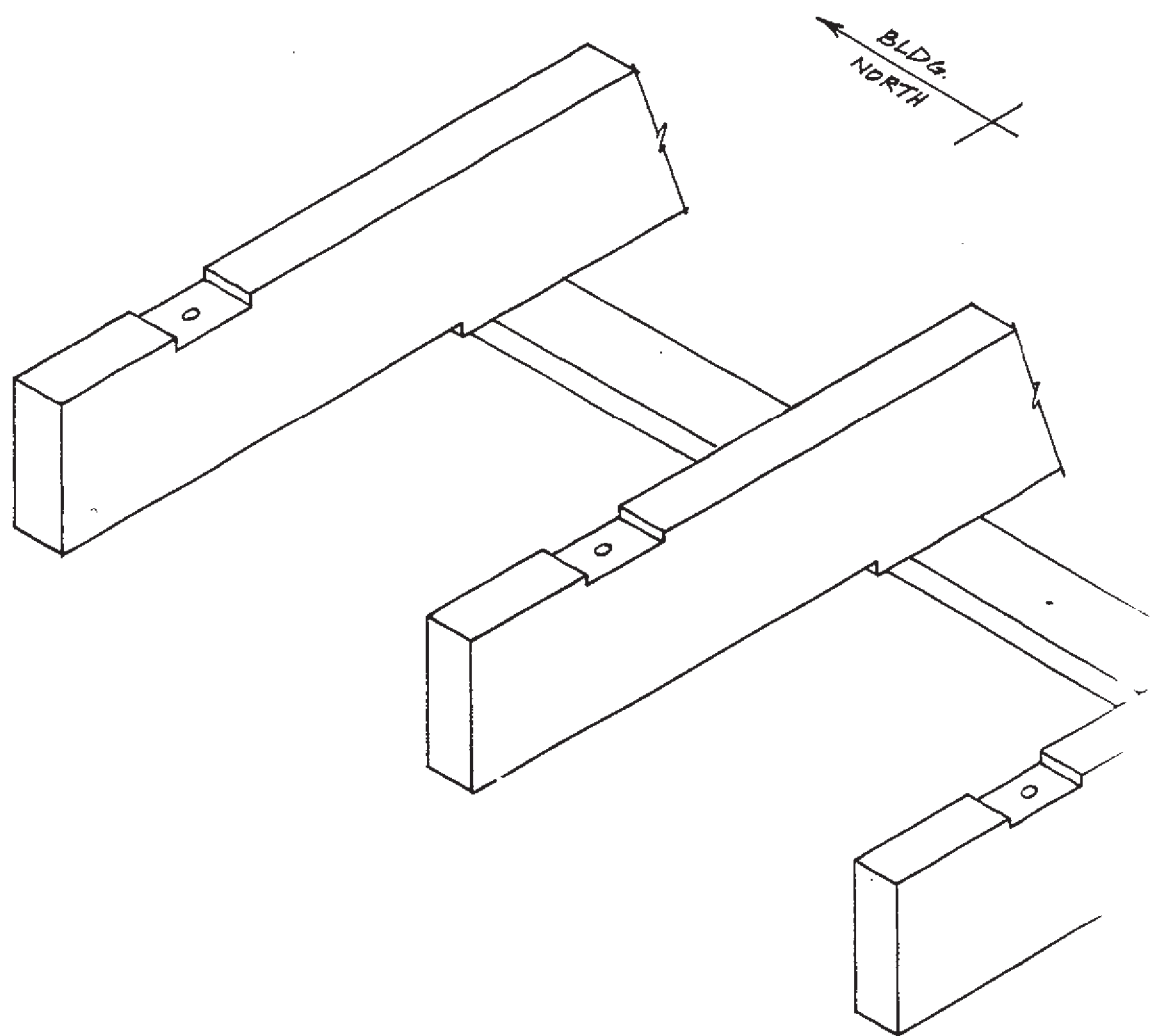
Figure 14.

# ATTIC FLOOR JOISTS DIAGRAM

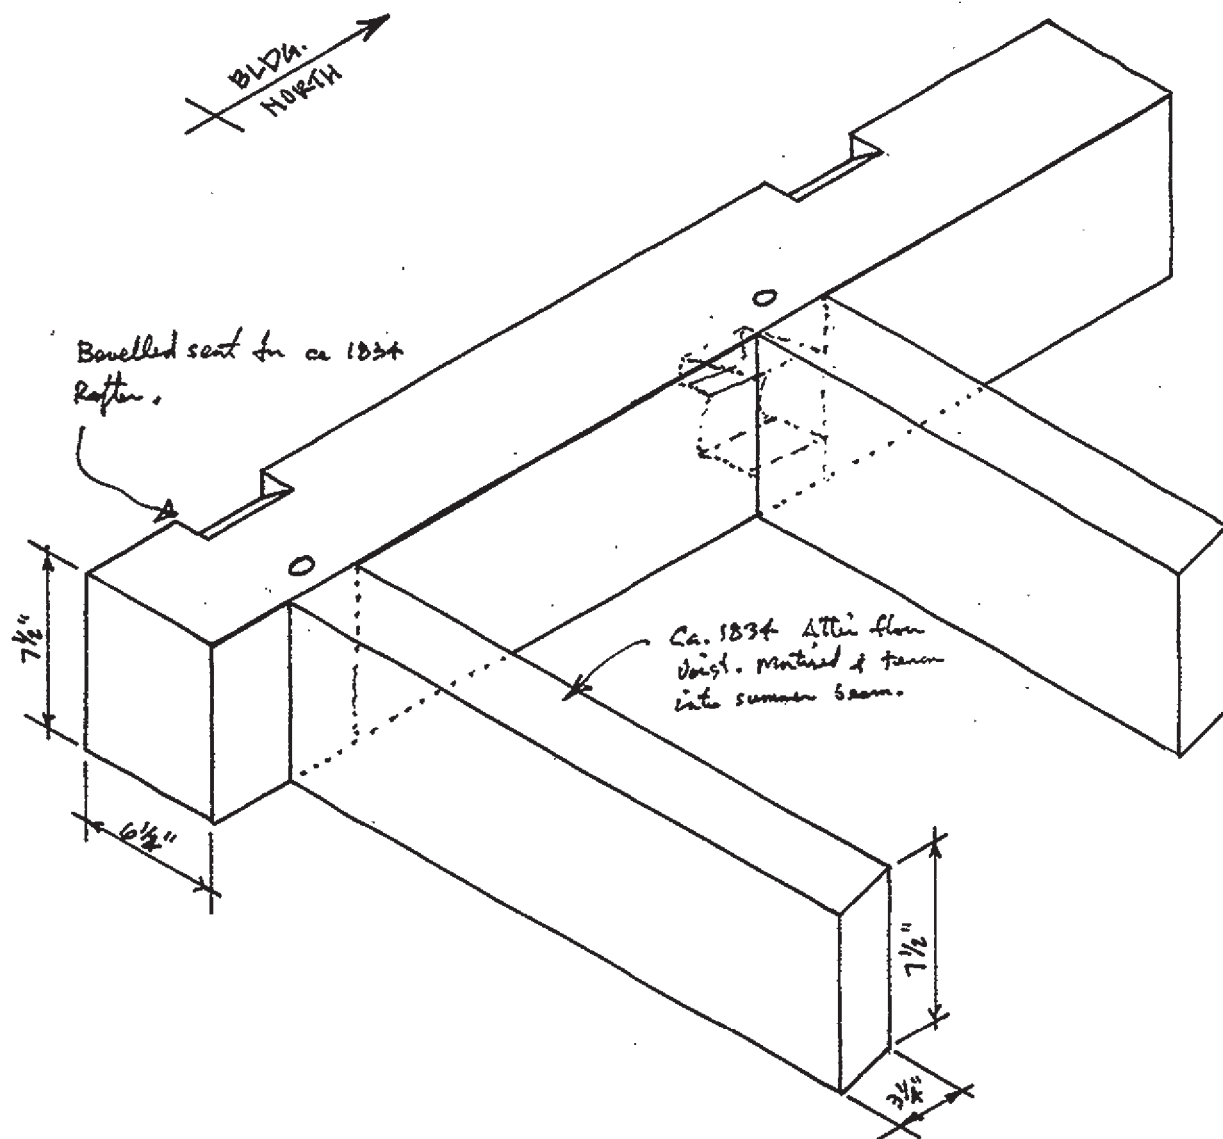
Figure 15.

Investigation of the attic floor framing of the house revealed the existence of a summer beam which supported the east-west floor joists and rafters at the south end of the attic, the space over Section 2 of the house. This summer beam was required because the floor joists could not rest on the western exterior wall. When the house was again renovated in c.1895, the attic floor area was extended to the west and the roof structure was removed and replaced with the gambrel roof which still survives. The c.1834 floor framing, floor boards and stairway remained in place.

# DETAIL OF SUMMER BEAM IN ATTIC FLOOR FRAMING (Section 2, c.1834)

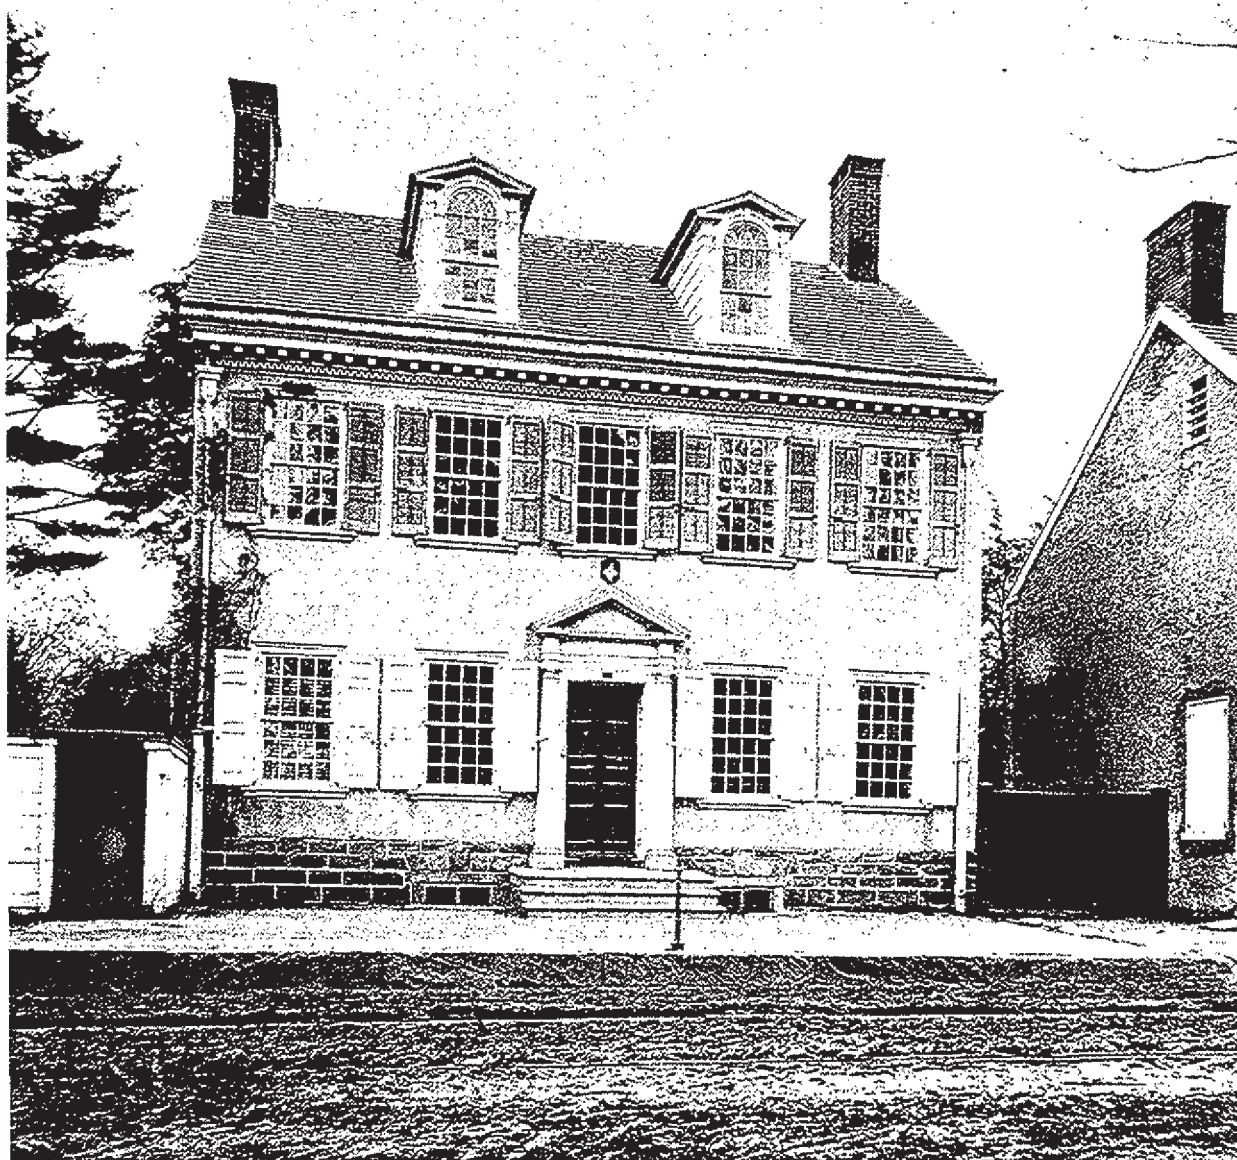
Plate 1. Historic photo of the Deshler-Morris house c.1861 showing the southern end of the Bringhurst House. Note the deteriorated condition of the chimney and patching around the ground floor window.

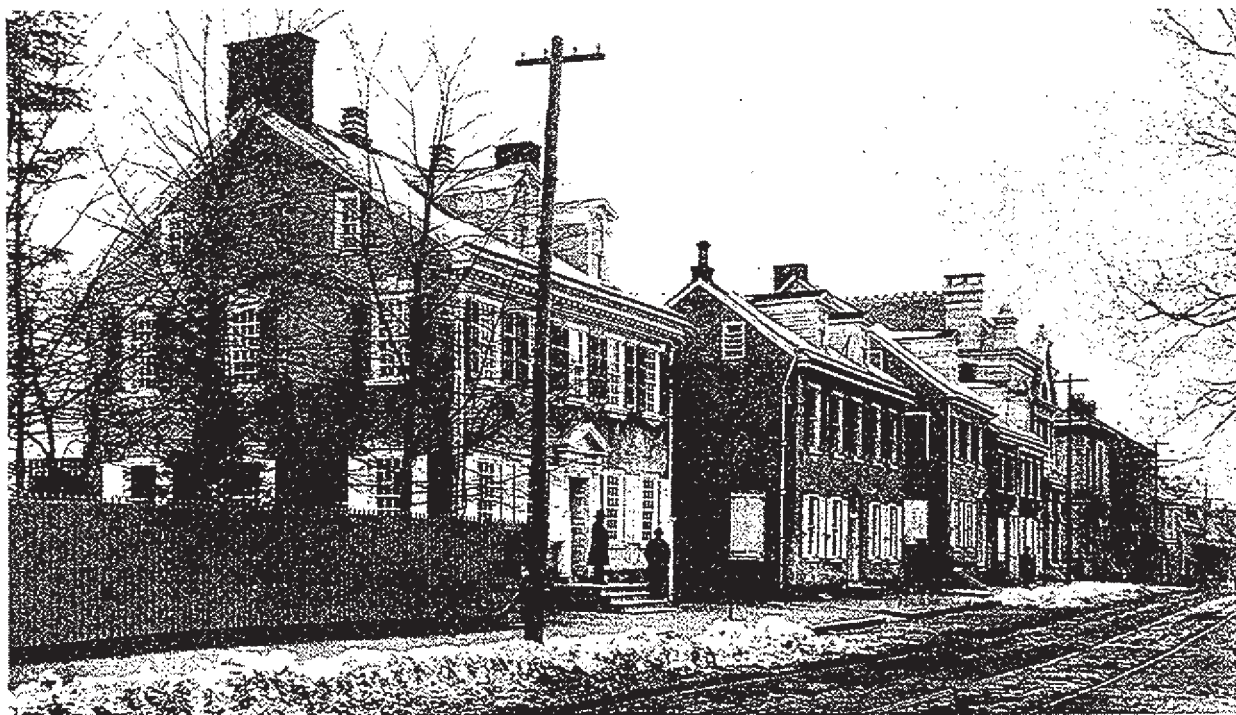
Plate 2. Historic photo showing the Bringhurst House as it looked c.1887. To it's left is the Deschler-Morris House. To it's right is the early 19th century Armat House.

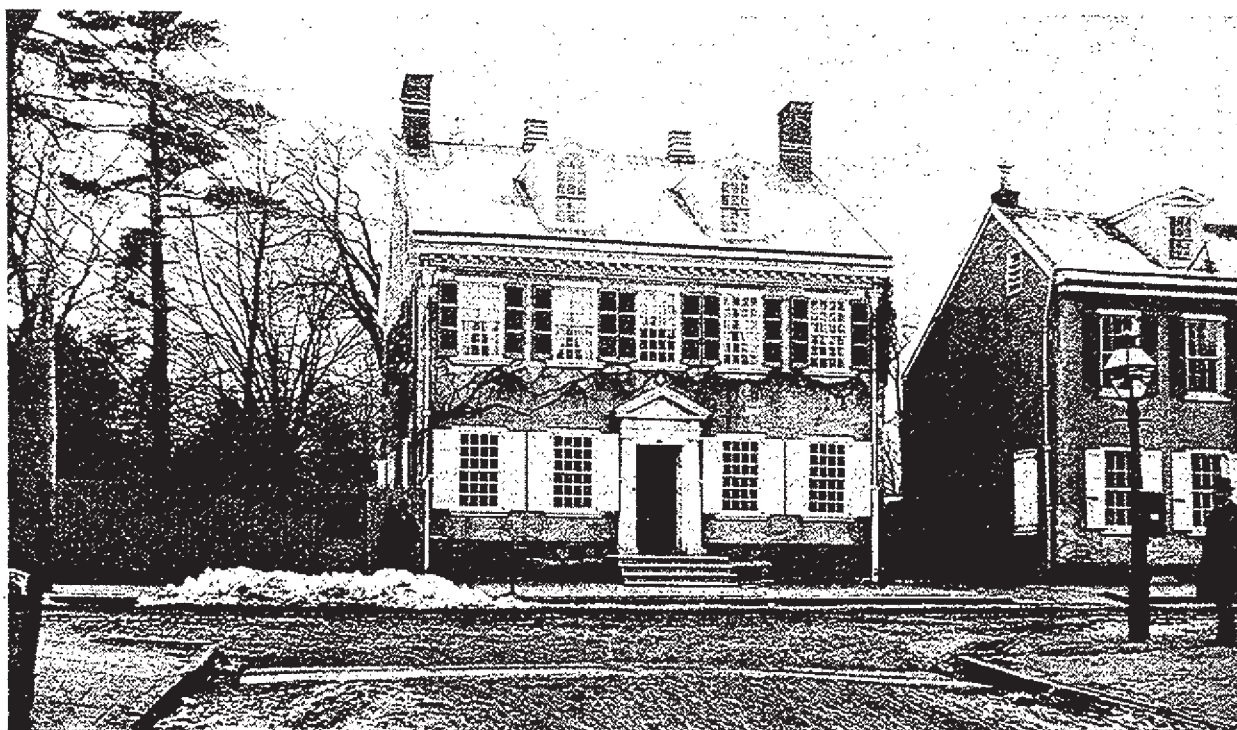
Plate 3. Historic photo showing the south gable end of the Bringham House c.1887. Note the definite salt-box shape of this gable. Also note the simple pedimented dormer window on the east side of the main roof.

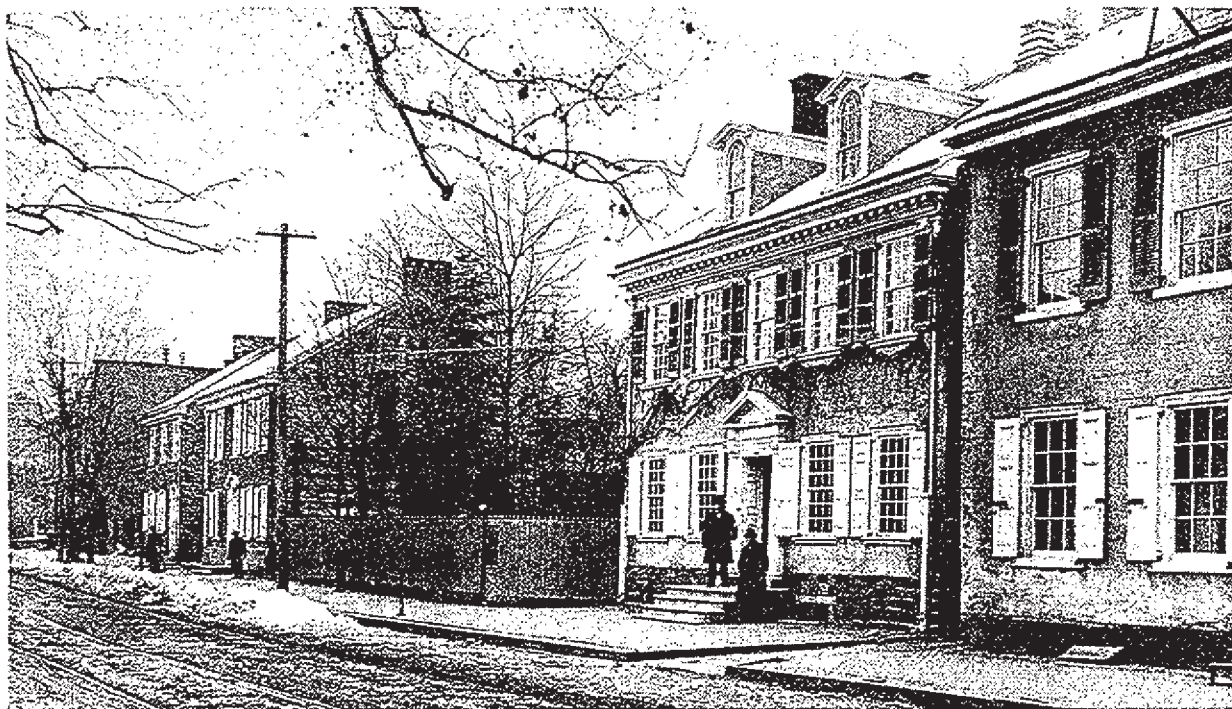
Plate 4. Historic photo showing a portion of the east facade of the Bringhurst House as it looked c.1887.  
Note the scored stucco on the east wall and the six over six window sash.

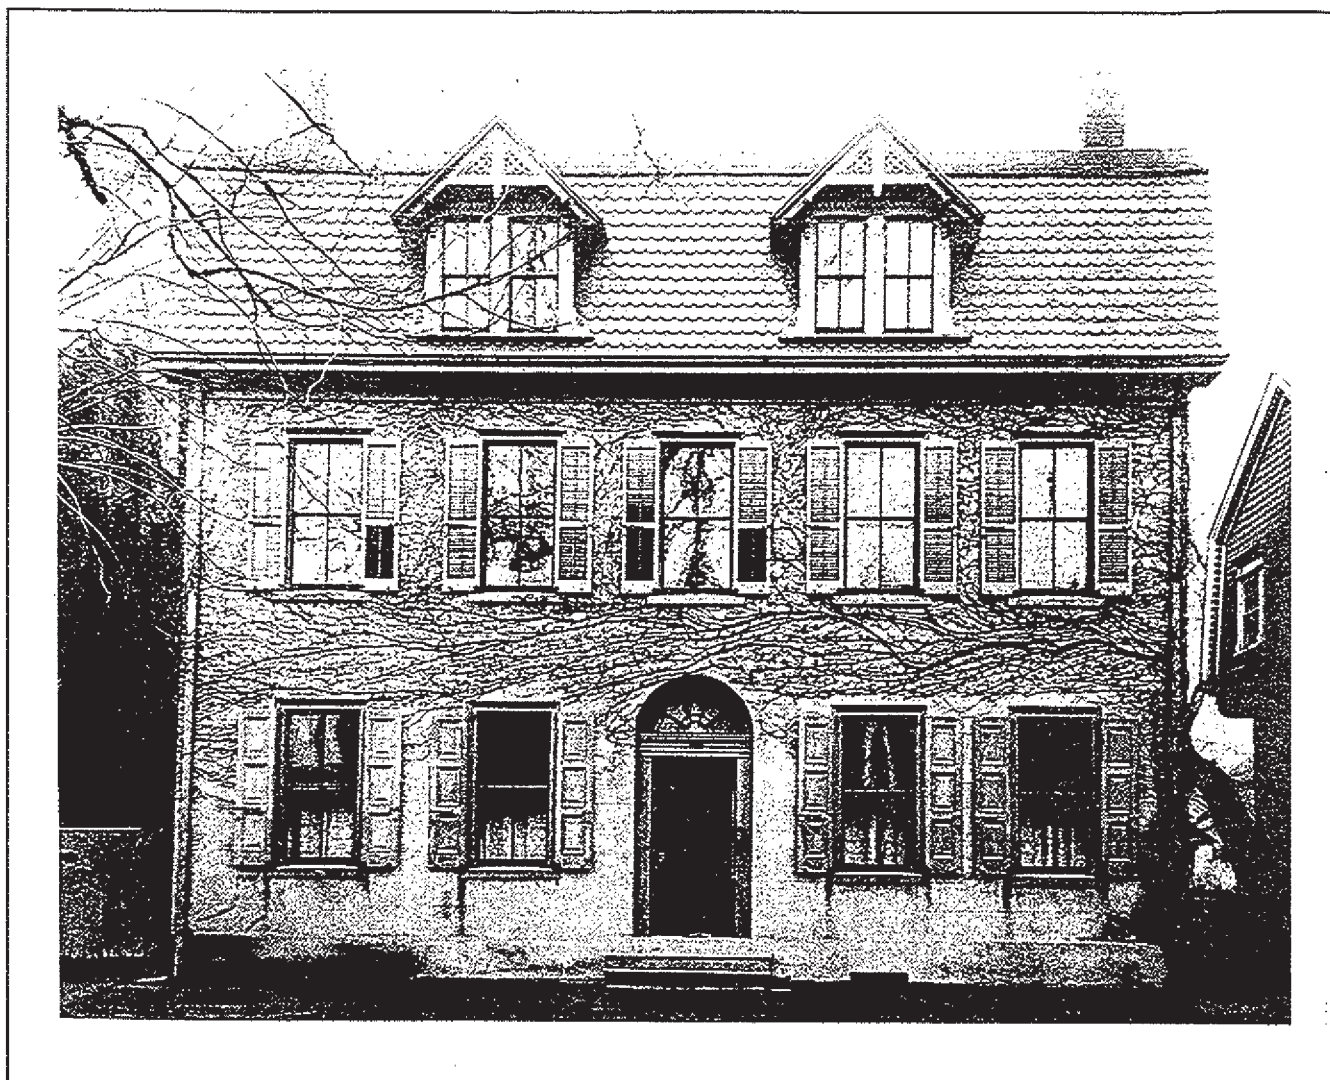
Plate 5. Historic photo showing the full east facade of the Bringhurst House as it looked in the early 20th century. This view clearly shows the full impact of the c.1895 renovation.

Other alterations that date from the Period 19-3 renovation include the replacement of the window sash of the eastern facade with Victorian two-over-two sash. The historic photo shown in Plate #5 portrays the house with Victorian detailing still complete. On the interior of the house, it appears that the pair of small rooms on the first floor south of the hall were combined at this time into a single large room.

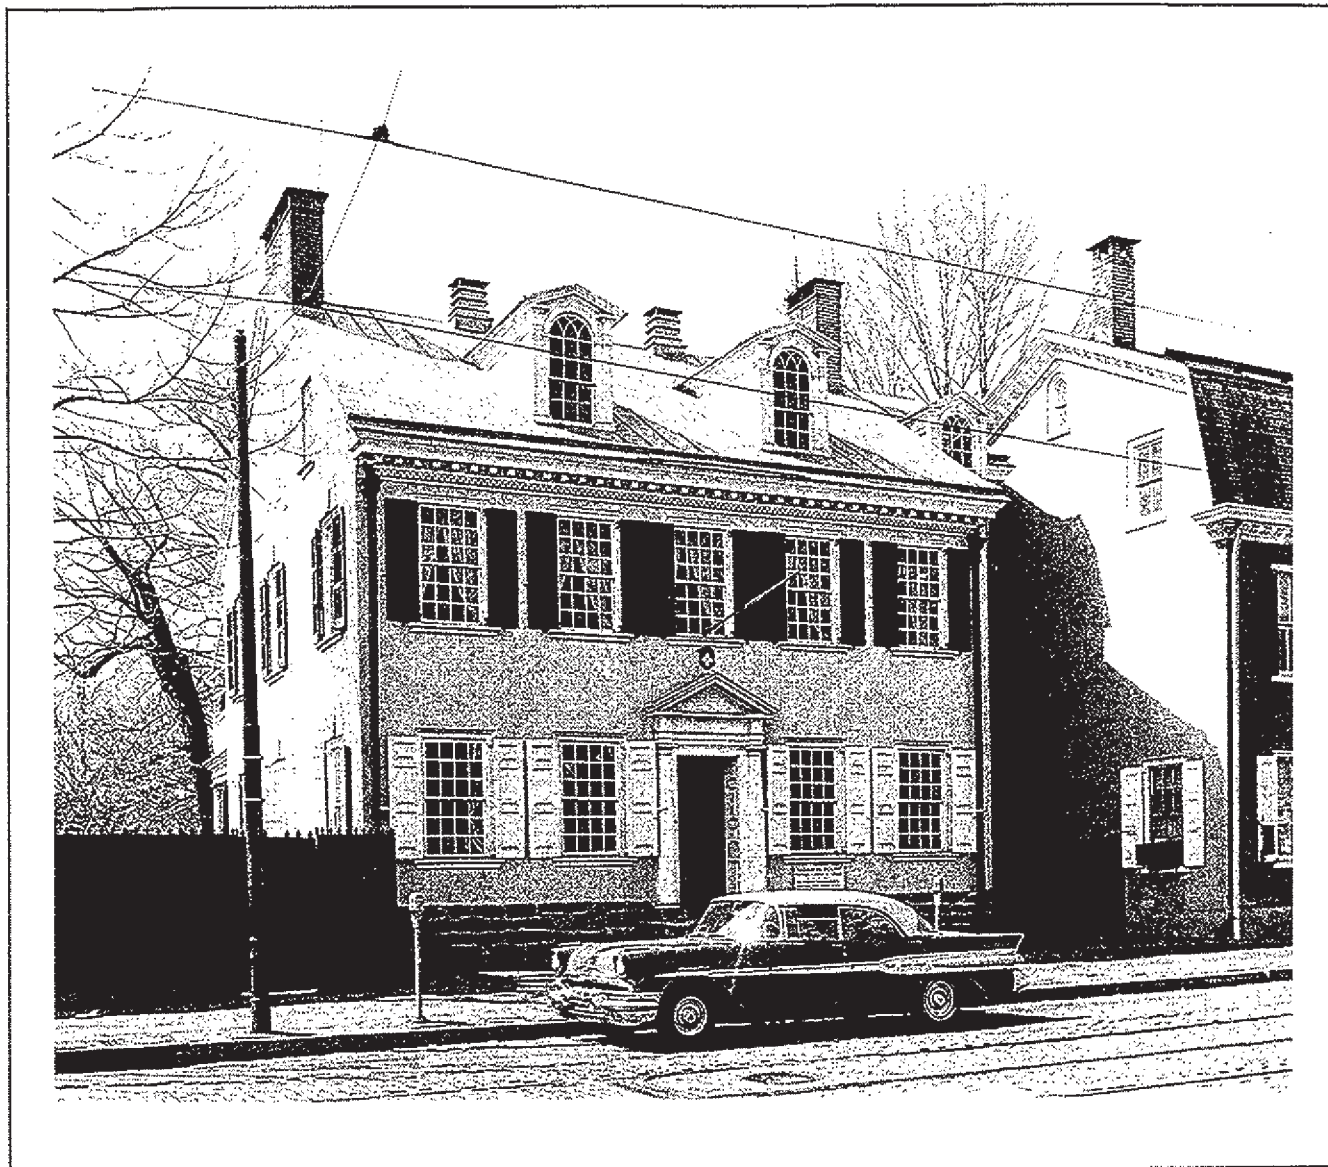
Plate 6. Historic photo showing the southeast corner of the Bringhurst House as it looked around 1960. The decorative roofing shingles have been replaced; otherwise little has been altered.

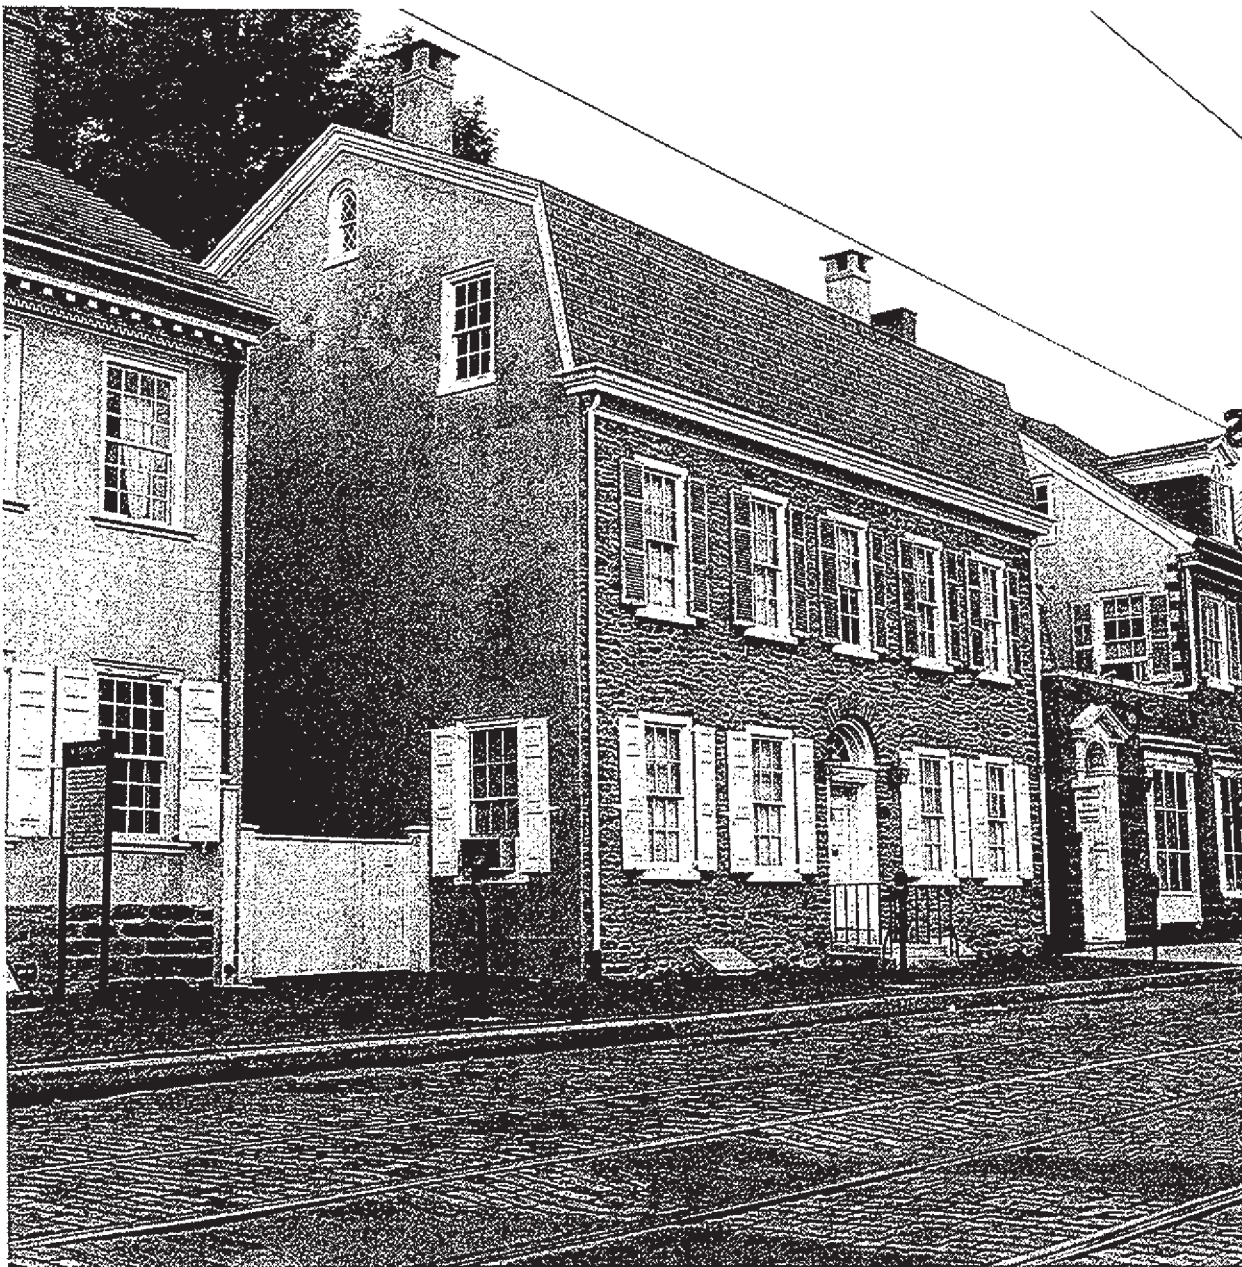
Plate 7. Historic photo showing the Bringhurst House from the southeast in 1979. The Victorian dormers, cornice, rakes and windows have been removed or replaced and the stucco has been removed from the east facade.

The changes to the exterior, dating from sometime after 1960, were much more unsympathetic to the character of the house than those to the interior. The eastern front of the house stripped of its stucco and the rubble stone beneath was repointed with hard gray cement. The two-over-two window sash were removed and replaced with six-over-six and the outer trim of the window frames was removed. At the roof level, the Victorian dormer windows were totally removed as were the pierce carved cornices and bargeboards. The decorative wood shingle roofing was replaced with slate. One can only surmise that the owners of the house were attempting to remove all of the Victorian elements and to restore the house to an earlier appearance. Unfortunately, the result was simply the defacement of the house and the creation of an appearance which has no historical basis.
