**BRINGHURST HOUSE**  
**HISTORIC STRUCTURES REPORT**  
**ARCHITECTURAL DATA SECTION**

**PART II**

by  
**Thomas Clinton McGimsey**  
**Historical Architect**

Independence National Historical Park

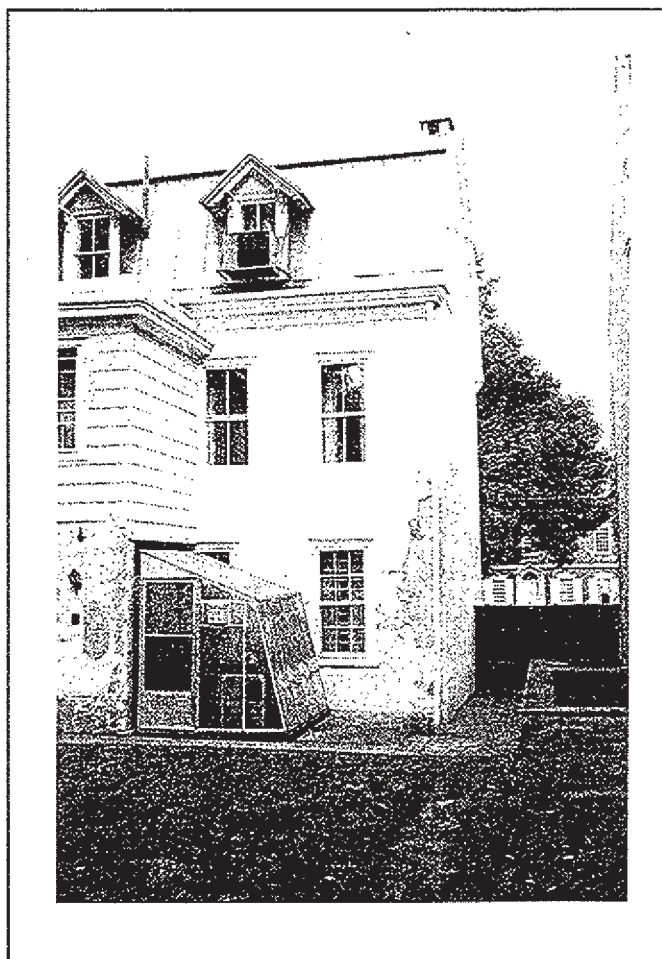
Plate 8. West side of Section 2. Lower windows retain c.1834 sash. The c.1895 two over two sash remain above.

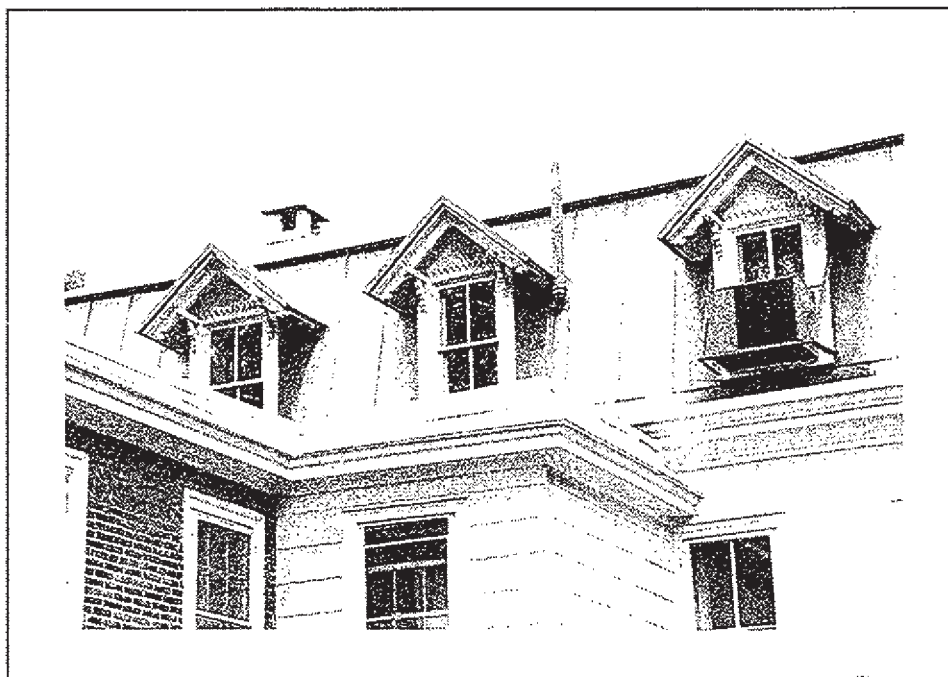
Plate 9. A detail of the c.1895 dormer windows surviving on the rear of the main roof.

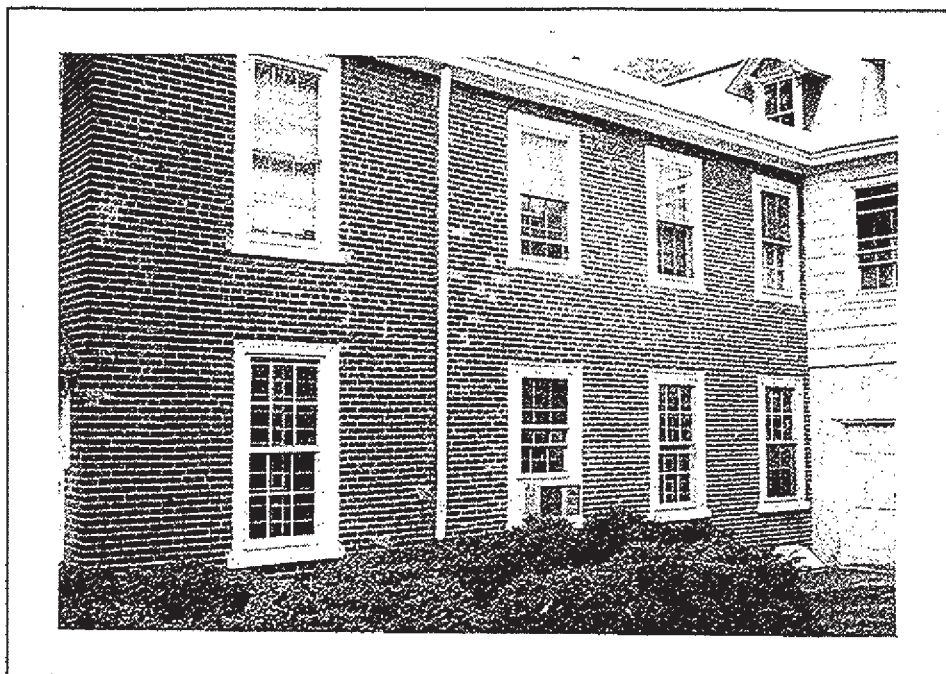
Plate 10. View of the rear extension showing Section 4 at the left of the downspout, Section 3 is to the right.  
Note the difference in the brick bonding patterns.

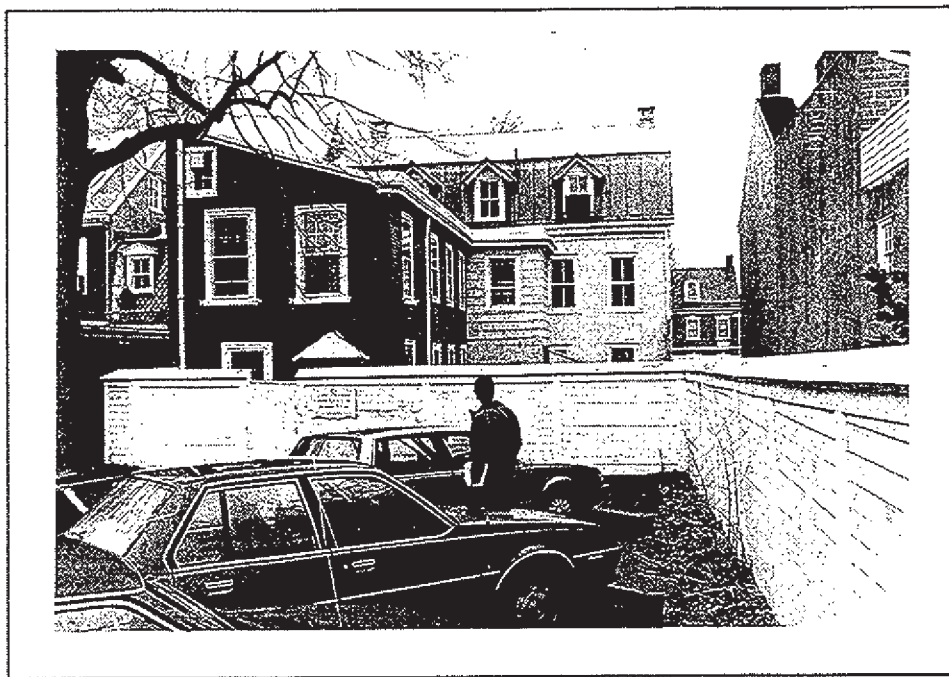
Plate 12. View of the Bringhurst House from the west. Most of the rear yard has been paved for parking.

Plate 12: View of Brighthurst House from the west, 1994.  
Most of rear yard is now paved for parking .....47

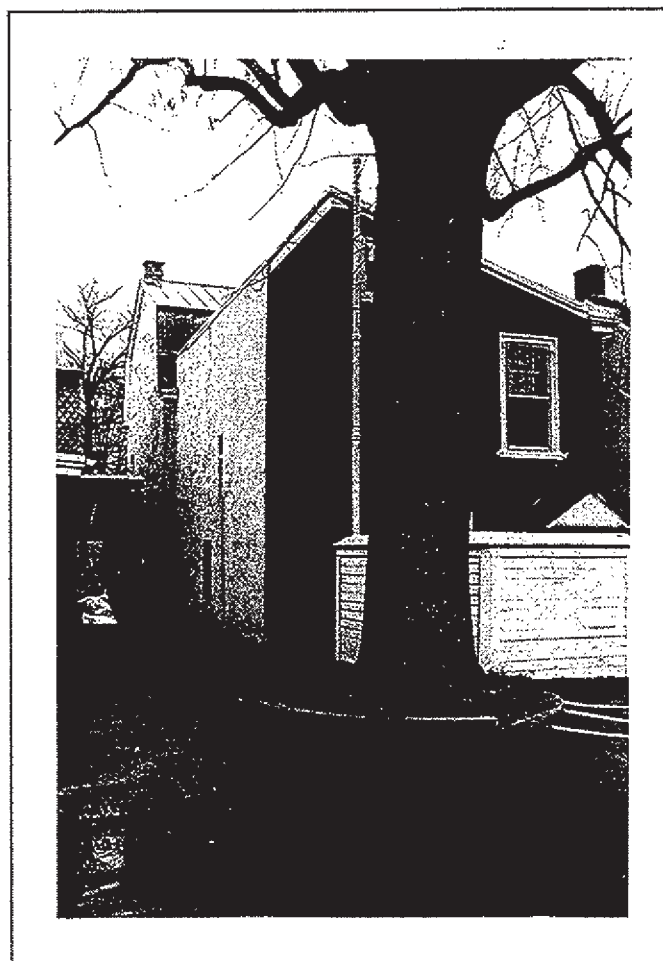
Plate 13. Rear of the house from the northwest. Note the off-set in the north wall.

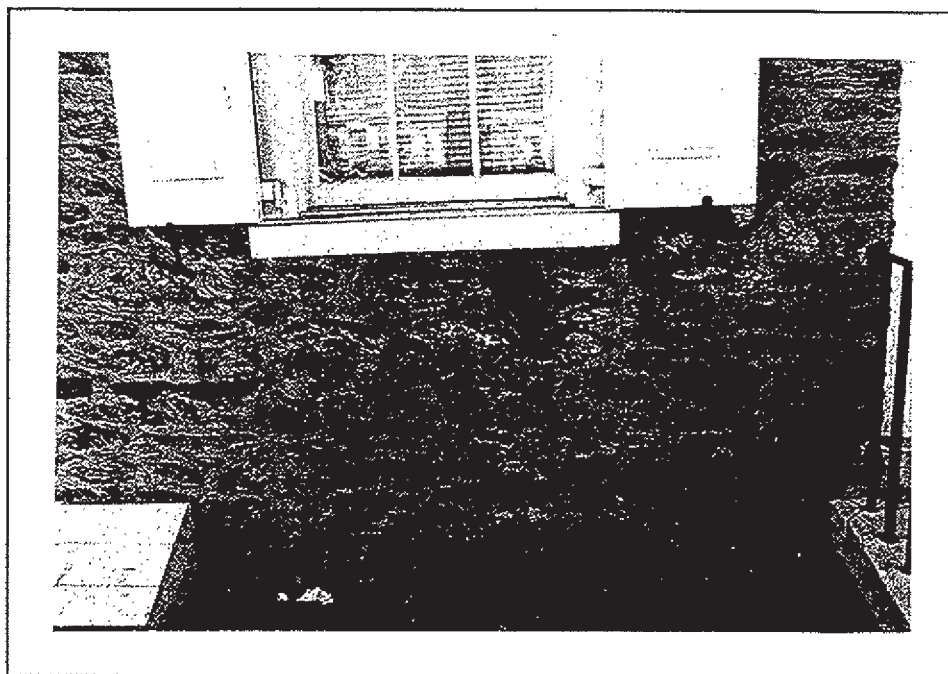
Plate 14. Detail of the east facade. Note the infill below the window at the location of an early doorway in Section 2.

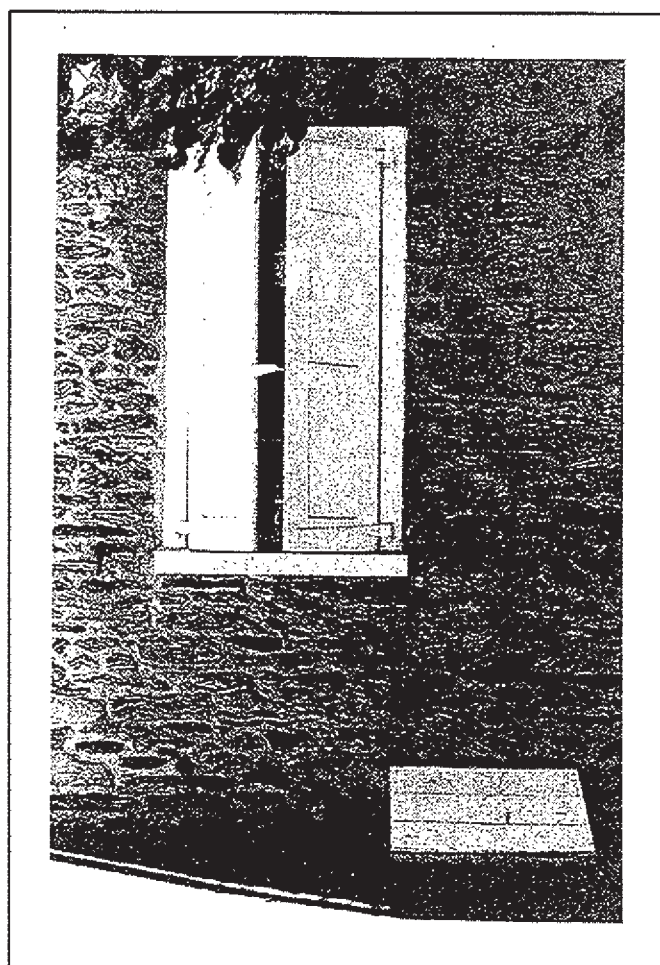
Plate 15. Detail of the east facade. Note the infilled stone below the raised window opening.

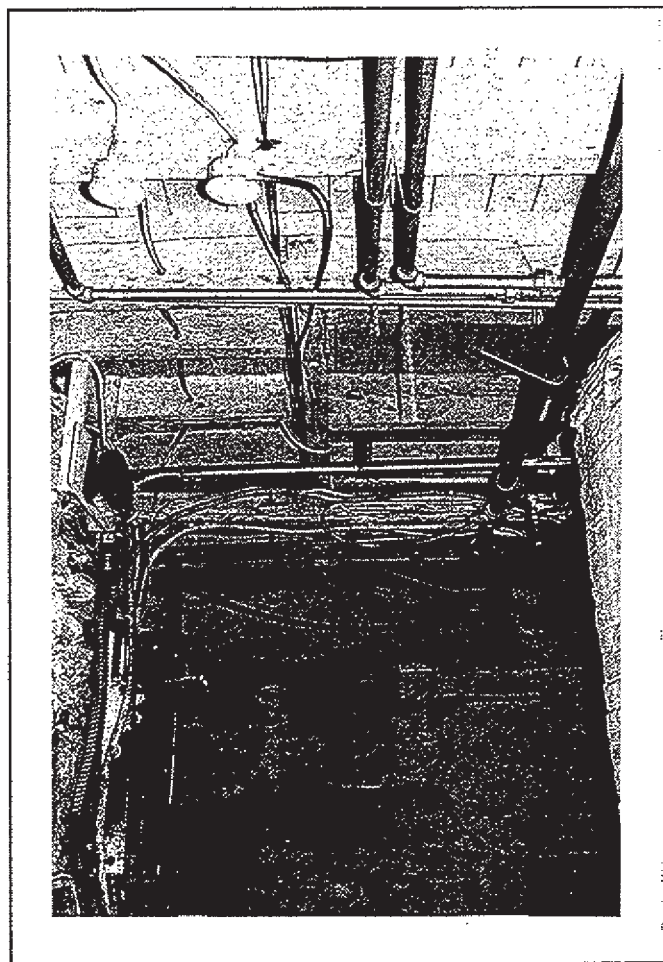
Plate 17. Cellar of Section 1. Detail of infilled opening for the stair in framing above. The stair was at the right of the header in the center of the photo. Note the corbels in the west wall beyond.

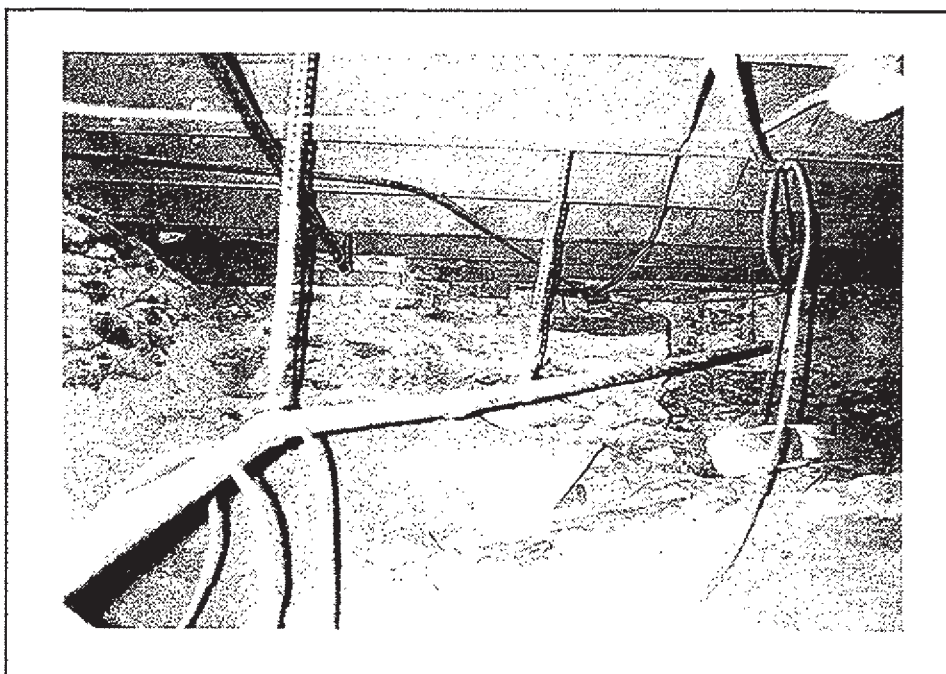
Plate 20. Crawl space, section 2. View looking south showing c.1834 stub wall at left and chimney base at center. Note the pre-1834 wall plaster at center right covered up by the 1834 chimney.

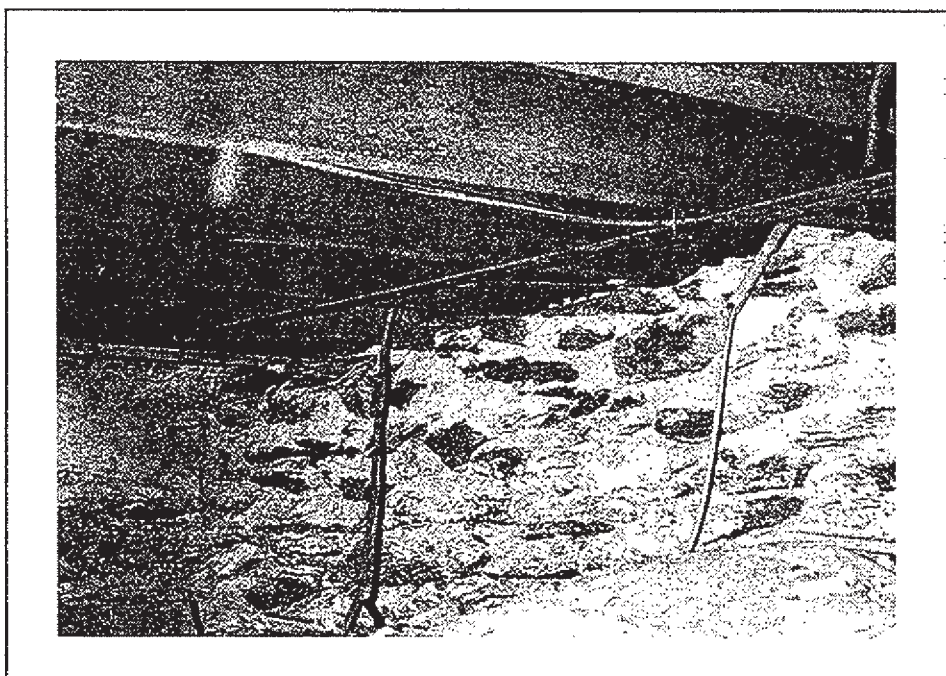
Plate 21. Crawl space, Section 2. View looking southwest showing c.1895 floor joists resting on c.1834 stonework built up against an earlier wall. Note the pre-1834 plaster on the south wall, covered up by c.1834 stonework.

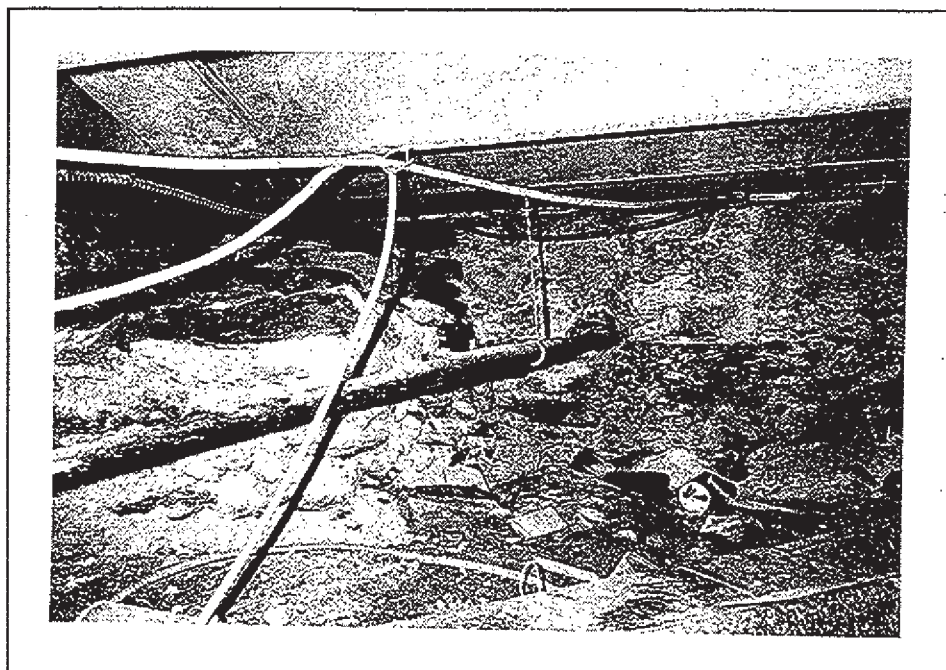
Plate 24. Crawl space, Section 2. View looking south toward chimney foundation. Note wall plaster at right continuing behind c. 1834 chimney.

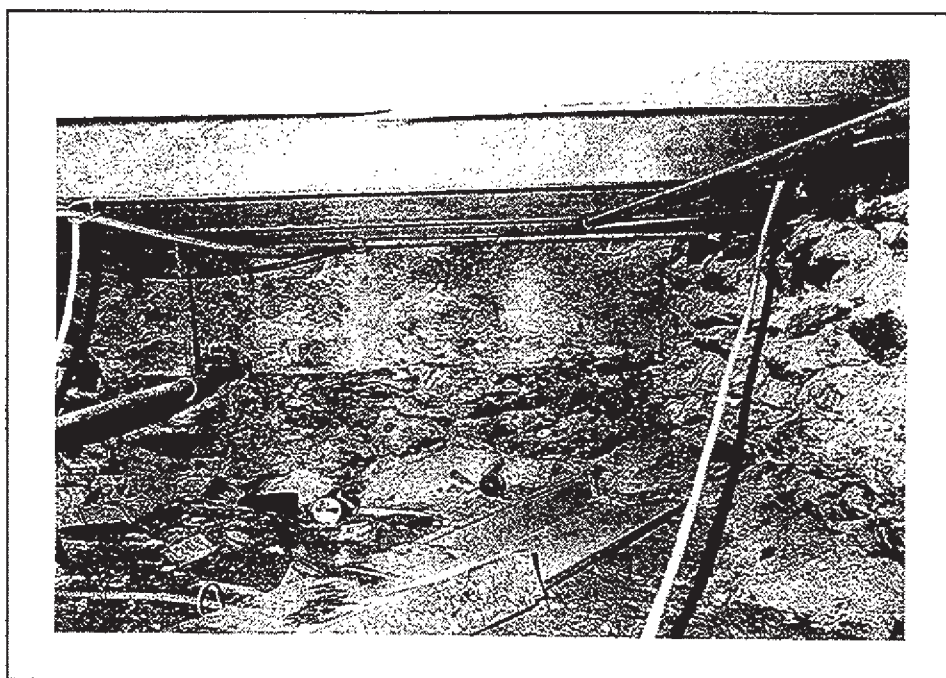
Plate 25. Crawl space, southwest corner of Section 2. Pre-1834 wall plaster on the south wall continues behind c. 1834 stonework at right, built up against the west wall to support the floor joists when the floor was raised.

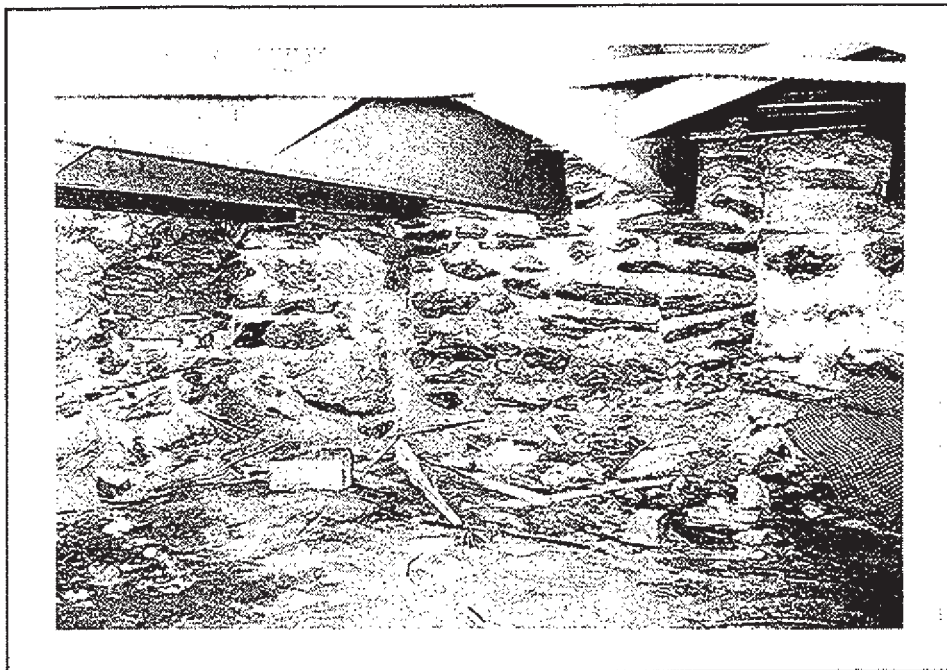
Plate 26. Crawl space, east end of Section 2. View looking east showing c.1834 masonry infill in the original doorway. Plate 14 shows this condition from the exterior.

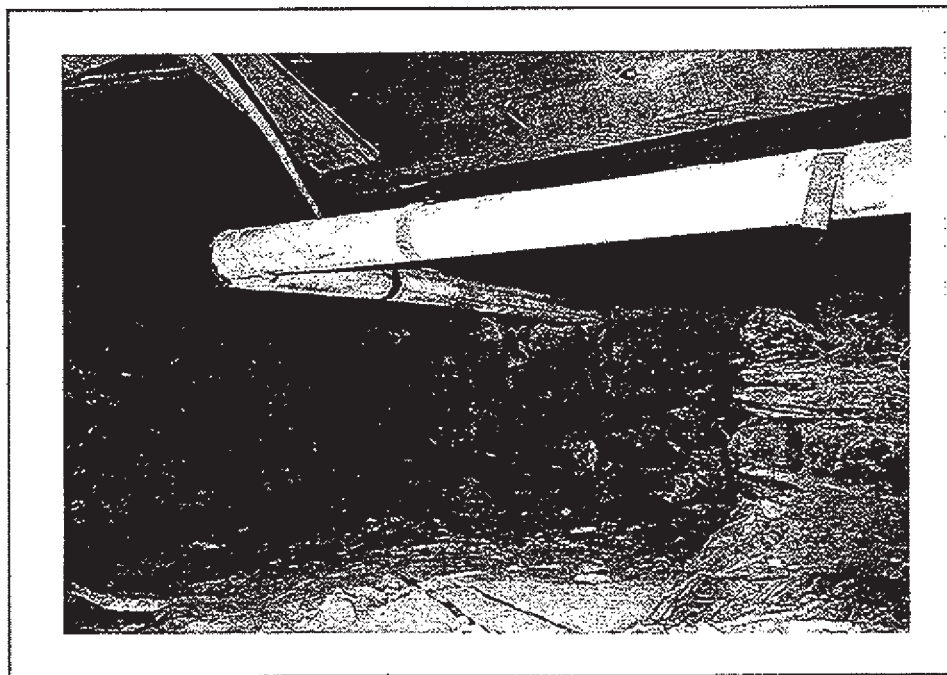
Plate 27. Crawl space, eastern end of Section 2. View looking south showing joist pockets close to soil level and chimney foundation to the right.

chimney bases on the south wall were also built over the plaster surfaces, confirming that they too were later additions to the space. Pockets in the stone masonry of the south wall can be seen close to the soil that carried the original timber floor joists. The original floor level would have been compatible with the early first floor level of Section 1. The timber first floor system that currently exists is of a different character from that found in Section 1. The joists are larger and more evenly spaced and the flooring is of consistent width. The fact that there are no hearths framed into the floor joists around the two chimney bases further suggests that the floor system postdates the renovation campaign in which the floor was initially raised and the pair of chimneys inserted.

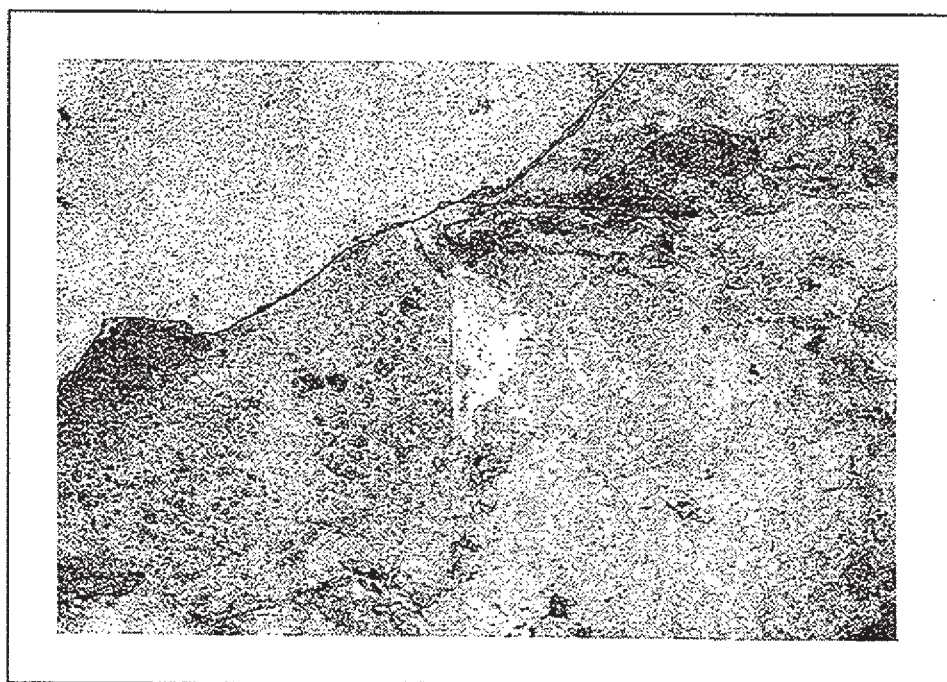
Plate 29. Cellar of Section 3, northwest corner. Detail of c.1850 stair tread in plaster of the north wall.

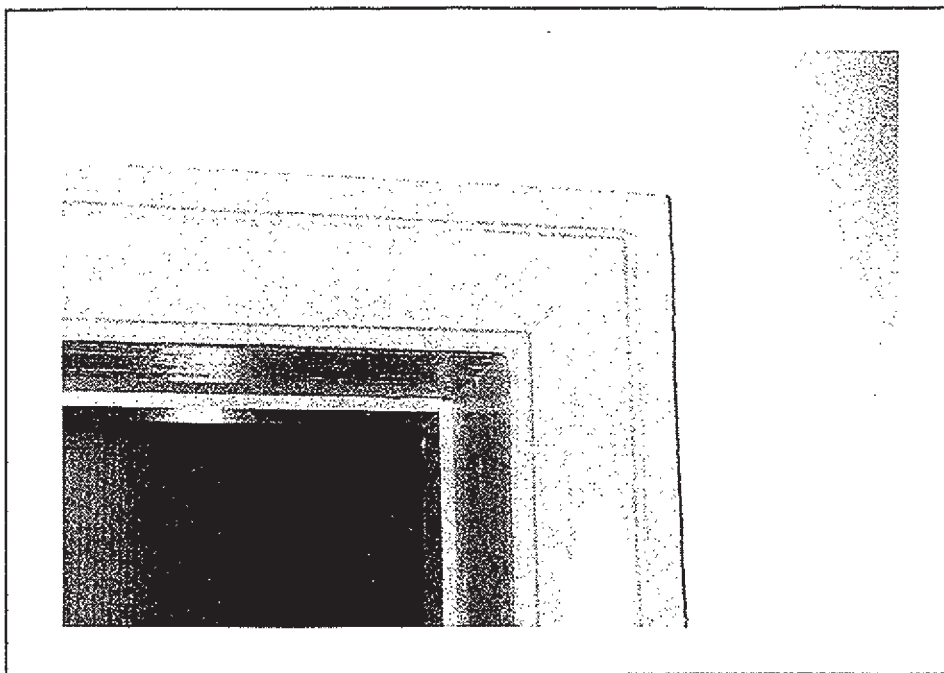
Plate 30. Detail of the door casing found only in the upper floors of Section 1.  
This casing is common from the 1820's through the 1840's.

north. To the south of the hall were two small chambers, each with a fireplace. The door and window casings shown in plates #30 and #31 are found on the two floors of eastern portion of the house. The profile of these casings are almost identical to comparable features at Wyck, a nearby house that was substantially altered in 1824. This molding profile can be found in houses in this area built from the 1820s through the 1840s.

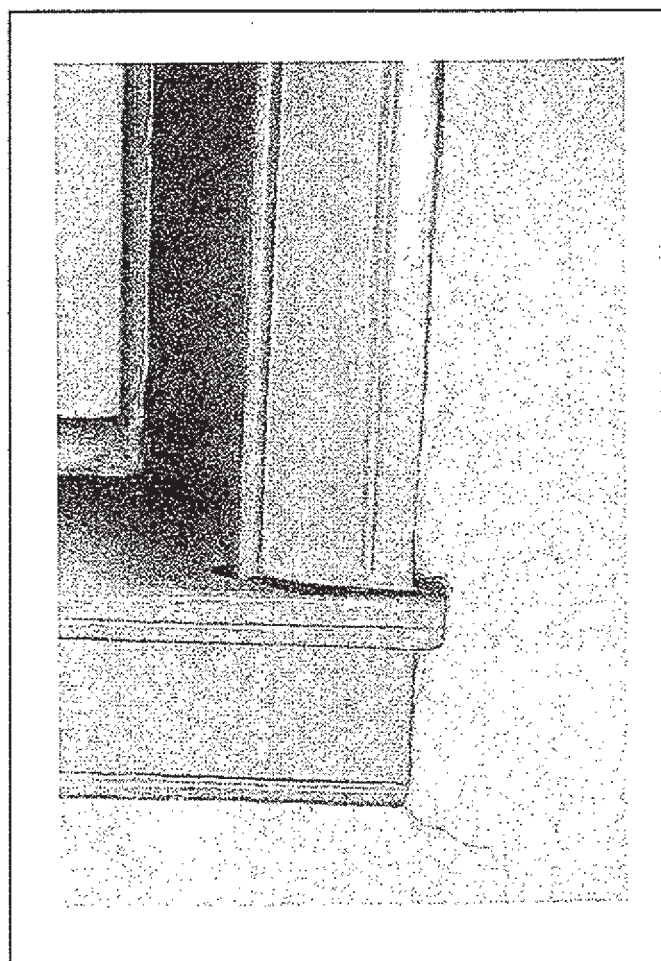
Plate 31. Detail of window casing and sill found in Section 1, corresponding to the door casing in Plate 30.

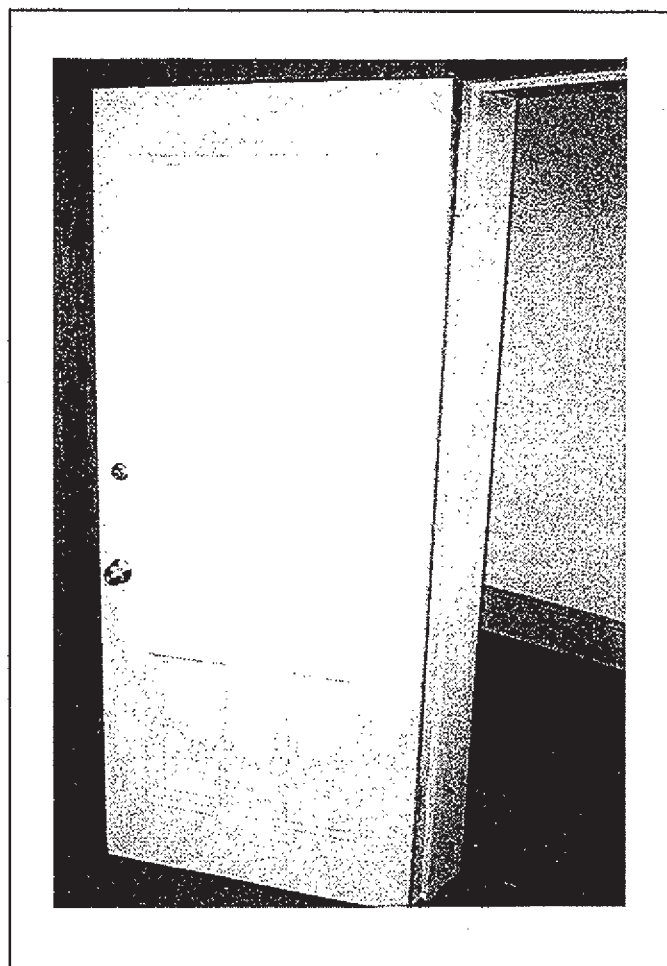
Plate 32. Detail of the door from the first floor hall into the southeast room.  
This door probably dates from c. 1834 renovation.

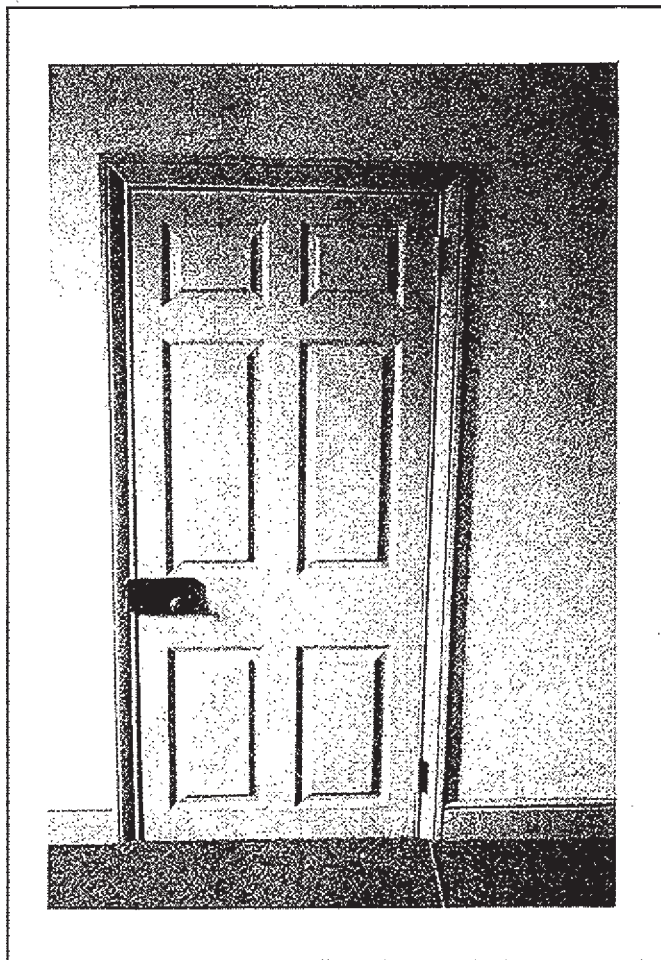
Plate 33. Detail of the door from the second floor hall into the southeast room. This raised panel door was probably reused in this location in c.1834.

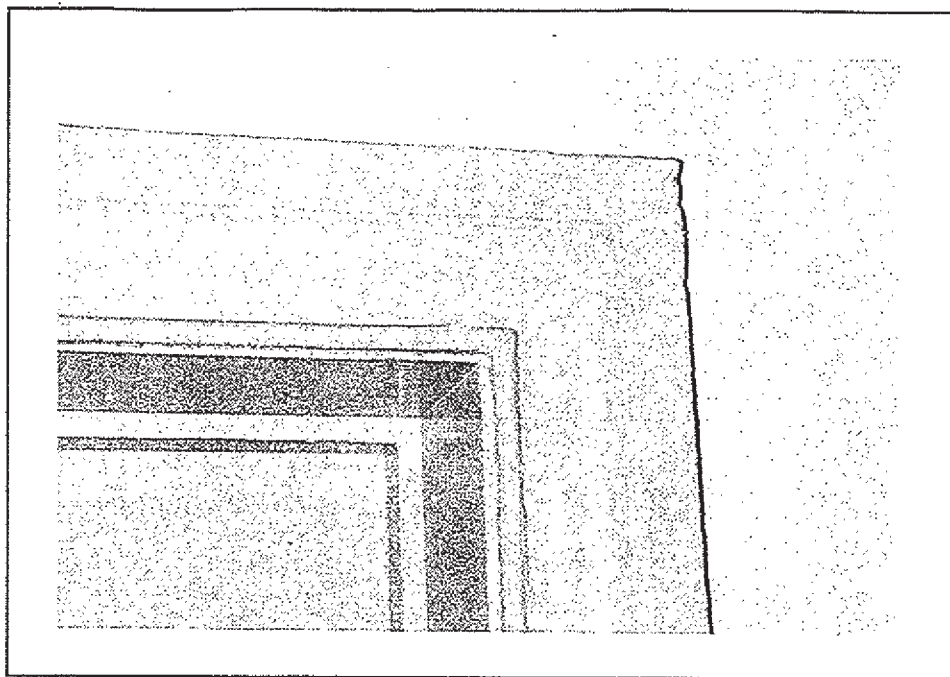
Plate 34. Detail of a mid-19th century door casing found throughout Section 3 and in some areas of Sections 1 and 2.

An examination of the door and window casings of the western extension reveals the consistent use of a molding profile which is also found in some sections of the eastern stone section of the house (see plates # 34 and # 35). This molding profile is also found on the window and doors associated with the main stair of the house, seemingly within the eastern section of the house.

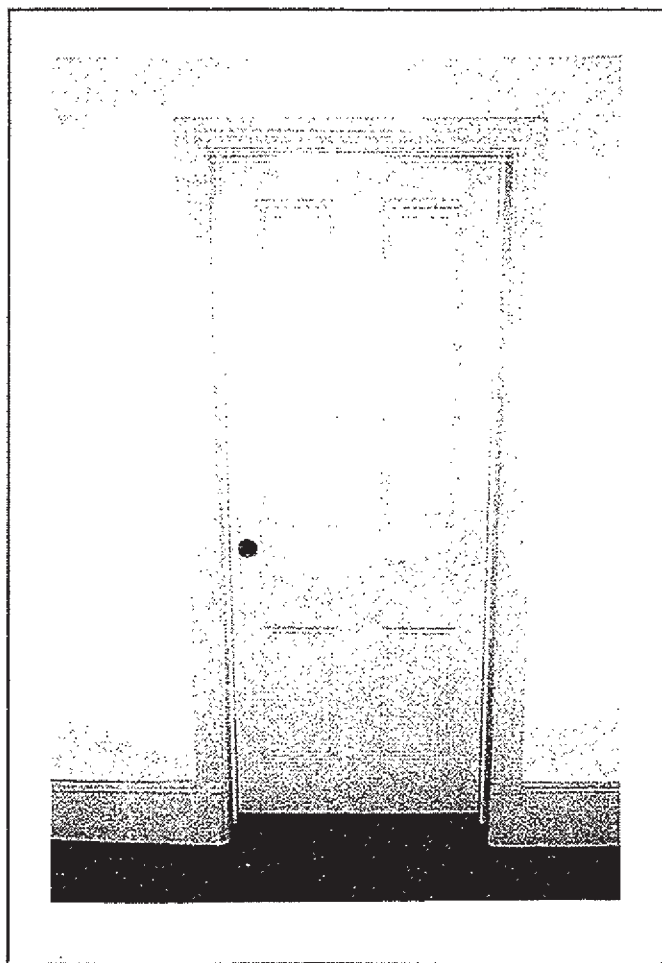
Plate 36. Detail of door from the first floor hall into a southwest room. This four panel door was inserted into this wall during the c.1850 renovation.

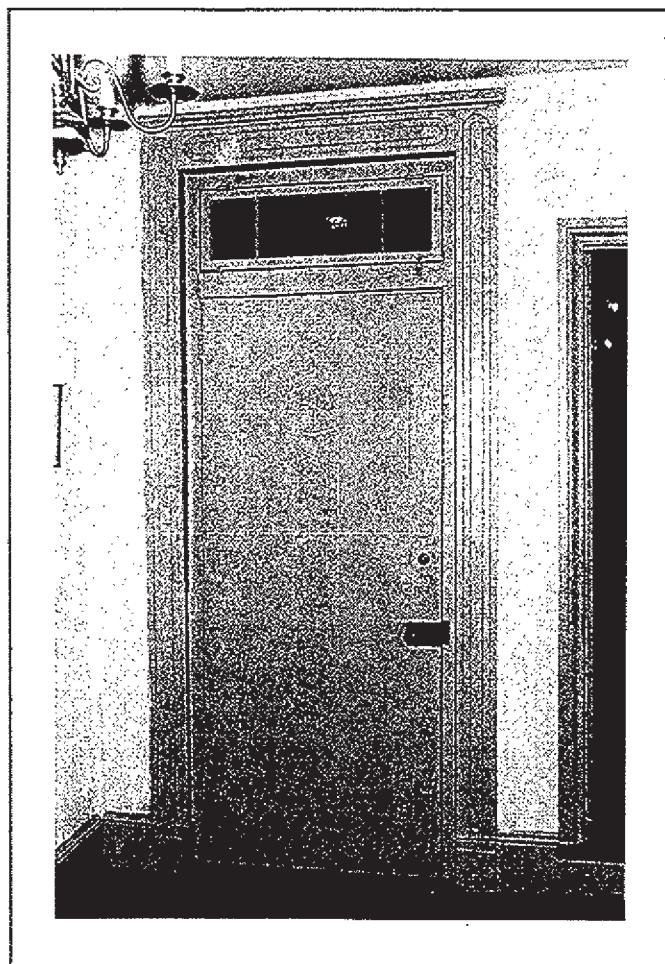
Plate 37. Detail of exterior doorway at the rear of the first floor hall. This door was installed in this location during the c.1850 renovation.

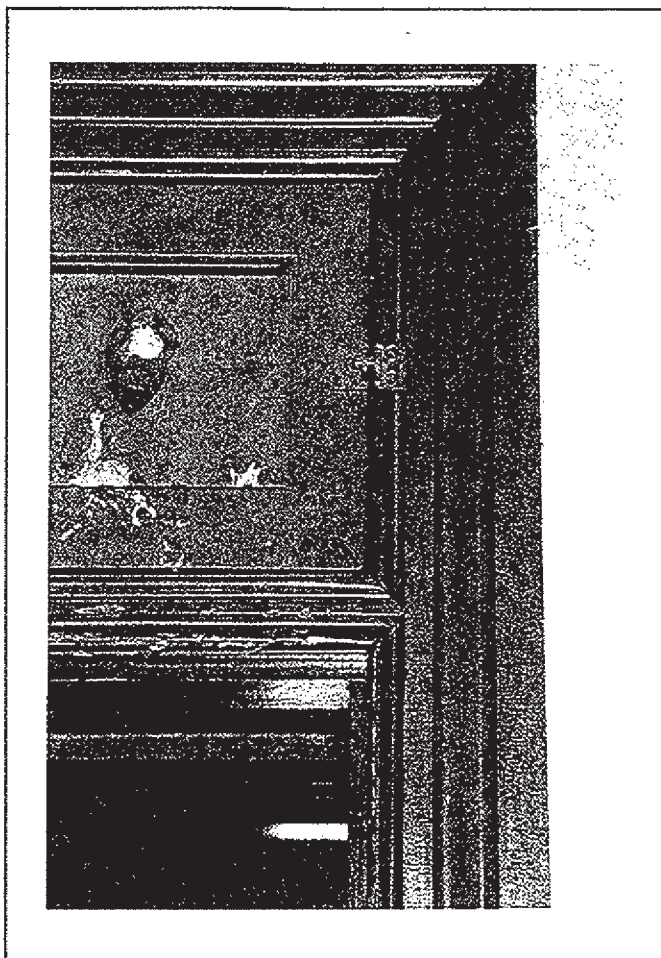
Plate 38. Typical door trim found in the third floor of the house dating from c.1895 renovation.

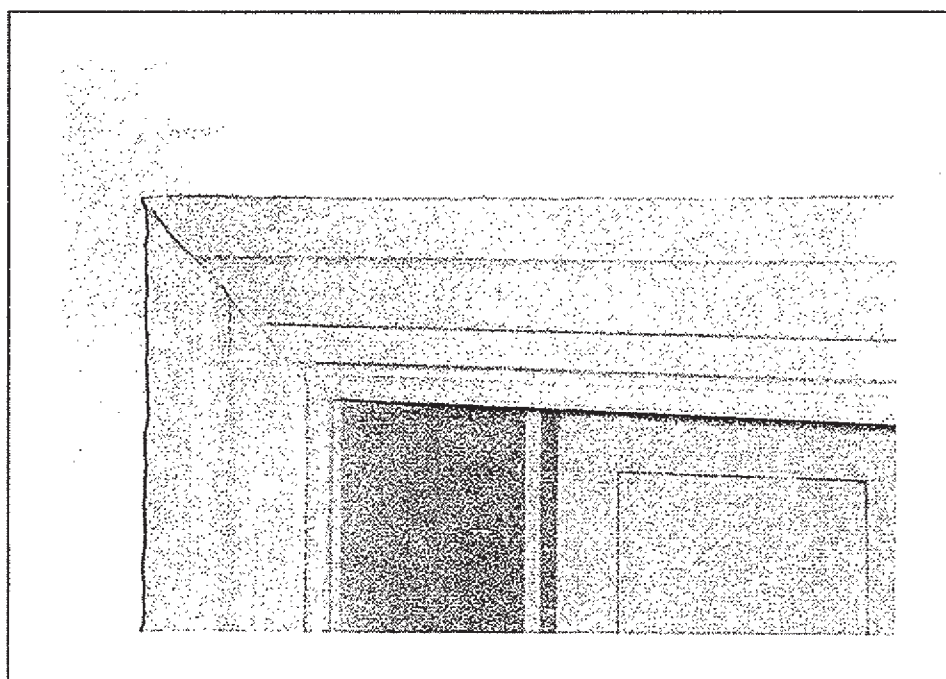
Plate 39. Detail of door casing found at the head of the stair leading into the northeast room of the second floor. This casing is typical of a c.1895 renovation.

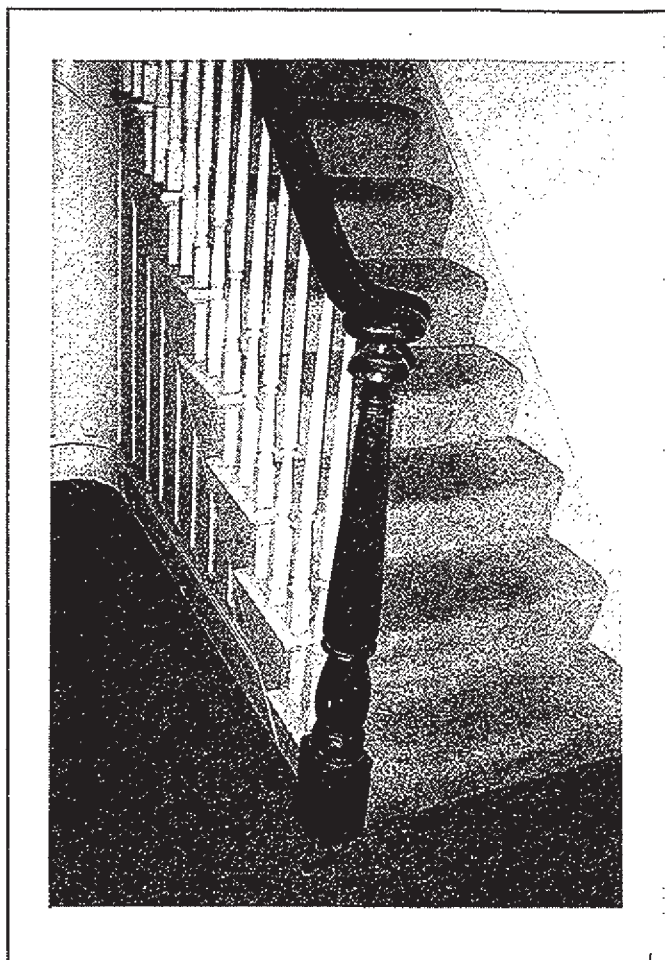
Plate 40. Detail of newell and stair on the 1st floor at the east end of Section 3.

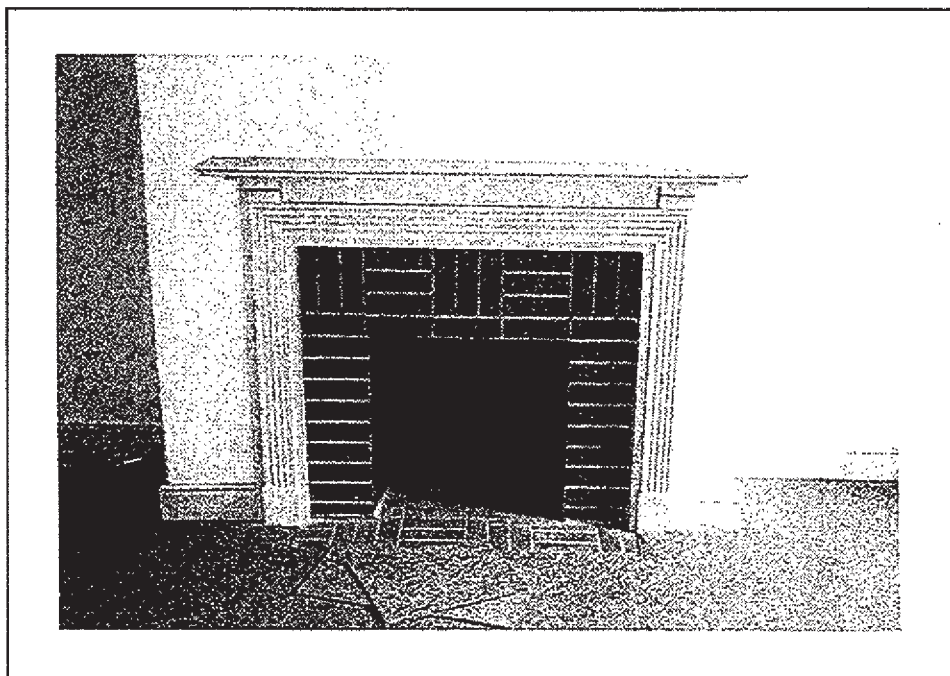
Plate 41. Detail of a mantel in the 2nd floor northeast room. This is the only mantel surviving in the house and probably dates from c. 1834.

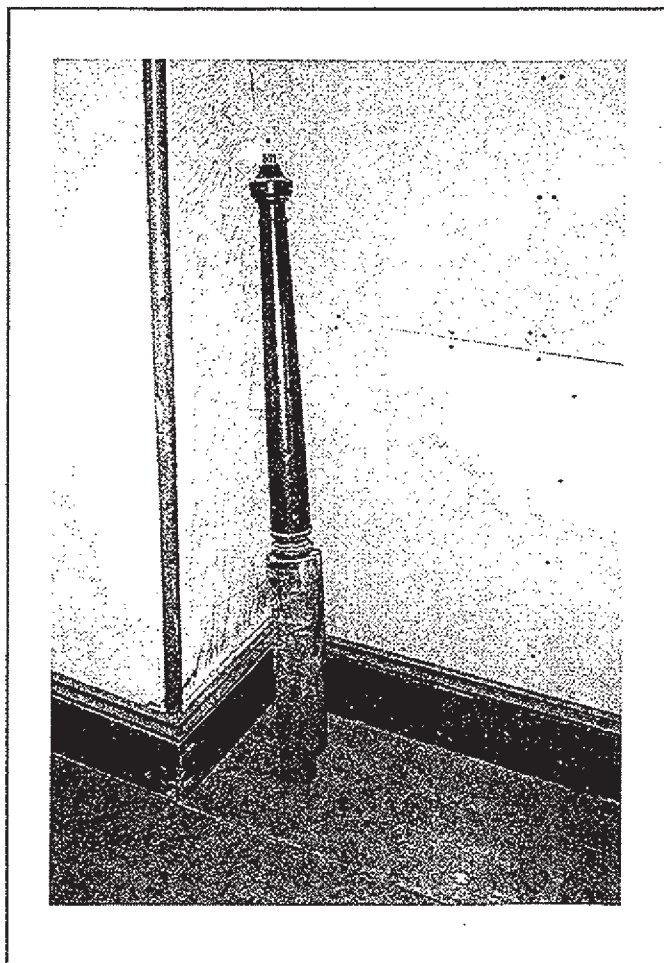
Plate 42. Detail of newell post from the stair that ran from the 2nd floor into the attic.  
This stair probably dates from c.1834.

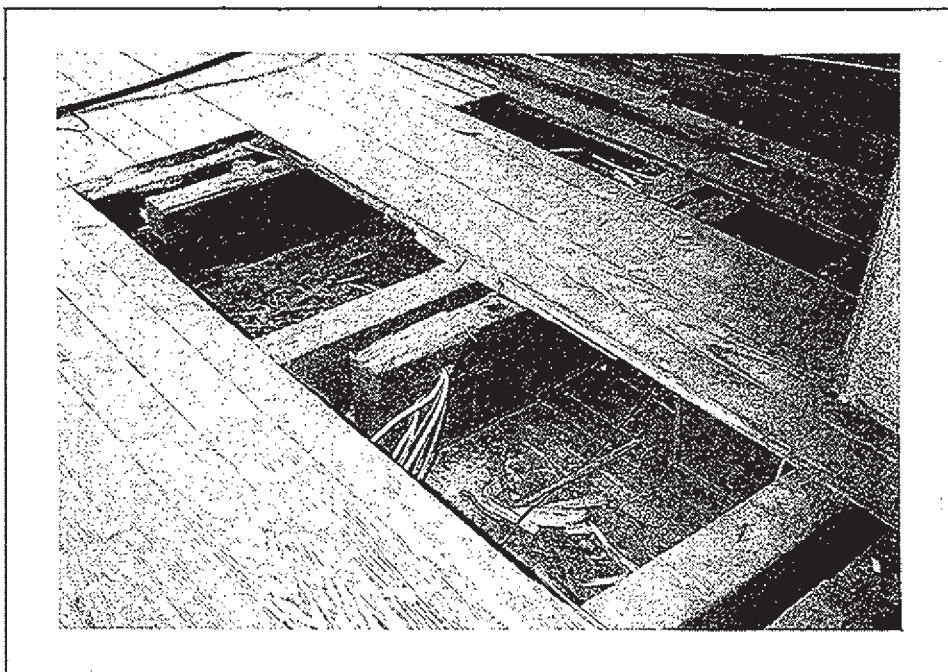
Plate 43. Detail of floor framing in the third floor, the northwest room, showing the ends of c.1834 attic floor joists. Note holes in tops of joists for attachment of false plate and rafters.

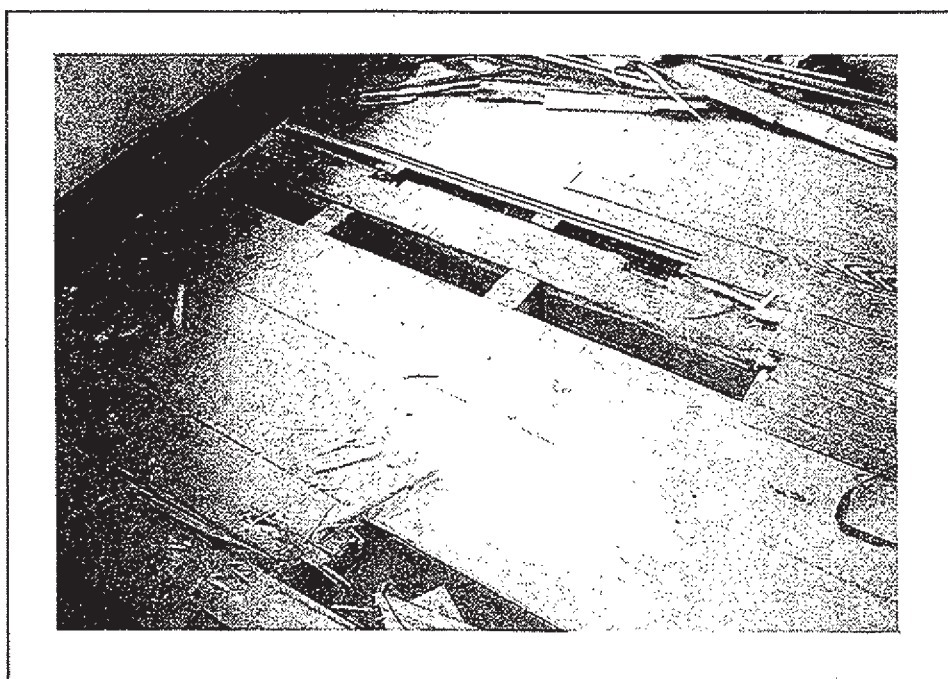
Plate 44. Detail of floor framing in the 3rd floor southwest room showing c.1834 summer beam. Note the wide floor boards of c.1834 in the foreground and the narrow boards beyond from c.1895.

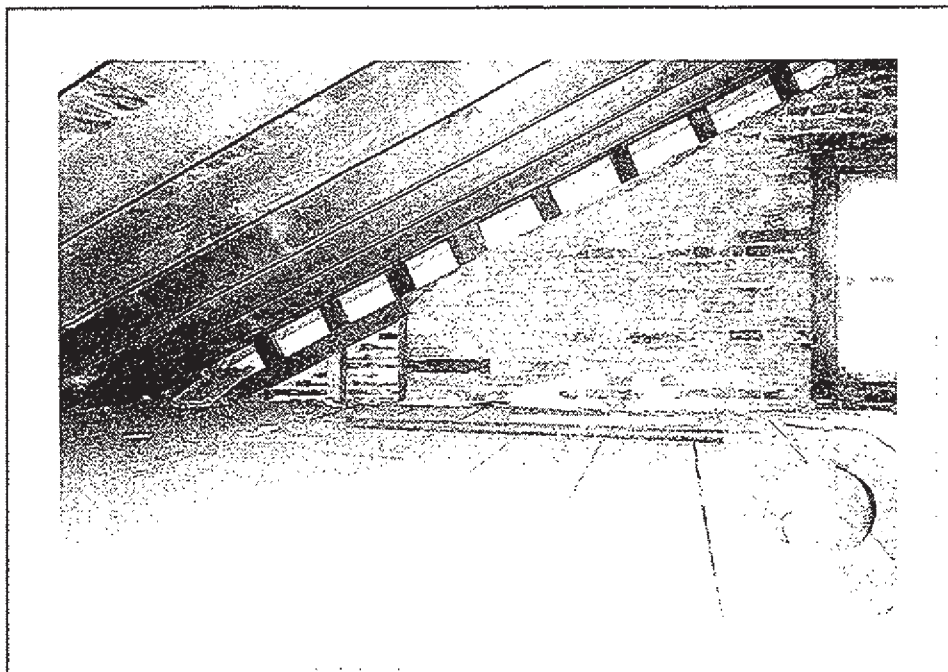
Plate 45. View of the attic looking north. Brick gable walls, window, rafters and floor system date from c.1895 renovation. Note the wood lath and plaster on the gable wall left of center.

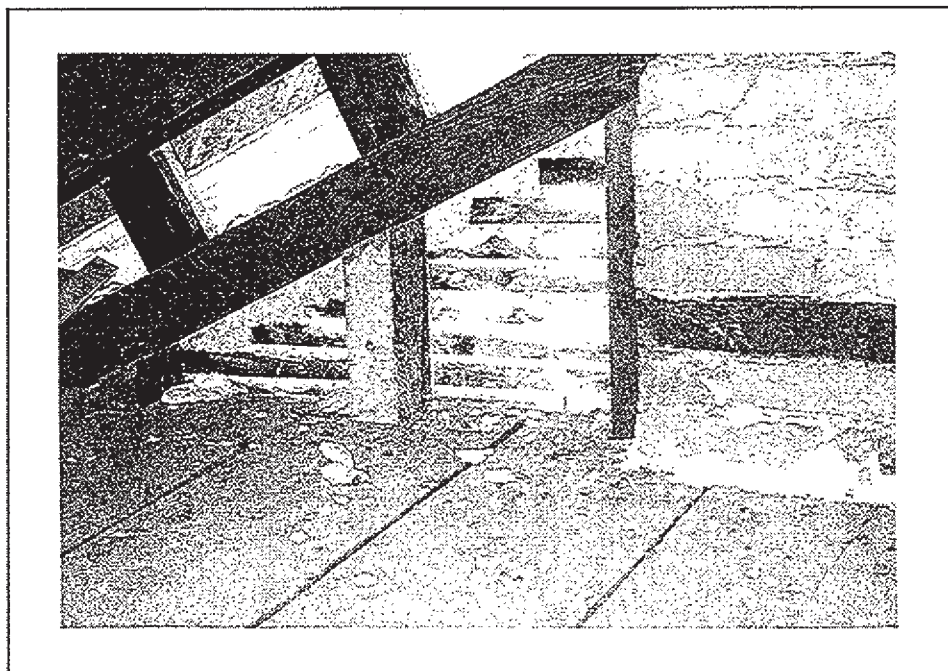
Plate 46. Close-up of Plate 45 showing exterior plaster on wood lath. This edge corresponds to the offset in the north wall of the cellar of the earliest portion of the house.
