# Status of Climate and Water Resources at Casa Grande Ruins National Monument

*Water Year 2017*

Natural Resource Report NPS/SODN/NRR—2018/1691

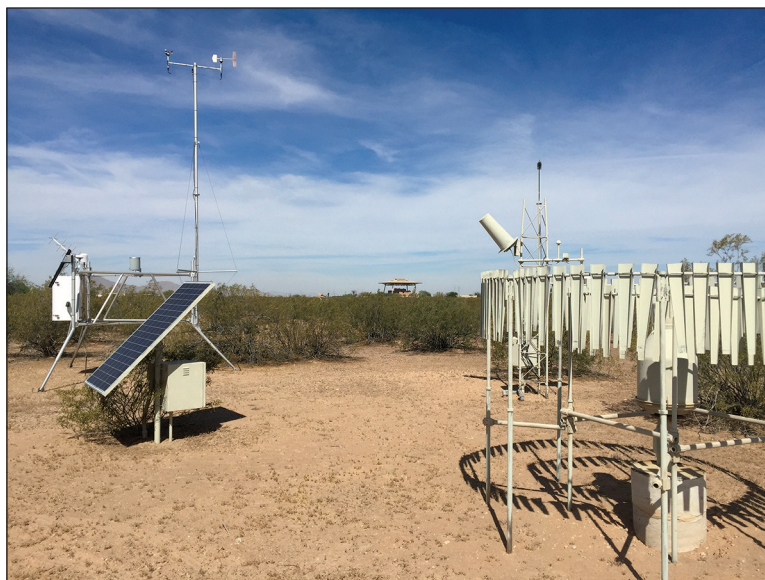
Figure 2-1. Weather stations at Casa Grande Ruins National Monument: A remote automated weather station, shown at left, and a high-precision regional climate reference network station, shown at right. A NOAA Cooperative Observer Program station is located near the Great House (seen in background).

The monument also contains two recently established climate stations: a remote automated weather station (RAWS), installed in 2014; and a Regional Climate Reference Network station, installed in 2011 (Figure 2-1). Both are maintained and operated by the National Park Service Sonoran Desert Network. In combination with the excellent, long-term, NOAA COOP dataset, these stations provide a unique opportunity to study climate and weather patterns in the Sonoran Desert.
