# Status of Climate and Water Resources at Montezuma Castle and Tuzigoot National Monuments

## *Water Year 2017*

Natural Resource Report NPS/SODN/NRR—2018/1692

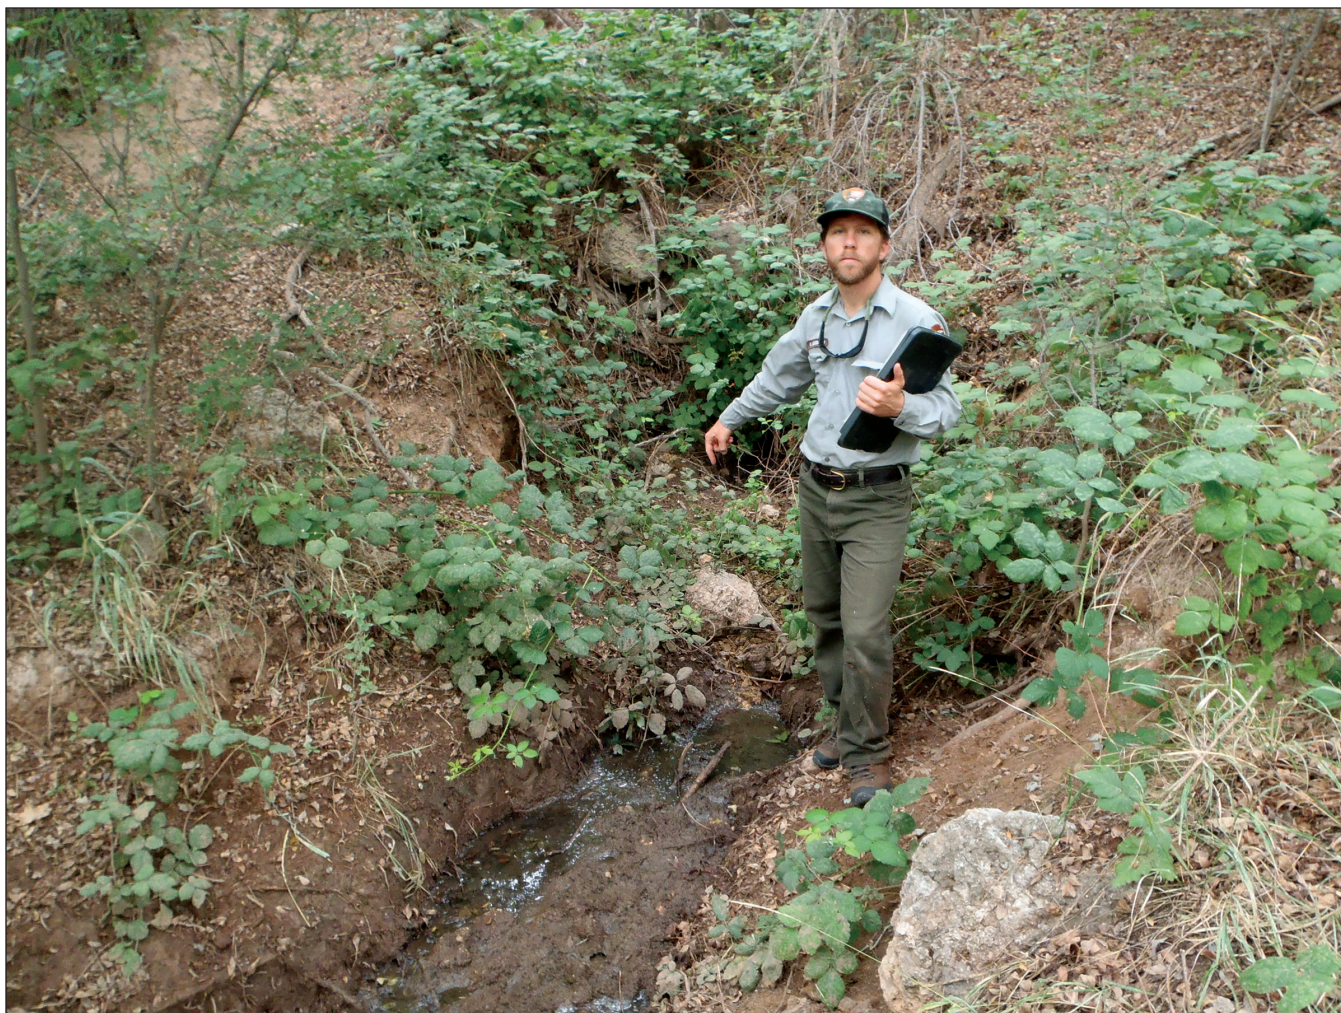
Figure 3-1. Expansion Spring orifice, Montezuma Castle National Monument (Castle unit). Employee is pointing at the spring orifice.

Expansion Spring (MOCA\_001; Figure 3-1) is a rheocrene spring that emerges from the west-facing drainage near the bank of Beaver Creek (Table 3-4). The spring emerges from a dirt embankment in the bed of a runoff-dominated channel, from which it forms a diffuse, low-flowing springbrook that extends for 11.5 meters. The water is warm and turbid, and flows over a loose silt substrate. Despite the springbrook terminating at 11.5 meters, a channel continues the remaining two meters to a confluence with Beaver Creek. In WY2017, the springbrook orifice had moved two meters downstream from its 2016 location.

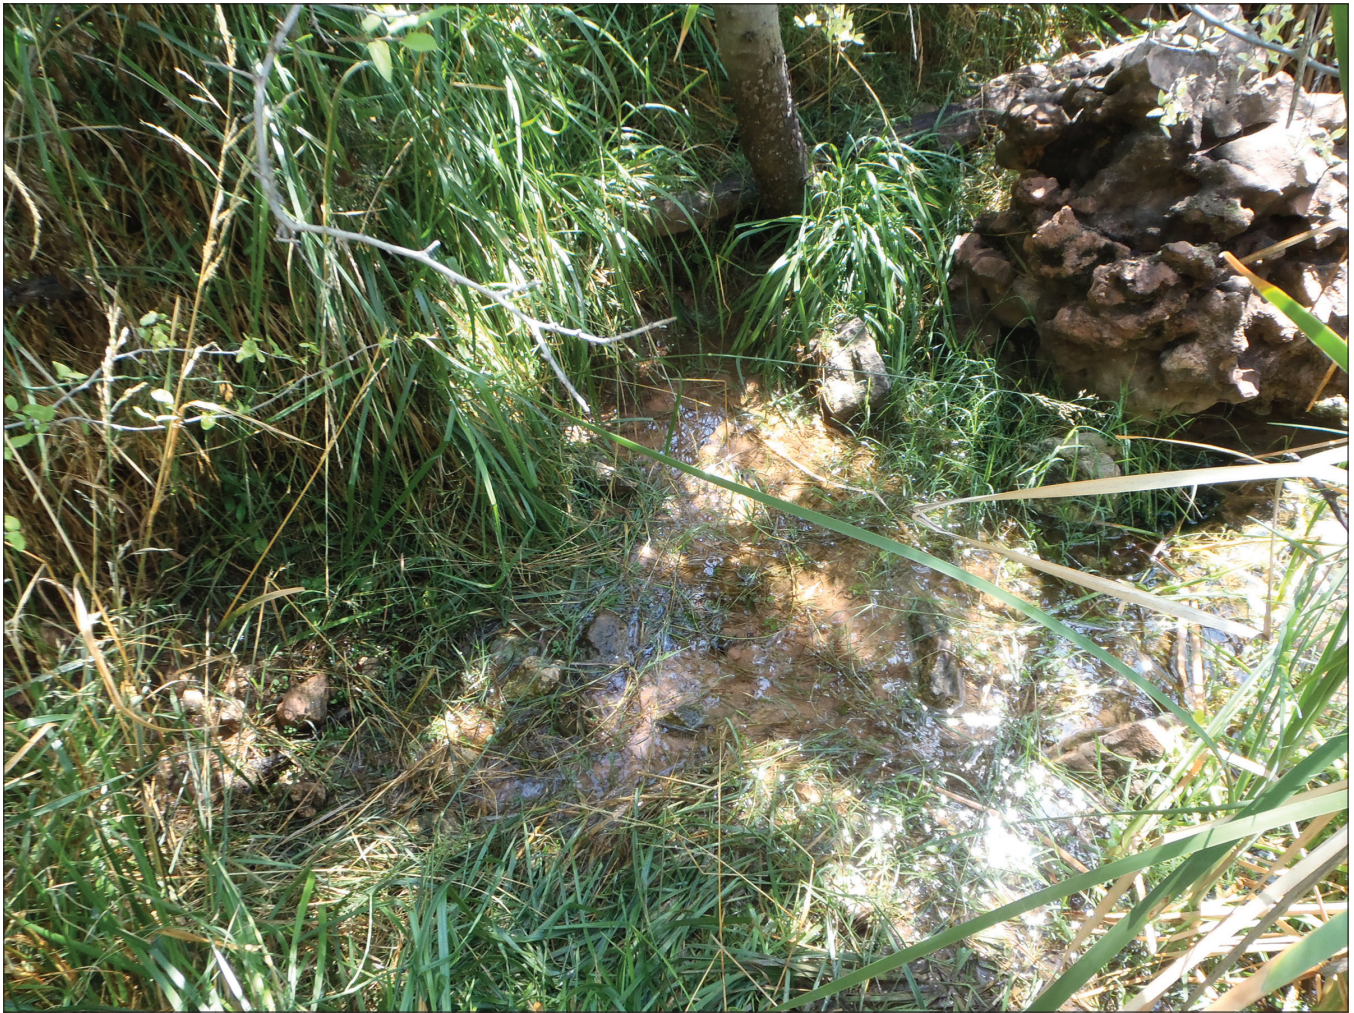
Shea Spring (TUZI\_001; Figure 3-2) is a limnocrene spring that emerges as an orifice pool

Figure 3-2. Shea Spring orifice, Tuzigoot National Monument.

on the banks of Tavaschi Marsh (Table 3-4). The spring emerges from multiple orifices. These include a small, rheocrene-like emergence from a soil embankment on the north end of the pool and multiple active upwellings on the bottom of the orifice pool. The substrate is primarily sand, with scattered gravel and cobbles throughout. The north, east, and west banks of the pool are distinct. The west (downstream) edge of the pool is an indistinct mix of surface water, soil, and dense southern cattail (*Typha domingensis*) and hardstem bulrush (*Schoenoplectus acutus*) that makes it challenging to characterize the features of the pool, such as possible location of multiple orifices or existence and metrics associated with spring channels. The water is clear and cool, with notable macroinvertebrate presence. Invasive northern crayfish (*Orconectes virilis*) were noted during sampling.

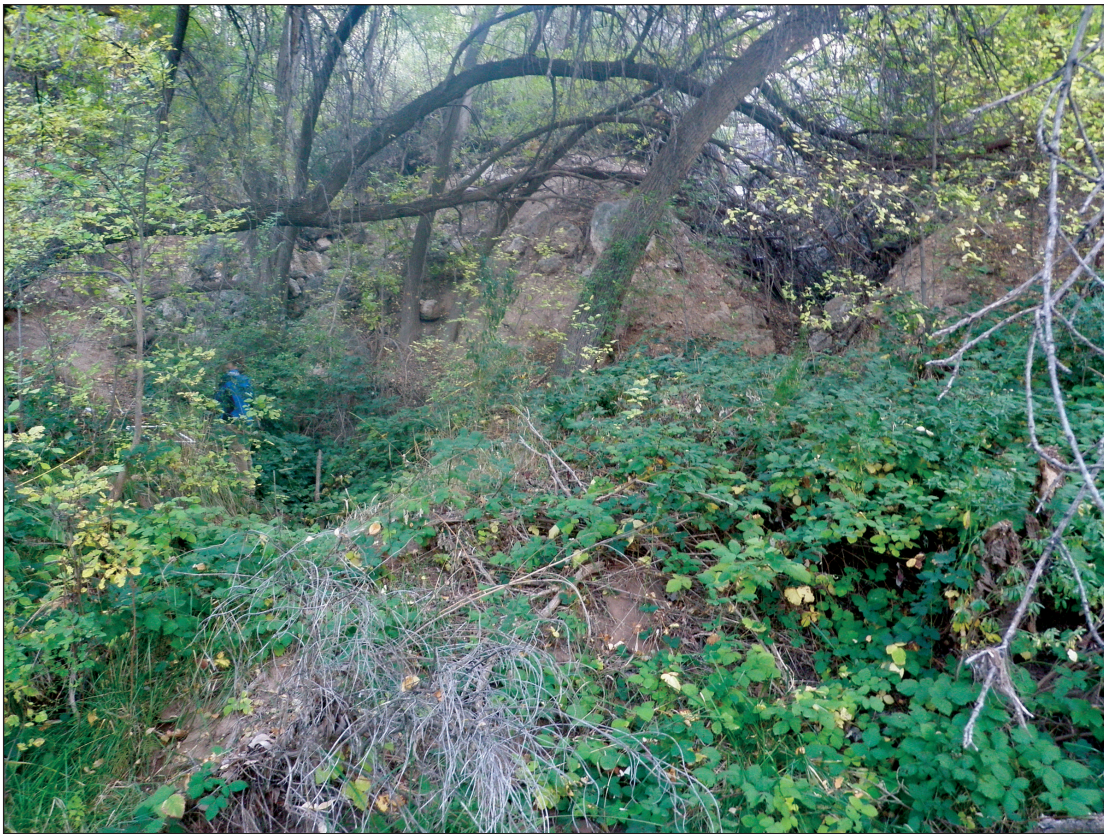
**Expansion Spring**—. There was little indication of natural disturbance at Expansion Spring in WY2017 (Table 3-6). The spring is located at the base of a collapsed ravine in the adjoining limestone slope. It is suspected that the ravine channels groundwater from upgradient, with the groundwater eventually emerging at the spring (Figure 3-3). The site may be susceptible to erosion; it is only several meters away from the active channel of Beaver Creek. Any erosion of the active channel of Beaver Creek could impact this spring (as noted above, the terminus of the springbrook is only two meters from the active channel).

Figure 3-3. Slope where Expansion Spring emerges. The upper half of this photo (from 2011) includes the bottoms of the collapsed ravine(s).

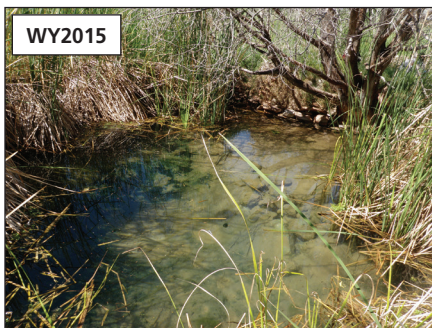
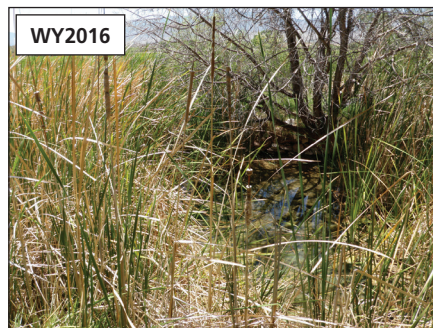
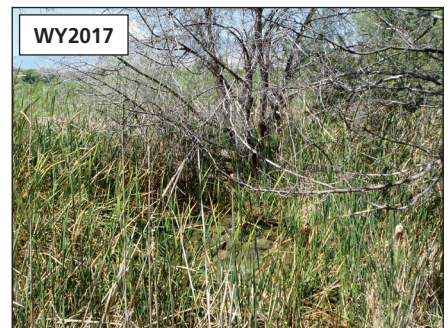
**Shea Spring**—. There was little indication of natural disturbance at Shea Spring in WY2017 (Table 3-6). Observers noted that the cover of southern cattails (*Typha dominicensis*) had increased since 2015 (Figure 3-4). The reason for the apparent increase in cover is unknown, but could indicate a change in nutrient availability or hydrologic regime (Urban et al. 1993).

Figure 3-4. Shea Spring at Tuzigoot National Monument, 2015–2017.

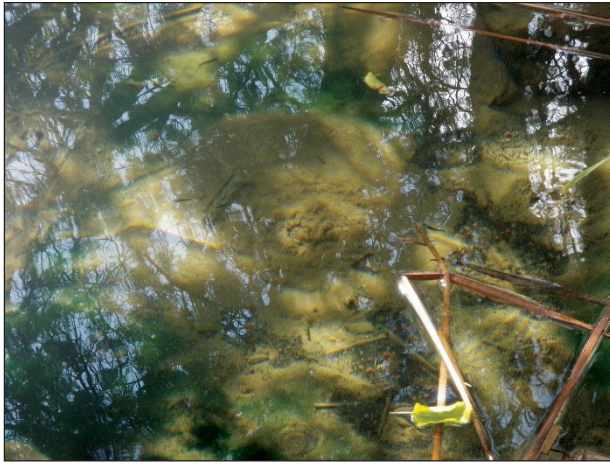
Figure 3-7. Water discharging in the bottom of the pool at Shea Spring. Note the roiling sediment in the center of the photo.

of mature *Typha*), Location B also receives groundwater discharged from the bottom of the pool (Figure 3-7). The pool is connected to the rest of Tavaschi Marsh.
