# Monitoring Climate and Water at Tumacácori National Historical Park

## Overview and Importance

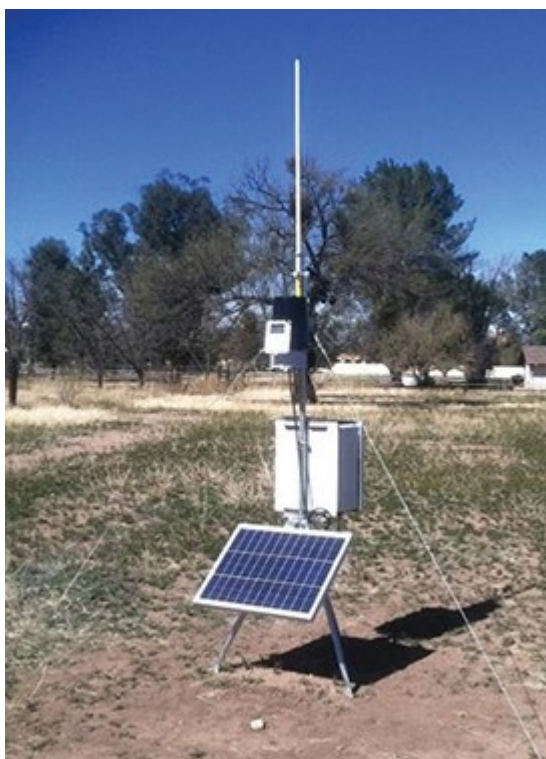
*Climate monitoring station at Tumacácori National Historical Park.*

In WY2016, overall annual precipitation was 108% of normal for Tumacácori National Historical Park. Precipitation was slightly below normal for the fall and winter. However, precipitation in September was 278% of normal, resulting in an extended monsoon season for the second year in a row. The reconnaissance drought index (a measure of soil dryness) reflected the extended regional drought that began in 2000, but results suggest the last three years have helped to remedy the multi-year precipitation deficit. Extremely cold days ( $<26^{\circ}\text{F}$ ) occurred about 80% more often than normal (24 days vs.  $13.3 \pm 2.3$  days) in WY2016. The overall number of days with extreme precipitation events was approximately normal—but almost three inches of rain fell in an event on September 7. Additional information can be found at [climateanalyzer.org](http://www.climateanalyzer.org) ([http://www.climateanalyzer.org/sonoran\\_desert/sagtuma](http://www.climateanalyzer.org/sonoran_desert/sagtuma)).

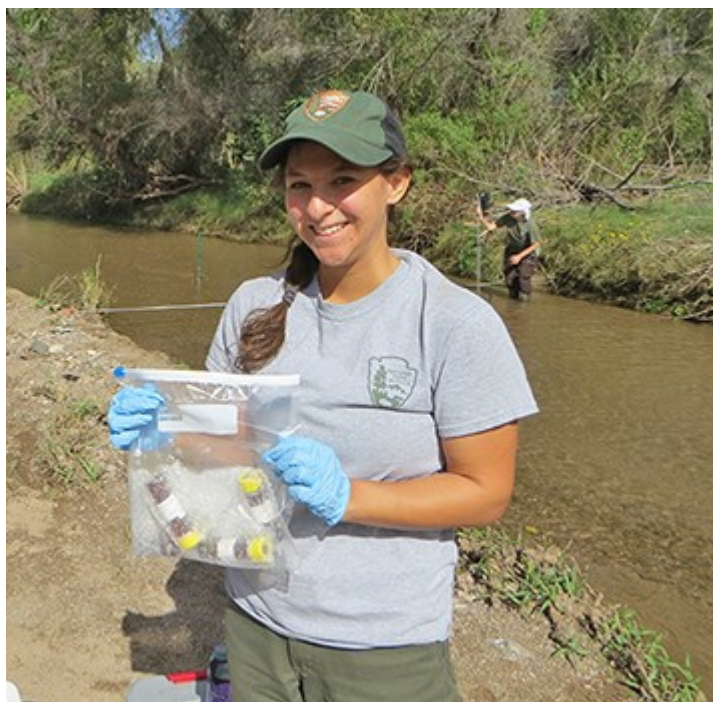
*Sonoran Desert Network staff display water quality samples (foreground) and monitor streamflow (background).*

Water quality monitoring occurred ~150 meters downstream from the southern boundary of the park, at the Santa Gertrudis index site. There was one exceedance of state water quality standards for *E. coli* during WY2016, resulting in an average of 99% overall compliance with state standards. However, it is likely that *E. coli* estimates exceeded the state standards on more than this single occasion, especially during and after precipitation events.
