# Freshwater Monitoring in Southwest Alaska Network Parks

## *2016 Field Season Summary*

Natural Resource Data Series NPS/SWAN/NRDS—2018/1188

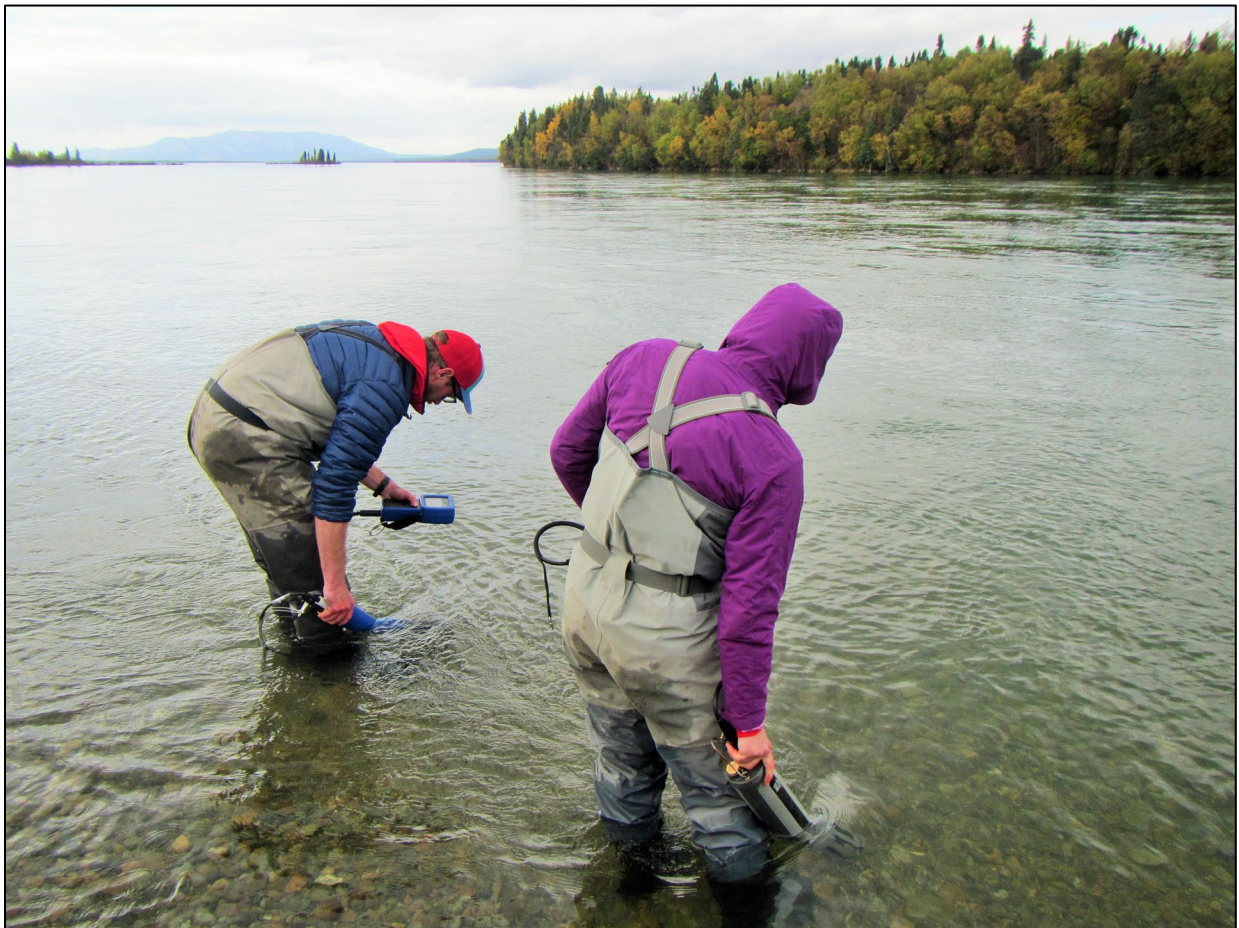
**Figure 2.** Evan Booher and Katie Junghans take side-by-side water quality measurements on September 15, 2016 to assess sensor fouling on the 6600 sonde deployed at the outlet of Lake Clark (NPS/KRISTA BARTZ).

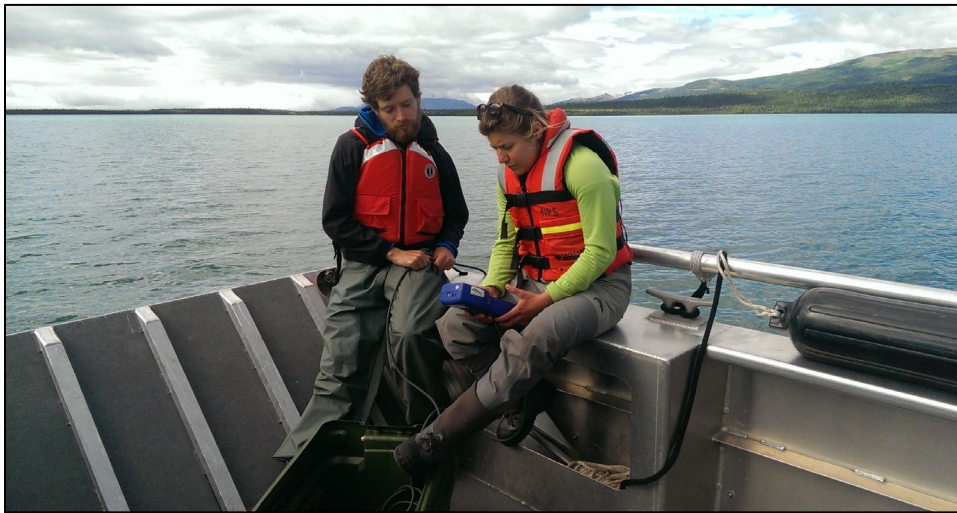
**Figure 5.** Katie Junghans (right) and Dan Monhollon (left) measure water quality parameters along a vertical profile in the lower basin of Lake Clark, LACL, on July 21, 2016 (NPS/KRISTA BARTZ).

Vertical lake profiles were completed at the following sites: L-001, L-002, L-003, L-004, L-005, L-006, L-007, L-008, L-009, and L-010 (Figure 5).

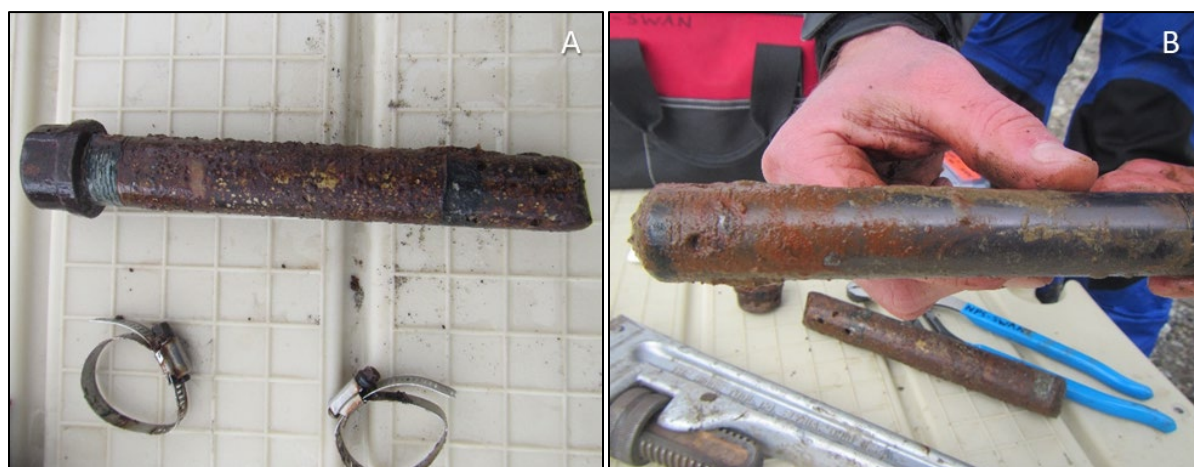
**Figure 9.** Biofouling and rust found on the housing (A) and level logger (B) at the outlet of Naknek Lake on May 2, 2016 (NPS/BOB PETERSON).

The level and baro loggers were downloaded and relaunched (launch date/time: 05/02/2016 16:00), but the HOBO Pro v2 water temperature logger was not recovered (S/N: 10010754). It had been installed the previous year on a dock piling accessible only in low water conditions. Consider moving it to an alternate location. A level survey was run to establish the elevation of the level logger, both before removal and after redeployment. Photos were taken of the survey benchmark and reference points. Biofouling and rust on the level logger and its housing were also documented (Figure 9).

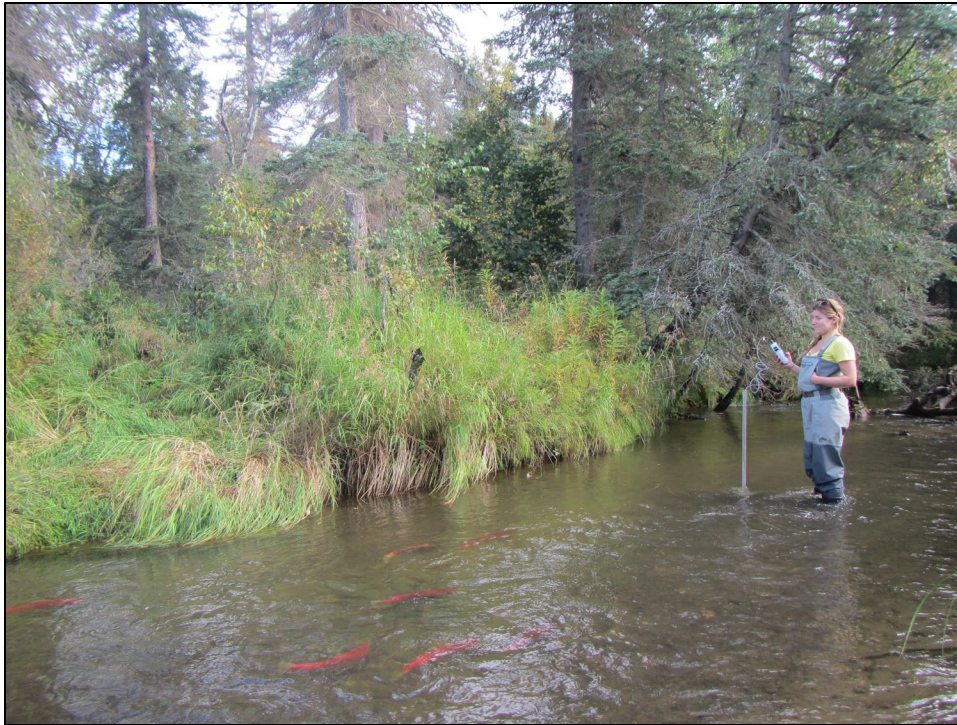
**Figure 11.** Katie Junghans measures interstitial water temperature at Up-A-Tree Creek on August 25, 2016. Spawning salmon were present in the reach during the site visit (NPS/EVAN BOOHER).

Both the HOBO (S/N: 9951824) and TidbiT (S/N: 10206472) loggers were easily located using the Aqua Scope. The loggers were removed, downloaded, and reinstalled. The galvanized steel cable securing the HOBO to its rebar anchor was deteriorating and was replaced with stainless steel cable. Vertical hydraulic gradient (VHG) measurement via mini-piezometer indicated slight upwelling (-0.164). Many salmon were present in the stream and redds were observed above the monitoring site (Figure 11). A brown bear sow and cubs were observed as well.

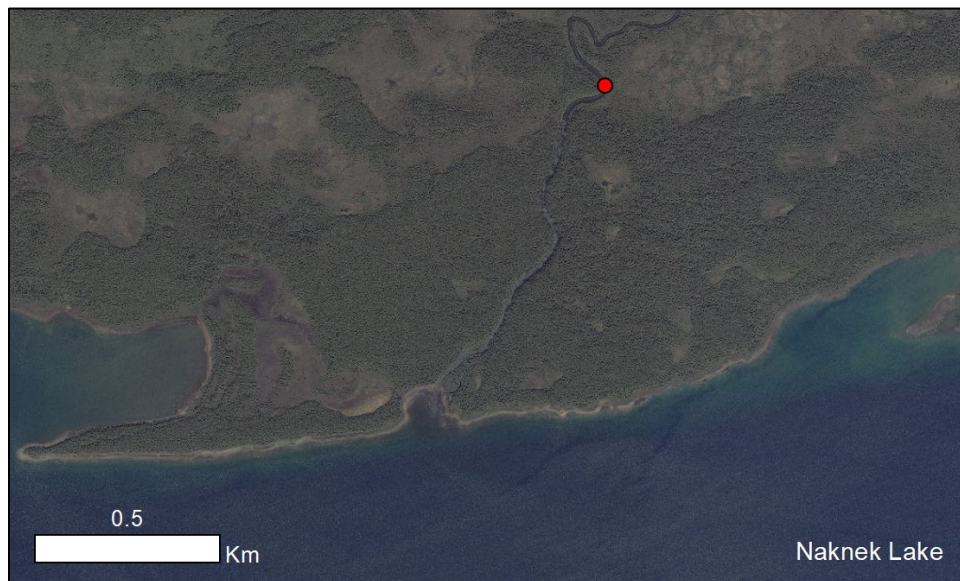
**Figure 12.** Location of the new pilot study site established at Idavain Creek on September 28, 2016.

A new monitoring site was established at Idavain Creek. The field crew followed a trail on the river-right bank for about 1.2 km (0.75 mi) until a relatively stable reach was encountered. The HOBO (S/N: 11001179) and TidbiT (S/N: 10980764) were installed river-right, on the inside of one of the first significant meanders upstream of the creek mouth (Figure 12). Rebar was not used to anchor the TidbiT. Photos of logger locations, distances of reference points, and coordinates were taken to assist in future relocation (58.66621, -155.67084). VHG measurement indicated slight upwelling (-0.076).

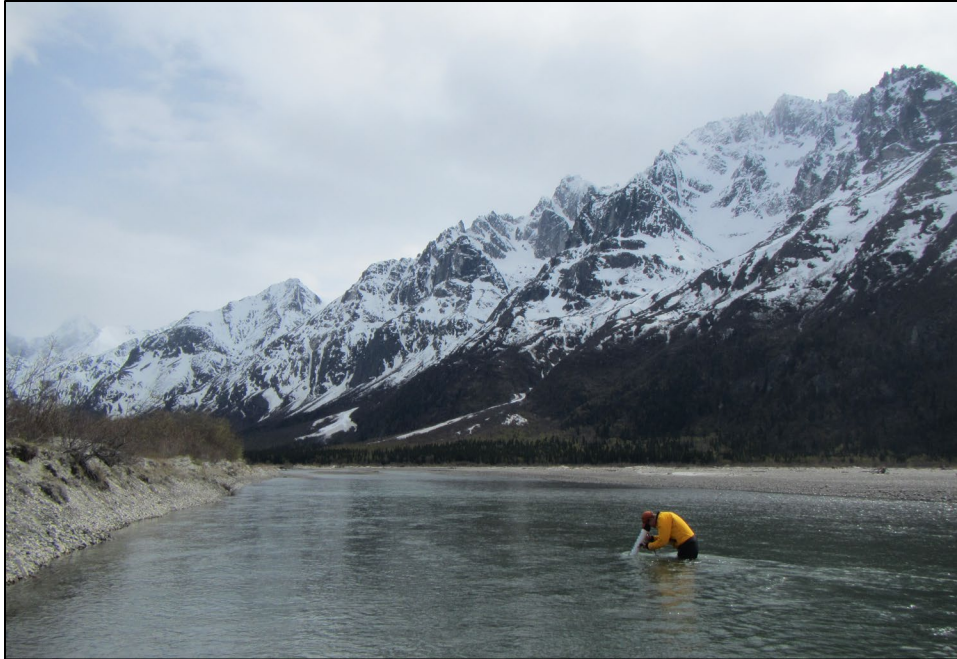
**Figure 13.** Dan Young searches for signs of the TidbiT logger using an Aqua Scope in the Tlikakila River on April 22, 2016 (NPS/EVAN BOOHER).

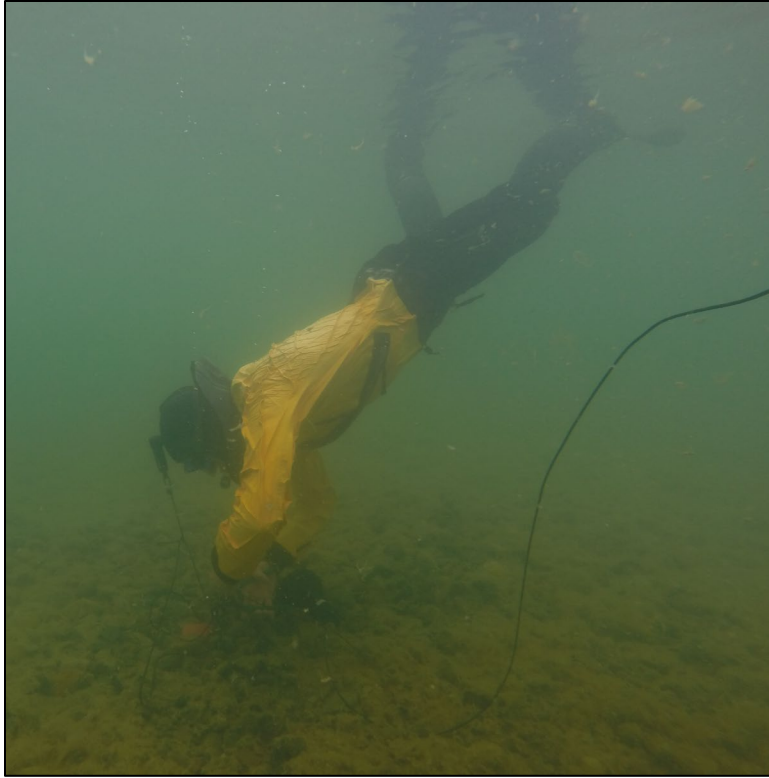
**Figure 14.** Dan Young redeploys a HOBO logger on May 17, 2016 at a beach near Chulitna Lodge, on Lake Clark (NPS/ANDREW KIRBY).

The TidbiT (S/N: 1026468) was reattached to a zip tie and surveyor's brush and reinstalled. The TidbiT was moved ~2 m from its former location, which had become disturbed by the digging done during the last trip. Coordinates of this new location were recorded (60.28065, -154.26601). A new HOBO (S/N: 10584827) was attached to the rebar using rope (as opposed to cable). The water was deep enough that this step required the use of a dry suit (Figure 14). VHG measurement indicated slight upwelling (-0.063).
