HISTORIC STRUCTURES REPORT

CAPTAIN EDWARD PENNIMAN HOUSE AND BARN

EASTHAM, MASSACHUSETTS

HISTORIC STRUCTURES REPORT  
PART I  
ARCHITECTURAL DATA SECTION  
ON  
CAPTAIN EDWARD PENNIMAN HOUSE AND BARN  
Cape Cod National Seashore

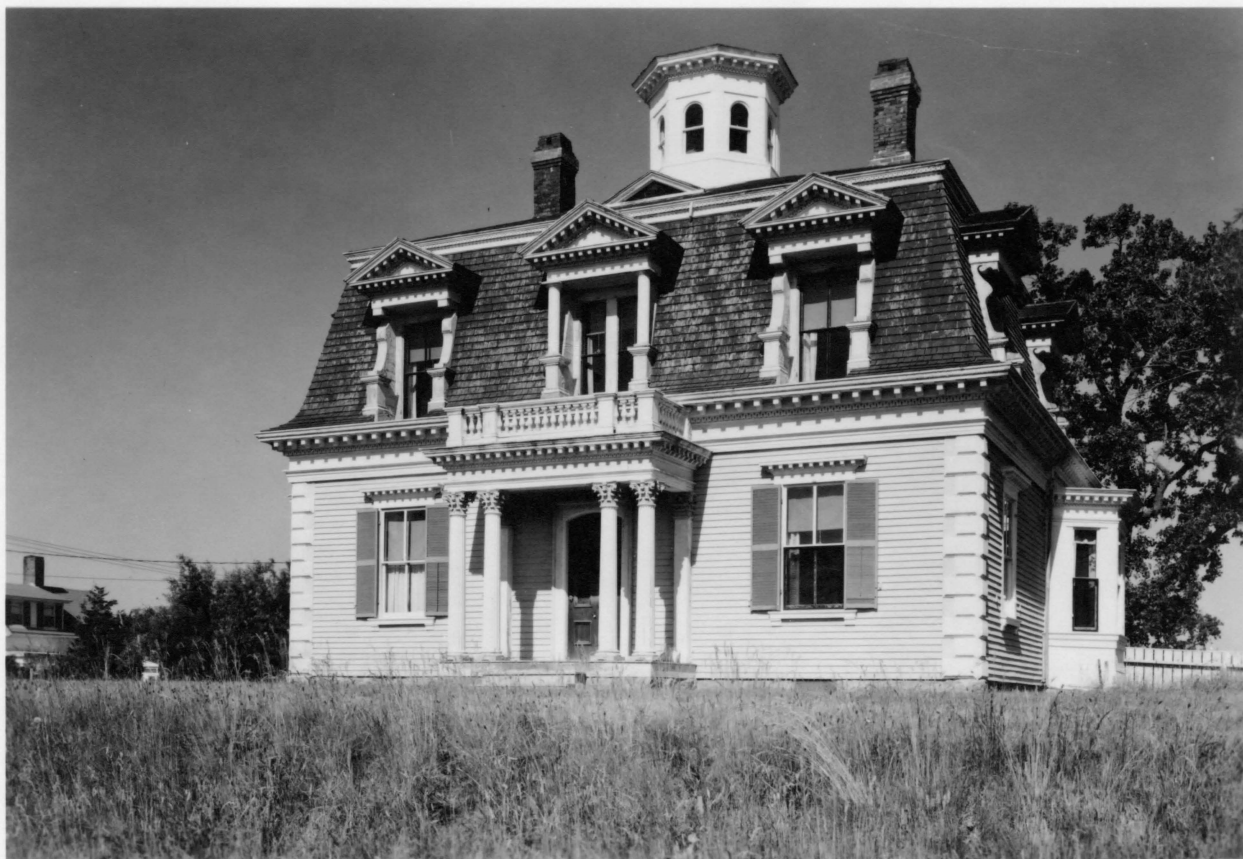
ILLUSTRATION NO. 1

The front, or west elevation of the Captain Edward Penniman house. The house as shown, remains basically unchanged. Note the classic entrance porch, wood quoins and finely detailed cornices.

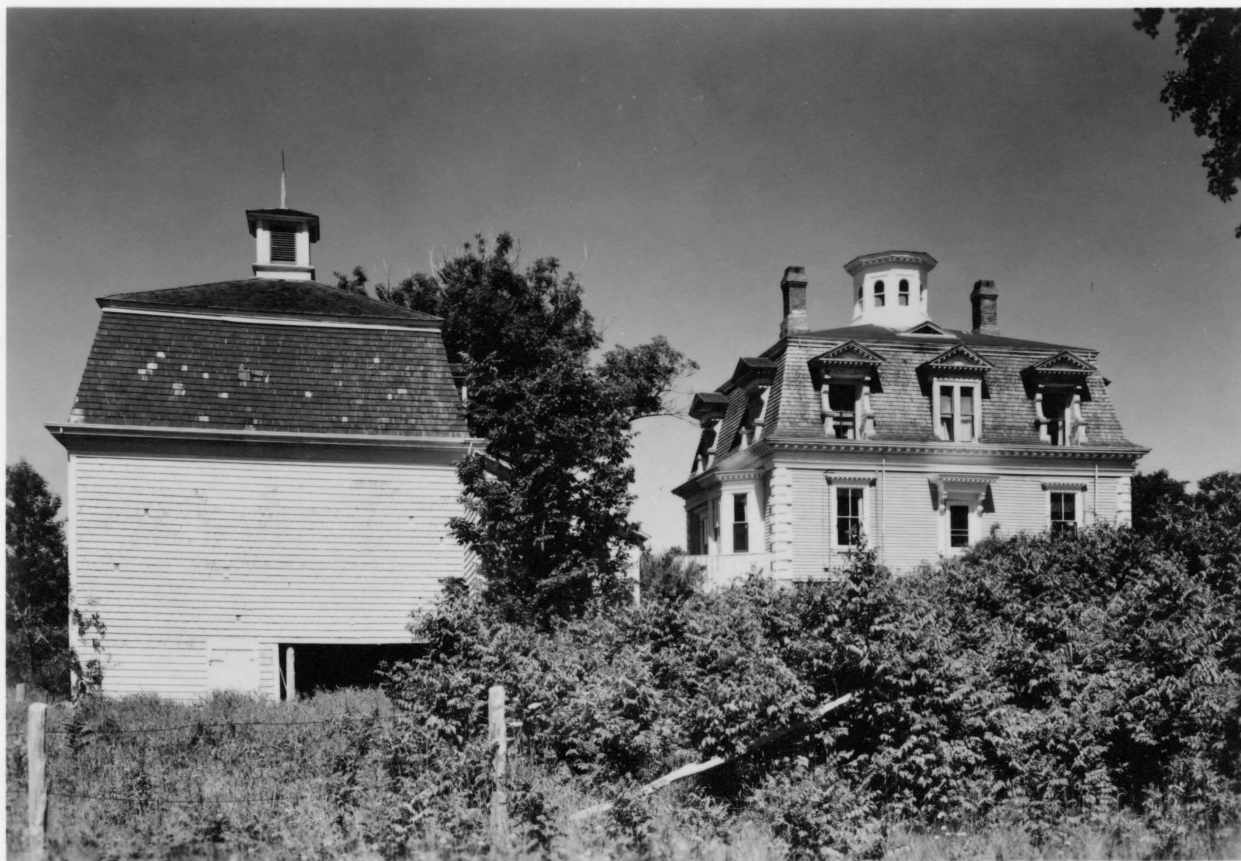
ILLUSTRATION NO. 2

The rear of house and barn from the southeast. This photograph illustrates the basic similarity of the two structures. The barn lacks the decorative quality given to the house in the treatment of cornices, dormers and corner trim. A dormer has been removed from this side of the barn and should be restored.

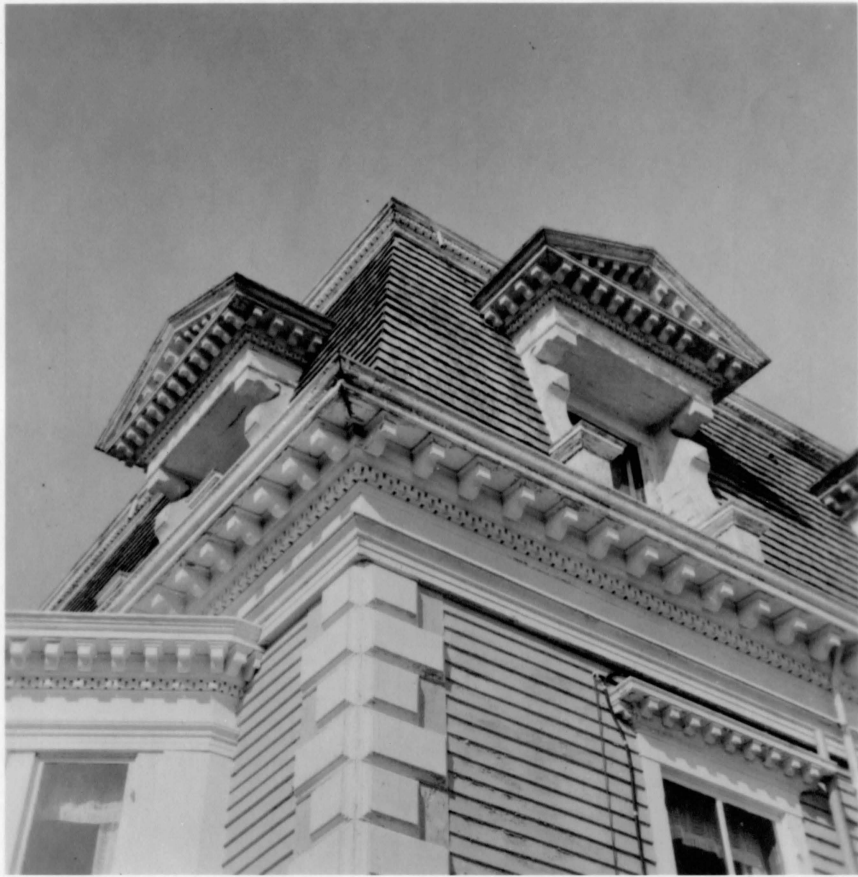
ILLUSTRATION NO. 3

Detail photograph of a corner of the house  
illustrating the corner quoins and the elaborate treatment  
of the cornices.

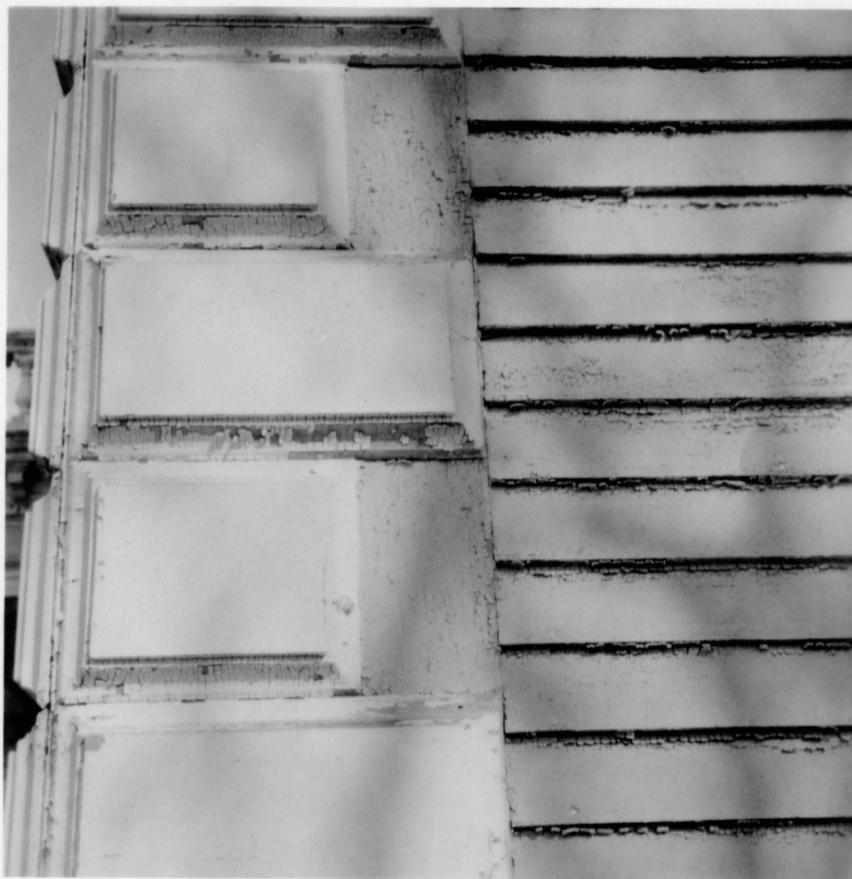
ILLUSTRATION NO. 4

A detail photograph of the wood quoin treatment at the corners of the house. Note the finely moulded edges of the quoins.

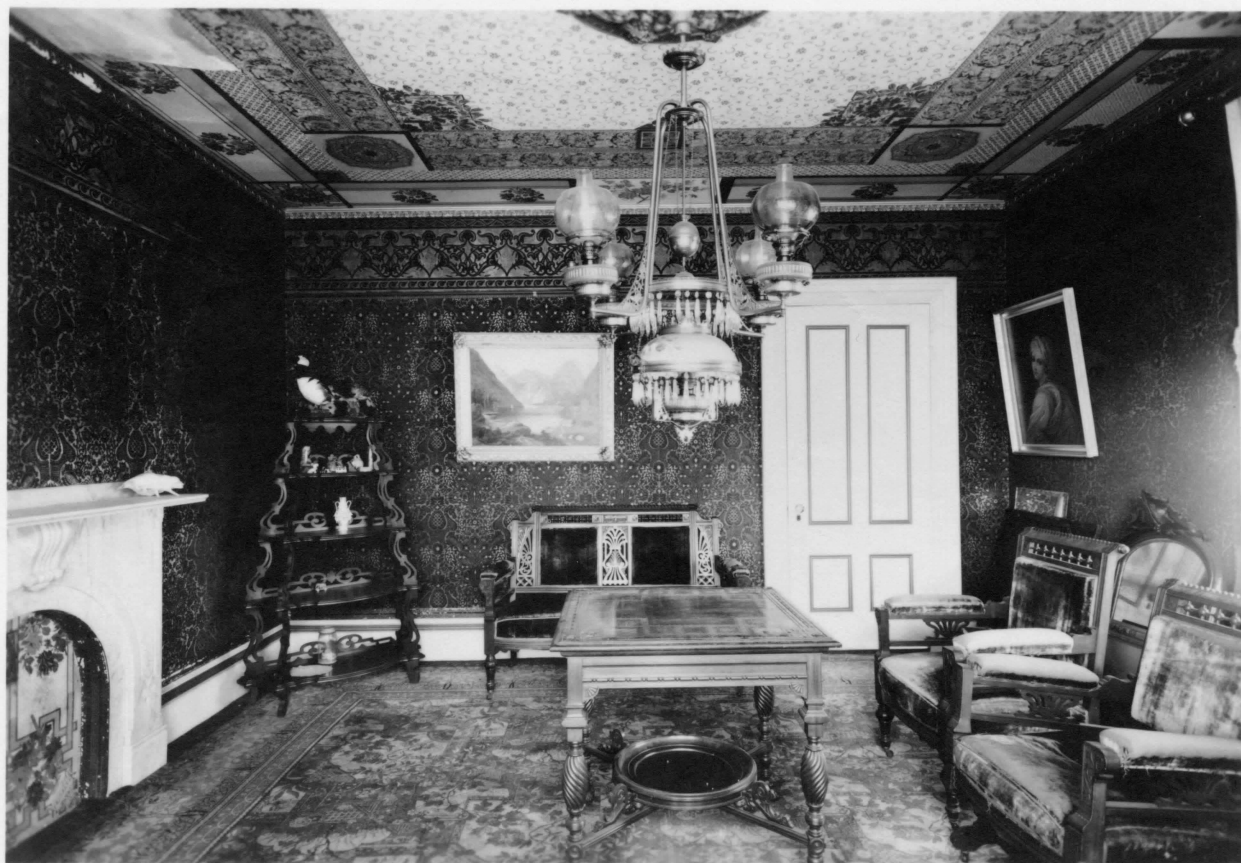
ILLUSTRATION NO. 5

Interior view of East Parlor. The decorative treatment of this room appears to be original. Note the elaborate ceiling paper reported to have been sent from France. The unusual chandelier also is in character with the house and period.

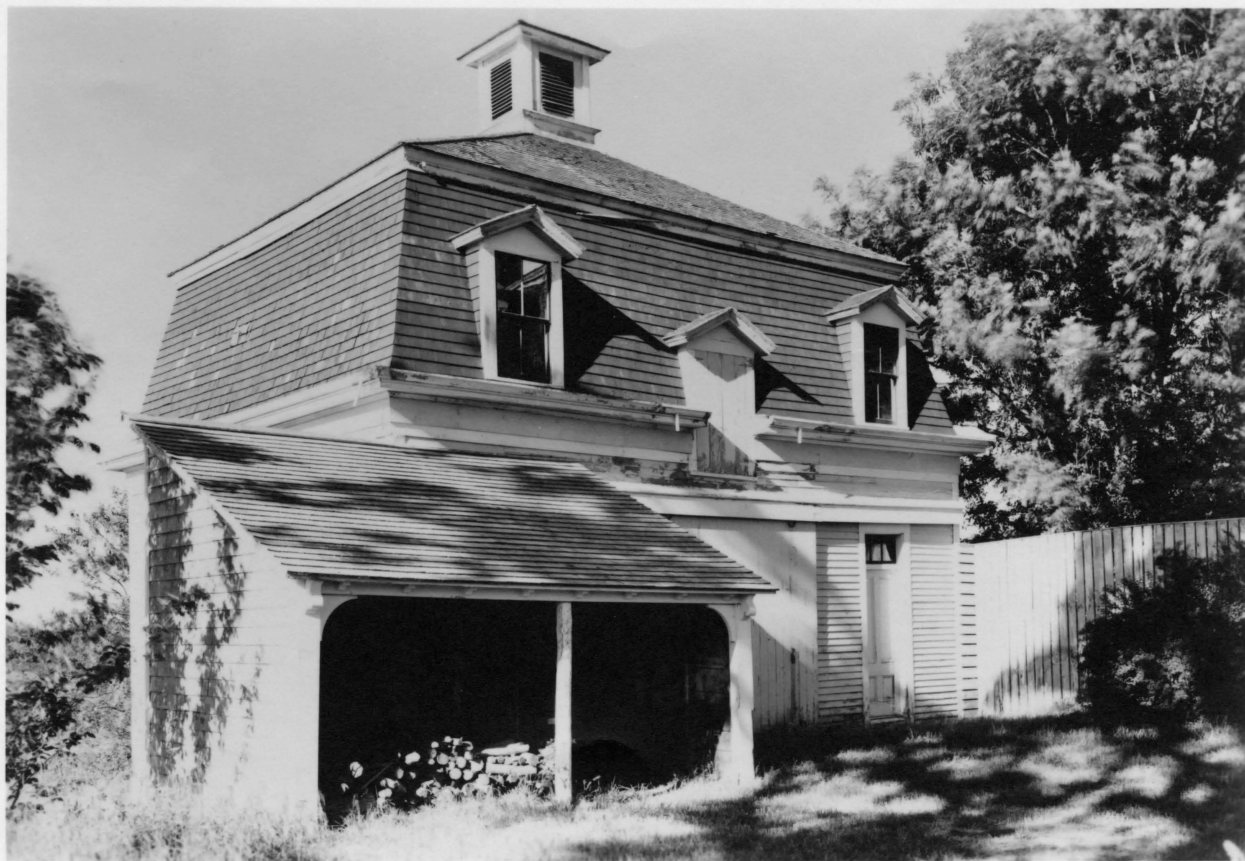
ILLUSTRATION NO. 6

Photograph of the barn and woodshed taken from the south. The shed is an addition to the barn but built within Captain Penniman's lifetime and should be preserved together with the house and barn. The simplicity of the treatment of cornices and dormers on the barn as compared with the same features on the house can be noted in this photograph.

The wood framed exterior walls and roof rafters of the barn seem to be in good condition and no major structural failures were apparent. The lower and upper Mansard roof surfaces as well as the roof of the ventilating cupola should be resingled. The eaves have serious cracks and rotted areas and should be rebuilt.

Clapboards on the east, north and west sides should be renailed where loose, and new red cedar clapboards installed where the present ones cannot be easily repaired.

The present asphalt shingles on the open wood shed, at the north-east corner of the barn should be replaced with wood shingles.

Wood shingles on the south wall of the barn should be replaced with new wood shingles stained to match the clapboard walls.
