# Monitoring Climate and Water at Montezuma Castle and Tuzigoot National Monuments

**Montezuma Castle National Monument (/moca/), Tuzigoot National Monument (/tuzi/)**

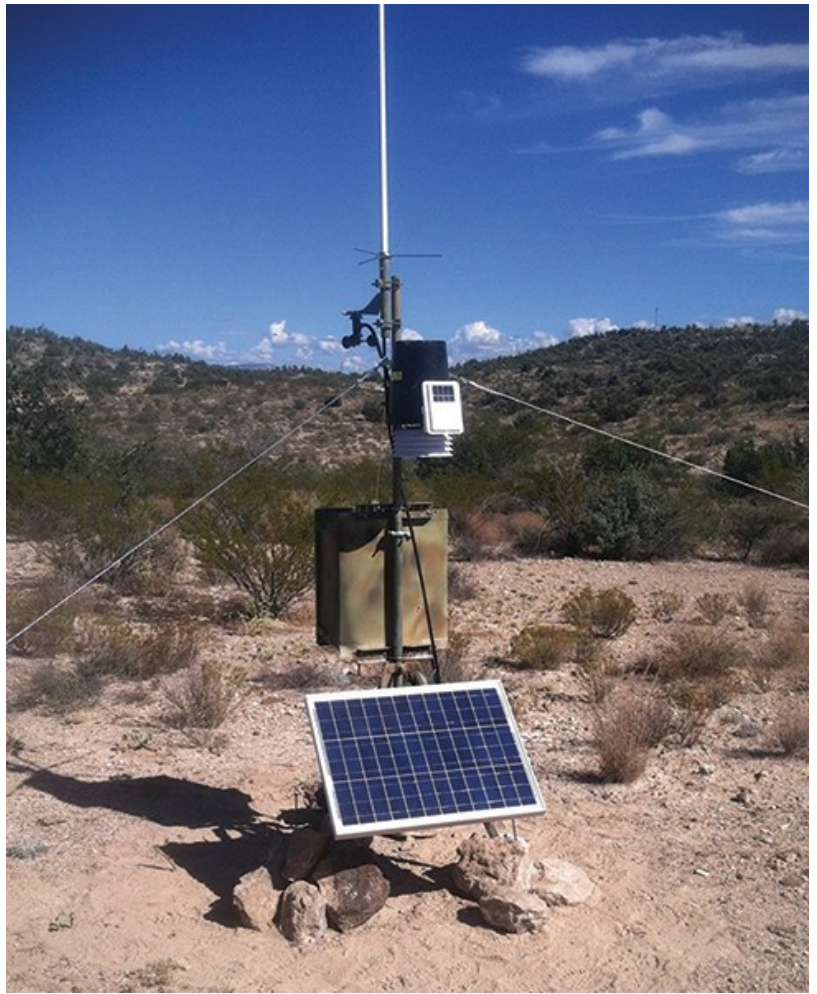
*Climate monitoring station, Montezuma Castle National Monument.*

In WY2017, overall annual precipitation was 117% of normal for Montezuma Castle National Monument (16.8" vs. 14.4") and 129% of normal for Tuzigoot NM (16.36" vs. 12.71"). Precipitation at both parks was above normal both for fall and winter and for spring and summer. Maximum and minimum temperatures were generally warmer than normal, except in January, when the mean maximum temperature was at least 5.0°F below normal in both parks. The reconnaissance drought index for both parks

reflected the extended regional drought that began in 2000, although conditions in WY2017 indicated a limited recovery. Extremely cold days occurred less often than normal at both parks (6 vs.  $22.3 \pm 1.4$  days for Montezuma Castle, 10 days vs.  $14.6 \pm 1.1$  days for Tuzigoot). A storm on August 12 dropped 2.9" of rain at Montezuma Castle—an event expected to occur once every 10 years, based on the historic record. Additional information can be found at [climateanalyzer.org](http://climateanalyzer.org)

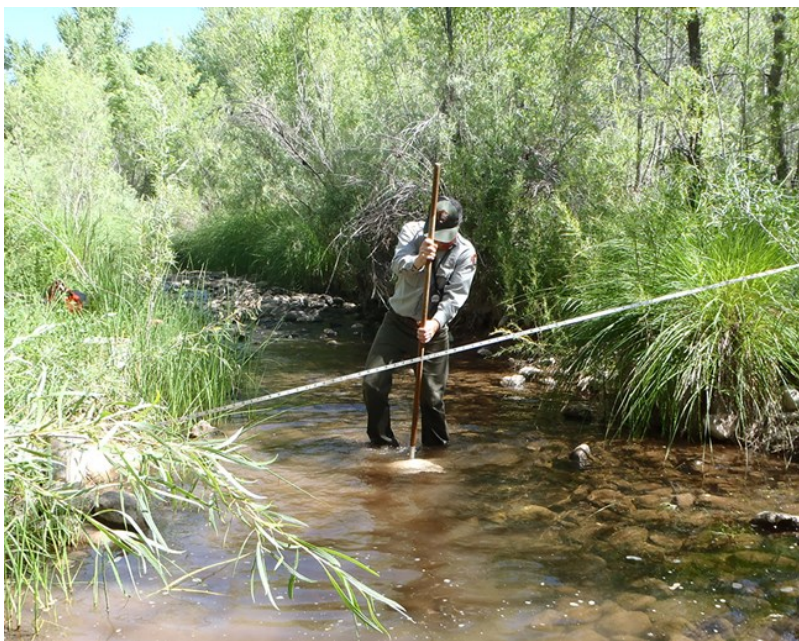
*Streams monitoring on the Verde River, Tuzigoot National Monument. NPS/L. Palacios*

Recorded flow at the Verde River gauge at Tuzigoot National Monument varied from 2.61 to 10.4 cfs during WY2017, depending on the integrity of the dam. Flow was either at or below the 25th percentile for most of the year. Flow data for Beaver Creek were provisional (results indicated that the Beaver Creek gauge accurately captures the occurrence and duration of flow events, but not their magnitude).
