# **Current Condition of Standards from the Denali Park Road Vehicle Management Plan**

## ***2017 Summary Report***

Natural Resource Report NPS/DENA/NRR-2018/1838

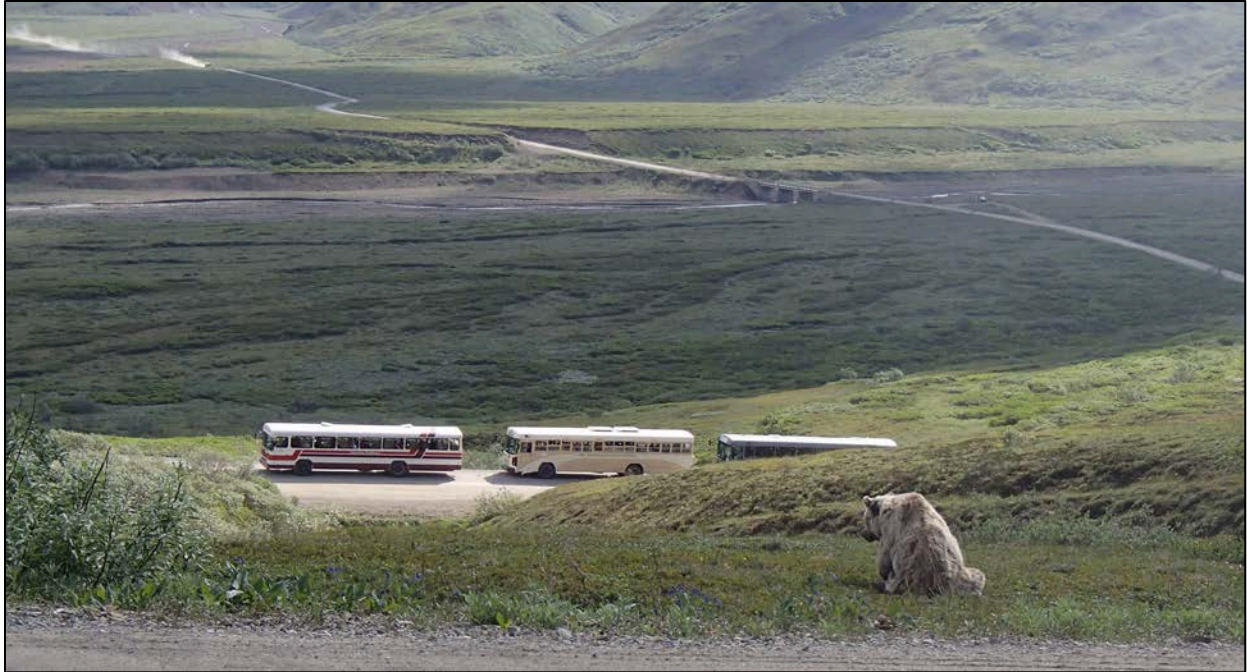
**Figure 3.** Two Lodge buses and one tour bus stop to view a grizzly bear near Stony Dome, Denali National Park, Alaska, USA. The number of vehicles stopped to view wildlife at one time is an indicator used to measure visitor experience quality and protect resources.

Wildlife stops are stochastic events that can occur at any point along the park road. They are defined as one or more vehicles stopped to observe wildlife on the controlled section of road (Figure 3). One or more individual animals, representing one or more species may be present at a given wildlife stop. The most frequent stops are to view caribou, grizzly bears, Dall sheep, moose, and wolves, although vehicles will stop for other species (e.g. ptarmigan, fox, and others). The VMP manages for traffic volume at wildlife stops by establishing thresholds for the number of vehicles stopped to view wildlife in the same location at the same time. The maximum tolerable number of vehicles at wildlife stops varies by Subzone.

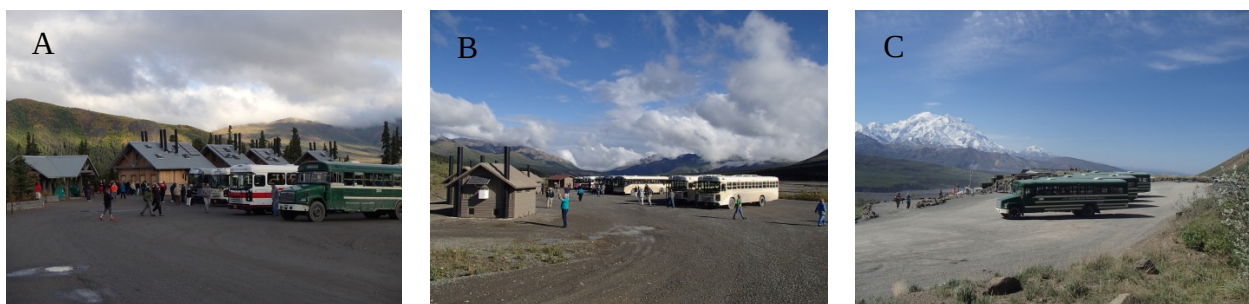
**Figure 4.** The number of vehicles parked at one time at the Teklanika rest stop (A), the Toklat rest stop (B), and the Eielson Visitor Center (C) is used as an indicator to measure visitor experience quality in Denali National Park and Preserve, Alaska, USA. The standard varies by site and describes a maximum number of buses and a maximum number of total vehicles that can be parked at one time.

We used NPSO and ROAR data to assess crowding conditions (maximum vehicles and maximum buses) at three rest stops (Figure 4). Based on NPSO, we recorded the maximum number of vehicles (by type) parked at the rest stop at the same time within 2-minute intervals for a period of 20 minutes (10 observations). This is distinct from recording a tally or count of all vehicles within the rest stop during each 2-minute interval. Vehicles must have been parked in the rest stop at the same time to count toward a maximum during a 2-minute interval. Composition of vehicles is recorded during the first instance of the vehicle maximum within a 2-minute interval and not changed if that maximum occurs another time within the same 2-minute interval. Thus, the composition of the maximum reflects that of the first instance of the maximum for that interval.

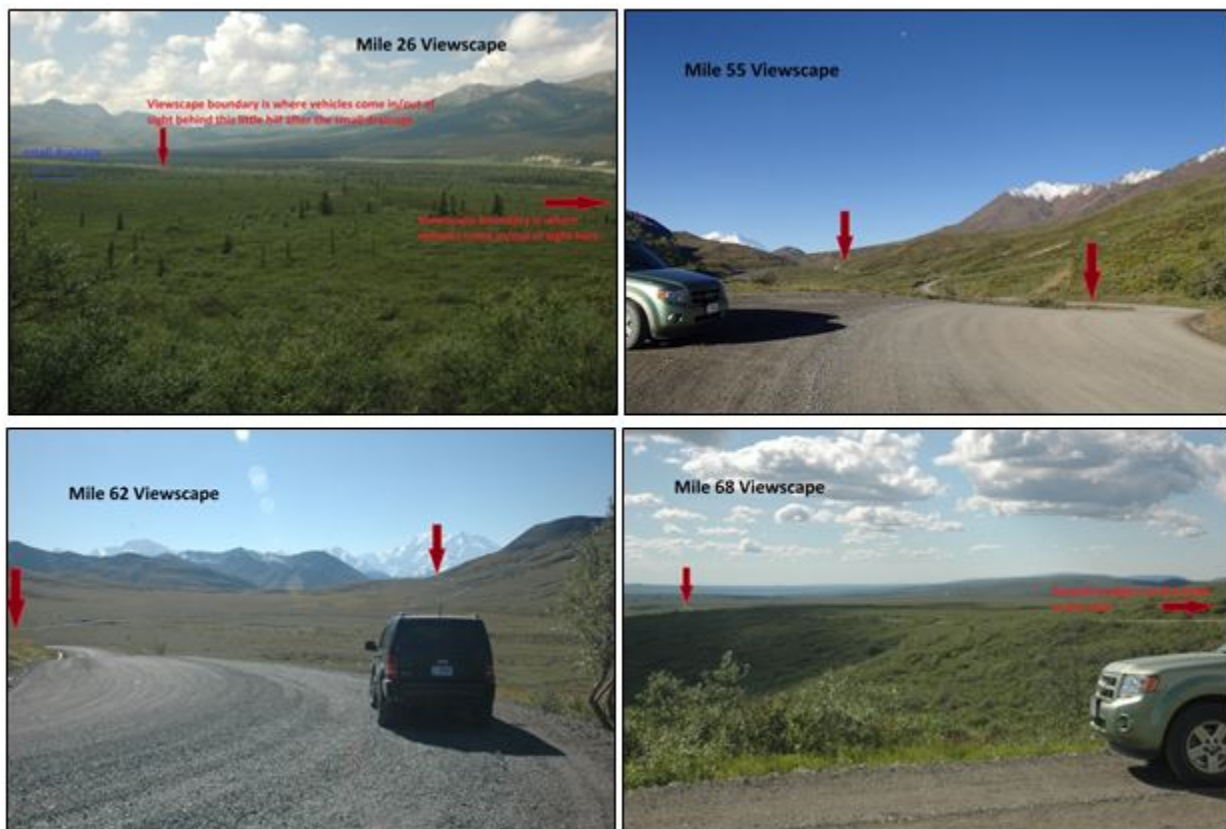
**Figure 5.** The number of vehicles visible in each of four viewscales is an indicator used to measure visitor experience quality in Denali National Park and Preserve, Alaska, USA. Arrows indicate the end points of the viewscape. The standard varies by Subzone and is described by a minimum percentage of time that fewer than a threshold number of vehicles are visible at one time.

The VMP identified four viewscapes: mile 26, mile 55, mile 62 (Stony Overlook), and mile 68 (Grassy Pass; Figure 5). The standard for each viewscape is based on the social normative curves

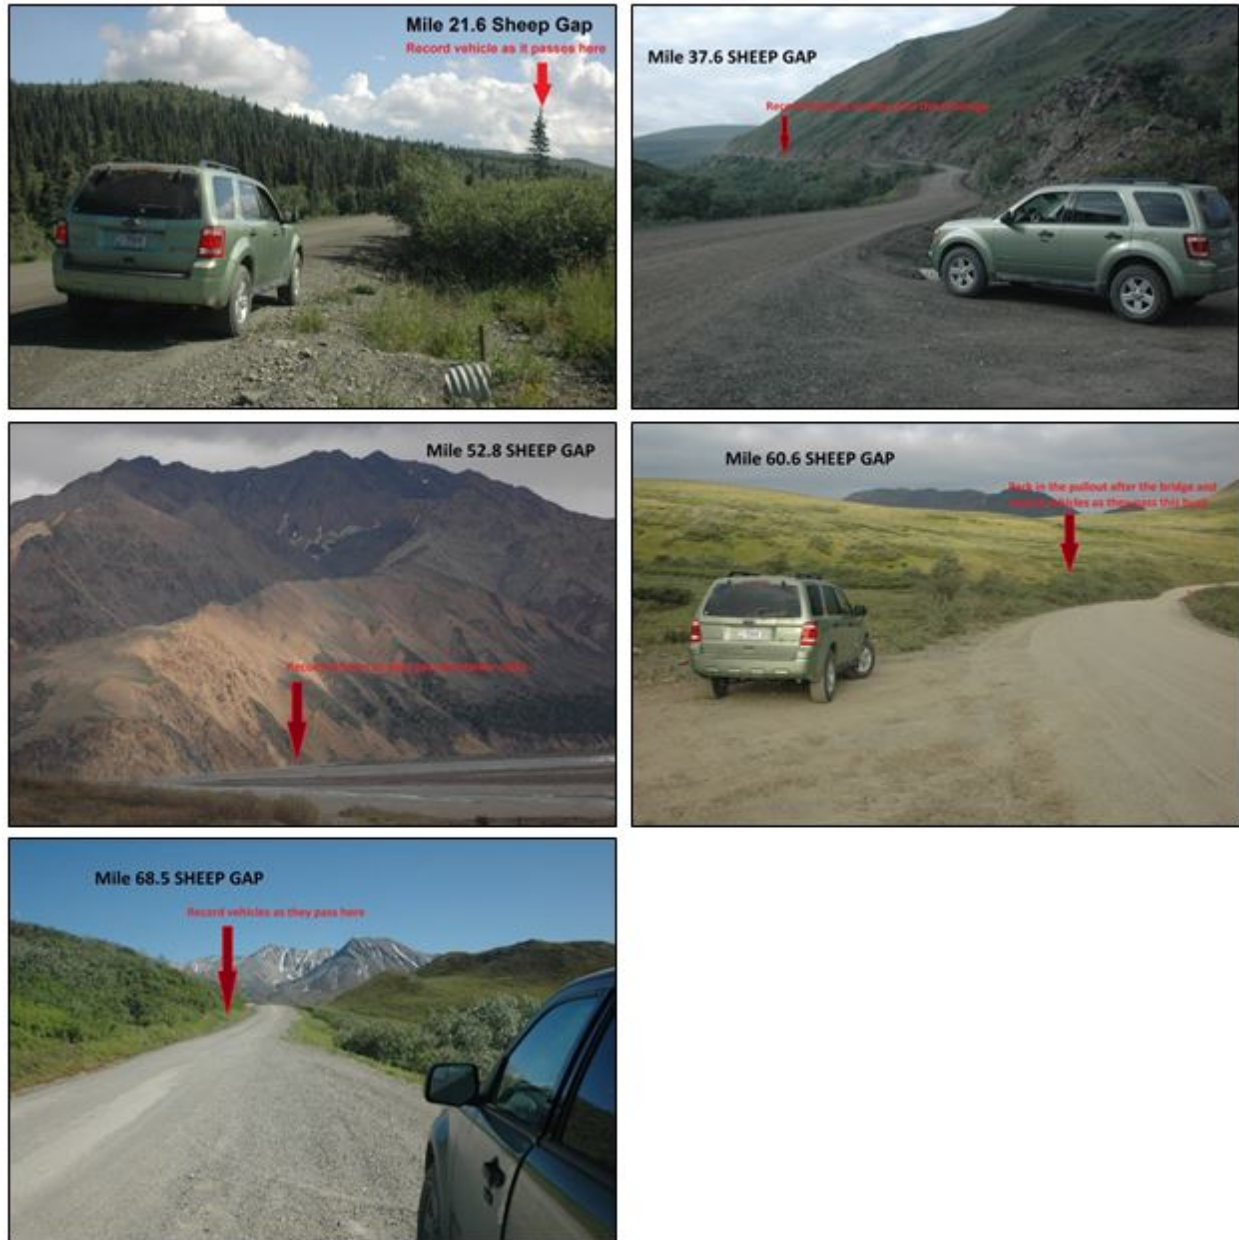
**Figure 6.** The spacing of traffic at five sheep crossing locations (i.e. sheep gaps) is used as an indicator to measure desired resource protection efforts along the Denali Park Road (Denali National Park and Preserve, Alaska, USA). Arrows indicate the monitoring reference point. The standard is a minimum percentage of hours that contain at least one 10-minute gap in traffic.

We assessed the standard for the sheep gap indicator using the NPSO protocol at five sites in addition to using the Grassy Pass traffic counter at one of those sites (Figure 6). Using the NPSO protocol, sheep gaps were monitored for between 10 and 60 minutes. The length of observation depended on traffic conditions. Once a 10-minute period passed with no vehicles, the observer recorded that a successful gap occurred. Observers remained at the site for an additional 10 minutes or until the next vehicle passed to get a better assess true gap length.
