**National Park Service  
Cultural Landscapes Inventory  
2018**

**Visitor Center Area Cultural Landscape  
Antietam National Battlefield (ANTI)  
December 2018**

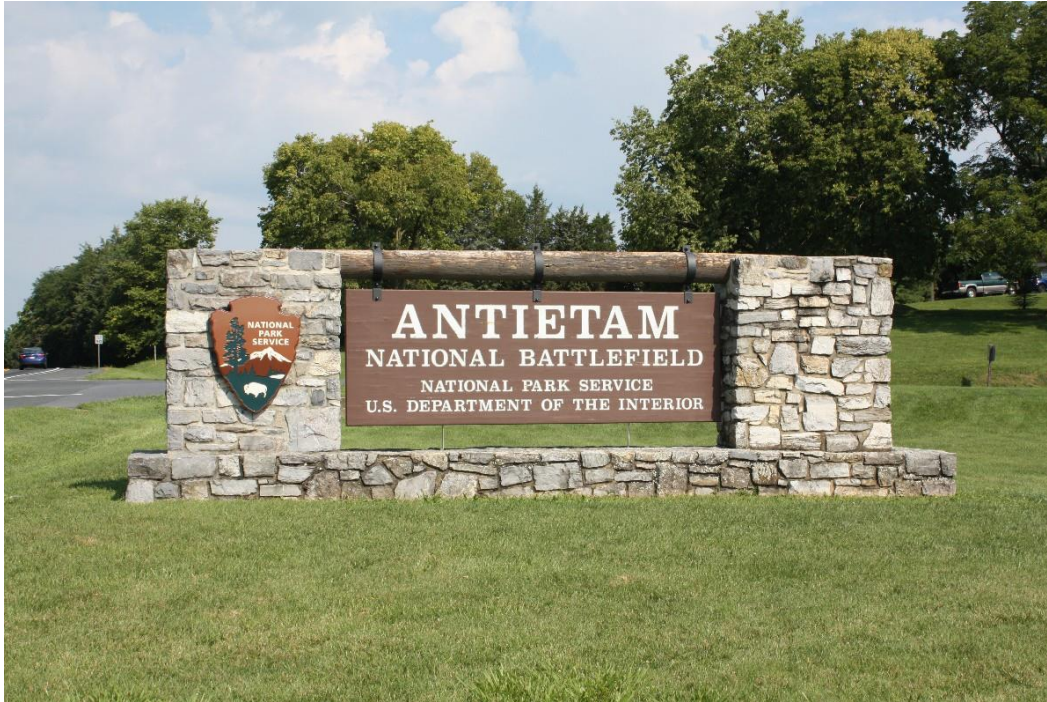
Figure 5 *The Antietam National Battlefield sign located to the west and south of the study area (NCR CLP 2018).*

In 1990, the entrance sign to Antietam National Battlefield was also modified. Originally the sign was L-shaped and consisted of the stone base, the eastern stone wall, and an adjacent wooden sign. In the late 1990s or early 2000s, the National Park Service modified the sign and expanded the base to the west, built the additional stone wall, and replaced the wood sign (Babin 2017: 7-17).

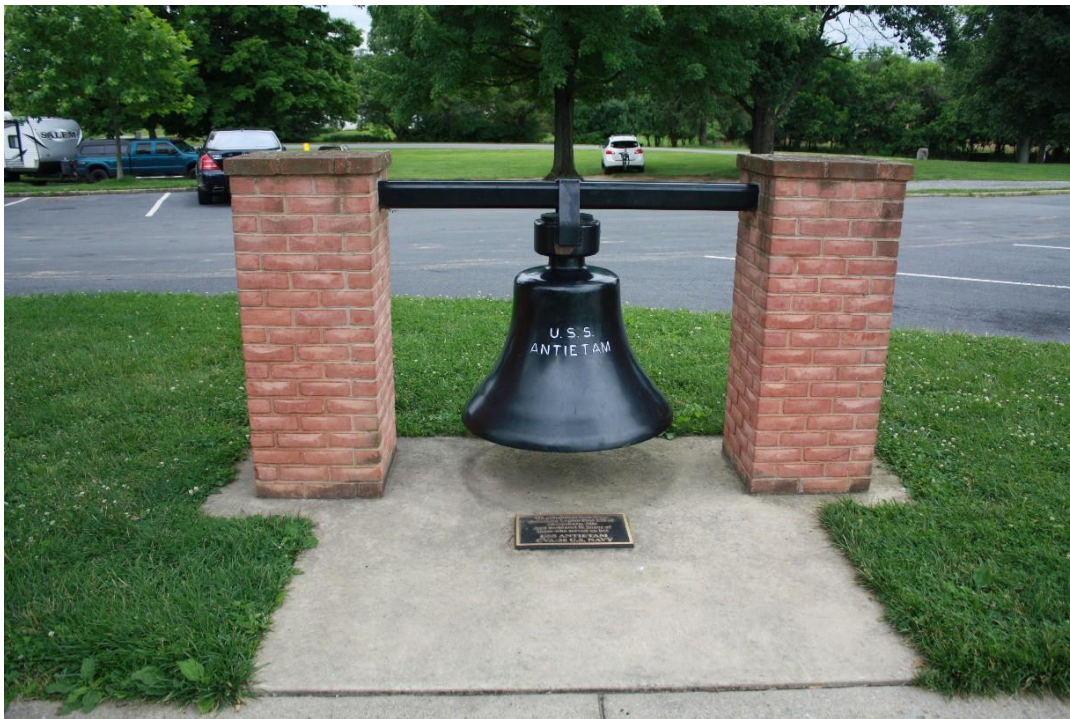
The *U.S.S. Antietam Bell* is located along the north east curve of the parking lot. The bell is a large, black, cast iron bell suspended on a black metal bar supported by two red brick pillars approximately four feet tall. The

brick piers are situated on a concrete plaza abutting a concrete path. Just in front (east) of the bell is a small plaque.

Figure 6 *The USS Antietam Bell (NCR CLP 2018).*

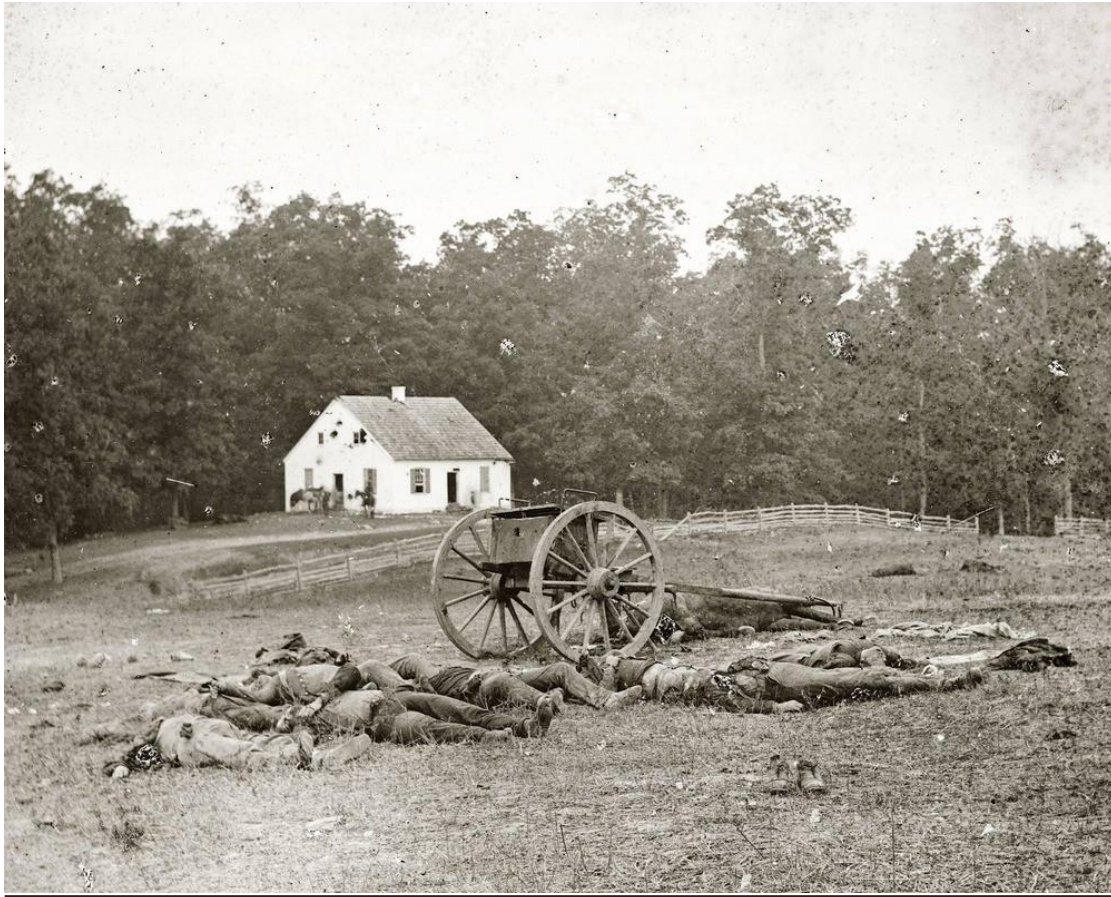
Figure 7: Gardner, Alexander, photographer. *Antietam, Maryland. Dunker church on battlefield.* United States, 1862. Sept. Photograph. <https://www.loc.gov/item/2018671471/>.

In the foreground of the image, bodies are scattered about with a caisson amongst the casualties. A post and rail fence lines the eastern edge of the turnpike, separating the circulation feature from the Mumma landholdings. The post and rail fence consists of at least four rails, with portions of the course appearing to have five rails. While the fence is not continuous along the turnpike, the author believes that the damage of the battle and not the land tenancy is the culprit for this condition. The field is in stubble, likely the result of grazing or a recent harvest of either grain or hay. The caveat for this statement is that the stubble could be the result of fighting. No edge vegetation is present in the photograph, specifically eastern red cedars, which is indicative of an actively maintained fence line.

West of the turnpike, the Dunker Church appears damaged, specifically on the south gable elevation of the structure. The church sits in the cleared yard which is very informal; no fences or walls are present to separate the yard from the turnpike or the woodlot beyond. The West Woods contain deciduous trees with a limited understory. This condition is indicative of active management, possibly of grazing of livestock to create a cleared condition. However, it should be noted that no fence or wall is visible in the image. It should be noted that portions of the road bed south of the Dunker church are visible. The surface material is indiscernible based on the quality of the image and the composition. However, the construction alludes to either a ditch or swale along the eastern side of the road course (Gardener 1862).

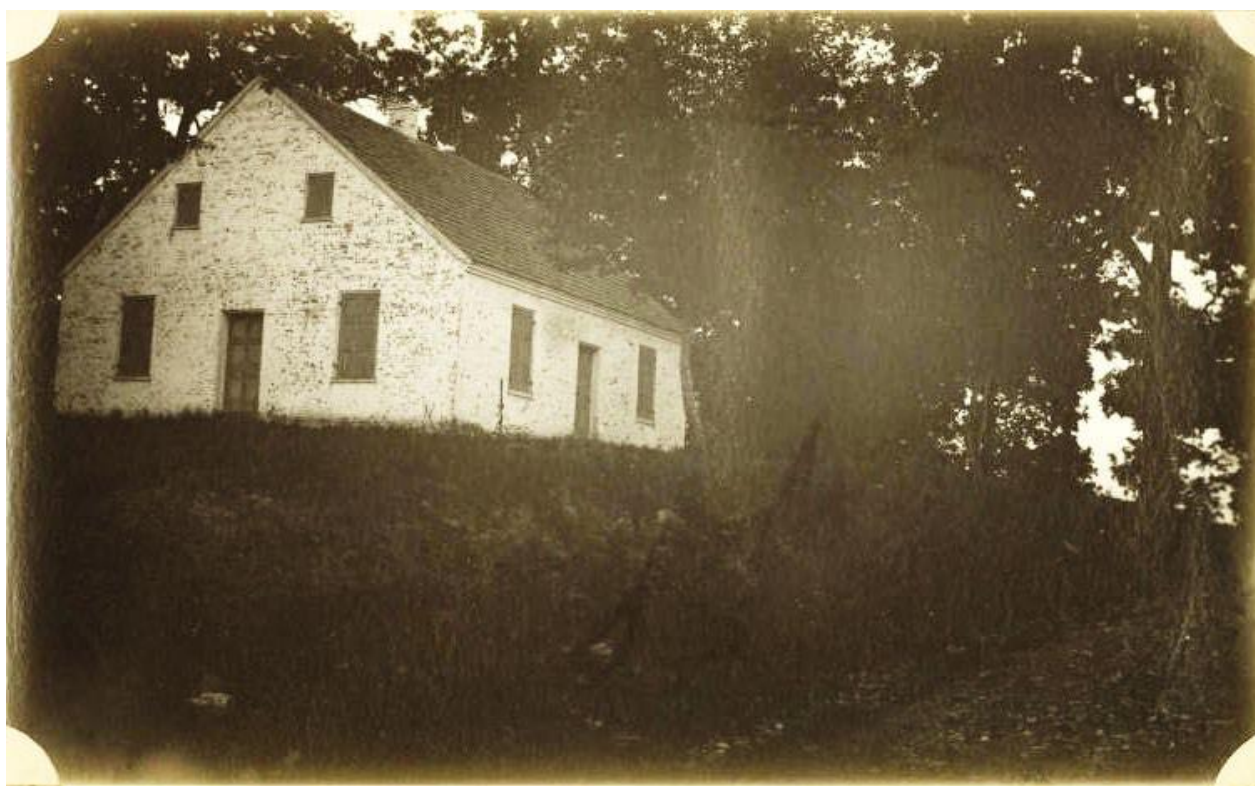
While visiting Sharpsburg, Maryland, the Biscoes captured the Dunker Church in two images. The first image captures the structure from a vantage south and east likely from the turnpike course itself. The building sits in a grassy yard with no formal demarcation. A review of the Gardner photograph and this image indicates the building is repaired from the damage of the battle. The building retains the same window and door openings as was present at the time of the battle. The whitewash of the structure appears to be fading in places. Trees associated with the West Woods are visible in the background. The image does not provide an understanding as to the extent of the historic woodlot. At this time, the course of the turnpike is a mixture of dirt and stone. The route appears to be well traveled. A ditch channel lines the western edge of the circulation feature (Biscoe 1884: 170 W. 71).

Figure 8. Biscoe, T.D. and Walter S., photographer. *Antietam, Dunker Church. Looking about N.W. Pike on right foreground.* United States, 1884. August. Photograph. <https://http://digitalcollections.smu.edu/cdm/singleitem/collection/civ/id/132/rec/25>

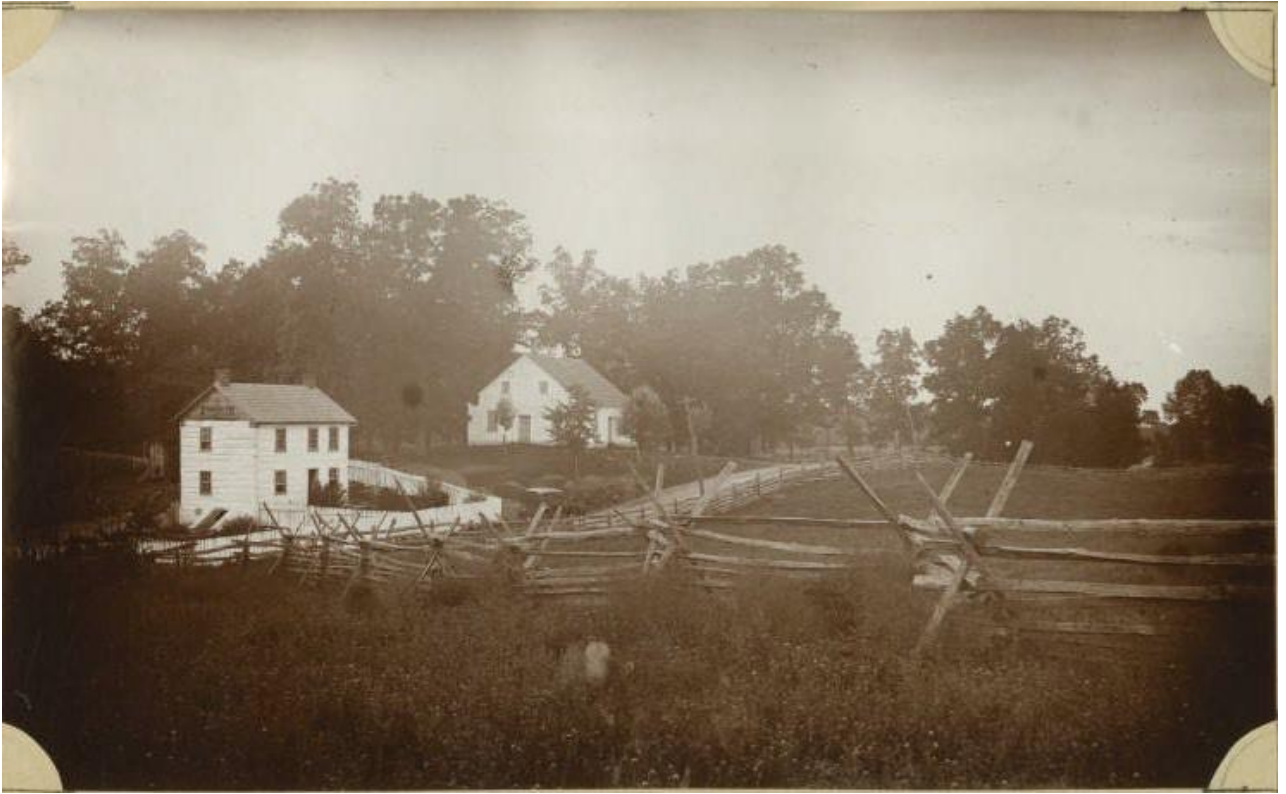
On the western side of the turnpike, in the mid ground of the image, a two story I-house is visible. Cyrus Munson owned the property and the structure at the time the photograph was taken. Munson likely erected the house after his purchase of the property from the Mumma's as there is no indication that the building existed prior. A picket fence defines a small yard space, which includes the house, immediately adjacent to the turnpike. Shrubs are present in the yard. By zooming into the image, a second smaller wood structure is visible west of the house. Based on the form, it appears to be a poultry coop, which is elevated off the ground with a ladder entrance for the fowl. A fence extends north and west of the coop along the property line.

The Dunker Church and the West Woods are visible in the image. The open understory of the West Woods suggests that the woodlot is likely used for grazing. The visibility of fields beyond the woods indicates that the West Woods has further to the west means the wood lot reduced in size from the time of the battle (Biscoe 1884: 171 D. 100).

Figure 9 Biscoe, T.D. and Walter S., photographer. *Antietam, Dunker Church. Looking from S.E. looking across the Hagerstown Pike.* United States, 1884. August. Photograph.  
<http://digitalcollections.smu.edu/cdm/singleitem/collection/civ/id/133/rec/26>

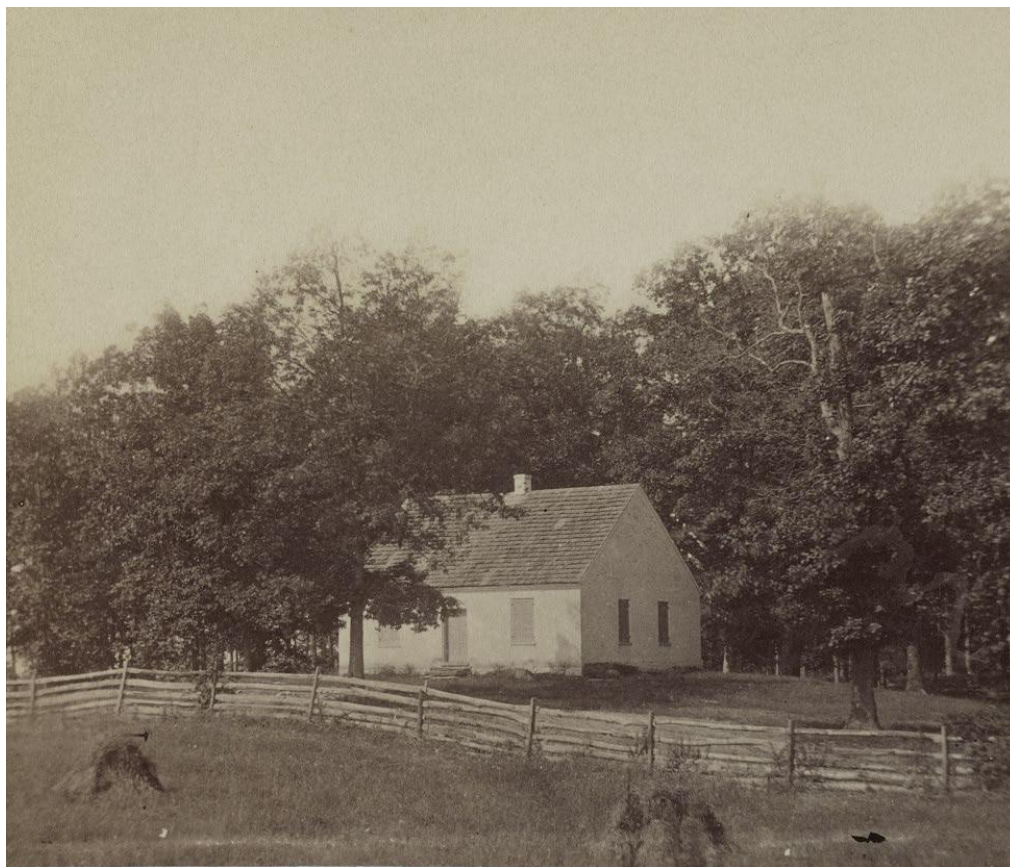
An additional photograph of the Dunker Church was taken during this period. However, the actual date is unknown but the associated Library of Congress entry information indicates a print date between 1880 and 1889. The fields on the east side of the turnpike have hay gathered into small bales. A post and rail fence lines the eastern edge of the turnpike. The Dunker Church appears is white with a fresh coat of paint (LOC 1880-1889: 2012647800).

Figure 11. *Antietam, Md., Dunker church*. Antietam Maryland United States, . [Photographed 1862, printed between 1880 and 1889] Photograph. <https://www.loc.gov/item/2012647800/>.

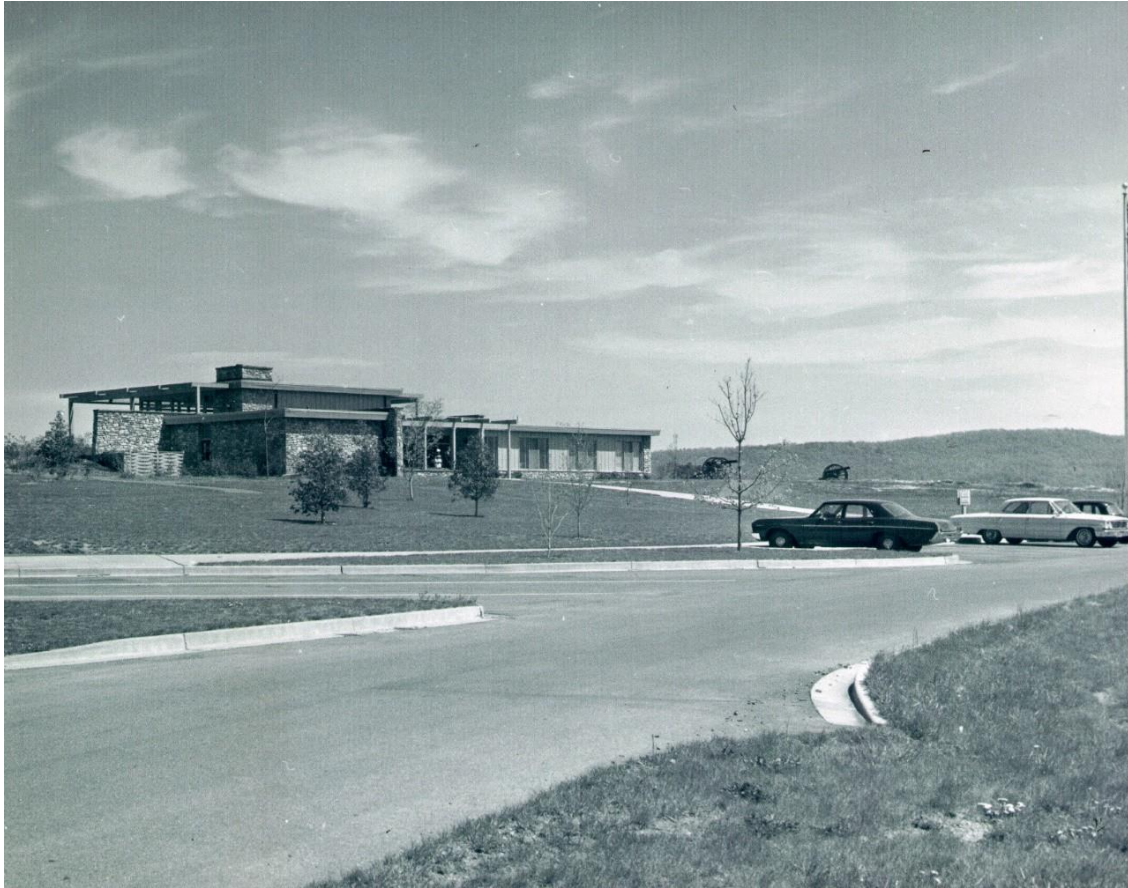
Figure 20: *Antietam Visitor Center East Elevation*. Antietam National Battlefield Archives 1965 Photograph. 213

Photo documentation of the Visitor Center from 1965 shows the completed structure and its surrounding features. The southwestern façade of the Visitor Center was finished with fieldstone, glass and steel. The roofline is flat and multilayered. Large, single pane windows are installed at the southern end of the front (southwestern) façade. Pergolas extend outward (southwest) from the entrance and to the southeast from the second story. Two cannons are located near the building entrance, and the Dunker Church Trail, as well as the New York State Monument, are visible to the northwest of the front façade. There are small shrubs at the southern end of the front façade. Large, single pane windows articulate the form of the observation room. Vegetation planted in the photograph corresponds to the locations proposed in the 1962 planting plan.

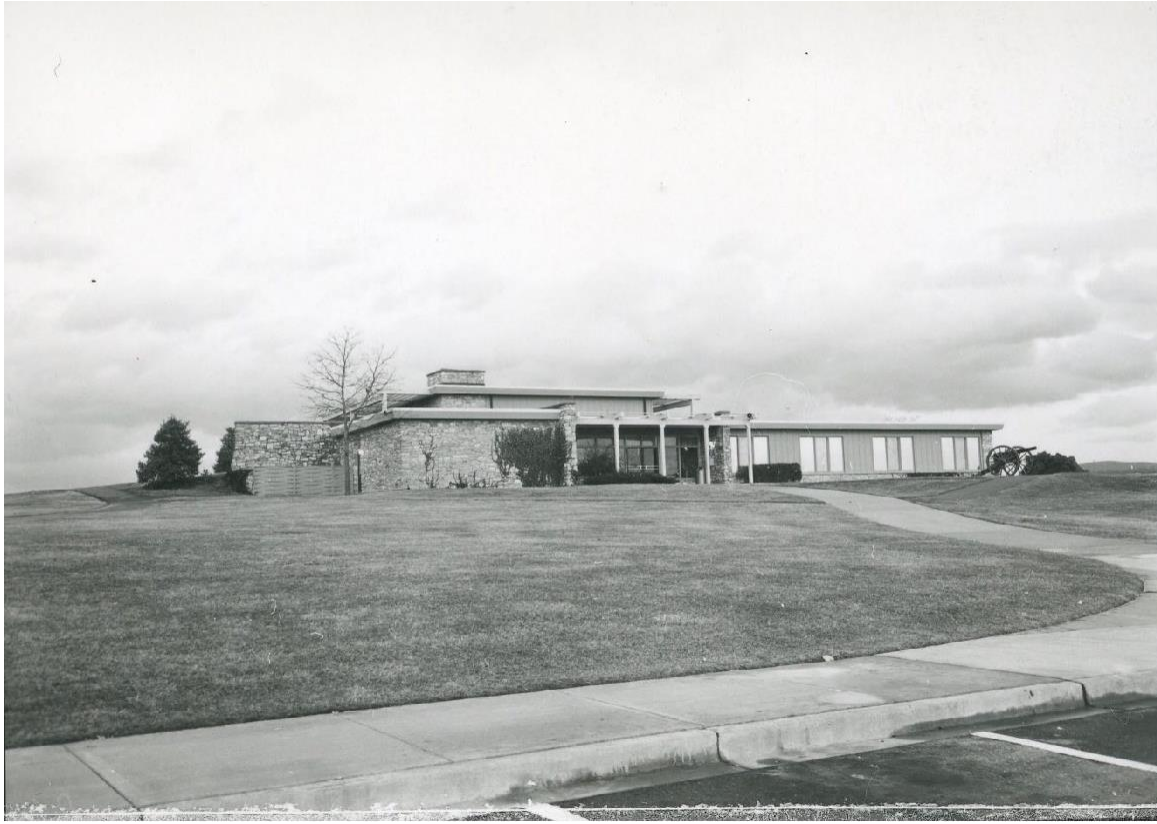
The battlefield continued to modify the Visitor Center, including significant additions to the massing and footprint of the structure. Between 1973 and 1974, the lobby was expanded to the west in order to accommodate large crowds during periods of heavy visitation. The expansion involved moving the existing glass wall 16 feet, making the feature flush with the existing flagstone patio. Prior to the expansion, a cantilevered roof covered the patio. The existing wall was reused from the original building. In order to make the addition harmonious with the structure, the side half walls were constructed of stone, similar to other elevations of the building, with windows above. The roof was extended to match the original design of the building. At the completion of the project, the brie-sole, or sun-shade, was once again attached to the structure in 1974 (Babin 2018: 7-13-15).

Figure 21: *Antietam Visitor Center*. Antietam National Battlefield Archives 1973  
Photograph. 16A62.

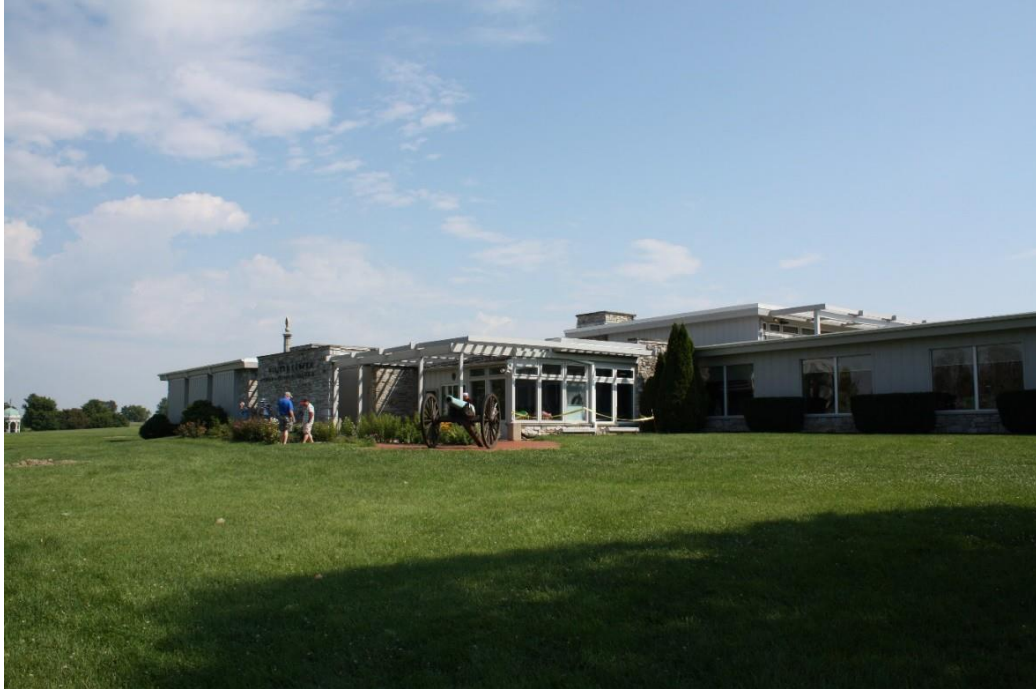
Figure 23: West elevation of the Visitor Center looking north and east (P. Babin NCR History Program 2017)

The Visitor Center demonstrates integrity based on location, setting, feeling, materials, workmanship, and association. While expanded several times, the building retains integrity of design, as the modifications to the footprint were in keeping with the character of the original design intent and followed the established design rules. The Visitor Center is a contributing feature of the cultural landscape.

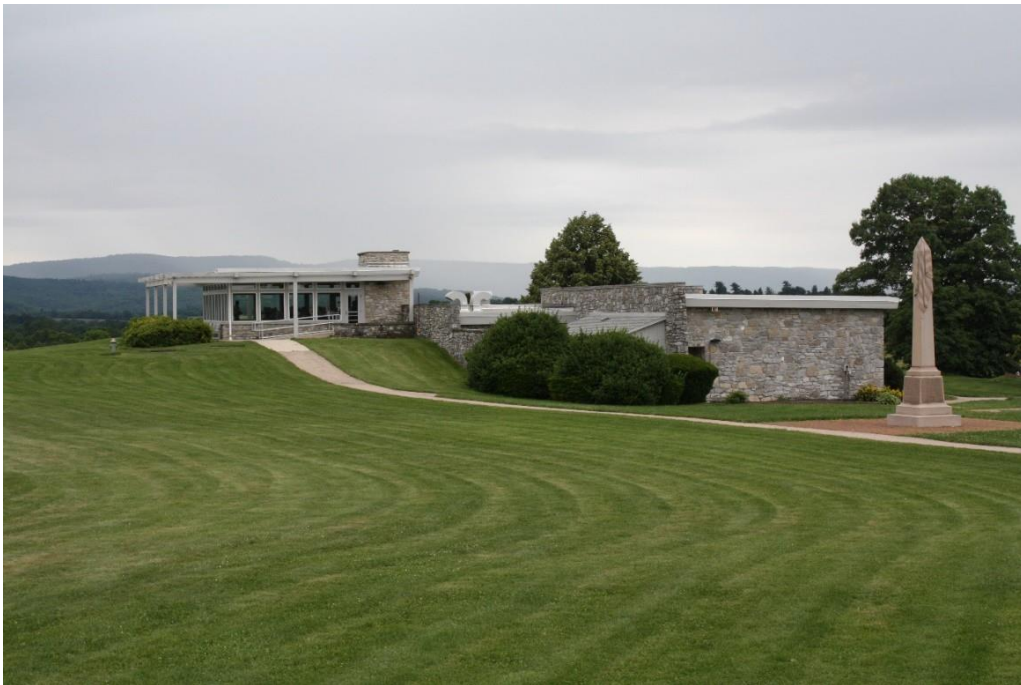
Figure 24: East elevation of the Visitor Center looking south and west (NCR CLP 2018).

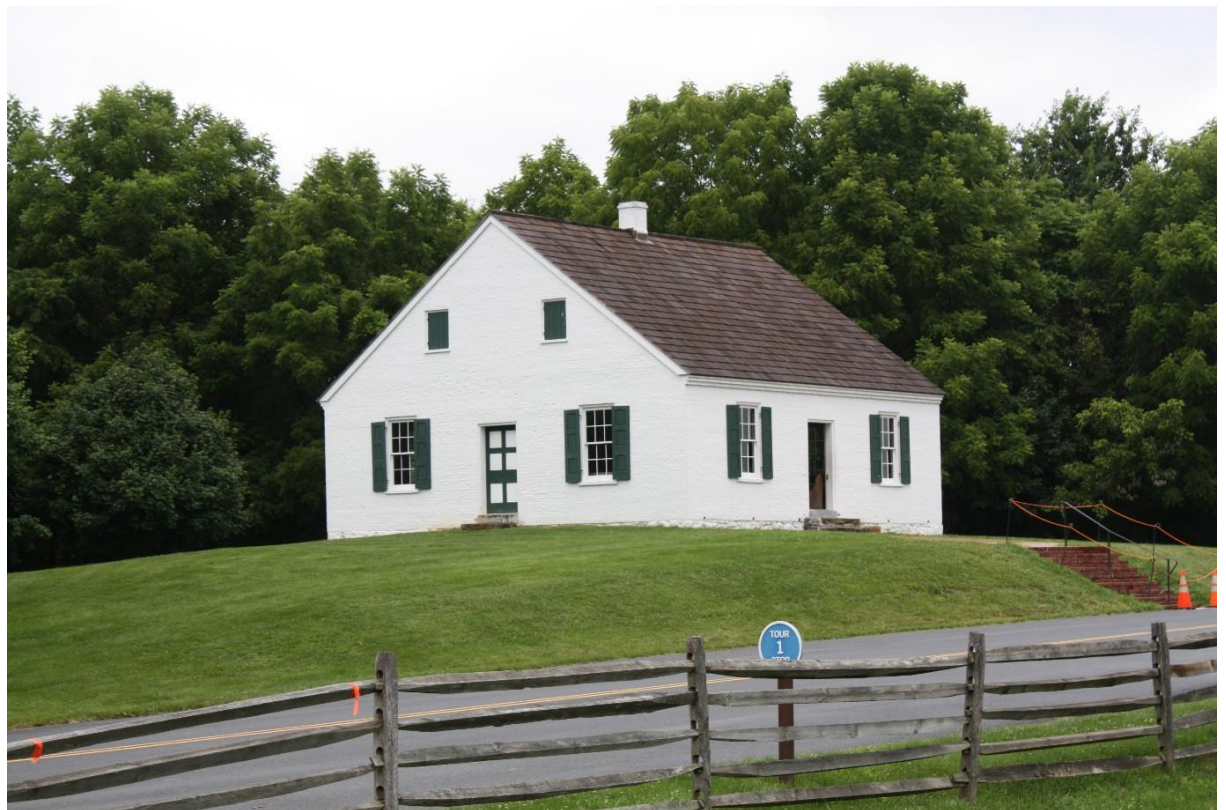
Figure 25: The Dunker Church (NCR CLP 2018).

The reconstructed Dunker Church demonstrates integrity of location, setting, feeling, design, materials, and association. The Dunker Church is a contributing feature of the cultural landscape.

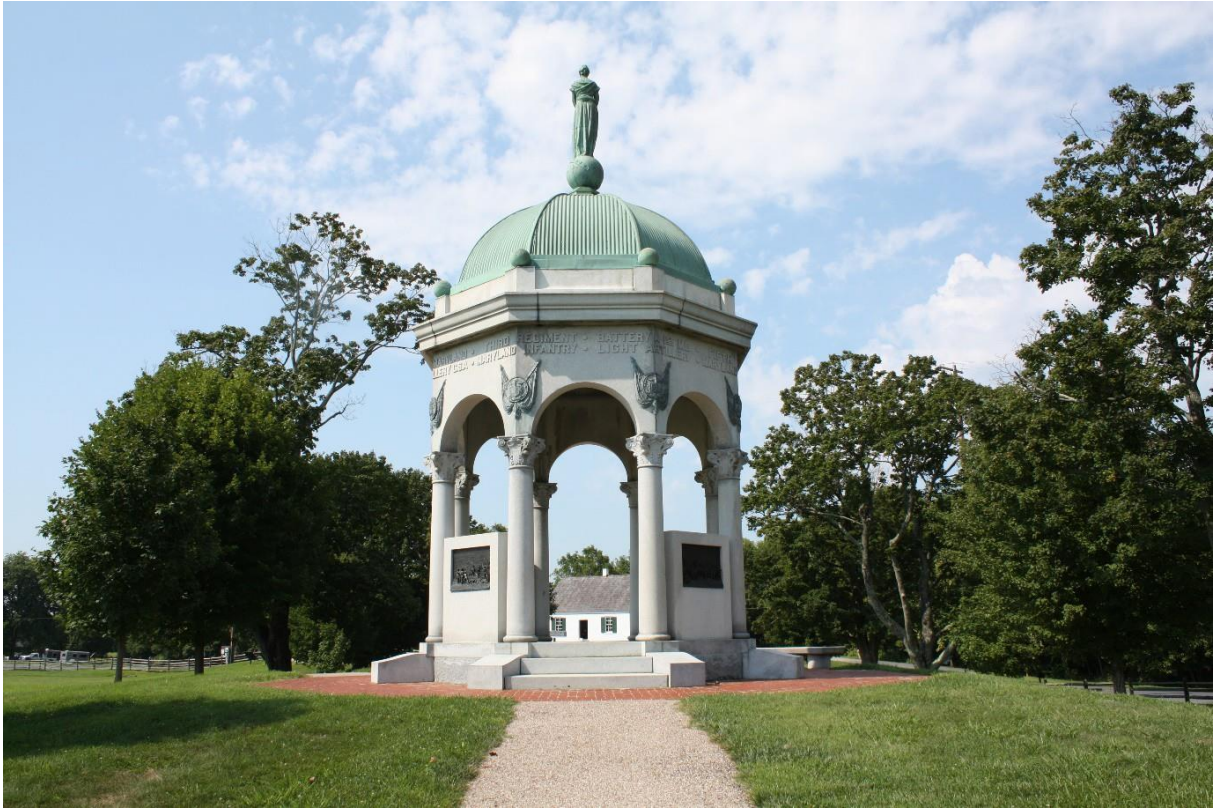
Figure 26: The Maryland State Monument looking towards the Dunker Church. The maples are to either side of the monument (P. Babin NCR History Program 2017)

The Maryland State Monument has integrity of location, setting, feeling, design, materials, workmanship, and association. The Maryland State Monument is a contributing resources of the cultural landscape.

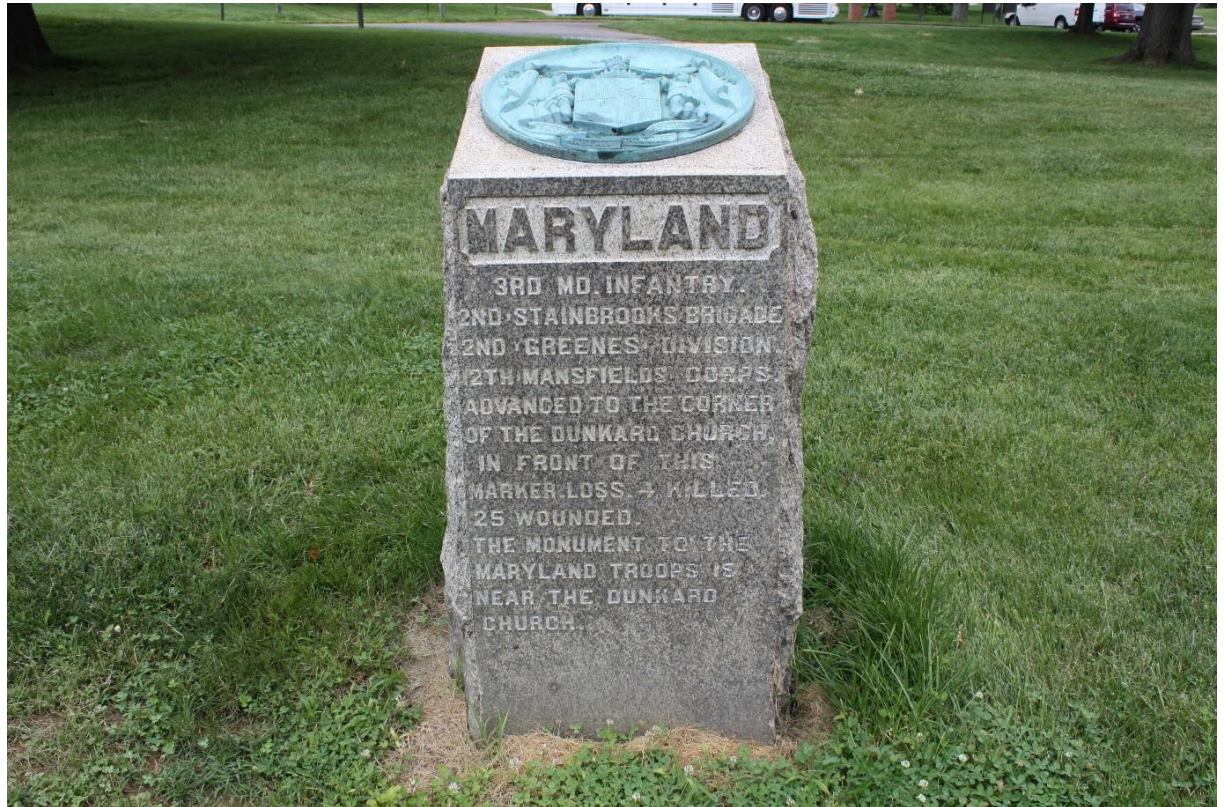
Figure 27: The 3<sup>rd</sup> Maryland Monument (NCR CLP 2018)

The 3<sup>rd</sup> Maryland Monument demonstrates integrity based on location, setting, design, and association, workmanship, and materials. The 3<sup>rd</sup> Maryland Monument is a contributing resource of the cultural landscape.

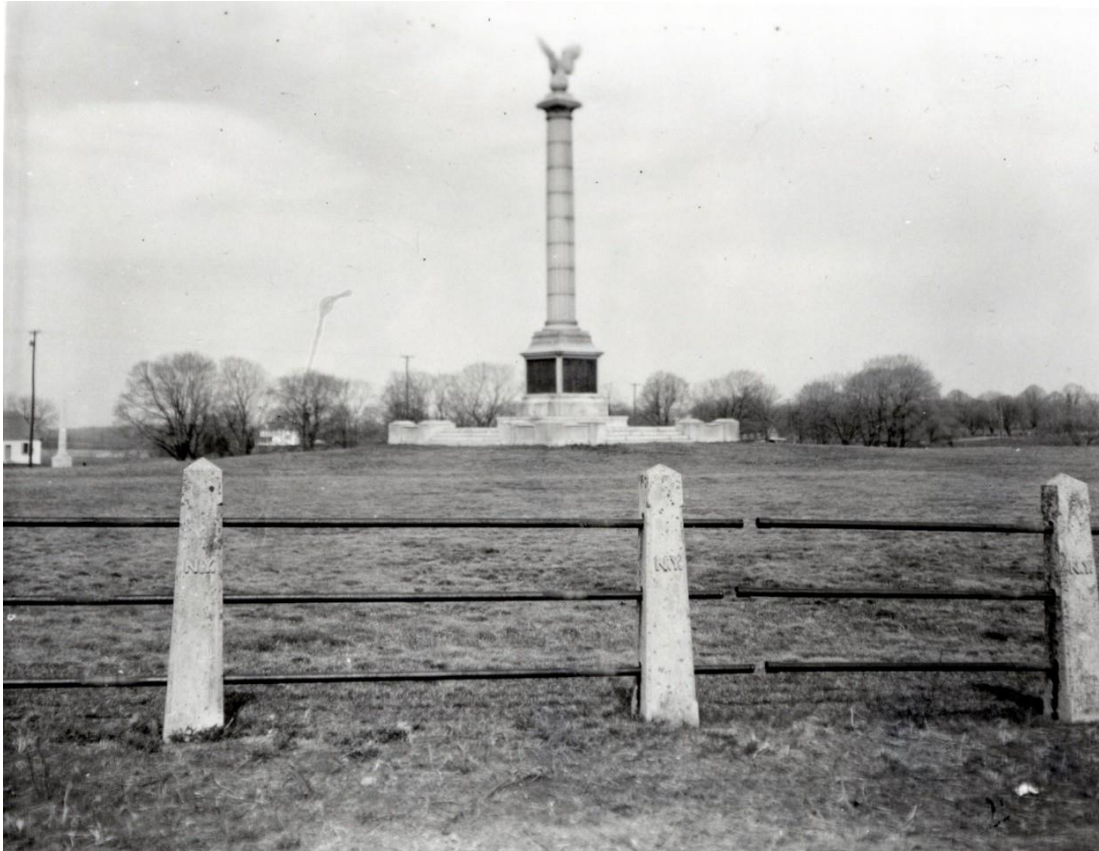
Figure 29: *Visitor Center Area New York Monument from Visitor Center perspective.* Antietam National Battlefield Archives 1963

In 1963, the battlefield staff replaced and reset the marble tiles of the monument. By 1966, the completed Dunker Church Trail progressed past the New York State Monument, extending north from the Visitor Center, and continuing north and west to the Maryland State Monument. In 2017, a project was requested for the New York State Monument. The scope of the work included cleaning the granite and replacing the deteriorated lead and mortar joints. The work was to be carried out by the Historic Preservation Training Center. The project was executed in 2018, with the site restored to its original character (Babin 2018: 8-78; PEPC 2017: #76111).

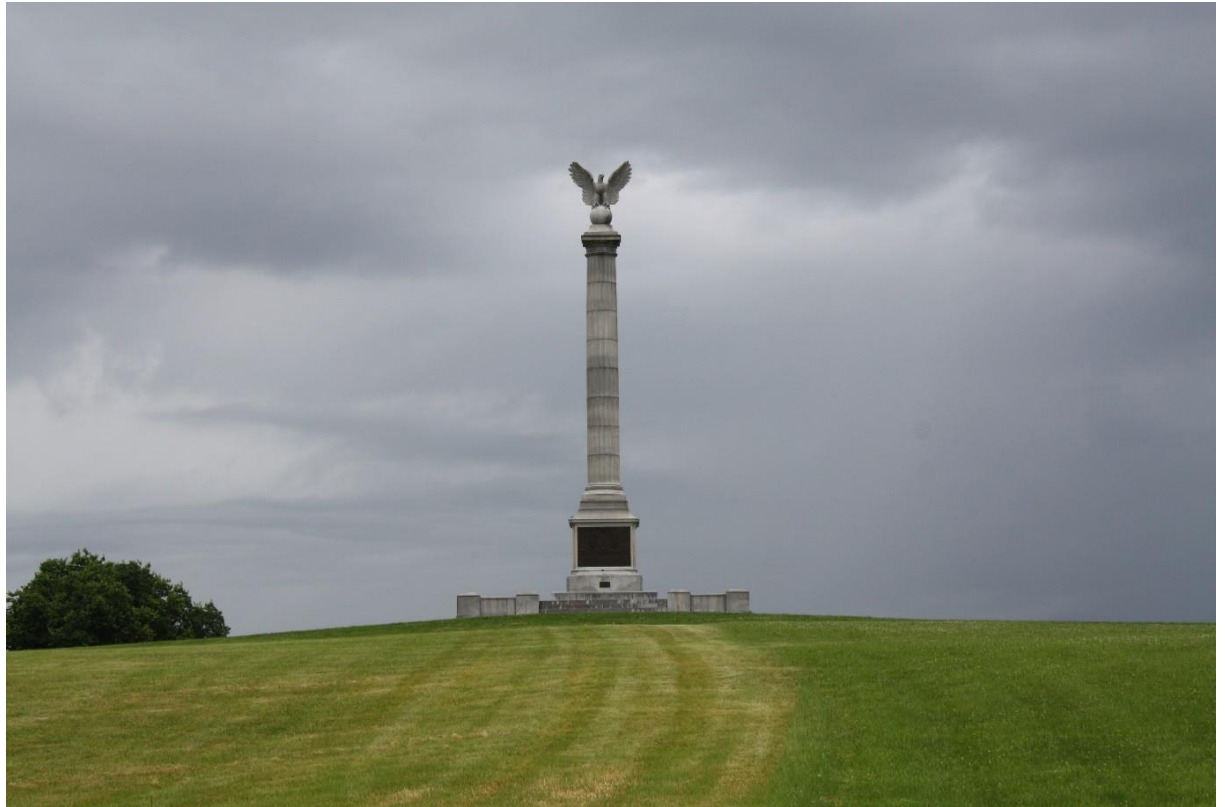
Figure 30: The New York State Monument looking east (NCR CLP 2018)

The New York State Monument demonstrates integrity based on location, setting, feeling, design, materials, workmanship and association. The New York State Monument is a character defining feature of the cultural landscape and is a contributing landscape feature.

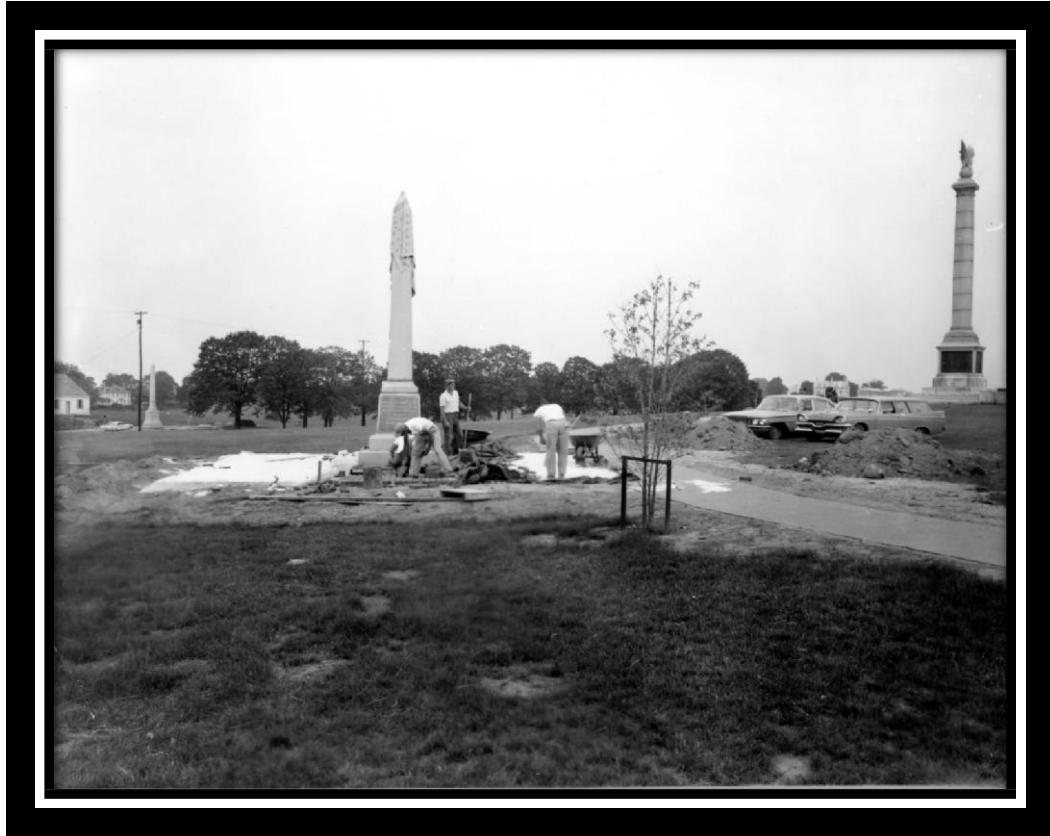
Figure 31: 20<sup>th</sup> New York pad installation July. Antietam National Battlefield Archives 1963 Photograph 133.

During the Mission 66 period, a brick plaza or pad was constructed around the base of the monument, connecting the feature to the Dunker Church Trail.

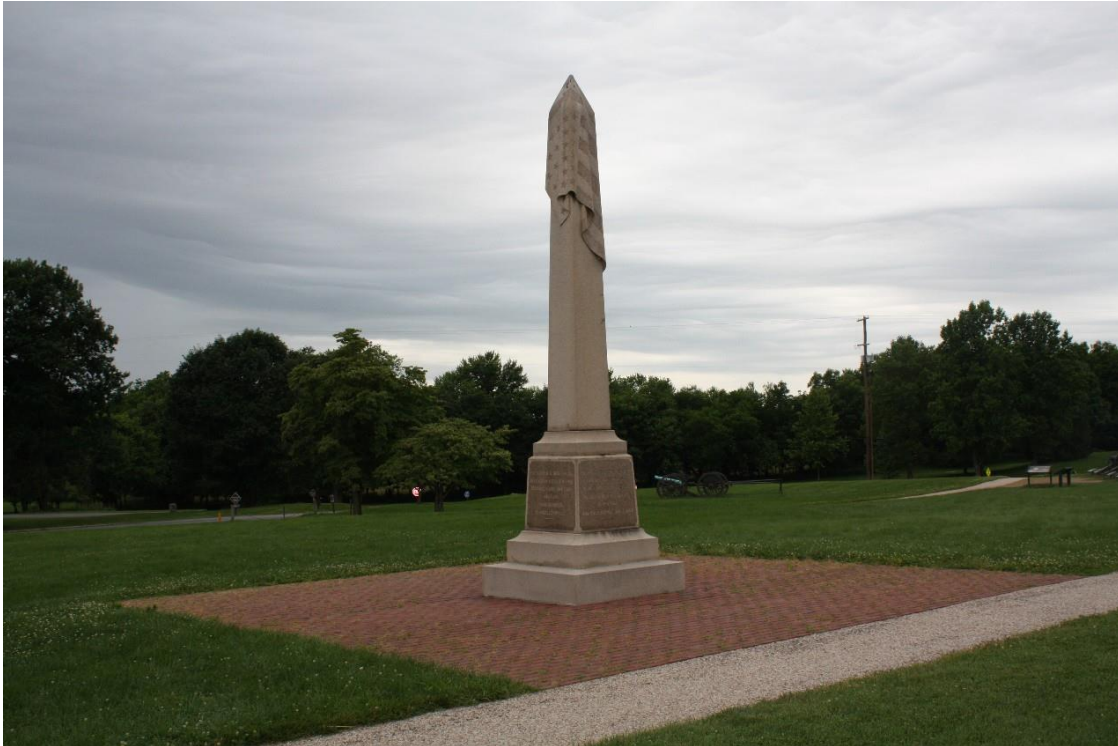
Figure 32: The 20<sup>th</sup> New York Volunteer Infantry Monument looking west (NCR CLP 2018)

The 20<sup>th</sup> New York Volunteer Infantry Monument demonstrates integrity based on location, setting, feeling, design, materials, and workmanship, and association. The 20<sup>th</sup> New York Volunteer Infantry Monument is a contributing landscape feature.

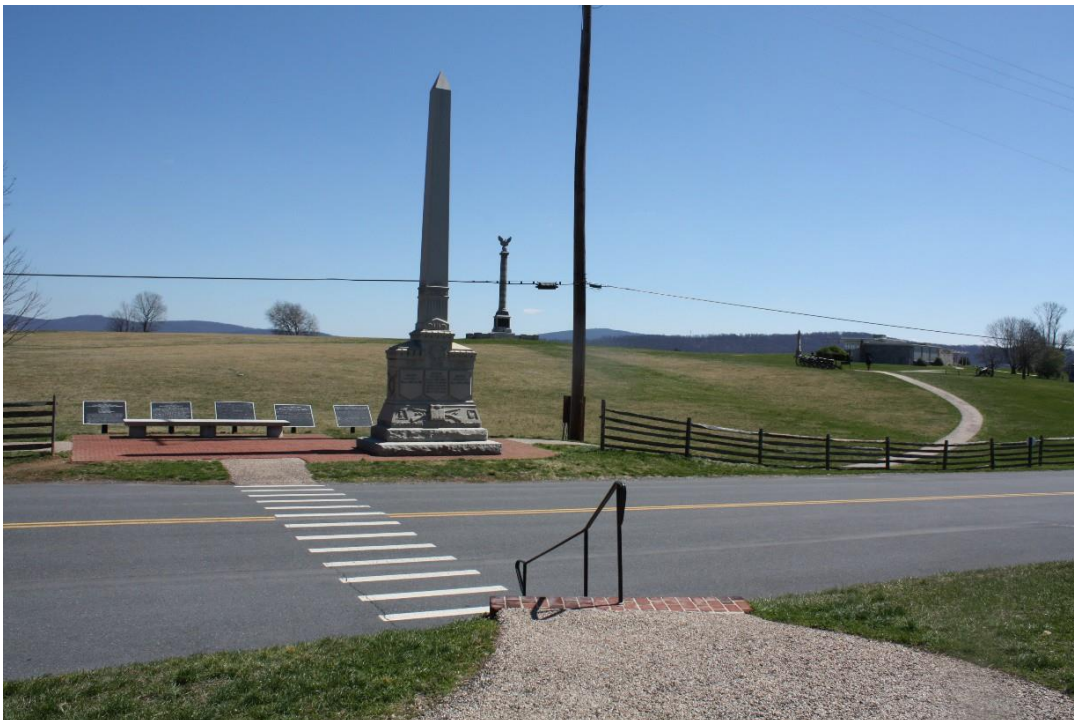
Figure 33: The 5<sup>th</sup>, 7<sup>th</sup>, 66<sup>th</sup> Ohio Infantry Monument, War Department Tablets, and Mission 66 era improvements (P. Babin NCR History Program 2017).

The 5<sup>th</sup>, 7<sup>th</sup>, 66<sup>th</sup> Ohio Infantry Monument demonstrates integrity based on location, setting, feeling, design, materials, workmanship, and association. The 5<sup>th</sup>, 7<sup>th</sup>, 66<sup>th</sup> Ohio Infantry Monument is a contributing landscape feature of the cultural landscape.

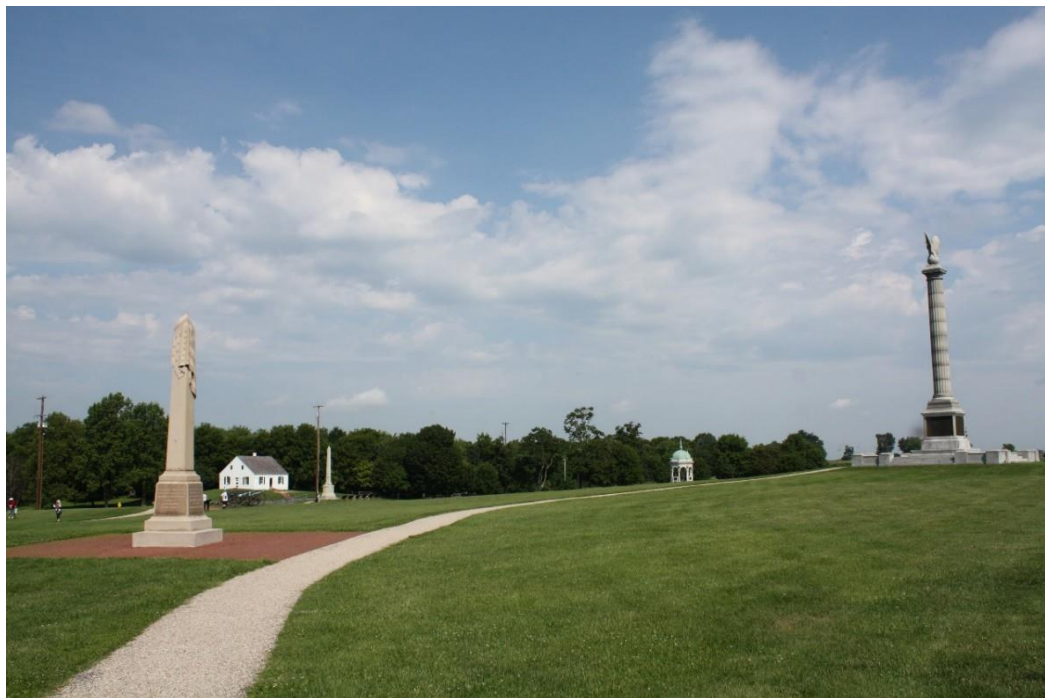
Figure 34: The Antietam Remembered Trail looking towards the Dunker Church (P. Babin NCR History Program 2017).

The Antietam Remember Trail follows the same course and direction as the original Mission 66 Design and demonstrates integrity based on location, design, setting, feeling, and association. This circulation feature is a contributing resource of the cultural landscape.

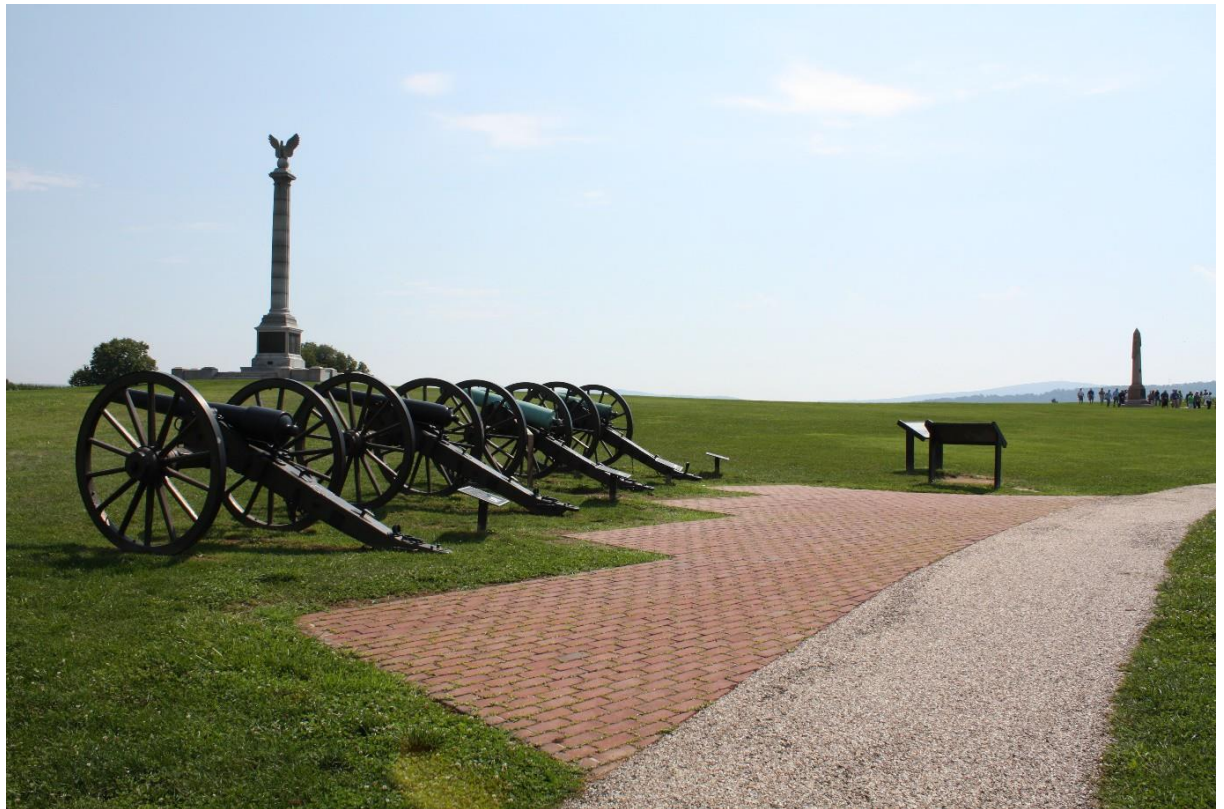
The terrace at S.D. Lee’s Battalion First Position Display demonstrates integrity based on location, setting, design, materials, workmanship, and association. The feature contributes to the character of the cultural landscape

Figure 35: The S.D. Lee’s Battalion First Position Display (P. Babin NCR History Program 2017).

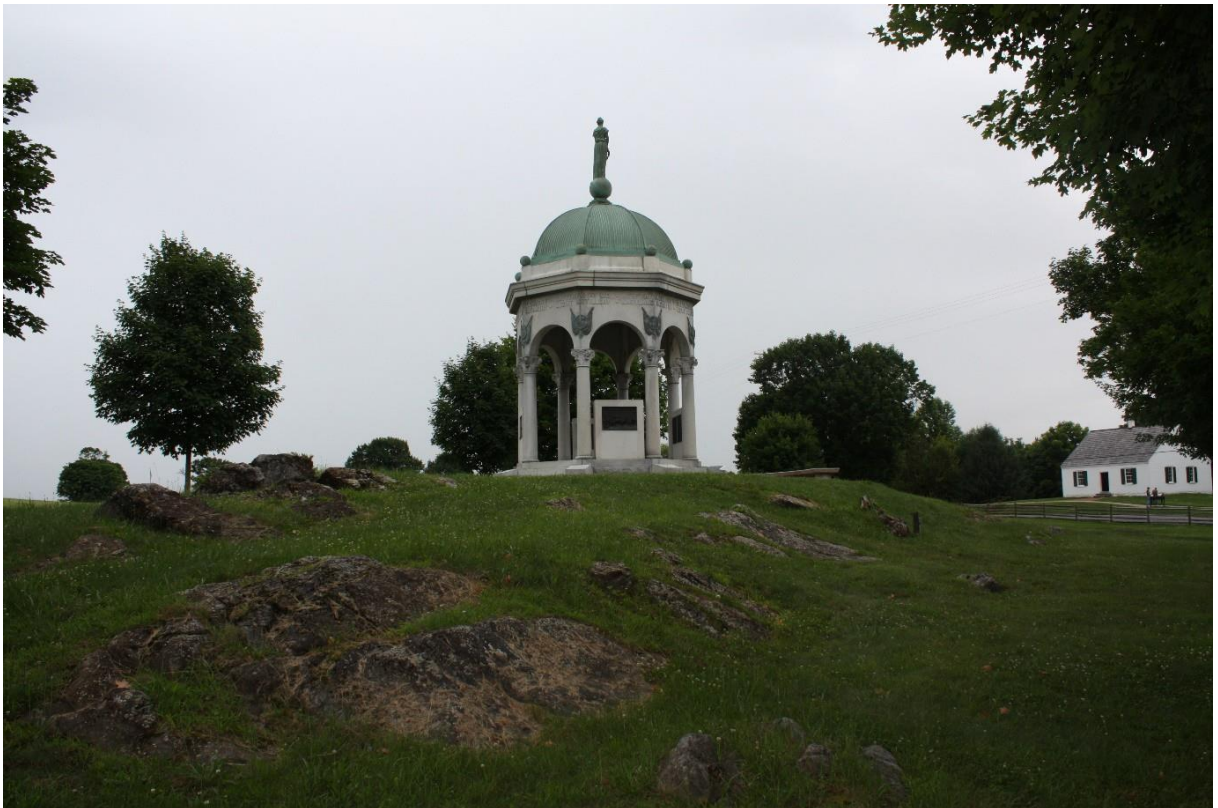
Figure 36: The limestone outcroppings at the Maryland State Monument (NCR CLP 2017).
