**National Park Service  
Cultural Landscapes Inventory  
2018**

**Visitor Center Area Cultural Landscape  
Antietam National Battlefield (ANTI)  
December 2018**

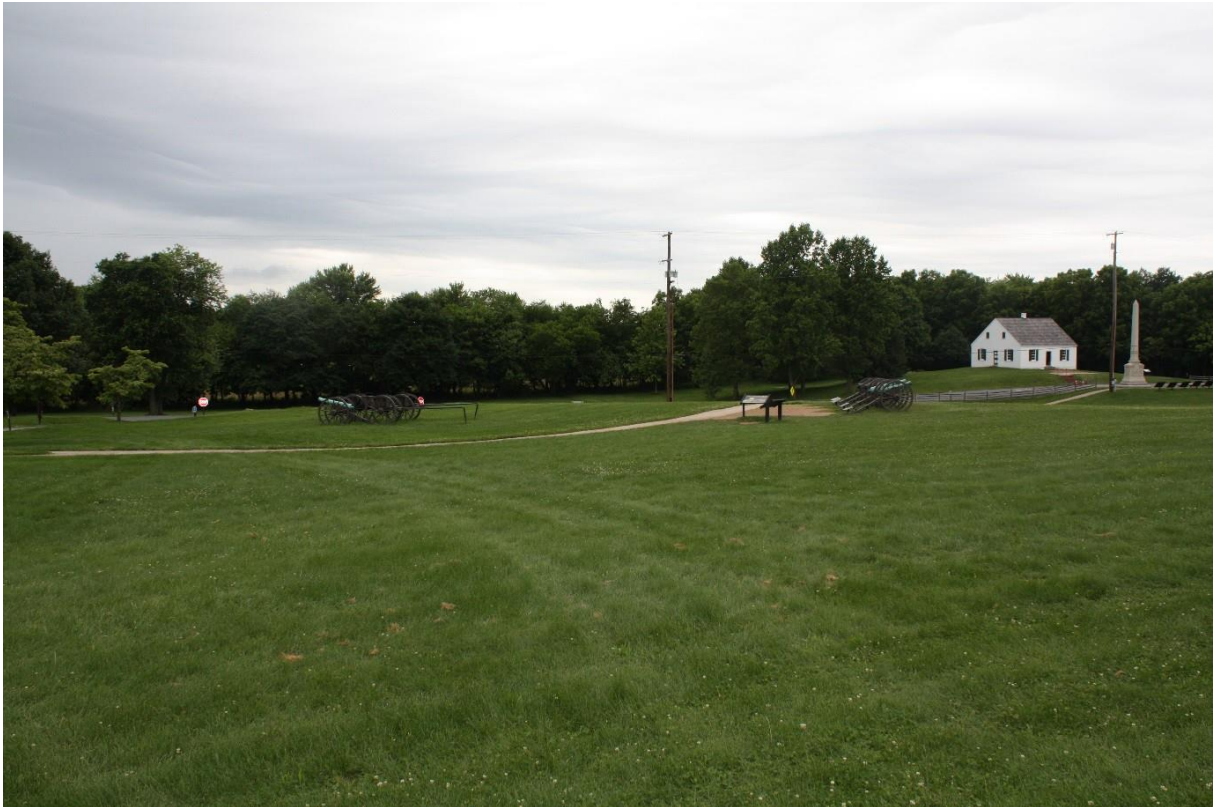
Figure 37: The S.D. Lee's Battalion First Position Display and other small scale features with the Dunker Church in the background (NCR CLP 2018).

The cannons demonstrate integrity based on setting, feeling, design, materials, and association. The cannons associated with the S.D. Lee's Battalion First Position Display position on the north side of the Antietam Remembered Trail exhibit integrity of location as well. The cannons are contributing resources to the cultural landscape.

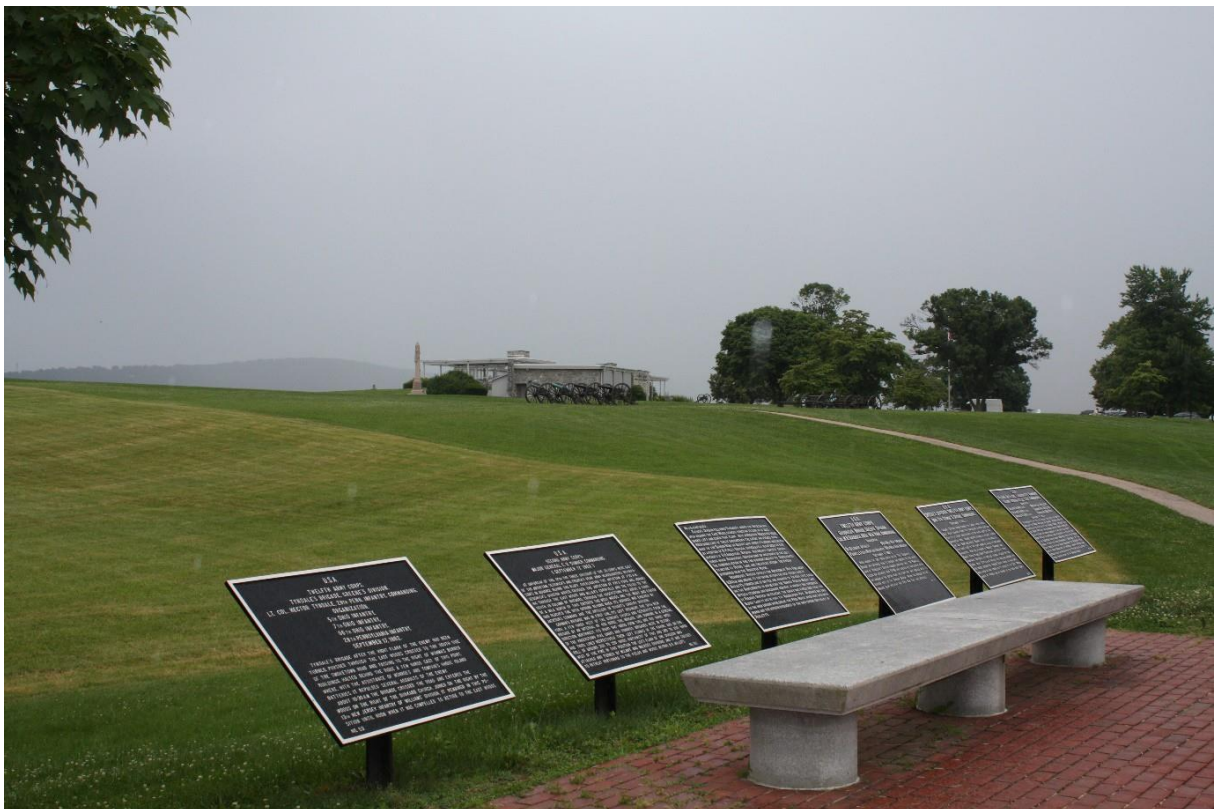
Figure 39: The War Department Tablets with the Mission 66 bench (NCR CLP 2018).

Both benches remains in the location of the Mission 66 proposal and retain the original design. Therefore the features are contributing to the cultural landscape.

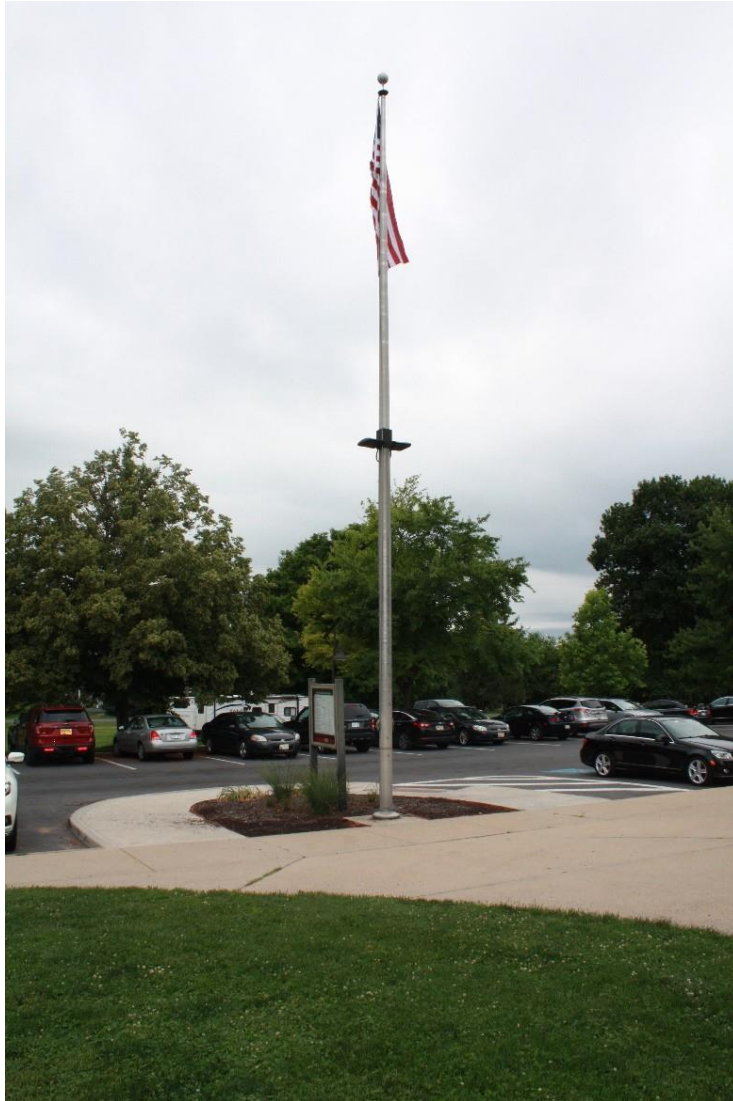
Figure 40: The flagpole with examples of the other signs and views into the parking lot (NCR CLP 2018).

The flagpole demonstrates integrity based on location, design, association, feeling, and setting. Additional research is needed to determine if the feature retains integrity of materials and workmanship. The flagpole is a contributing resource to the overall character of the cultural landscape.

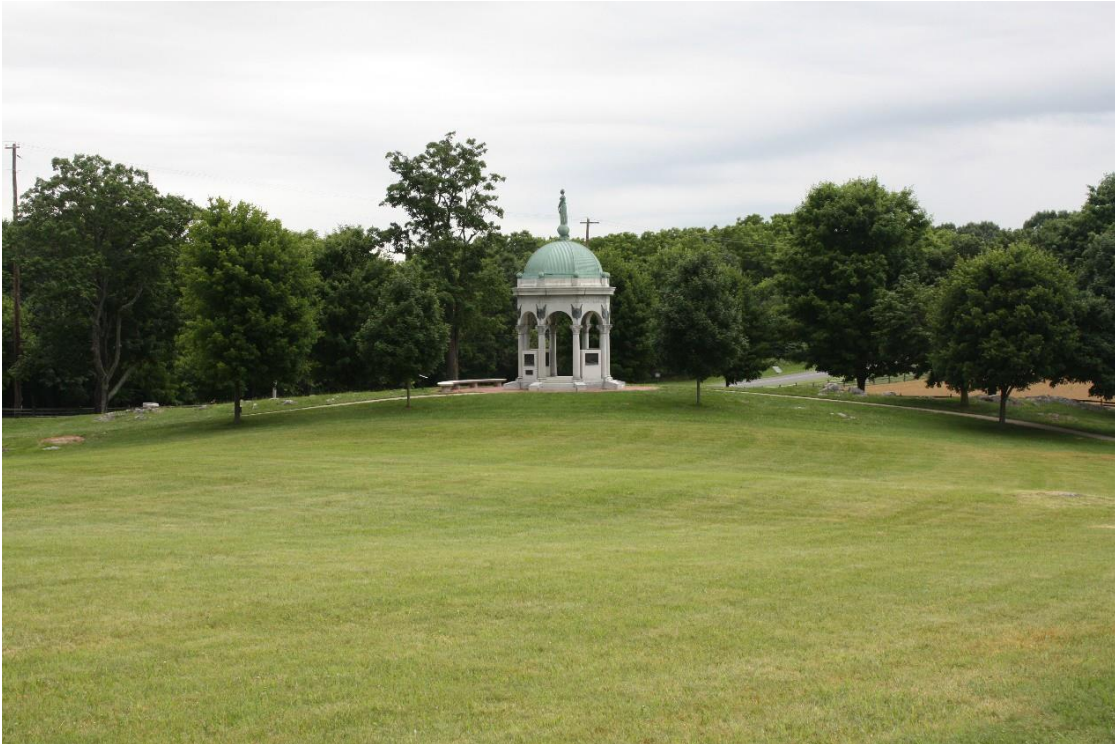
Figure 42: The Maryland Monument grove (NCR CLP 2018).

The maples at the Maryland State Monument demonstrate historic integrity based on location, setting, feeling, materials, and association. The trees are contributing resources to the overall character of the cultural landscape.

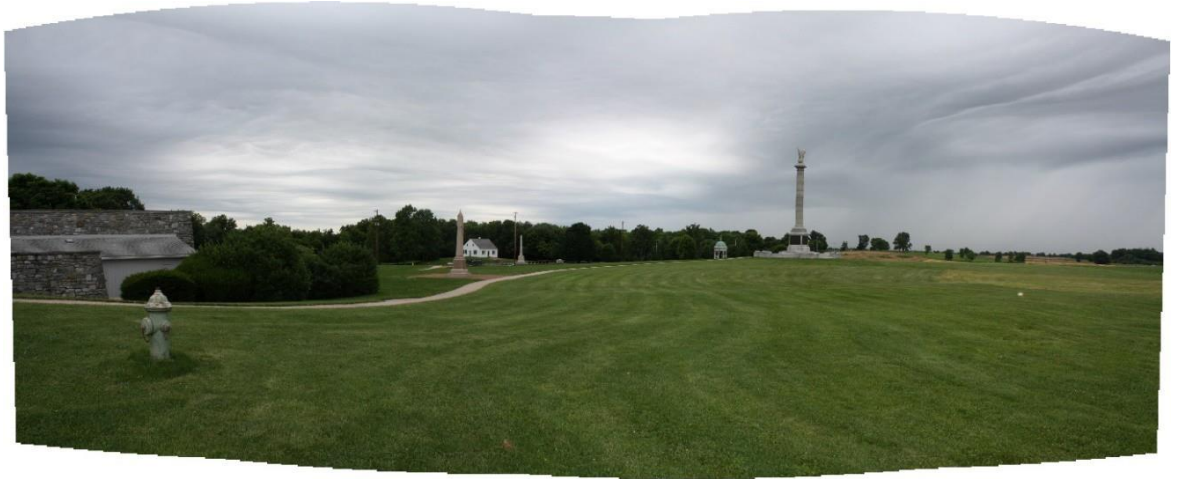
Figure 43: View towards the Dunker Church and the monument (NCR CLP 2018)

From the eastern elevation of the Visitor Center, one can view the Mumma Farmstead, Roulette Farm, Piper Farmstead, the Bloody Lane, and the Observation Tower. Trees have grown along fence lines and encroached upon the planned sight lines. This is most noted in the total obstruction of views towards the Pry House from the visitor center. The views towards the monuments remain unobstructed.
