# Pacific Crest Well Pipeline Revegetation Project

## *2018 Annual Report*

February 2019

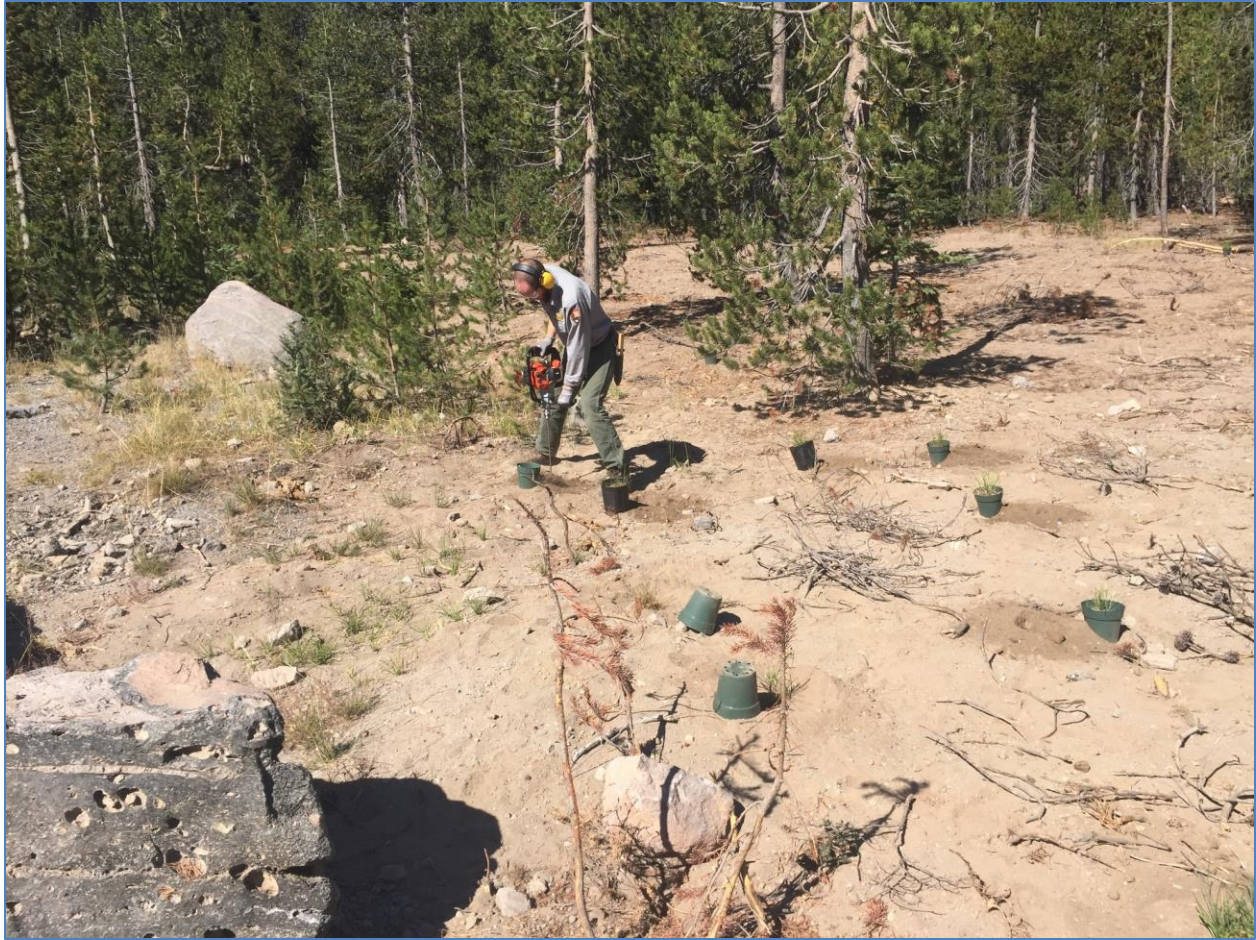
Drilling planting holes in compacted soil with an augur ahead of outplanting salvaged plants.  
Photo by Carrie Wyler.

Outplanting of these salvaged plants was conducted in October 2018. Outplanting was conducted following standard practices used by the Botany program. Due to extremely compacted soils in the restoration area resulting from construction activity, an auger bit attached to a gas engine drill was used to create holes for planting. The 3.5” auger bit was driven repeatedly into the selected planting sites, forming areas of loosened soil modestly larger and deeper than the one-gallon pots the salvaged plants were contained in. Each loosened planting hole was then cleared of enough soil to place a plant’s root ball into it (level with the surrounding ground). The root ball and loose soil surrounding it were then tamped down, and a small water catching well was formed with soil adjacent to the planting site. A handful of Park-sourced compost was added to each planting site, and the planting was generously watered to settle the roots (Figure 7).

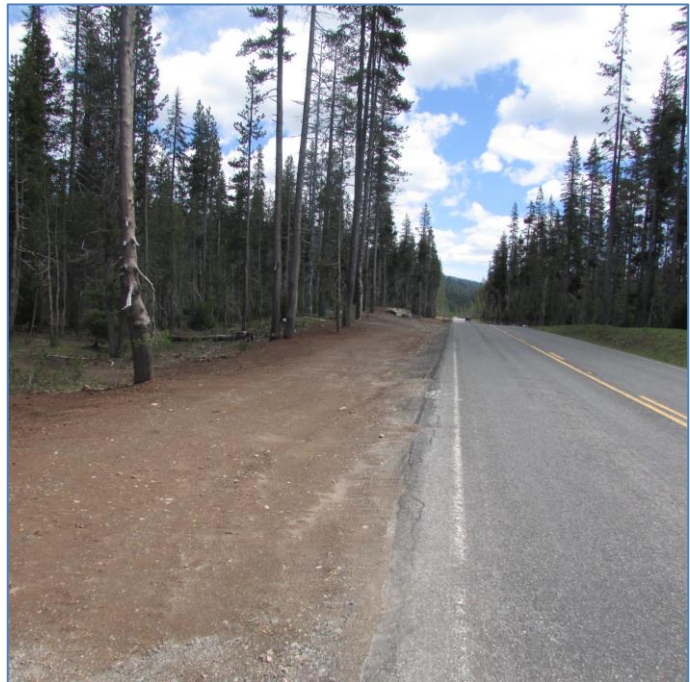
**Figure 1.** Heavy roadside disturbance along Highway 62. Photo by Jen Hooke.

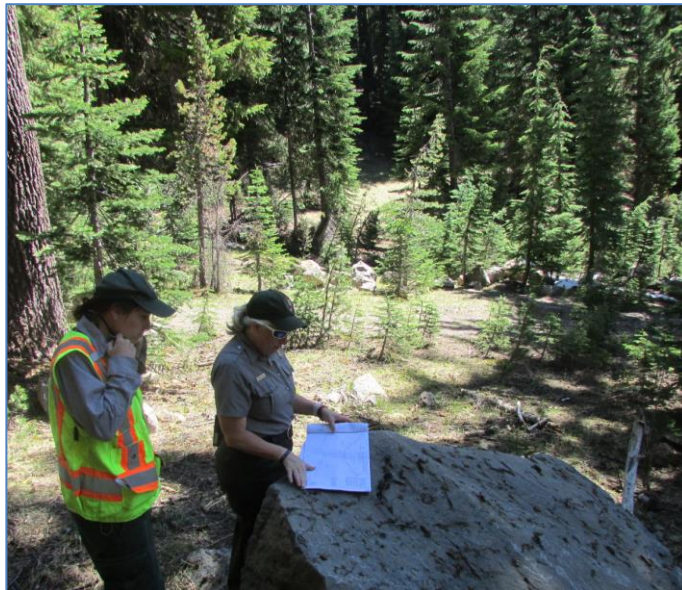
**Figure 2.** Planning for revegetation efforts prior to construction. Photo by Jen Hooke.

A revegetation plan was developed in 2017 containing revegetation prescriptions and site documentation for the two main habitats and plant communities observed within the project area (Figure 2). The area was divided into two zones: an upper zone dominated primarily by grasses, sedges, and forbs; and a lower zone that was more densely forested. This documentation was created to provide guidelines for restoration efforts and to serve as a baseline from which to monitor the progress of these efforts. The documentation will need extensive updates in 2019 to assess 2018 restoration efforts.

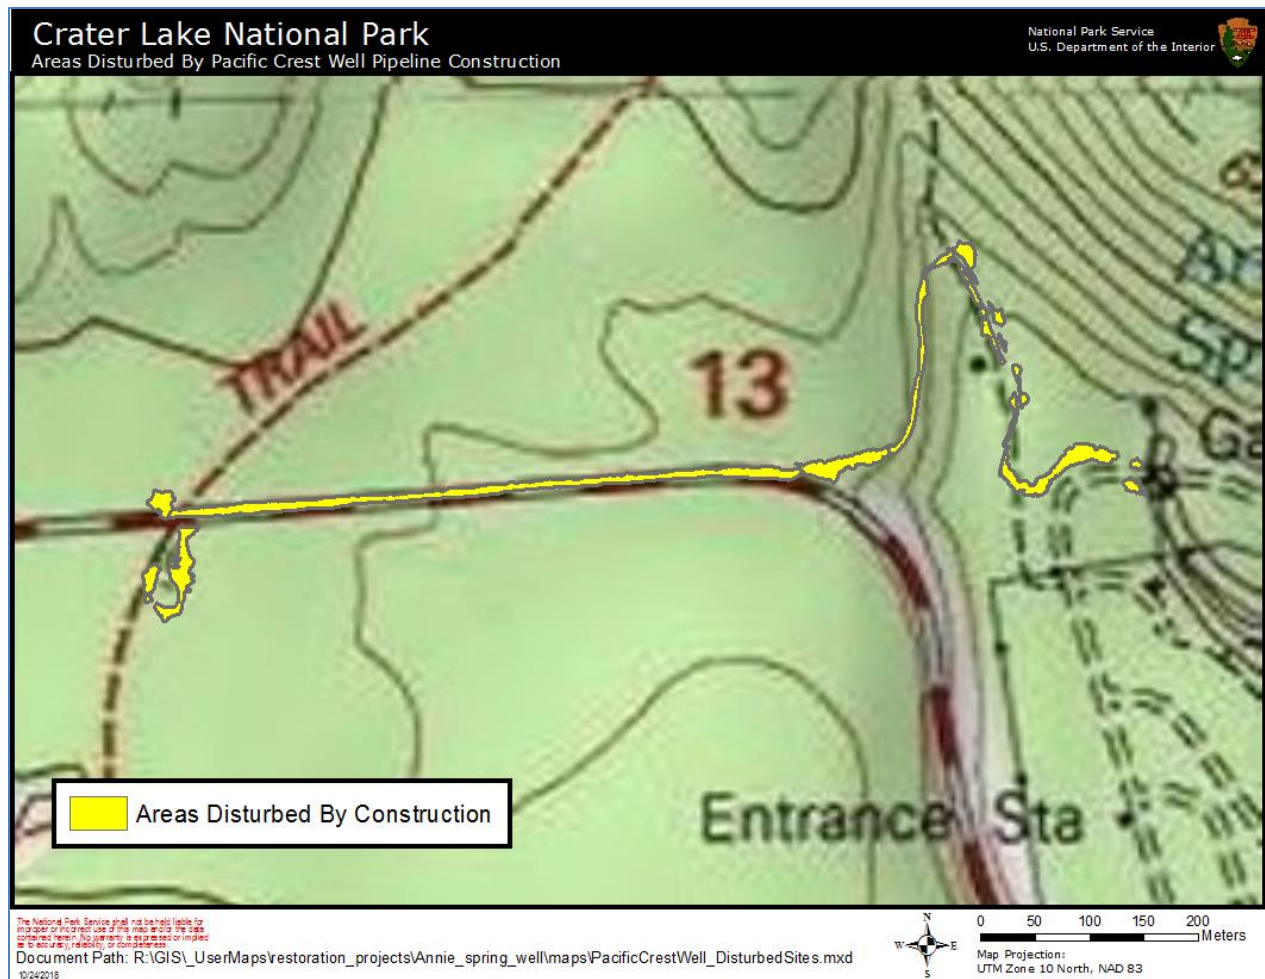
**Figure 3.** Areas disturbed by the PCT Well Pipeline are highlighted in yellow and total 2.3 acres. Map by Scott Heisler.

old highway grade that will be utilized as a service road. The project area is highlighted in Figure 3.

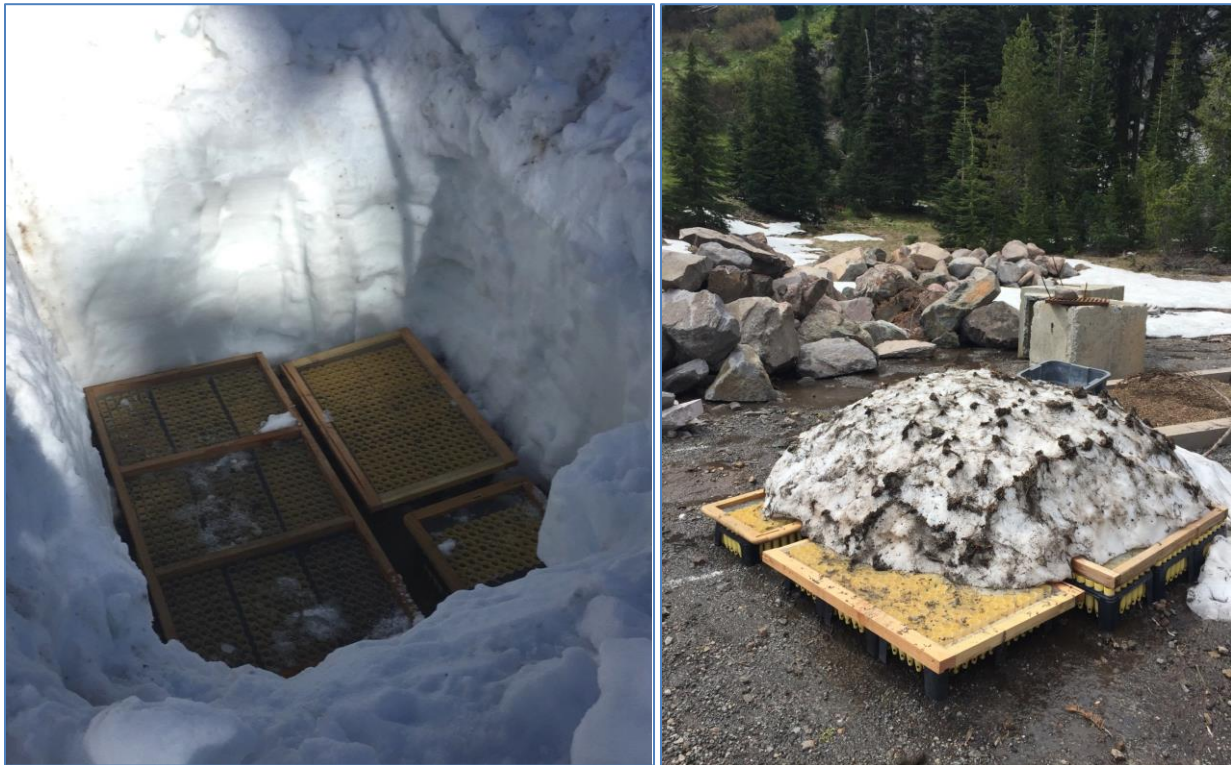
**Figure 4.** Left: Racks of pots were protected from rodent predation and buried in snow to expose seeds to freezing temperatures to stimulate germination. Photo by Carrie Wyler. Right: Snow cover was maintained on the racks for three weeks. Photo by Carrie Wyler.

headquarters. To prevent rodent predation on the seeds, wood frames covered with 1/8" hardware cloth were placed over the racks (Figure 4). The hole was then backfilled with snow. To extend the duration of the cold stratification period, additional snow was piled on the top of the racks to maintain cover as the snowpack melted. Snow cover was maintained on top of the racks for three weeks (Figure 4). These racks remained covered by the rodent-excluding screens for another three weeks, and then placed, uncovered, inside the Botany program's shadehouse and watered according to established Botany program protocol. To address initial over-seeding, in August 2018 the plant growth was thinned down to three—four plants per pot by careful plucking with tweezers.

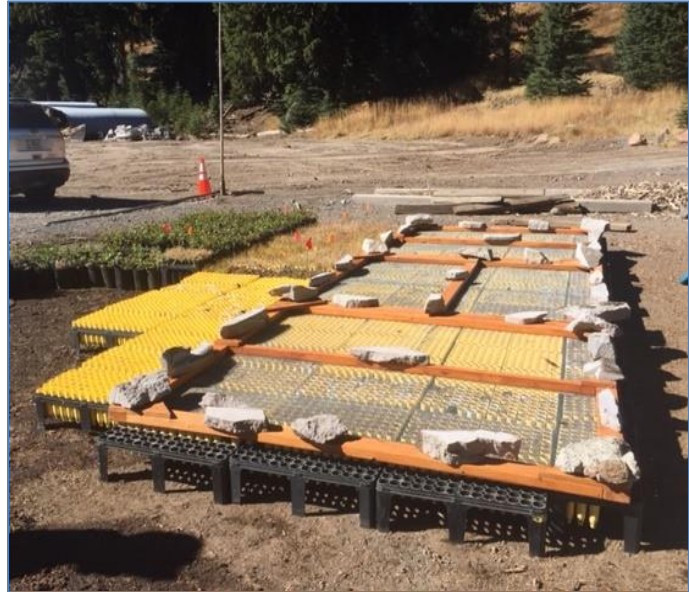
**Figure 5.** Racks of pots bunched together for overwintering at the Ball Diamond. Photo by Carrie Wyler.

The pots, soil, and preparation used for the October 2018 propagation were the same as used in the May 2018 propagation. The seed used for the October 2018 propagation was collected from the restoration area during the 2018 field season, and seeds from individual plant species were utilized rather than species mixes. The selection of perennial species used for propagation was based on the Botany program's past experience with successful containerized propagation for other restoration projects. The seeded pots were placed under rodent-excluding screens, and left to cold stratify over the winter. For overwintering, all of the pots were placed in a tight group, and mulch was packed around the perimeter to protect roots from exposure to severe cold and desiccation (Figure 5).

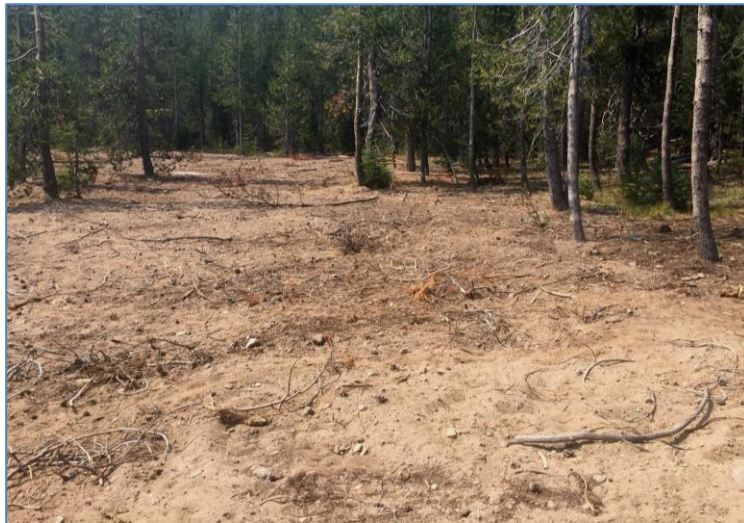
**Figure 6.** Addition of woody debris and forest litter incorporated organic matter into disturbed soils. Photo by Carrie Wyler.

Prior to adding organic debris, soils were raked and smoothed as needed by the Revegetation crew to destroy berms and obliterate vehicle tracks left behind by construction contractors. Additionally, some areas required heavy equipment to re-contour slopes, smooth and feather out fill piles and edges, and remove excessive amounts of rocks and boulders that would be impediments to revegetation. The CRLA Roads crew rehabilitated these heavily disturbed areas and prepared them for restoration efforts.

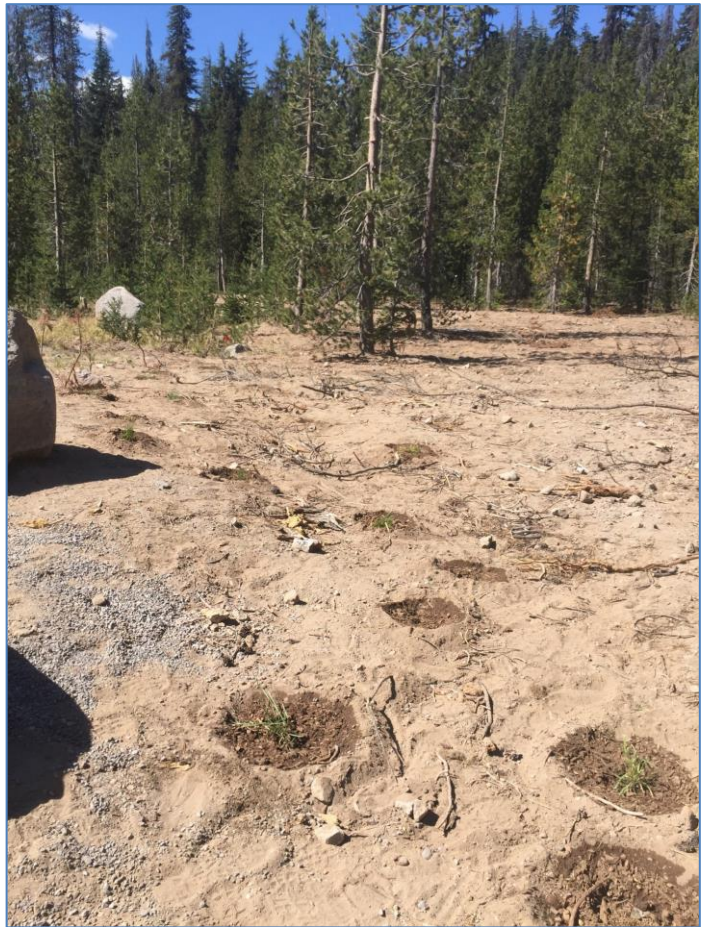
**Figure 7.** Outplanting of salvaged native plants to help jumpstart vegetative recovery in disturbed areas.  
Photo by Carrie Wyler.

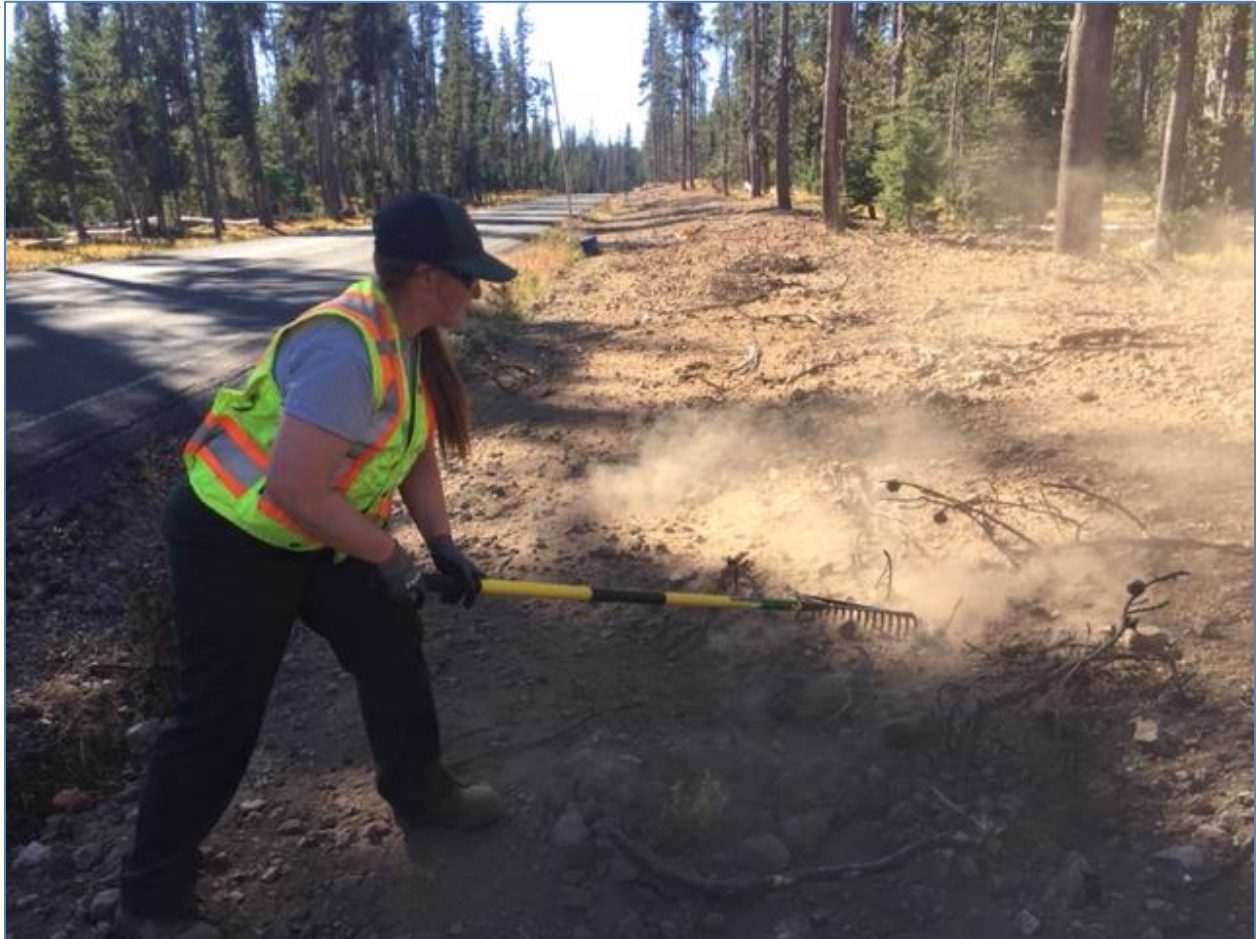
**Figure 8.** Raking in hand-broadcast seed mixes along Highway 62. Photo by Carrie Wyler.

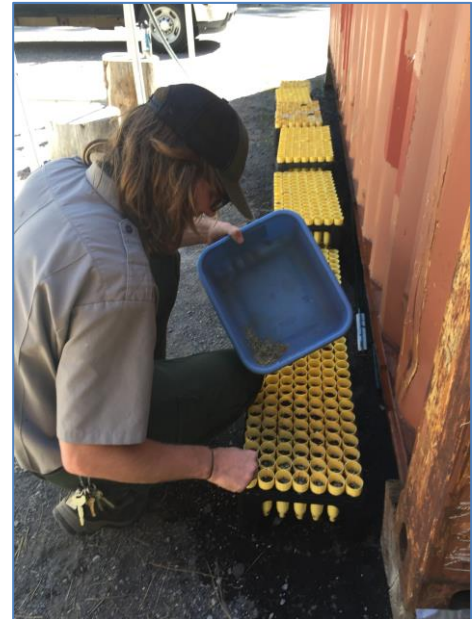
**Figure 9.** Seeding containers with a forb mix for plant propagation. Photo by Carrie Wyler.

In total, 3,136 pots were seeded for propagation (Figure 9), as outlined in Table 2. All of the 1,274 pots seeded in the May 2018 experimental round of propagation produced germinated plants. This bodes well for continued in-Park plant propagation efforts at CRLA, despite the staffing limitations of the current Botany program. These plants experienced modest growth during the 2018 growing season at the Ball Diamond. These plants were not planted in the fall of 2018 in order to allow the root systems more time to become established, with the hopes that this would help their establishment success when planted in the field.

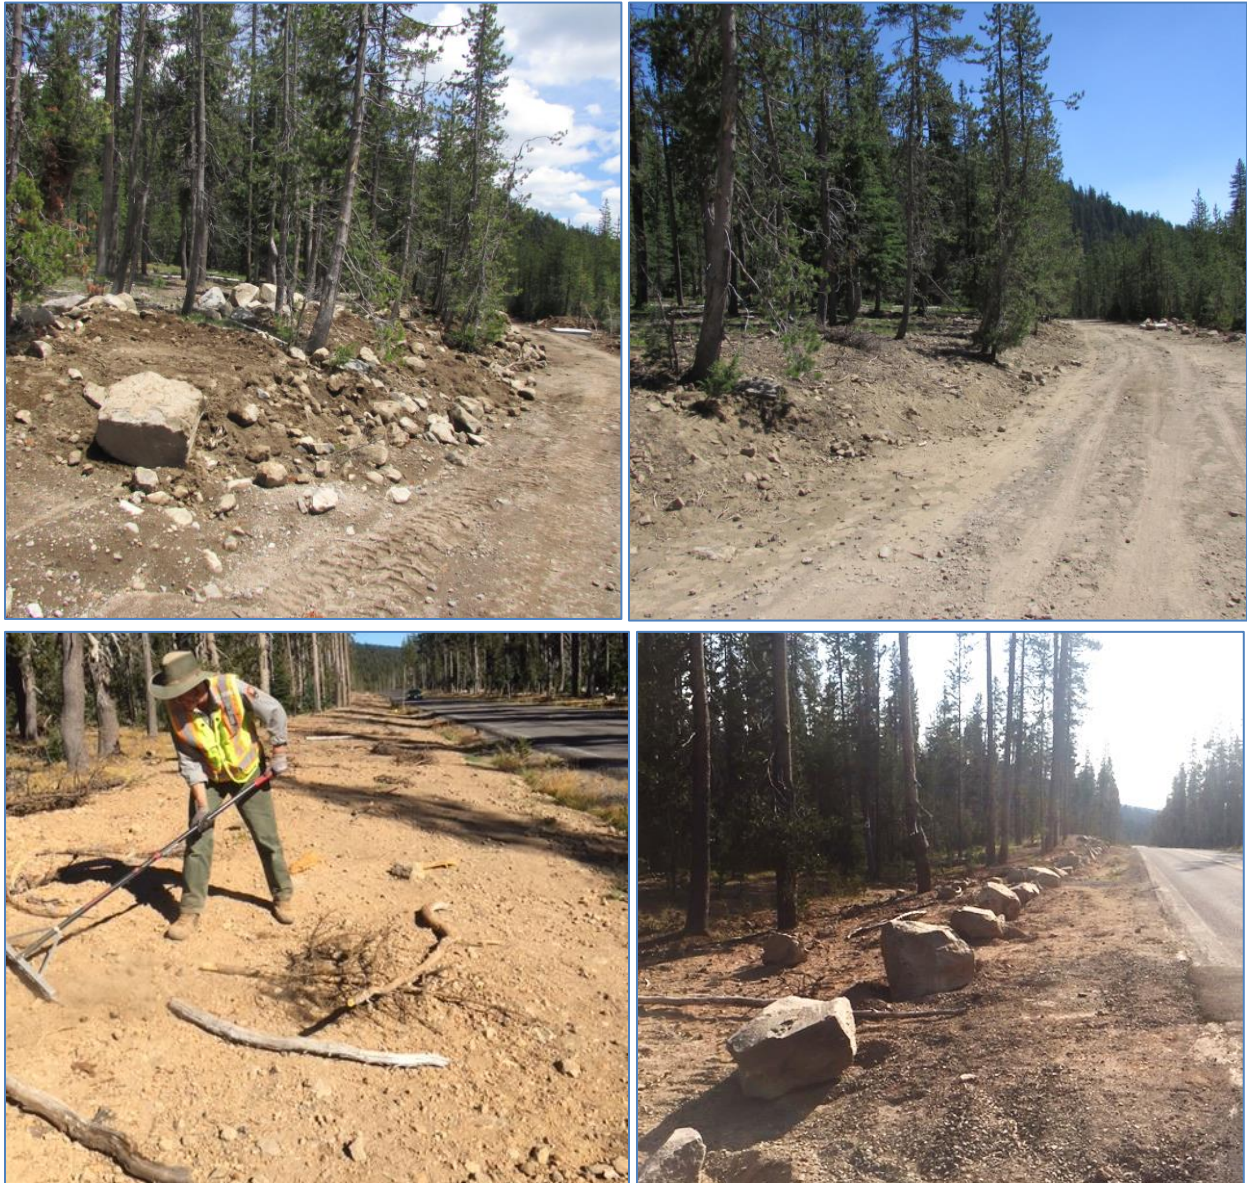
**Figure 10.** Top: Before (left) and after (right) slope recontouring work by the CRLA Roads crew. Photos by Jen Hooke. Bottom: (left) Adding organic debris to and smoothing out disturbed soils; (right) boulder placement to prevent damage of restored areas by vehicles. Photos by Carrie Wyler.

Woody debris and forest litter were spread over bare surfaces encountered across the entire project area. This included excessively wide spots alongside the service access roads. Heavy rehabilitation work by the Roads crew greatly facilitated revegetation efforts by pushing disturbed areas closer to natural conditions and placing boulders along roadsides to protect restoration efforts from vehicle damage (Figure 10). The Revegetation crew applied finishing touches by hand to reduce the impacts of construction and help soil recovery by incorporating local, site-specific organic materials (Figure 10).

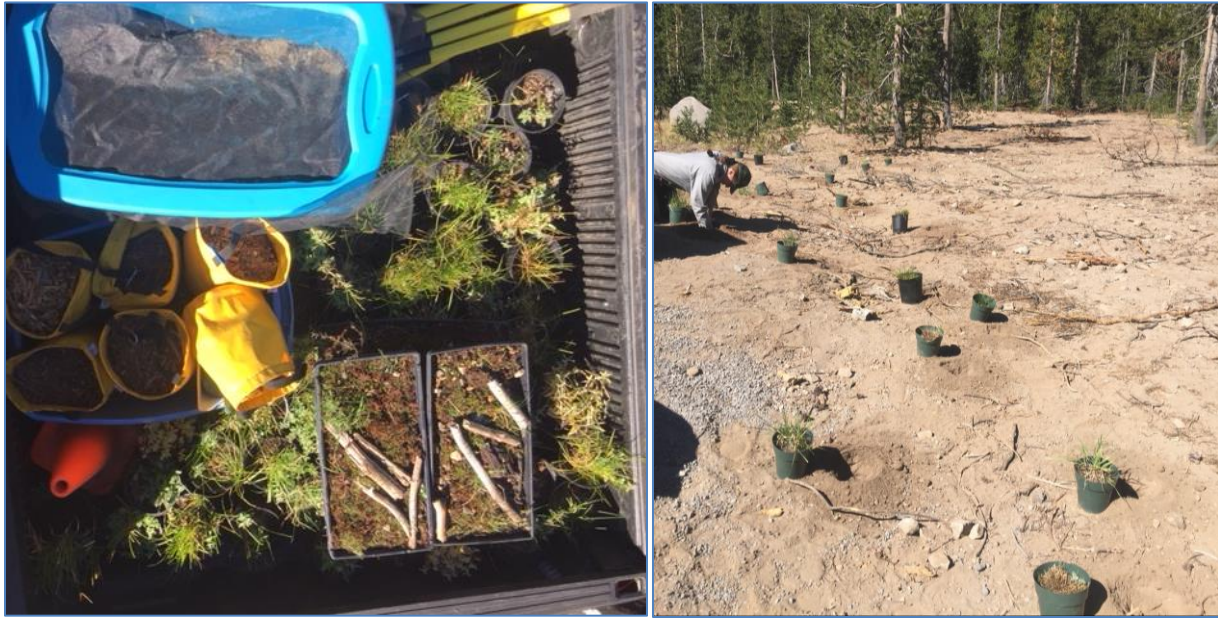
**Figure 11.** Left: Salvaged plant materials prior to being outplanted in disturbed areas. Right: planting salvaged plants near the Annie Spring trail. Photos by Carrie Wyler.

All 189 containers of plants salvaged in 2017 contained living plants at the time of outplanting (Figure 11), and were replanted in the areas where they were salvaged. They will be monitored in 2019 for survival and establishment success. Revegetation areas experiencing poor survivorship will be augmented with additional planting and seeding efforts in 2019. Outplanting propagated plants in the project area will commence in 2019.

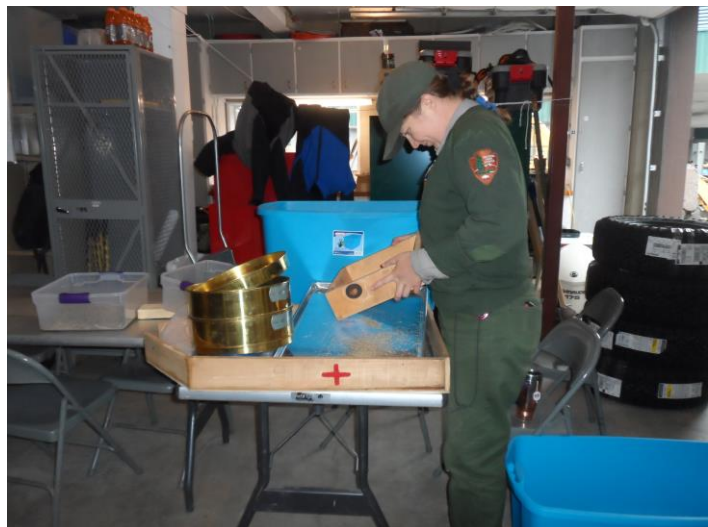
**Figure 12.** Rough-cleaning seed at Park headquarters. Photo by Carrie Wyler.

A total of 2,587 g of rough-cleaned native seed was collected during the 2018 field season, as outlined in Table 3. The seed remaining in storage after 2018 broadcast seeding and propagation efforts is detailed in Table 4. This seed was dried and cleaned at the Park (Figure 12), and is stored in the Botany program's seed storage freezer. This will be available for subsequent seeding and plant propagation efforts. Additional seed collection efforts will be made during the 2019 field season, especially from plant species that have exhibited high levels of field survivorship.
