# Back Barrier Erosion Monitoring at Cumberland Island National Seashore

## *2018 Data Summary—Version 2.0*

Natural Resource Data Series NPS/SECN/NRDS—2019/1201

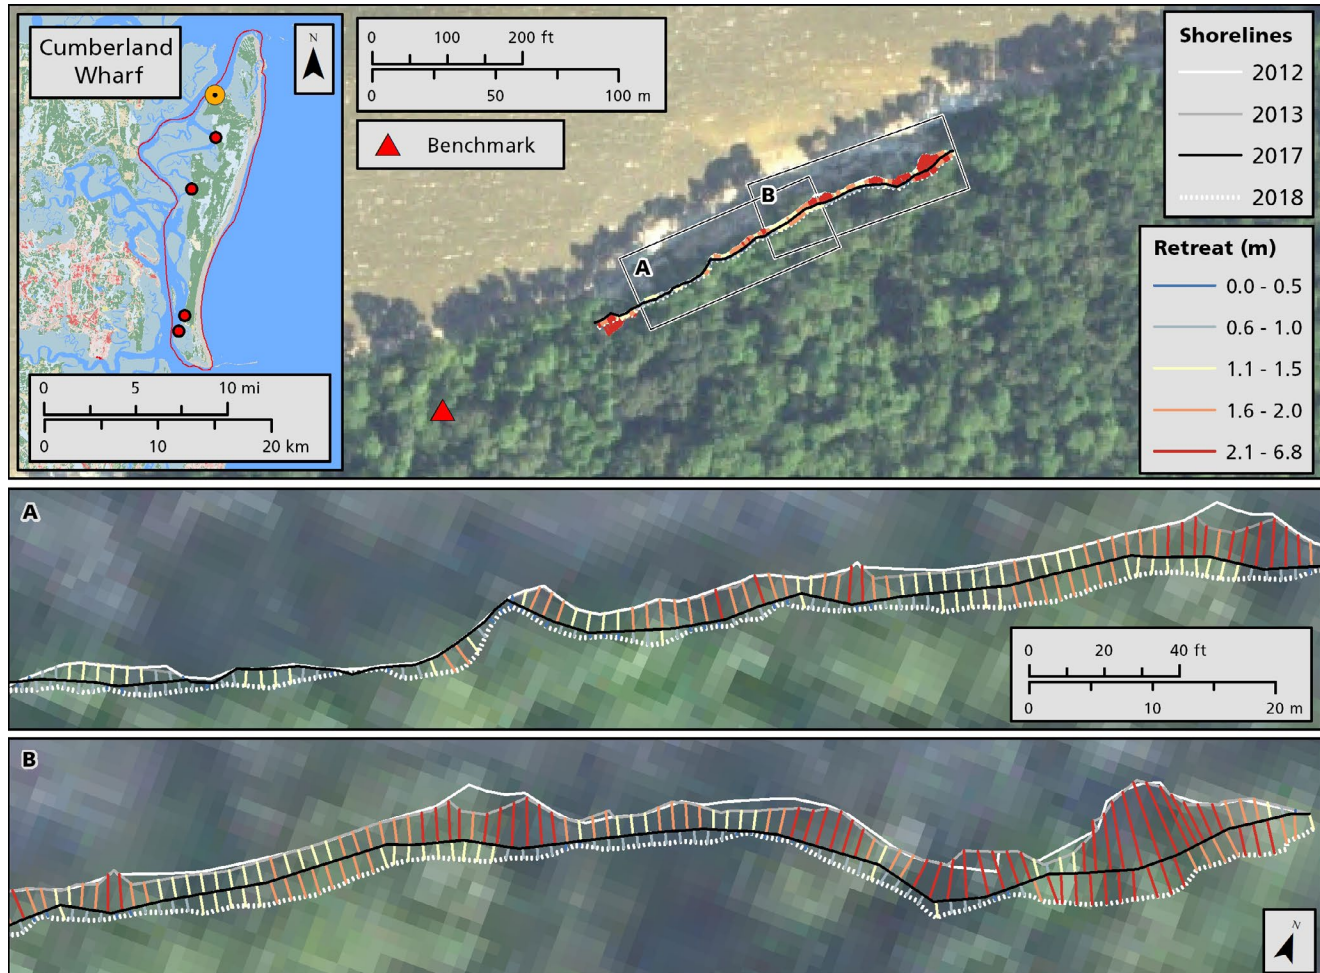
The 2017 survey was approximately 153 meters (502 ft) in length of which 84% showed some signs of retreat (Table 1). The maximum amount of change was detected on the far eastern portion of the surveyed area where a rotational slump caused approximately 5.74 meters (18.8 ft) of retreat (Figure 3). The surveyed margin had an average of 1.82 meters (6 ft) of retreat and a mean annual rate of retreat of 0.43 meters per year (1.4 ft per year). This mean annual rate of retreat is greater than the USGS surveyed rate (2011–

The 2018 survey was approximately 150 meters (492 ft) in length of which 100% showed some signs of retreat (Table 1). Similar to the 2017 survey, the maximum amount of change was detected on the far eastern portion of the bluff margin where 2.37 meters (7.8 ft) of retreat was recorded (Figure 3). The average amount of retreat for this portion of Cumberland Wharf was 0.98 meters (3.2 ft) which is less than the average amount of retreated observed by the 2017 survey. The average amount of retreat is much greater than the mean annual rate from the 2011–2013 and 2017 surveys but less than the mean annual rate from Jackson (2006) for 1983–2002. The significant amount of island margin retreat that was observed at CW between the 2017 and 2018 surveys includes the effects of Hurricane Irma.

**Figure 3.** Island margin retreat at Cumberland Wharf.
