## United States Department of the Interior FISH AND WILDLIFE SERVICE

September 10, 2012

SUBJECT: Cave Safety Evaluation and Trash Removal

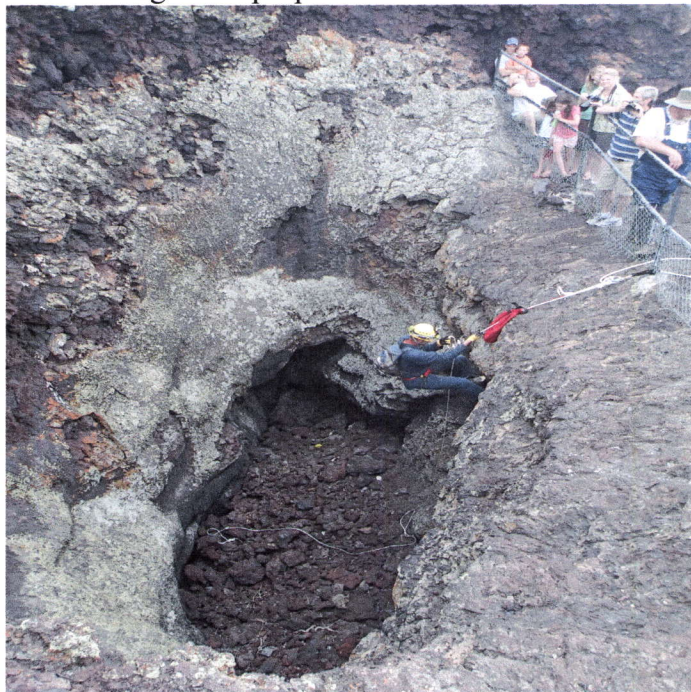
Brian and Aaron entered the Curving Trail Spatter Cone to remove trash and conduct a quick evaluation. Trash was removed and a lower internal pit was discovered. If this portion of the Spatter cone cave hasn't been mapped, it's recommended that that work be completed for resource management purposes.

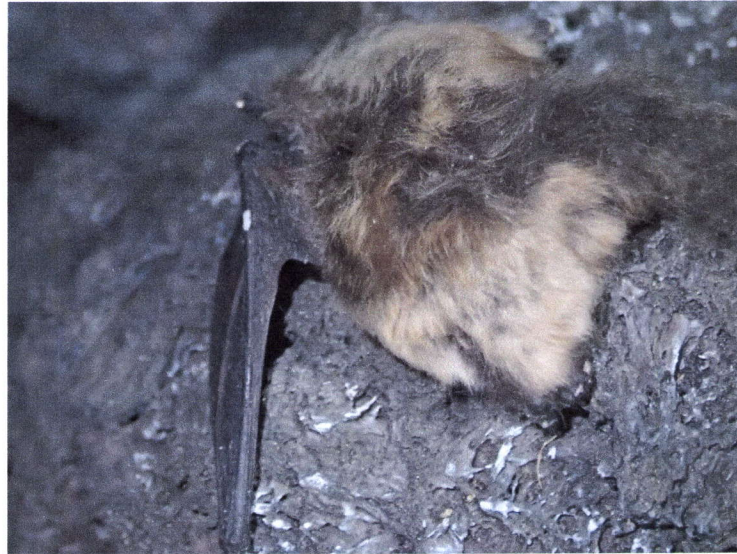
These same individuals, along with Thomas entered Snow Cone to remove trash and conduct a quick evaluation. They removed about 2/3 of a garbage bag of trash, and while on rope rappelled down to a frozen lake with 4-10 inches of water on top. No further access was available during this entry to the lower portion of the cave. One bat was photographed, visually suggestive of a Small Footed Myotis (*Myotis ciliolabrum*). A noticeable white spot on the ear and forearm appear in this picture.
