# Real-time Monitoring to Support Environmental Impact Management Strategies for Road Construction Activities on Foothills Parkway: Wears Valley

Natural Resource Data Series NPS/XXXX/NRDS—201X/XXXX

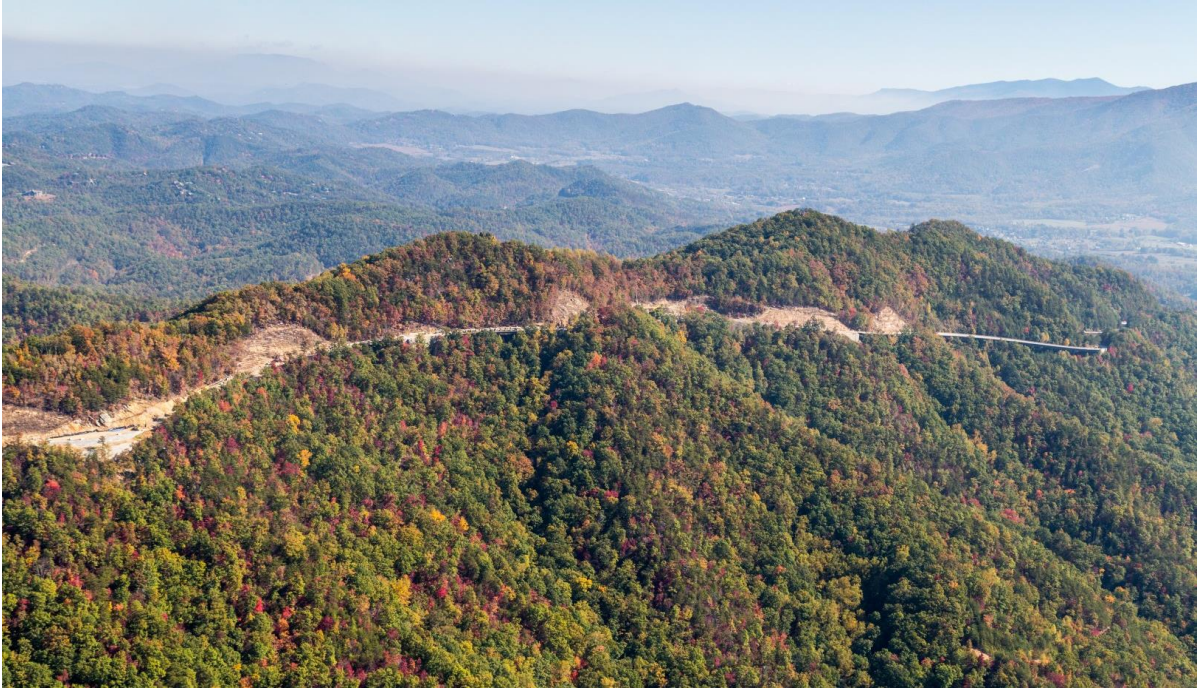
**Figure 2.** Aerial image of Foothills Parkway construction. (Photo Credit: Great Smoky Mountains National Park Service).

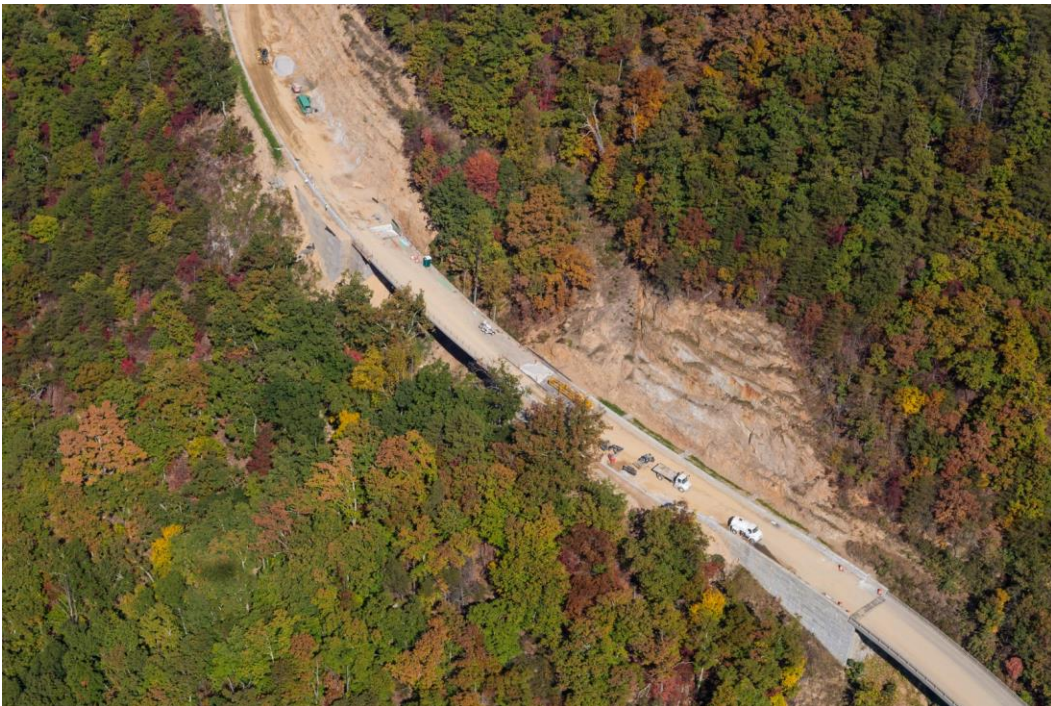
**Figure 3.** Aerial Photo of Foothills Parkway construction of Bridge 3. (Photo Credit: Great Smoky Mountains National Park Service).

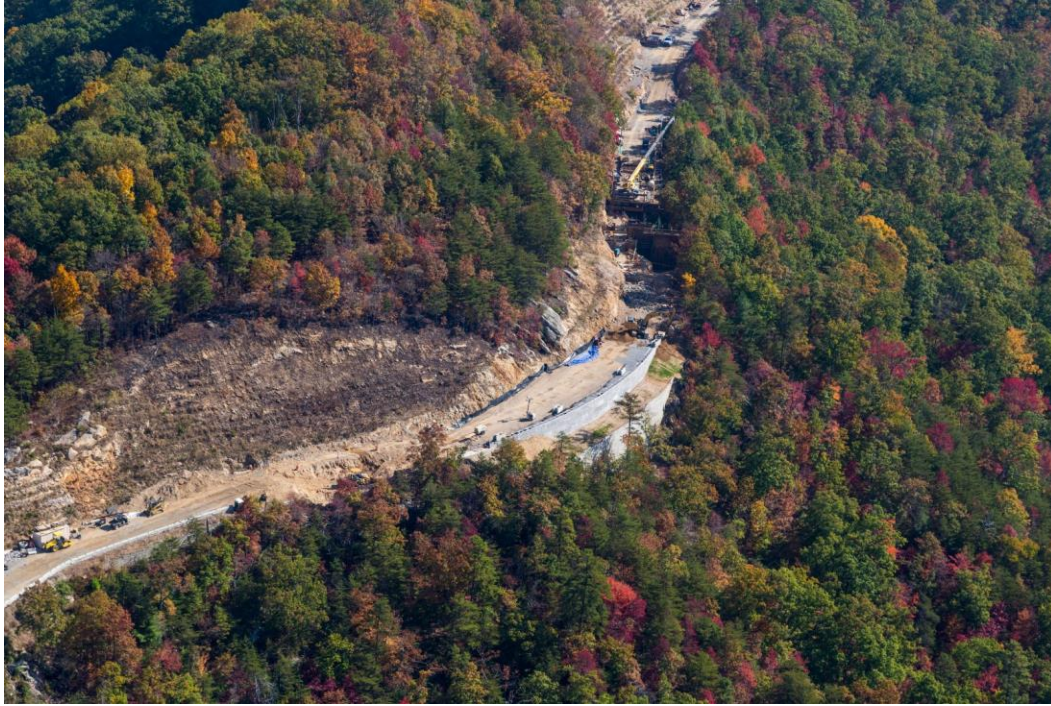
**Figure 4.** Aerial photo of Foothills Parkway construction highlighting land disturbance activities. (Photo Credit: Great Smoky Mountains National Park Service)

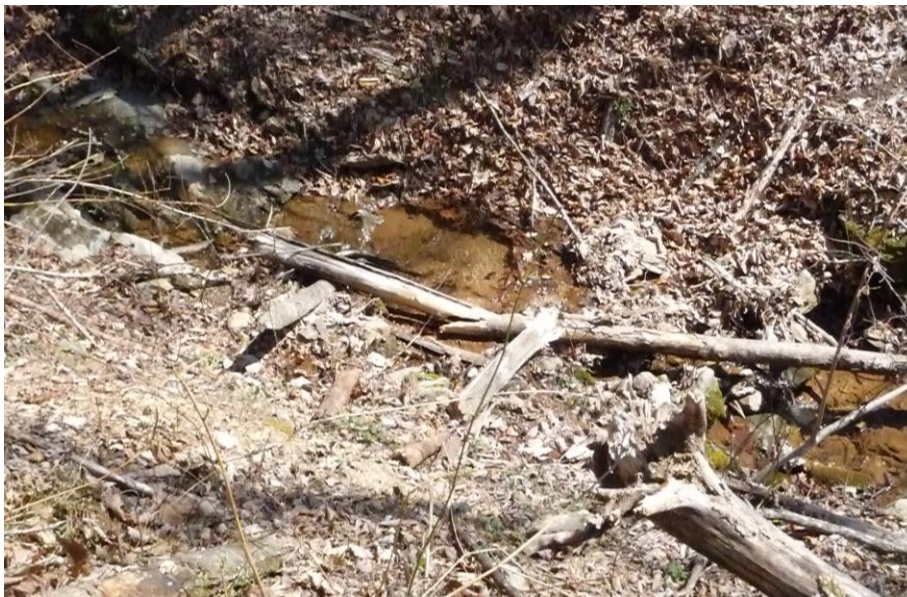
**Figure 10.** Hembree Hollow stream within the Foothills Parkway stream monitoring area.

HH stream bed material consisted primarily of sandy material transported by runoff from various places within the watershed; occasional bedrock was exposed in stream. Woody debris frequently blocked flow and in some cases acted to trap sediment. Several fallen trees lay across the stream above sonde location. Trapezoidal channel geometry and negligible sinuosity was predominantly observed in the stream. An average slope of 10-20% characterized this stream.

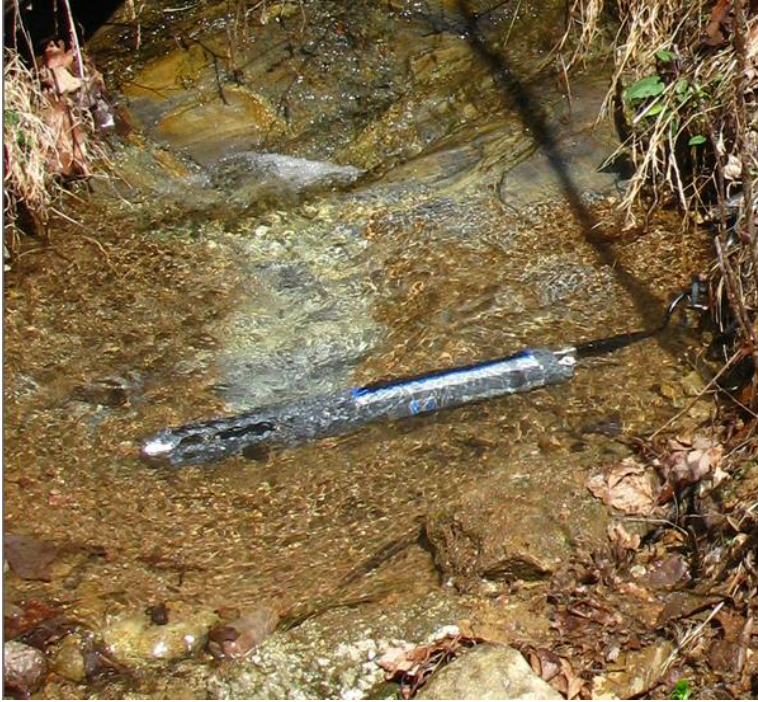
**Figure 11.** Hembree Hollow sonde before storm event.

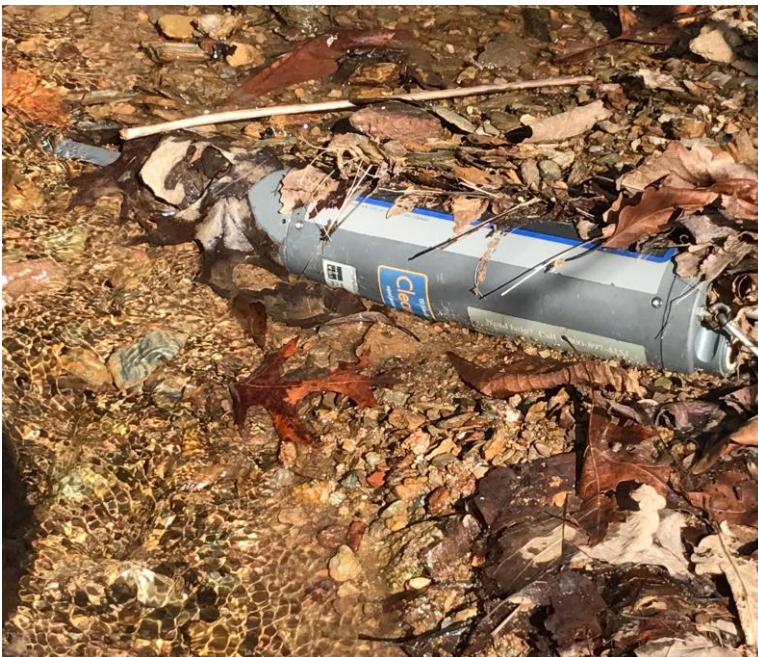
**Figure 12.** Hembree Hollow sonde after storm event.

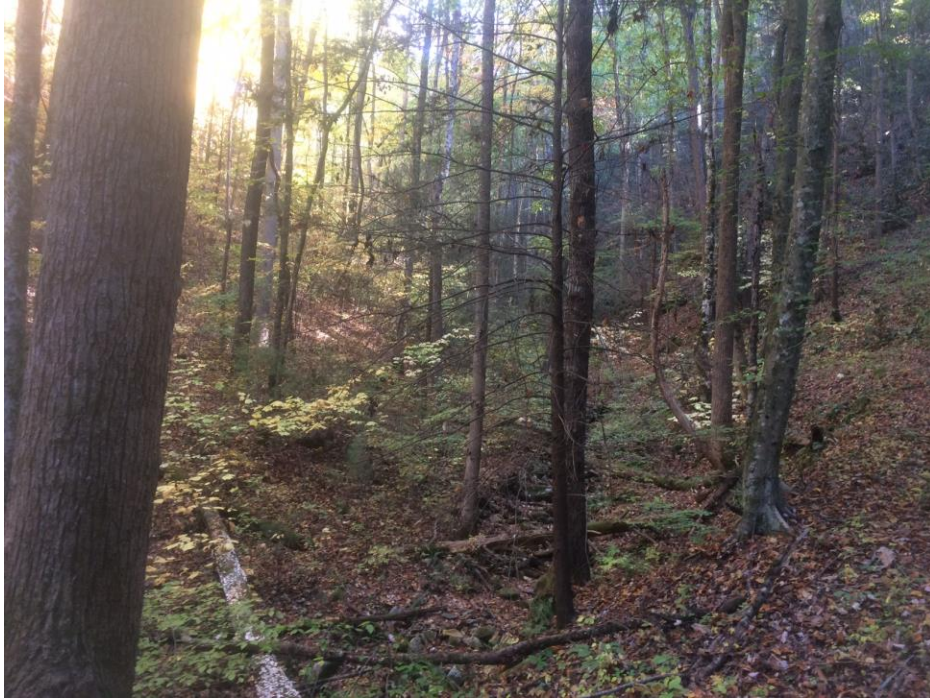
**Figure 13.** Dunn Hollow watershed near the Foothills Parkway stream monitoring site.

Ramsey slaty silt loam underlay DH, just as with HH. The same bedrock geology was found in DH as in HH. Slaty rocks were apparent less than one foot below ground surface, as well as in stream and along banks. Topsoil appeared to be thin, being less than two feet in certain places. Stream sediments appeared more silty and fine and less sandy than in HH. Soil pH was 5.5, CEC was 9.5 meq/100 g, and soil acidity was 5.2 meq/100 g.

The stream at DH was classified as a type A1a+, first-order stream. Trapezoidal channel geometry was dominant with minimal sinuosity. Slope averaged 10-20% in stream. Streamflow was more consistent in this watershed and less dependent on rainfall, which made for ideal monitoring conditions. In only very few places did streamflow disappear underground. Pools were frequent in this stream, and the sonde was located in a larger pool where flow appeared most consistent. In contrast to HH, this stream was relatively free of fallen trees blocking flow. Bed material consisted mostly of bedrock with some silty sediments observed after rain events. Leaves and fine organic matter were frequently observed in bottom of the pool. Testing at Clemson Agricultural Laboratory indicated that stream chemistry consisted of the following species: K (0.4 ppm), Ca (3.8 ppm), Mg (2.2), SO<sub>4</sub> (3 ppm), and Na (1 ppm). No PO<sub>4</sub> or NO<sub>3</sub> were present. TDS was 38 ppm, and EC was 0.06 mmhos/cm.

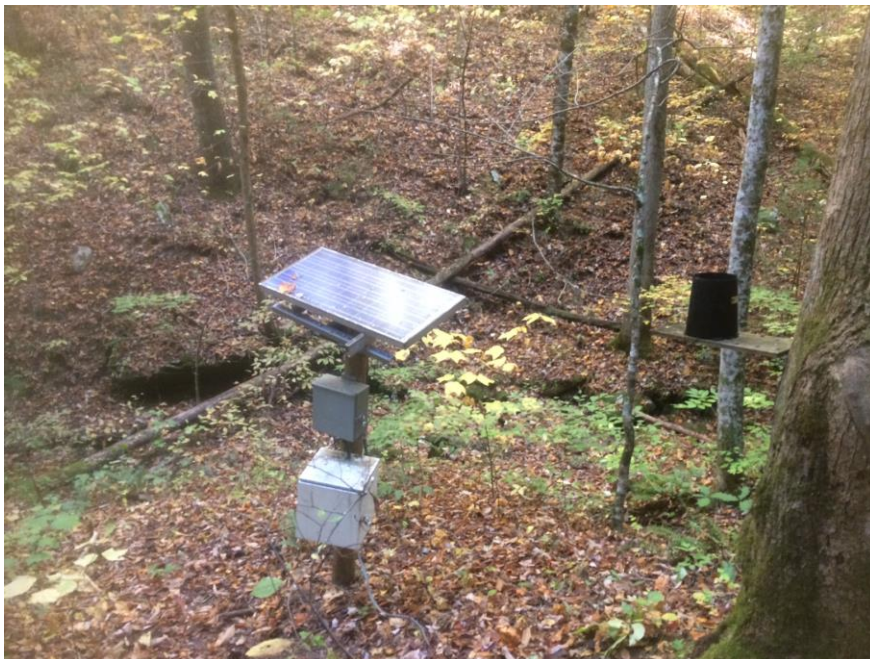
**Figure 14.** Dunn Hollow monitoring station at the Foothills Parkway stream monitoring site.

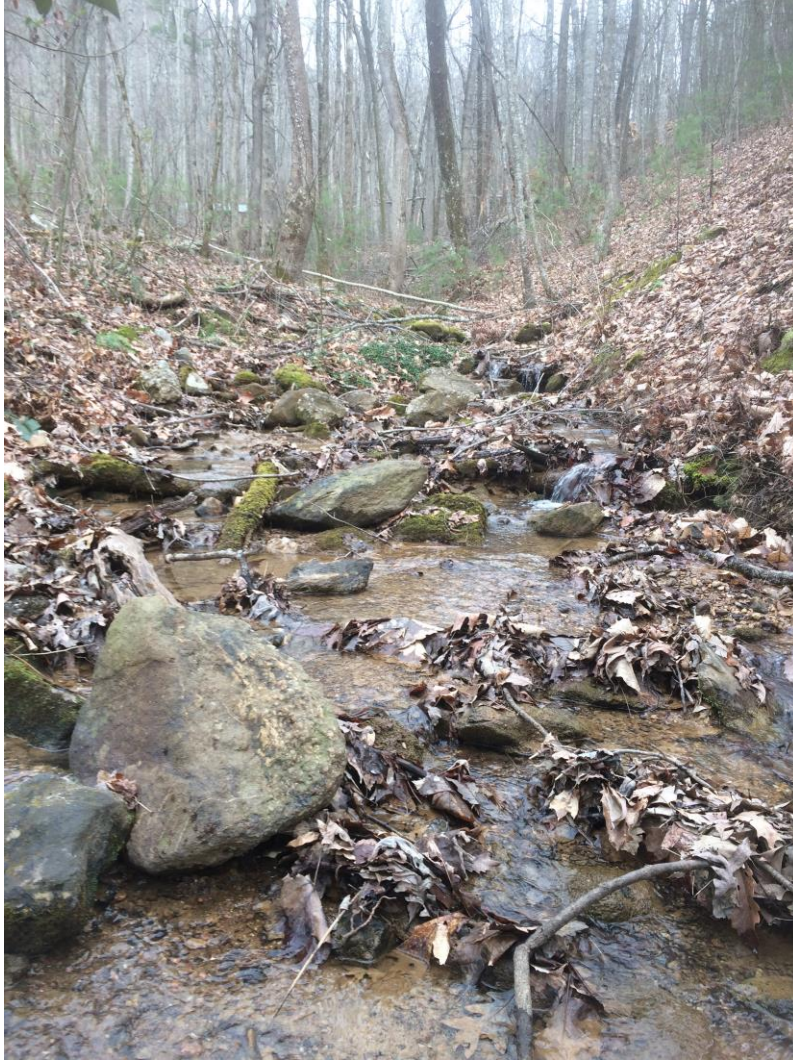
**Figure 16.** Rudd Hollow watershed and stream within the Foothills Parkway monitoring area.

Rudd contained Ramsey slaty silt loam as with the other two watersheds. Again, as with HH and DH, Cambrian shale siltstone comprised bedrock geology. Soil pH was 4.8, CEC was 5.9 meq/100 g, and soil acidity was 4.4 meq/100 g. Stream bed material consisted primarily of sand and small pebbles; very little fine sediments were observed. Similar to Hembree, Rudd experienced periods of no flow during summer months, which posed problems for monitoring. Sandy/gravelly material transported during heavy rain events tended to constrict flow. Rudd was classified as a type A5a+ due to the amount of sand/gravel mix present with little bedrock observed. Stream channel geometry was trapezoidal, and sinuosity was minimal. Stream chemistry consisted of the following

constituents: K (0.4 ppm), Ca (2.7 ppm), Mg (1.3 ppm), SO<sub>4</sub> (2 ppm), and Na (1 ppm). No PO<sub>4</sub> or NO<sub>3</sub> were detected. TDS was 26 ppm, and EC was 0.04 mmhos/cm.

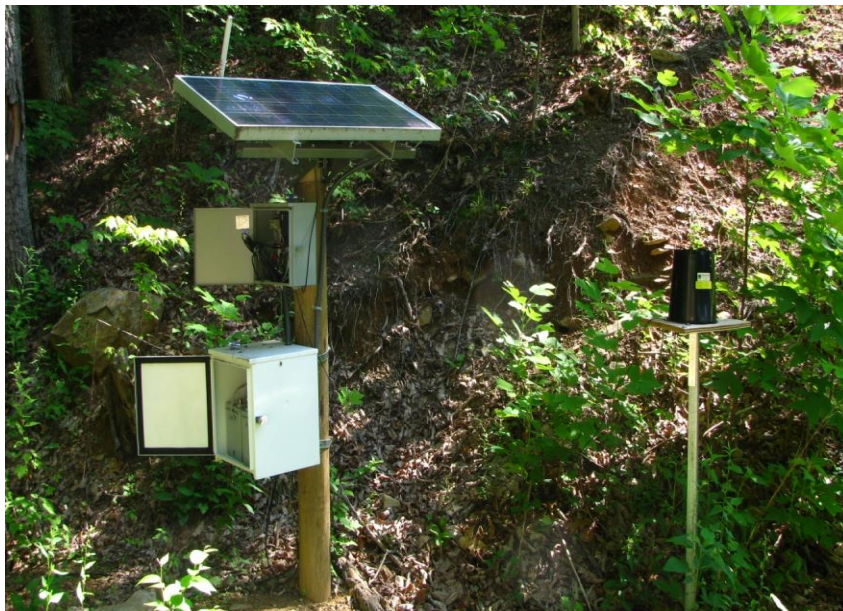
**Figure 17.** Station setup at HH showing solar panel, equipment boxes, and rain gauge.

Equipment was contained within NEMA 3R metal boxes that were weather-resistant and sturdy. Each site had two boxes attached to an eight-foot, six-inch wooden post. Solar panels were positioned on top of posts. All external wires were protected inside PVC conduit. The bottom box contained 12-V batteries and solar charge controller, while the top box contained datalogger and modem. Figure 7 provides an example of station setup, specifically at HH. This setup was used for each study site.

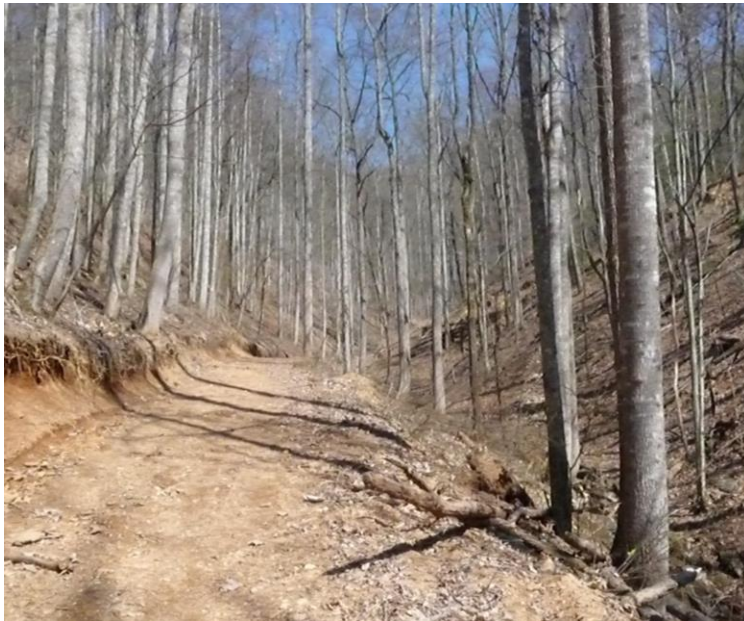
**Figure 30.** Road cut alongside Hembree Hollow stream within the Foothills Parkway monitoring area.

As mentioned earlier in this section, a couple of the monitored watersheds did contain internal disturbances. Hembree Hollow had existing road cuts already in place before monitoring began (Figure 30). As the monitoring period progressed, additional road cuts and land disturbing activities took place (Figure 31).

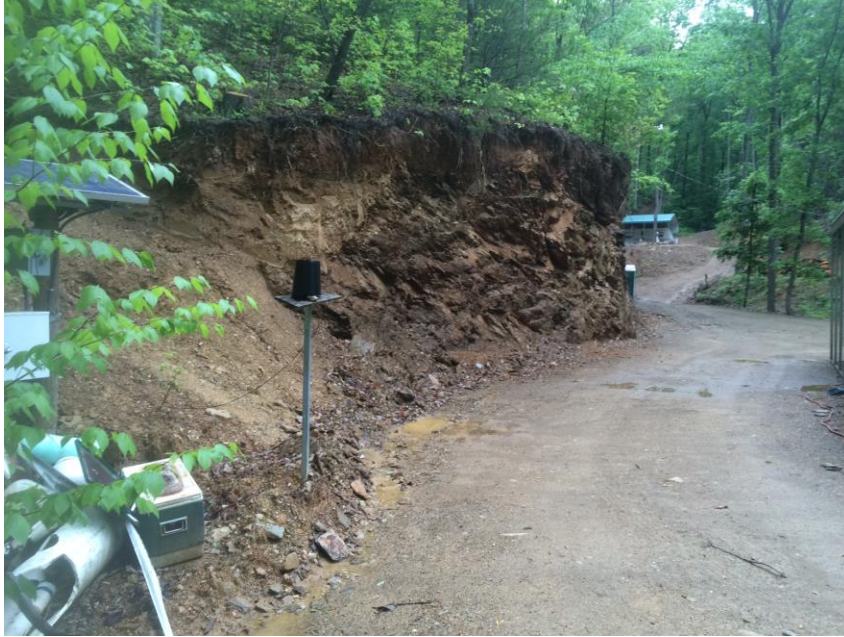
**Figure 31.** Internal disturbances within Hembree Hollow Watershed.

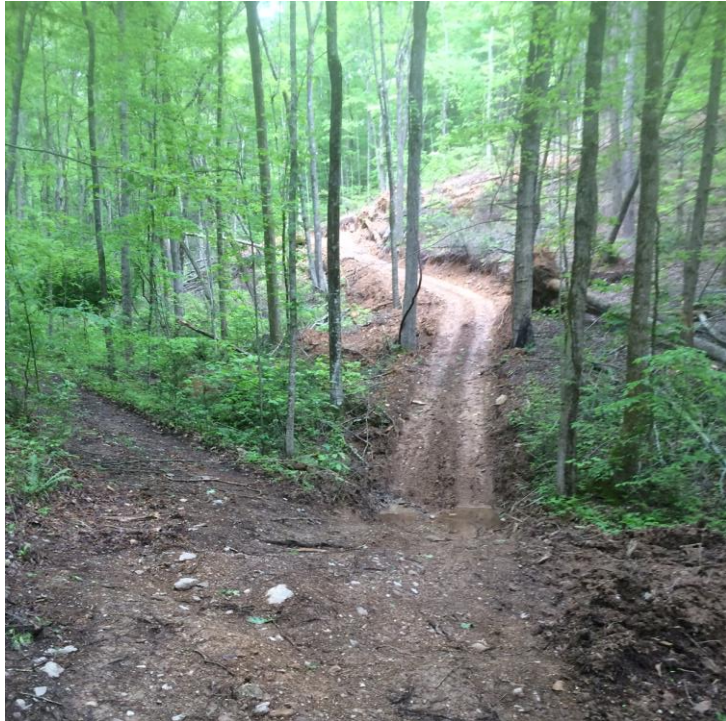
**Figure 32.** New road cut across Rudd Hollow stream within the Foothills Parkway monitoring area.

The second watershed which had minimal internal disturbances before monitoring began was Rudd Hollow. However in winter of 2016, new road cuts were graded primarily for ATV use within this watershed. The location of one of the road cuts was just upstream of where the NPS monitoring station was located. Figure 32 shows the road cuts that was graded just upstream from the monitoring location within Rudd Hollow. Figure 33 shows the fine material that has been deposited on the monitoring sonde after this road cut was graded.

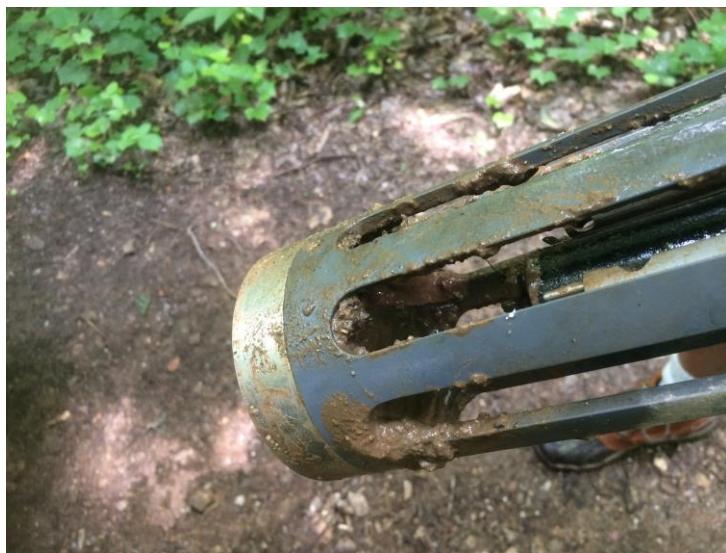
**Figure 33.** Sonde showing signs of sediment deposition after new road cuts within Rudd Hollow.
