# Protocol Implementation Plan for Monitoring Geomorphic Change along the Rio Grande in Big Bend National Park

Natural Resource Report NPS/CHDN/NRR—2019/1881

March 2019

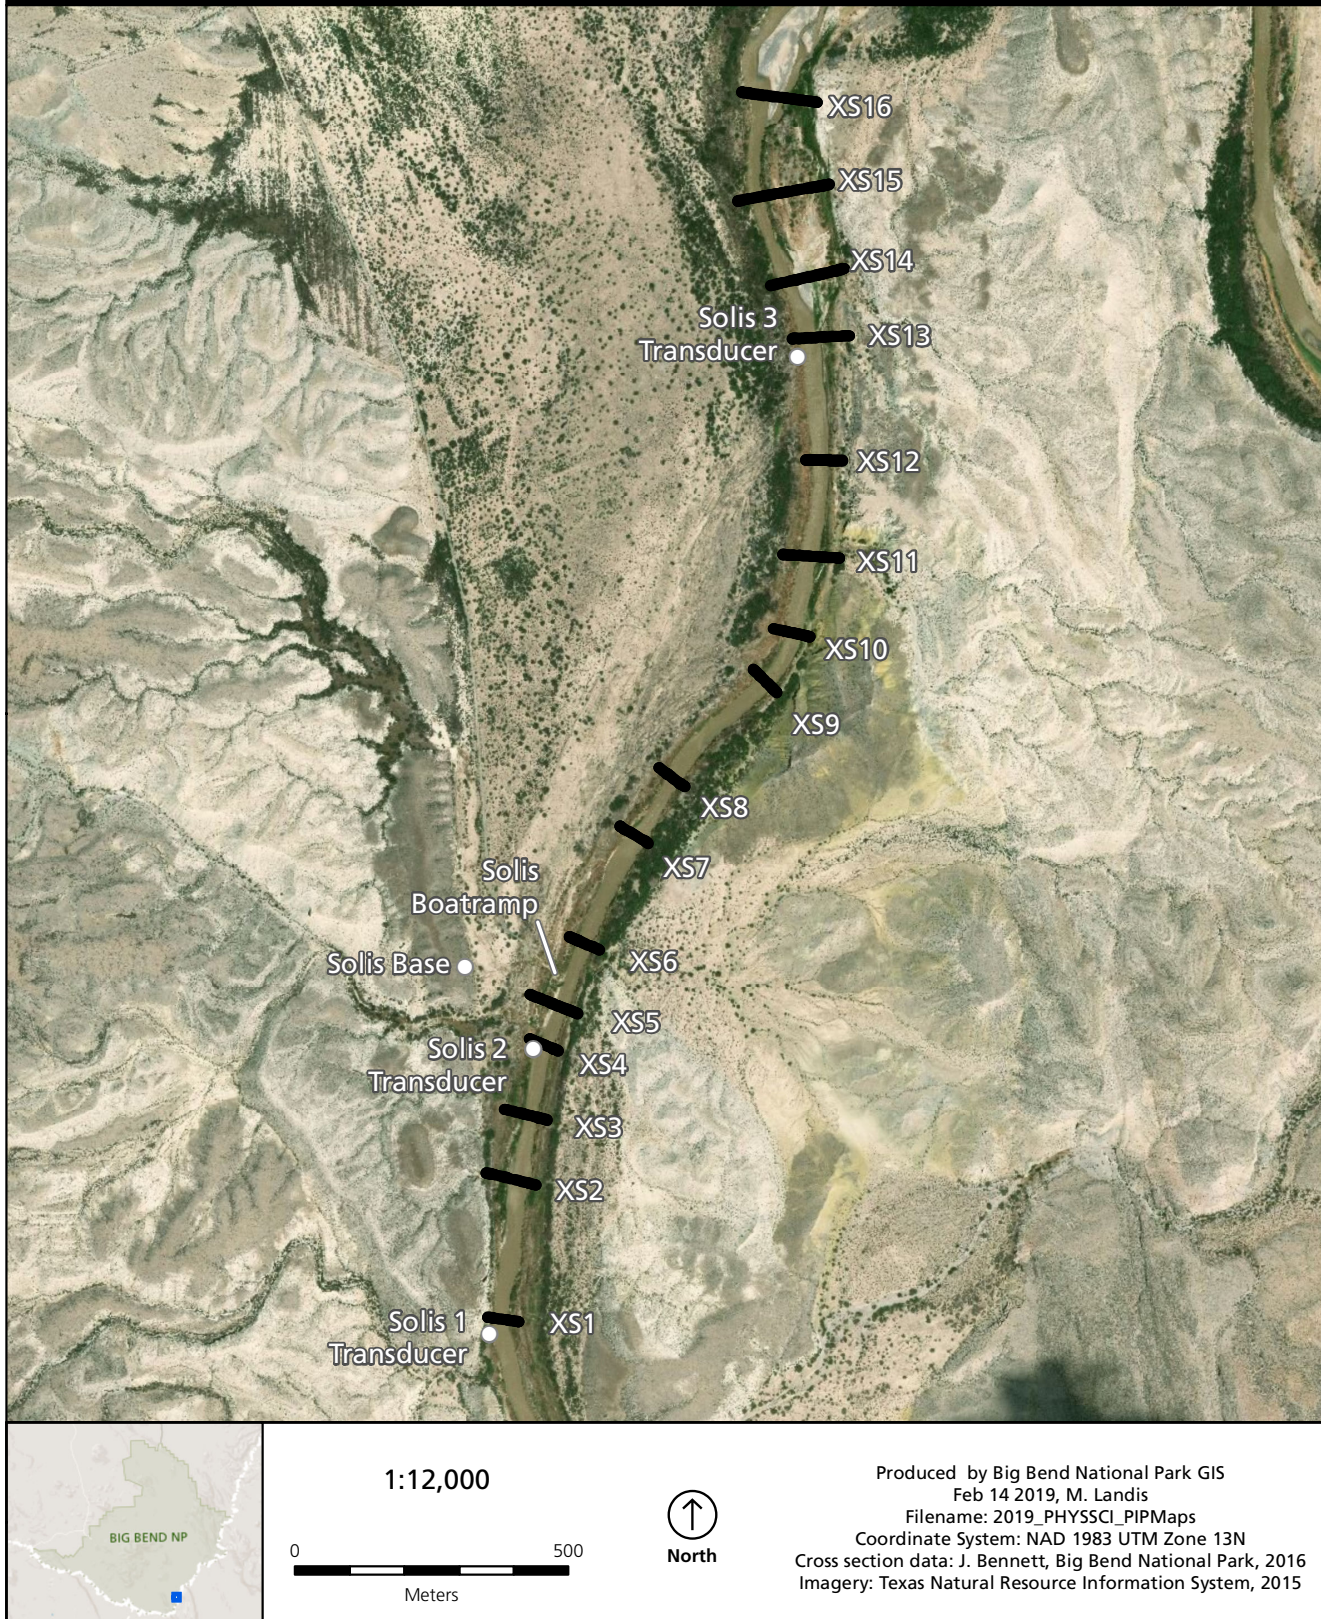
## Cross sections: Solis

Figure A1 .Big Bend National Park Rio Grande Geomorphology Monitoring Location - Solis Reach

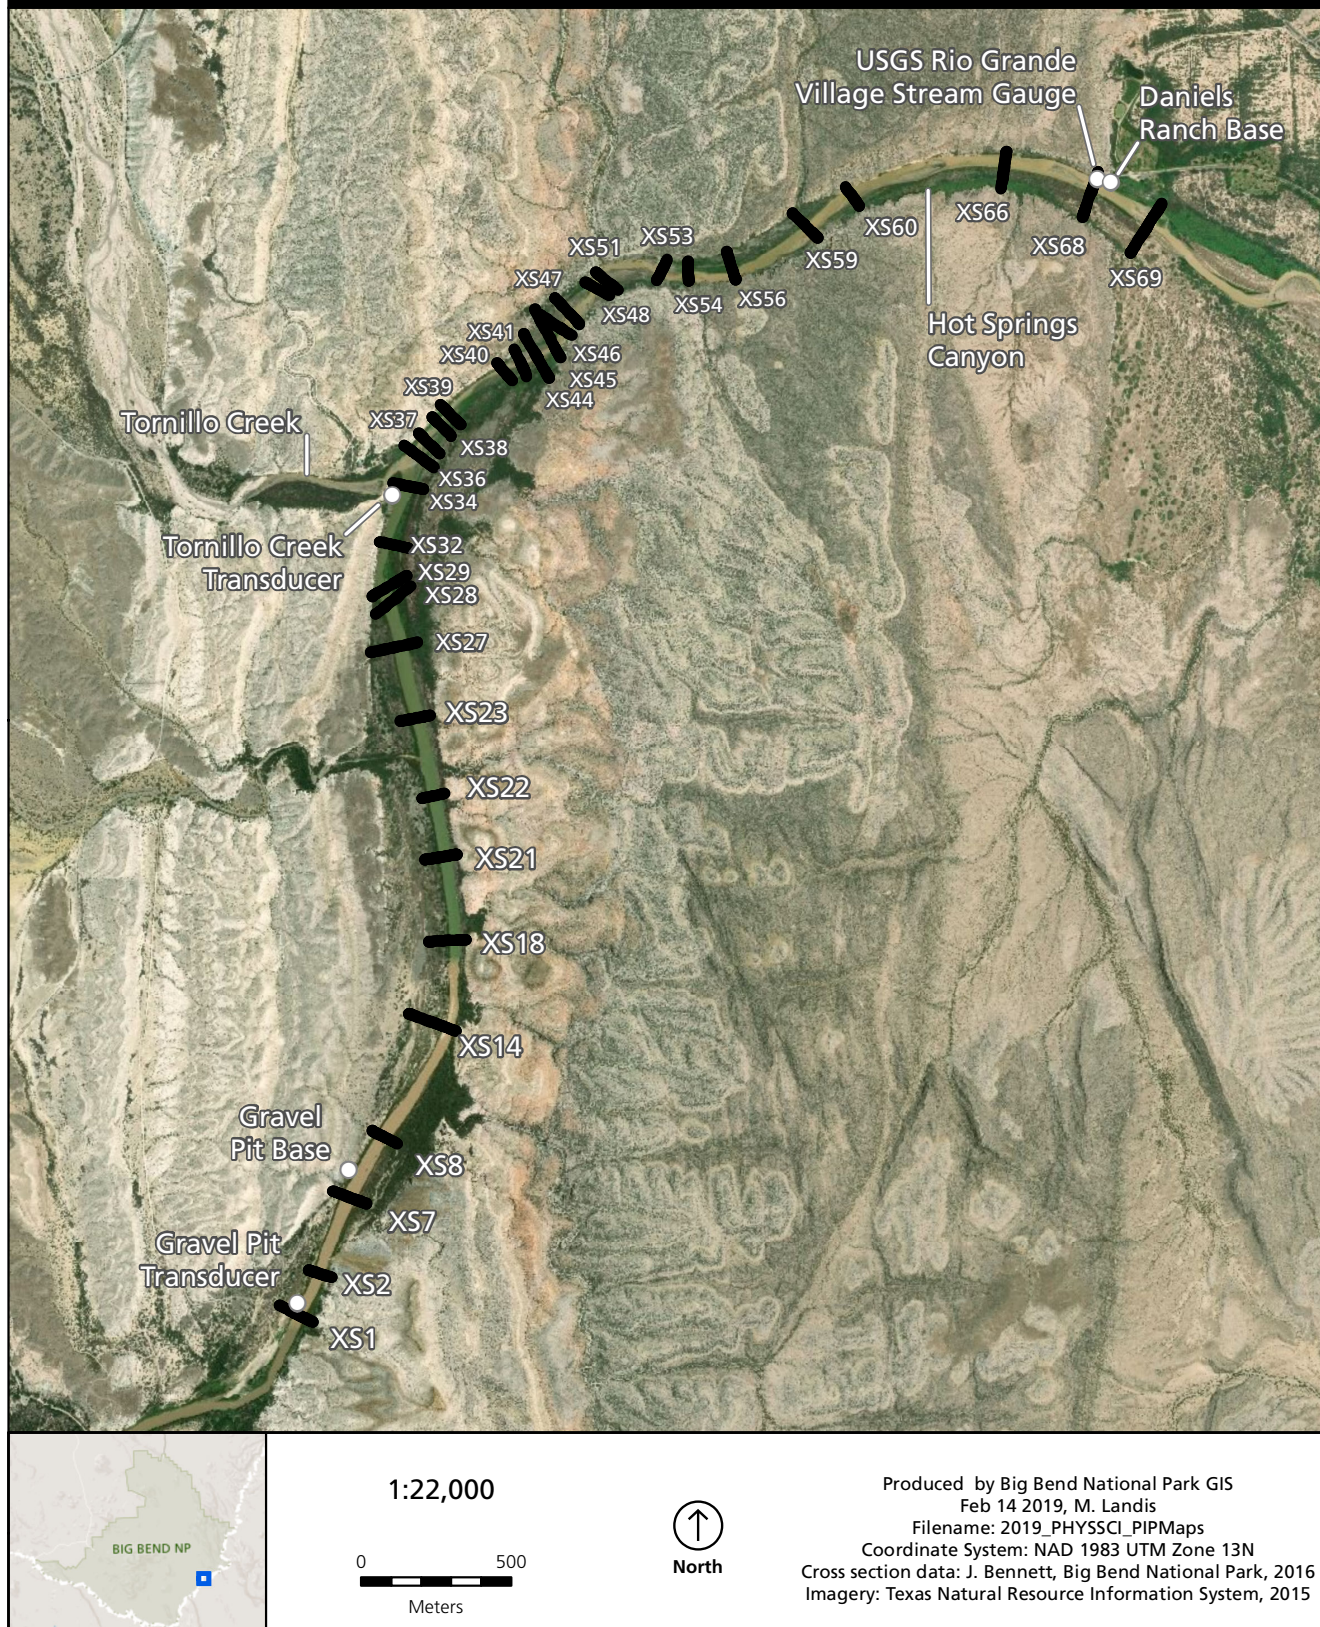
# Cross sections: Hot Springs Canyon

Figure A2. Big Bend National Park Rio Grande Geomorphology Monitoring Location - Hot Springs Reach
