# Replace Rim Village Barriers Revegetation Project

*2018 Annual Report*

Jennifer S. Hooke, Scott E. Heisler, Tara L. Chizinski, and Carolyn S. Wylar

March 2019

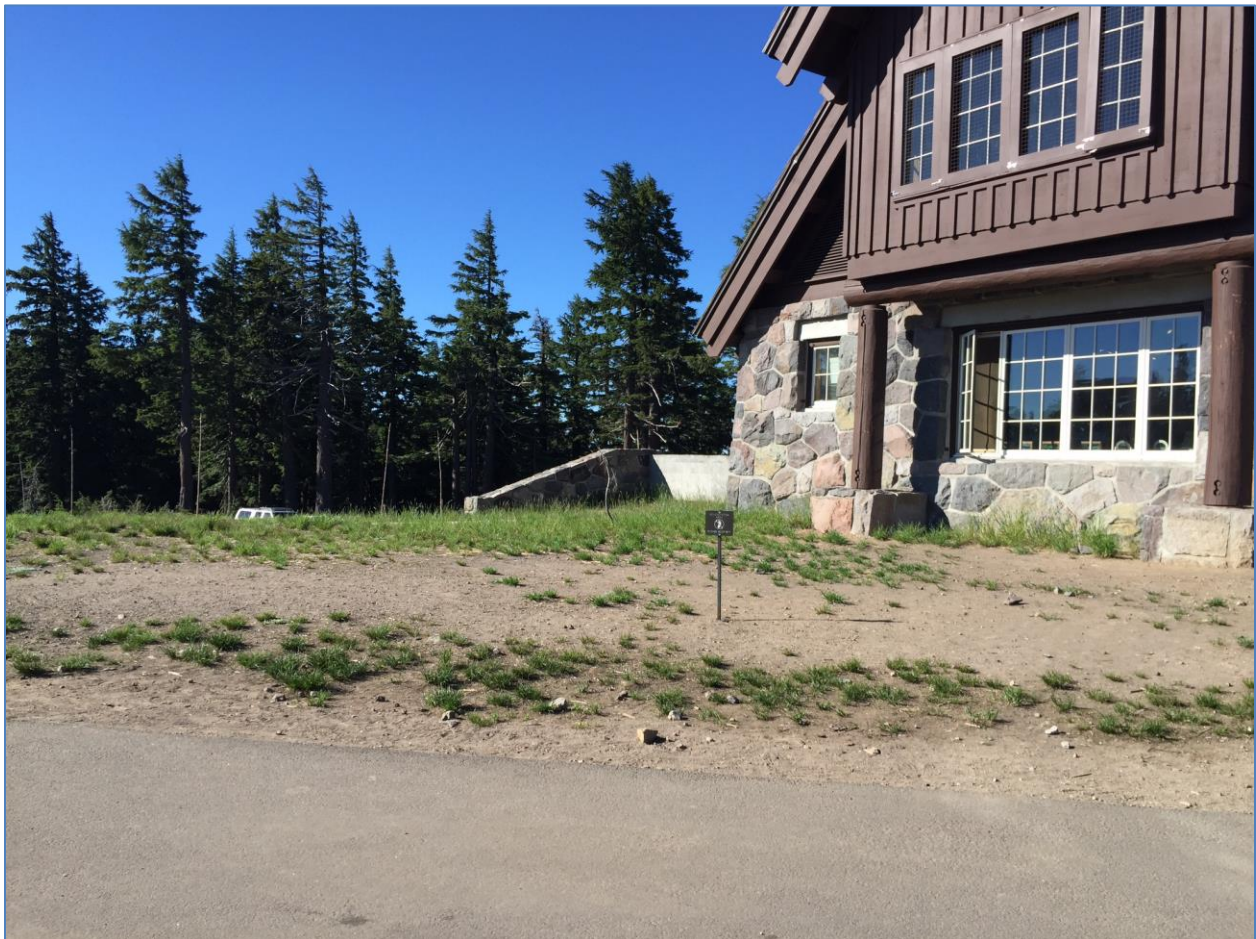
Park visitors stroll across revegetation areas during the sensitive time when plants are emerging from the winter snowpack.  
Photo by Jen Hooke.

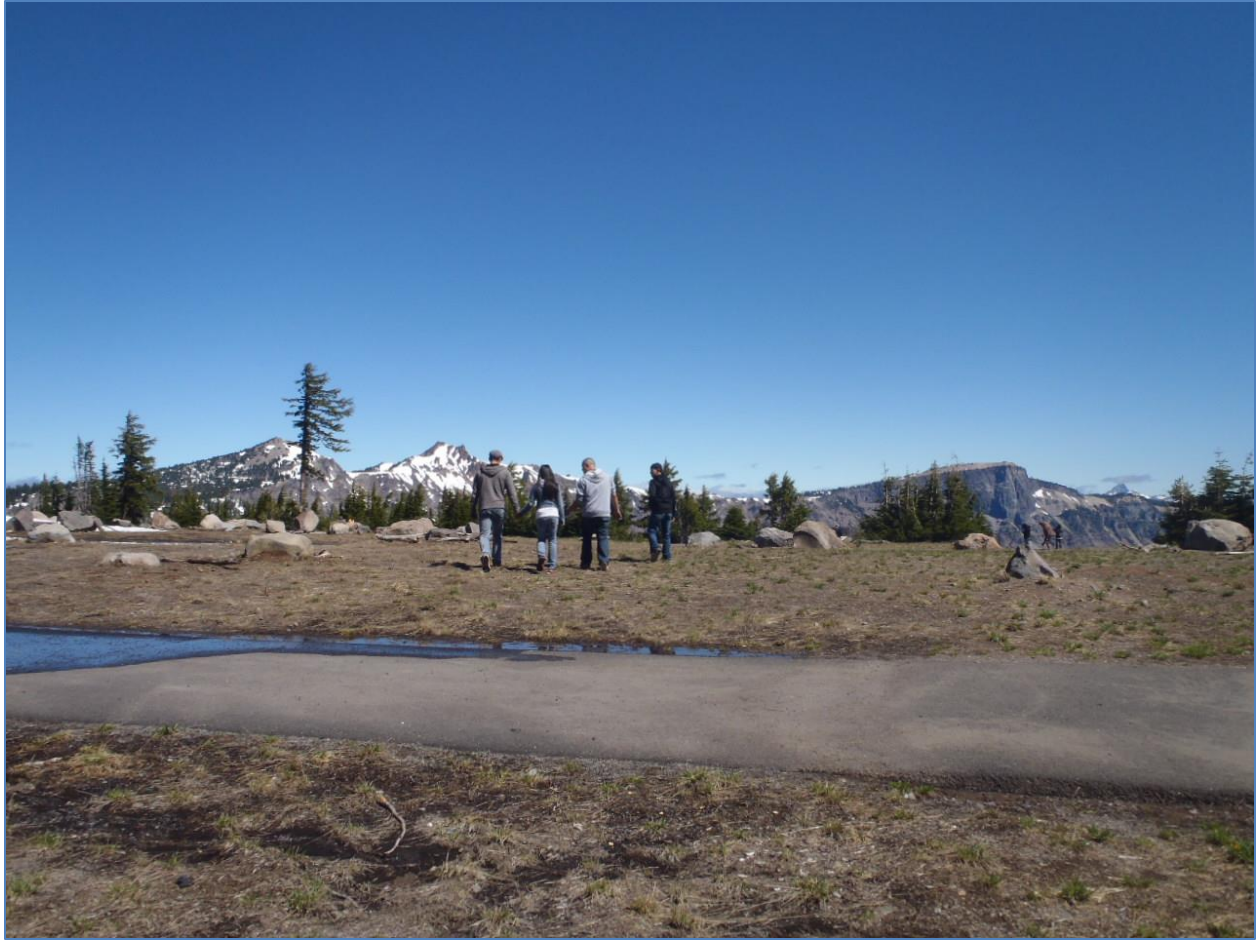
Trampling impacts to vegetation and soils in an unfenced area by the Rim Village Café and Gifts building.  
Photo by Jen Hooke.

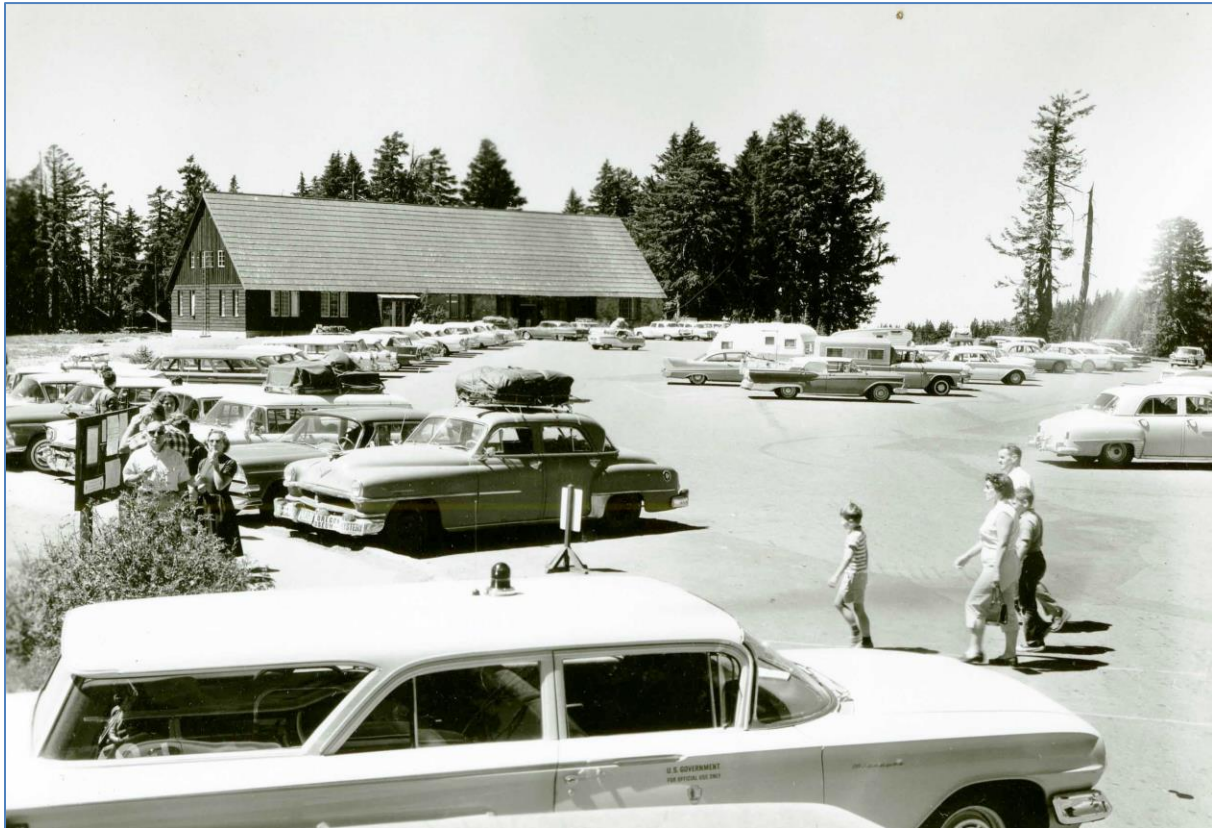
**Figure 1.** The former parking lot in front of the cafeteria building (now called the 1928 building) at the western end of Rim Village. Photo courtesy of the Crater Lake National Park Museum & Archives Collection.

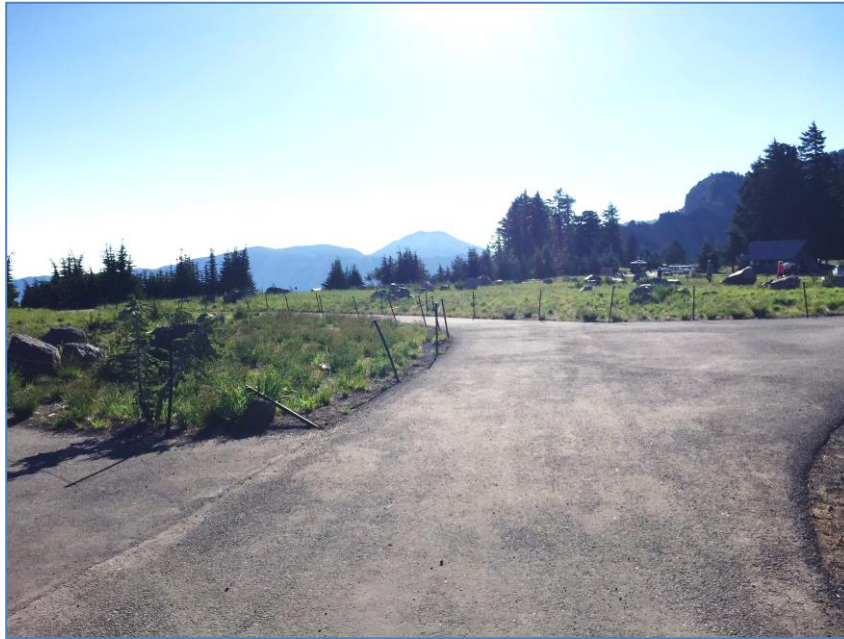
Prior to the inception of the Replace Rim Village Barriers project, fencing of the landscaping islands at the former parking lot site consisted of plastic posts slipped over rebar stakes that were installed each spring at snowmelt. When the former parking lot was removed, site preparation by the

**Figure 2.** The old fencing was prone to leaning and/or falling over, as it was lightweight and easily dislodged, and its rebar stake supports were difficult to install in the compacted ground. Photo by Carrie Wyler.

contractors was minimal prior to revegetating the site, resulting in heavy soil compaction in the landscaping islands (Hudson and Thomas 2010). Installing rebar stakes into hard, compacted ground each spring was difficult, and the fencing tended to lean and become unstable as a result (Figure 2). This projected an unkempt and neglected appearance at one of the Park's most heavily visited locales. A need existed for a more durable and attractive fencing option to protect the vegetation and whitebark pine seedlings within the landscaping islands.

- 1) Replace the current deteriorated fencing at Rim Village with a new fencing design that is sturdy, durable, and compatible with cultural resource values in the Rim Village Historic District.
- 2) Stabilize vegetation in areas that have been damaged by heavy visitor use through revegetation of social trails and barren or sparsely vegetated areas.
- 3) Share the story of this restoration project with Park visitors through the creation of an interpretive wayside display.

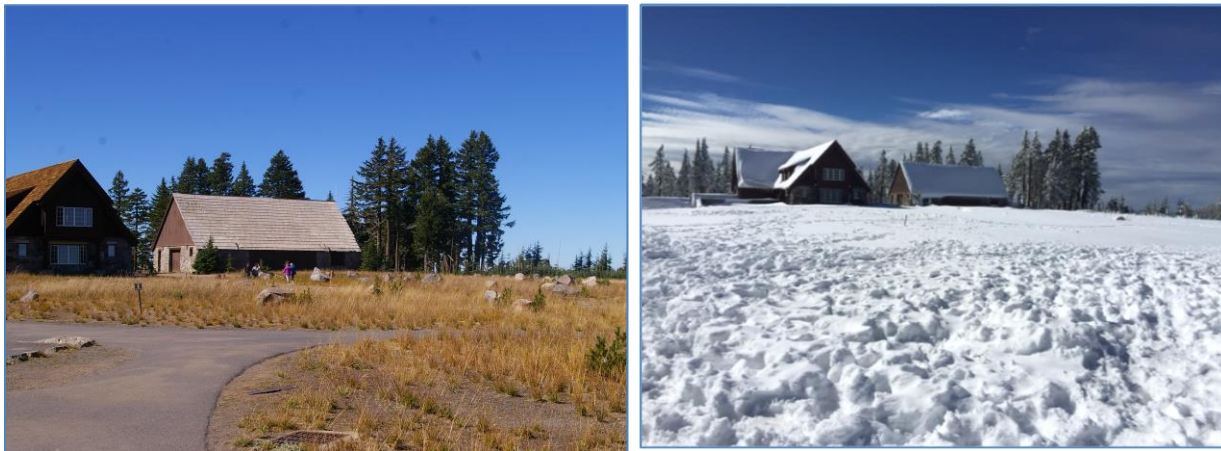
**Figure 3.** The former parking lot area in summer/fall (left) with walking paths delineated; and in winter/spring (right) when visitors wander freely across the area. Photos by Carrie Wyler.

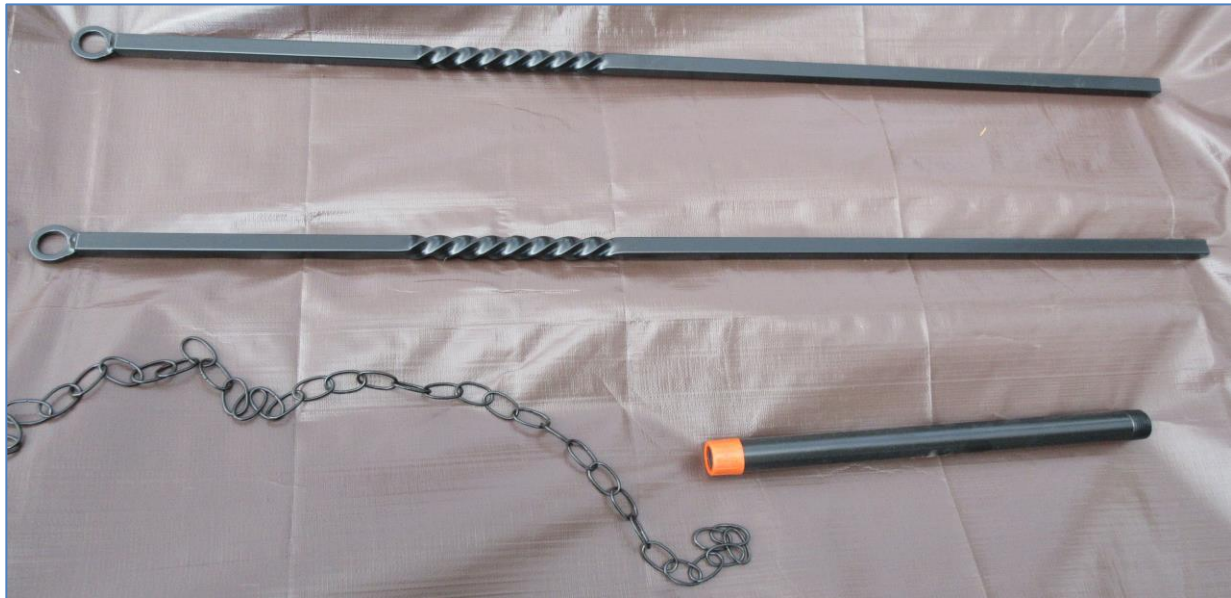
Since the fencing design had to be removable, it was decided to use receivers to secure posts to facilitate easy installation and removal each year. The in-ground post receivers for the fence posts are 18" x 1" National Pipe Thread (NPT) threaded "black iron" pipe nipples. Threaded pipe nipples were selected due to their durability, market availability, ability to drain collected water, ability to accept a durable cap when not in use, and their facilitation of non-damaging installation by utilizing the pipe threads. The rounded corners on the posts allow them to fit inside the 1" diameter pipes (the diagonal of a perfect  $\frac{3}{4}$ " square is 1.06"), and leaves minimal room for the posts to wobble. The 18" length of the pipe nipples was selected as the closest available fit to the desired 16.5" length.

The pipe nipples received a powder coat finish (Figure 5) to provide corrosion resistance and an

**Figure 5.** Fence posts (top, middle) and receiver (bottom right) after powder coating. Photo by Scott Heisler.

aesthetically pleasing finish. The coating applied was a double coat of Cardinal brand "Black 20% Gloss" TGIC polyester, with a surface-preparation of sand blasting. The threads of the pipes were coated without affecting their usability.

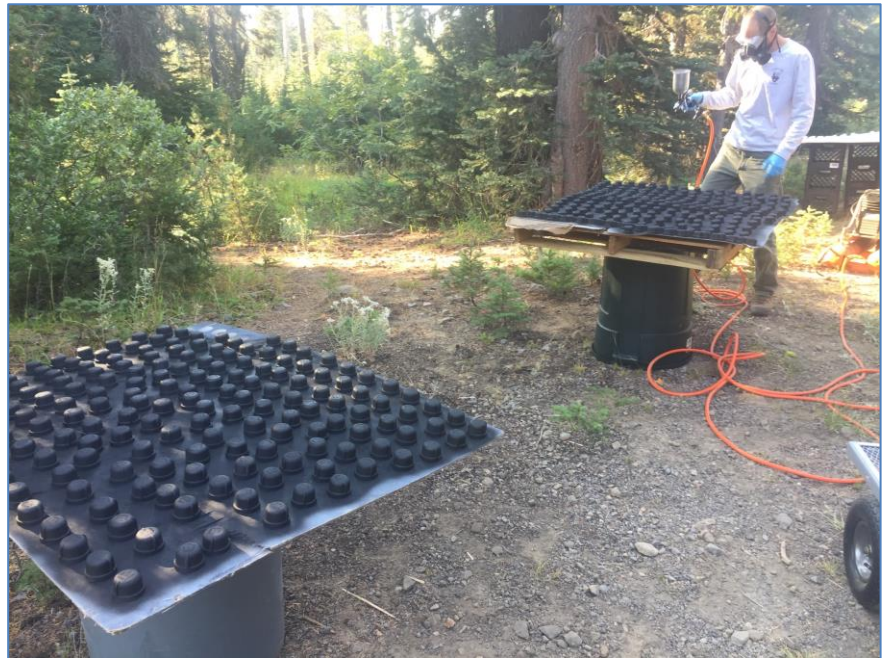
The caps received a paint finish, applied by CRLA Botany staff. Painting was chosen as an acceptable finish for the caps due to their low-visibility while in service and simplicity of upkeep. Surface preparation for painting consisted of removing oil residue with acetone. The paint coating consists of a single coat of Rust-Oleum brand “Stops Rust Clean Metal Primer,” and a double coat of Rust-Oleum brand “Stops Rust Protective Enamel” in flat black color. The paint was applied using a high-pressure low-volume (HPLV) paint sprayer, allowing the use of low-VOC paint (Figure 6).

**Figure 6.** Painting caps for fence post receivers. Photo by Carrie Wyler.

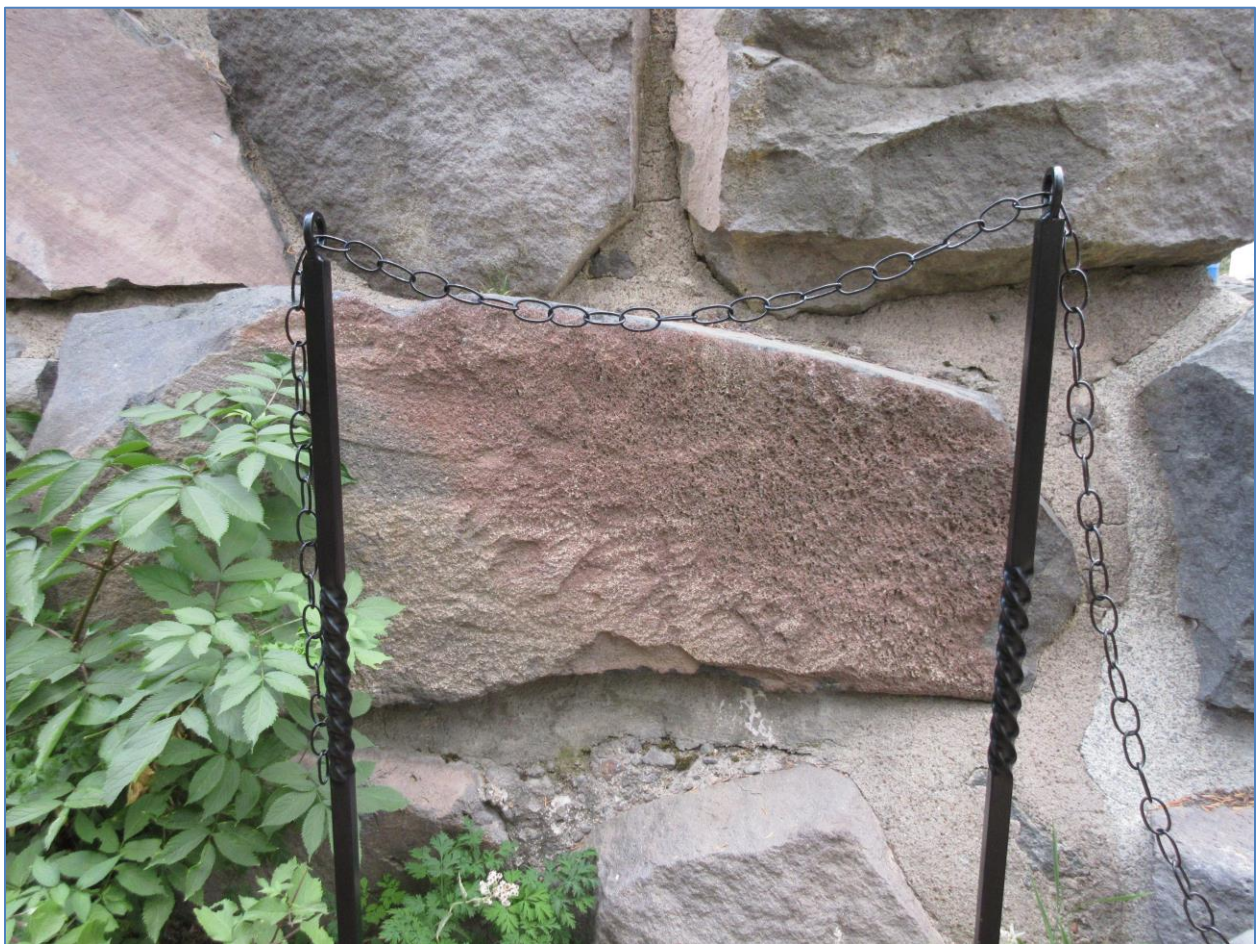
The new fencing posts and chain (Figure 10) were procured and in-ground post receivers installed in October of 2018. The new fencing will extend 3,576' to protect the landscaping islands outlined in red in Figure 10. The fencing materials are currently being stored at the South Yard. Installation will begin as the snow melts in June of 2019. An assessment of the in-ground post receiver positions will also be made during installation to determine impacts of frost-heaving and overwintering. Any receivers that were frost-heaved will be lowered to an appropriate height to avoid tripping hazards.

**Figure 10.** The new fence posts and chain for the Replace Rim Village Barriers project. Photo by Carrie Wyler.

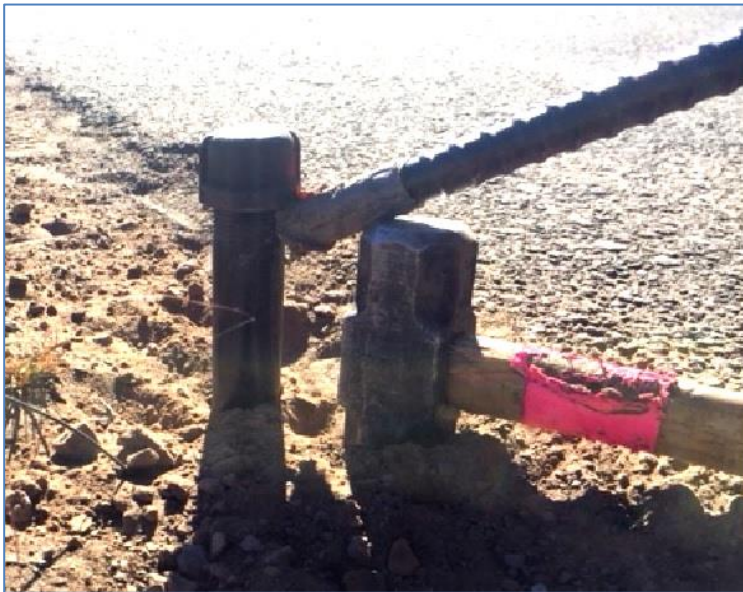
The initial installation of the in-ground post receivers was completed during the 2018 field season, but a level of troubleshooting is expected when the fence is fully assembled in spring 2019. The effects of overwintering on the post receivers will need to be assessed, and some may need to be reinstalled. The receivers should be checked to ensure that they are plumb, and that the posts sit in them at the correct level. Removal of the receivers can be accomplished by installing a cap, and using the lower lip of the cap as a lever-point (Figure 12). Due to manufacturing variations in the opening size of the receivers and in the powder coating thickness on the posts, incompatible fit

**Figure 12.** Using a cap as a lever point to remove a post receiver. Photo by Carrie Wyler.

combinations may be encountered. If a lack of fit is found with an individual posts/receiver combination, it is suggested to try a different combination. If the problem is commonly encountered, a possible remedy is to lightly grind down two adjacent corner edges on one of the section of the posts which are contained by the receivers (approximately the bottom 16.5"). This grinding is best accomplished using either a light application of an electric angle grinder, or a mill file. The use of water to solidify the borehole walls during installation of the receivers occasionally resulted in deposits of mud adhered to the

internal walls of the pipes. If these residues are found to complicate insertion of the posts, careful use of a modified (cutting head has been ground down) 1" x 18" round shank masonry drill bit or pipe brush may be able to clear the obstruction. Water may also be used to clean out the caked dirt.
