# Wadeable Stream Suitability Assessment for Long-Term Monitoring

## *Ocmulgee National Monument*

Natural Resource Data Series NPS/SECN/NRDS—2019/1221

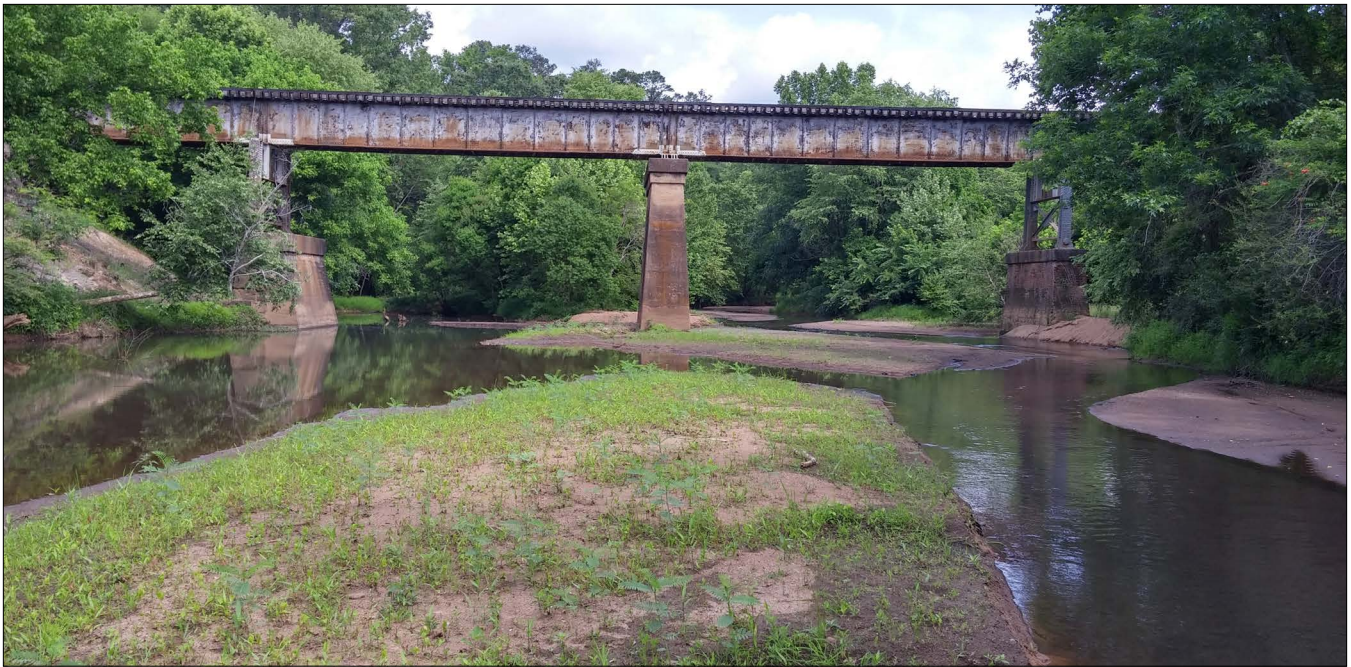
**Park Unit:** OCMU  
**Proposed Site Number:** Oc002  
**Stream Name:** Walnut Creek (middle 1)  
**Date:** 5.22.2017  
**Time:** 11:00 a.m.  
**Assessed by:** JMM, ENS and CSC  
**Accessible:** Yes  
**Gate Key Required:** No  
**Wadeable:** Yes  
**Recommend for Monitoring:** No

**Management Issues Noted:** Trash in the stream.

**Site Summary—** Walnut Creek (middle 1) is a large sand bedded stream with a high concentration of bar surfaces. Wetted width was estimated to be approximately 15 meters (49.2 feet) and bankfull width around 25 meters (82 feet). Water depth was approximately 0.15 meter (0.49 feet). Bank heights were approximately 1.5 meters (4.9 feet). Initial assessment of the creek classified the entrenchment of the segment as low. Floodplains have developed on both sides of the stream. The banks were fairly well vegetated (approxiamtely 50–90%) with grasses, shrubs, and trees being the dominant cover where present. Large woody debris is present and is mostly serving as bank protection (though most pieces are not buried and will likely be extirpated by the next flood). The stream is multi-thread and complex upstream of the railroad bridge. Immediately downstream, Walnut Creek makes a sharp turn toward the hillslope (leading to Oc003). At the sharp turn, Walnut Creek has a large flood chute that leads to a power line easement to the southeast.

**Monitoring Recommendation—** This site is not recommended for monitoring because of the quasi-multi-thread nature of the stream and because there is not a long enough length of stream to install a monitoring site (due to presence of the railroad bridge).

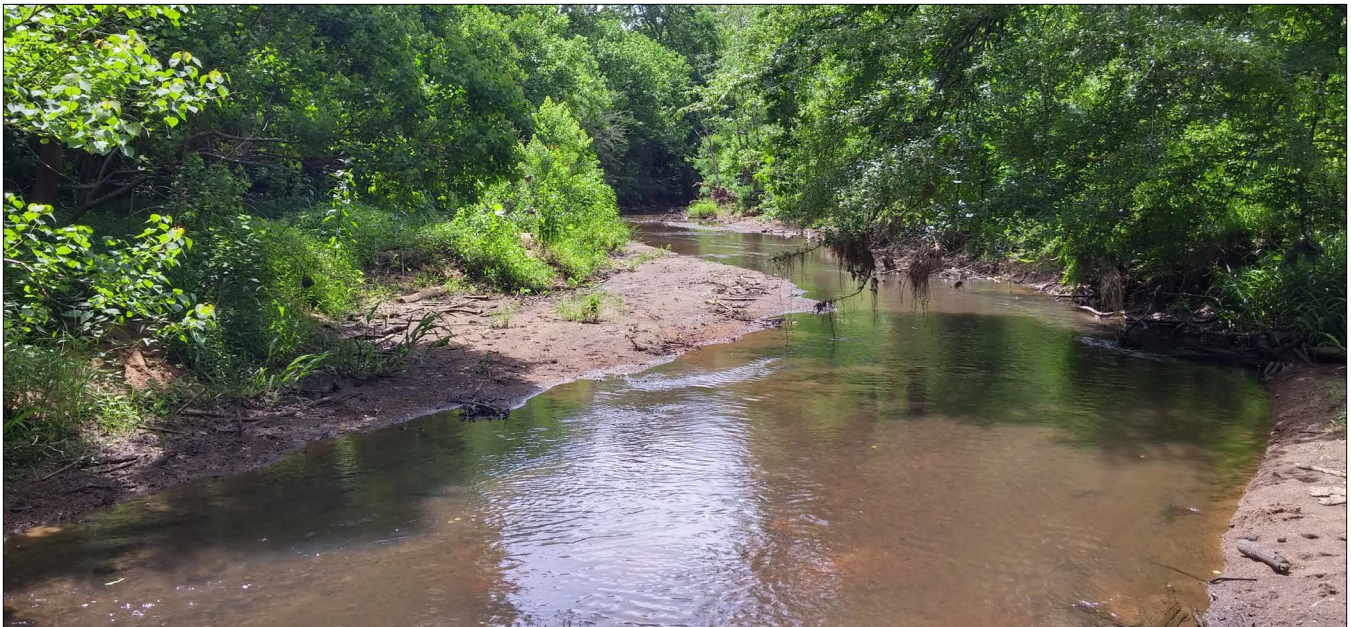
**Park Unit:** OCMU  
**Proposed Site Number:** Oc003  
**Stream Name:** Walnut Creek (middle 2)  
**Date:** 5.22.2017  
**Time:** 12:12 p.m.  
**Assessed by:** JMM, ENS and CSC  
**Accessible:** Yes  
**Gate Key Required:** No  
**Wadeable:** Yes  
**Recommend for Monitoring:** Yes

**Management Issues Noted:** Privet and Chinese Tallow are prevalent.

**Site Summary—** Walnut Creek (middle 2) is a medium-sized, sand-bedded stream. Wetted width was estimated to be approximately 6.5 meters (21.3 feet) and bankfull width around 10 meters (32.8 feet). Water depth ranged from 0.2–0.5 meters (0.7–1.6 feet). Bank heights were approximately 1 meter (3.3 feet) where floodplains were present and around 1.5 meters (4.9 feet) where the stream was entrenched. Initial assessment of the creek classified the entrenchment of the segment as low (downstream portions were more entrenched). Floodplains have developed throughout the segment. The banks were fairly well vegetated (approximately 50–90%) with grasses, shrubs, and trees being the dominant cover where present. Large woody debris is present and serving multiple functions such as habitat creation and bank protection. A number of smaller (ephemeral) drainages were observed entering the stream (on river left) throughout the segment. Privet and Chinese Tallow were prevalent along the banks. Side and mid-channel sand bars were observed throughout the segment.

**Monitoring Recommendation—** This site is recommended for monitoring because it is representative of the single-thread portions of Walnut Creek in the park. Additionally, this segment may be affected by the Privet and Chinese Tallow clearing that is taking place throughout the park. Placement of a monitoring site in one of these areas will help determine the influence these management practices are having on the streams in the park.

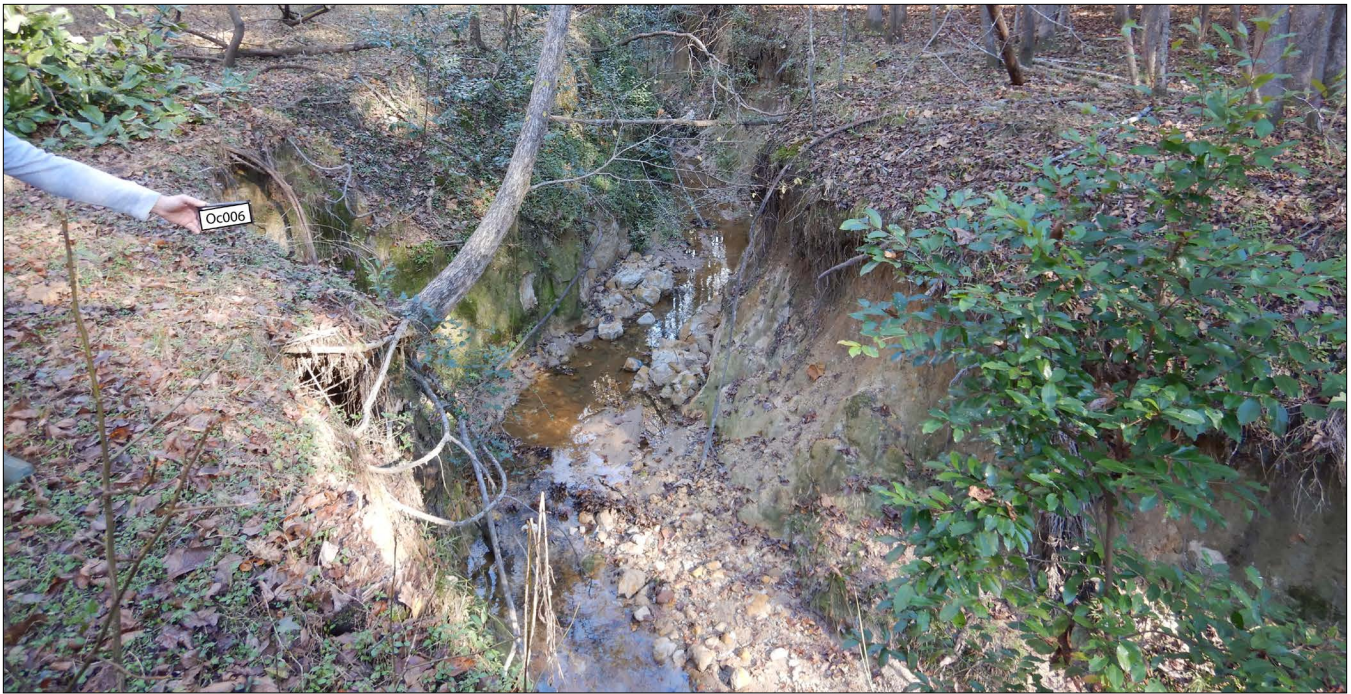
**Park Unit:** OCMU  
**Proposed Site Number:** Oc006  
**Stream Name:** 'Temple Mound Creek' (upstream)  
**Date:** 12.06.2018  
**Time:** 9:56 a.m.  
**Assessed by:** JMM and CSC  
**Accessible:** Yes  
**Gate Key Required:** No  
**Wadeable:** Yes  
**Recommend for Monitoring:** No (Maybe)

**Safety Concerns:** High steep banks, undercut trees.

**Site Summary—** 'Temple Mound Creek' (upstream; unnamed first order) is a small sand and clay-bedded stream with high steep banks. Wetted width was estimated to be approximately 1.5 meters (4.9 feet) and channel-full width around 5 meters (16.4 feet). Water depth was estimated to be approximately 0.05 meters (0.2 feet). Bank heights were approximately 2.8 meters (9.2 feet) high. Initial assessment of the creek classified the segment as extremely entrenched. The banks were mostly bare, with mosses and leaves being the dominant cover where present. Many of the trees that lined the banks were deeply undercut. Large woody debris is present and serving multiple functions such as habitat creation and bank protection. Bank slumping is prevalent and there are a lot of slump blocks on the sides of the channel. Downstream the stream is not as entrenched and a monitoring site could be successfully surveyed.

**Monitoring Recommendation—** This site is not recommended for monitoring due to the dangerous survey conditions. If this portion of 'Temple Mound Creek' is determined to be of management concern, a site could be surveyed in the less entrenched portions of the stream.

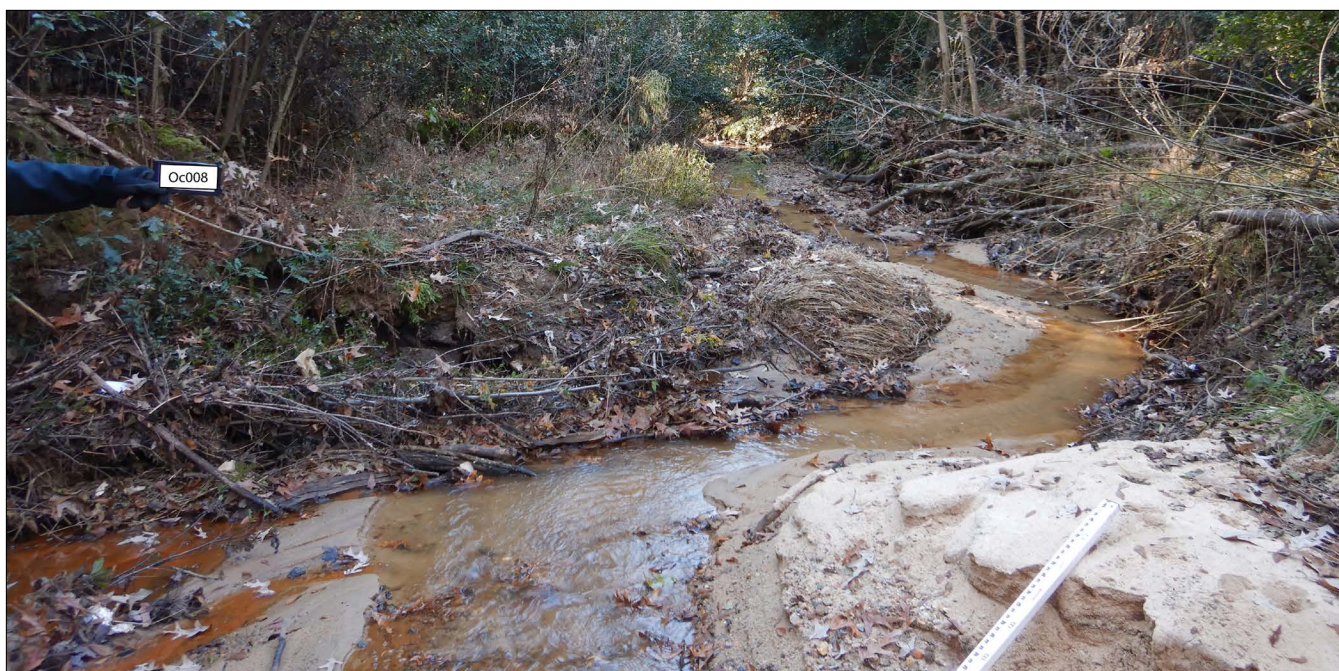
**Park Unit:** OCMU  
**Proposed Site Number:** Oc008  
**Stream Name:** 'Temple Mound Creek' (middle)  
**Date:** 12.06.2018  
**Time:** 9:05 a.m.  
**Assessed by:** JMM and CSC  
**Accessible:** Yes  
**Gate Key Required:** No  
**Wadeable:** Yes  
**Recommend for Monitoring:** Yes

**Management Issues Noted:** Trash in the stream and Chinese Tallow.

**Site Summary—** 'Temple Mound Creek' (middle; unnamed first order) is a small sand-bedded stream with a high frequency of large slumps. Wetted width was estimated to be approximately 1 meter (3.3 feet) and bankfull width around 3 meters (9.8 feet). Water depth was approximately 0.09 meters (0.3 feet). Bank heights were approximately 0.4 meters (1.3 feet) where floodplains were present and around 1.5 meters (4.9 feet) where the stream was cutting into the high terrace. Initial assessment of the creek classified the entrenchment of the segment as moderate. Floodplains have developed in a few areas along the segment. The banks were fairly well vegetated (approximately 50–90%) with grasses and shrubs being the dominant cover where present. Large woody debris is present and serving multiple functions such as habitat creation and bank protection. Though the channel bed is very sandy there is a high proportion of gravel in the point and side bars.

**Monitoring Recommendation—** This site is recommended for monitoring because it is representative of 'Temple Mound Creek' and installation and surveying of the stream will not affect visitor experience. An archaeological survey may be needed prior to installing the survey benchmarks.

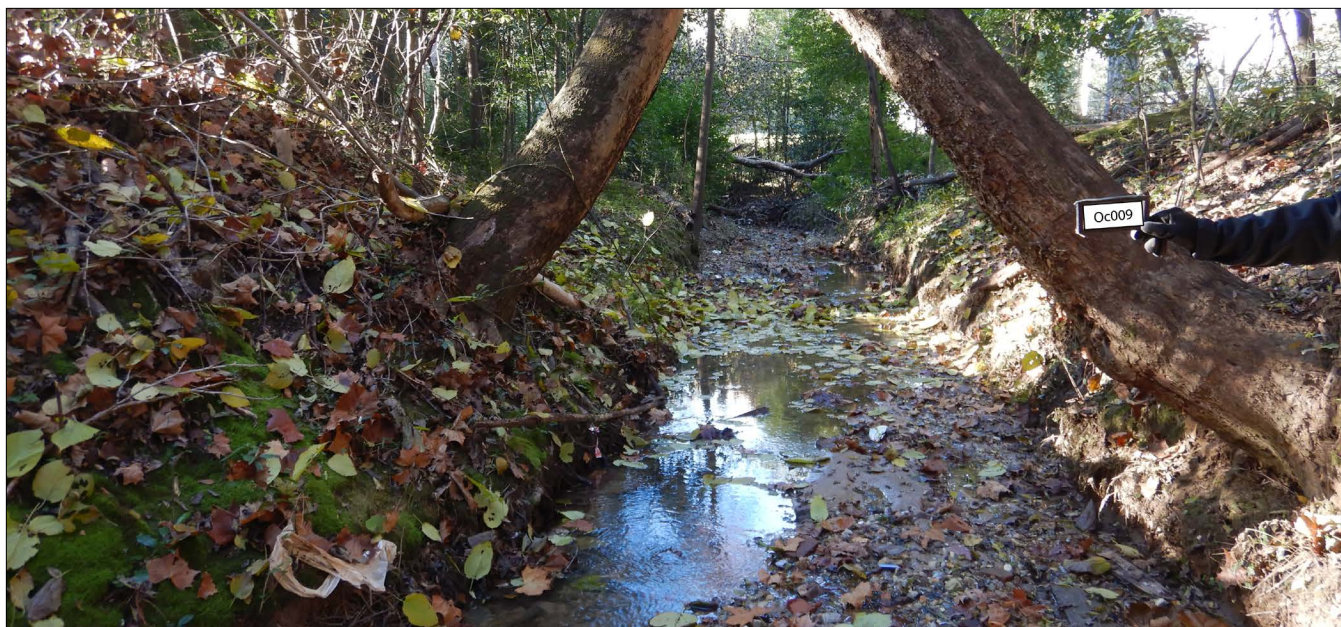
**Management Issues Noted:** Trash in the stream, bamboo growing along the stream.

**Safety Concerns:** High banks.

**Site Summary—** 'Bamboo Creek' (unnamed first order) is a small sand and gravel bedded stream. Wetted width was approximately 1.65 meters (5.4 feet) and channel-full width was around 6 meters (19.7 feet). Water depth was approximately 0.1 meters (0.3 feet). Bank heights were approximately 1.85 meters (6.1 feet) where the stream was cutting into the high terrace. Initial assessment of the creek classified the entrenchment of the segment as high. No floodplains have developed within the entrenched channel. Slumping has created some lower surfaces inset within the higher terrace surface. The banks were sparsely vegetated (approximately 30–60%) with mosses and leaves being the dominant cover where present. Large woody debris is present and serving multiple functions such as habitat creation and bank protection. A small drainage was observed entering the stream on river left. In addition to some coarser pieces of sediment, there were a lot of bricks in the bed of the stream. Bank slumping and undercutting have progressed to the point where there are quite a few trees close to falling into the stream.

**Monitoring Recommendation—** This site is not recommended for monitoring because, due to the steep high walls and undercut trees, it would be difficult to safely survey the stream. Additionally, the high amount of development upstream of the segment likely makes the flow regime very flashy and little to no management can be done within the park that would ameliorate the conditions imposed on this stream.

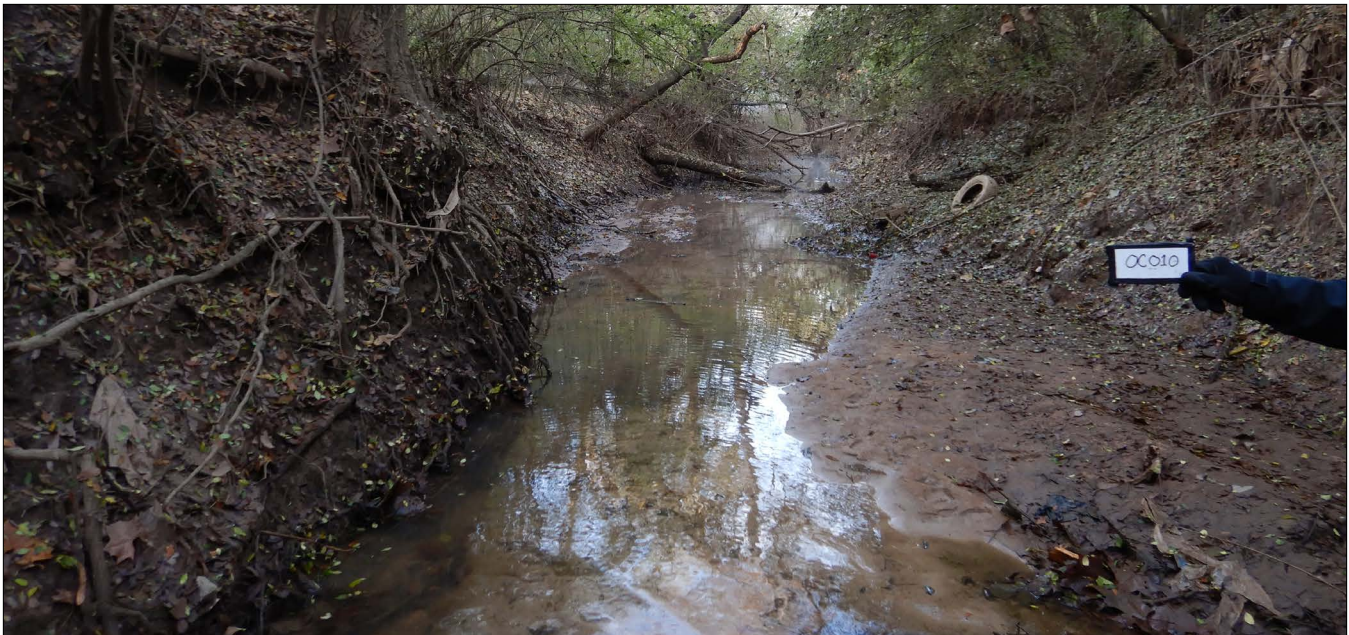
**Park Unit:** OCMU  
**Proposed Site Number:** Oc010  
**Stream Name:** 'Bamboo Creek' (downstream)  
**Date:** 12.06.2018  
**Time:** 8:08 a.m.  
**Assessed by:** JMM and CSC  
**Accessible:** Yes  
**Gate Key Required:** No  
**Wadeable:** Yes  
**Recommend for Monitoring:** No

**Safety Concerns:** High banks and slippery.

**Site Summary—** 'Bamboo Creek' (downstream; unnamed first order) is a smaller sand and fine bedded stream. Wetted width was approximately 1.5 meter (4.9 feet) and bankfull width around 5.25 meters (17.2 feet). Water depth was approximately 0.2 meters (0.7 feet). Bank heights were approximately 2 meters (6.6 feet) where the stream was cutting into the high terrace. Initial assessment of the creek classified the entrenchment of the segment as high. Floodplains have not developed within the segment. Some lower slump surfaces were observed inset within the high terrace. The banks were sparsely vegetated (approximately 10–40%) with mosses and leaves being the dominant cover where present. Large woody debris is present and serving multiple functions such as habitat creation and bank protection. Many of the banks are either undercut or slumping (or both). There is a large drainage canal approximately 5 meters (16.4 feet) upstream of the assessment point. Flood deposits (dusting of fines) and trash were in the trees overhanging the stream (up to 2.5 meters [8.2 feet] high). The downstream culvert may be too small for the stream and may cause the stream to back up which allows the flood deposits to get so high.

**Monitoring Recommendation—** This site is not recommended for monitoring because of the safety concerns associated with surveying a stream with steep high banks. Additionally, the segment is too short (due to the drainage canal and the up- and downstream culverts).

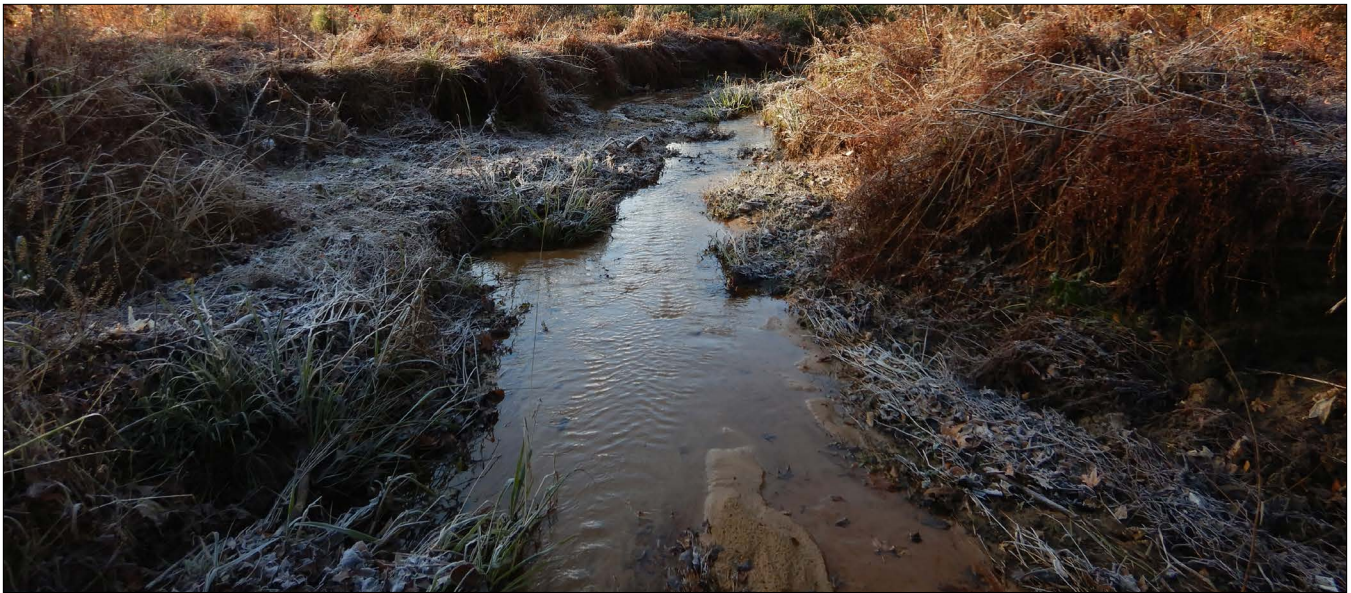
**Park Unit:** OCMU  
**Proposed Site Number:** Oc011  
**Stream Name:** 'Temple Mound Creek' (downstream)  
**Date:** 12.06.2018  
**Time:** 8:44 a.m.  
**Assessed by:** JMM and CSC  
**Accessible:** Yes  
**Gate Key Required:** No  
**Wadeable:** Yes  
**Recommend for Monitoring:** Yes

**Management Issues Noted:** Trash in the stream.

**Site Summary—** 'Temple Mound Creek' (downstream; unnamed first order) is a small sand-bedded stream. The stream is located in the center of a small valley. The segment that was assessed was approximately 25 meters (82 feet) downstream from a pedestrian footbridge. Wetted width was estimated to be approximately 1.25 meters (4.1 feet) and bankfull width around 3 meters (9.8 feet). Water depth was approximately 0.04 meters (0.13 feet). Bank heights were approximately 0.25 meters (0.82 feet) where floodplains were present and around 1 meter (3.3 feet) where the stream was cutting into the higher terrace. Initial assessment of the creek classified the entrenchment of the segment as low. Floodplains have developed on point bars and on slump surfaces throughout the segment. The banks were fairly well vegetated (approximately 50–90%) with grasses being the dominant cover where present. Large woody debris is not observed within the stream and no large trees were within 10 meters (32.8 feet) of either bank. Channel banks were not undercut but slumps and benches were prevalent. Most if not all of the bars were vegetated. Briars were very common on the higher terrace on both sides of the stream.

**Monitoring Recommendation—** This site is recommended for monitoring because it is representative of similar-sized streams in the region and understanding the rates of erosion will help determine rates at which cultural resources may be eroded from the banks. Due to its proximity to the mound sites, an archaeological survey is likely needed prior to installing the survey benchmarks.
